Brocade Fabric OS v6.3.2a

Release Notes v1.0

September 2, 2010

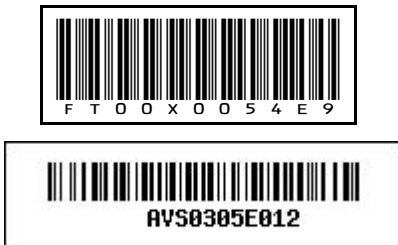
The switch serial number is provided on the serial number label, examples of which are shown here:

The serial number label is located as follows:

- Brocade 4100, 4900, and 7500/7500E — On the switch ID pull-out tab located inside the chassis on the port side on the left
- Brocade Encryption Switch, VA-40FC, 300, 5000, 5100, and 5300 — On the switch ID pull-out tab located on the bottom of the port side of the switch
- Brocade 7600 — On the bottom of the chassis
- Brocade 7800 — On the pull-out tab on the front left side of the chassis underneath the serial console and Ethernet connection and on the bottom of the switch in a well on the left side underneath (looking from front)
- Brocade 8000 — On the switch ID pullout tab located inside the chassis on the port side on the left and also on the bottom of the chassis.
- Brocade 48000 — Inside the chassis next to the power supply bays
- Brocade DCX — Bottom right of the port side
- Brocade DCX-4S — Back, upper left under the power supply
