# Brocade Fabric OS v6.3.2b

## Release Notes v1.0

November 11, 2010

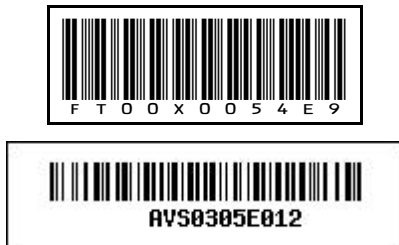
The switch serial number is provided on the serial number label, examples of which are shown here:

The serial number label is located as follows:

- Brocade 4100, 4900, and 7500/7500E — On the switch ID pull-out tab located inside the chassis on the port side on the left
- Brocade Encryption Switch, VA-40FC, 300, 5000, 5100, and 5300 — On the switch ID pull-out tab located on the bottom of the port side of the switch
- Brocade 7600 — On the bottom of the chassis
- Brocade 7800 — On the pull-out tab on the front left side of the chassis underneath the serial console and Ethernet connection and on the bottom of the switch in a well on the left side underneath (looking from front)
- Brocade 8000 — On the switch ID pullout tab located inside the chassis on the port side on the left and also on the bottom of the chassis.
- Brocade 48000 — Inside the chassis next to the power supply bays
- Brocade DCX — Bottom right of the port side
- Brocade DCX-4S — Back, upper left under the power supply
