# Brocade Fabric OS v6.4.1 Release Notes v1.0

October 7<sup>th</sup> , 2010

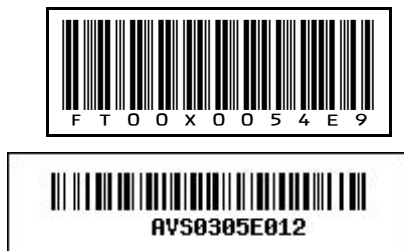
The switch serial number is provided on the serial number label, examples of which are shown here:

The serial number label is located as follows:

- Brocade 4100, 4900, and 7500/7500E — On the switch ID pull-out tab located inside the chassis on the port side on the left
- Brocade Encryption Switch, VA-40FC, 300, 5000, 5100, and 5300 — On the switch ID pull-out tab located on the bottom of the port side of the switch
- Brocade 7600 — On the bottom of the chassis
- Brocade 7800 — On the pull-out tab on the front left side of the chassis underneath the serial console and Ethernet connection and on the bottom of the switch in a well on the left side underneath (looking from front)
- Brocade 8000 — On the switch ID pullout tab located inside the chassis on the port side on the left and also on the bottom of the chassis
- Brocade 48000 — Inside the chassis next to the power supply bays
- Brocade DCX — Bottom right of the port side
- Brocade DCX-4S — Back, upper left under the power supply
