# Brocade Fabric OS v6.4.2a

## Release Notes v3.0

August 19, 2011

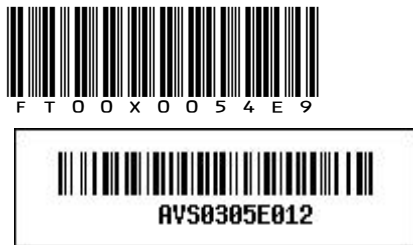
The switch serial number is provided on the serial number label, examples of which are shown here:

The serial number label is located as follows:

- Brocade 4100, 4900, and 7500/7500E — On the switch ID pull-out tab located inside the chassis on the port side on the left
- Brocade Encryption Switch, VA-40FC, 300, 5000, 5100, and 5300 — On the switch ID pull-out tab located on the bottom of the port side of the switch
- Brocade 7600 — On the bottom of the chassis
- Brocade 7800 — On the pull-out tab on the front left side of the chassis underneath the serial console and Ethernet connection and on the bottom of the switch in a well on the left side underneath (looking from front)
- Brocade 8000 — On the switch ID pullout tab located inside the chassis on the port side on the left and also on the bottom of the chassis
- Brocade 48000 — Inside the chassis next to the power supply bays
- Brocade DCX — Bottom right of the port side
- Brocade DCX-4S — Back, upper left under the power supply
