# Brocade Fabric OS v7.0.0a

## Release Notes v3.0

July 22, 2011

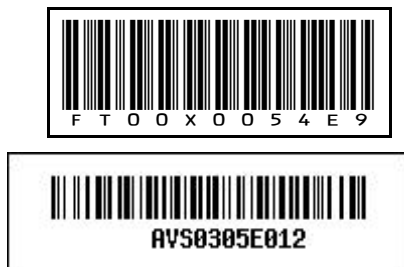
The switch serial number is provided on the serial number label, examples of which are shown here:

The serial number label is located as follows:

- Brocade Encryption Switch, VA-40FC, 300, 5000, 5100, 5300, 6510 — On the switch ID pull-out tab located on the bottom of the port side of the switch
- Brocade 7800 — On the pull-out tab on the front left side of the chassis underneath the serial console and Ethernet connection and on the bottom of the switch in a well on the left side underneath (looking from front)
