# Brocade Fabric OS v7.0.0c Release Notes v1.0

November 18, 2011

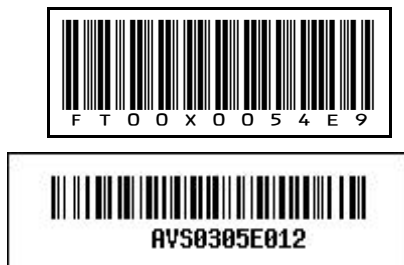
The switch serial number is provided on the serial number label, examples of which are shown here:

The serial number label is located as follows:

- Brocade Encryption Switch, VA-40FC, 300, 5000, 5100, 5300, 6510 — On the switch ID pull-out tab located on the bottom of the port side of the switch
- Brocade 7800 — On the pull-out tab on the front left side of the chassis underneath the serial console and Ethernet connection and on the bottom of the switch in a well on the left side underneath (looking from front)
