# Brocade Fabric OS v7.0.0c

## Release Notes v3.0

December 5, 2011

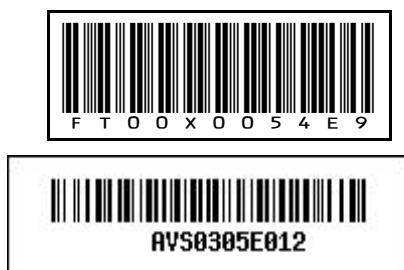
The switch serial number is provided on the serial number label, examples of which are shown here:

The serial number label is located as follows:

- Brocade Encryption Switch, VA-40FC, 300, 5000, 5100, 5300, 6510 — On the switch ID pull-out tab located on the bottom of the port side of the switch
- Brocade 7800 — On the pull-out tab on the front left side of the chassis underneath the serial console and Ethernet connection and on the bottom of the switch in a well on the left side underneath (looking from front)
