Brocade Fabric OS v7.0.1b

Release Notes v1.0

May 16, 2012

Fabric OS (FOS) v7.0.1b is a patch release based on FOS v7.0.1a. All hardware platforms and features supported in FOS v7.0.1a are also supported in FOS v7.0.1b.

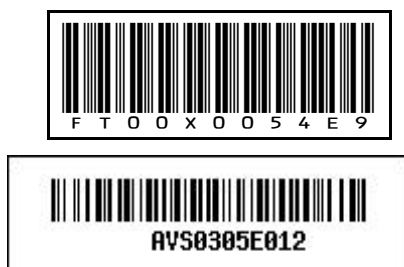
The switch serial number is provided on the serial number label, examples of which are shown here:

The serial number label is located as follows:

- Brocade Encryption Switch, VA-40FC, 300, 5100, 5300, 6510, 6505 — On the switch ID pull-out tab located on the bottom of the port side of the switch
