# Preface

The *Cisco VCO/4K Troubleshooting Guide* provides information that will enable you to properly diagnose and resolve many of the problems that you may encounter with the VCO/4K system. Problems that cannot be resolved with the information in this guide must be elevated to a Cisco TAC (Cisco Technical Assistance Center). Procedures to ensure accuracy and timeliness of your input are also contained in this guide.

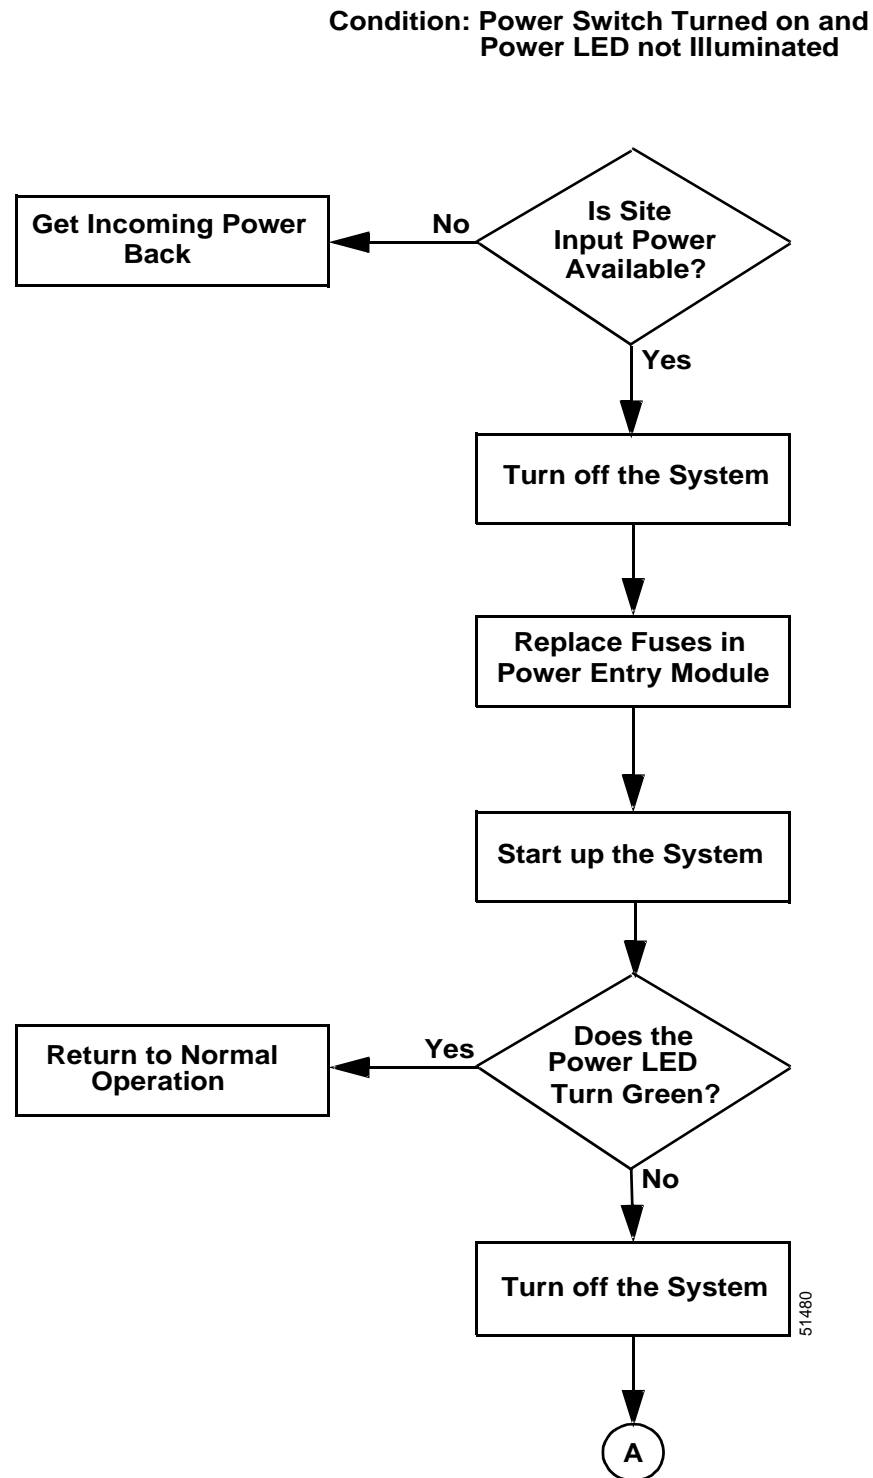
*Figure 4-11 Troubleshooting the VCO/4K Power Subsystem*

Figure 4-11 Troubleshooting the VCO/4K Power Subsystem (continued)

*Figure 4-11 Troubleshooting the VCO/4K Power Subsystem (continued)*

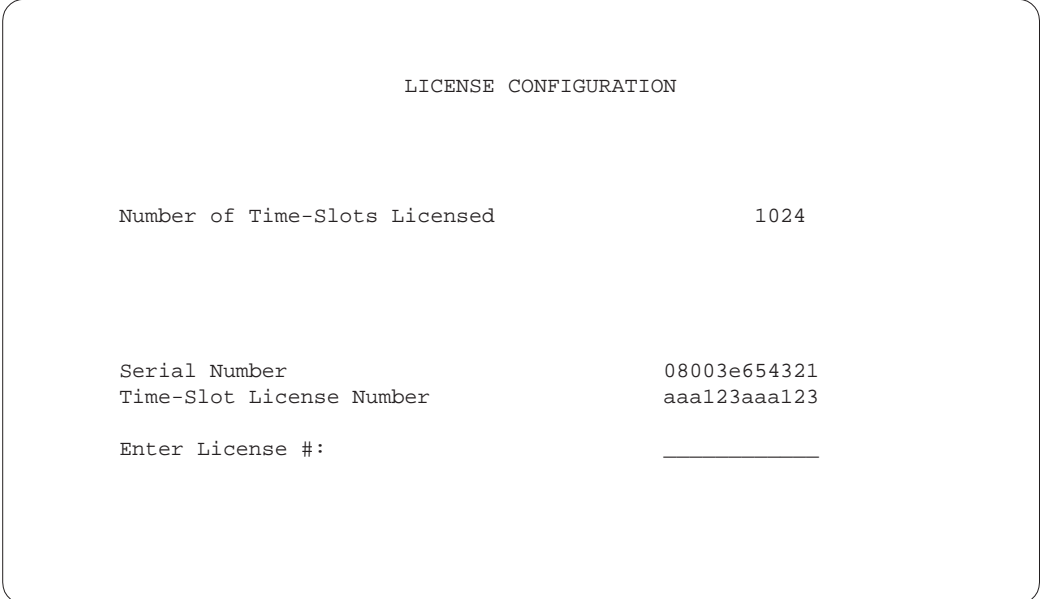
*Figure C-3 License Configuration Screen, 1024 Time Slots*

**Step 2** Type **6** and press **Return** to get to the License Configuration screen (see Figure C-3).

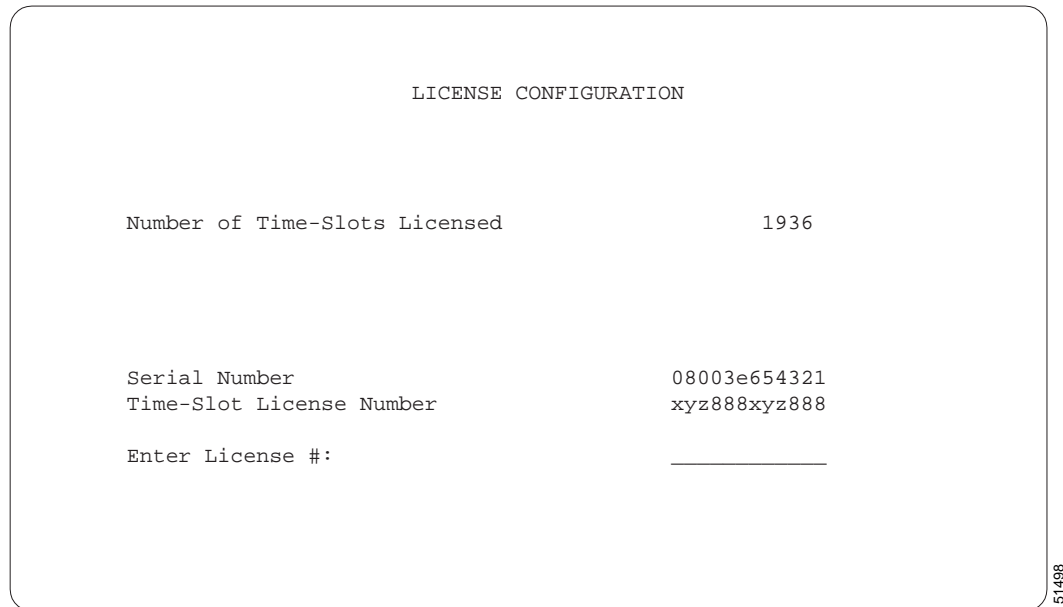
**Figure C-4 License Configuration Screen, 1936 Time Slots**

If you entered a license number for 3960 time slots (the email from Cisco TAC would say that this is a license number for 4088 time slots), then you would see the output shown in Figure C-4.
