Release Notes:

Version K.14.47 Software

for the HP ProCurve Series 3500, 3500yl, 5400zl, 6200yl, 6600, and 8200zl Switches

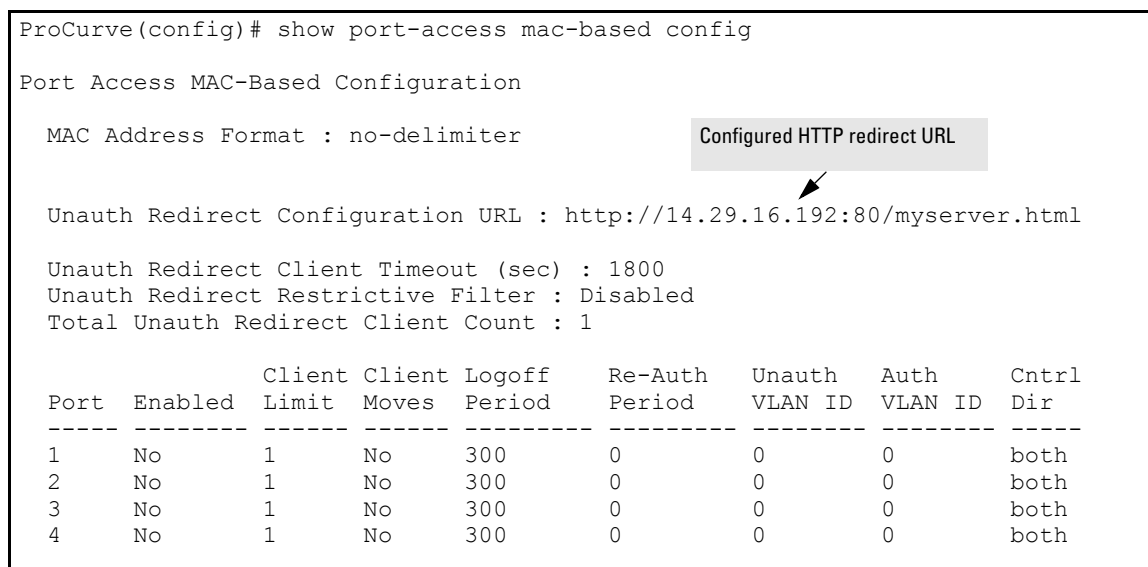
Figure 10. Example of HTTP Redirect Configuration

Figure 10 is an example of the **show** command that displays the HTTP redirect configuration.

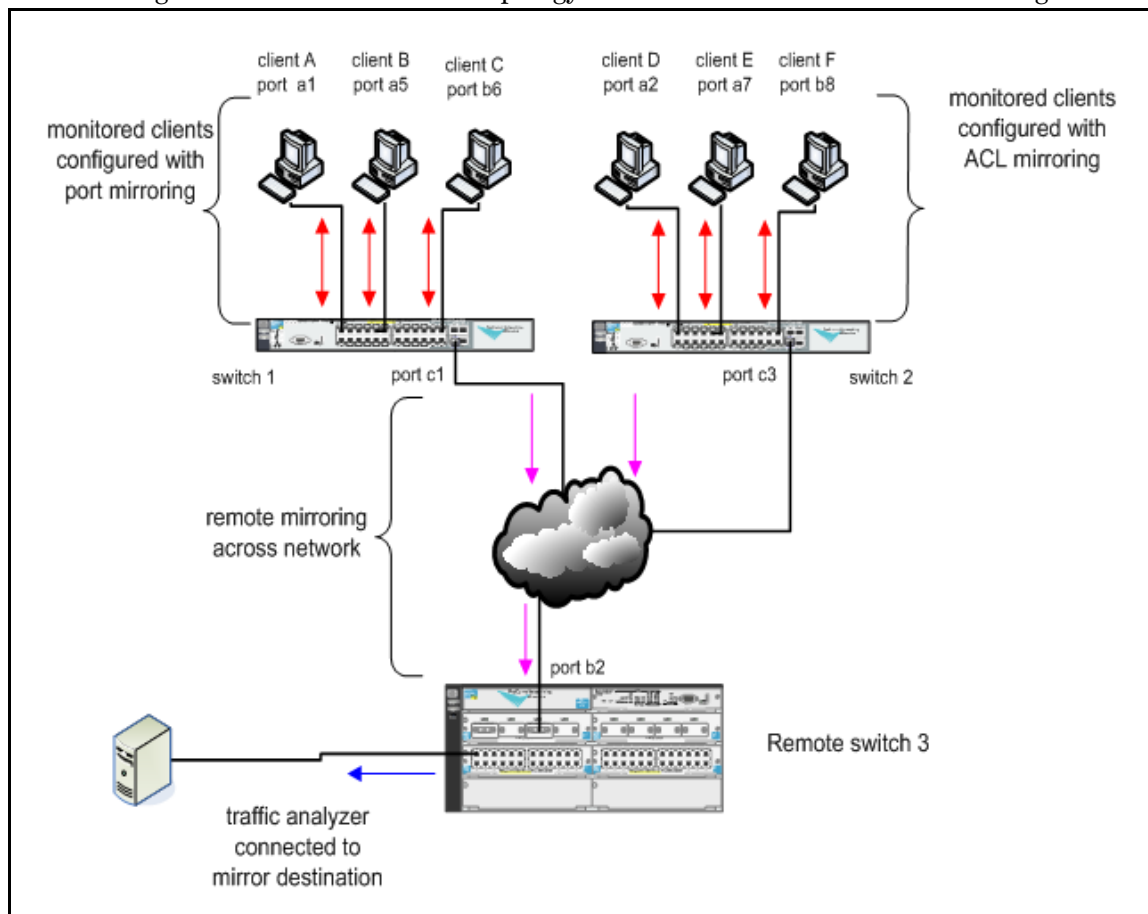
Figure 54. Example of Remote Mirroring

The following illustration shows a basic topology that could be used for remote mirroring.

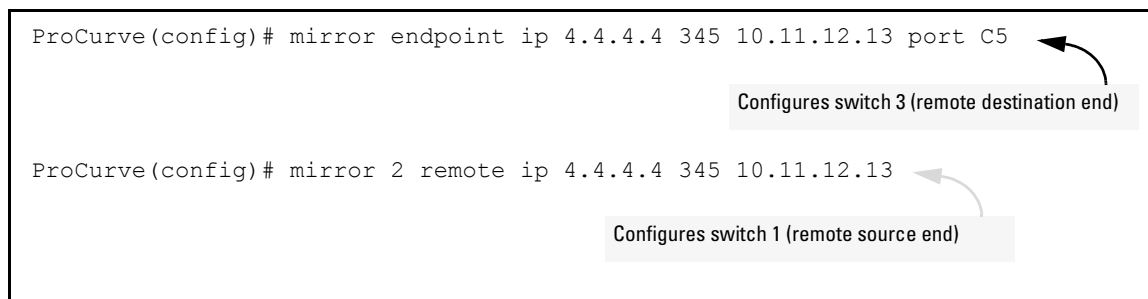
Figure 56. Example of Configuring a Loopback IP Address for the Source IP Address

To configure switch 1 to encapsulate the traffic from mirror session 2 with a loopback address of 4.4.4.4, a source UDP port of 345, and a destination IP address of 10.11.12.13, enter the following commands:

- Loopback address 4.4.4.4 is configured on switch 1
- Switch 3, port B2 has an IP address of 10.11.12.13

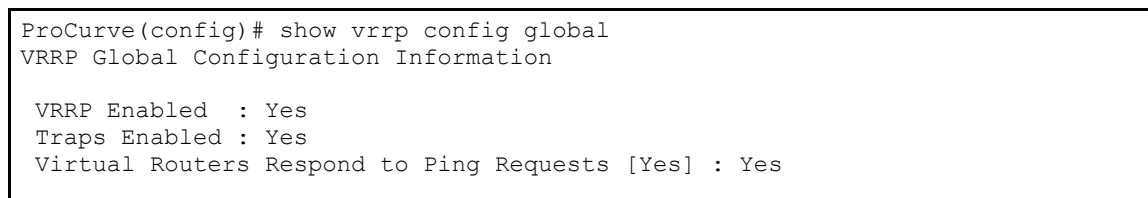
Figure 77. Example of VRRP Global Configuration Information

Display global VRRP configuration information by entering the **show vrrp config global** command.
