# HPE 5130HI-CMW710-R3507P18-US Release Notes

The information in this document is subject to change without notice.  
© Copyright 2015, 2022 Hewlett Packard Enterprise Development LP

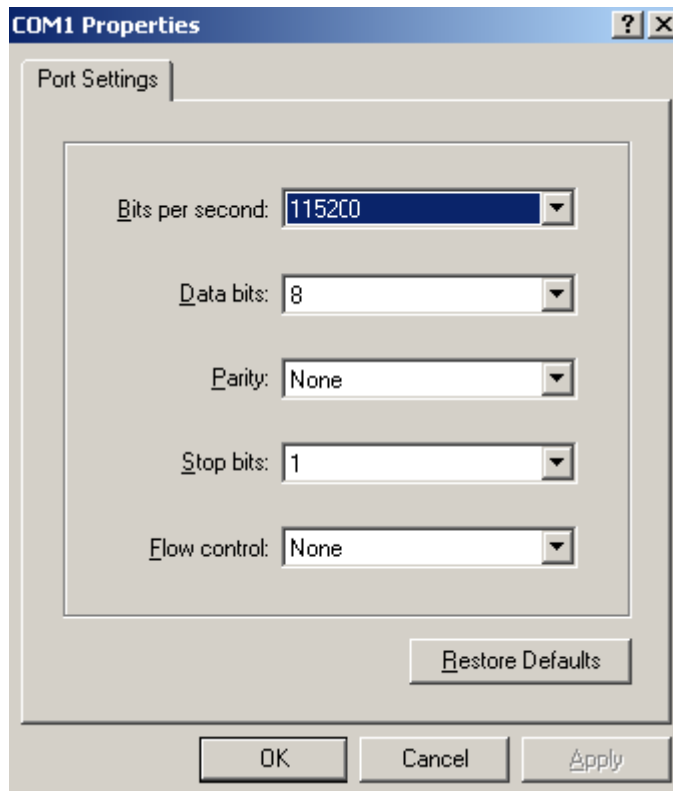
**Figure 4 Modifying the baud rate**

- c. Select 115200 from the Bits per second list and click OK.
