MICRO-FC SECTION

MICRO-FC

Two types of MICRO-FCs are provided with micro-program exchange and on-line patch. Micro-program exchange is explained in chapter 1 to 5, and on-line patch in chapter 6.

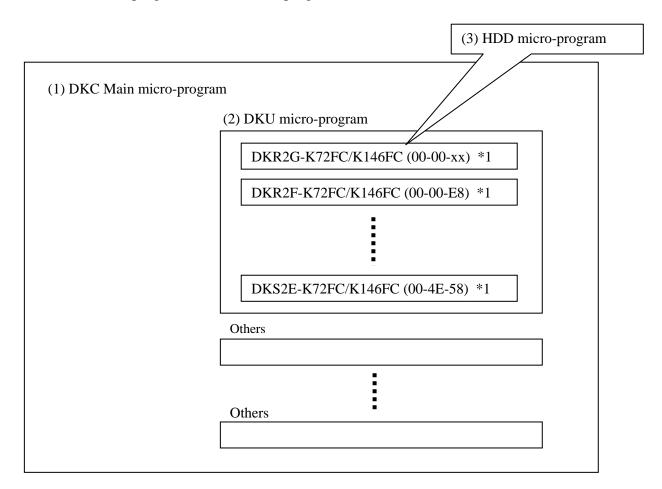
(1) DKC Main micro-program: Micro-program for DKC

(2) DKU micro-program : Group of HDD micro-programs(3) HDD micro-program : Micro-program for each HDD model

- (1) DKC Main micro-program combines DKU micro-program.
- (2) DKU micro-program consists of plural HDD micro-programs.
- (3) HDD micro-program defined as the micro-program for each HDD model.
- *1: HDD Model name and Version is an example

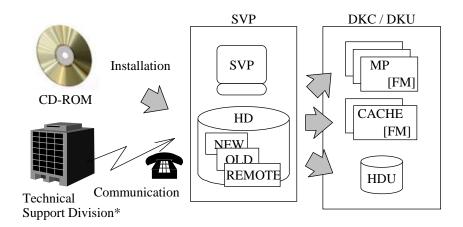
1.2 Micro-program Exchange Flow

The SVP keeps two generations (new and old versions) of micro-programs.

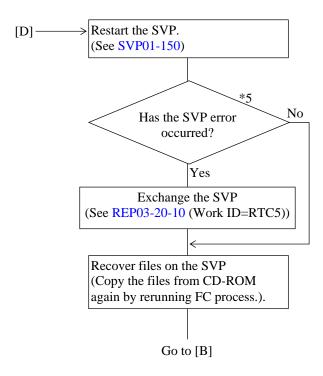
[Recovery Procedure for I/O Error on SVP Hard Disk]

*1: Reference code "7900XY" or "7901XY"

XY: Shows processor id. (See SIMRC02-540)

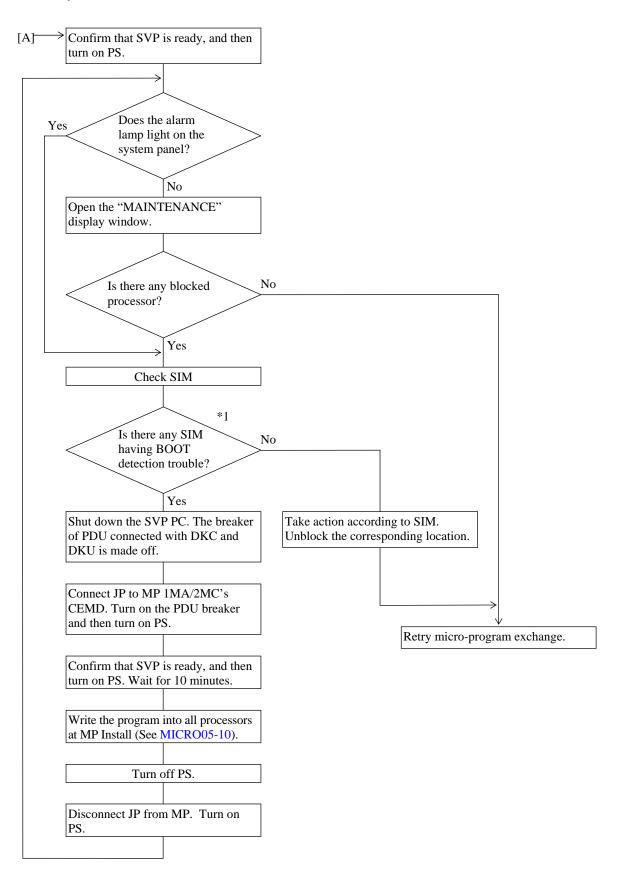
[Recovery Procedure for Power Failure]

If trouble occurs while the micro-programs are being exchanged, symptoms (1) to (5) below can be observed apparently. In these cases, use the recovery procedures shown in flowcharts [A] to [F].

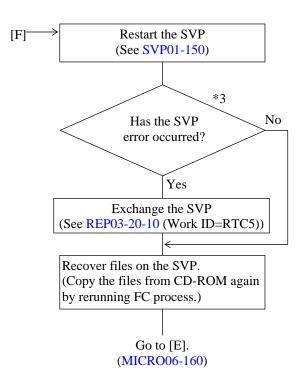
[Recovery Procedure for I/O Error on SVP Hard Disk]

*1: Reference code "7900XY" or "7901XY"

XY: Shows processor id. (See SIMRC02-540)

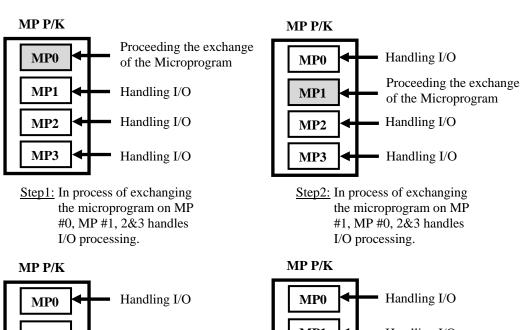
One microprocessor; MP proceeds the exchange of the microprogram and the other 3MPs handle I/O in each MP P/K. DKC make possible to exchange the microprogram without stopping host I/O by repeating this process sequentially for 4MPs.

Step3: In process of exchanging the microprogram on MP #2, MP #0, 1&3 handles I/O processing.

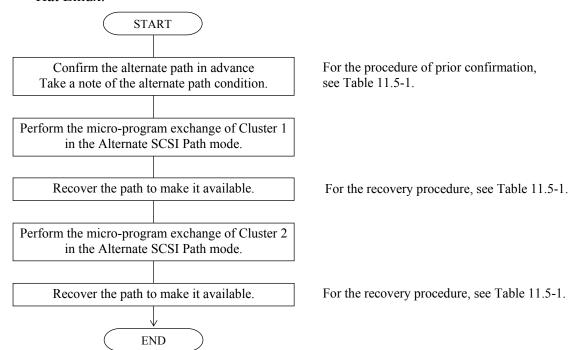
(1) Procedure of the FOEF micro-program exchange for HP-UX, Solaris, AIX, Windows, and Red Hat Linux.
