MICRO-FC SECTION

Contents

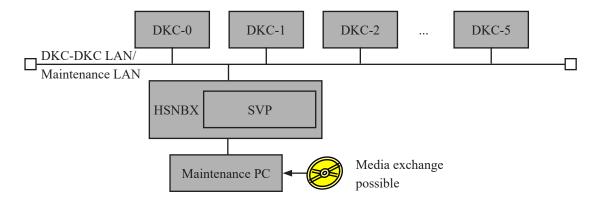
Figure 1-1 System Diagram

Read each micro-program data from the media inserted into the Maintenance PC drive.

The SVP contains up to two generations of media data, and its temporary area is used for executing the micro-program exchange. The micro-program exchange uses up to 2 GB of SVP capacity.

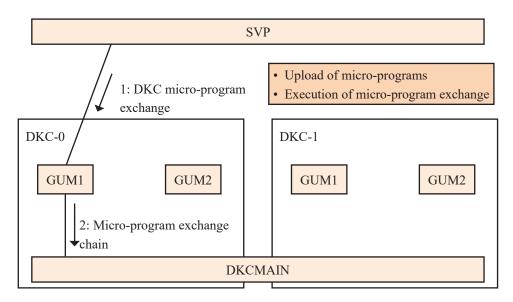
• Exchange process outline of DKC micro-programs other than GUM micro-program

SVP keeps two generations (NEW and OLD version) of the micro-programs.

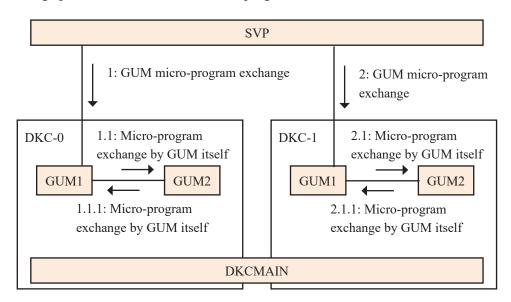
• Exchange process outline of GUM micro-program

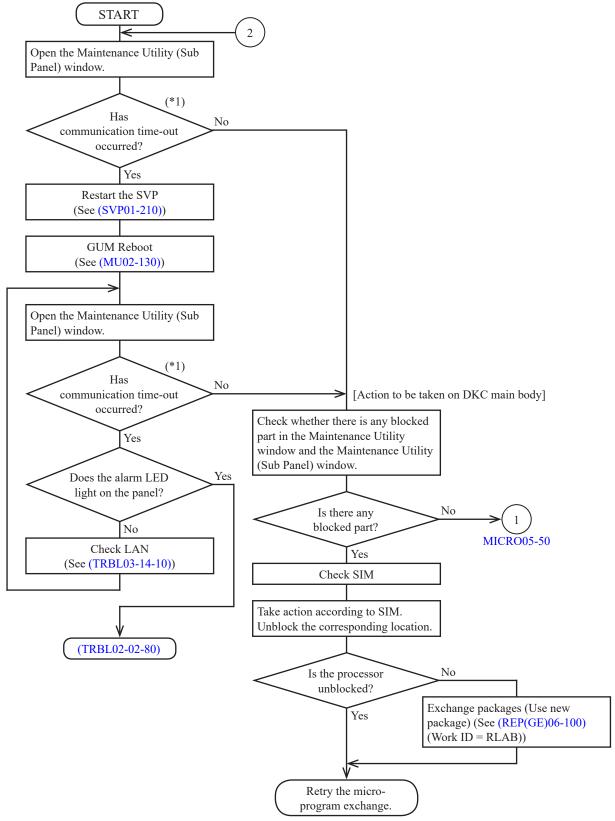
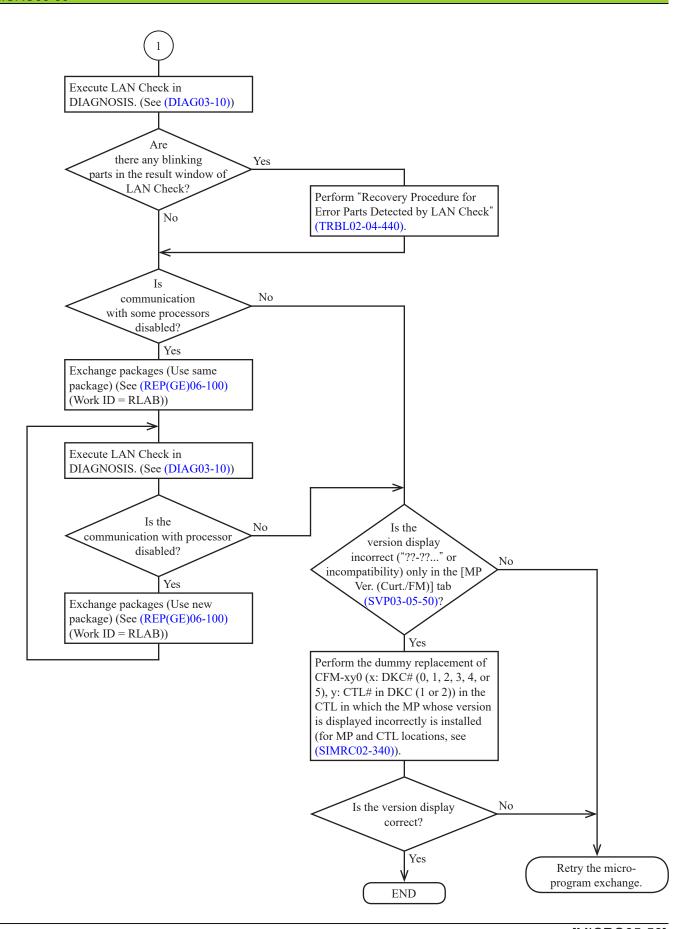
[Recovery Procedure for Communication Time-out/PC Trouble in Downloading Micro-program /Version incompatibility]

*1: The message "communication error occurred SVP-DKC" is displayed.

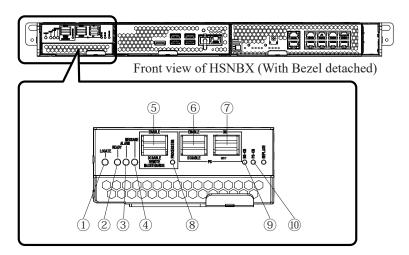
Table 5-1 Switch and LEDs of HSNPANEL

- 1. Perform non-volatile PS off for the storage system. ("Non volatilization power-off and restarting procedure" (TRBL08-20))
- 2. While holding the PS SW ENABLE switch (⑤) on the HSNPANEL in the ENABLE position, turn on the PS ON/PS OFF switch (⑦) and confirm that the PS ON LED (⑥) turns green. (LOC03-10)
