EXTERNAL STORAGE MAINTENANCE SECTION

DKC615I Copyright © 2007, 2011, Hitachi, Ltd.

1. Outline

The following is a collection of matters to be given considerations when doing maintenance works or failure recovery actions for the external storage connected by means of the Universal Volume Manager function.

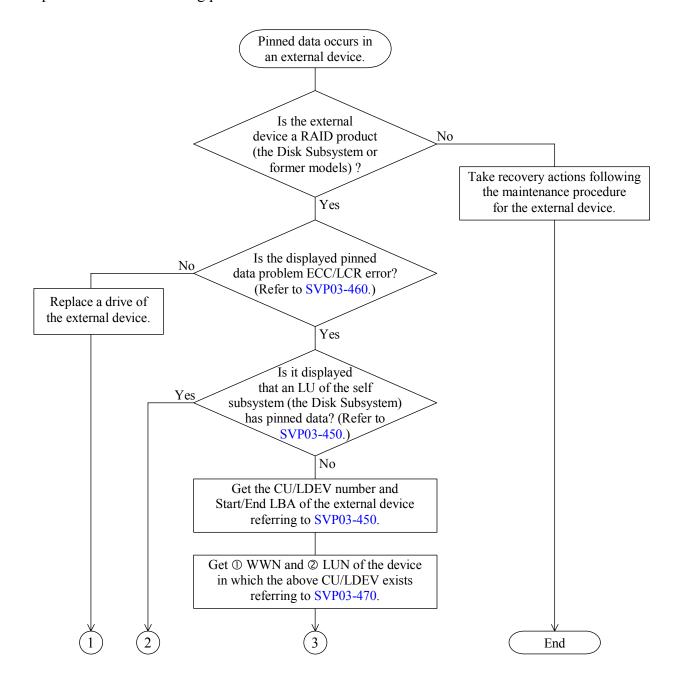
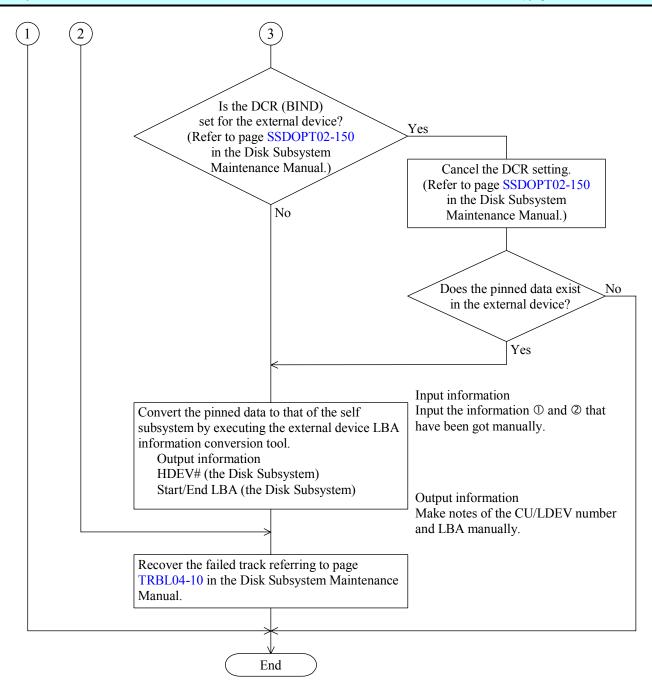
3. Procedure for Eliminating Pinned Data in External Storage

A procedure for eliminating pinned data when it occurs in an external device is shown below.

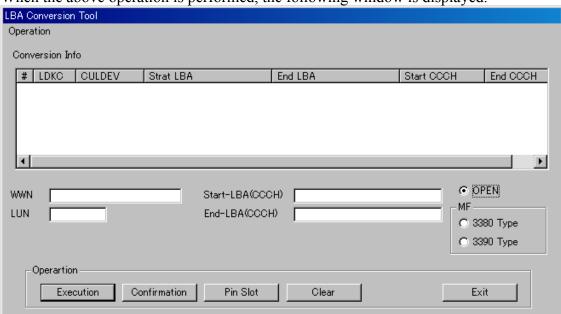
1. <Procedure for starting the tool> Select (CL) [Run...] from the [Start] menu. Enter "C:\DKC200\mp\pc\LbaCon.exe" and select (CL) the [OK] button.

When the above operation is performed, the following window is displayed.

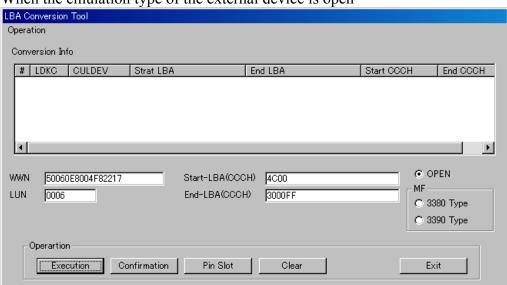
When the emulation type of the external device is open

Enter the WWN, LUN, and Start and End LBA (CCCH, in the case of the MF type device) of the external device and select (CL) the emulation type (open, 3380, or 3390) of the device whose LBA you want to convert using the radio button.

Note: (1) The maximum number of figures of the Start/End LBA is 16.

- (2) As to the Start/End CCCH, enter H as the lower one figure and CCC as the upper figures.
- (3) If you make a wrong selection of the emulation type (open, 3398, or 3390), you cannot get correct information.

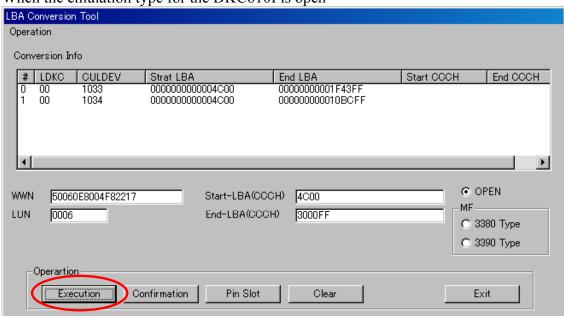
When the emulation type for the DKC610I is open

When you press the [Execution] button after making sure that the information you have entered is correct, the converted LDKC#, CULDEV#, start LBA (CCCH), and end LBA (CCCH) for the DKC610I is displayed in the Conversion Info list.

Note: When two or more LDEVs extend over the range of the specified LBA (CCCH), information on all the LDEVs concerned is displayed.

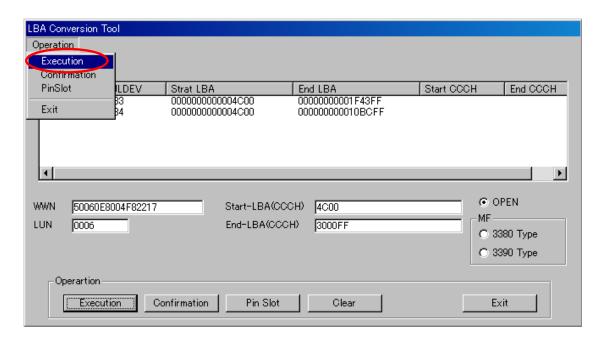
You can also execute the conversion by selecting the [Execution] button from the [Operation] menu bar.

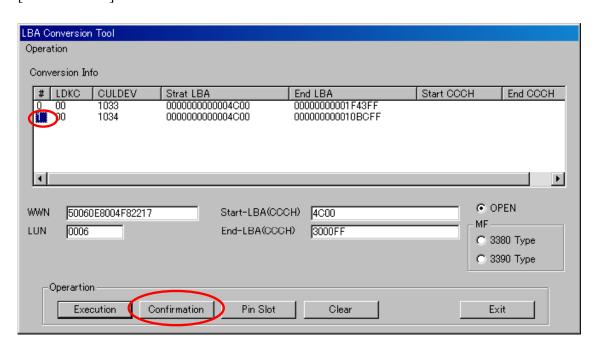
<Verifying the converted information> Select (CL) an item number of the converted information (in the "#" column) and press the [Confirmation] button.

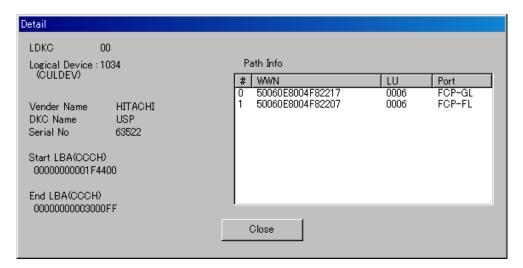
When the process is completed, the LDKC number and the CULDEV number for the DKC610I, the Start and End LBA (CCCH, in the case of the MF type) for the external device, and the Vender Name, DKC Name, Serial No, and path information of the external device are displayed.

Note: Up to eight (the maximum number of paths) pieces of path information are displayed.

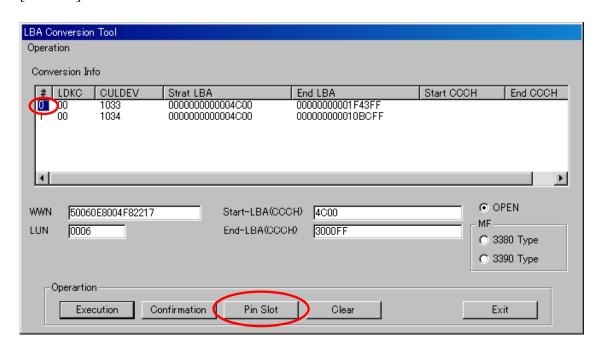
<Displaying the Pin Slot> Select (CL) an item number of the converted information (in the "#" column) and press the [Pin Slot] button.

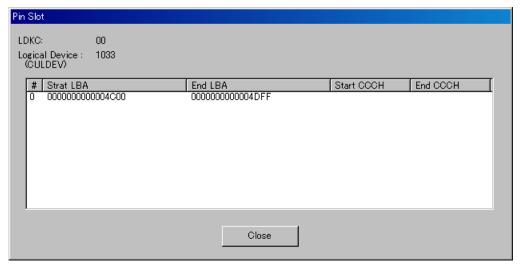
When the process is completed, the Start and End LBA (CCCH) of the slot concerning the converted LBA are displayed. (Display of the Start/End LBA (CCCH) in the case where the Pin Erasure Tool is used: The display is done for each slot.)

Note: • Up to 128 pieces of information can be displayed.

• When the terminal slot is displayed, it may be displayed as smaller than one slot size.

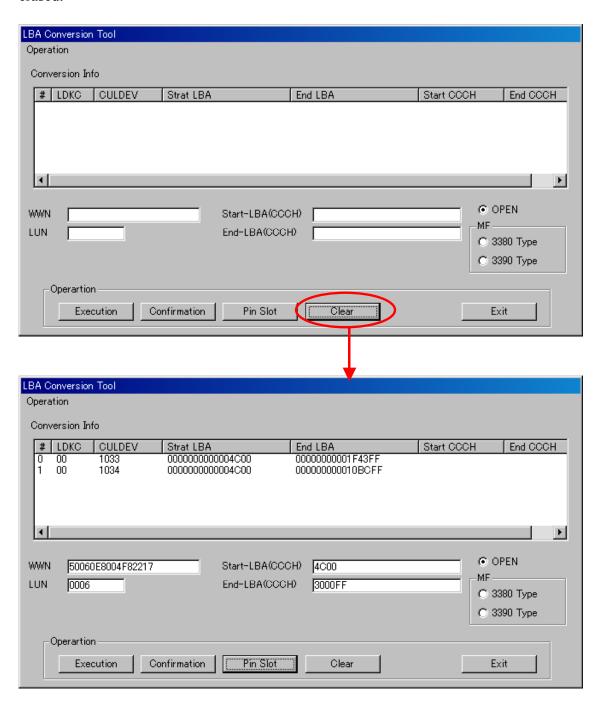
6. <Procedure for erasing information displayed in the main window> When you press the [Clear] button in the main window, information displayed in the window is erased.

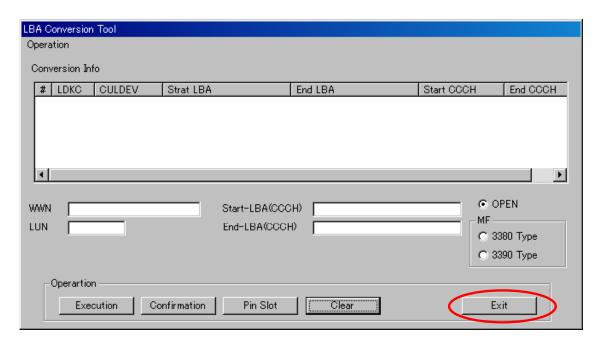
7. <Procedure for quitting the tool>
To quit the tool, press the [Exit] button in the main window.
