# **Trouble Management of Nokia UltraSite EDGE BTS SW CX5 CD3.0**

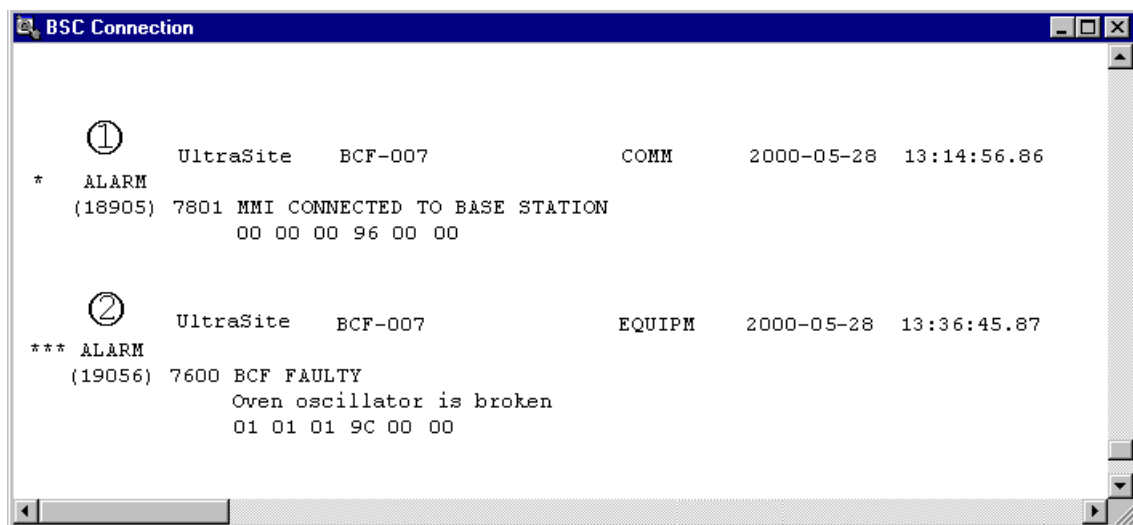
Nokia UltraSite EDGE Base Station alarms issued at the BSC or NMS/ NetAct have a four-digit alarm number and an alarm name, and an optional fault reason (see the figure below). For other fields in the below figure, please refer to BSC documentation.

Figure 1. Examples of active alarms as seen at the BSC

The text under the alarm name gives the fault reason that has caused the alarm, for example see 2. in the figure above: Oven oscillator is broken.

4. If the fault reason cannot be found in the *Fault reason* field, follow the instructions given for *Other faults*.
5. If there is no fault reason text with the alarm (see 1. in Figure 'Examples of active alarms as seen at the BSC'), refer to the correct alarm description table and follow the possible instructions given in the *Instruction* field.

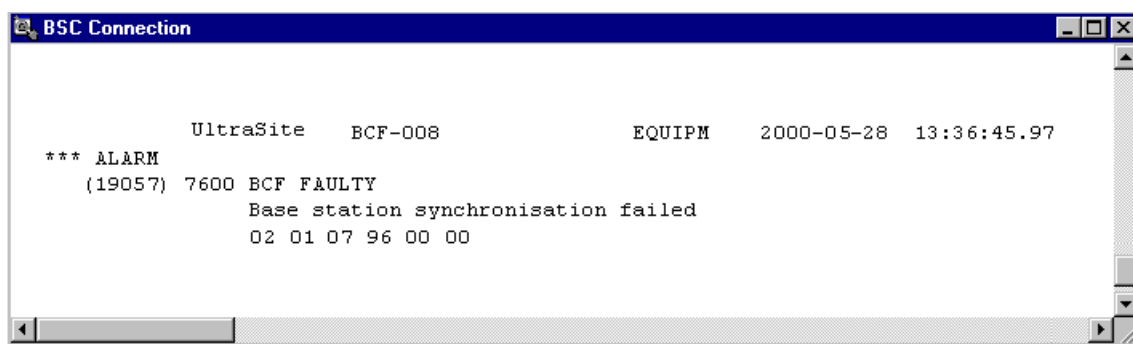
The fault reason 2. displayed in the above figure is different from what is displayed in the figure below, although the alarm number remains the same. Different faults may have the same effect on the operation of a base station object, therefore they have the same alarm number and name. The fault reason specifies the fault and helps in troubleshooting.

Figure 2. Example of an active alarm as seen at the BSC

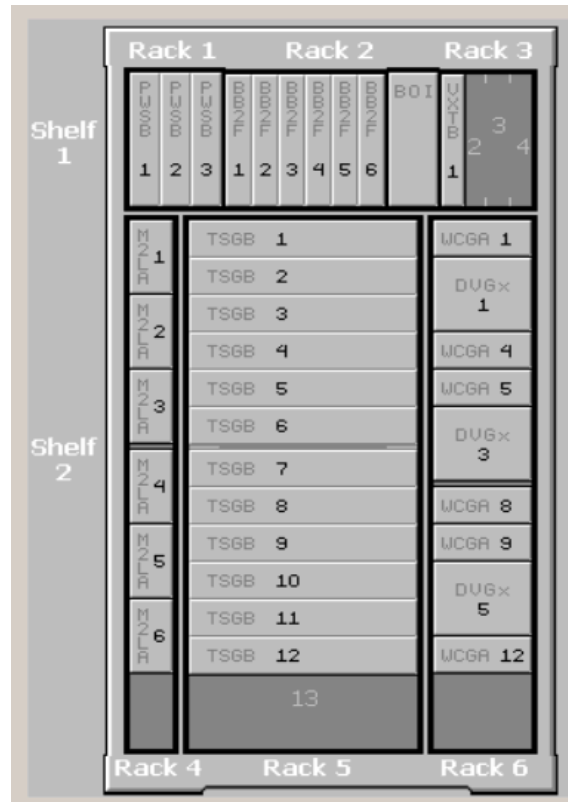
Unit location numbers are used in alarm information to locate a failed unit. The main principle for numbering locations is from top to bottom and from left to right (see the figure below). Location numbers are defined with the following parameters:

RACK	specifies the rack of the cabinet
SHELF	specifies the shelf in the cabinet
SLOT	specifies the location on the shelf

Figure 3. Rack, shelf, and slot information in UltraSite EDGE BTS

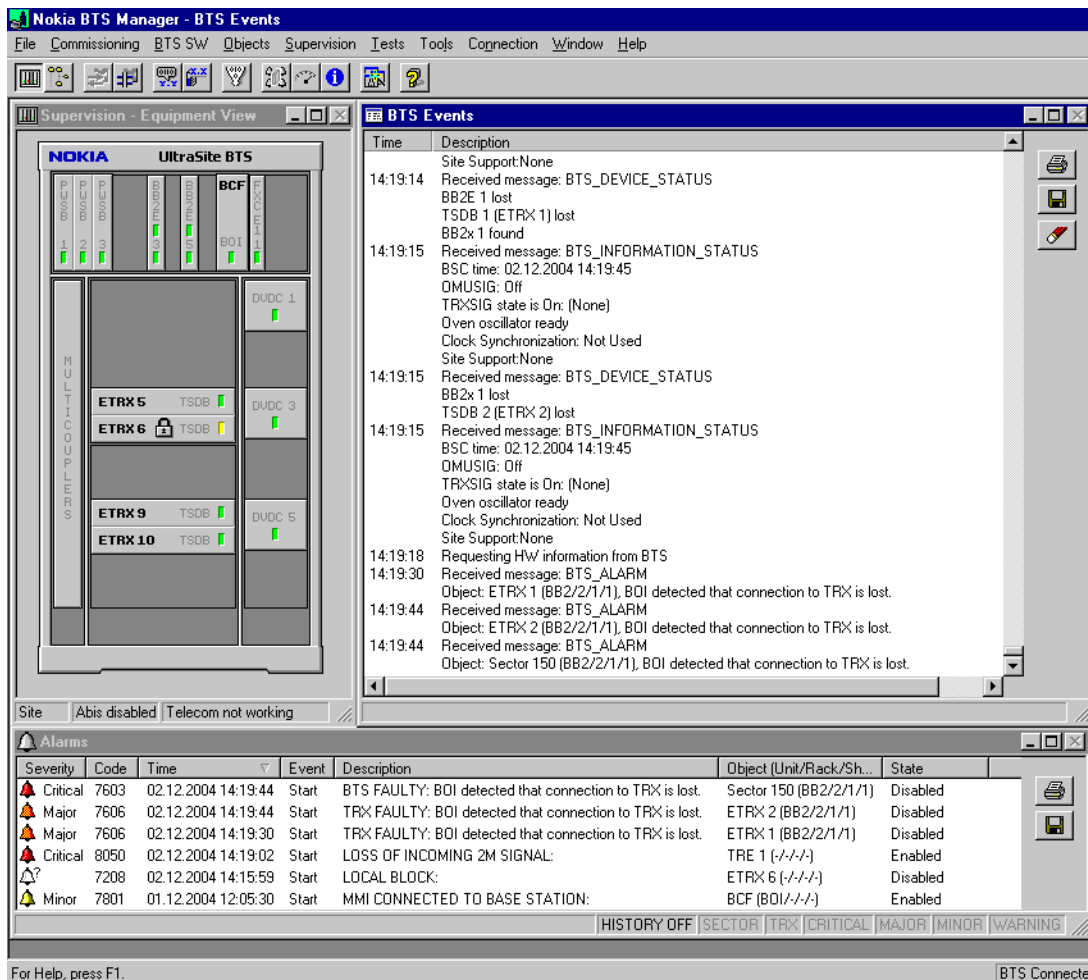
The figure below shows how alarms (number, name, and fault reason) are seen in the Alarms window on Nokia BTS Manager desktop. See for example BB2's location (location number 2/1/1) in rack 2, shelf 1, slot 1.

Figure 4. Nokia BTS Manager desktop showing the alarms in the Alarms window

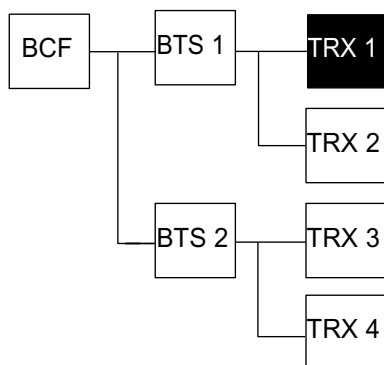
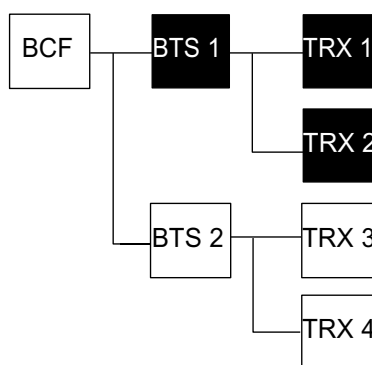
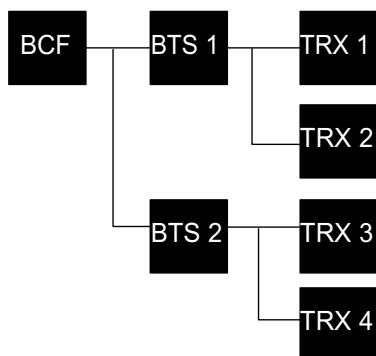
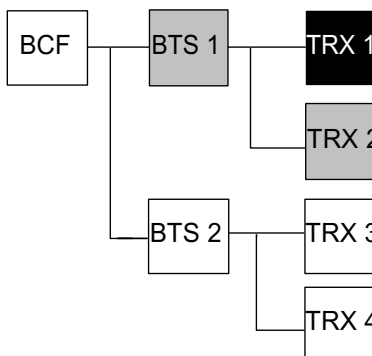
① Alarm Output:

7606 TRX FAULTY (TRX 1)

② Alarm Output, in this order:

7606 TRX FAULTY (TRX 1)  
7606 TRX FAULTY (TRX 2)  
7603 BTS FAULTY (BTS 1)

③ Alarm Output, in this order:

7606 TRX FAULTY (TRX 1)  
7606 TRX FAULTY (TRX 2)  
7603 BTS FAULTY (BTS 1)  
7606 TRX FAULTY (TRX 3)  
7606 TRX FAULTY (TRX 4)  
7600 BCF FAULTY (BCF)

④ Alarm Output, in this order:

7606 TRX FAULTY (TRX 1)  
7607 TRX DEGRADED (TRX 2)  
7604 BTS OPERATION DEGRADED (BTS 1)

- Functioning object
- Degraded object
- Faulty object

Figure 5. Faulty and degraded object alarm reclassification

1. TRX 1 becomes faulty and ceases to operate. 7606 TRX FAULTY alarm is issued.
2. TRX 2 becomes faulty and ceases to operate. 7606 TRX FAULTY alarm is issued.
3. Now both TRXs are not operating, which causes BTS 1 cease to operate. A BTS alarm, 7603 BTS FAULTY, is issued.

1. TRX 1 becomes faulty and ceases to operate. 7606 TRX FAULTY alarm is issued.
2. TRX 2 becomes faulty and ceases to operate. 7606 TRX FAULTY alarm is issued.
3. Now both TRXs are not operating, which causes BTS 1 cease to operate. A BTS alarm, 7603 BTS FAULTY, is issued.
4. TRX 3 becomes faulty, and another 7606 TRX FAULTY alarm is issued.
5. TRX 4 becomes faulty, and another 7606 TRX FAULTY alarm is issued. BTS 2 ceases to operate.
6. Now both sectors in the BCF are not operating, and a BCF alarm, 7600 BCF FAULTY, is issued.

1. TRX 1 becomes faulty and ceases to operate. 7606 TRX FAULTY alarm is issued.
2. TRX 2 becomes partially faulty but calls are getting through. 7607 TRX DEGRADED alarm is issued.
3. Now the sector is partially faulty, and a BTS alarm, 7604 BTS OPERATION DEGRADED, is issued.

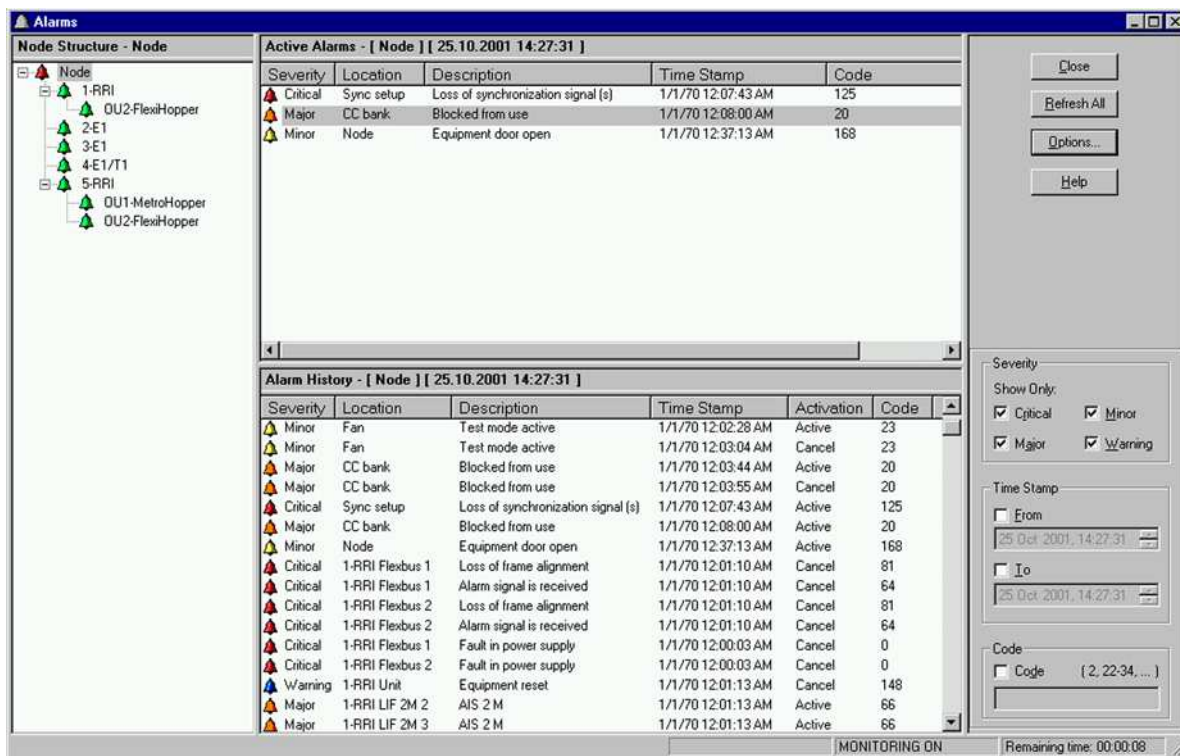
- **Severity** - severity class of the alarm
- **Location** - unit the alarm is located in
- **Description** - brief description of the alarm
- **Time stamp** - date and time when the alarm was detected
- **Code** - fault code of the alarm
- **Activation** (in the alarm history view) – indicates if an alarm is active or cancelled

Figure 6. Alarms window

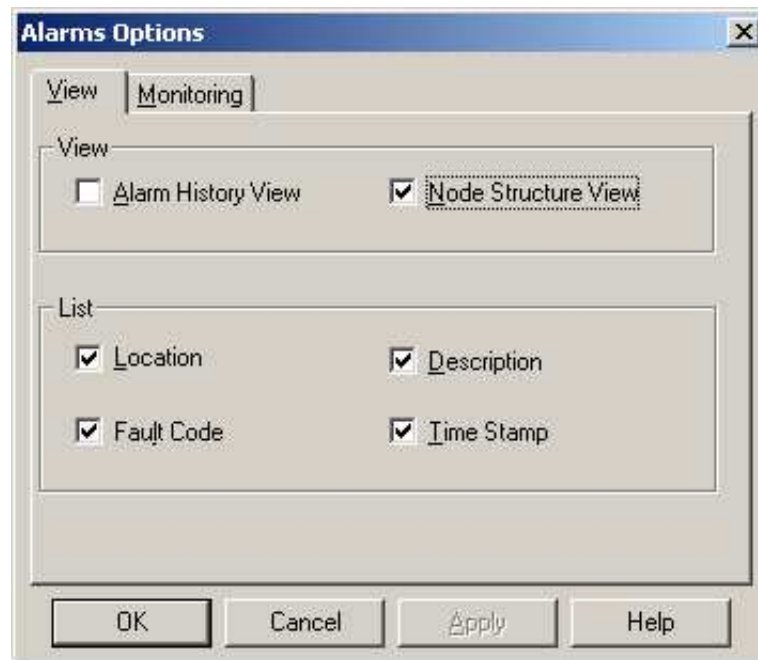
Figure 7. Alarm Options window, View tab

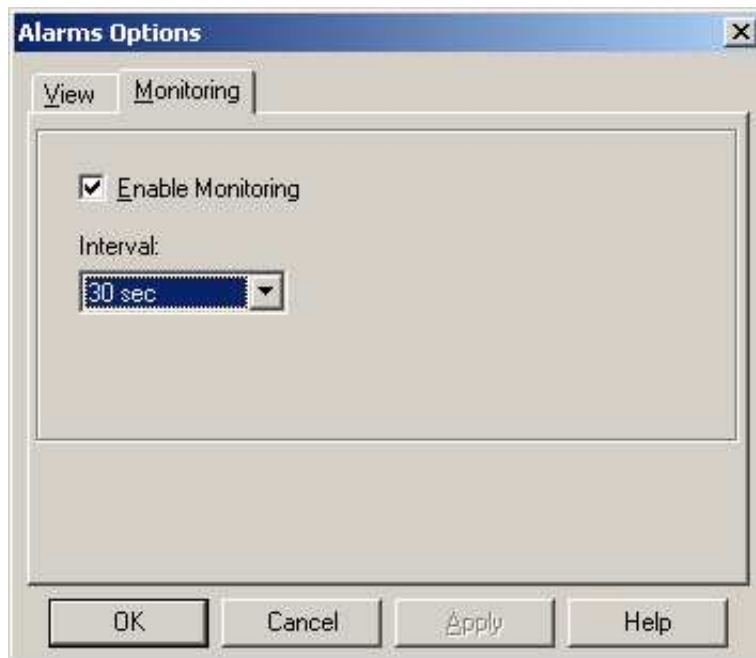
Figure 8. Alarm Options window, Monitoring tab

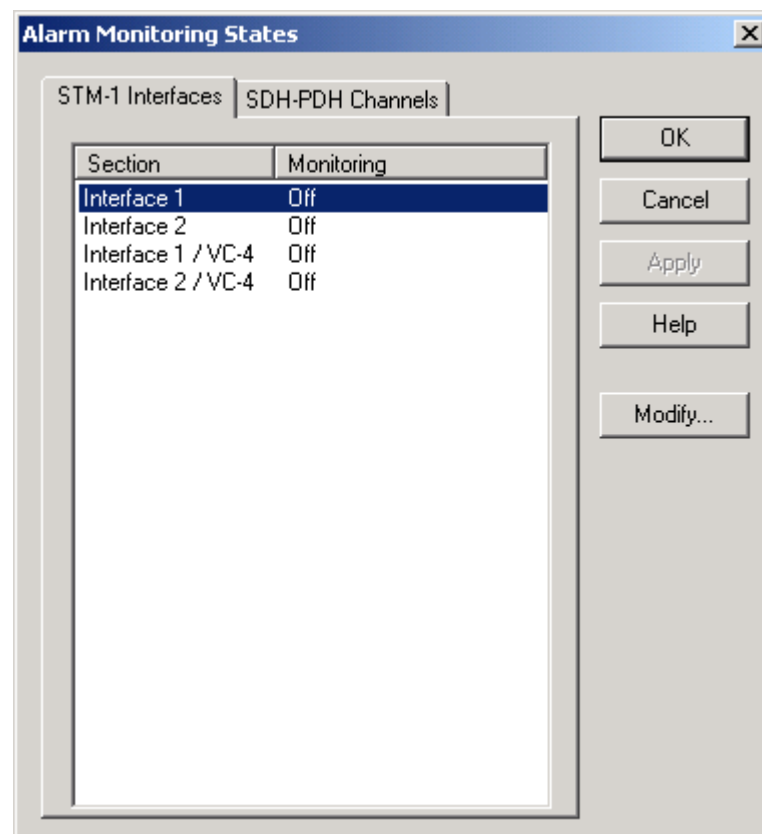
Figure 9. FXC STM-1 Alarm Monitoring States, STM-1 Interfaces

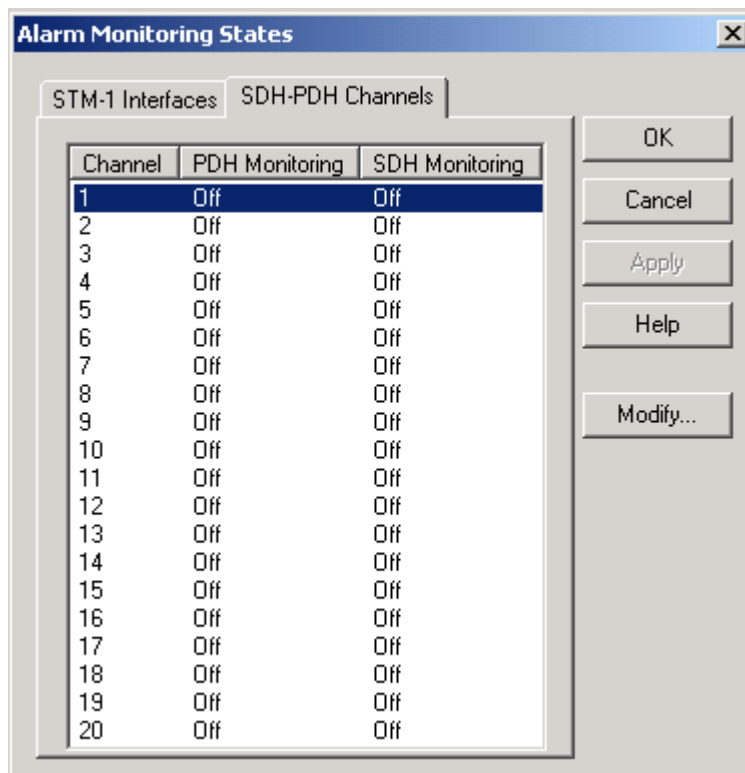
Figure 10. STM-1 Alarm Monitoring States, SDH-PDH Channels

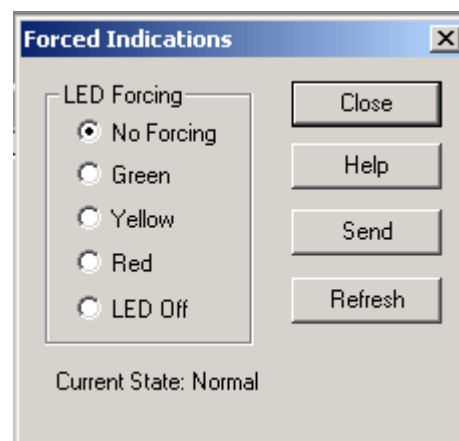
Figure 11. FXC STM-1 or FXC Bridge Forced Indications

2. **View the Current State of the LED; usually, this is Normal or No Forcing.**
3. **Select the state you want to force the LED to (No Forcing, Green, Yellow, Red, or LED Off).**
4. **Click Send.**
5. **Click Refresh to read the current state of the LED from the unit.**

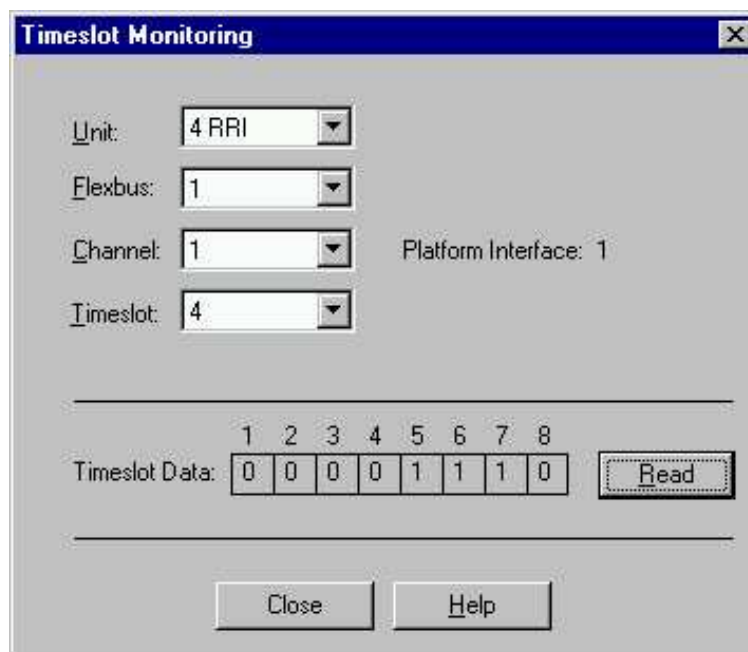
Figure 12. Timeslot Monitoring dialogue box

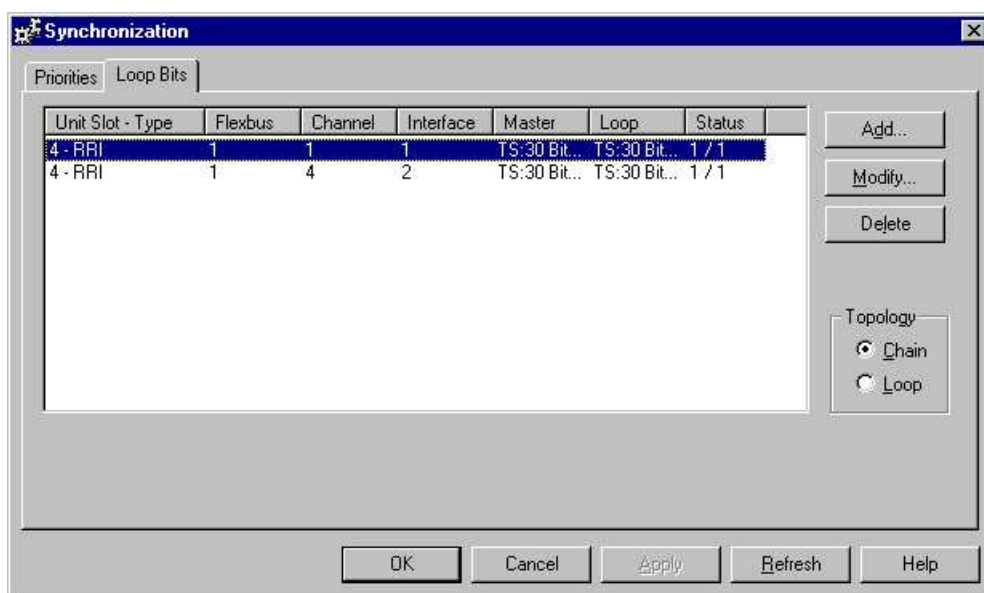
Figure 13. MCB/LCB status in the Synchronization dialogue box

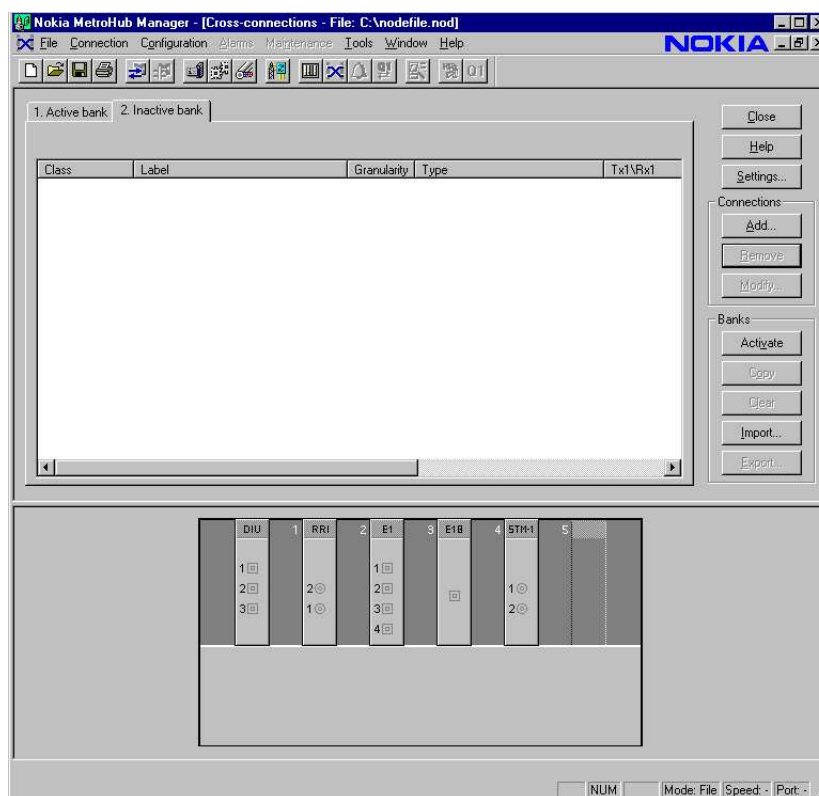
Figure 14. The Cross-connections window

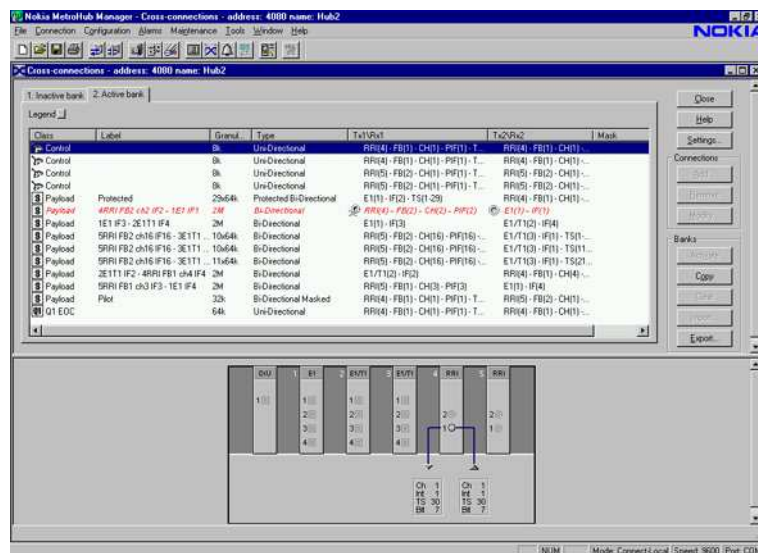
Pending cross-connections are displayed in the **Cross-connections** window with the colour red. Cross-connections are in the pending state when something is preventing them from working normally. See the following diagram.

Figure 16. Pending cross-connections because of disabled interface 1 of the FXC E1/T1 unit in slot 2

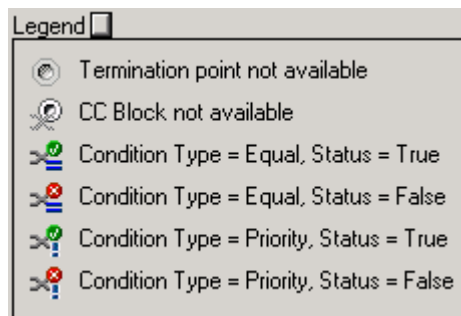
Reasons for the pending state can be that one end (termination point) of the cross-connection is an interface that is not in use. Another reason is that it is not operational, because of an active alarm. The responsible end (termination point) for each pending cross-connection is shown by the icon next to the termination point. Click the **Legend** button to see an explanation of the symbols, as shown in the figure below.

Figure 17. Symbols used in the cross-connections window

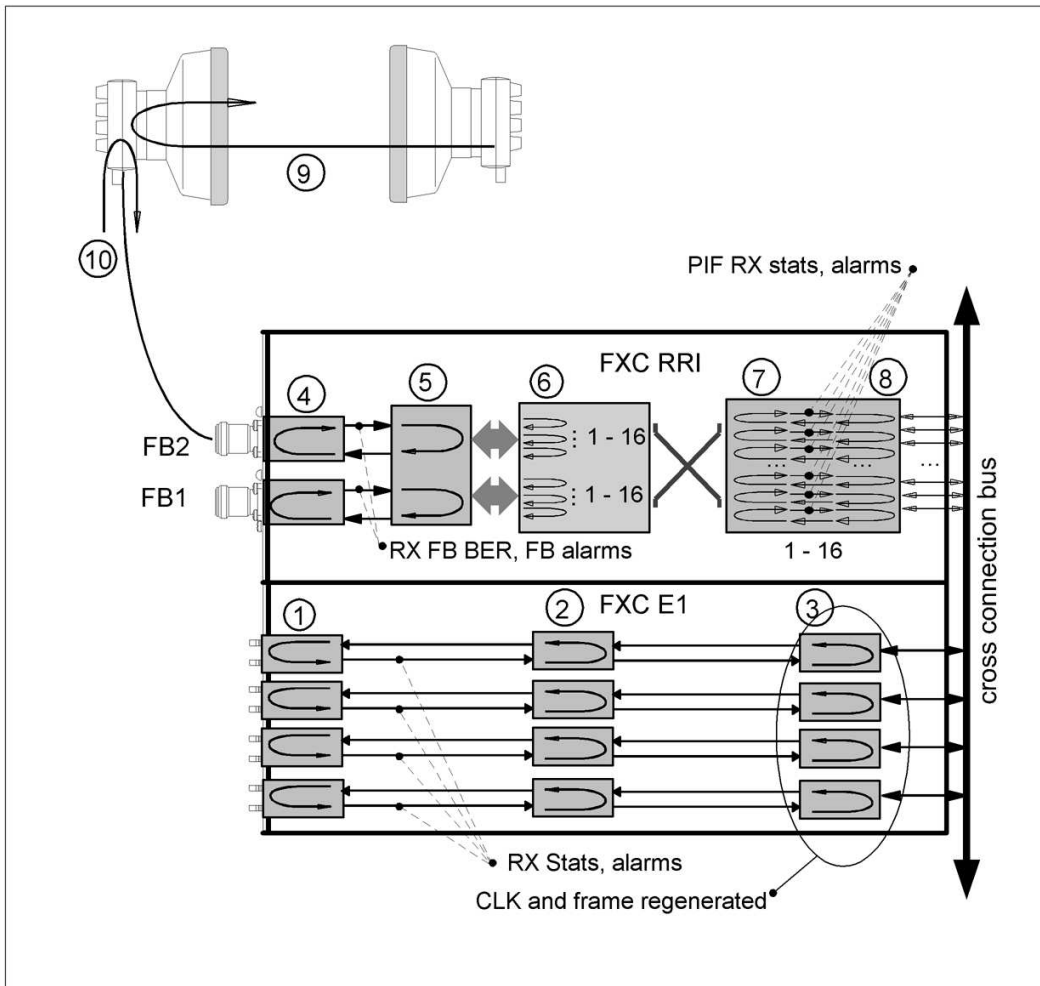
The units contain several loopback points that you can set to test the node. These loopbacks are accessed through Nokia FXC E1/(T1) Manager or FXC RRI Manager or FXC STM-1 Manager (standalone or embedded in MetroHub Manager or UltraSite BTS Hub Manager).

Figure 18. Loopbacks in FXC E1 unit, FXC RRI unit, Nokia FlexiHopper and Nokia MetroHopper

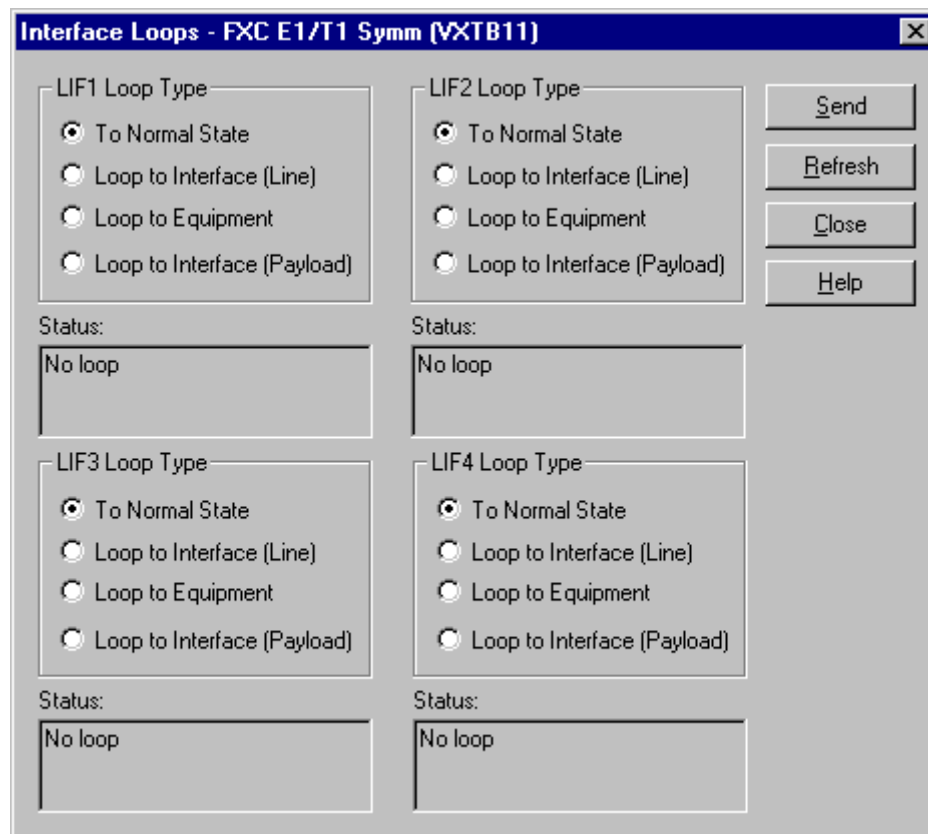
Figure 19. Interface loops dialogue box in the FXC E1/T1 manager

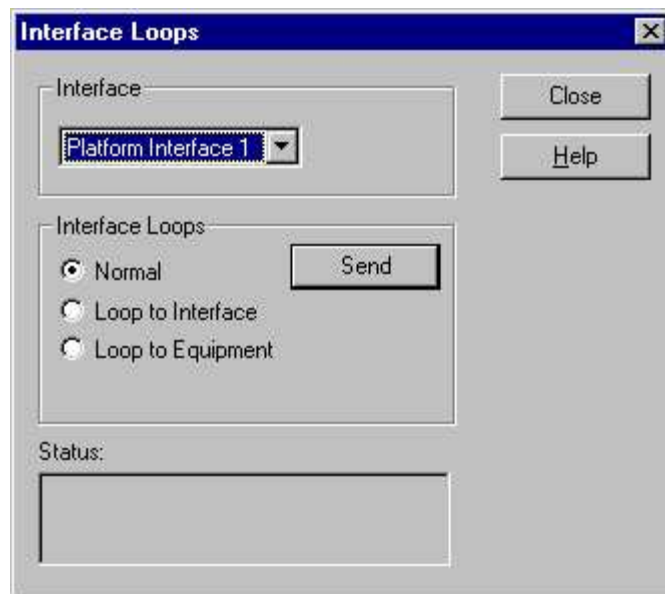
Figure 20. Interface loops dialogue box in the FXC RRI manager

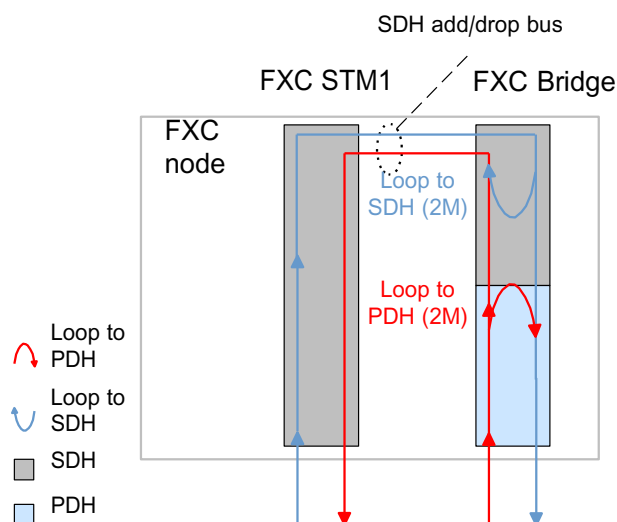
You can set interface loops manually to test the FXC STM node interface loops. These are 2M loops to SDH or PDH.

Figure 21. FXC STM node 2M loops

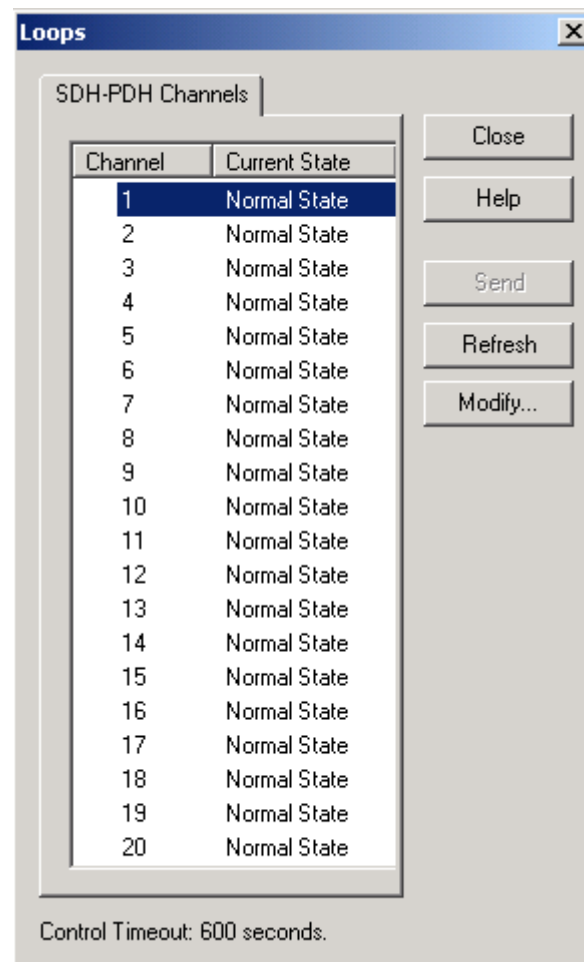
Figure 22. The Loops window, SDH-PDH Channels

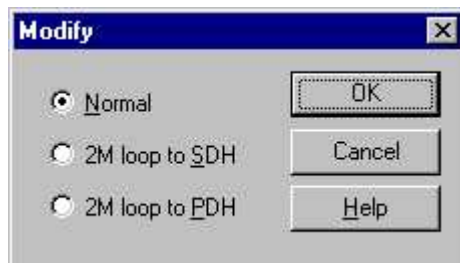
Figure 23. The Modify dialogue box

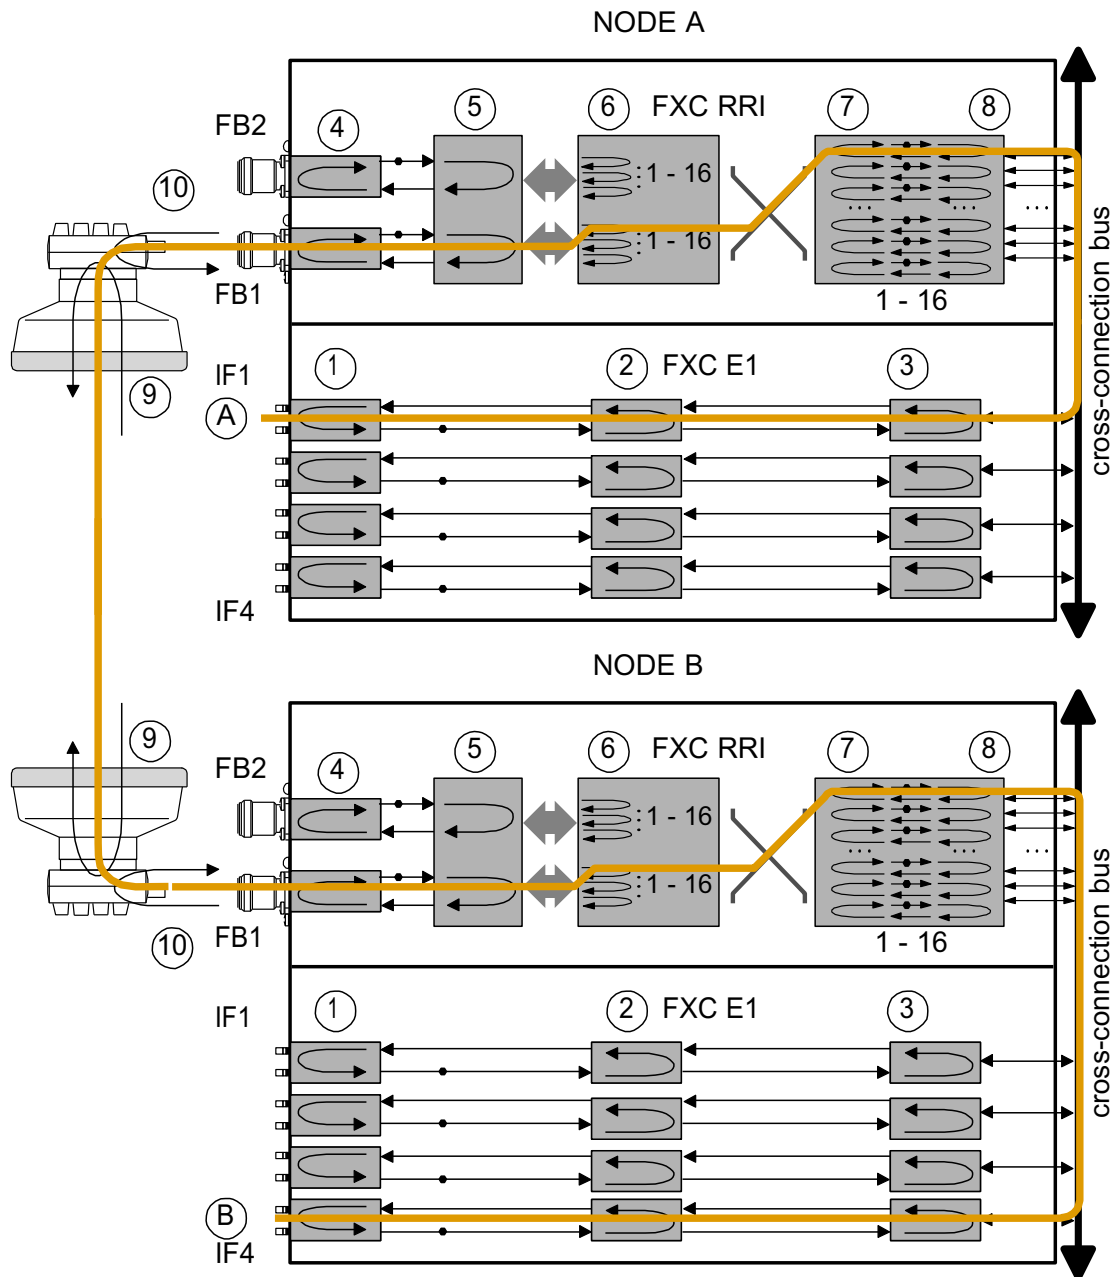
Figure 24. Example of loopback usage during a traffic cut

Let us assume that there is traffic cut between interface (A) in node A and interface (B) in node B. The signal path is presented in the figure *Example of loop usage during a traffic cut*. Loopbacks can be used to find where the cut is located. There are several approaches to the problem, but the principle is the same in all of them, which is looping the signal back at different positions in the signal path and thus ensuring that the signal is acceptable from the measurement point to the loop position. One possible approach is presented below.

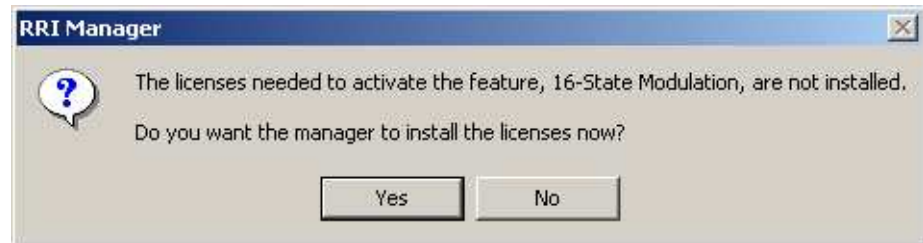
The following error message is displayed if the licences to be activated have not been installed:

Figure 25. Licence not installed

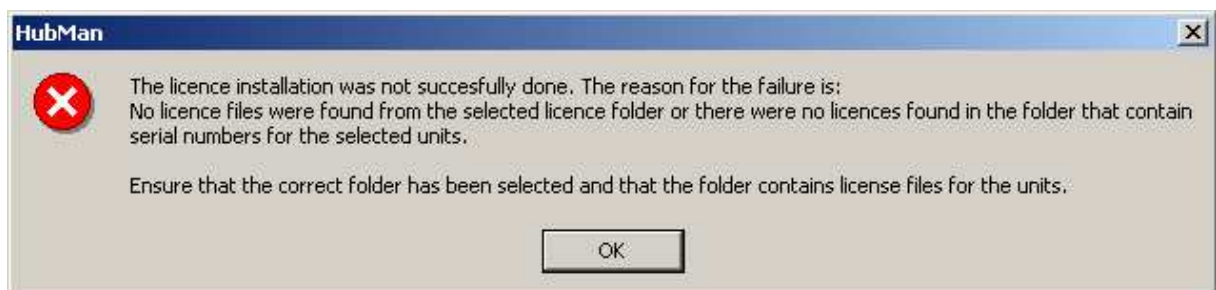
The following error message is displayed if the licence is not found in the system:

Figure 26. The licence installation was not successful

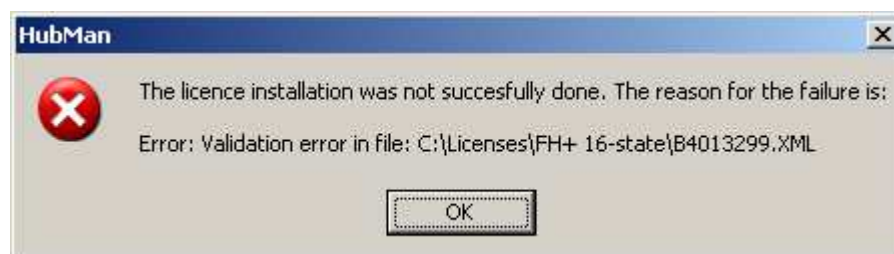
The following error message is displayed if there are typographic errors or other problems with the licences:

Figure 27. Error message: validation error in a file
