**Nokia Flexi EDGE Base Station
BTS SW EP2**

Trouble Management of Nokia Flexi EDGE BTS

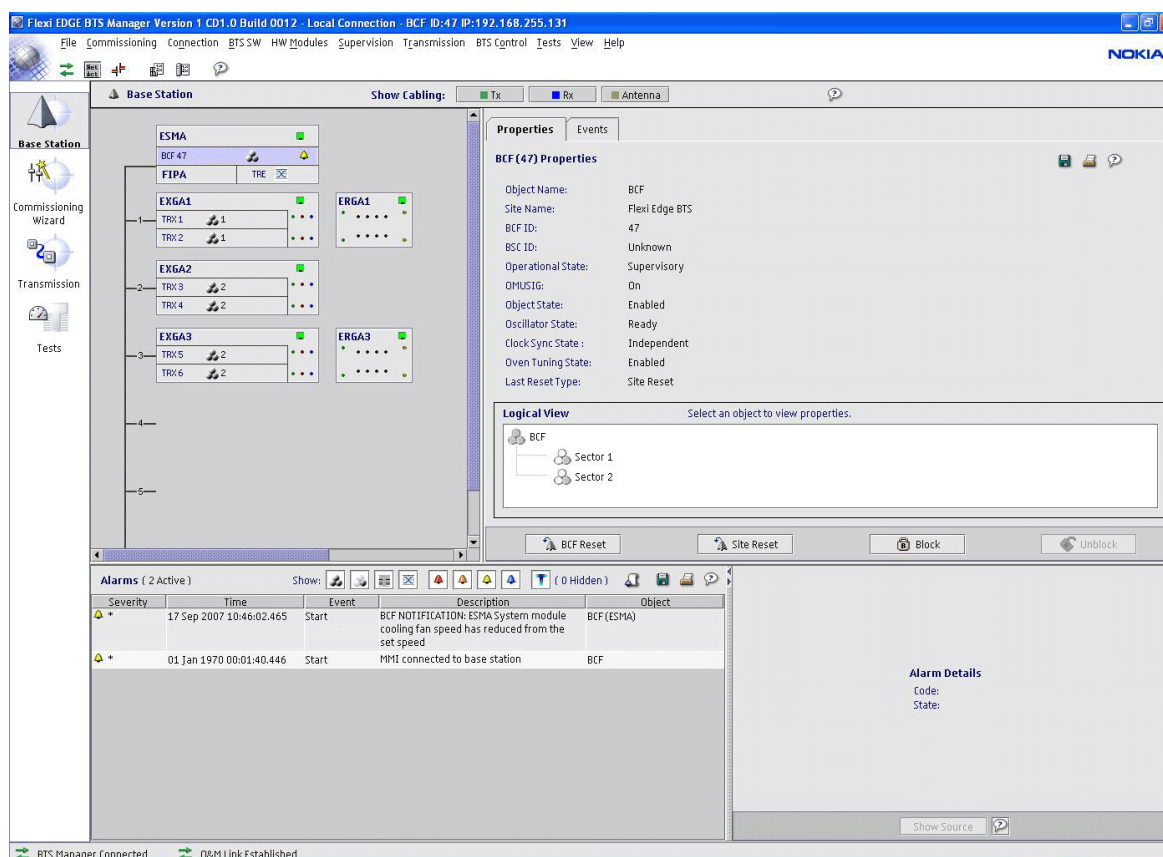
Figure 1. Alarm examples, Nokia Flexi EDGE BTS Manager view

In Nokia Flexi EDGE BTS Manager, the fault reason is reported in the **Description** column, as shown in the following figure.

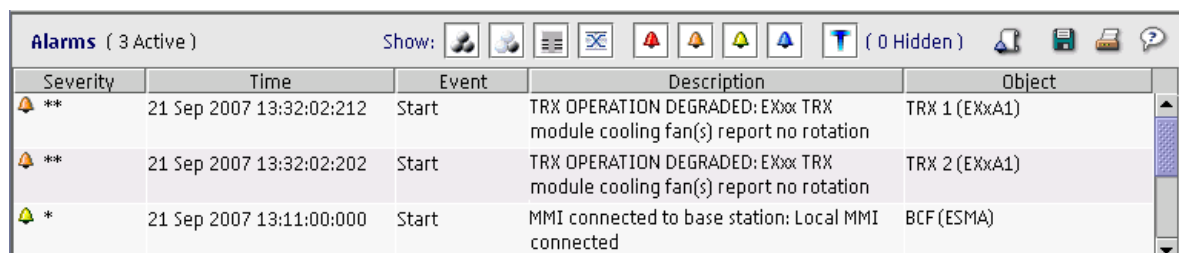
Figure 2. Alarms window of Nokia Flexi EDGE BTS Manager

Severity	Time	Event	Description	Object
**	21 Sep 2007 13:32:02:212	Start	TRX OPERATION DEGRADED: EXxx TRX module cooling fan(s) report no rotation	TRX 1 (EXxA1)
**	21 Sep 2007 13:32:02:202	Start	TRX OPERATION DEGRADED: EXxx TRX module cooling fan(s) report no rotation	TRX 2 (EXxA1)
*	21 Sep 2007 13:11:00:000	Start	MMI connected to base station: Local MMI connected	BCF (ESMA)

In the Alarms window of Nokia Flexi EDGE BTS Manager, you can see the object that the alarm refers to in the Object column. When troubleshooting the alarm at the site, follow the troubleshooting instructions in *Nokia Flexi EDGE BTS Trouble Management*. It is not always the alarming module that is faulty, it may also be the connected cable or the interworking module that causes the alarm.

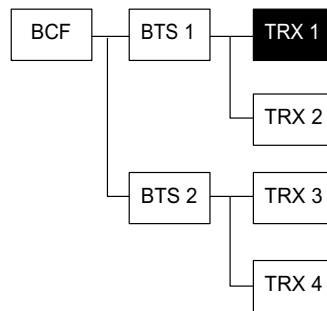
① Alarm Output

7606 TRX FAULTY (TRX 1)

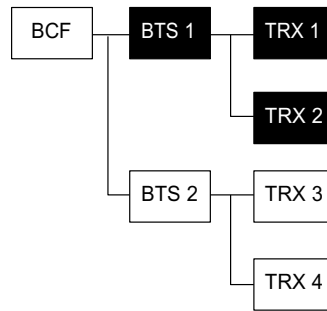
② Alarm Output, in this order

7606 TRX FAULTY (TRX 1)
7603 BTS FAULTY (BTS 1)

1. TRX 1 becomes faulty and ceases to operate. 7606 TRX FAULTY alarm is issued.
2. TRX 2 becomes faulty and ceases to operate.
3. Now both TRXs are not operating, which causes BTS 1 cease to operate. A BTS alarm, 7603 BTS FAULTY, is issued.

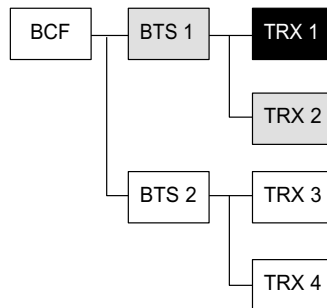
③ Alarm Output, in this order

7606 TRX FAULTY (TRX 1)
7604 BTS OPERATION DEGRADED
(BTS 1)

1. TRX 1 becomes faulty and ceases to operate. 7606 TRX FAULTY alarm is issued.
2. TRX 2 becomes partially faulty but calls are getting through.
3. Now the sector is partially faulty, and a BTS alarm, 7604 BTS OPERATION DEGRADED, is issued.

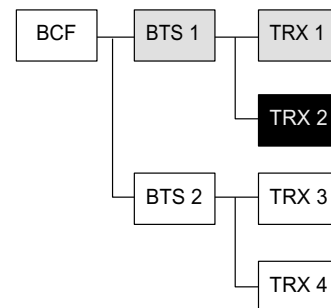
Figure 3. Faulty and degraded object alarm reclassification

④ Alarm Output, in this order

7607 TRX DEGRADED (TRX 1) start
7607 TRX FAULTY (TRX 2)
7607 TRX DEGRADED (TRX 1) cancel
7607 BTS OPERATION DEGRADED
(BTS 1)

- ☐ Functioning object
- ☐ Degraded object
- ☒ Faulty object

1. TRX 1 becomes partially faulty but calls are getting through. 7607 TRX DEGRADED alarm is issued.
2. TRX 2 becomes faulty and ceases to operate. 7606 TRX FAULTY alarm is issued for TRX 2. 7607 TRX DEGRADED alarm is cancelled for TRX 1.
3. Now the sector is partially faulty and a BTS alarm, 7604 BTS OPERATION DEGRADED, is issued.

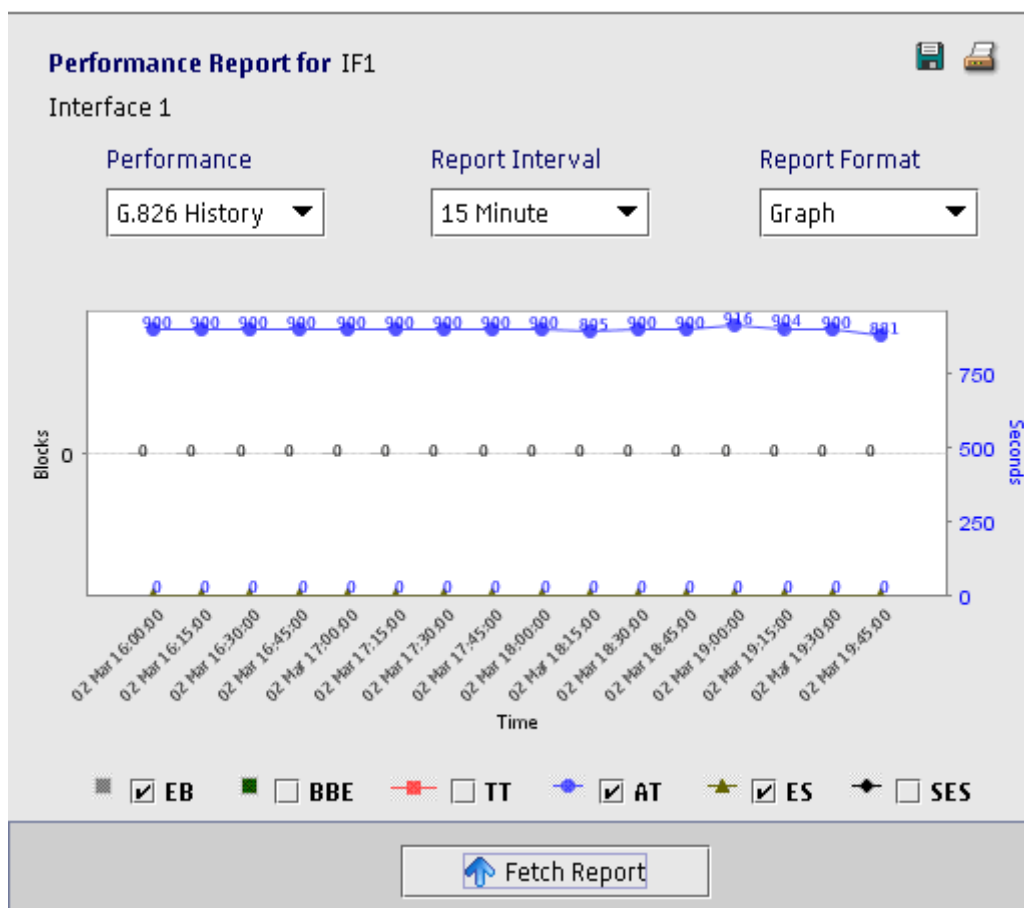
Figure 4. Report Format: Graph

If the selected Report Format is **Graph**, the counters fetched from the BTS are displayed as a line graph. With the **EB**, **BBE**, **TT**, **AT**, **ES** and **SES** check boxes below the graph, you can show (select a check box) or hide (clear a check box) the counter values in the graph.

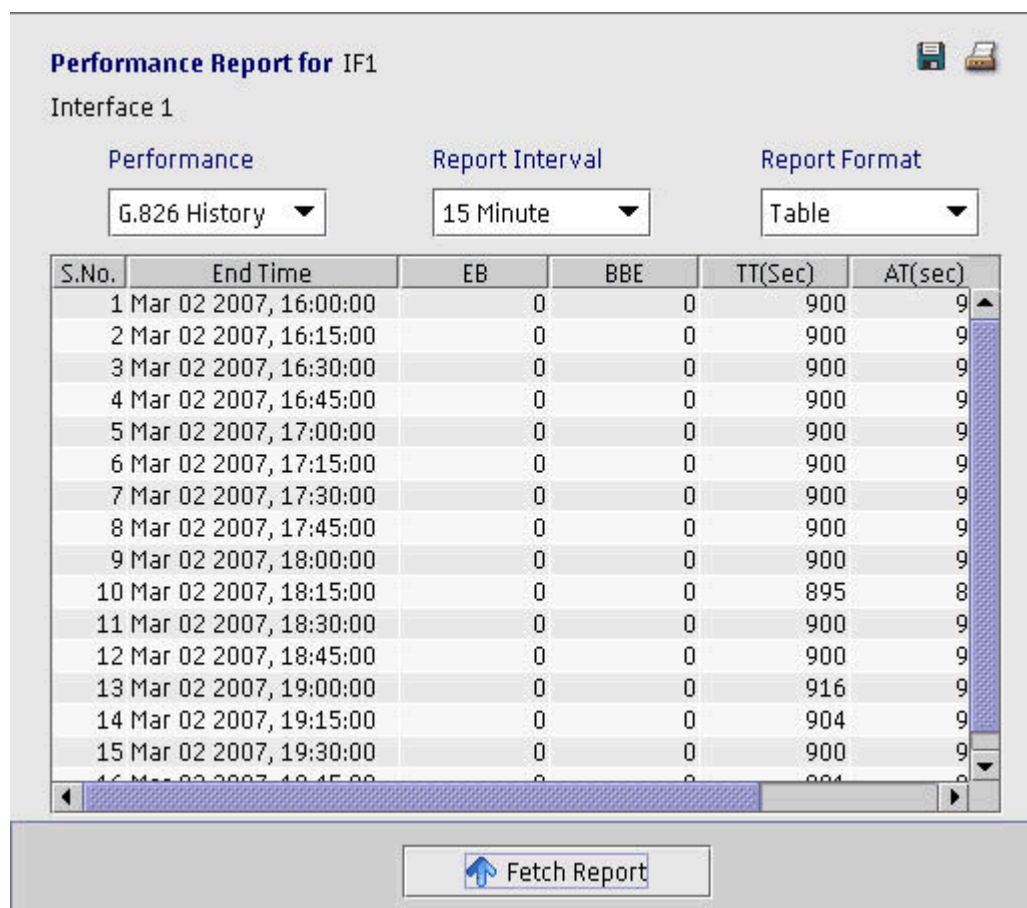
Figure 5. Report Format: Table

If the selected Report Format is **Table**, the counters fetched from the BTS are displayed in a table.

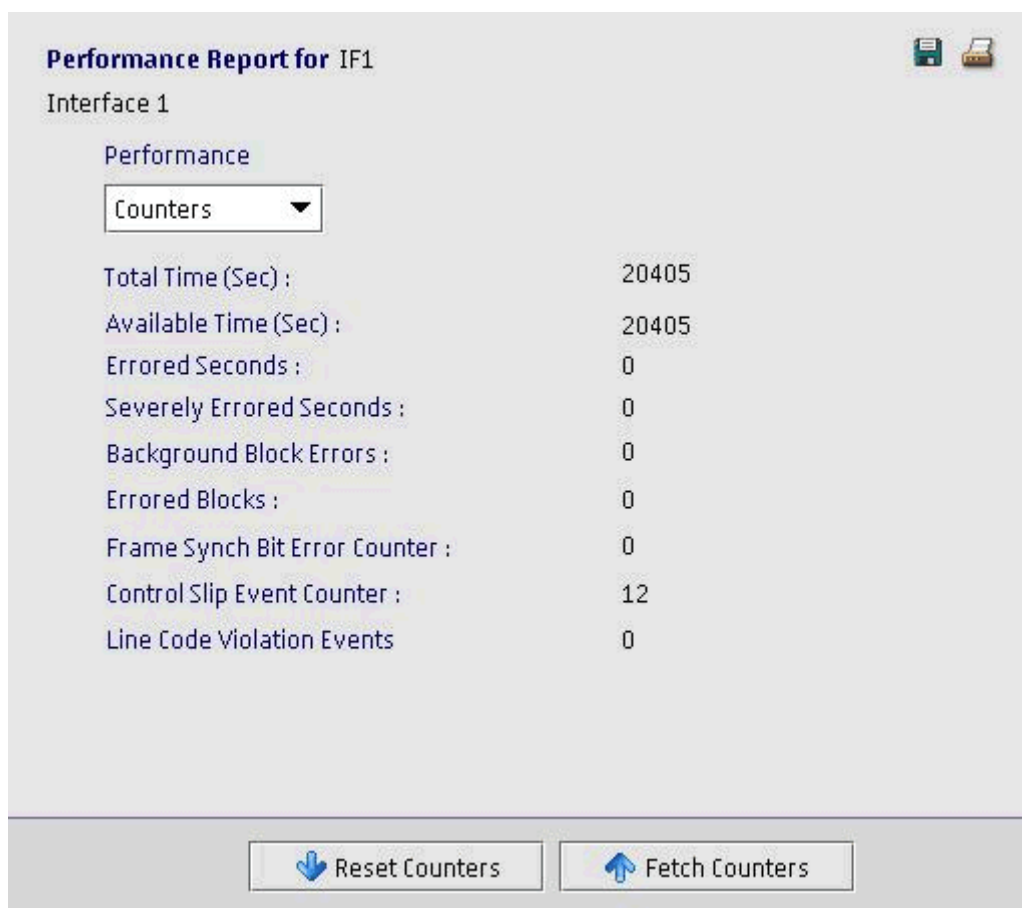
Figure 6. Performance view: Counters

If the selected Performance option is **Counters**, the counters and the following buttons are displayed in the view:

- **Fetch Counters** - Fetches the current values of the performance counters from the TRS.
- **Reset Counters** - Resets all performance counters.

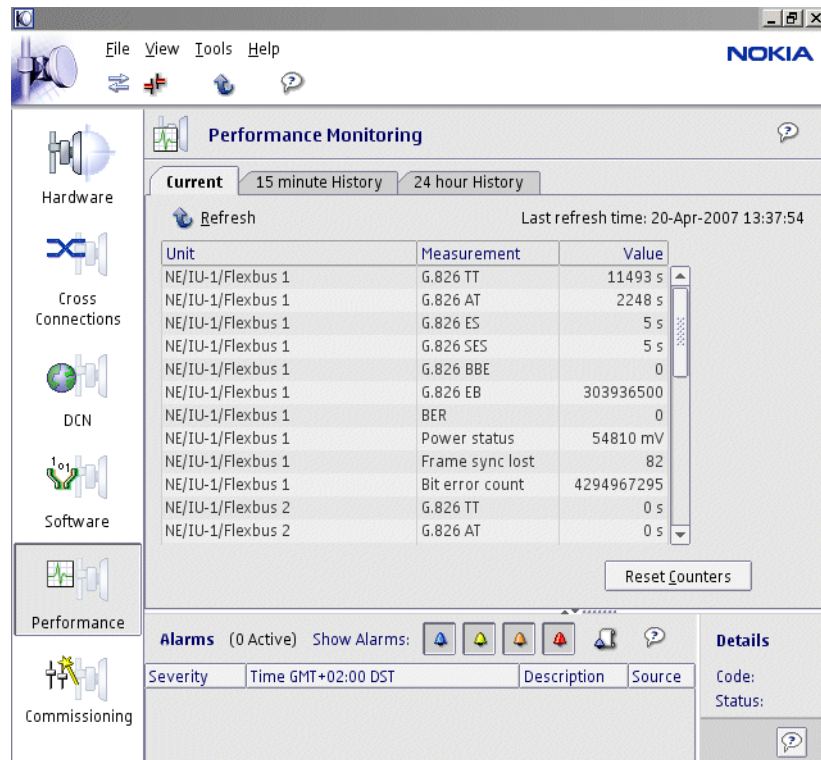
Figure 7. Performance View

3. On the FlexiHub Manager menu, select View → Performance, or select Performance from the View Bar.

The **Performance View** opens.
