# MOTOTRBO

## Connect Plus Upgrade Guide

February 2019  
Version 1.84

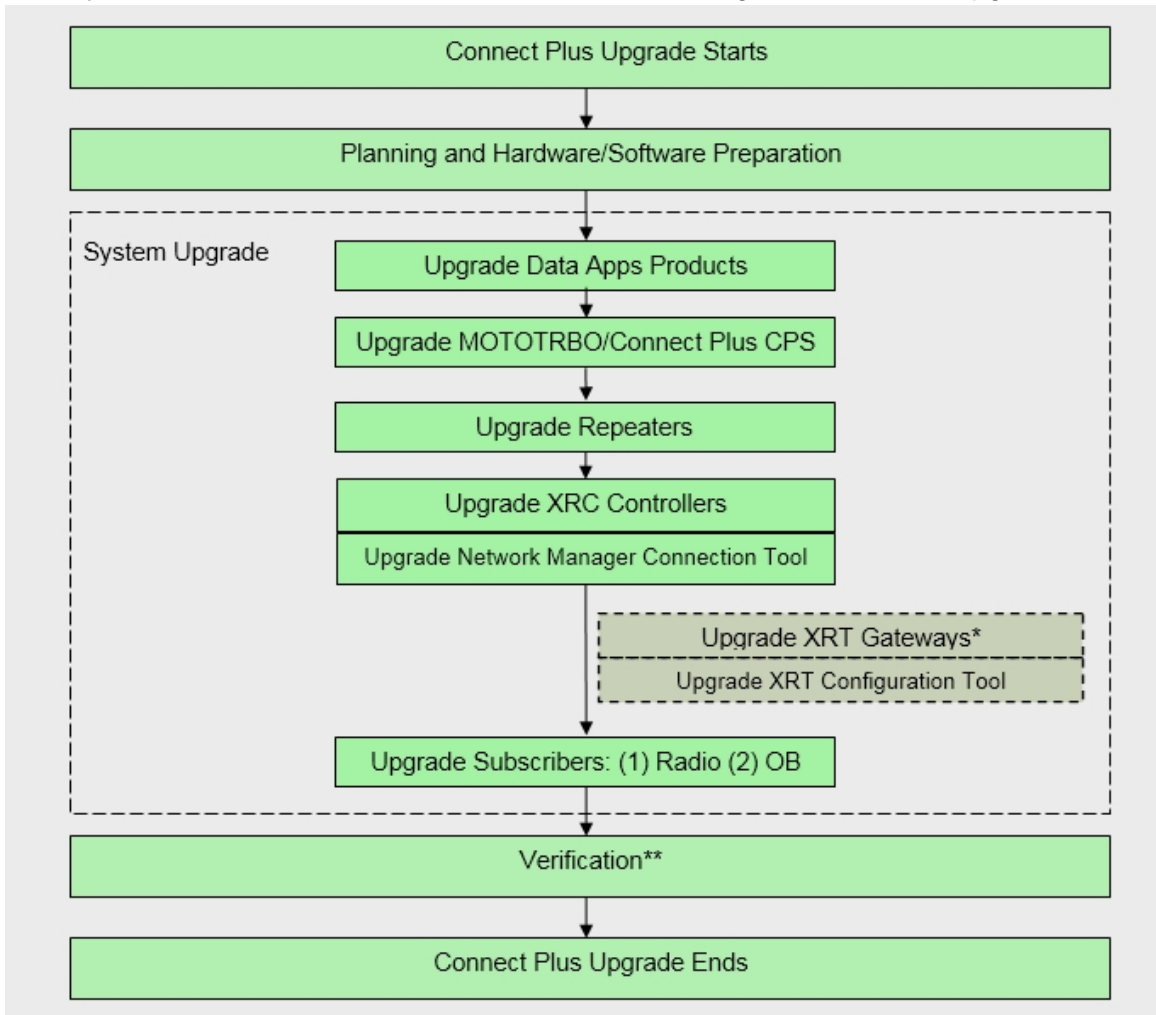
Figure 5-1 Connect Plus General Upgrade Sequence

The Connect Plus system downtime could be minimized if the following recommended upgrade order is followed:

\* Optional system components that should be upgraded at the time when the XRC controllers are upgraded.

It is assumed that the Connect Plus system components – controllers, repeaters and radios – are operating with the corresponding released firmware for Connect Plus Release 1.7 (MOTOTRBO Release 2.6.X) or the corresponding Release firmware for MOTOTRBO Release 2.7.X (refer to Table 2). See Figure 5-1 for the recommended upgrade sequence for devices in the Connect Plus System.
