MOTOROLA

MOTOTRBO

Connect Plus Upgrade Guide

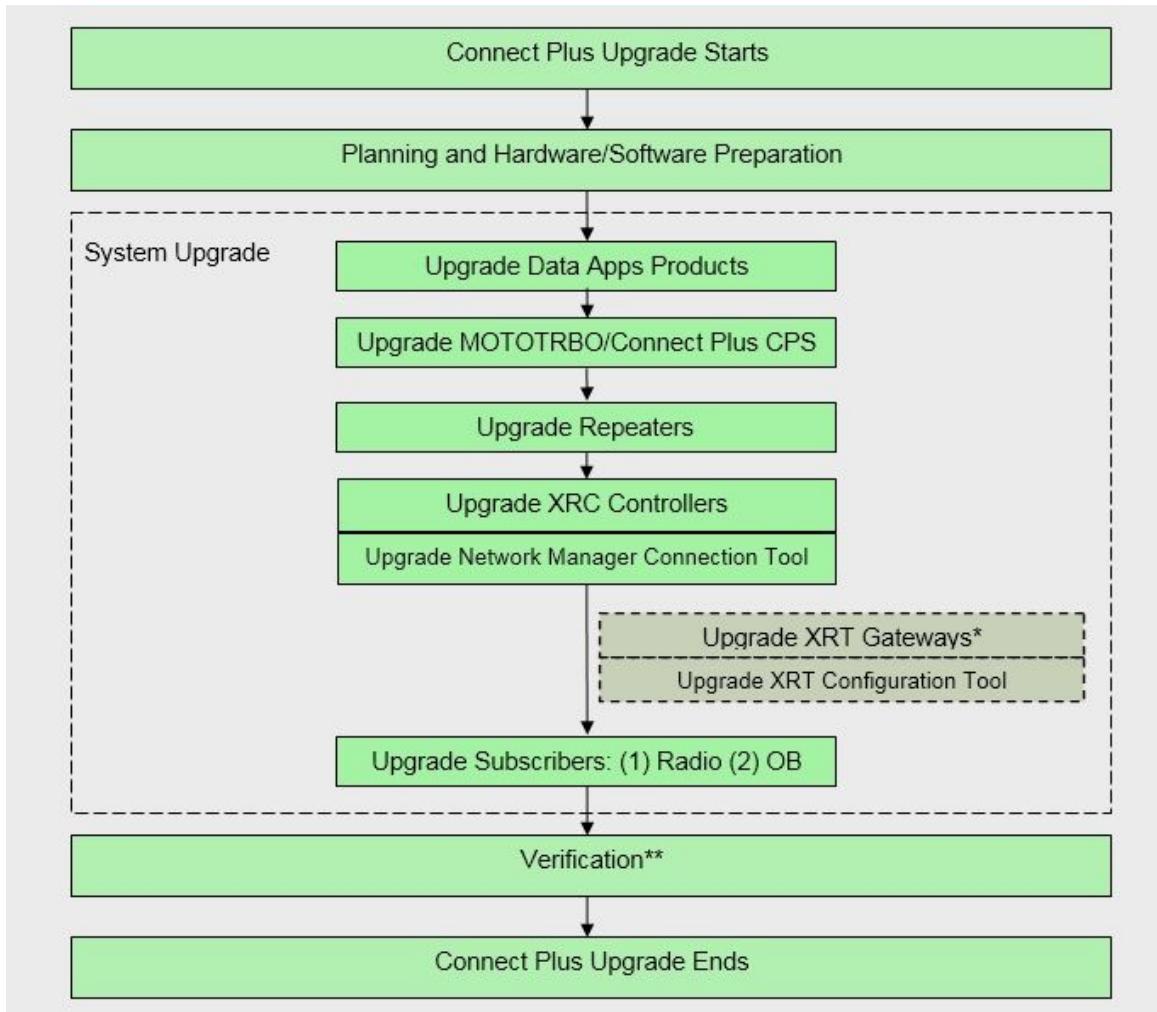
The Connect Plus system downtime could be minimized if the following recommended upgrade order is followed:

Figure 5-1 Connect Plus General Upgrade Sequence

* Optional system components that should be upgraded at the time when the XRC controllers are upgraded.
