## Technical Note TN-3390d-SR

### P25 Firmware v3.01.05

### P25 Programming Application v3.1.2.174

### Tx9000 Calibration Application v3.1.1.1

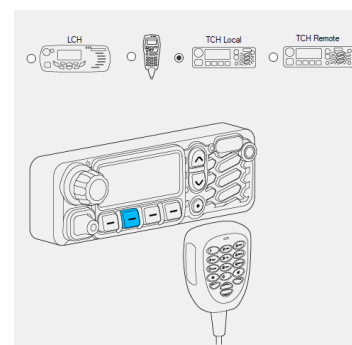
- **JIRA-XPA-712: Add TCH images to Key Settings page**

Updated the TM9400 and TM9800 Function Ctrl Settings page to include the display of the (TCH) color control heads and location of the relevant function keys for all head variants.
