## 918B MULTISPEED AND CODE CONVERTER MAINTENANCE

**1.01** This section contains information concerning the maintenance and trouble location for the 918B multispeed and code converter. The 918B multispeed and code converter will hereafter be referred to as the converter.

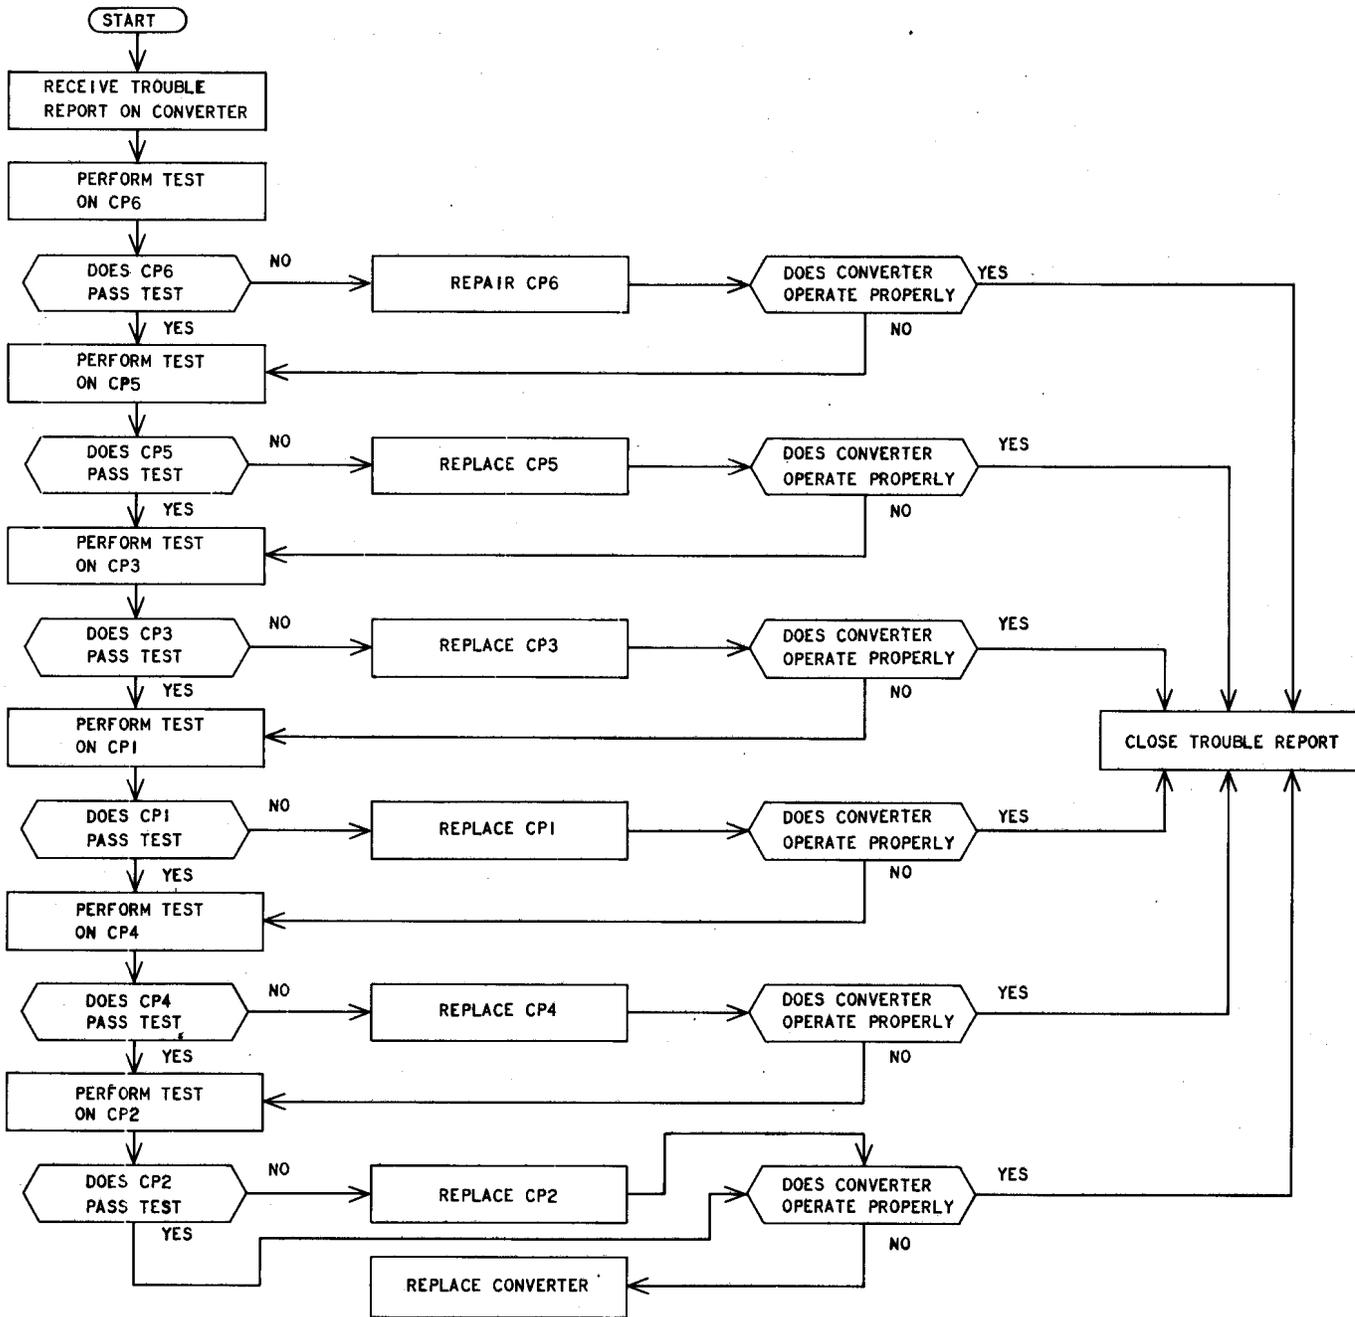
Fig. 1—Procedure for Trouble Clearing 918B Multispeed and Code Converter

**2.03** When investigating a trouble report, proceed as directed on Fig. 1. Refer to the section entitled 918B Multispeed and Code Converter—Test Procedures (103-814-501) for test procedures applicable to the converter.
