**METHODS OF DENYING AND RESTORING SERVICE
ON CUSTOMERS' LINES
STEP-BY-STEP AND COMMUNITY DIAL OFFICES**

1.01 This section describes ways to deny and restore service on subscriber lines (individual and party) in step-by-step (SXS) and community dial offices (CDOs).

SECTION 226-155-300PT

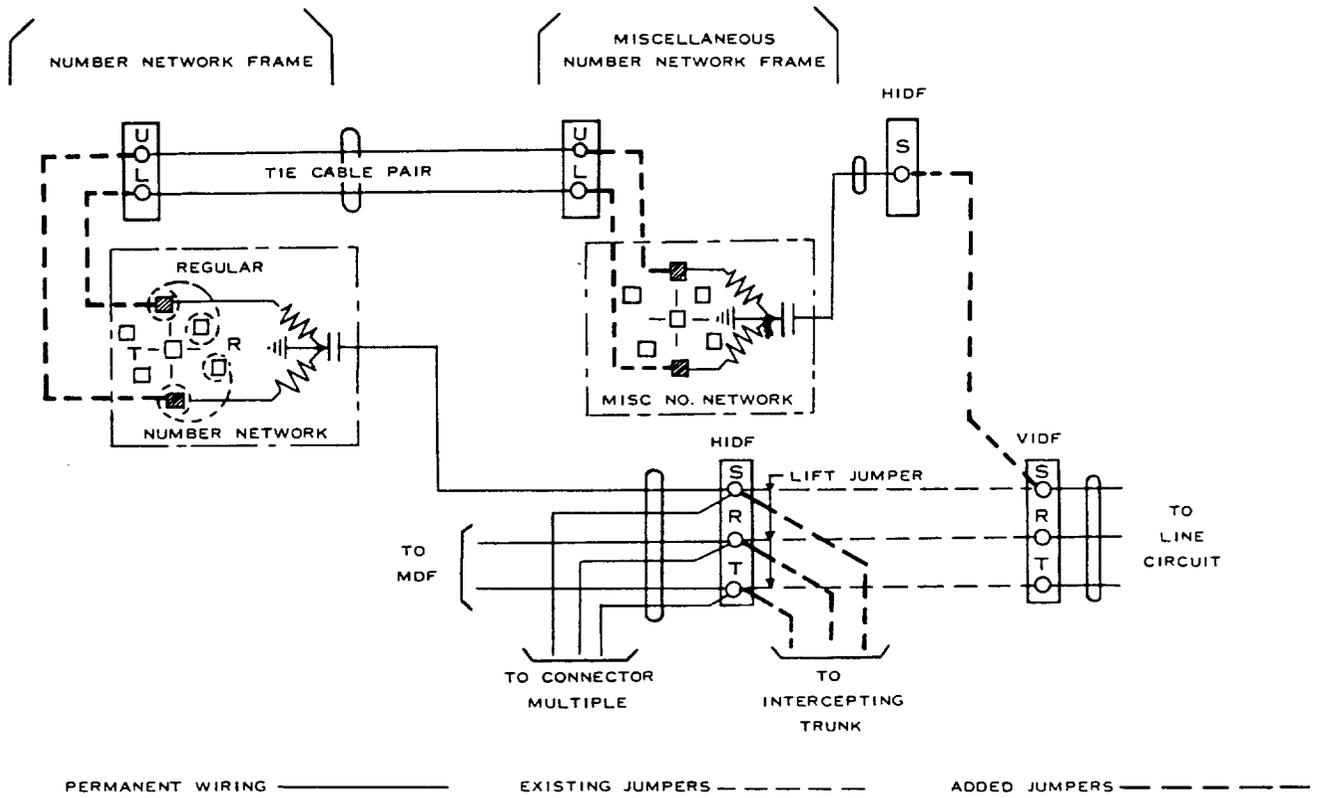
ANI-B Cross-Connections Using Miscellaneous Number Networks
Fig. 1

(a) Run a cross-connection from the sleeve of the group and terminal involved to the assigned miscellaneous number network. (See Fig. 1 for ANI-B [Type B] cross-connections).

- (a) Run a cross-connection from the sleeve of the group and terminal involved to the assigned miscellaneous number network. (See Fig. 1 for ANI-B cross-connections.)
- (b) At the miscellaneous number network frame, cross-connect the miscellaneous number network to the assigned tie pair to the number network frame where the connector terminal appears.
- (c) At the number network frame, cross-connect the tie pair used in (b) to the number network of the connector terminal. Half-tap over the existing straps.

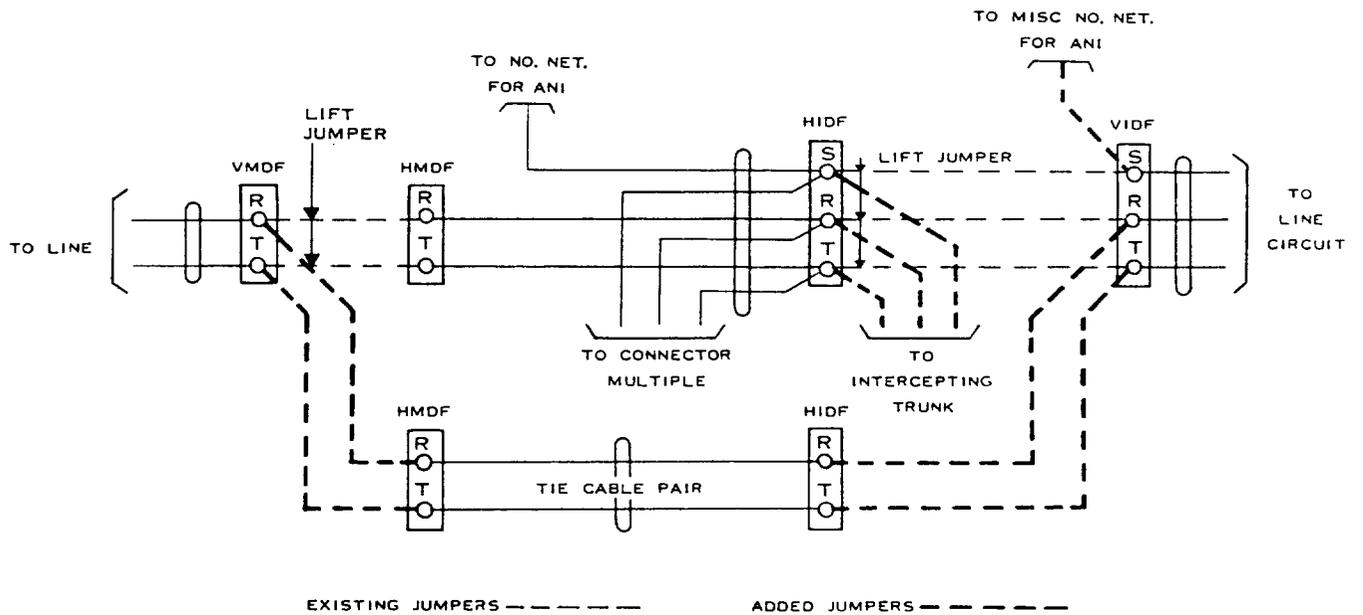
Temporary Denial of Incoming Service
ANI-B Offices Where The Connector Multiple Appears
On The MDF And The Number Networks Are Cabled
To The Connector S Terminals
Fig. 2

(b) At the MDF, run a cross-connection from the cable and pair to the IDF tie pair used in (a). Lift the existing jumper at the cable and pair and connect the jumper from the IDF tie cable. (See Fig. 2 and 3.)

- Cross-connect the cable pair to the tip and ring line switch or line finder terminals normally associated with the line to be intercepted. Use a tie cable pair between the MDF and the IDF (Fig. 2).

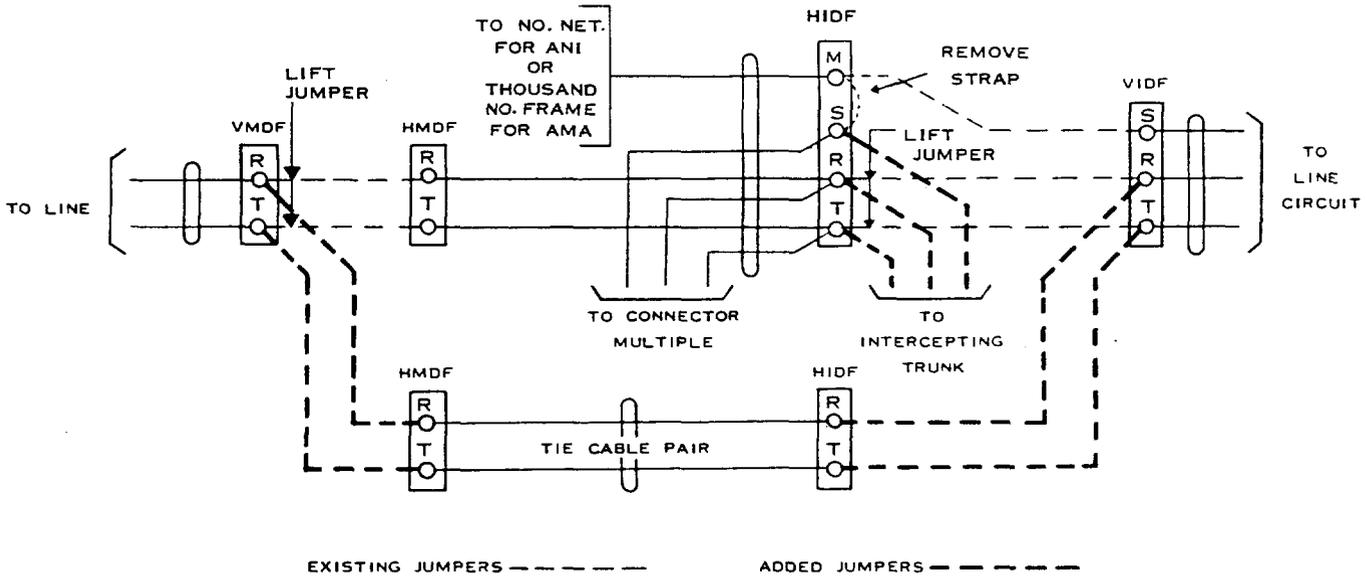
Fig. 3

**Temporary Denial of Incoming Service
Offices With The Connector Multiple On The MDF
AMA Offices, Also ANI-B Offices Where The Number
Networks Are Cabled To M Terminals**

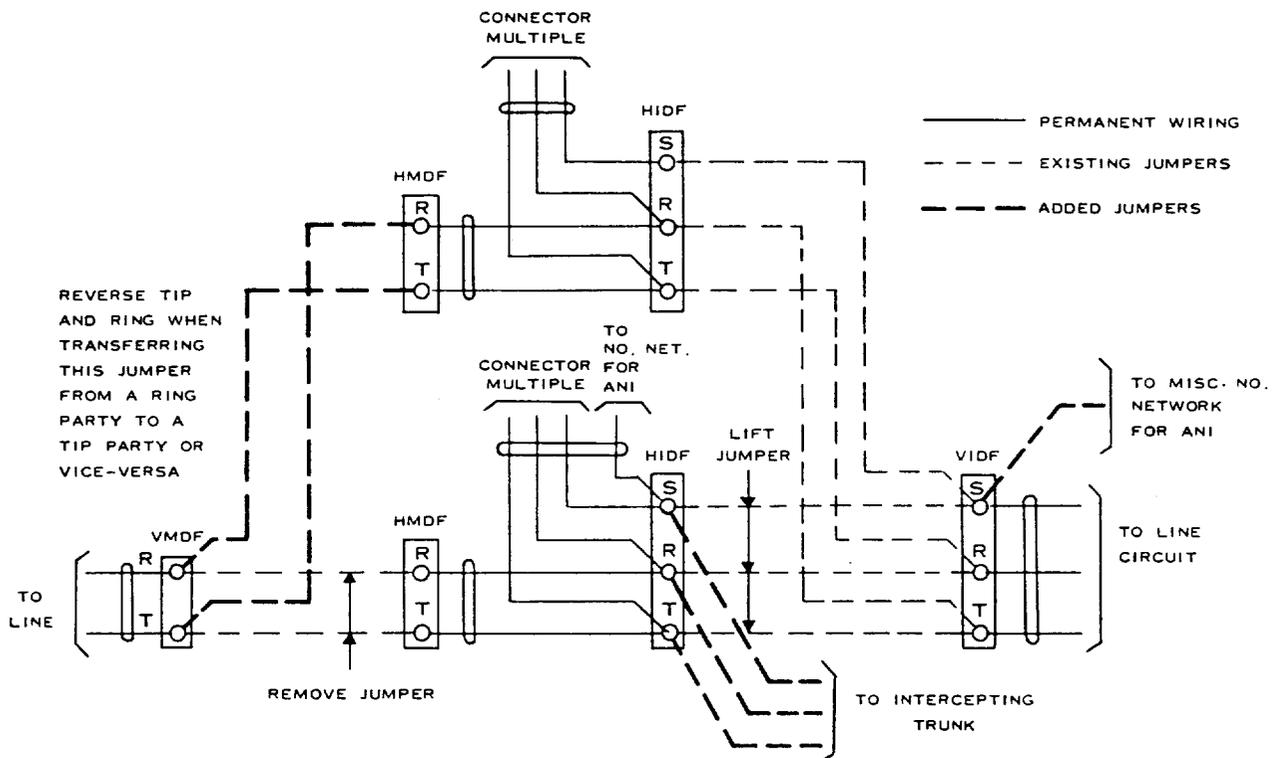
**Denial Of Incoming Service To Master Station Of Party Line
Offices With The Connector Multiple On The MDF
ANI-B Office Where The Number Networks Are Cabled To The Connector S Terminals
Fig. 4**

(2) If the MDF jumper is run to the connector terminals of the party to be denied service, and there are one or more parties on the line whose calls are not being intercepted, transfer the cross-connection to a working party terminal. If the station associated with the terminal to which the cross-connection is transferred is on the other side of the line, reverse the position of the tip and ring jumper (Fig. 4 and 5).

Note: VIDF blocks in Fig. 4 and 5 are shown as typical examples.

(a) At the HIDF, disconnect the tip and ring jumper wires from the terminals. If the S and M terminals are not strapped, remove the sleeve jumper wire also. If the S and M terminals are strapped, remove the strap and leave the sleeve connected to the M terminal (Fig. 4 and 5).

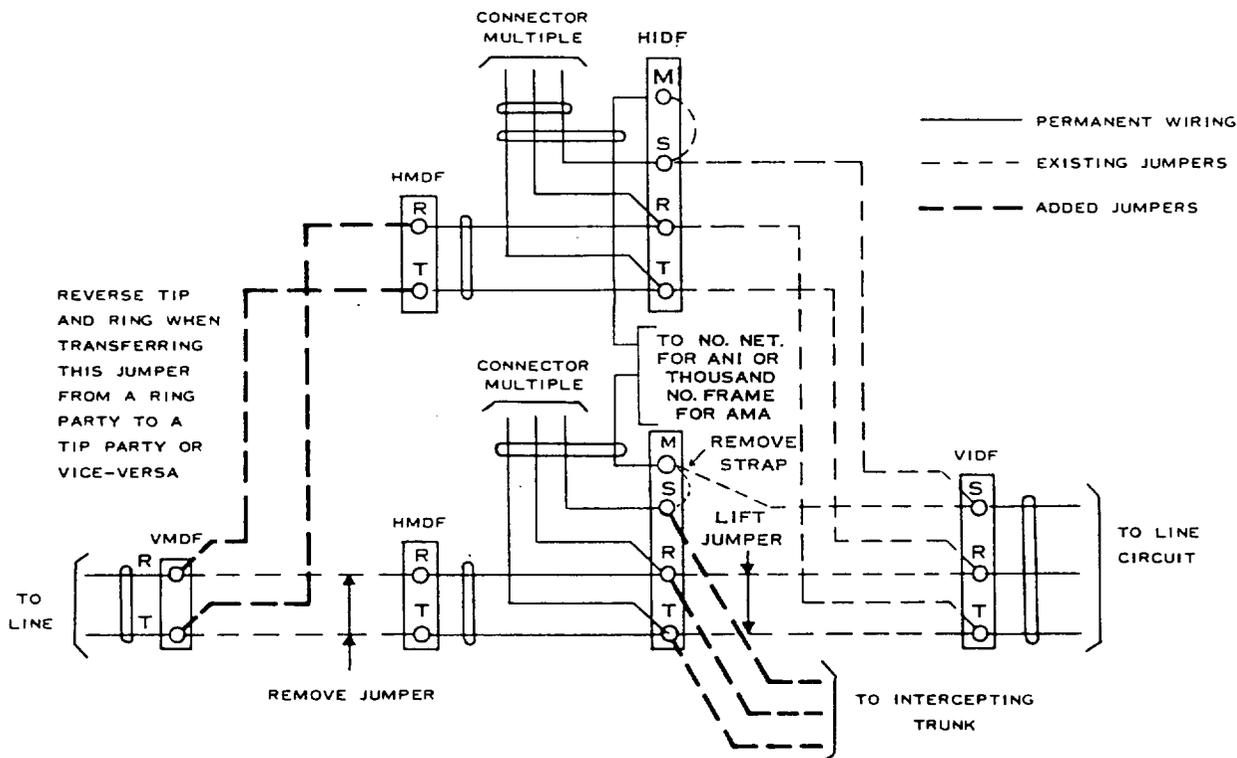
**Denial of Incoming Service To Master Station Of Party Line
Offices With The Connector Multiple On the MDF
AMA Offices, Also ANI-B Offices Where The Number Networks Are Cabled To M Terminals
Fig. 5**
