JUNCTOR REASSIGNMENT PROCEDURES

NO. 2A AND NO. 2C ELECTRONIC SWITCHING SYSTEMS

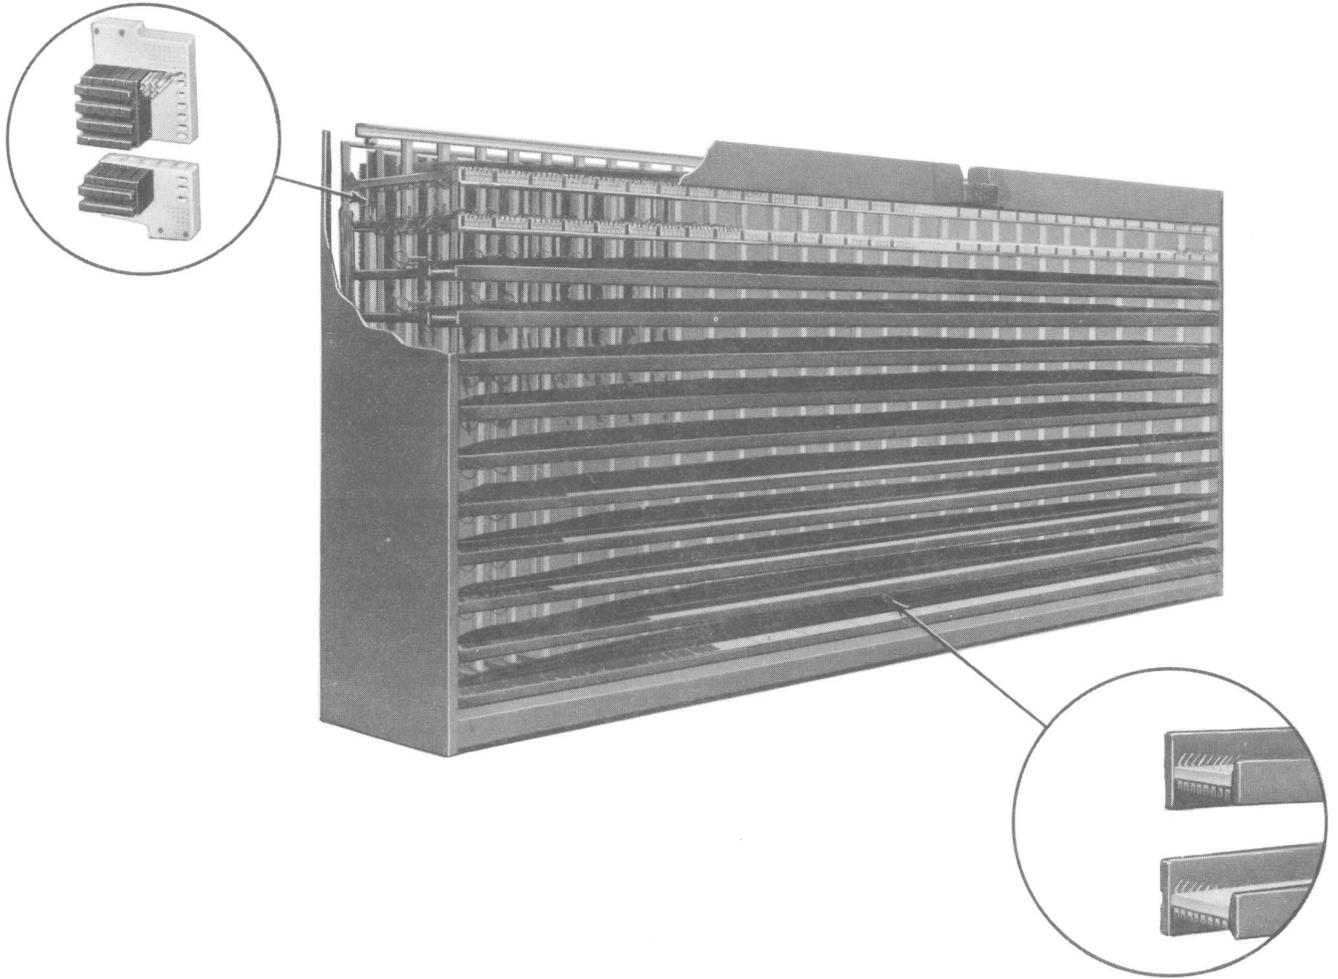
Fig. 1—Combined Distributing Frame

1.02 All network junctor terminals in No. 2A and No. 2C ESS are cabled to a peripheral frame called Combined Distributing Frame (CDF). The two top shelves of the CDF (shelves L and M) provide the space for mounting two groups of 16 junctor grouping assemblies (Fig. 1).

of a network. This, coupled with the network wiring scheme, provides each line or trunk with two possible paths to each junctor. Each subgroup is terminated in either a plug or jack on the CDF (Fig. 1).

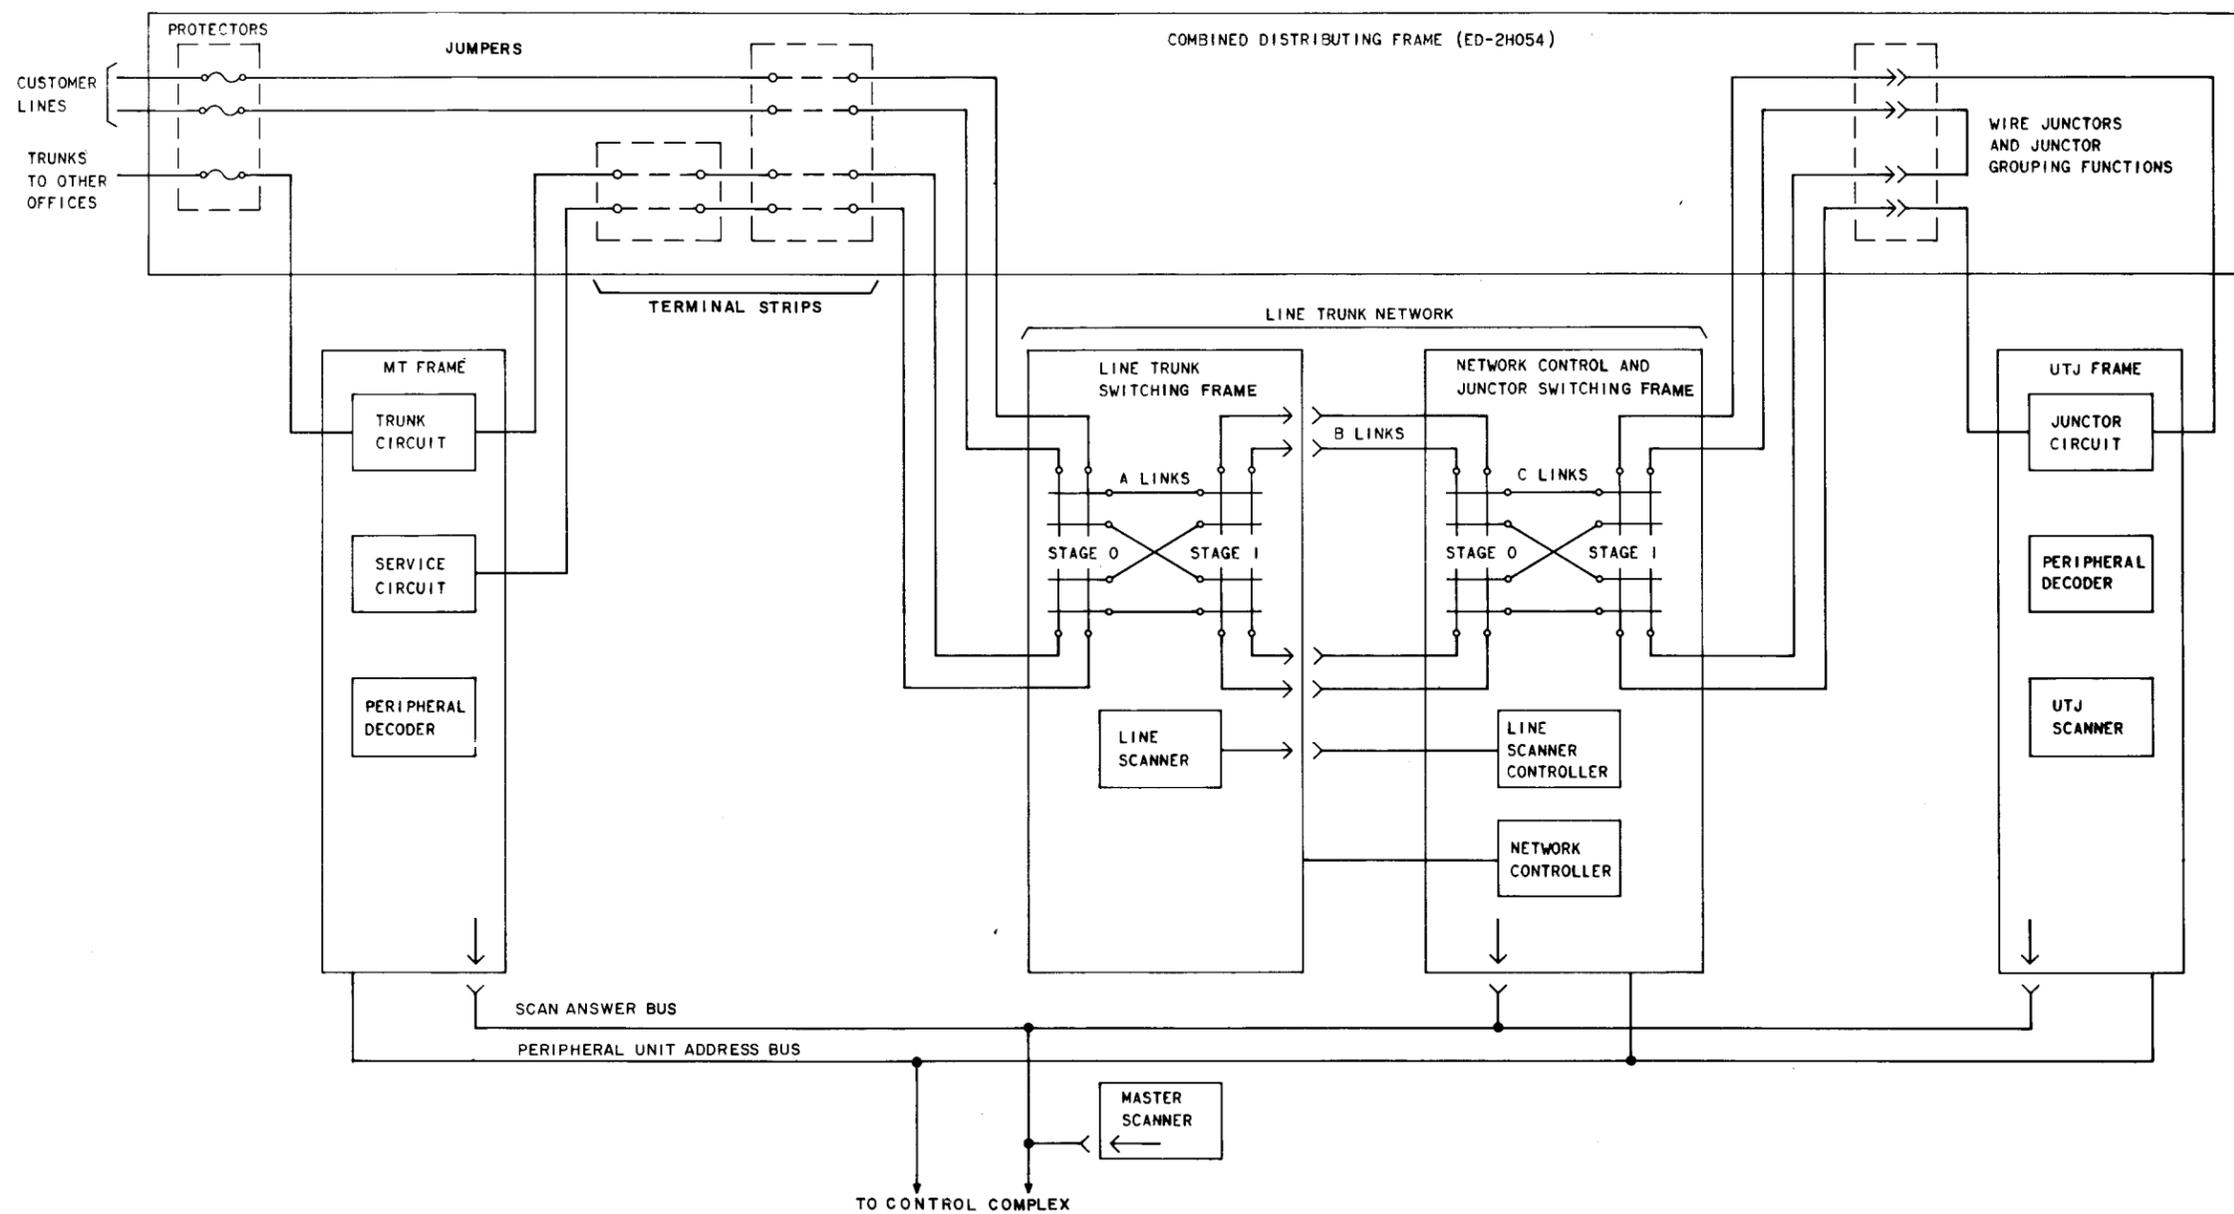
Fig. 2—No. 2A ESS Network

1.06 The junctor grouping area of the CDF is divided into four sectors. Each sector is further divided into two shelves for a total of eight shelves. Each shelf contains four groups of junctor grouping assemblies for a total of 32 groups numbered 00 through 31. Each plug is equipped with a 20-foot long cord that allows any network to be interconnected to any other network. An extension cord is available for longer connections between modules. Wire junctor subgroups are formed by connecting plug-ended subgroups of one network into the jack-ended subgroup of itself or another network (Fig. 2). Circuit junctors subgroups are formed by the following:

- (a) connecting a plug-ended subgroup of one network into the jack-end of a circuit subgroup (Fig. 2),
- (b) connecting the plug-end of the same circuit junctor subgroup into a jack-ended subgroup of the second network (Fig. 2).

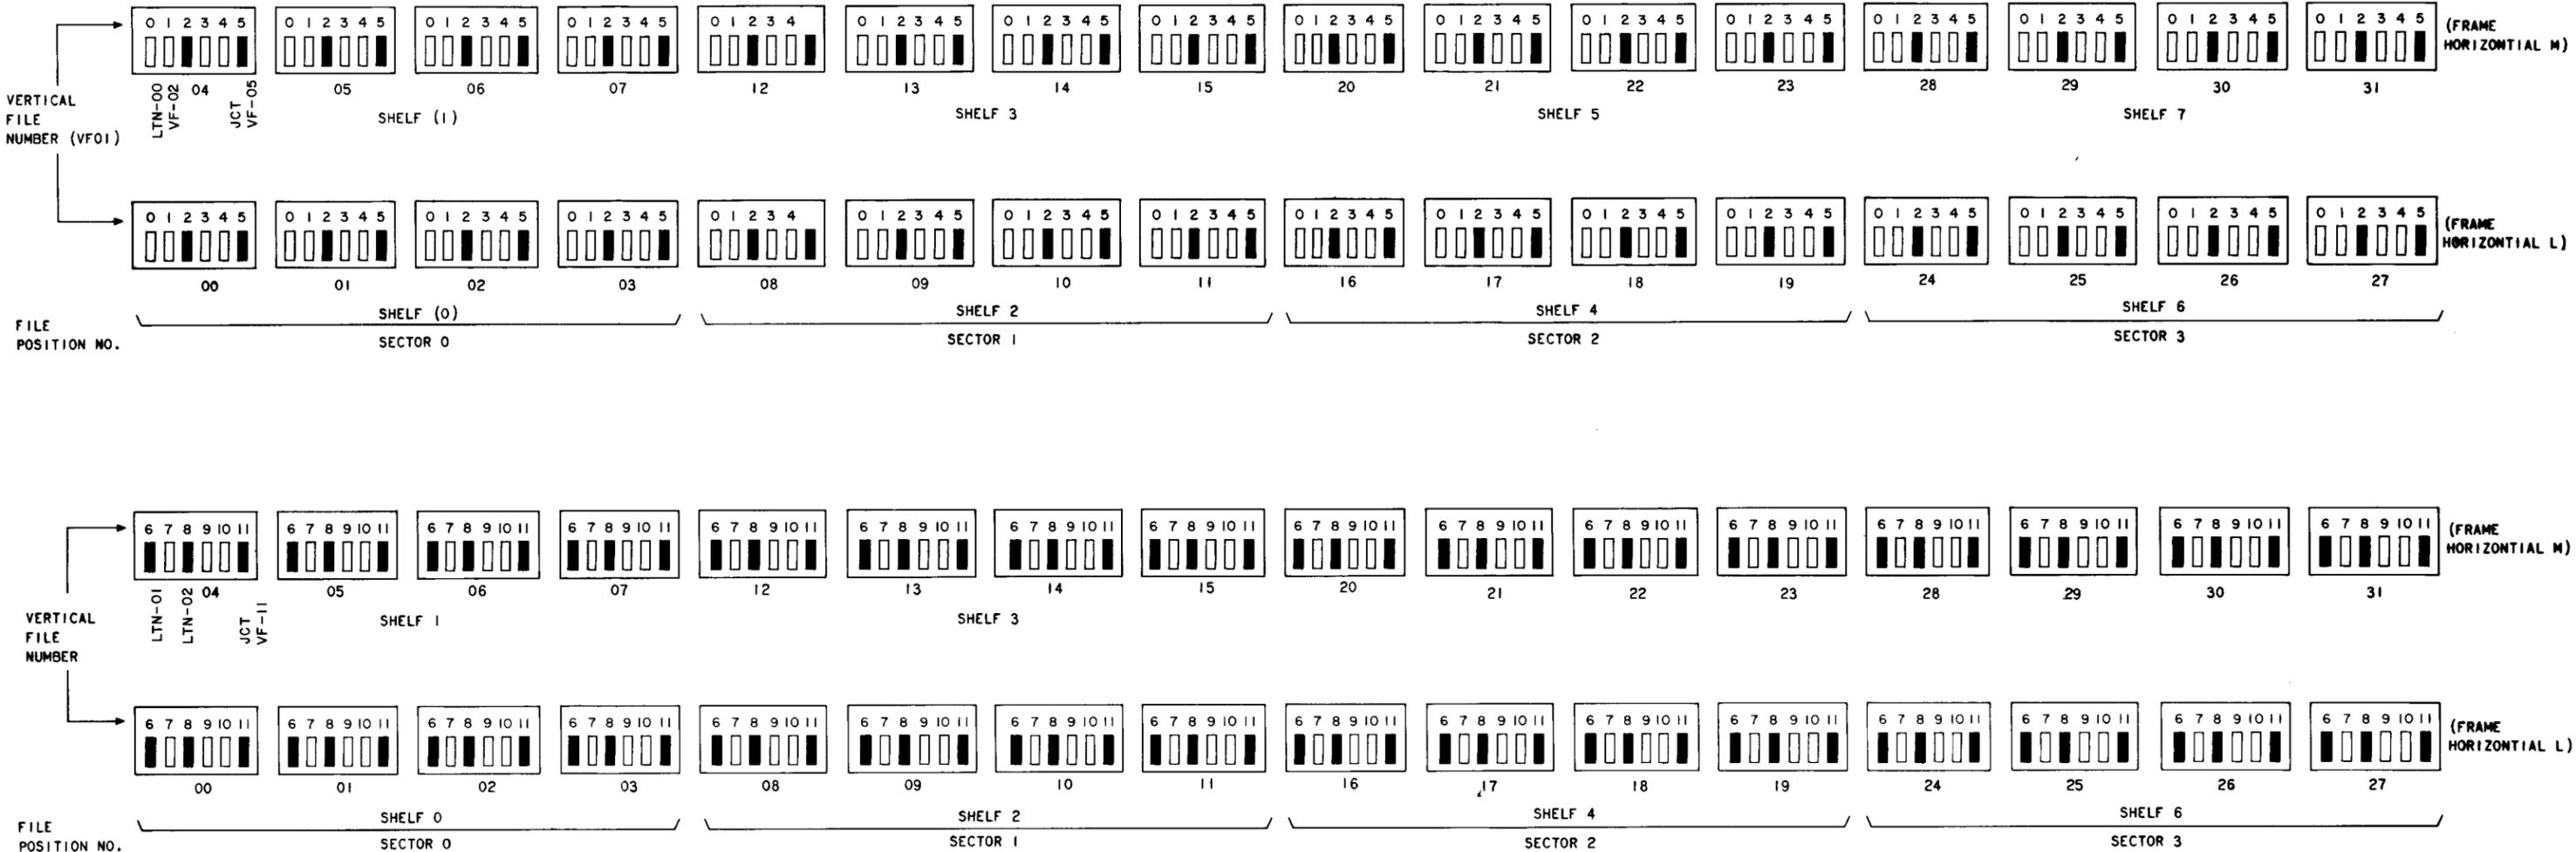
Fig. 3—CDF Junctor Grouping Jackfield Modules

1.08 Interconnections between networks should be done, if possible, within the same shelf. Plugs corresponding to a given switch and level should be connected to jacks of another fixed switch and level. Subgroups corresponding to levels 0 to 3 on each switch are terminated on plugs on the CDF. The subgroups corresponding to levels 4 to 7 on each switch terminate on jacks. In the event that it is necessary to interconnect plugs and jacks on different shelves, the interconnections will be confined to within the following pairs of shelves: Shelves 0 and 1; 2 and 3; 4 and 5; 6 and 7. These pairs of shelves are referred to as sectors 0 through 3 for each jackfield module (Fig. 3).

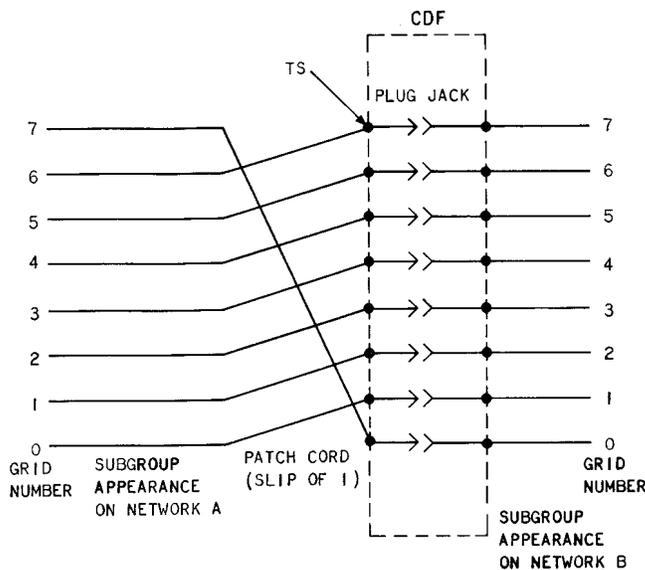
NETWORK A SEES A SLIP OF ONE.
(PLUG TO JACK SLIP)

NETWORK B SEES A SLIP OF SEVEN (MINUS ONE)
(JACK TO PLUG SLIP)

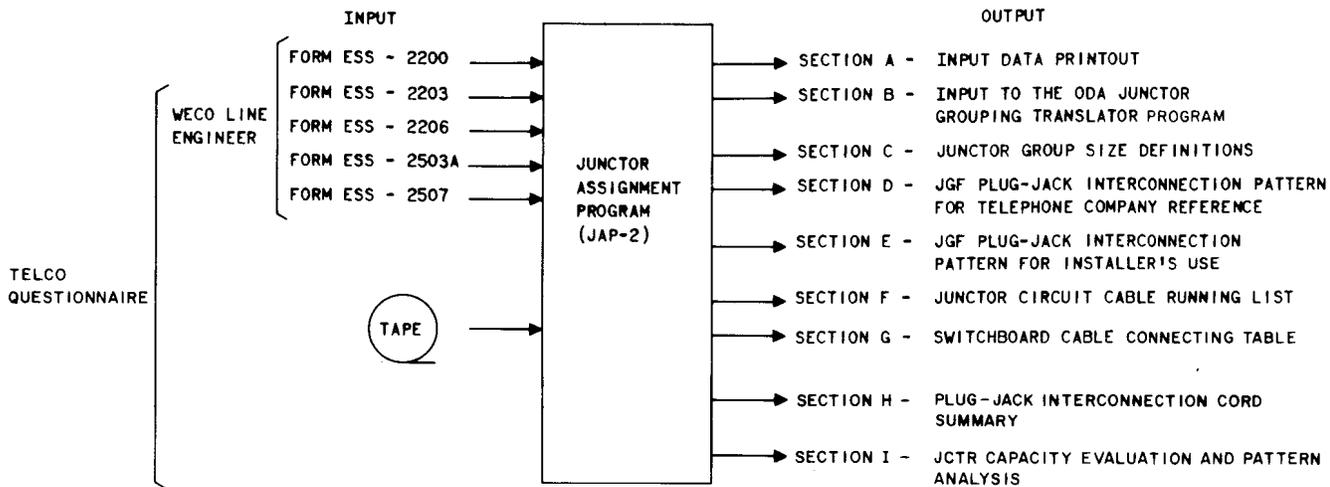
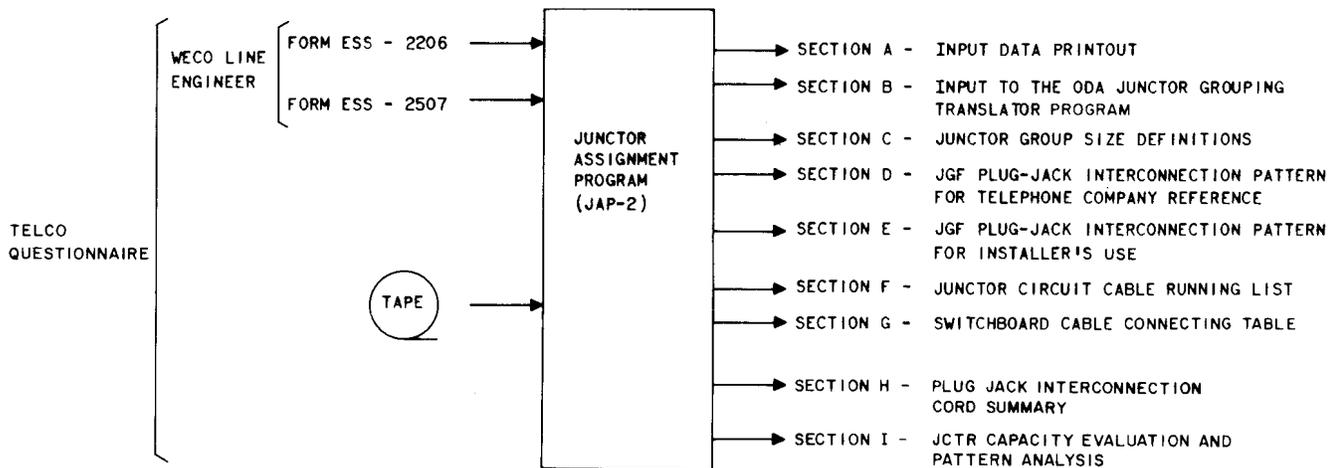
Fig. 5—Processing of Junctor Assignments

GROWTH AND NEW OFFICES

BALANCING AN OFFICE

2.02 The input to the JAP-2 will be completed by the Western Electric Company line engineer using the data supplied to him by the operating company (Fig. 5). A description of each of the forms filled out by the line engineer and the operating company is as follows.

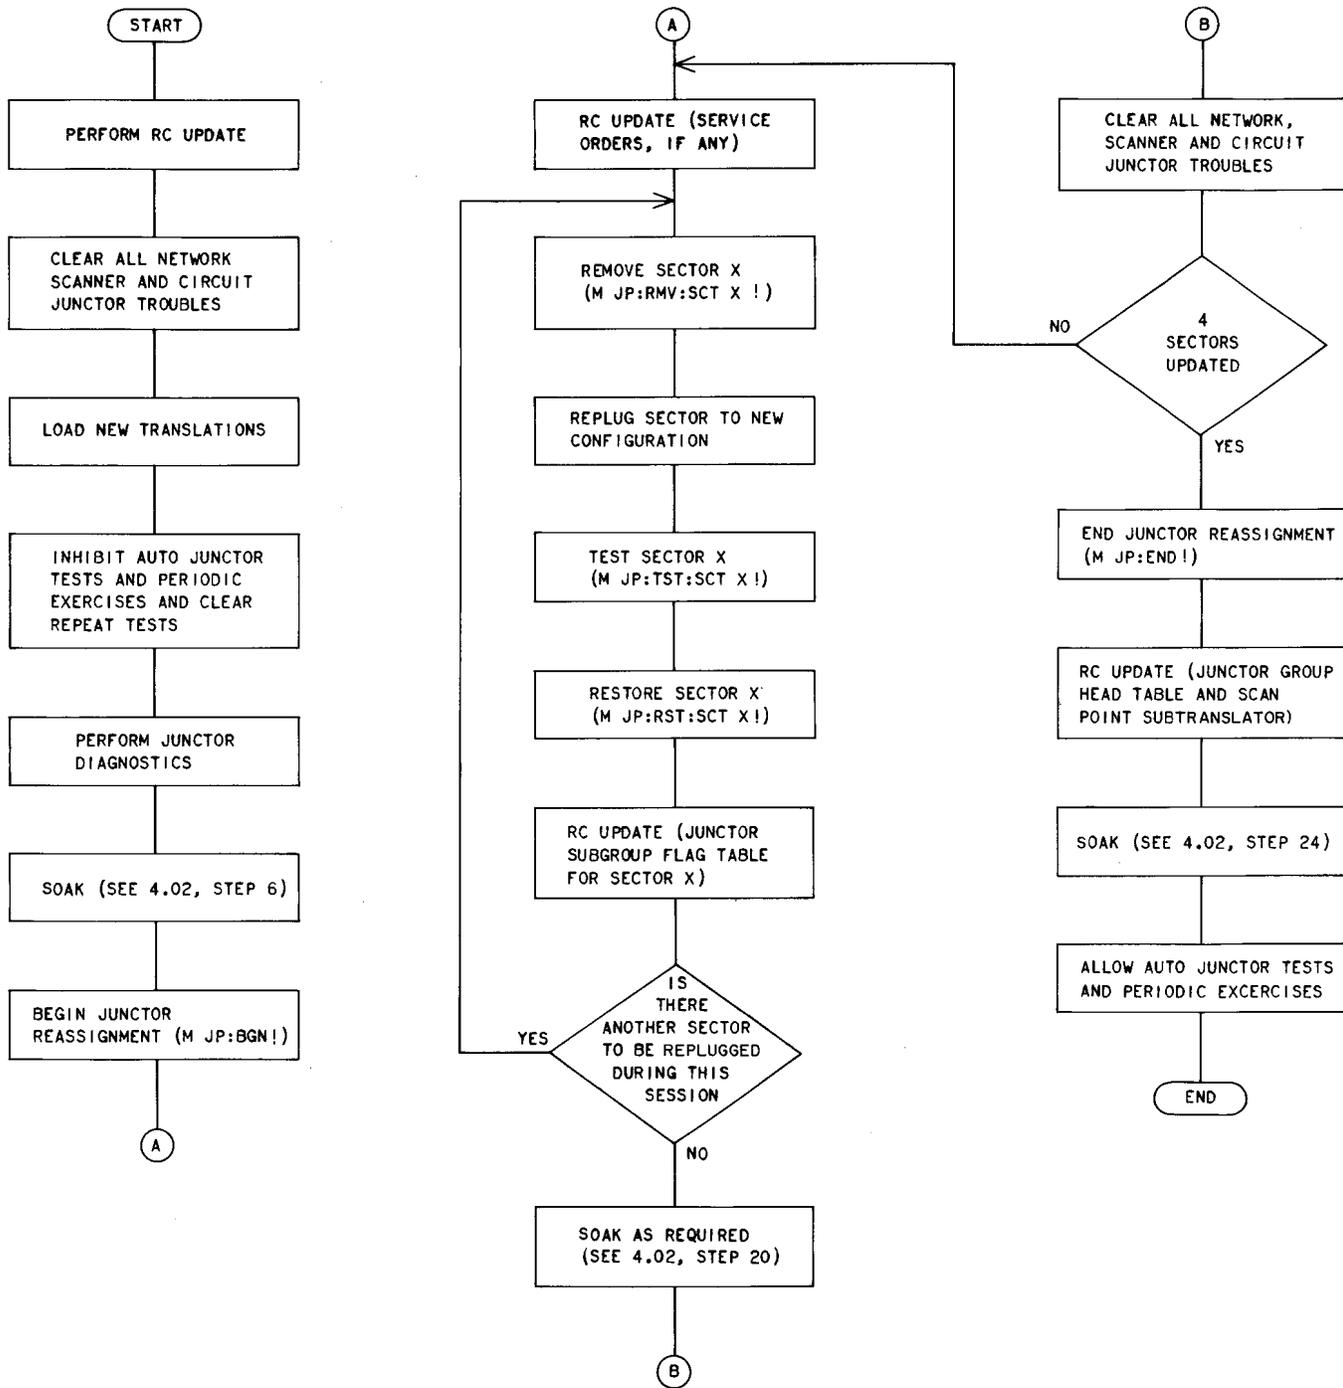
Fig. 20—Flow Chart of Junctor Reassignment Procedure

4.01 A simplified flow chart of the junctor reassignment procedure is shown in Fig. 20.
