CHANGE IN PROGRAM STORE WORD

DESCRIPTION

NO. 2B ELECTRONIC SWITCHING SYSTEM

SECTION 232-304-101

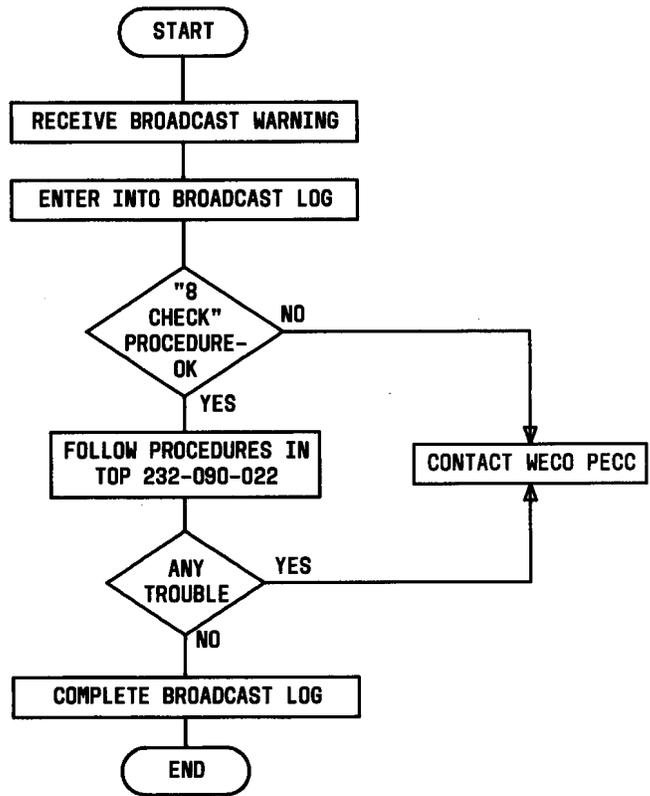
Fig. 2—Flowchart of Procedure for Inserting No. 2B ESS Broadcast Warnings

3.12 A flowchart of the inspection of overwrites is given in Fig. 2.
