Task Oriented Practice (TOP)

4ESS™ Switch With 1B Processor Expanded Time Slot Interchange (XTSI) Cabinet Trouble Clearing Procedures

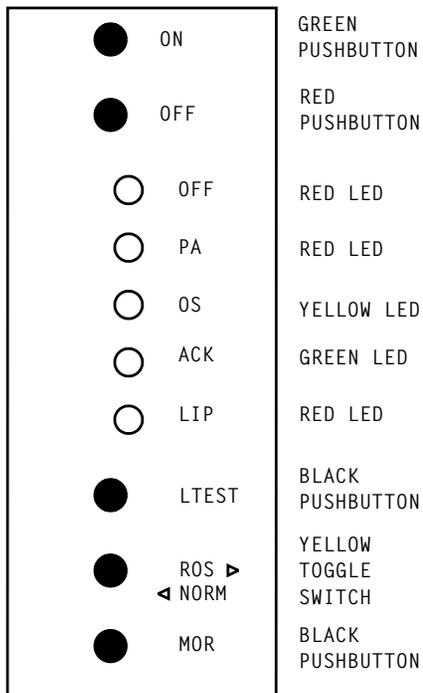
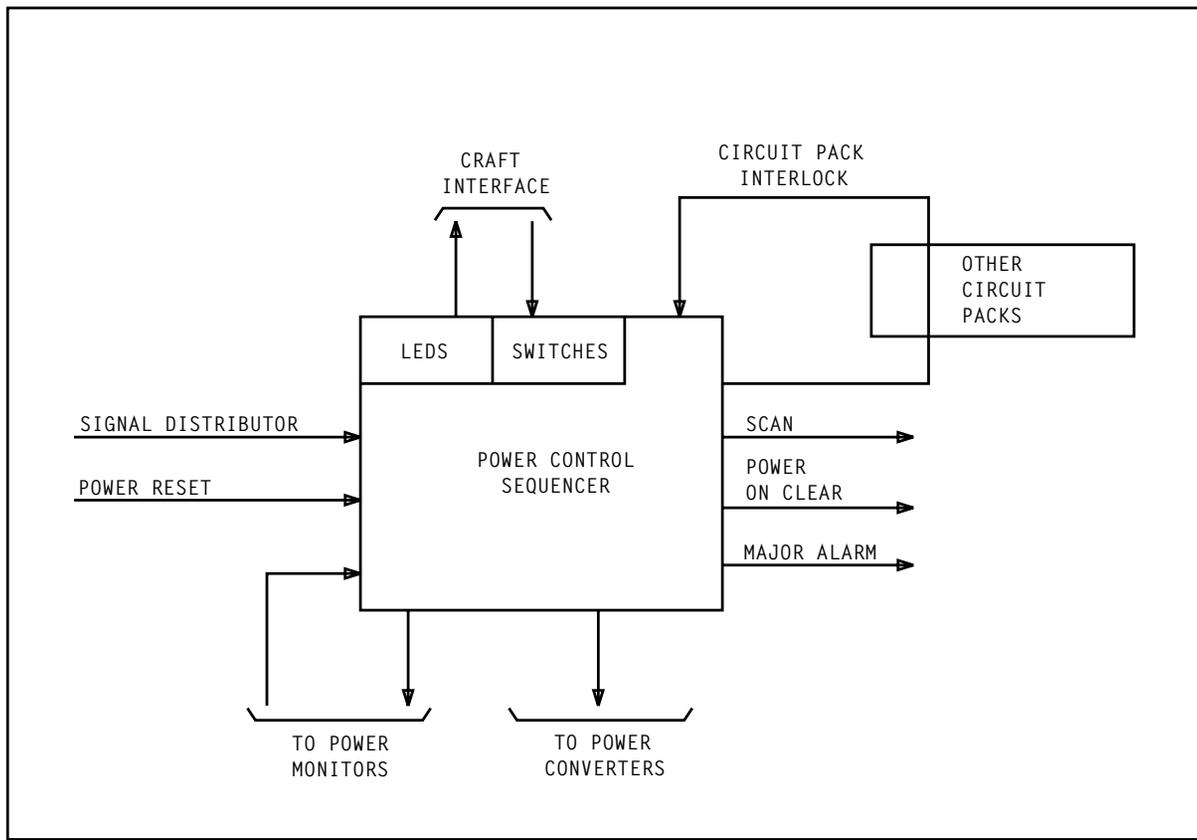
XTSI CABINET UNIT POWER SWITCHES

TABLE B POWER SWITCH FUNCTIONS			
IDENTIFIER	NAME	SWITCH TYPE	FUNCTION
ON	Power On	Pushbutton	Powers up unit from power off state. No software intervention required
OFF	Power Off	Pushbutton	Powers down out-of-service unit. When operated simultaneously with MOR pushbutton, powers down in-service unit. Clears any alarm state. No software intervention required.
ROS/ NORM	Request Out-of-Service/ Normal	Two Position Toggle	When positioned to the right (request out-of-service position), a request to remove unit from service is initiated. ACK LED will flash and OS LED will light. Software intervention required.
			When positioned to the left (normal position), a request to restore unit to service is initiated. ACK LED will flash and OS LED will go off. Software intervention required.
LTEST	Lamp Test	Pushbutton	Test power switch LED indicators and PA LEDs on power group circuit packs.
MOR	Manual Override	Pushbutton	When operated simultaneously with OFF pushbutton, powers down in-service unit. No software intervention required.

Power Switch Functional Block Diagram

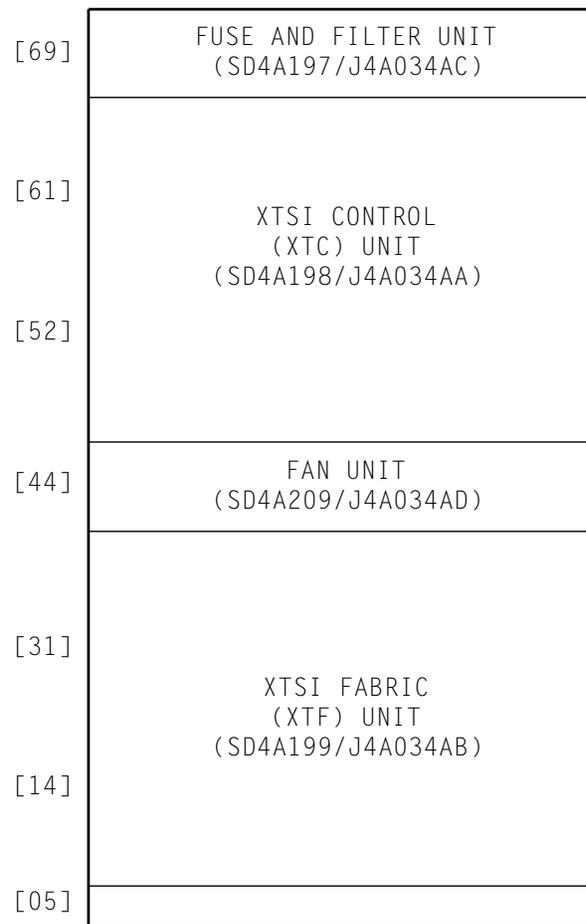
XTSI CABINET PHYSICAL LAYOUT AND ASSOCIATED EQUIPMENT DRAWINGS

Physical Layout of XTSI Cabinet (SD4A196/J4A034A)

The Expanded Time Slot Interchange (XTSI) complex includes two XTSI cabinets measuring 72 inches high, 29.92 inches wide and 23.39 inches deep. Only one XTSI cabinet is required to house equipment for the initial XTSI release. The second cabinet will remain vacant for the initial XTSI release and be utilized in future XTSI releases. The XTSI is a 4ESS Switch peripheral that replaces the functionality of the Digital Interface Frame (DIF) and Time Slot Interchange (TSI) frames. In addition to functionally replacing the DIF and TSI frames, the XTSI cabinet will accept a DS3 transmission interface. The XTSI cabinet is composed of four units:

The XTSI fan unit houses six fans and is mounted between the XTC and XTF units. The fan unit directs air from three fans upward through the XTC unit and from the other three fans downward through the XTF unit. In addition to fans, the fan unit is equipped with two replaceable air filters; control circuitry and thermistors that sense the cabinet's cooling demands. The complete fan system includes 6 thermistors that sense the air temperature exiting at the top and bottom of the cabinet. A major alarm is activated when a failure of any fan system component is detected.

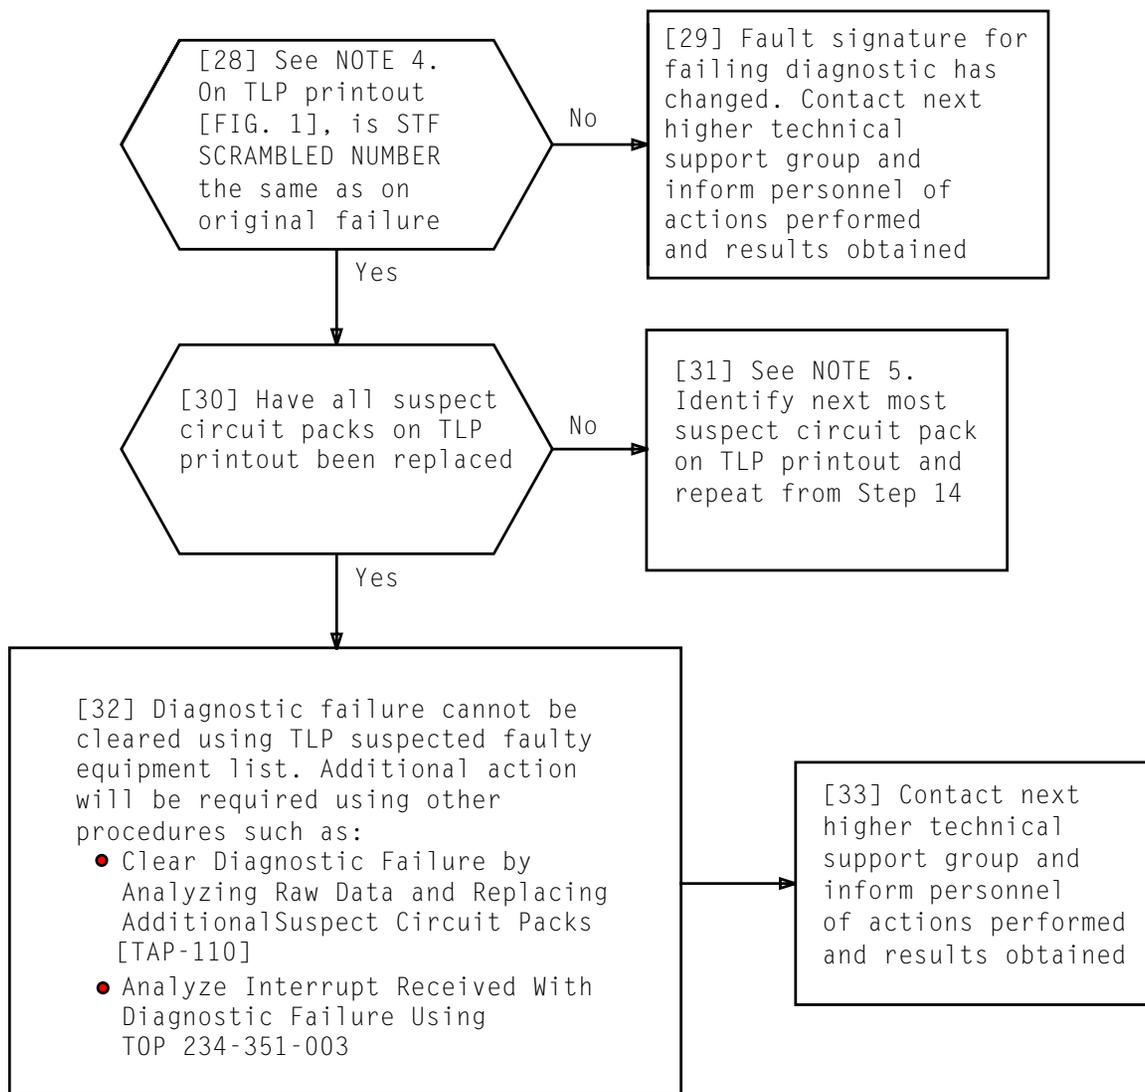
4. The STF SCRAMBLED NUMBER indicates if all the diagnostic raw data (test and mismatch) is identical or different for two diagnostic runs. If STF SCRAMBLED NUMBER value is same, diagnostic raw data is identical. Otherwise, diagnostic raw data has changed in some manner

5. Suspect circuit packs are printed on TLP printout in the order that they are to be replaced

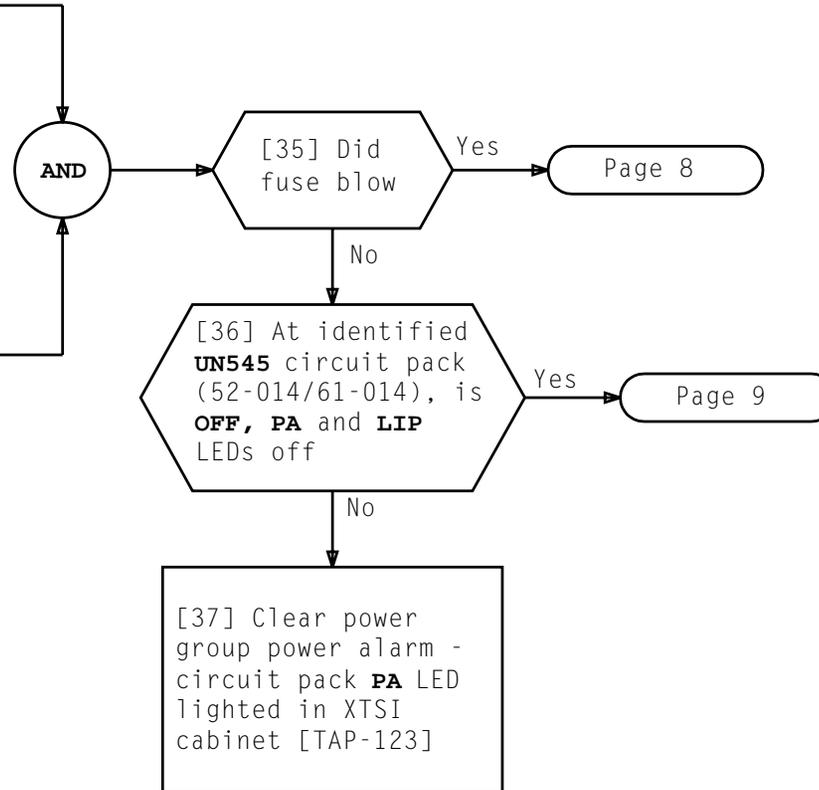
[33] At identified **UN545** circuit pack (52-014/61-014), depress **OFF** pushbutton to clear alarms

[34] At identified **UN545** circuit pack (52-014/61-014), depress **ON** pushbutton

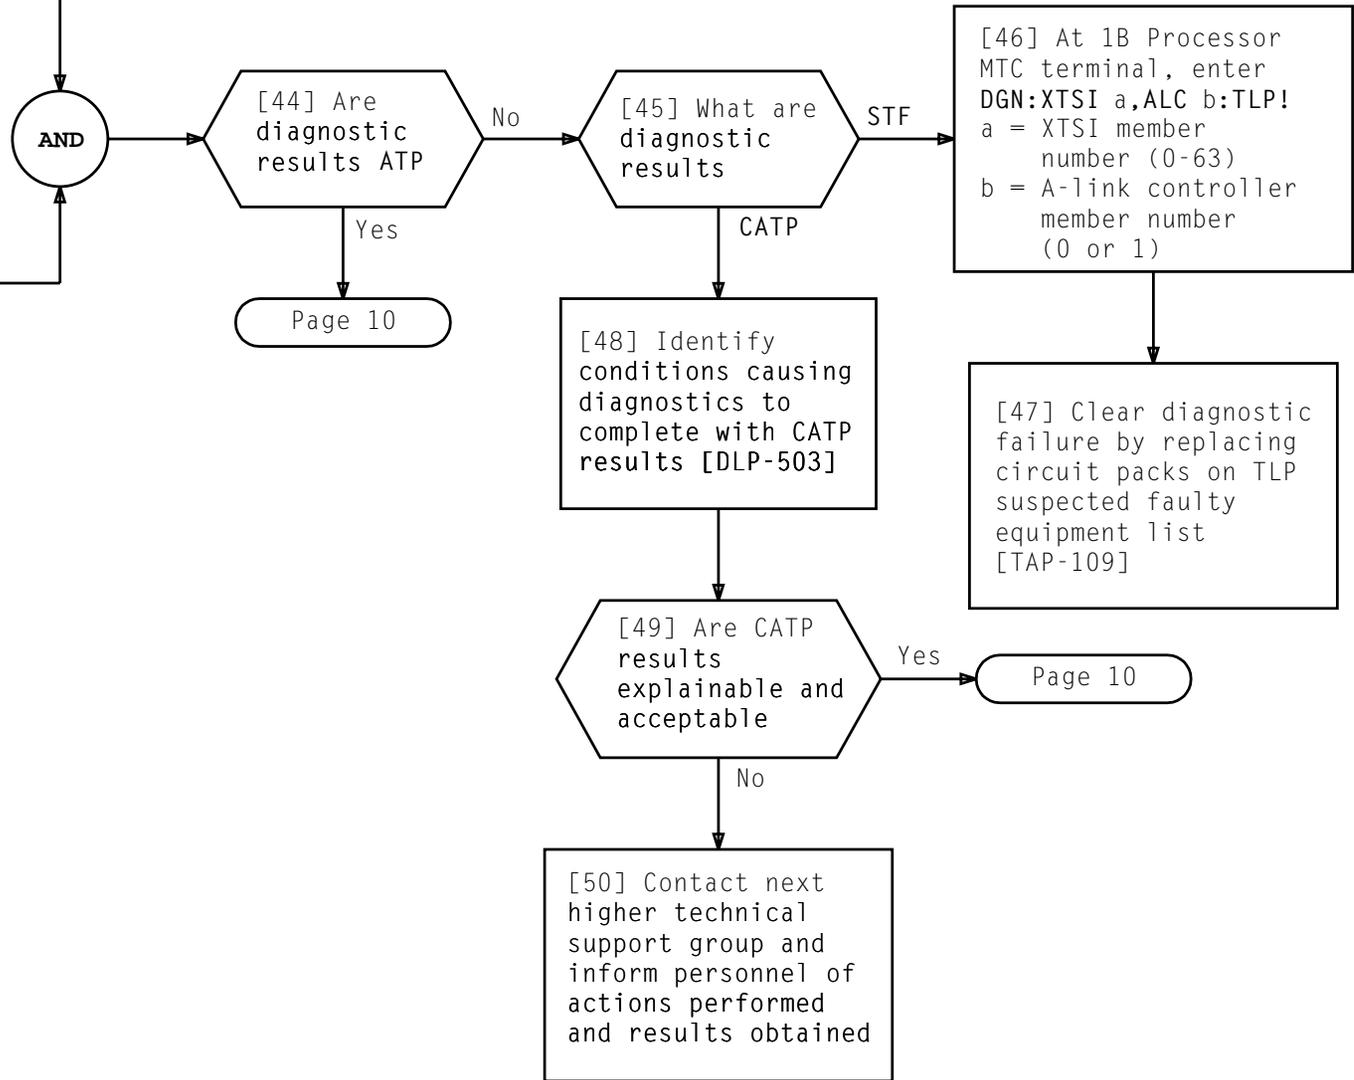
[42] At identified **UN545** circuit pack (52-014/61-014), move **ROS** switch left to normal position

[43] Allow ample time for diagnostics to complete

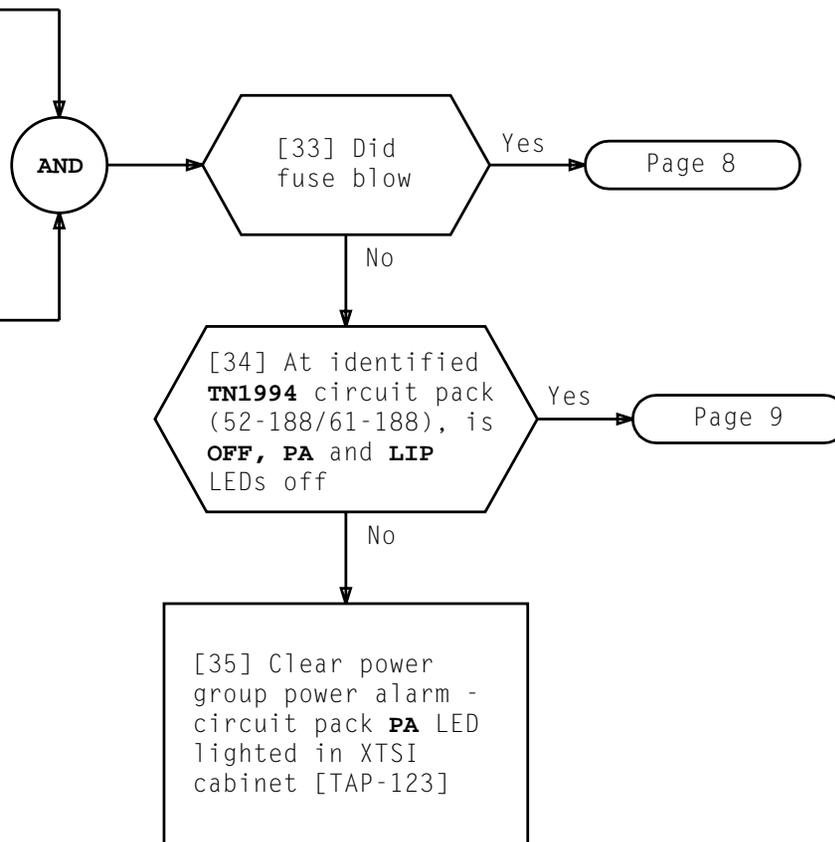
[31] At identified **TN1994** circuit pack (52-188/61-188), depress **OFF** pushbutton to clear alarms

[32] At identified **TN1994** circuit pack (52-188/61-188), depress **ON** pushbutton

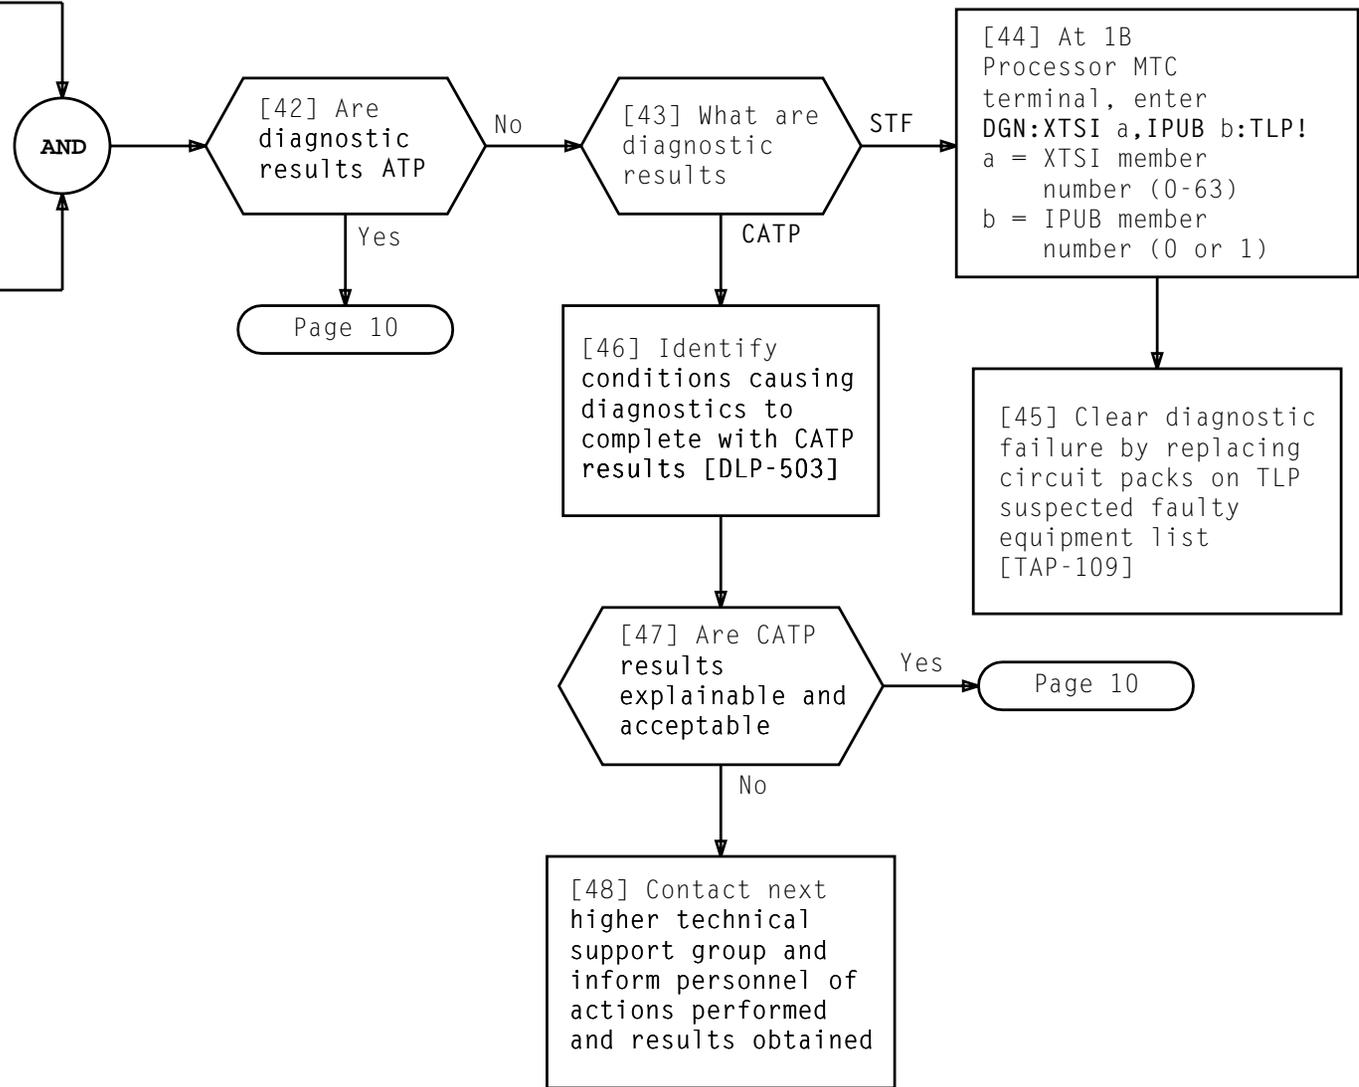
[40] At identified **TN1994** circuit pack (52-188/61-188), move **ROS** switch left to normal position

[41] Allow ample time for diagnostics to complete

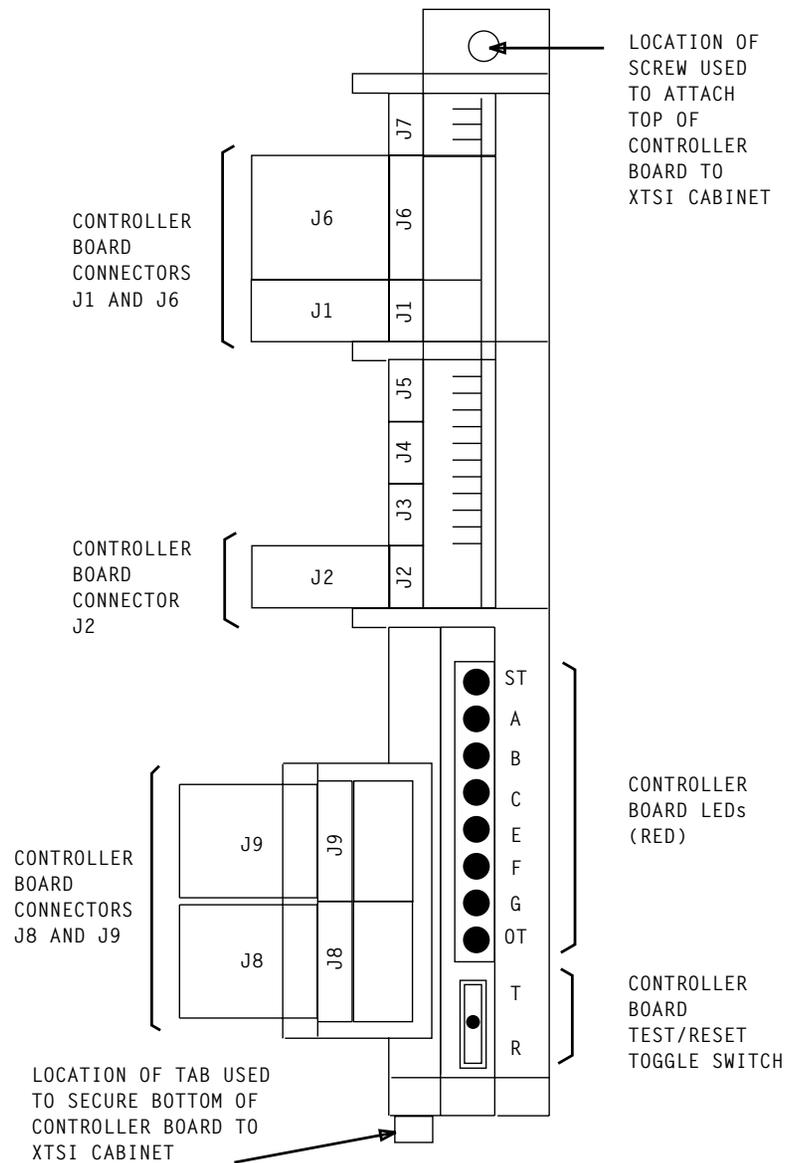
FIG. 1 - Fan System Controller Board (44-004R)

FAN SYSTEM CONTROLLER BOARD LEGEND		
CONTROLLER BOARD INDICATOR	INDICATOR IDENTIFICATION	
ST LED	STATUS LED	
A LED	FAN A FAIL LED	
B LED	FAN B FAIL LED	
C LED	FAN C FAIL LED	
E LED	FAN E FAIL LED	
F LED	FAN F FAIL LED	
G LED	FAN G FAIL LED	
OT LED	OVER TEMPERATURE LED	
TWO FUNCTION TOGGLE SWITCH	T	TEST
	R	RESET
