DMS-100 Family

DMS VoiceMail

Maintenance Messages (SEER) Manual

SPM 02 Standard 02.02 March 1994

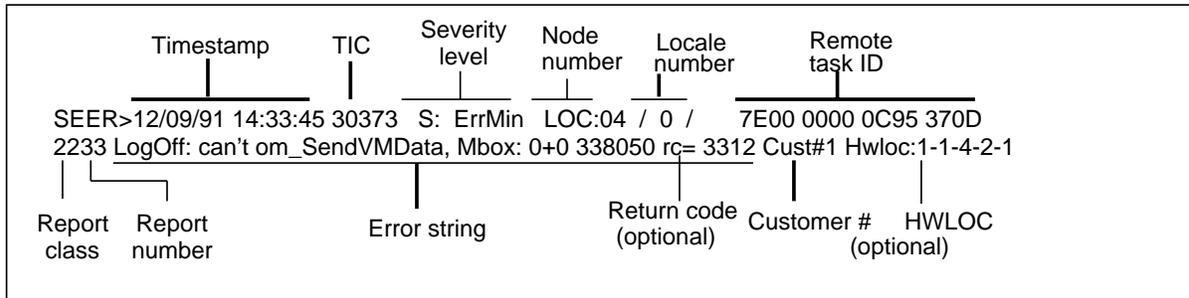
Figure 1
Parts of a SEER

A sample SEER is shown in Figure 1.

Each SEER is identified by a number. This number consists of two parts:

- 1 Report Class
- 2 Report number

Each class contains up to 99 reports. Depending on the problem, reports may generate one of several messages. Figure 1 shows a SEER as it appears on the printer and terminal.
