DATA SWITCHING NETWORK

M3212 SYNCHRONOUS/ASYNCHRONOUS MULTIPLEXER

1.01 This section describes how to install and test the Computer Transmission Corporation's (TRAN*) M3212 Synchronous/Asynchronous Multiplexer. GAEL 1695 authorizes the use of this equipment in Pacific Company (PAC).

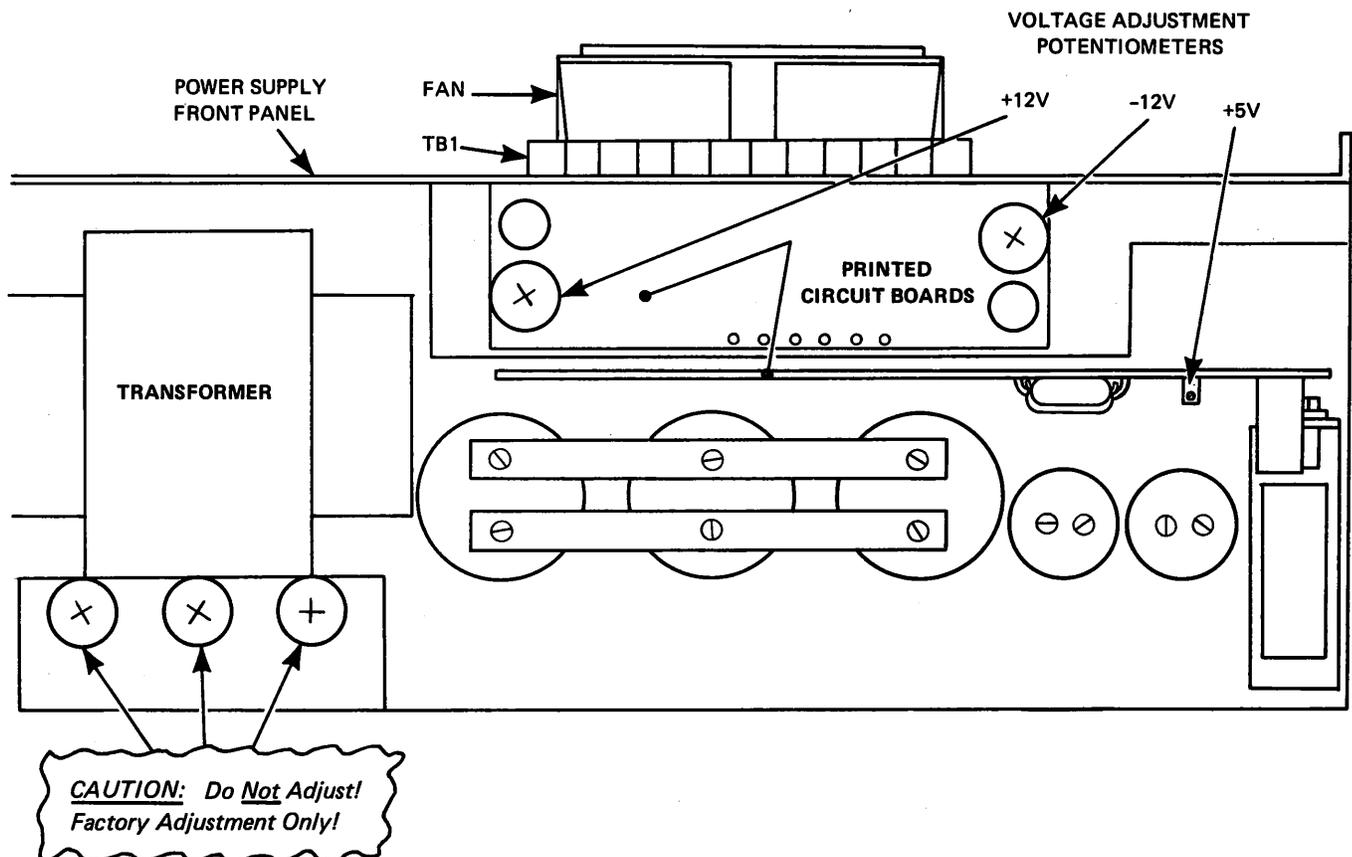
Rear View of Early 30-Amp Power Supply
Showing Location of Voltage Adjustment Potentiometers
Fig. 3

3.01 Adjustment of the power supply depends upon whether the multiplexer is equipped with a single or a dual power supply. Also, there are two models of the 30 Amp power supply. The early version has adjustments in the rear as shown in Fig. 3. The current version has adjustments at the top as shown in Fig. 4.

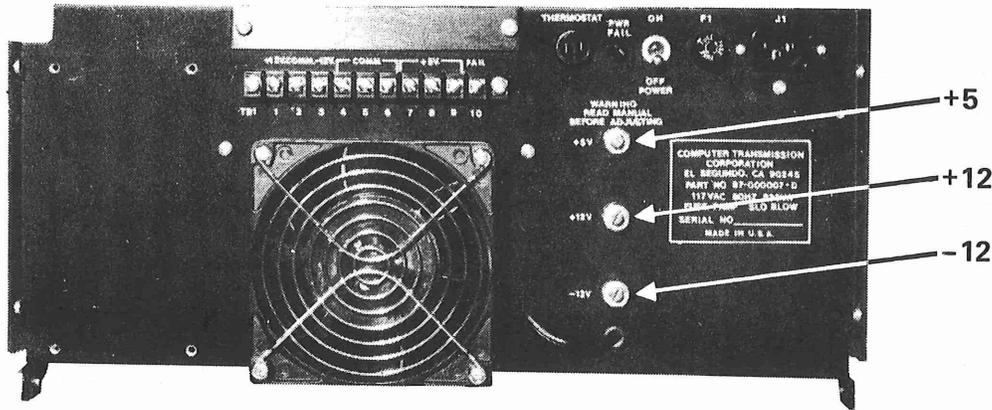
New Power Supply
Fig. 4
