Part No. 314754-C Rev 00
March 2003

Release Notes for the Passport 8000 Series Switch Software Release 3.3.2

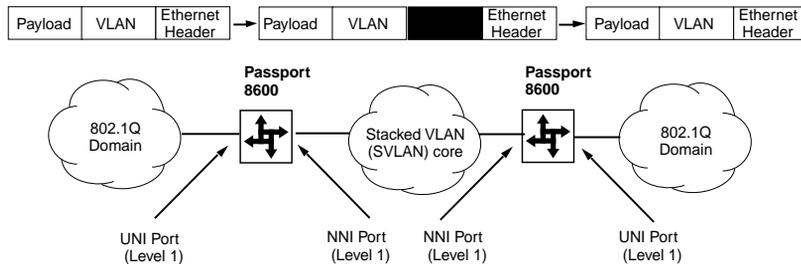
Figure 2 One layer SVLAN

You can stack SVLANs in a hierarchical fashion to achieve greater VLAN scalability. An SVLAN level defines the hierarchy for the operating switch. When configuring the switch, you must specify only one level at a time. Figure 2 shows a one layer SVLAN, while Figure 3 shows two layers.

SVLAN tags are added onto SVLAN NNI ports and removed on SVLAN UNI ports. You must configure UNI ports on both ends of the tunnel at the same level. Since SVLAN switching is MAC-addressed based, the normal issues of VLAN switching apply.
