**EQUALIZATION OF
15KC LOCAL PROGRAM CIRCUITS**

1.001 This addendum supplements Section 320-145-504 Issue 3. The attached pages must be inserted in the section in accordance with the filing instructions above.

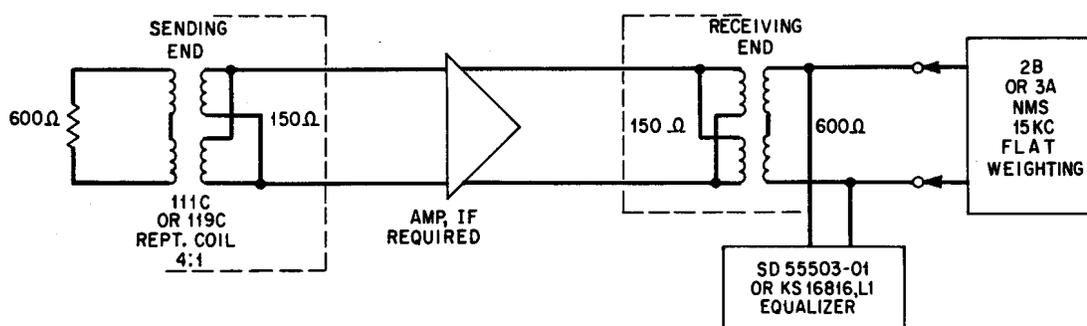
Fig. 3 - Final Noise Test for 15 kc Circuit

3.01 For 15 kc circuits, the test setup for the final noise measurements is shown in Fig. 3. The 2B Noise Measuring Set should be modified for 15 kc flat weighting. The 3A NMS should be equipped with the 15 kc flat weighting network. The sets should be connected to the circuit in accordance with the standard practices for the instruments.

3.04 The crosstalk should be observed using the setup of Fig. 3 and using the monitoring receiver provided with the 2B or 3A set. No intelligible words or syllables should be heard with the DB dial of the set adjusted to the same dial setting for measuring noise. The circuit should be monitored for at least 10 minutes during the heavy traffic load period.
