LambdaXtreme[™] Transport

Alarms, Messages, and Trouble Clearing Guide

Release 1.1

365-575-783R1.1
Issue 1
June 2002

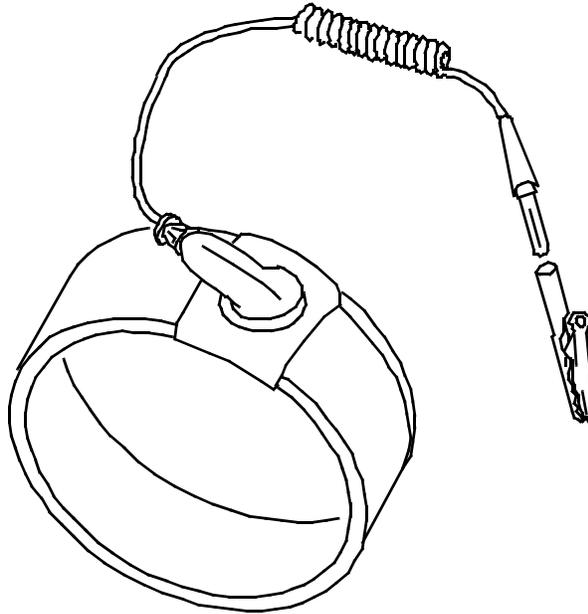
Any connectors on the shelf interconnection panel that are not cabled should be fitted with a plastic dust cap to provide ESD protection. To reduce the possibility of ESD damage, shelves are equipped with grounding jacks to enable personnel to ground themselves using wrist straps while handling circuit packs/units or working on a shelf. See

the figure below. The wrist straps should be checked periodically with a wrist strap tester to ensure that they are working properly.

Important! The grounding jacks for connection of wrist straps are located at the front of the bay on the right side, just below the hinge for each shelf cover.

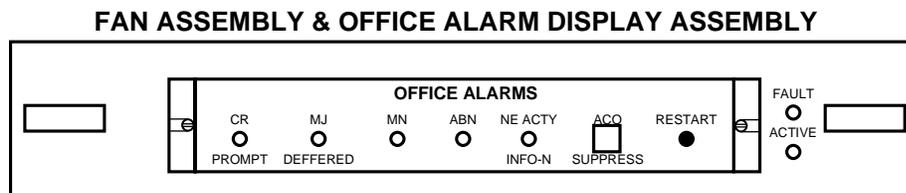
Figure 1-1 *LambdaXtreme* Transport User Panel

[Figure 1-1, “*LambdaXtreme* Transport User Panel” \(1-7\)](#) shows the Office Alarms panel, located in the System Bay, between each pair of shelves, on the ‘Fan Assembly & Office Alarms Assembly’ circuit pack.

The Office Alarms panel features from left to right, three alarm indicator LEDs, two status indicator LEDs, and two control buttons/switches. Each LED is labeled with the SONET-based name above the light, and the SDH-based name below. In case of suspected trouble, the LEDs can be tested using the procedure detailed in [“TAP-612: Address ‘Test alarm in progress’ and ‘Test LED in progress’” \(6-177\)](#).

CR/Prompt LED In the SONET environment, Critical Alarms indicate that a severe, service-affecting condition has occurred and immediate corrective action is imperative regardless of the time of day or day of week.

In the SDH environment, Prompt Maintenance Alarm (PMA) is generated to initiate activities (normally immediately) by maintenance personnel to remove defective equipment in order to restore good service and repair the failed equipment. This LED is red and is labeled *CR/Prompt*.

NE ACTY/Info-N LED When lit, this yellow LED indicates that there is an alarm or status condition active on the local network element. This includes any condition identified, regardless of the alarm level. An alarm condition is one with a severity attribute of Critical (CR), Major (MJ), Minor (MN), Prompt, or Deferred. A status condition is one with an alarm attribute of NA, NR, NO, No_Alarm, or No_Report. The NE-ACTY LED is lit for both types of conditions.

Alarm Cut Off/Suppress LED When lit, the green Alarm Cut Off/Suppress LED indicates that an alarm condition exists, but the audible alert associated with the condition has been turned off. The LED is labeled **ACO (Suppress)**.

The Alarm Cut Off (ACO)/Suppress button turns off any audible alarm indicators. After the ACO/Suppress button has been pressed, any subsequent alarm conditions reactivate the audible alarm.

The Restart Switch restarts system software using the provisioned parameter values that were defined prior to the restart. A restart causes the local network element to reset. This switch is recessed to avoid accidental activation.

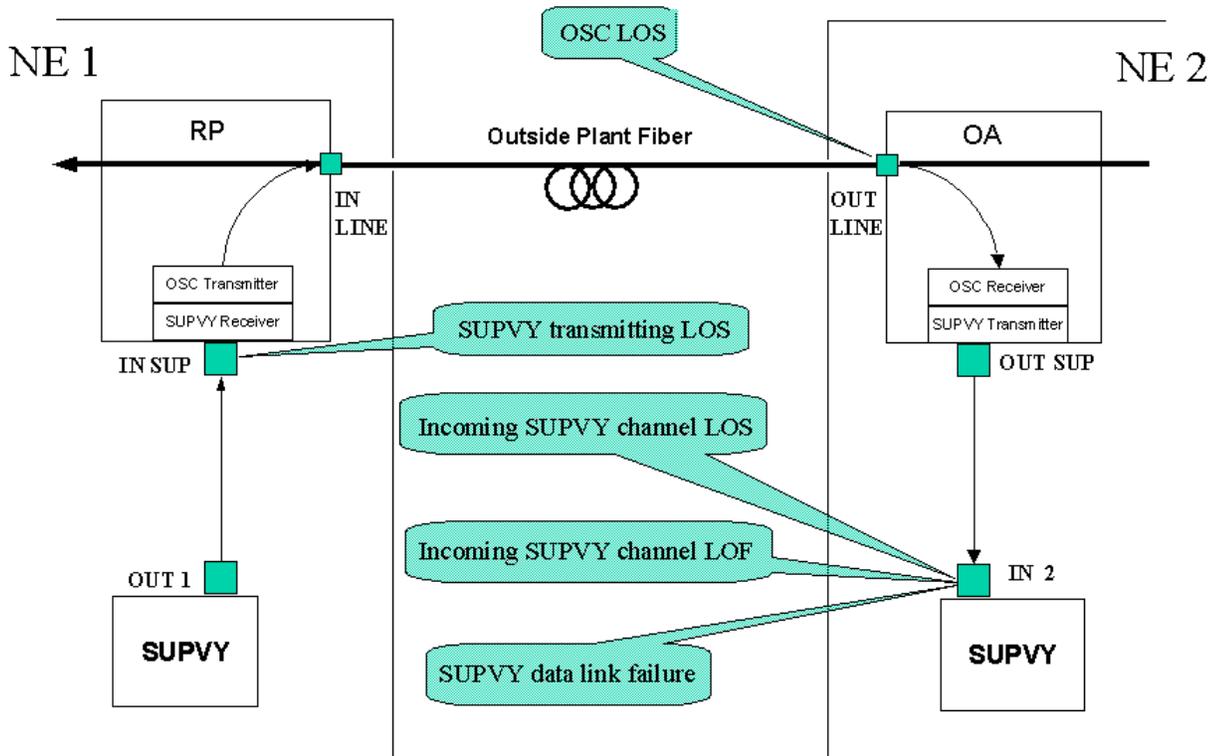
Figure 2-1 SUPVY Link Failures

Figure 2-1, “SUPVY Link Failures” (2-20) shows the SUPVY transmit path between two adjacent NEs, indicating failure detection points and associated alarm conditions.

If SUPVY transmitting LOS is detected at NE1, Incoming SUPVY channel LOF will be raised at the SUPVY circuit pack in NE2, as illustrated in [Figure 2-1, “SUPVY Link Failures” \(2-20\)](#).

- SUPVY circuit pack failure at the transmitting NE (NE1 in [Figure 2-1, “SUPVY Link Failures” \(2-20\)](#))
- Presence of SUPVY transmitting LOS at the transmitting NE
- Degradation of the OSC transmission in the outside plant or degradation of SUPVY signal between OA and SUPVY circuit packs

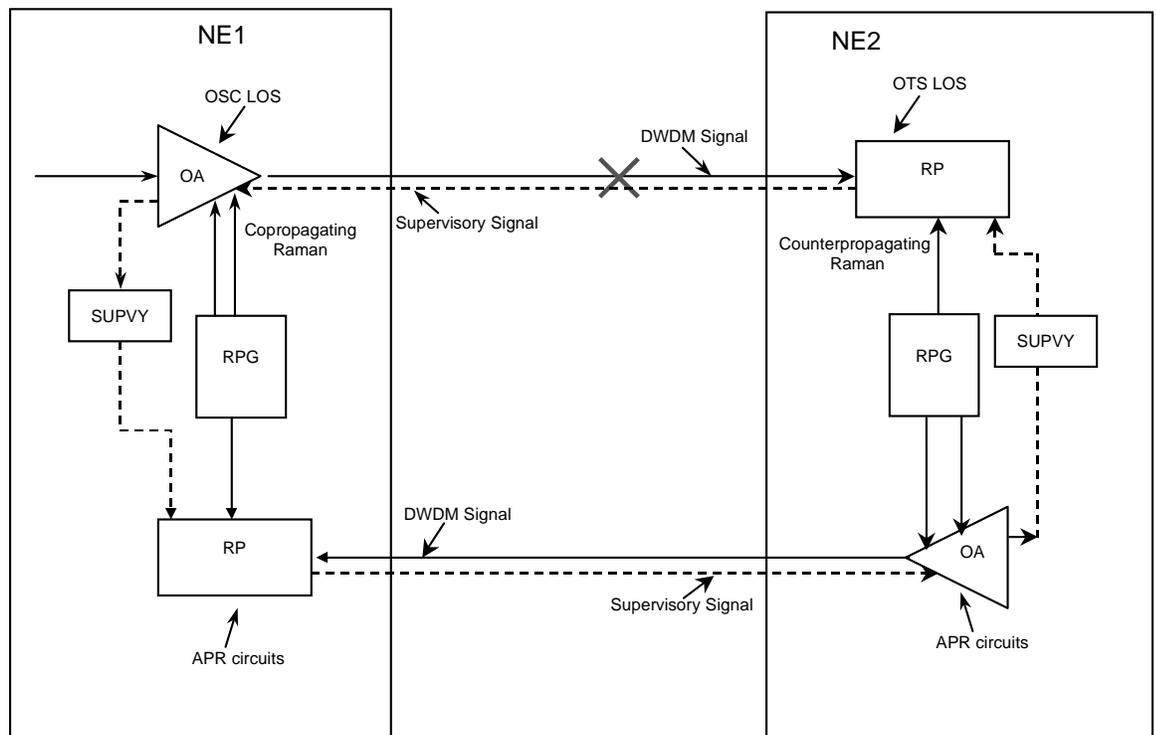
Figure 3-1 APR for a single fiber cut

APR activation [Figure 3-1, “APR for a single fiber cut” \(3-3\)](#) shows APR for a single fiber cut case. The fiber cut affects all the channels in the Extended L band transmitted from NE1 to NE2 and the supervisory channel transmitted from NE2 to NE1.

The system performs automatic restart as soon as the damaged fiber is repaired. The automatic restart at NE1 is triggered by the successful detection of the Supervisory signal sent by NE2 to NE1. After detecting the supervisory signal, NE1 notifies NE2 that the Supervisory defect has been cleared. This notification causes NE2 to initiate the restart process. See [Figure 3-1, “APR for a single fiber cut” \(3-3\)](#).

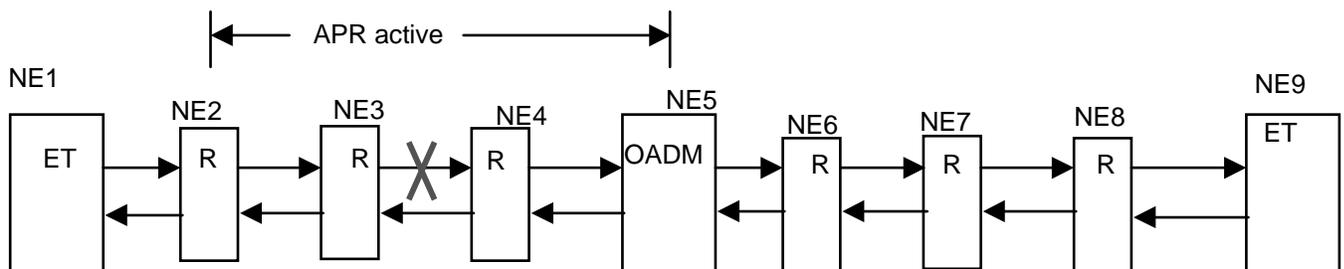
Figure 3-2 APR Active Zone for single-fiber cut

[Figure 3-2, “APR Active Zone for single-fiber cut” \(3-5\)](#) shows the APR active zone for a single fiber cut. The APR condition is expected in NE2 through NE5. NE2 will have APR active- line non-alarmed condition indicating the turn down of OA and the copropagating pumps. NE3 and NE4 will have the APR active-line non-alarmed condition for copropagating,, counterpropagating, and DCM pumps for the impacted transmission direction only. NE5 will have the APR active-line non-alarmed condition for counterpropagating pumps in RP and RPG for the impacted transmission direction only.

It is necessary to look at the upstream nodes to determine whether the reported APR condition is caused by a problem in the local node or if it has propagated to this node from a problem further upstream. Once you have identified the node furthest upstream that is reporting an APR active: line alarm condition, you can expect to find the source of the problem located between the second and third downstream nodes. See [Figure 3-2, “APR Active Zone for single-fiber cut” \(3-5\)](#).

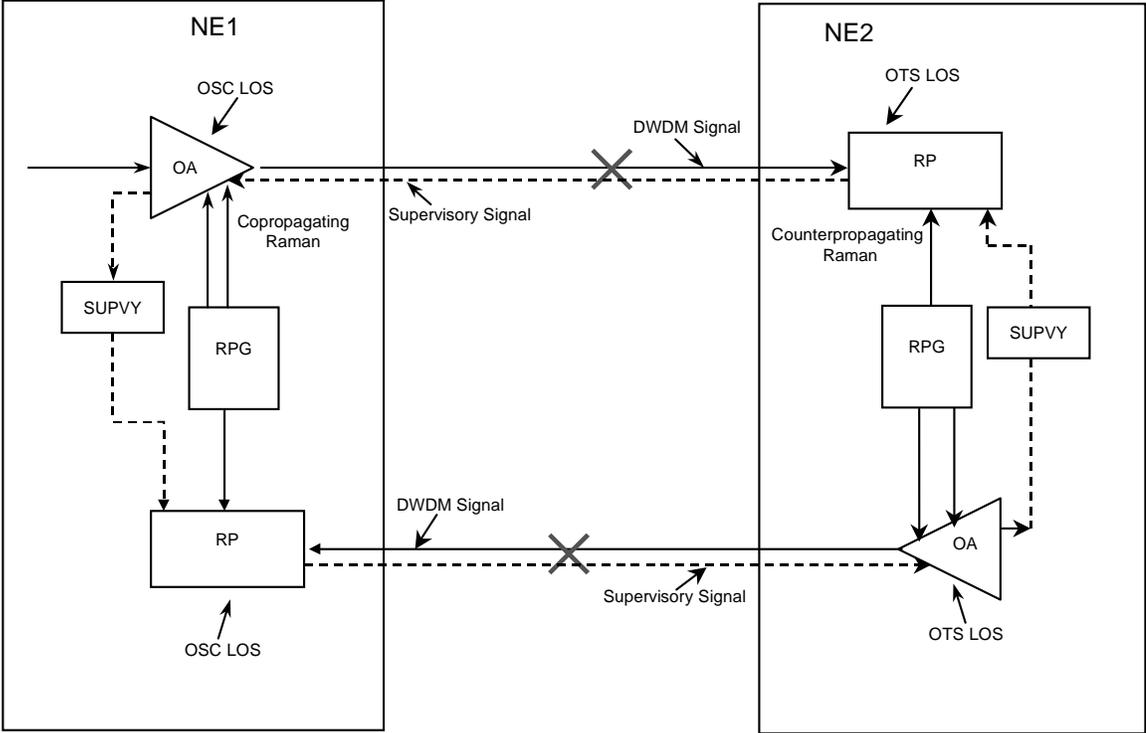
Figure 3-3 APR for two-fiber cuts

APR Activation Figure 3-3, “APR for two-fiber cuts” (3-8) shows a two-fiber cut.

When both fibers between two adjacent NEs are cut simultaneously, the two NEs react identically because both NEs detect a loss of Supervisory signal and loss of DWDM signal. Each NE detects the loss of the supervisory channel and initiates the APR procedure to lower the copropagating and counterpropagating Raman power associated with the two fibers.

In a two fiber-cut, when Fiber 1 has been repaired, and Fiber 2 is still awaiting repair, the following occurs (see [Figure 3-3, “APR for two-fiber cuts” \(3-8\)](#)):

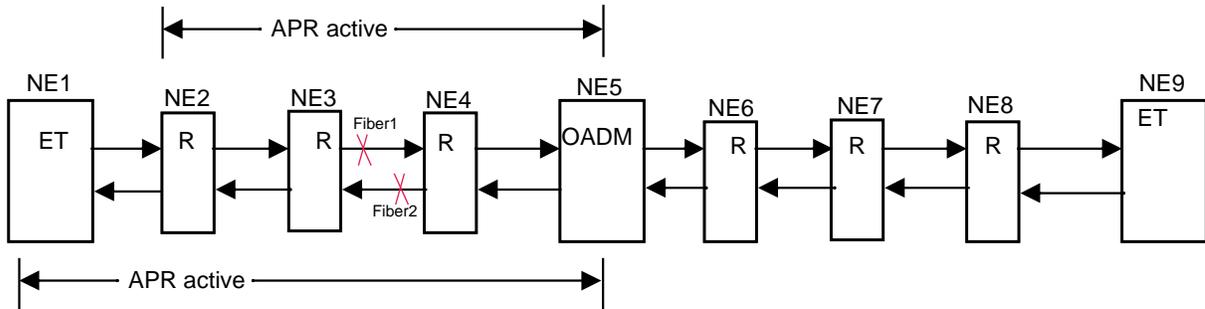
Figure 3-4 APR Active Zone for two-fiber cut

[Figure 3-4, “APR Active Zone for two-fiber cut” \(3-10\)](#) shows an example of the APR Zone for a 2-fiber cut. An APR condition is present in NE2 through NE5 for transmission in the direction of NE9. APR condition is present in NE1 through NE5 for transmission in the direction of NE1. NE2 has APR active for the OA and the copropagating pumps in the RPG for the transmission direction travelling from NE1 to NE5. In the other direction, NE2 will have APR active for copropagating, counterpropagating, and DCM pumps. NE3 and NE4 have APR active for copropagating, counterpropagating

and DCM pumps for both transmission directions. If the OADM has only 1 to 3 channels, then the APR active condition may extend to nodes further downstream.

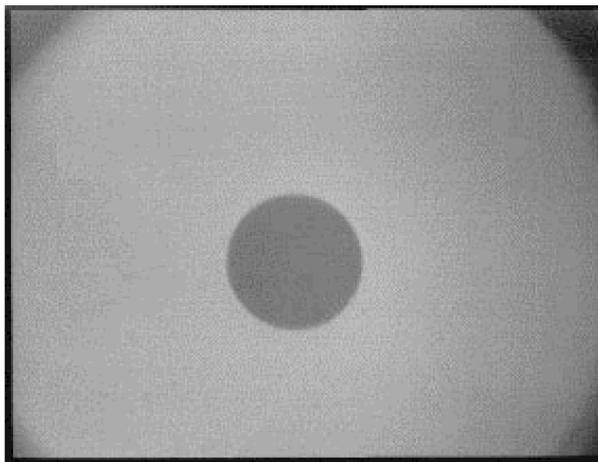
Figure 7-1 Image of Clean Connector

Clean connector [Figure 7-1, “Image of Clean Connector” \(7-11\)](#) shows an example of a clean fiber connector.

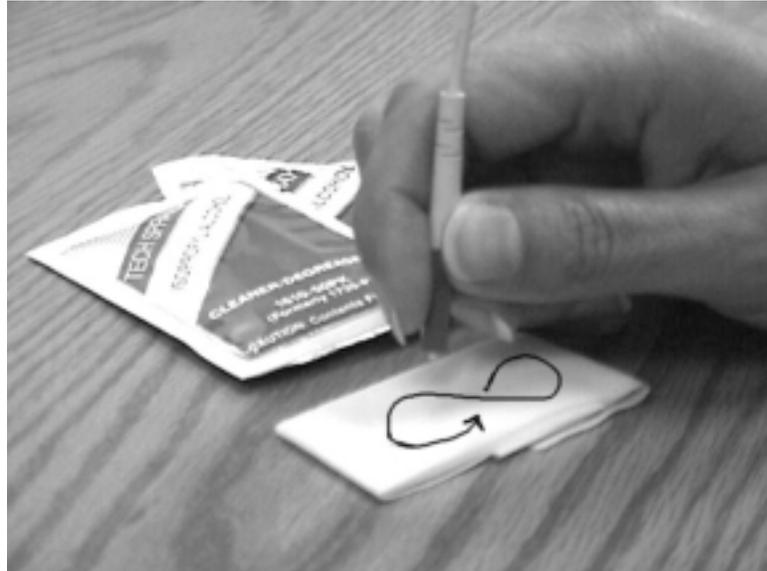
Figure 7-2 Cleaning the Ferrule Endface

Drag it against the wipe three (3) times in a figure eight pattern. This action applies the alcohol solvent to the endface and initially loosens and scrubs away organic/solid contaminants. Refer to [Figure 7-2, “Cleaning the Ferrule Endface” \(7-13\)](#).

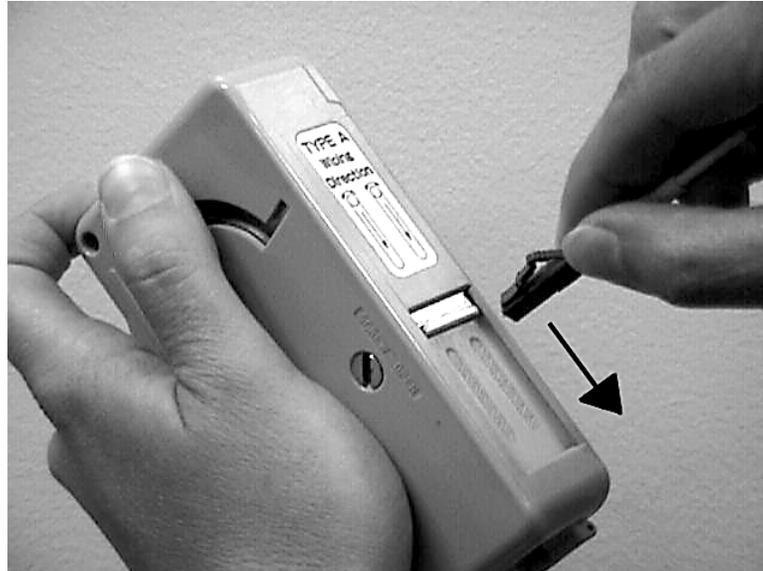
Figure 7-3 CLETOP Cleaner

-
- 3 If a CLETOP cassette cleaner is not available, proceed with [Step 7](#). Otherwise, hold the CLETOP cassette cleaner in the palm of your hand with the cassette shutter door facing up. See [Figure 7-3, “CLETOP Cleaner” \(7-14\)](#)

Rotate the cassette lever all the way down with your thumb. Do not release the lever. The lever advances the “dry” Luminex cleaning cloth inside the case and simultaneously opens the shutter. The

CLETOP cassette shutter door is now open and ready for cleaning the connector.

-
- 4** Insert and press the connector ferrule endface perpendicular against the cleaning cloth in the first of two slots of the cleaner.
Drag it down in the direction indicated by the arrows on the cleaner. Do not release the lever of the cassette.

- 5** Lift the connector from the first slot and rotate it 90 degrees and repeat the wiping procedure using the second slot. Be sure the ferrule is pressed snug against the cleaning cloth while dragging the ferrule to assure the proper cleaning action.

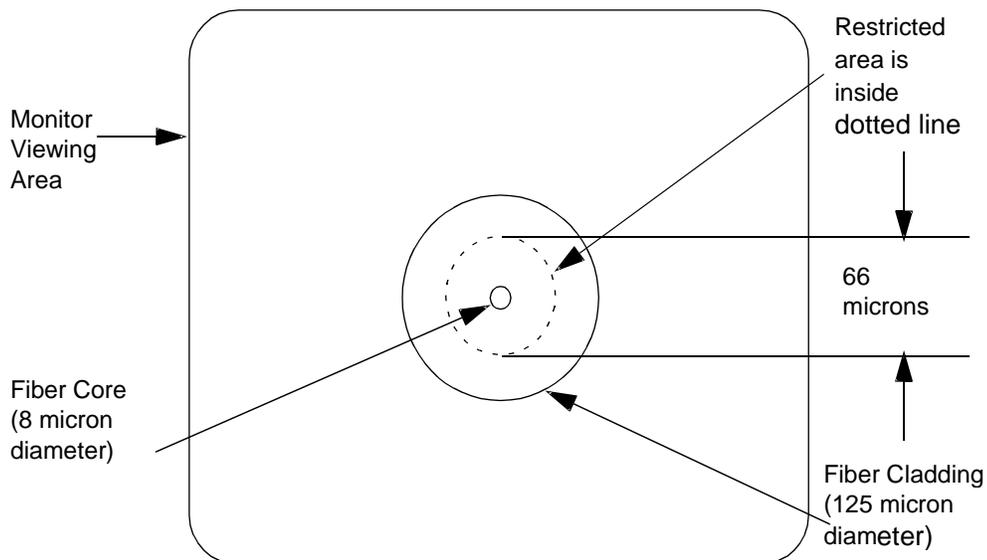
Figure 7-4 Acceptability Criteria for Single-Mode and Multimode Fibers

Restricted Area: A circle with a diameter of 66 microns centered on the fiber core. This diameter is equal to half the sum of the single-mode fiber core and fiber cladding diameters.

Fixed Contamination: Contamination that cannot be removed, and does not change appearance or location, during or after three cleaning attempts.

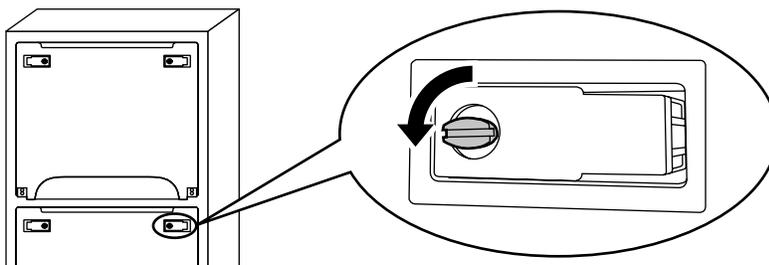
- 1 Each shelf cover is secured by a pair of latches located in the top-right and top-left corners of the shelf cover. Rotate the locking screws 90 degrees counter-clockwise to release the latch handles.

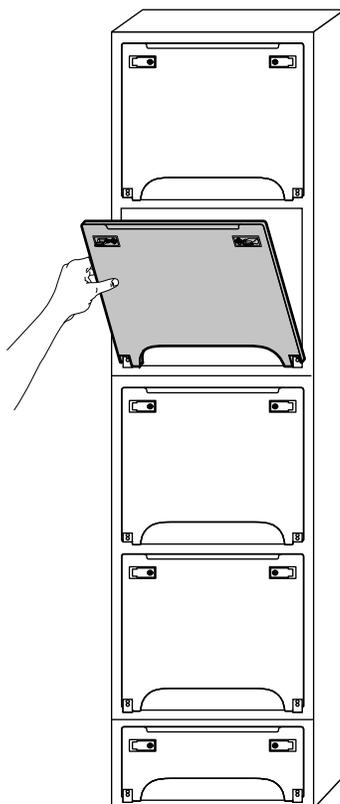
-
- 4 Pull the top of the cover several inches toward you, while supporting it so that it does not fall.

-
- 5 Remove the cover by lifting it straight up to free it from the two hinge brackets located at the bottom of the shelf.

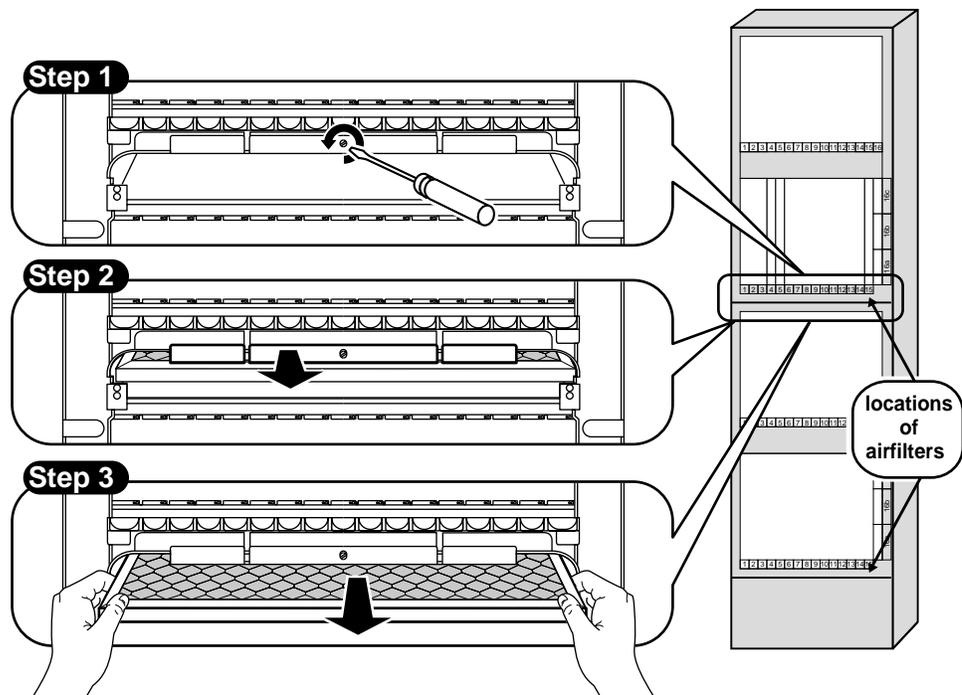
Figure 7-5 Air filter removal process

- 1 Identify the location of the plastic cover on the shelf that contains the air filter. See [Figure 7-5, “Air filter removal process” \(7-34\)](#).
- 2 Remove the front cover (for details, see [“DLP-607: Remove/Install Front Cover” \(7-17\)](#)) to expose the air filter slide holder assembly. The following figure shows the steps to remove the air filter.

-
- 3 Turn the screw (counterclockwise) on the air filter slide holder to free it and then pull it toward you.

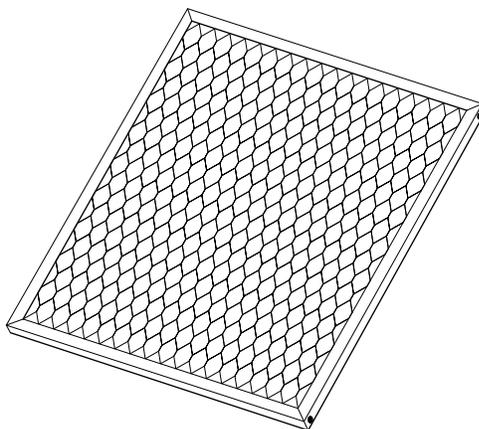
Figure 7-6 System Bay Air Filter

- 4 Remove the air filter and inspect it for any dirt or dust accumulation that may clog it. The following figure shows the air filter.

-
- 5 The filter can be reused if in good condition, but must be replaced if dirt or dust has accumulated.
-
