**OPERATION AND MAINTENANCE
1×N FREQUENCY DIVERSITY
DR 6/11-135A AND 135EC
RECEIVER SUBROUTINES**

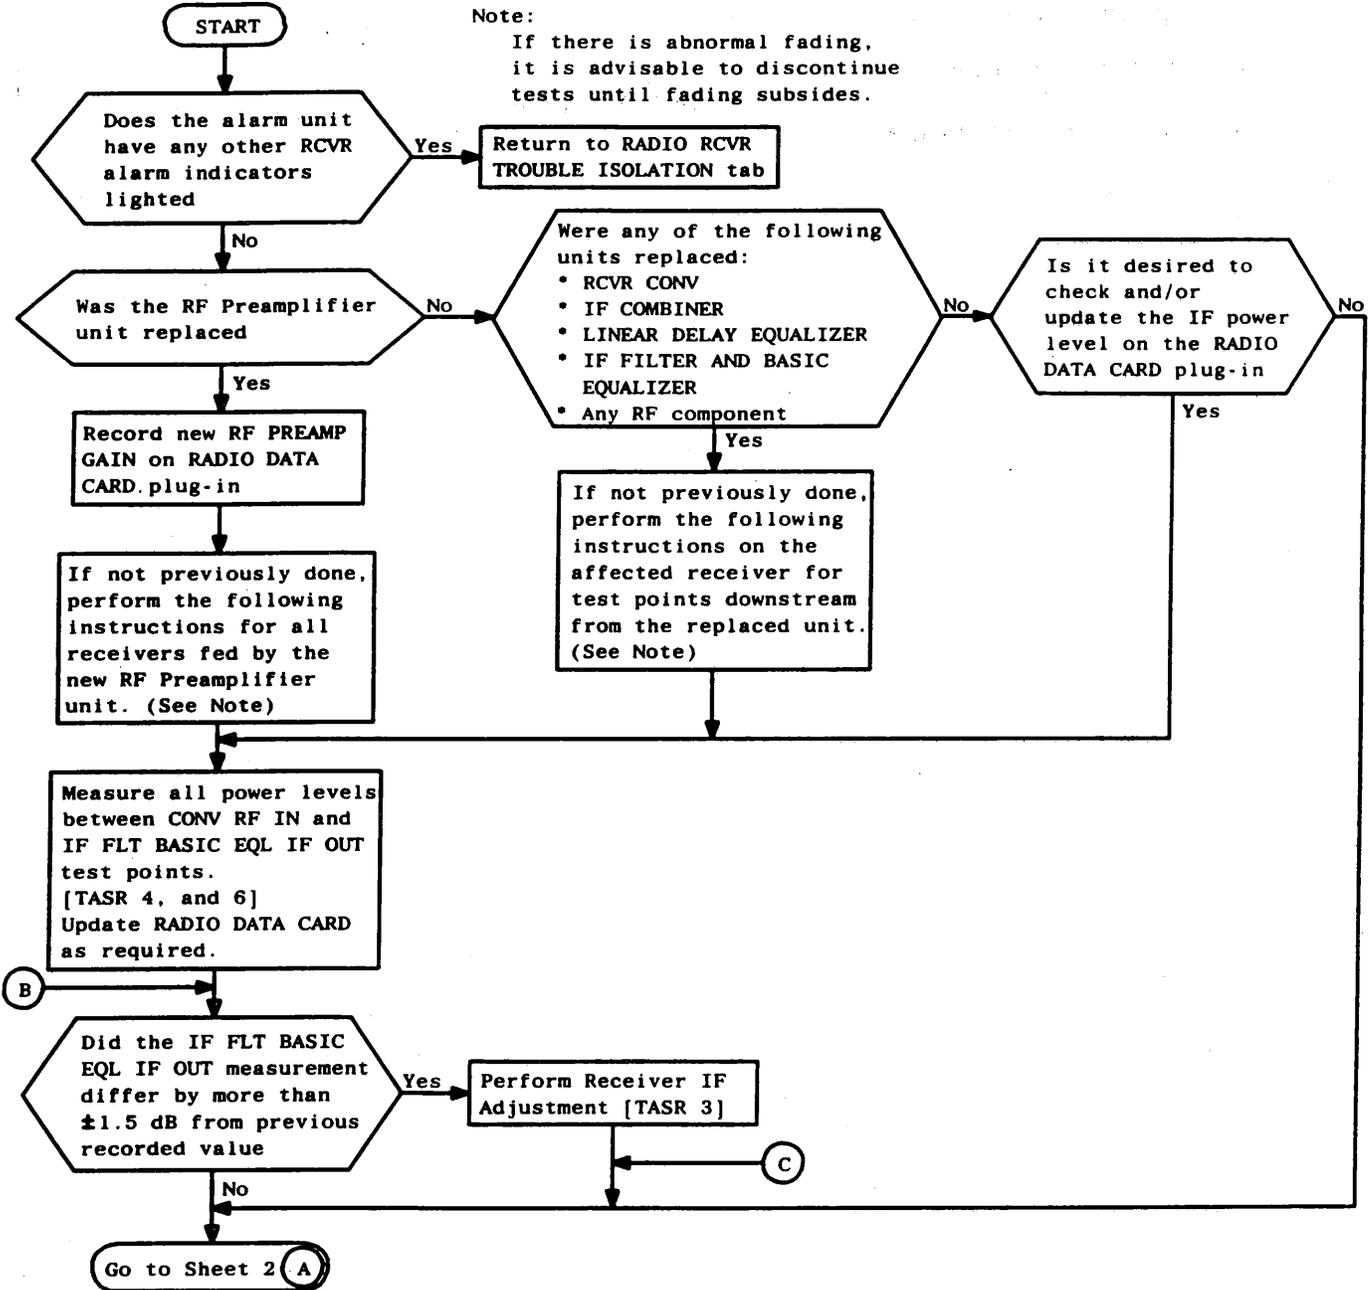
SR 1—Condition Receiver/Update RADIO DATA CARD Prior to Repair Verification (Sheet 1 of 2)

PREREQUISITE: A radio receiver alarm condition was just cleared.

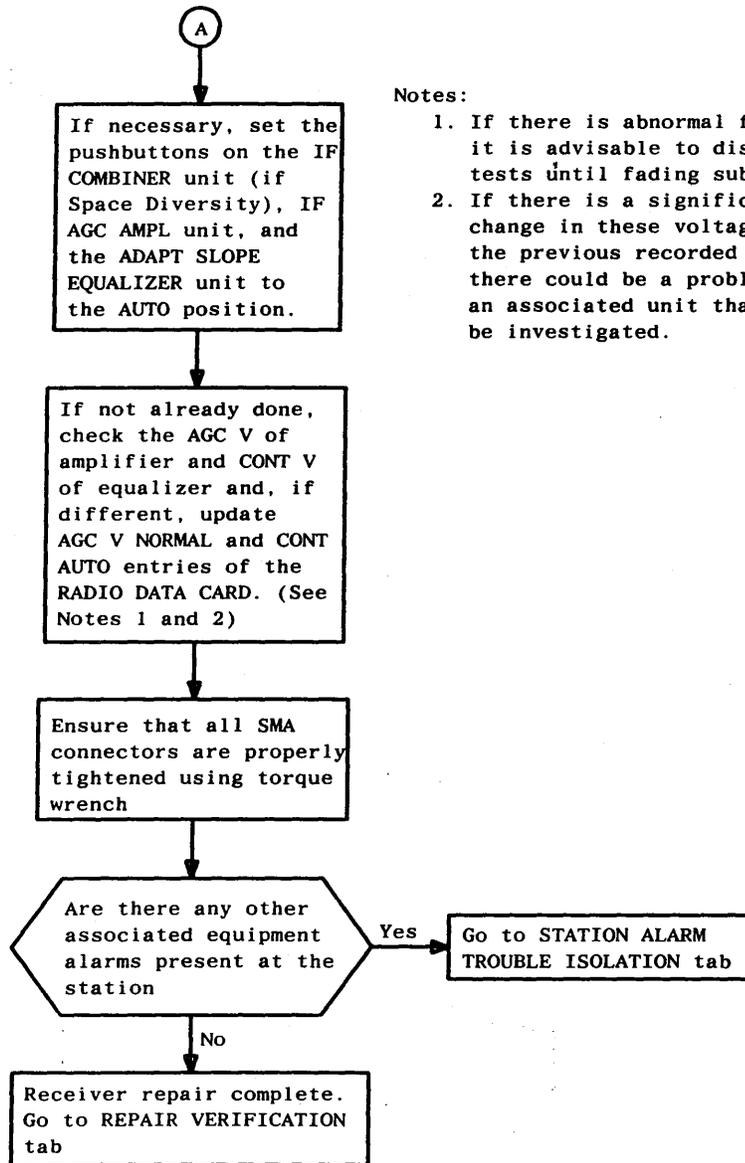
SR 1—Condition Receiver/Update RADIO DATA CARD Prior to Repair Verification (Sheet 2 of 2)

1. If there is abnormal fading, it is advisable to discontinue tests until fading subsides.
2. If there is a significant change in these voltages from the previous recorded value, there could be a problem in an associated unit that should be investigated.

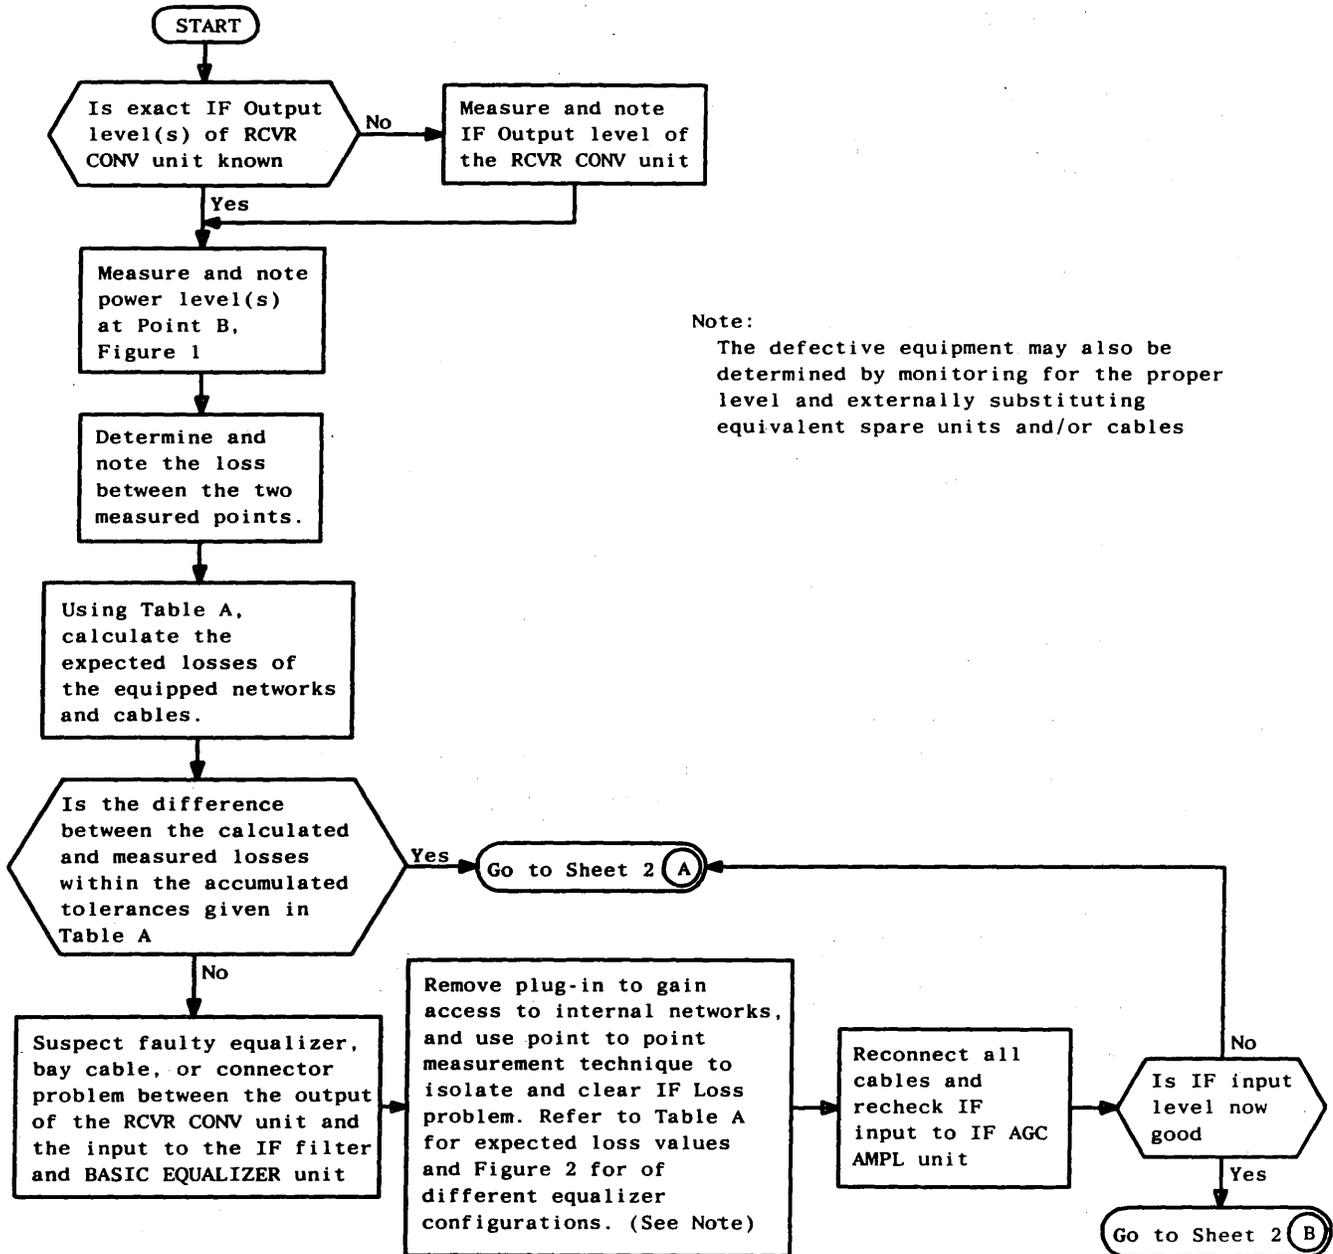
SR 2—Resolving Receiver IF Loss Problem (Sheet 1 of 2)

Prerequisite: RCVR CONV IF Output is within ± 3 dB of RADIO DATA CARD value.
IF AGC AMPL IF input is bad.

Note:
The defective equipment may also be determined by monitoring for the proper level and externally substituting equivalent spare units and/or cables

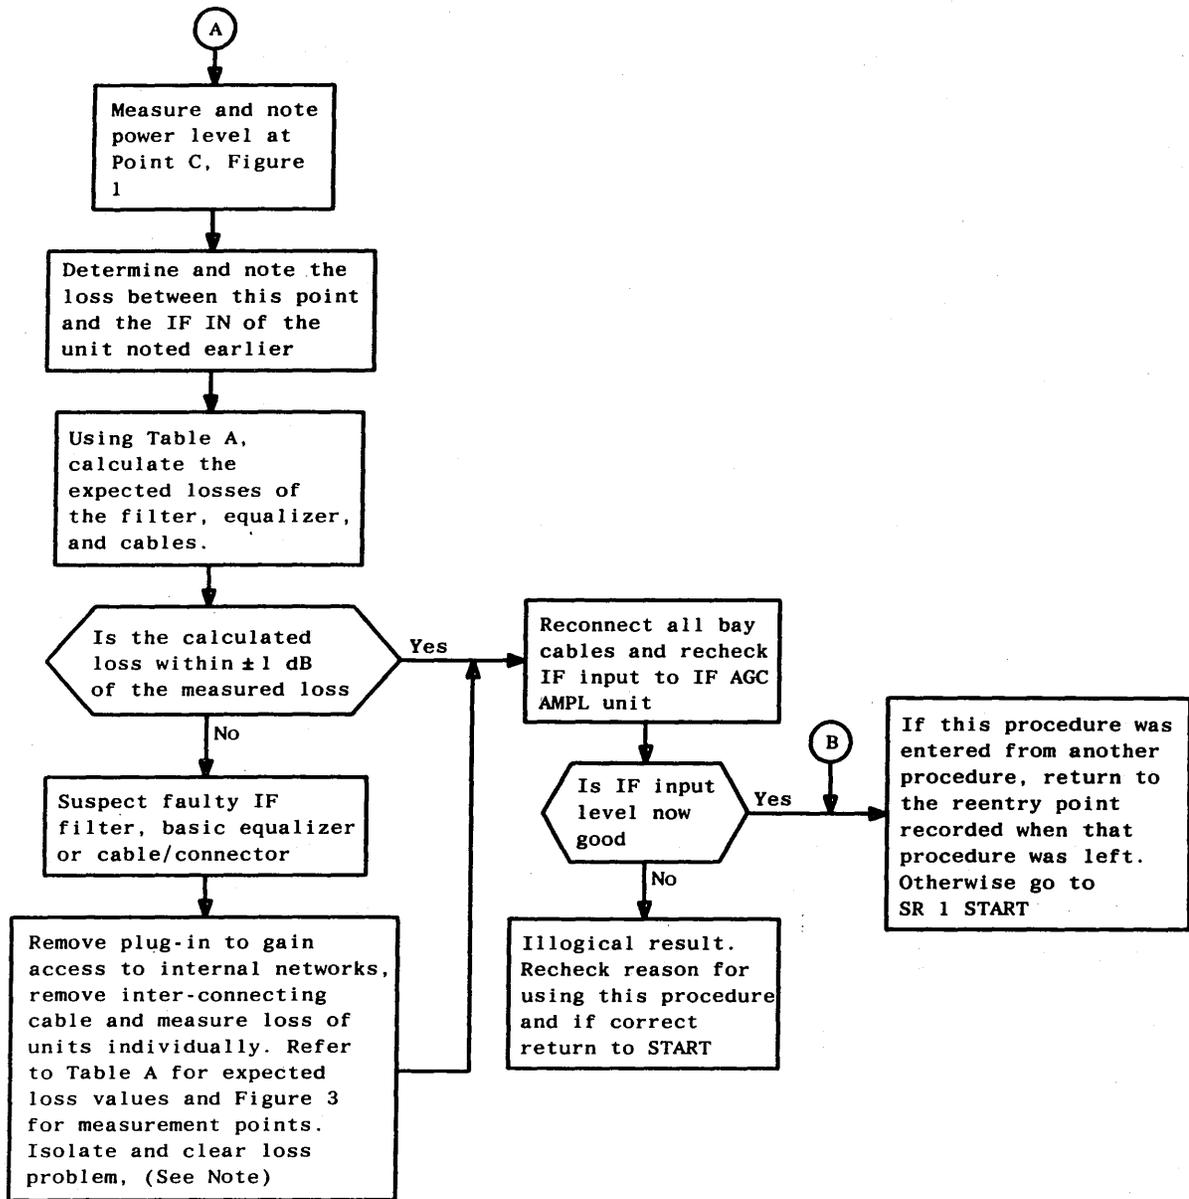
SR 2—Resolving Receiver IF Loss Problem (Sheet 2 of 2)

Note:
 The defective equipment may also be determined by monitoring for the proper level and externally substituting equivalent spare units and/or cables

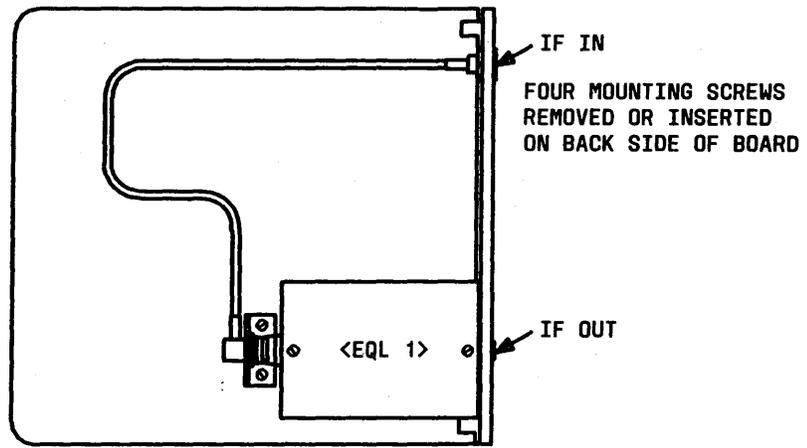
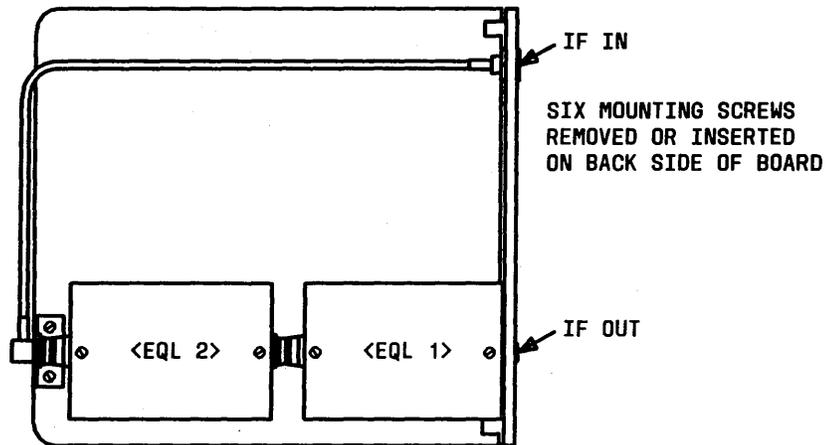
Figure 2-Frequency Diversity Receiver Linear Delay Equalizer, Side View

A. ONE EQUALIZER EQUIPPED

B. TWO EQUALIZERS EQUIPPED

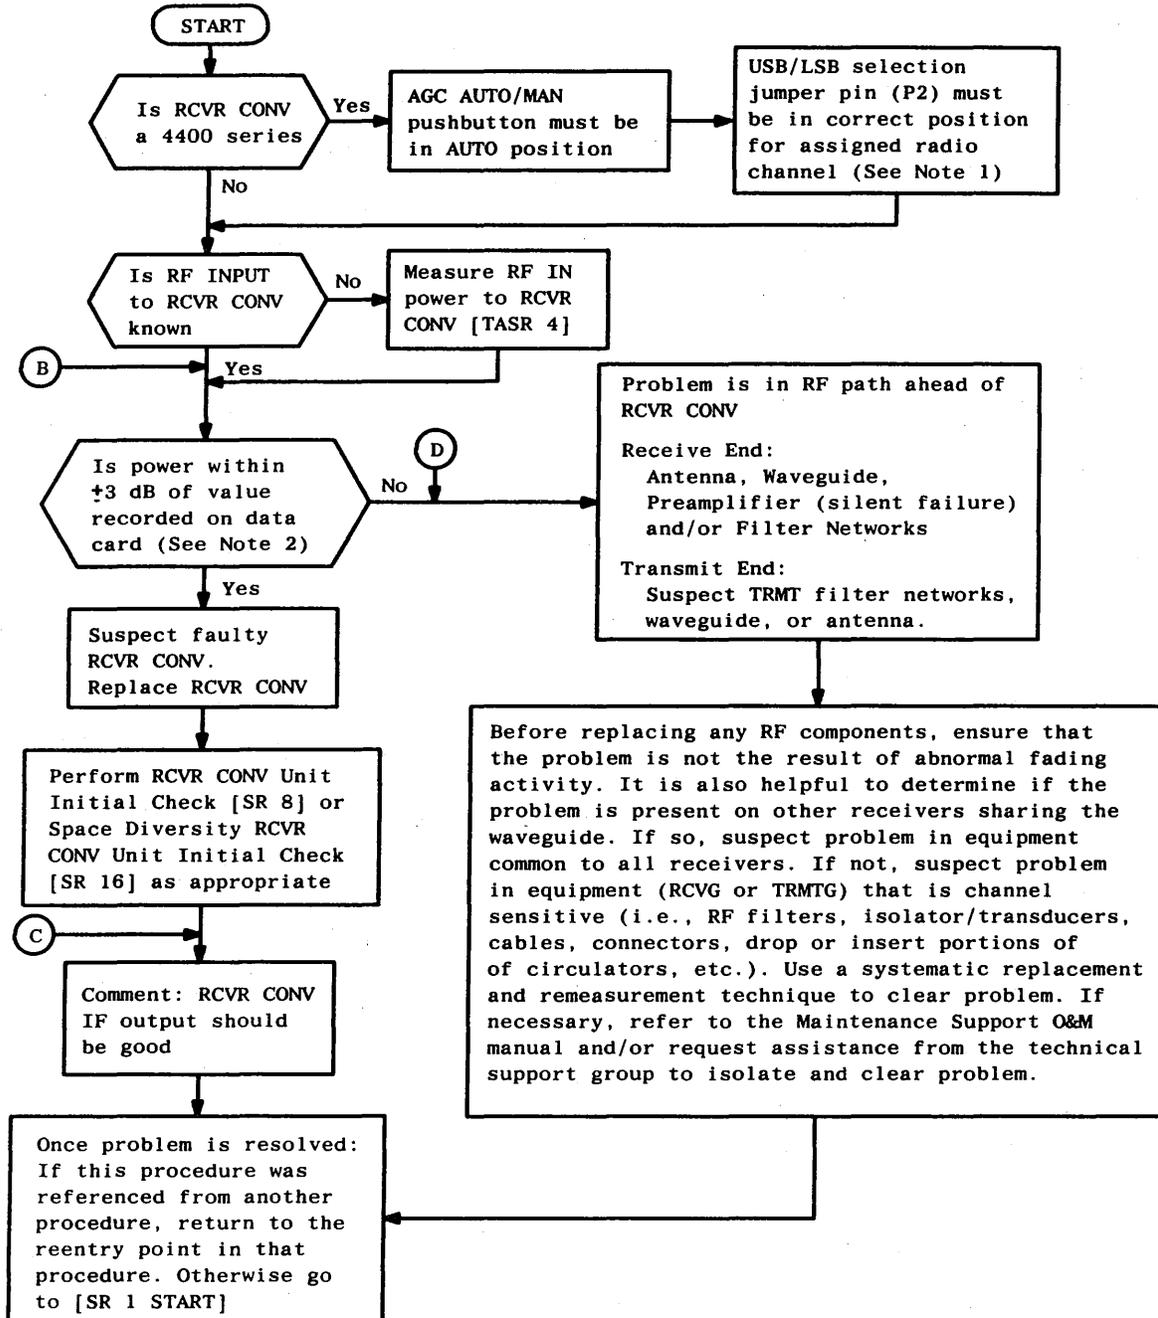
SR 3—Resolving RF-to-IF Loss Problem

PREREQUISITE: IF Output level of RCVR CONV unit is bad.

Note 1: It is necessary to unplug the RCVR CONV unit to observe jumper pin P2.

Note 2: If there is abnormal fading, it is advisable to discontinue tests until fading subsides.

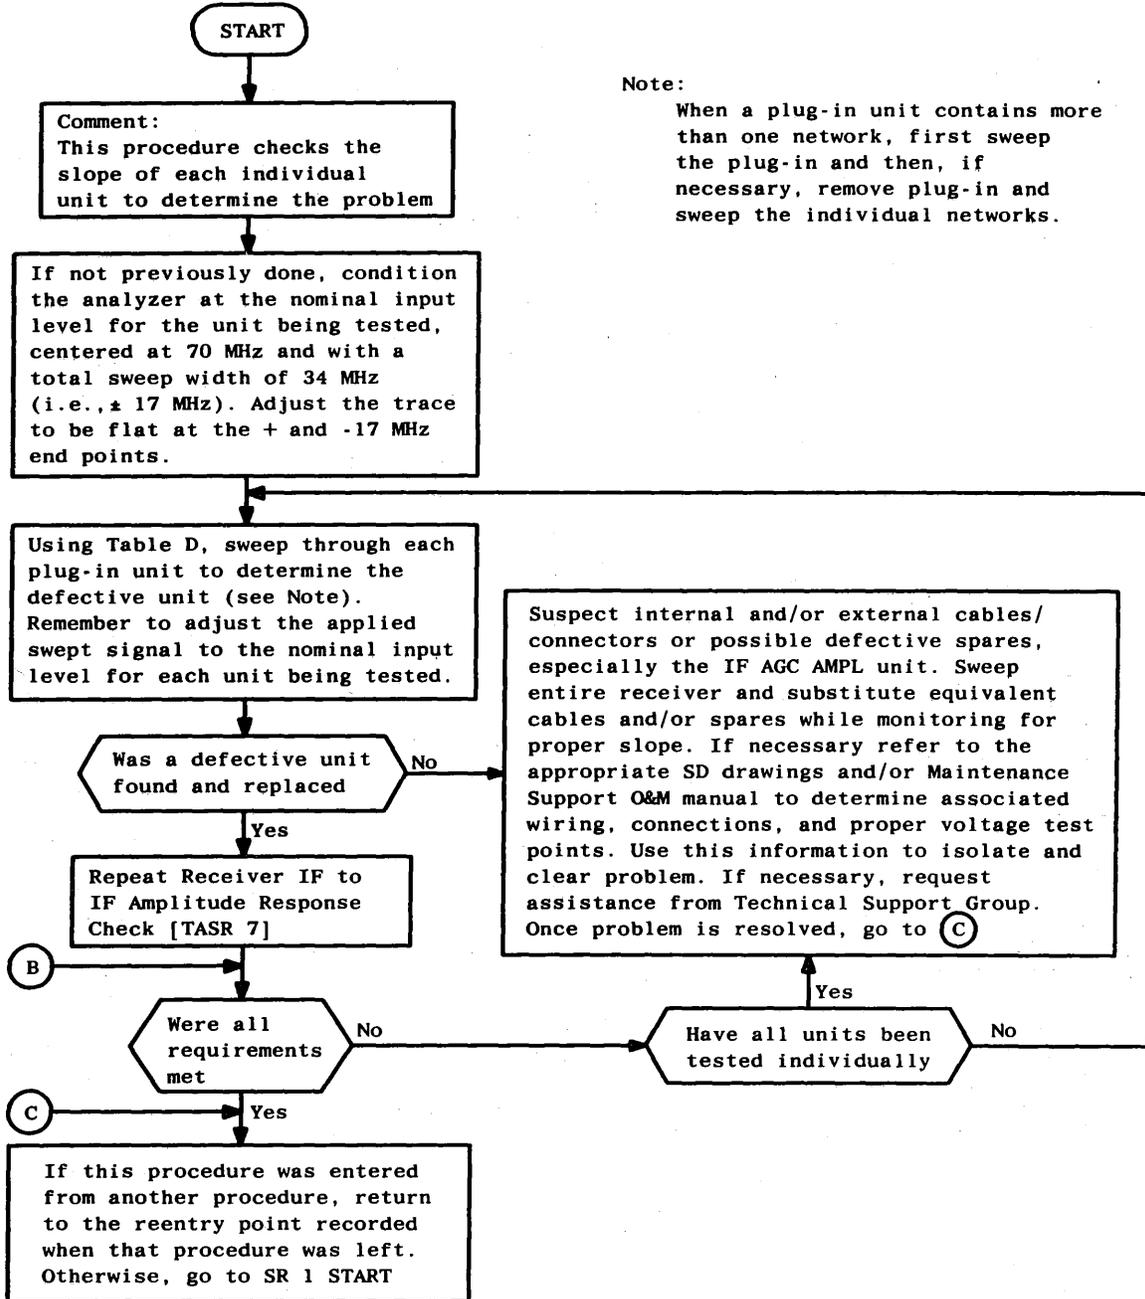
SR 4—Resolving Receiver IF Slope Problem (Sheet 1 of 2)

PREREQUISITE: Received IF-to-IF Slope measurement did not meet requirement

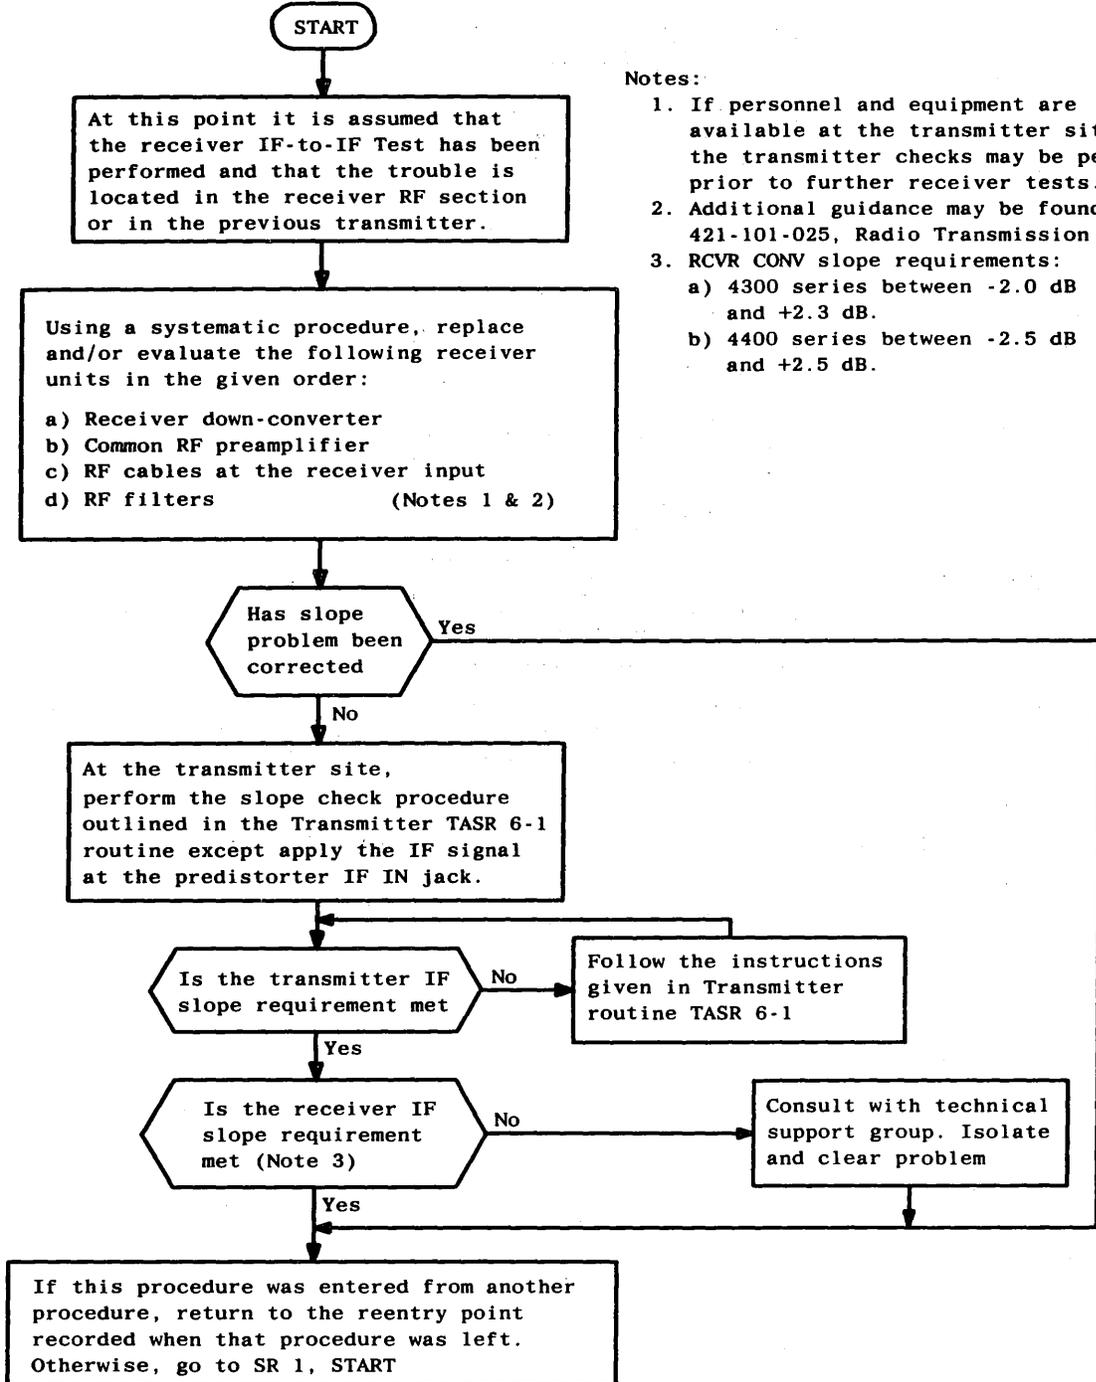
SR 5—Resolving RF Slope Problem

PREREQUISITE: Excessive IF slope exists at the RCVR CONV-IF OUT jack.

- Notes:
1. If personnel and equipment are available at the transmitter site, the transmitter checks may be performed prior to further receiver tests.
 2. Additional guidance may be found in AT&T 421-101-025, Radio Transmission Tests.
 3. RCVR CONV slope requirements:
 - a) 4300 series between -2.0 dB and +2.3 dB.
 - b) 4400 series between -2.5 dB and +2.5 dB.

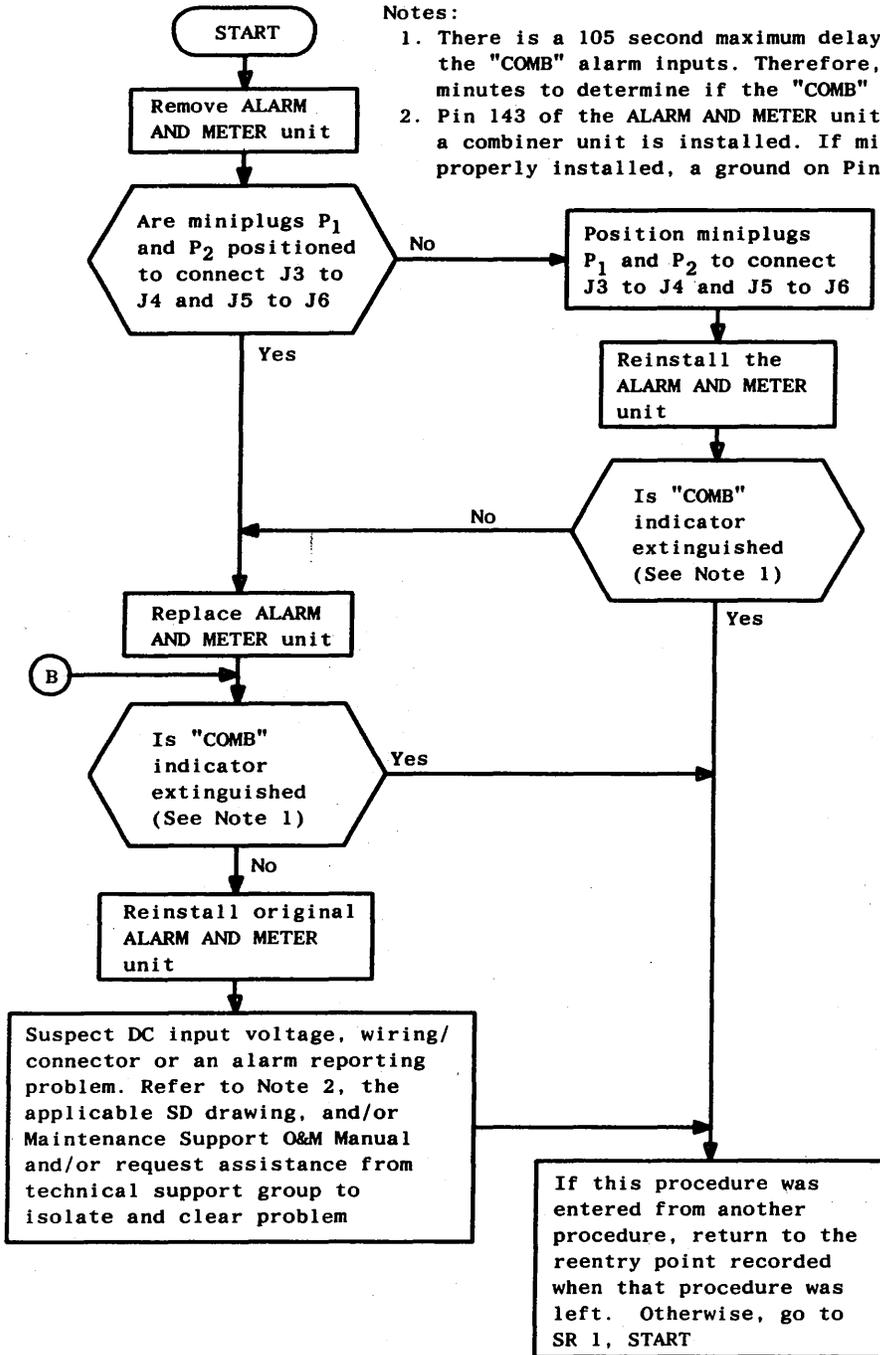
SR 6—Resolving Combiner Indicator Problem

PREREQUISITE: COMB indicator lighted on ALARM/ALARM AND METER unit when IF COMBINER Unit is not equipped in receiver.

1. There is a 105 second maximum delay associated with one of the "COMB" alarm inputs. Therefore, wait a minimum of two minutes to determine if the "COMB" indicator will extinguish.
2. Pin 143 of the ALARM AND METER unit is used to sense if a combiner unit is installed. If miniplugs P1 and P2 are properly installed, a ground on Pin 143 will cause an alarm.

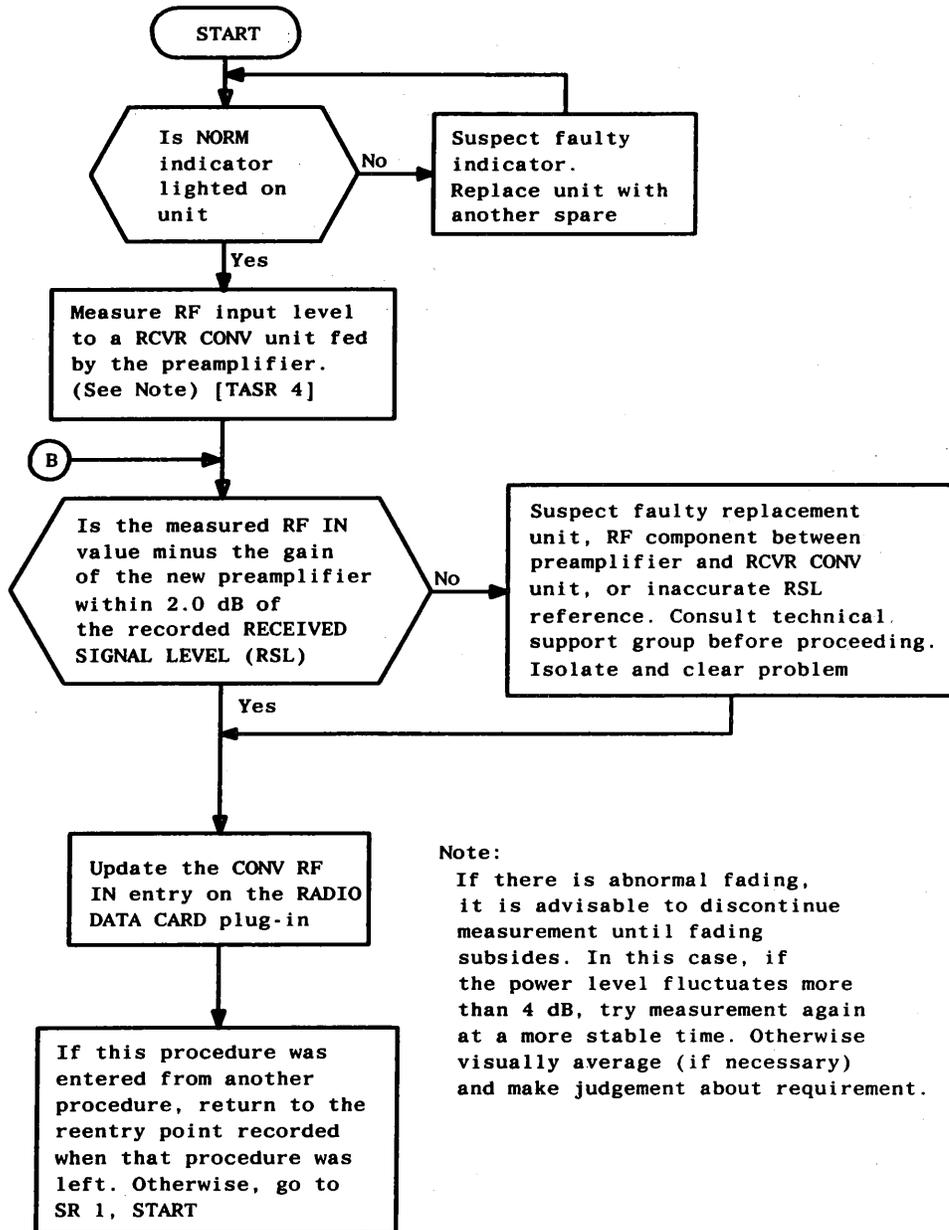
SR 7—RF Preamp Unit Initial Check

PREREQUISITES: 1. New RF Preamp just installed.
2. The DC input voltages to RF Preamp are good (+15 V and -15 V 0.4 V)

Note:
If there is abnormal fading, it is advisable to discontinue measurement until fading subsides. In this case, if the power level fluctuates more than 4 dB, try measurement again at a more stable time. Otherwise visually average (if necessary) and make judgement about requirement.

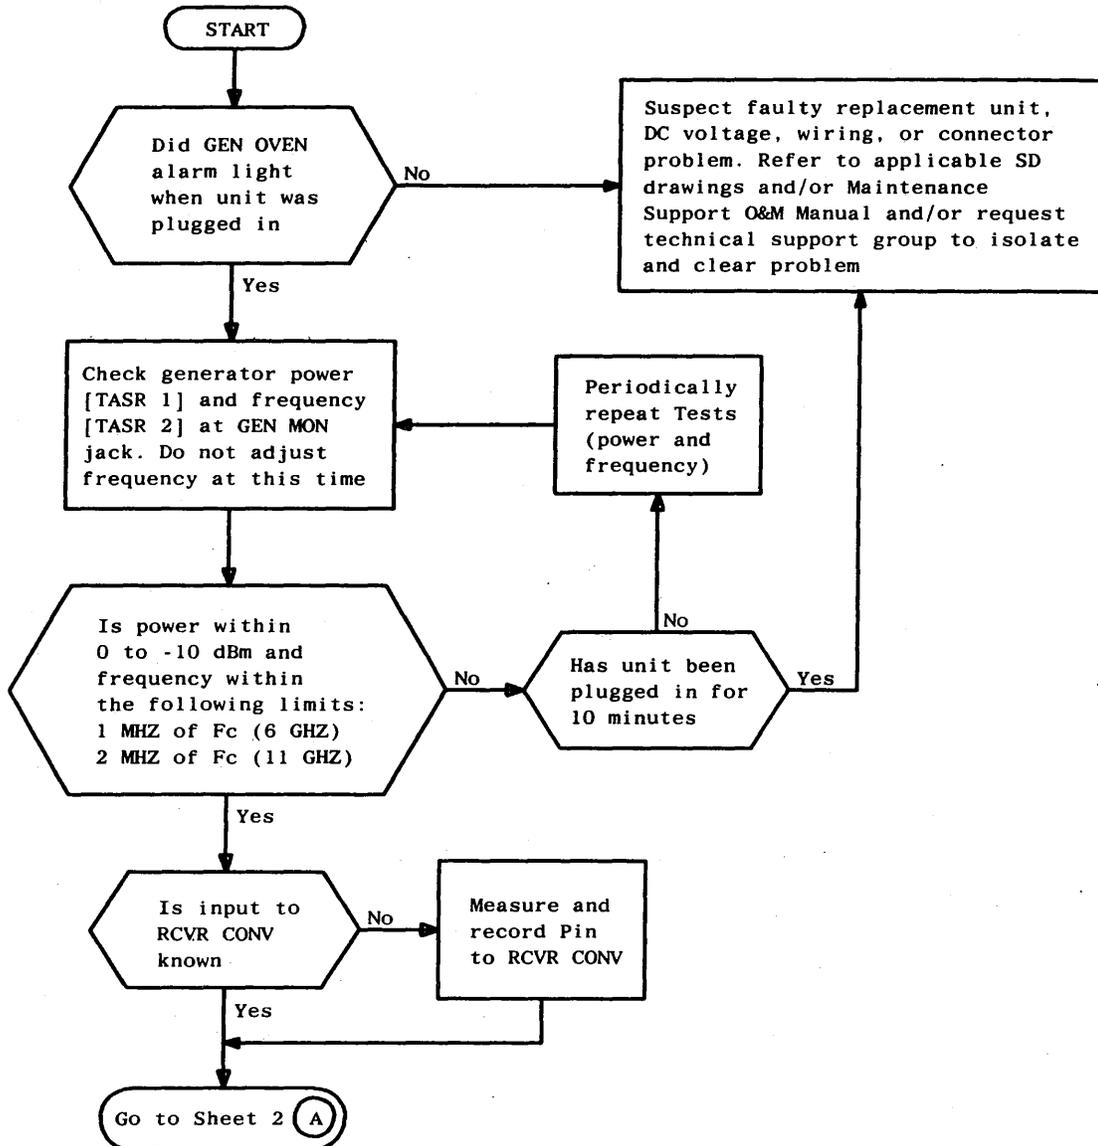
SR 8-A—4300 Series RCVR CONV Unit Initial Check (Sheet 1 of 4)

PREREQUISITE: RCVR CONV unit just installed.

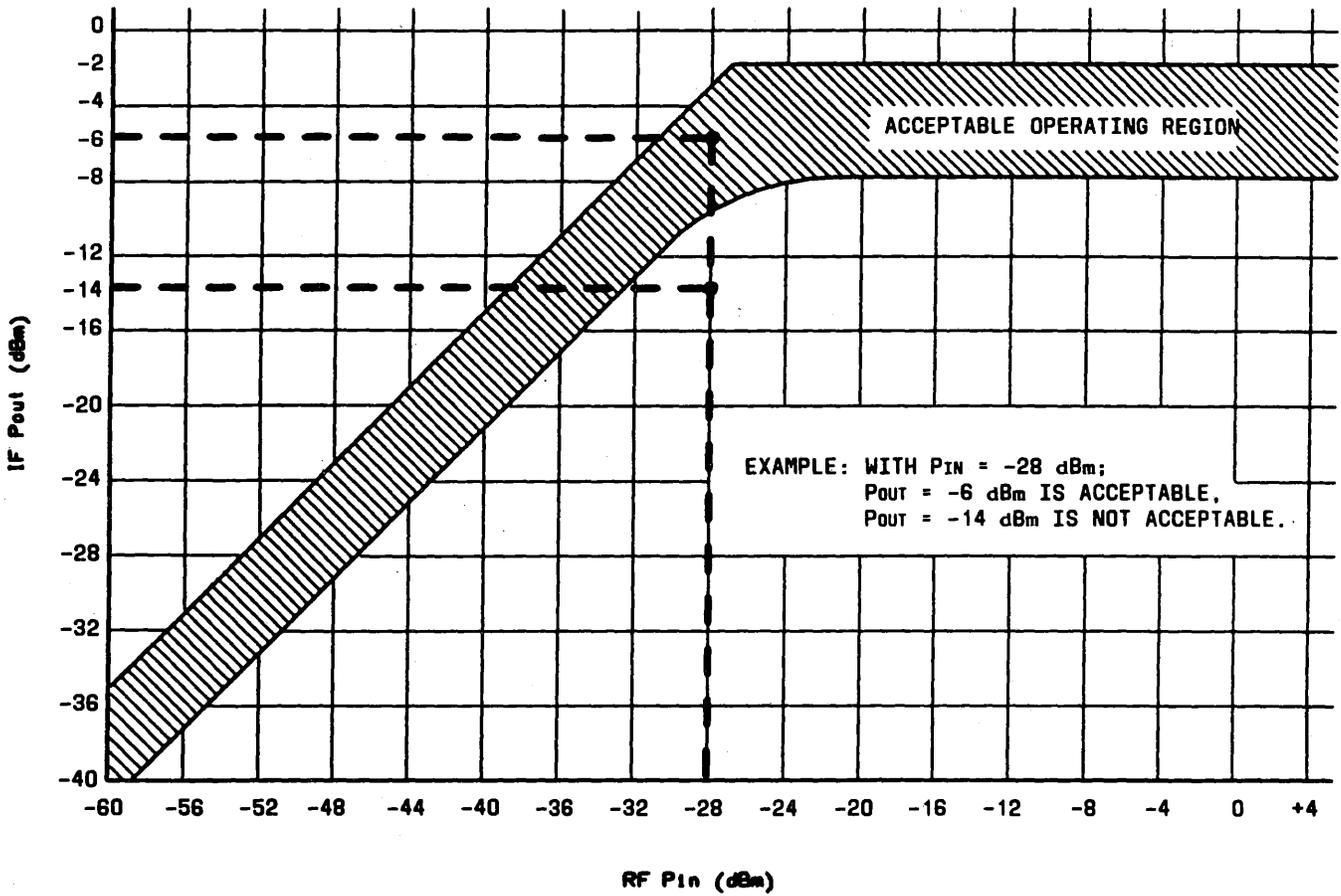
P_{out} vs P_{in} Requirements for DR 6/11 4300 Series Nonspace Diversity Receiver Down Converters
SR 8-A—4300 Series RCVR CONV Unit Initial Check (Sheet 4 of 4)

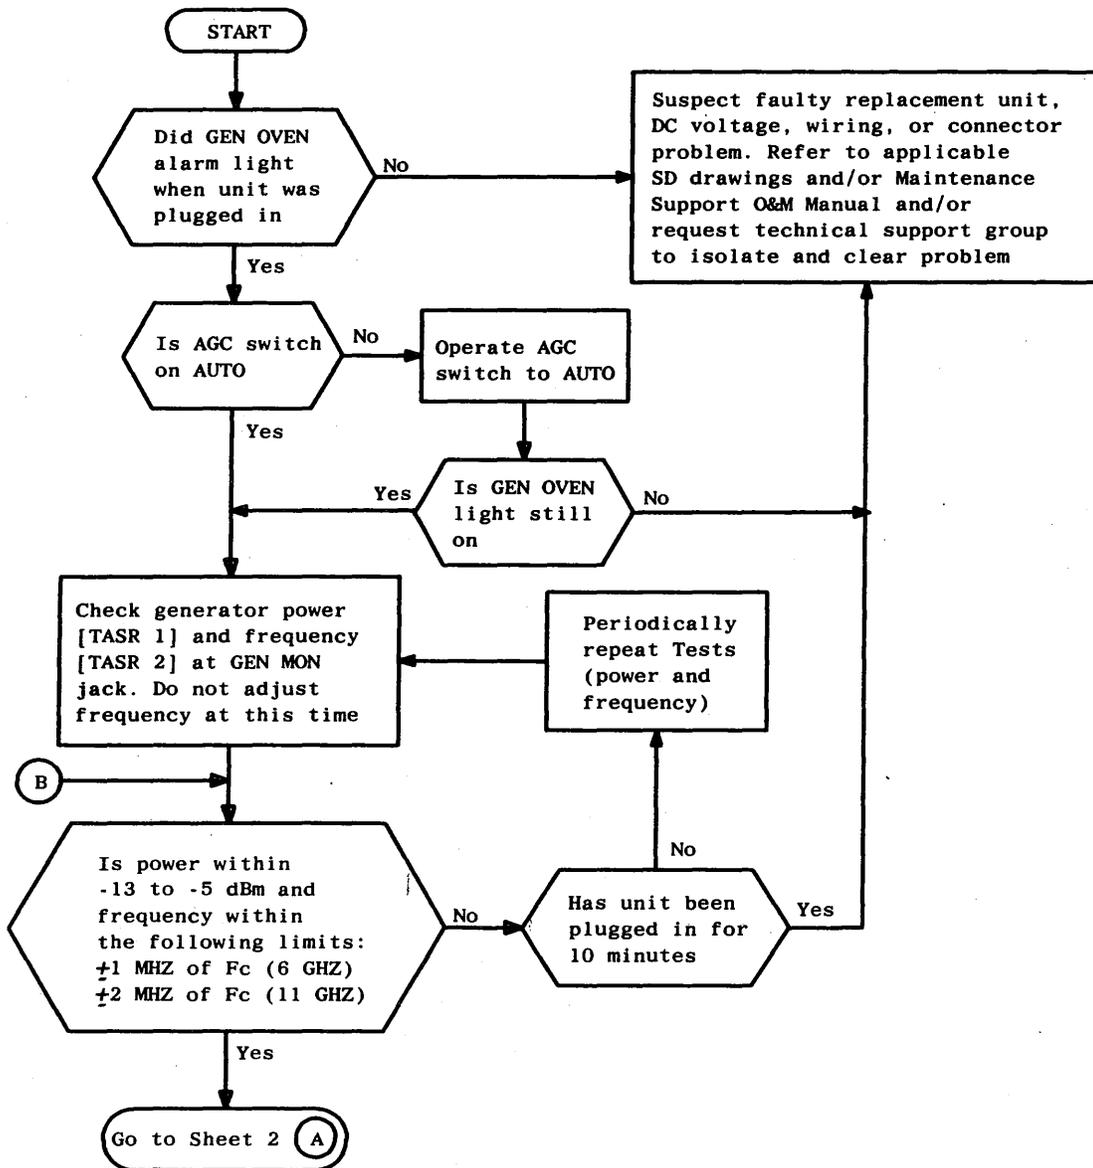
SR 8-B—4400 Series RCVR CONV Unit Initial Check (Sheet 1 of 5)

PREREQUISITE: RCVR CONV unit has just been installed and the sideband selector pin (P2) is in correct position in accordance with assigned radio channel.

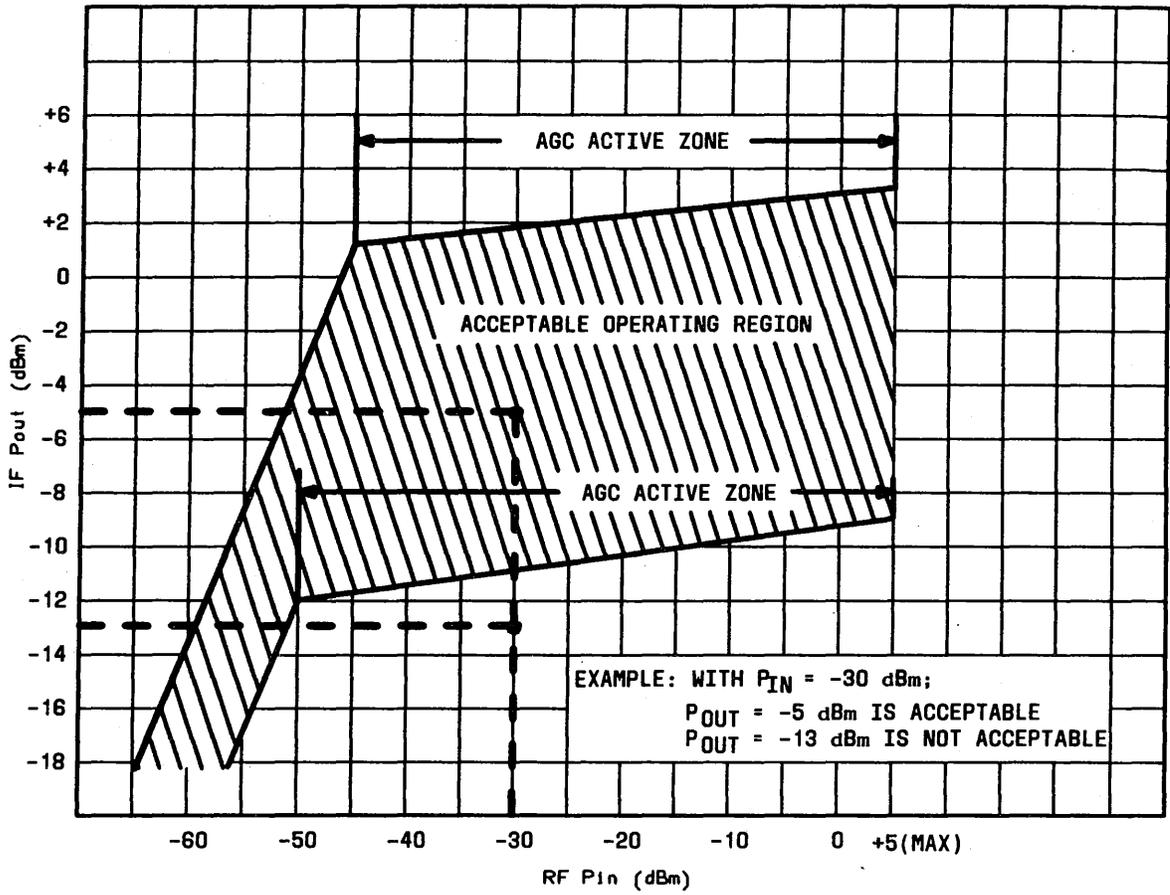
SR 8-B—4400 Series RCVR CONV Unit Initial Check (Sheet 3 of 5)

Maximum IF P_{out} vs RF P_{in} for 4470() and 4471() Down-Converters

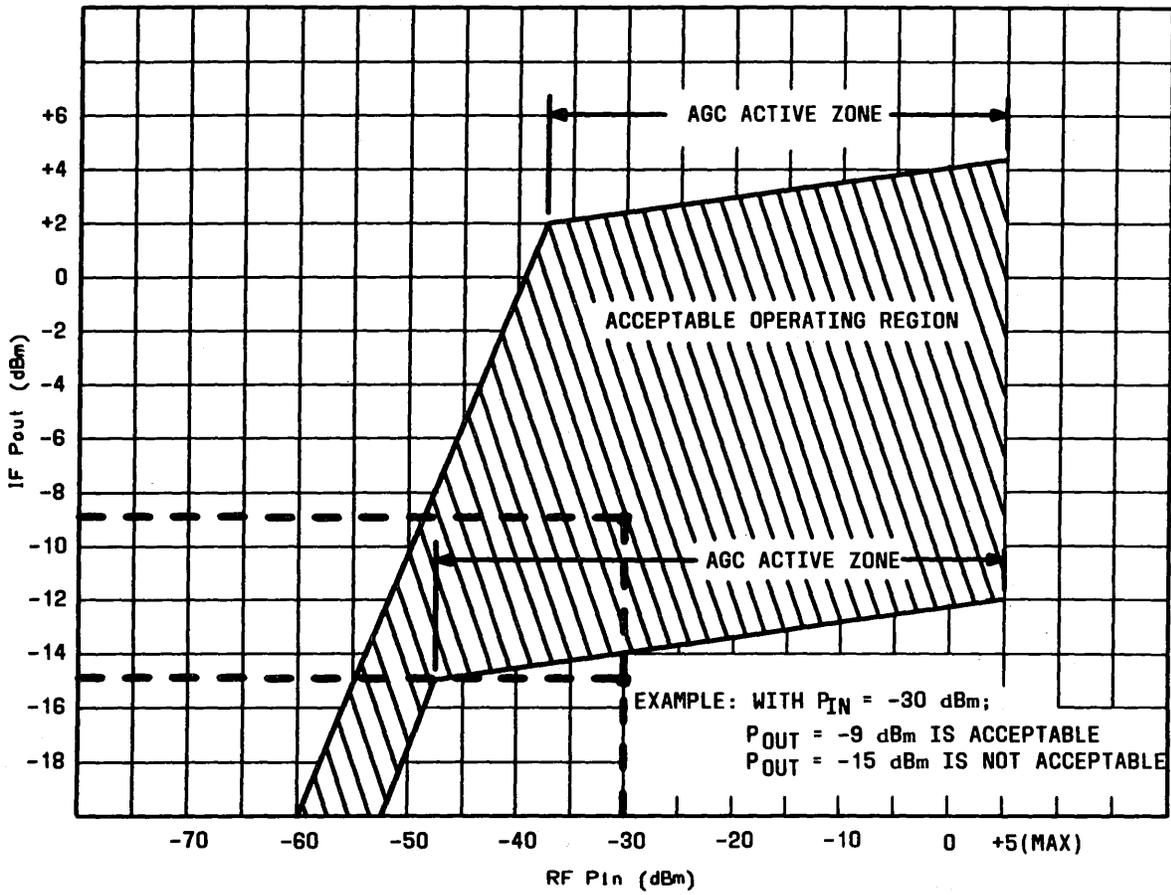
SR 8-B—4400 Series RCVR CONV Unit Initial Check (Sheet 4 of 5)

Maximum IF P_{out} vs RF P_{in} for 4472() and 4473() Down-Converters

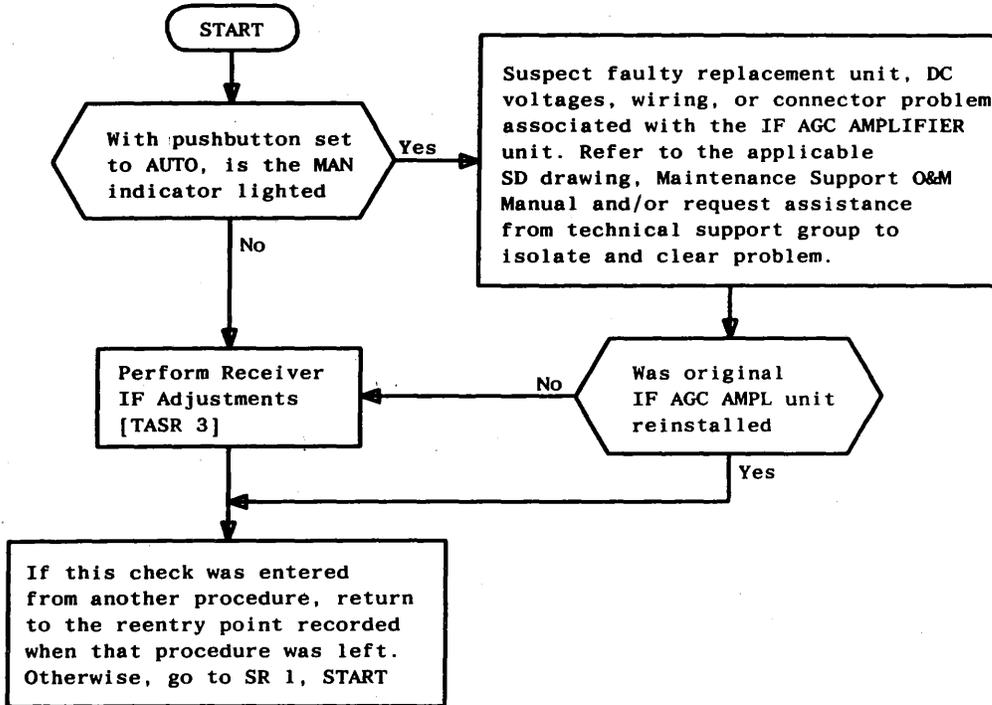
SR 9—IF AGC AMPL Unit Initial Check

PREREQUISITE: IF AGC AMPL unit just installed.

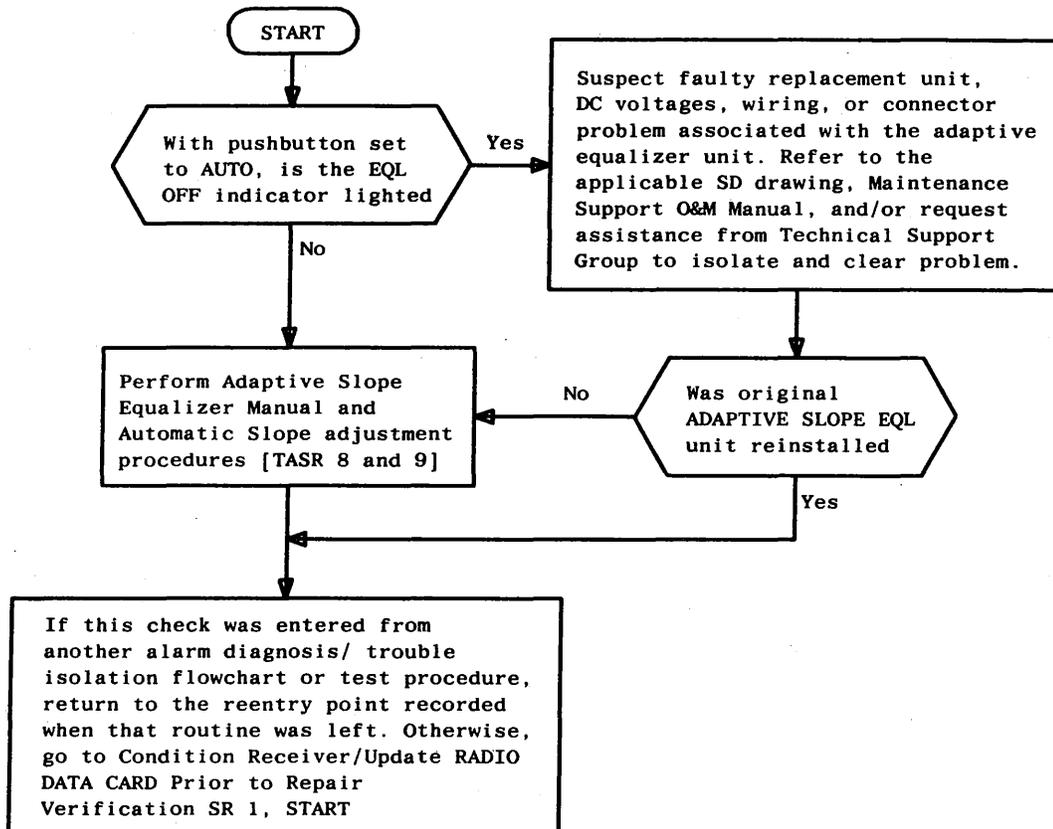
SR 10—Adaptive Slope Equalizer Unit Initial Check

PREREQUISITE: IF ADAPTIVE SLOPE EQL unit just installed.

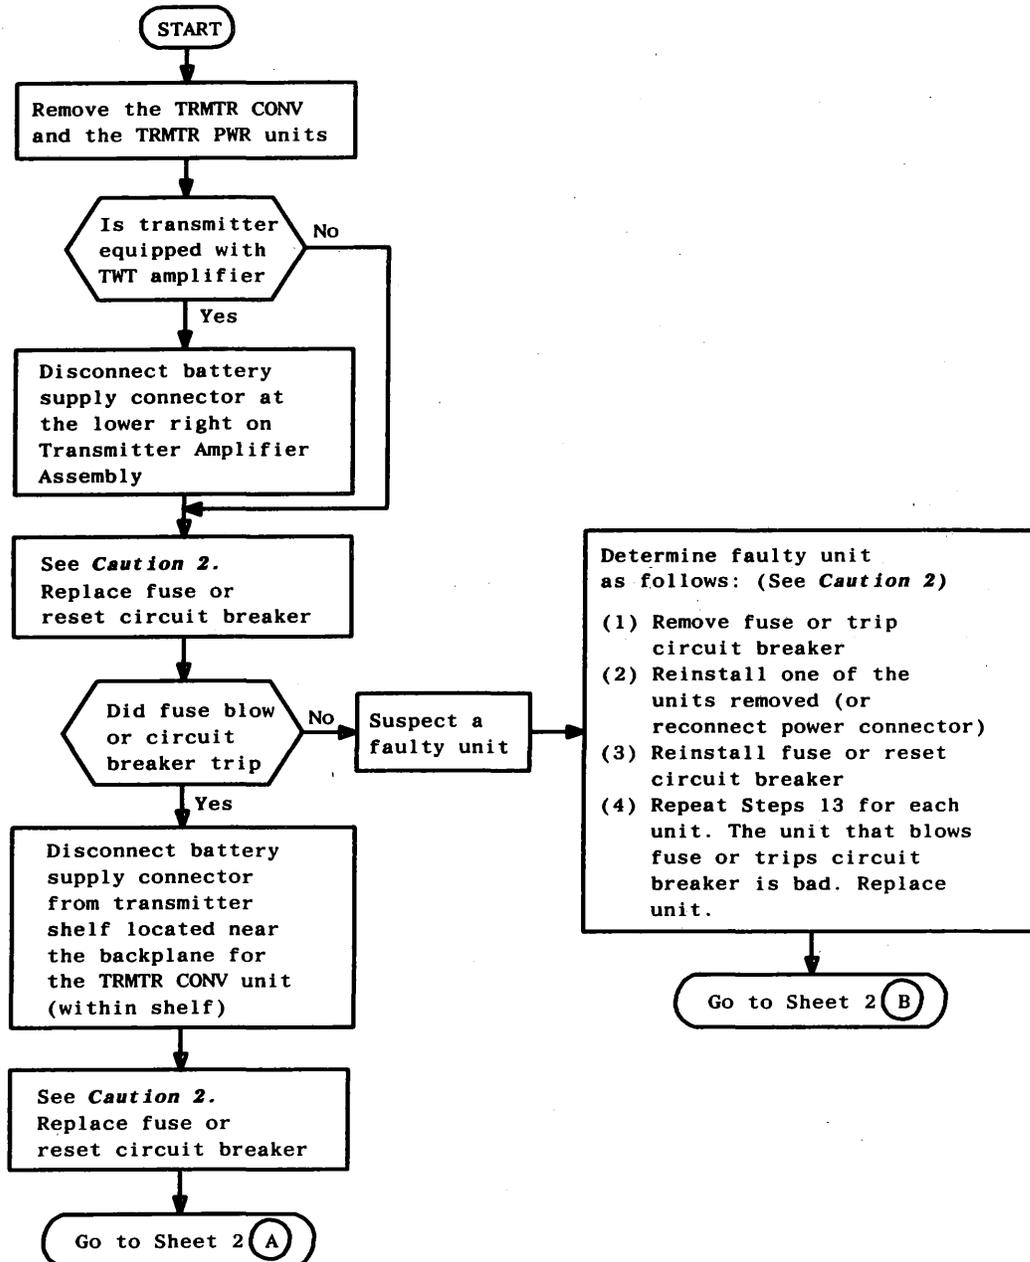
SR 11—Resolving Transmitter Shelf DC Input Problems (Sheet 1 of 2)

- PREREQUISITES:**
1. -24 V or -48 V input voltage does not meet requirements.
 2. The circuit breaker tripped/fuse blown at battery distribution fuse bay.
