**OPERATION AND MAINTENANCE
1×N FREQUENCY DIVERSITY
DR 6/11-135A AND 135EC
RECEIVER SUBROUTINES**

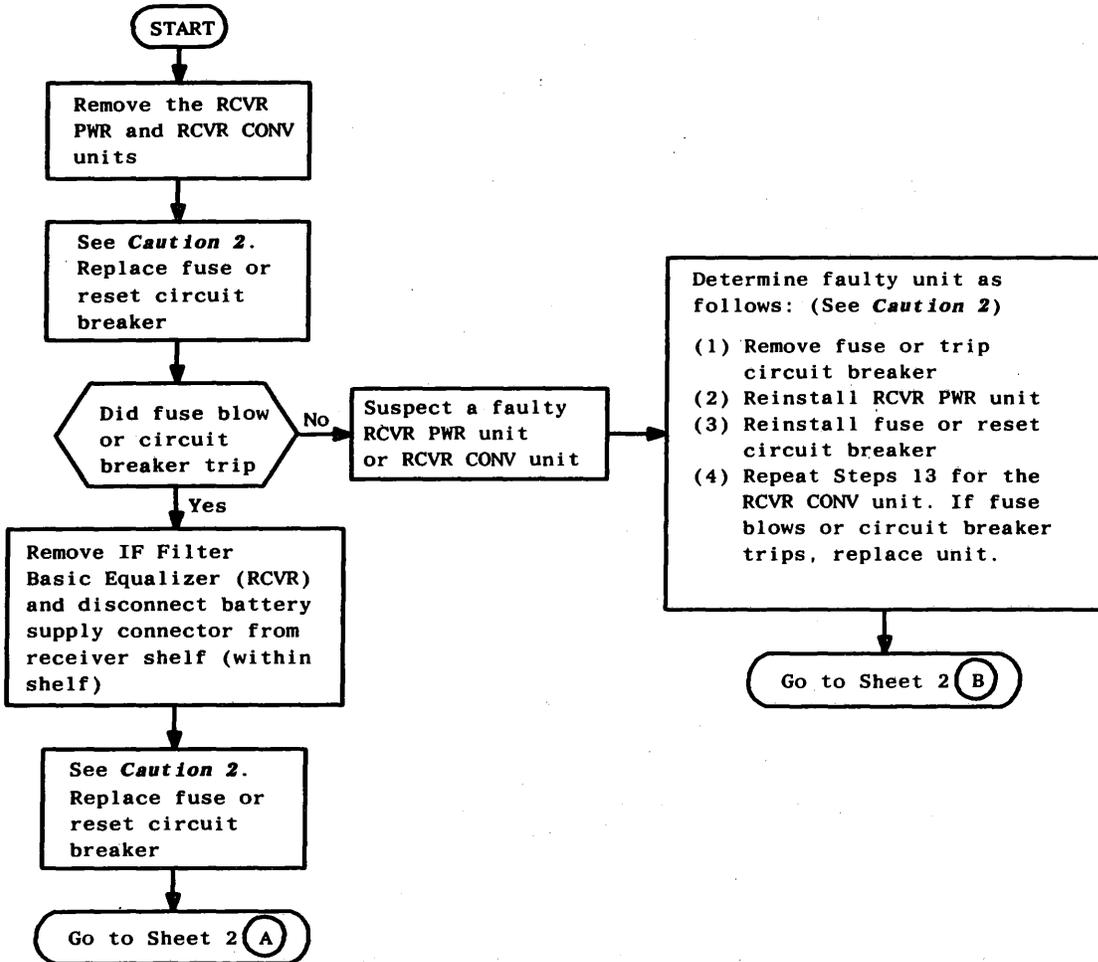
SR 12—Resolving Receiver Shelf DC Input Problems (Sheet 1 of 2)

- PREREQUISITES:**
1. -24 V or -48 V input voltage does not meet requirements.
 2. The circuit breaker tripped/fuse blown at battery distribution fuse bay.

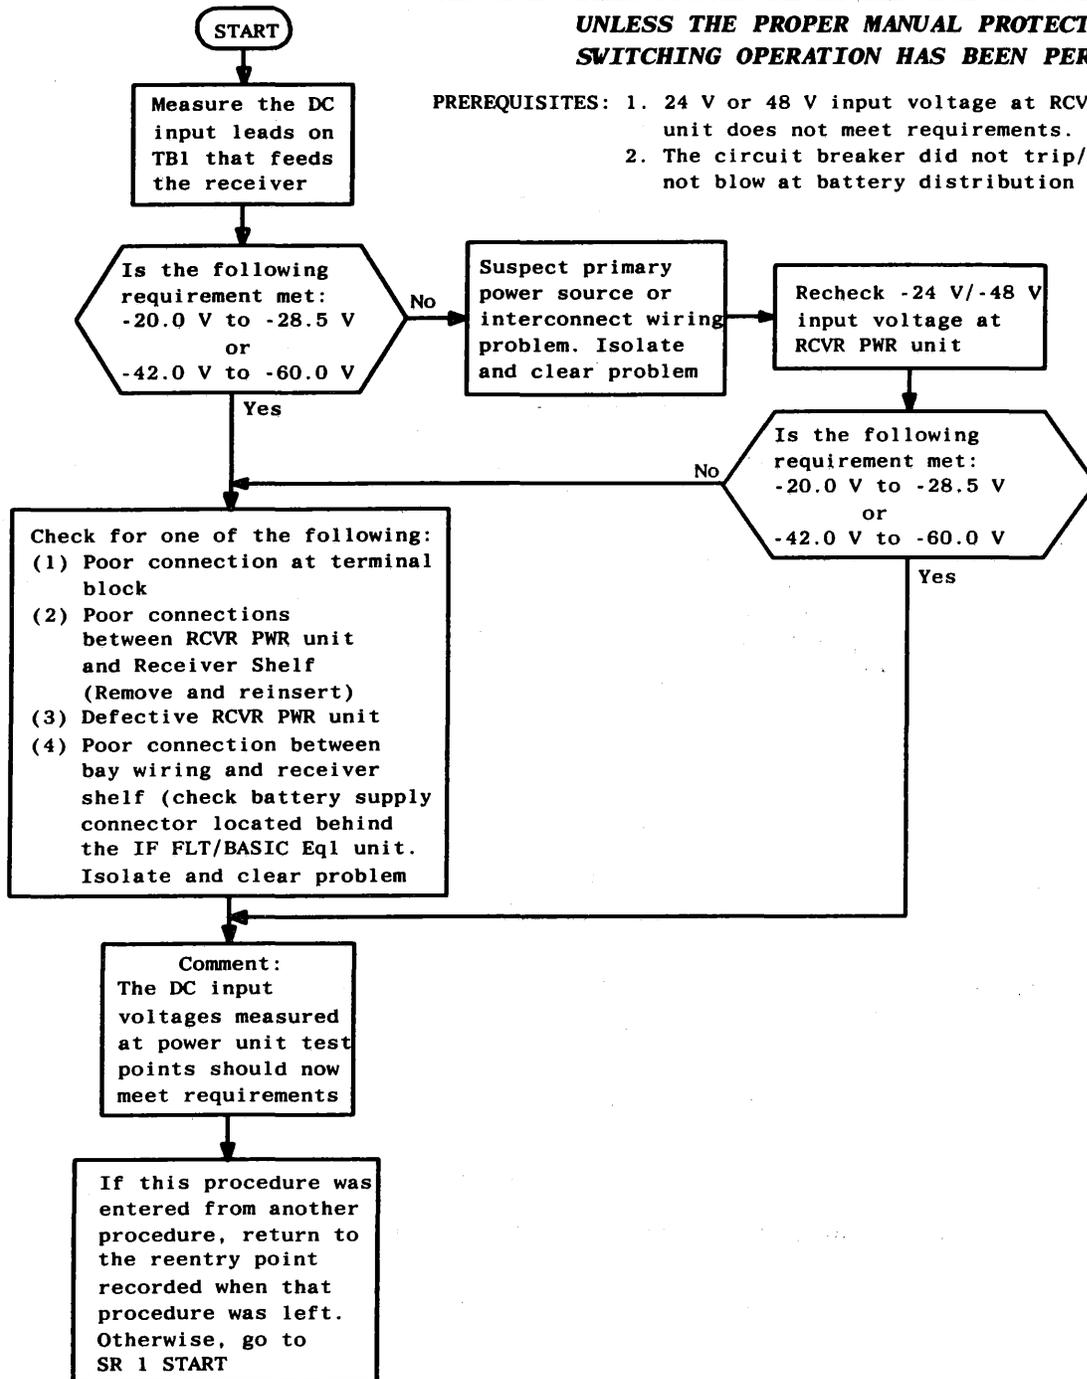
SR 13—Resolving DC Input Problems When Circuit Breaker and Fuse Did Not Blow/Trip

PREREQUISITES: 1. 24 V or 48 V input voltage at RCVR PWR unit does not meet requirements.
 2. The circuit breaker did not trip/fuse did not blow at battery distribution fuse bay.

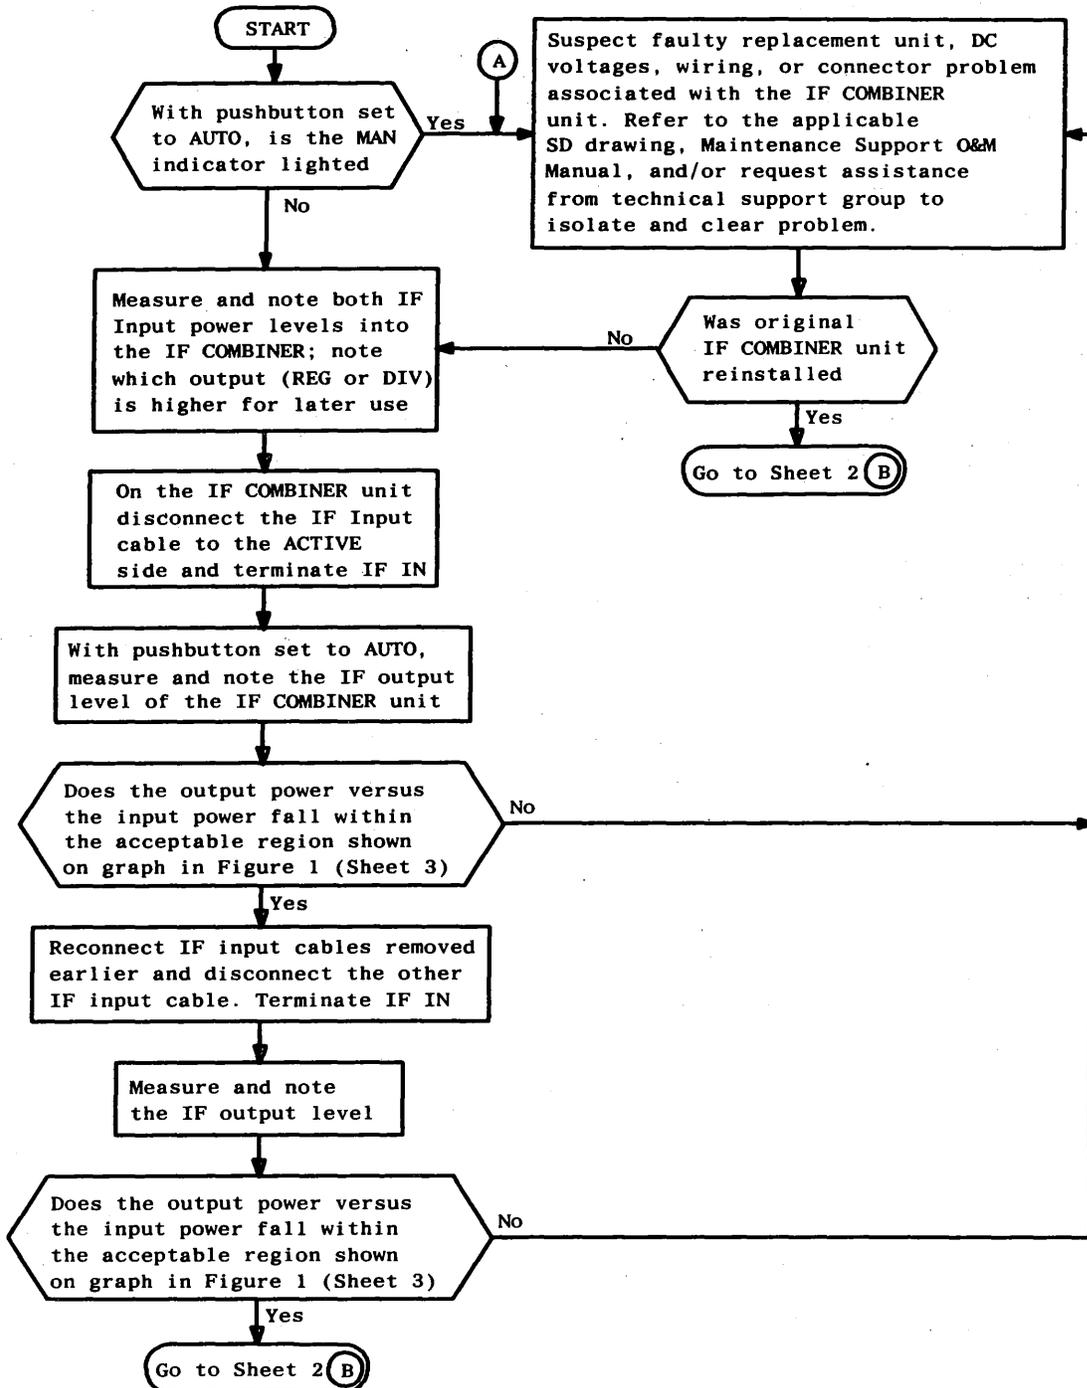
SR 15—IF COMBINER Unit Initial Check (Sheet 1 of 3)

PREREQUISITE: IF COMBINER unit just installed.

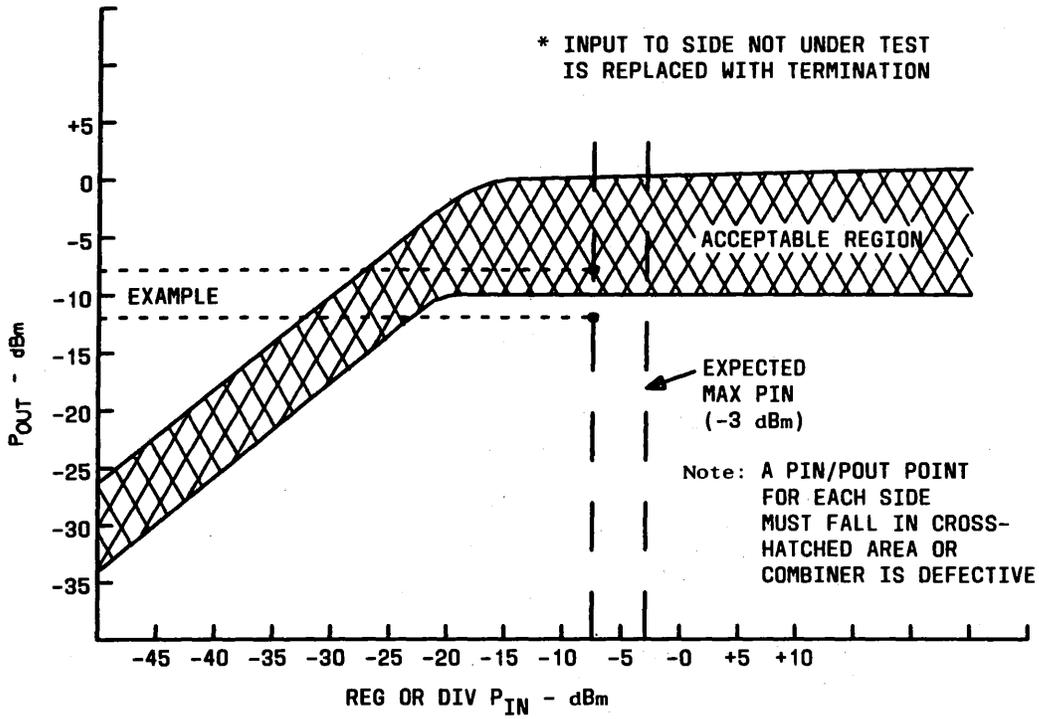
SR 15—IF COMBINER Unit Initial Check (Note) (Sheet 3 of 3)

- EXAMPLE WITH P_{IN} IF -7 dBm:
- POUT OF -12 dBm IS NOT ACCEPTABLE
 - POUT OF -8 dBm IS ACCEPTABLE

* WYII P_{OUT} VS P_{IN} CHARACTERISTICS IN AUTOMATIC MODE WITH INPUT TO REG OR DIV SIDE ONLY

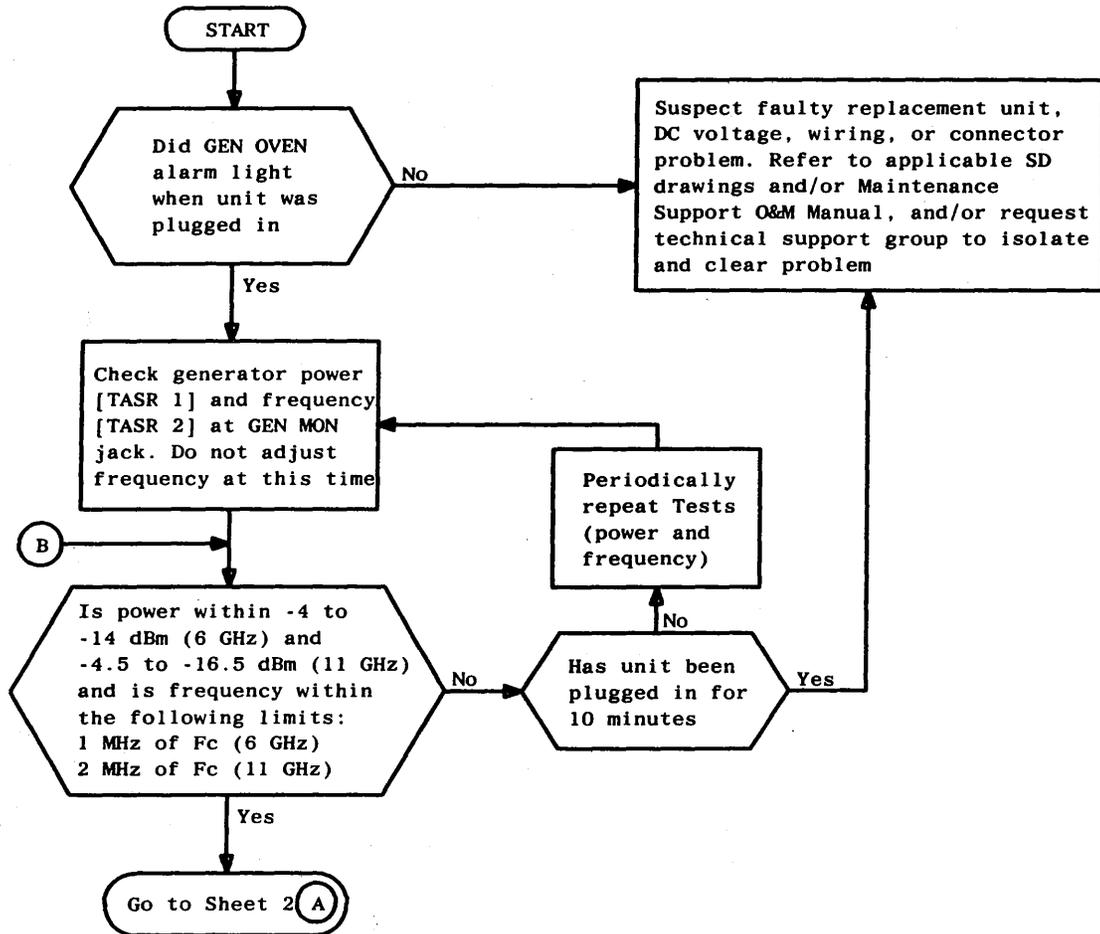
SR 16-A—4300 Series Space Diversity RCVR CONV Unit Initial Check (Sheet 1 of 5)

PREREQUISITE: RCVR CONV unit just installed

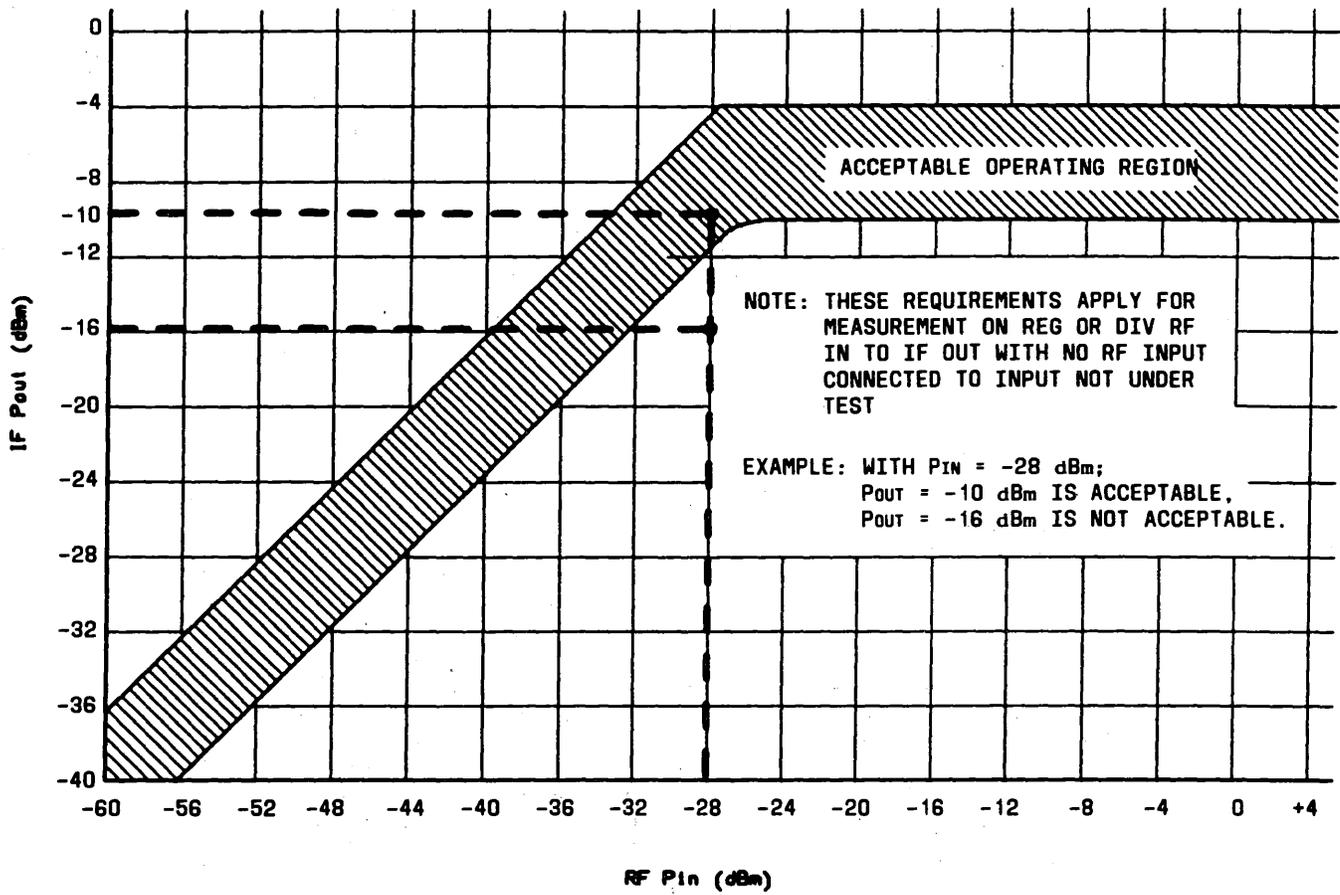
SR 16-A—4300 Series Space Diversity RCVR CONV Unit Initial Check (Sheet 4 of 5)

P_{out} vs P_{in} Requirements for DR 6/11 4300 Series Space Diversity Receiver Down-Converters

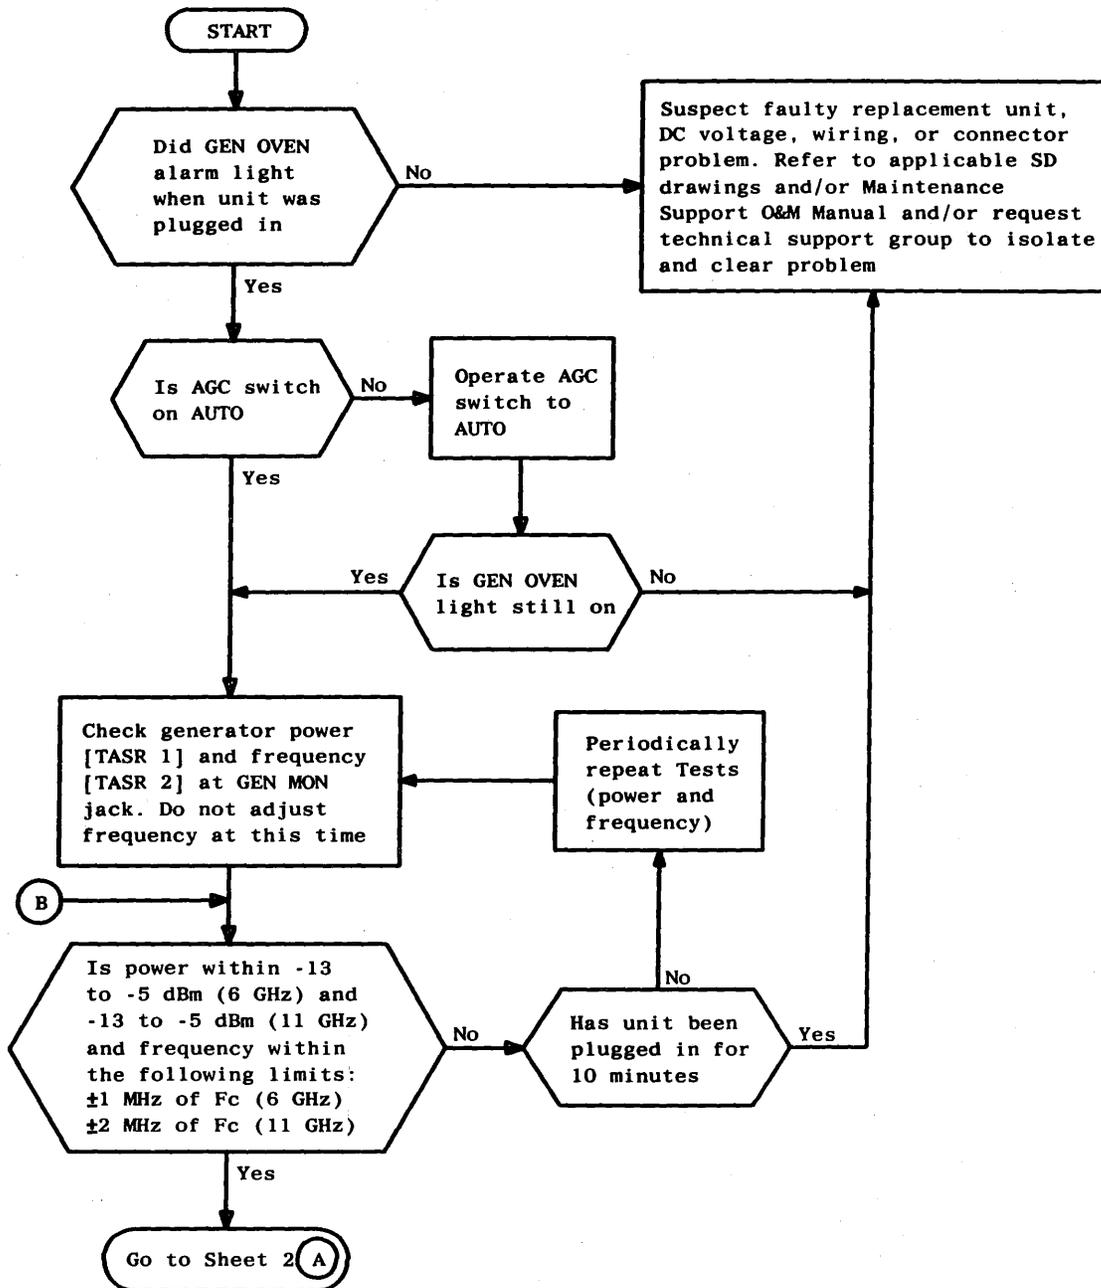
SR 16-B—4400 Series Space Diversity RCVR CONV Unit Initial Check (Sheet 1 of 6)

PREREQUISITE: RCVR CONV unit just installed

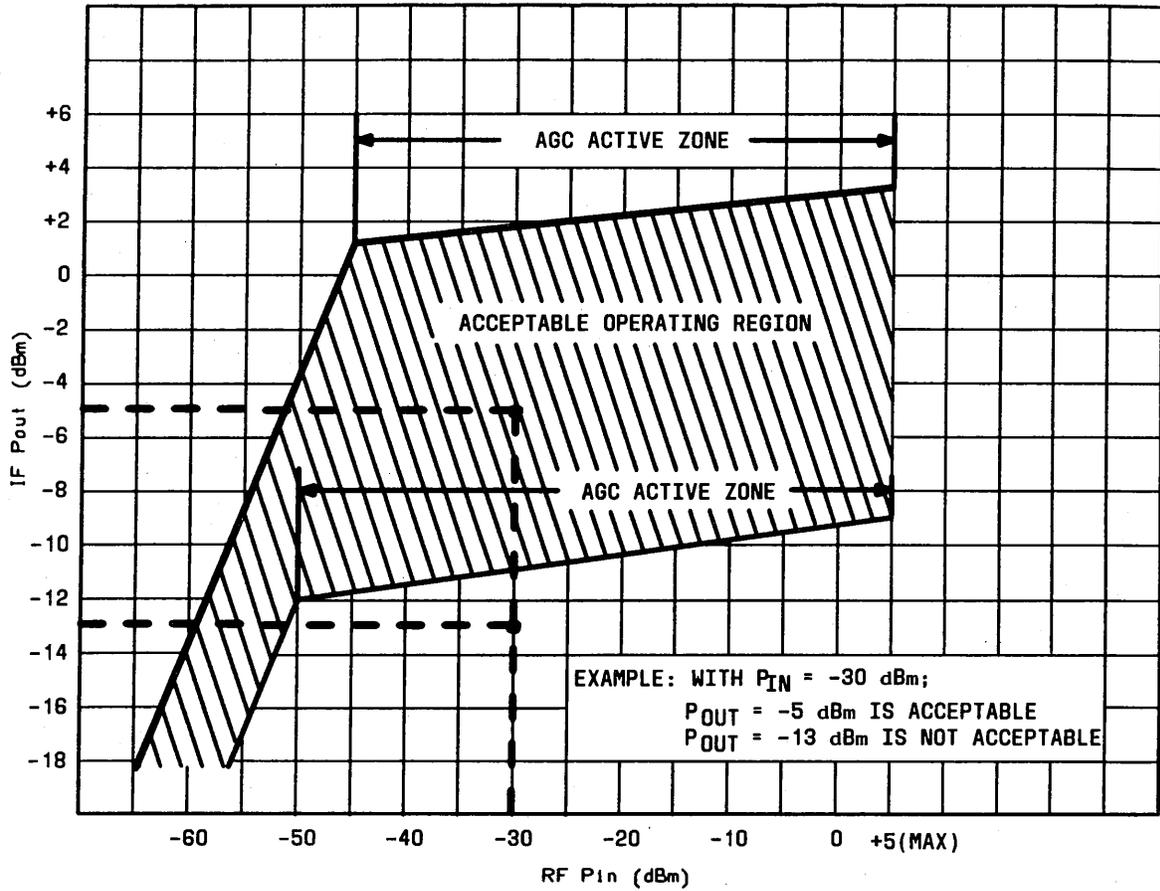
SR 16-B—4400 Series Space Diversity RCVR CONV Unit Initial Check (Sheet 4 of 6)

Maximum IF P_{out} vs RF P_{in} for 4470() and 4471() Down Converters

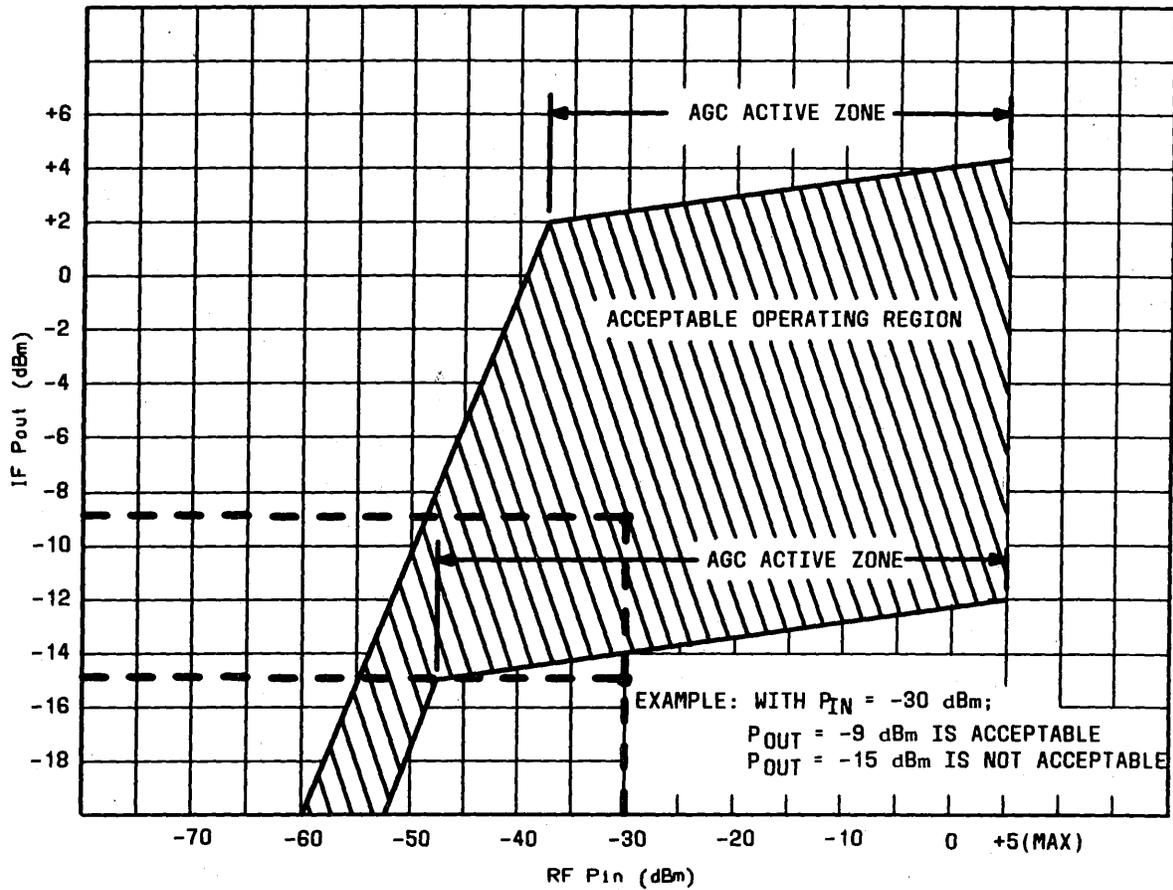
SR 16-B—4400 Series Space Diversity RCVR CONV Unit Initial Check (Sheet 5 of 6)

Maximum IF P_{out} vs RF P_{in} for 4472() and 4473 Down Converters

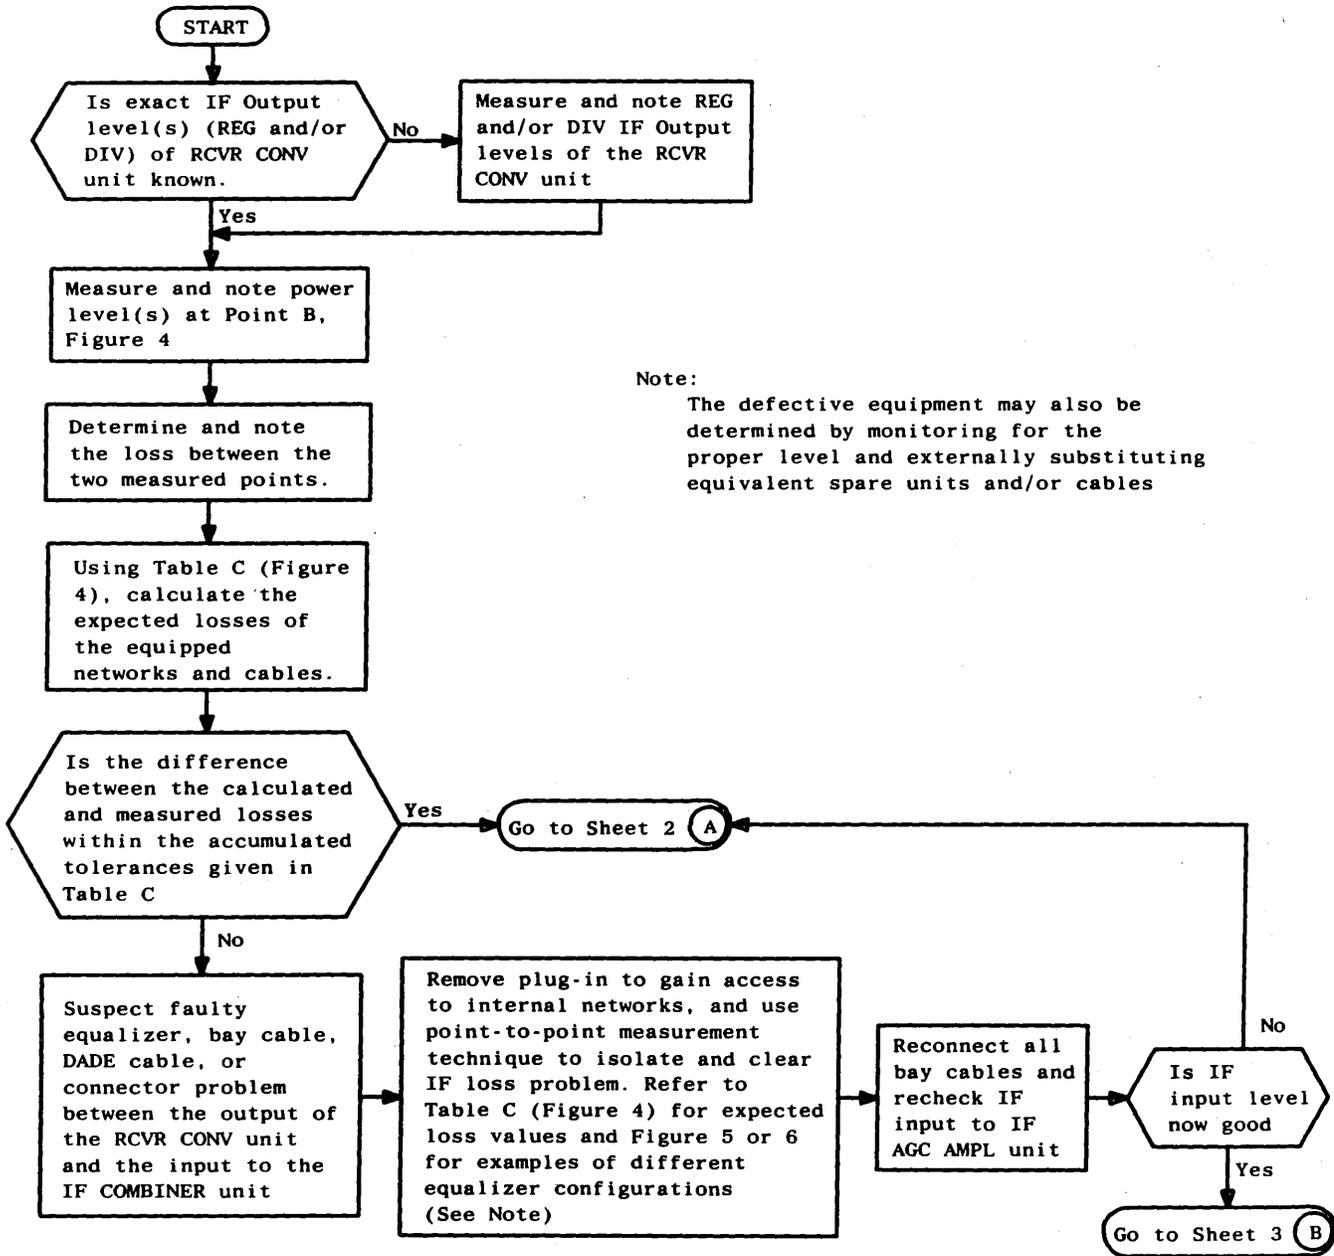
SR 17—Resolving Space Diversity Receiver IF Loss Problem (Sheet 1 of 3)

PREREQUISITE: RCVR CONV IF Output is within 3 dB of RADIO DATA CARD value.
IF AGC AMPL IF input is bad.

Note:
The defective equipment may also be determined by monitoring for the proper level and externally substituting equivalent spare units and/or cables

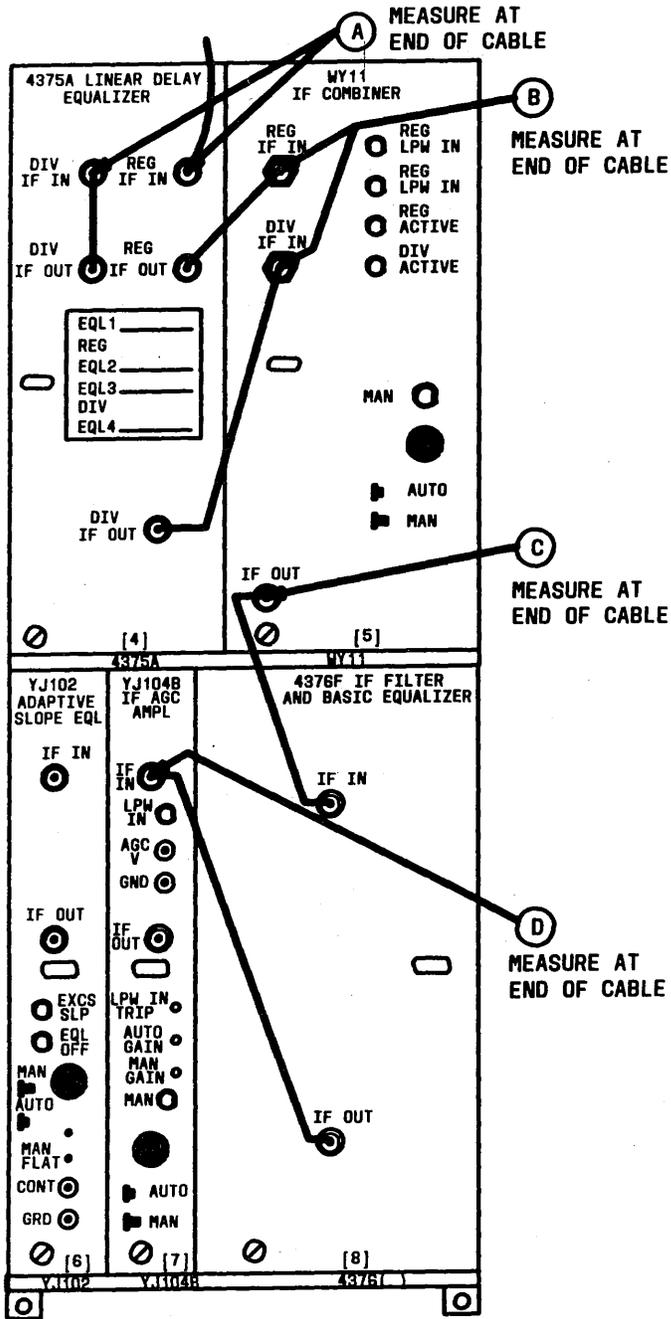
SR 17—Resolving Space Diversity Receiver IF Loss Problem (Sheet 3 of 3)

The defective equipment may also be determined by monitoring for the proper level and externally substituting equivalent spare units and/or cables

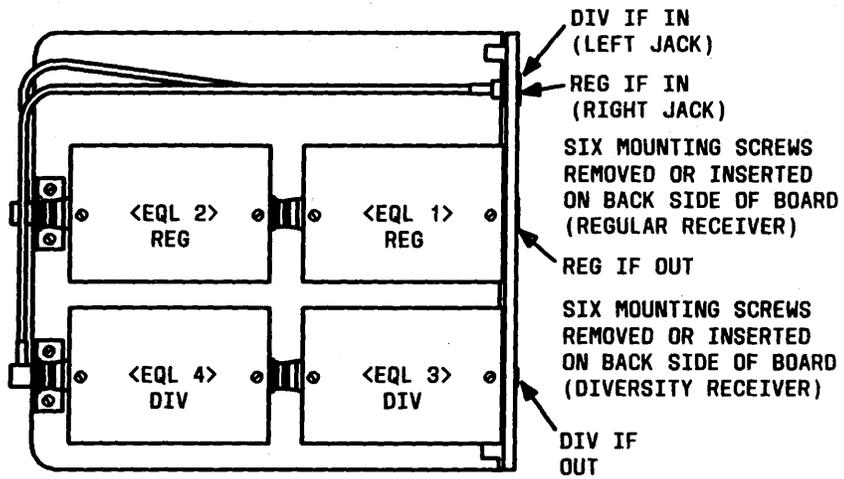
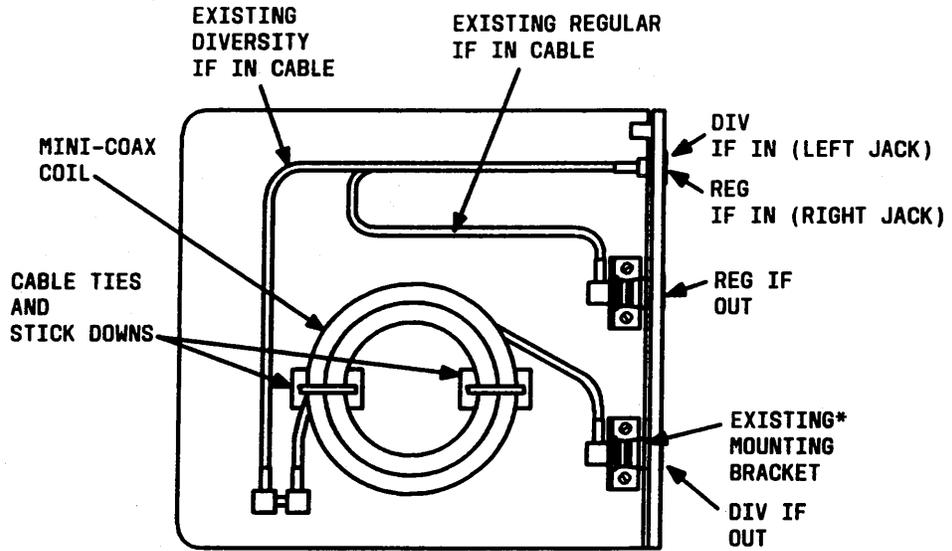
Figure 5-Space Diversity Receiver Linear Delay Equalizer, Side View

A. ONE EQUALIZER EQUIPPED PER RECEIVER

B. TWO EQUALIZERS EQUIPPED PER RECEIVER

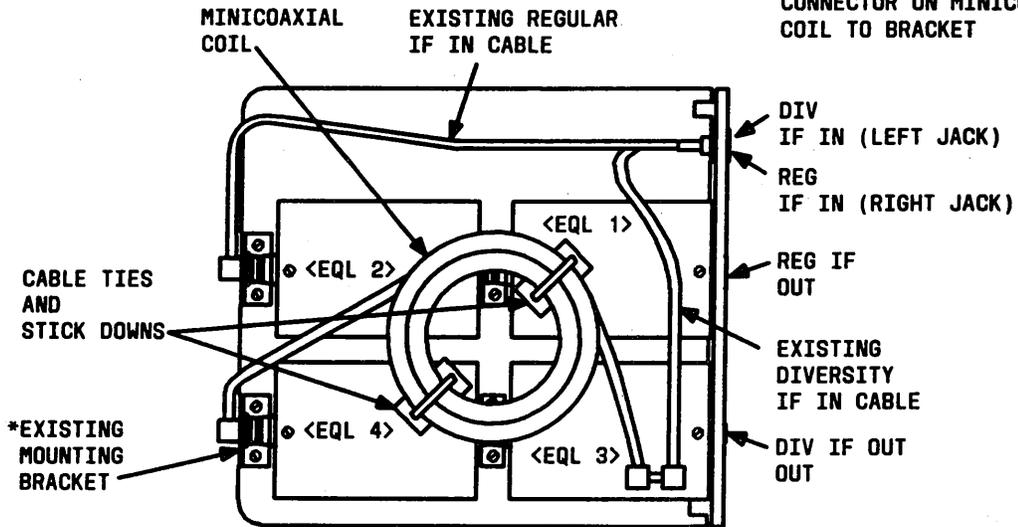
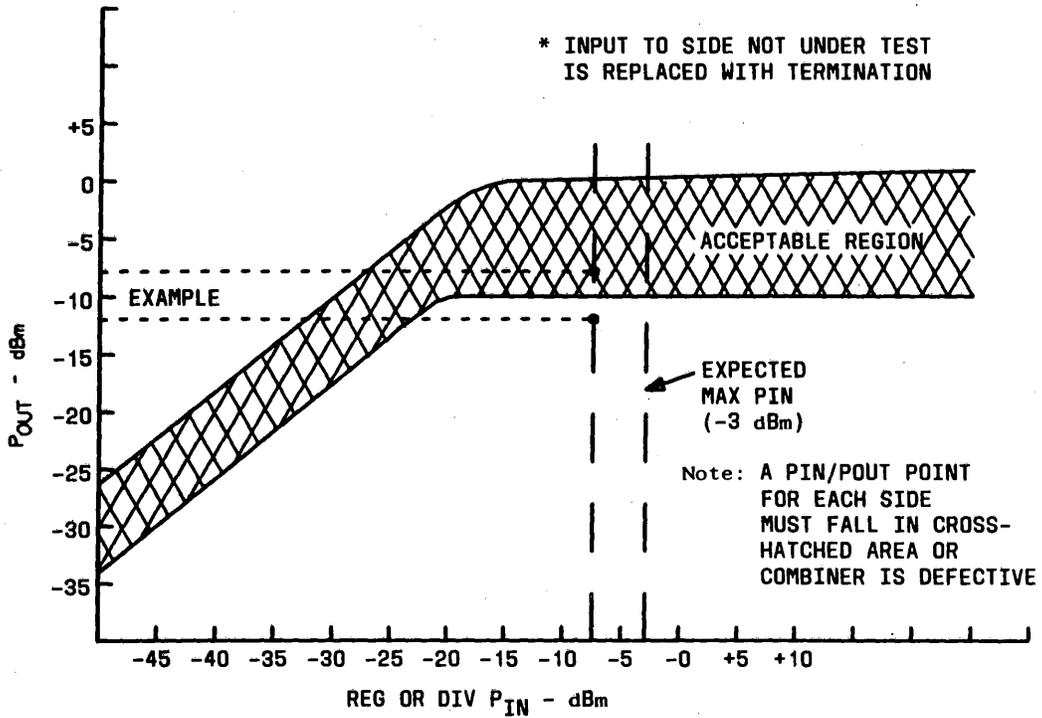
Figure 6-Space Diversity Receiver Linear Delay Equalizer Equipped With Minicoaxial DADE Cable

A. NO EQUALIZER EQUIPPED MINI-COAXIAL IN DIVERSITY IF PATH

* USE HARDWARE REMOVED FROM EXISTING CABLE ASSEMBLY TO MOUNT CONNECTOR ON MINICOAXIAL COIL TO BRACKET

B. FOUR EQUALIZERS EQUIPPED MINI-COAXIAL IN DIVERSITY IF PATH

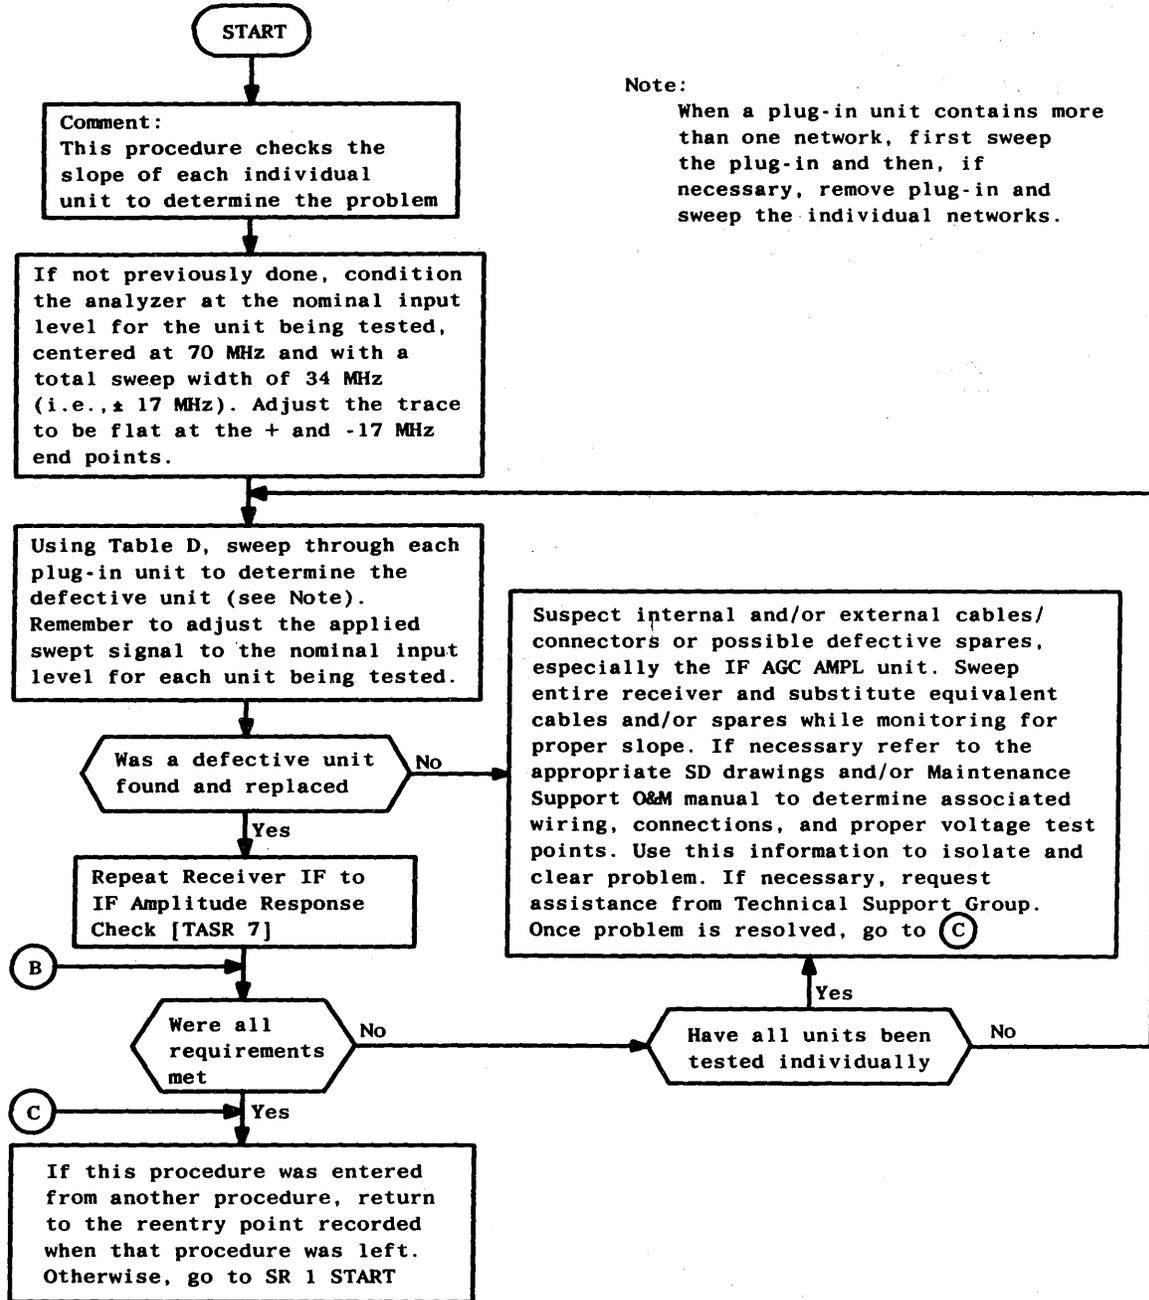
SR 18—Resolving Space Diversity IF Slope Problem (Sheet 1 of 2)

Caution: This procedure is service-affecting unless the proper switching operation has been performed.

PREREQUISITE: Received IF-to-IF Slope measurement did not meet requirement
