**OPERATION AND MAINTENANCE  
1×N FREQUENCY DIVERSITY  
DR 6/11-135A AND 135EC  
COMBINER ALARM**

**MR 1—Receiver COMB Alarm Diagnosis**

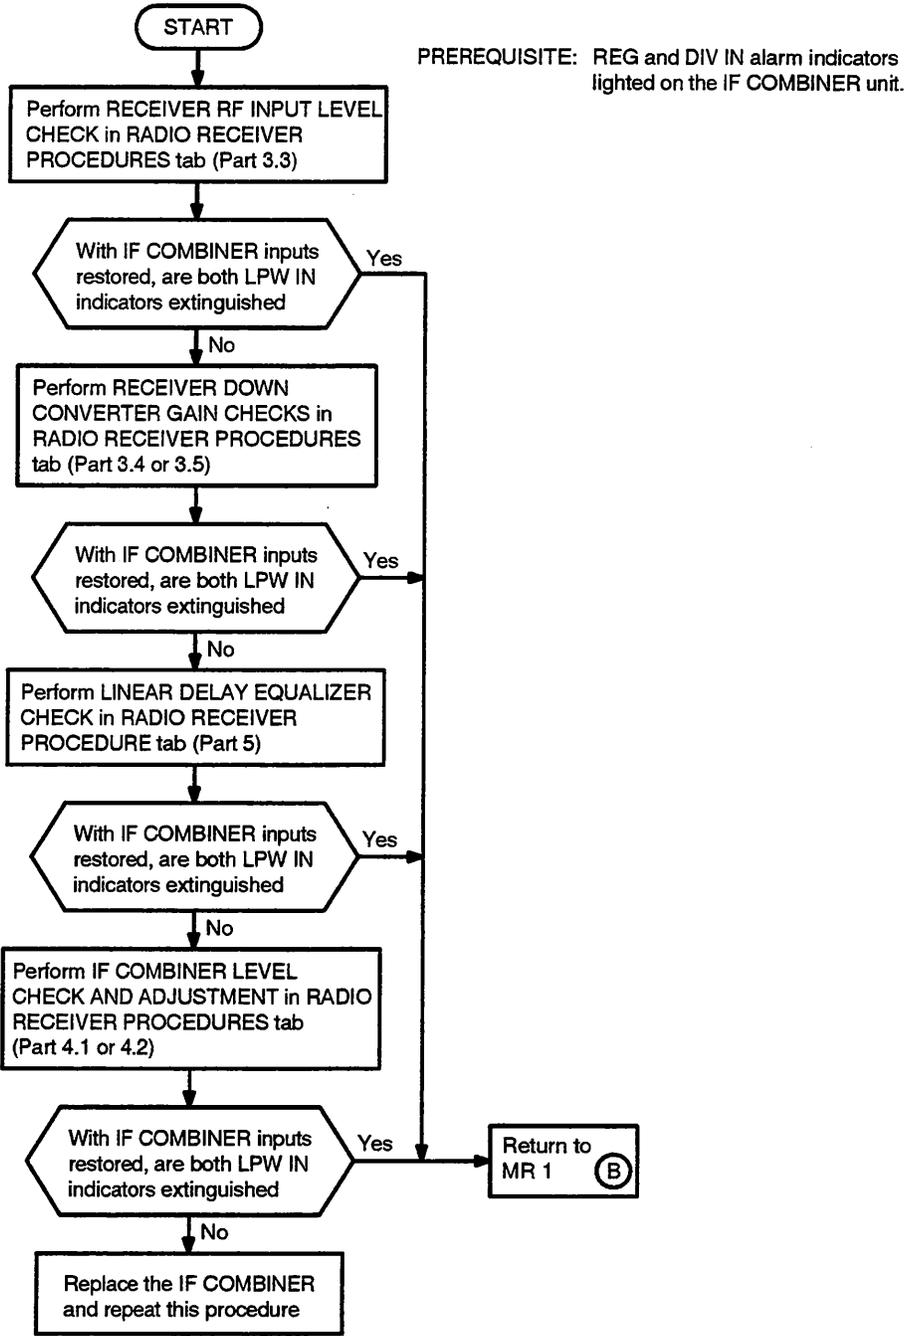
**MSR 1—Combiner REG and DIV LPW IN Alarm Diagnosis,  
REG and DIV LPW IN Alarm Indicators Lighted**

- REG ACTIVE: Status condition. The combiner has selected the signal from the regular channel.
- DIV ACTIVE: Status condition. The combiner has selected the signal from the diversity channel.
- REG LPW IN: Red LED, local alarm on the combiner. The COMB alarm on the alarm and meter network activates after the LPW IN indicator is on continuously for 60 to 100 seconds, caused by a deep fade or signal loss on the regular receiver.
- DIV LPW IN: Same as for REG LPW IN except that it is caused by a deep signal fade or signal loss on the diversity receiver.
- MAN: Caused by operating the pushbutton on the unit to the MAN position. The COMB indicator appears simultaneously when the switch is operated to MAN.
