**OPERATION AND MAINTENANCE
HOT STANDBY
DR 6/11-135A AND 135EC
RECEIVER SUBROUTINES**

This section contains the subroutines (SR) referenced from the receiver trouble-clearing main routines (MR), main subroutines (MSR), and receiver test and adjustment subroutines (TASR).

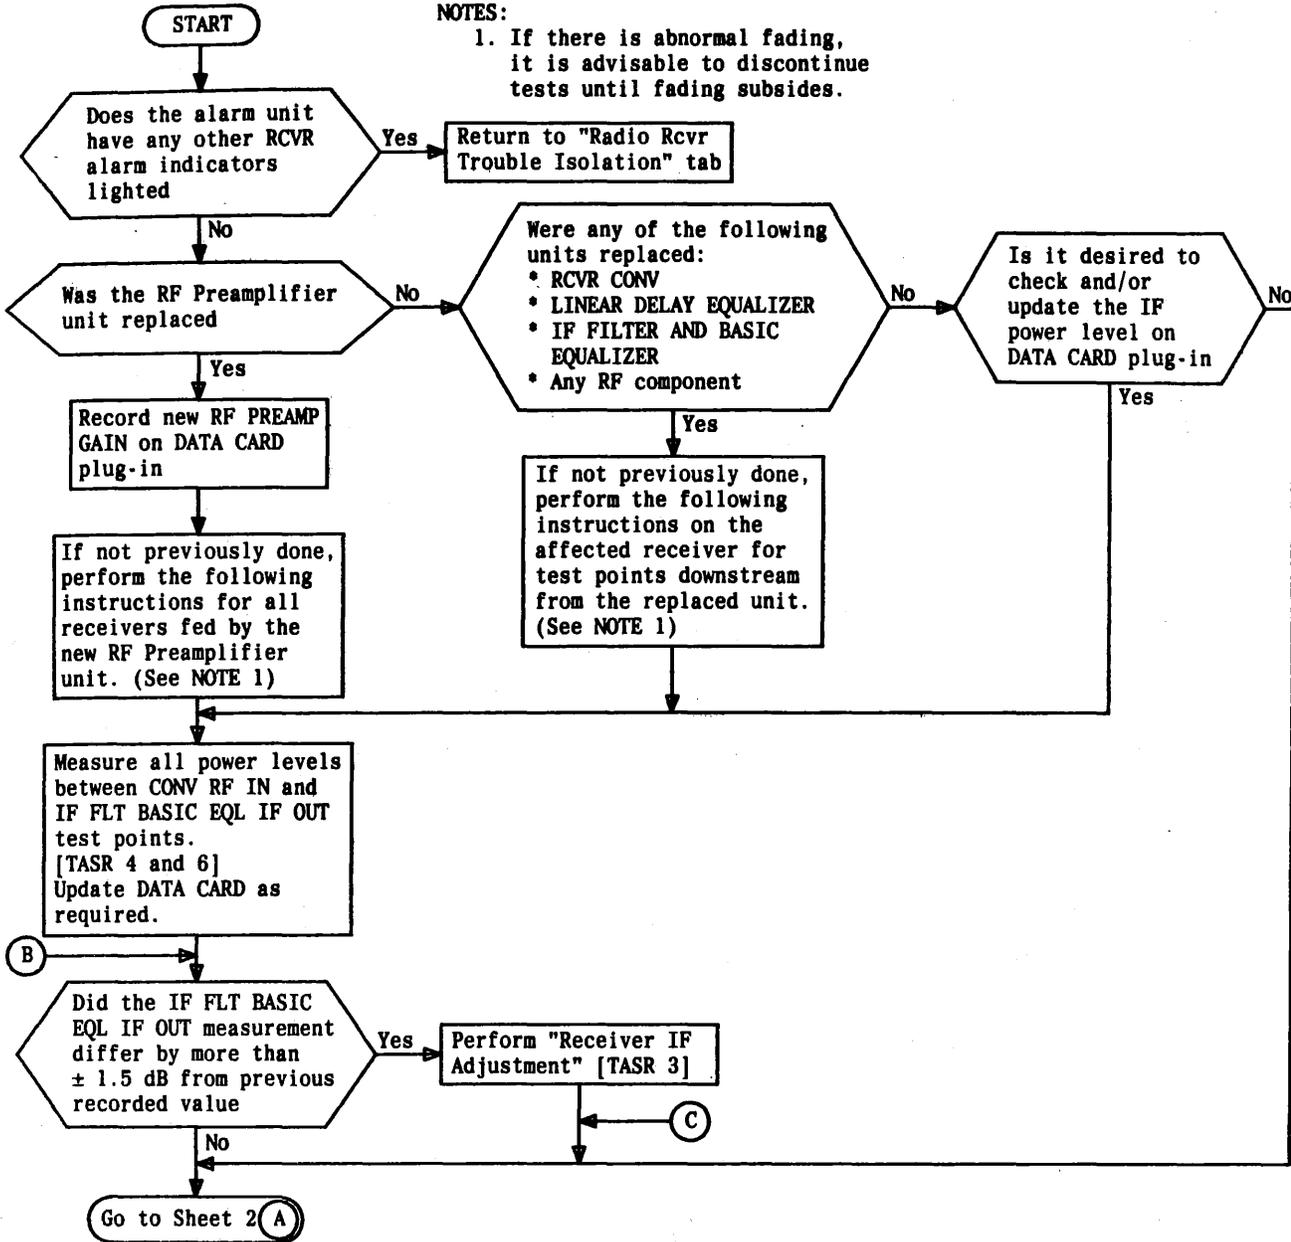
SR 1—Condition Receiver/Update Data Card Prior to Repair Verification (Sheet 1 of 2)

1. If there is abnormal fading, it is advisable to discontinue tests until fading subsides.

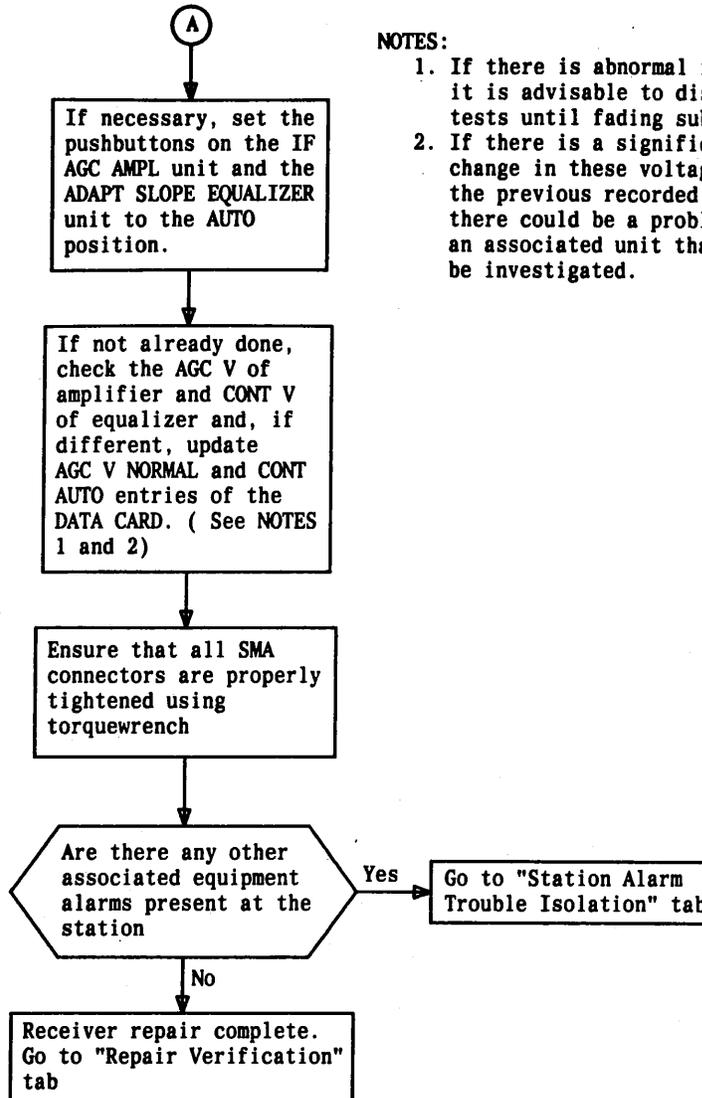
SR 1—Condition Receiver/Update Data Card Prior to Repair Verification (Sheet 2 of 2)

1. If there is abnormal fading, it is advisable to discontinue tests until fading subsides.
2. If there is a significant change in these voltages from the previous recorded value, there could be a problem in an associated unit that should be investigated.

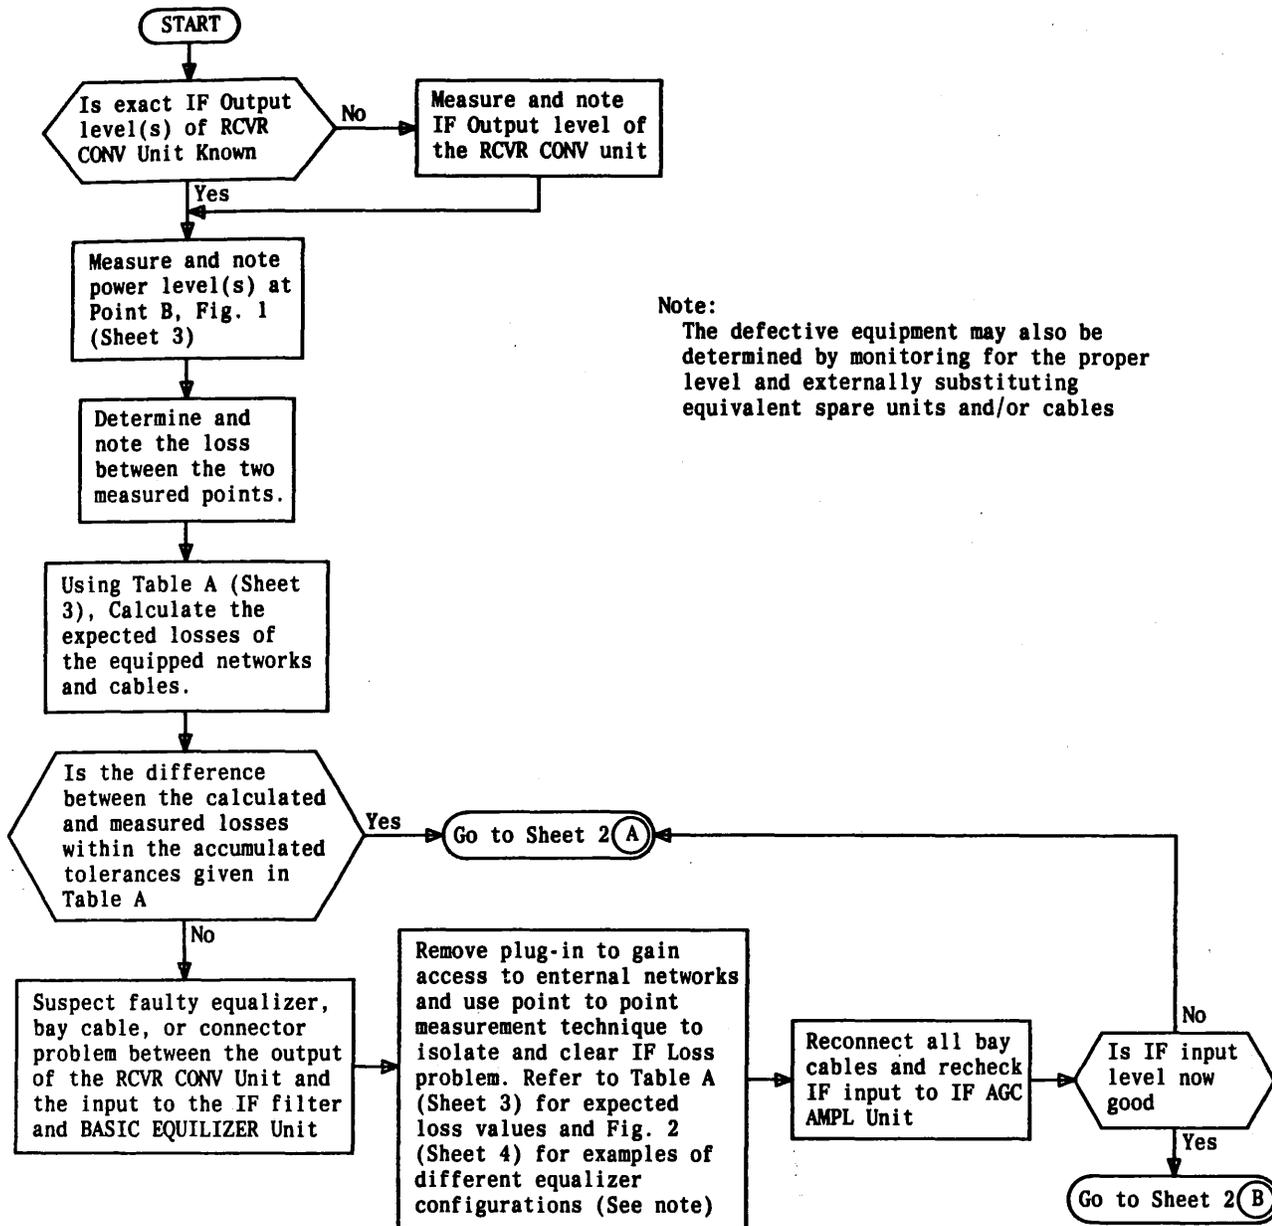
SR 2—Resolving IF EQ/FLTR Loss Problem (Sheet 1 of 2)

Prerequisite: DOWN CONV IF Output is within $\pm 3\text{dB}$ of DATA CARD value.
IF AGC AMPL IF input is bad.

Note:
The defective equipment may also be determined by monitoring for the proper level and externally substituting equivalent spare units and/or cables

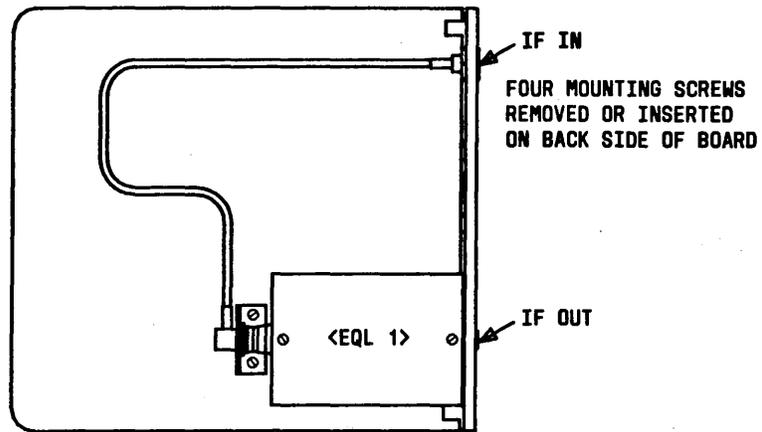
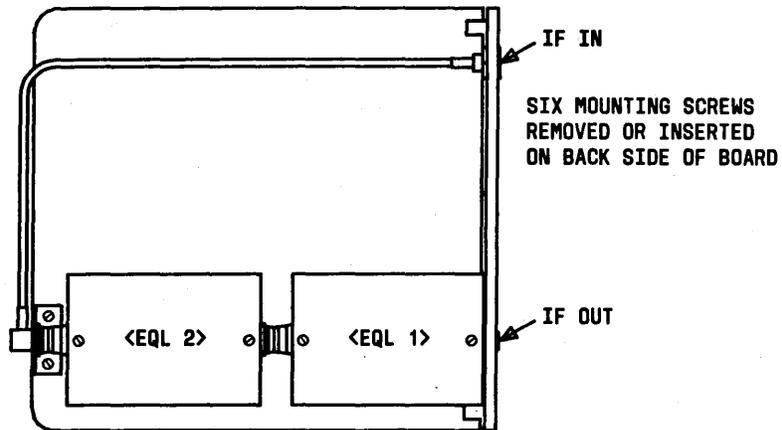
Fig. 2—Hot Standby Receiver Linear Delay Equalizer, Side View

A. ONE EQUALIZER EQUIPPED

B. TWO EQUALIZERS EQUIPPED

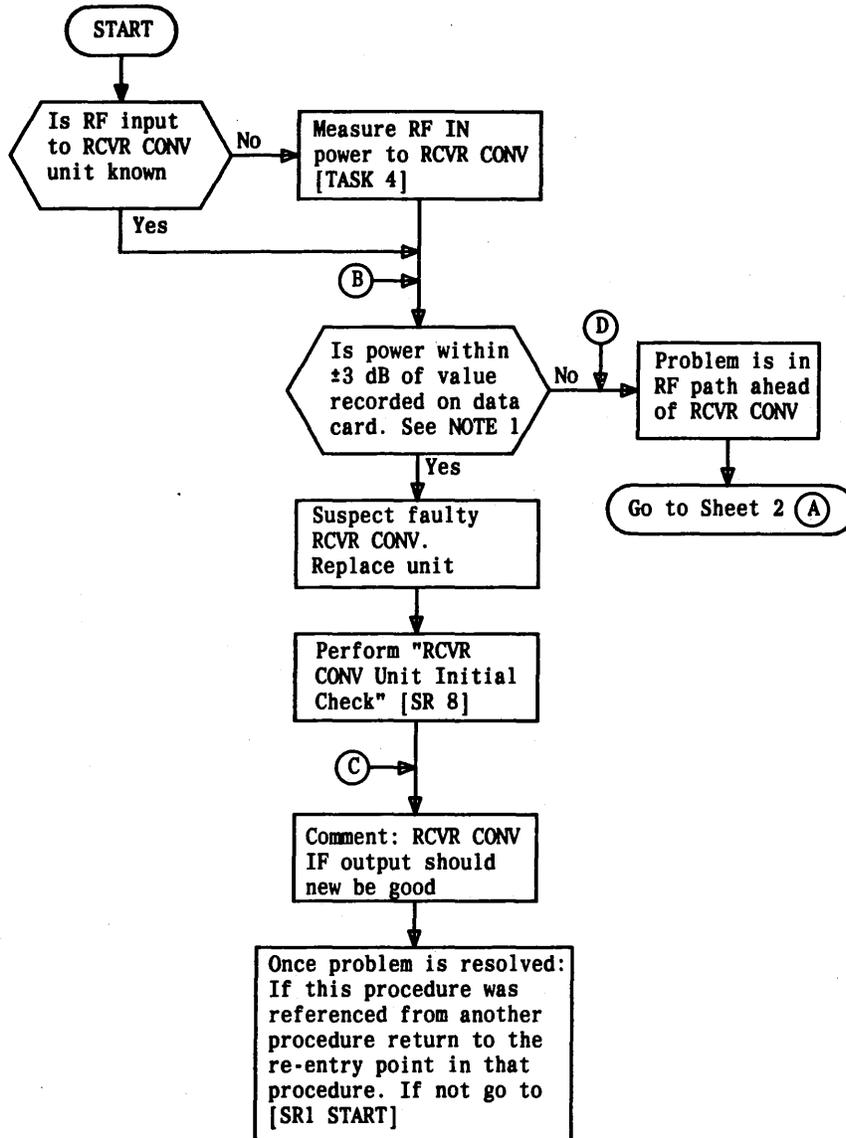
SR 3—Resolving RF-to-IF Loss Problem (Sheet 1 of 2)

If the RF input signal to the RCVR CONV is undergoing an abnormal fading condition (>4.0 dB fluctuations), defer measurement to a more stable time. Otherwise, it will be necessary to visually average and evaluate results relative to requirement on this basis.

PREREQUISITE: IF output level of RCVR CONV unit is bad

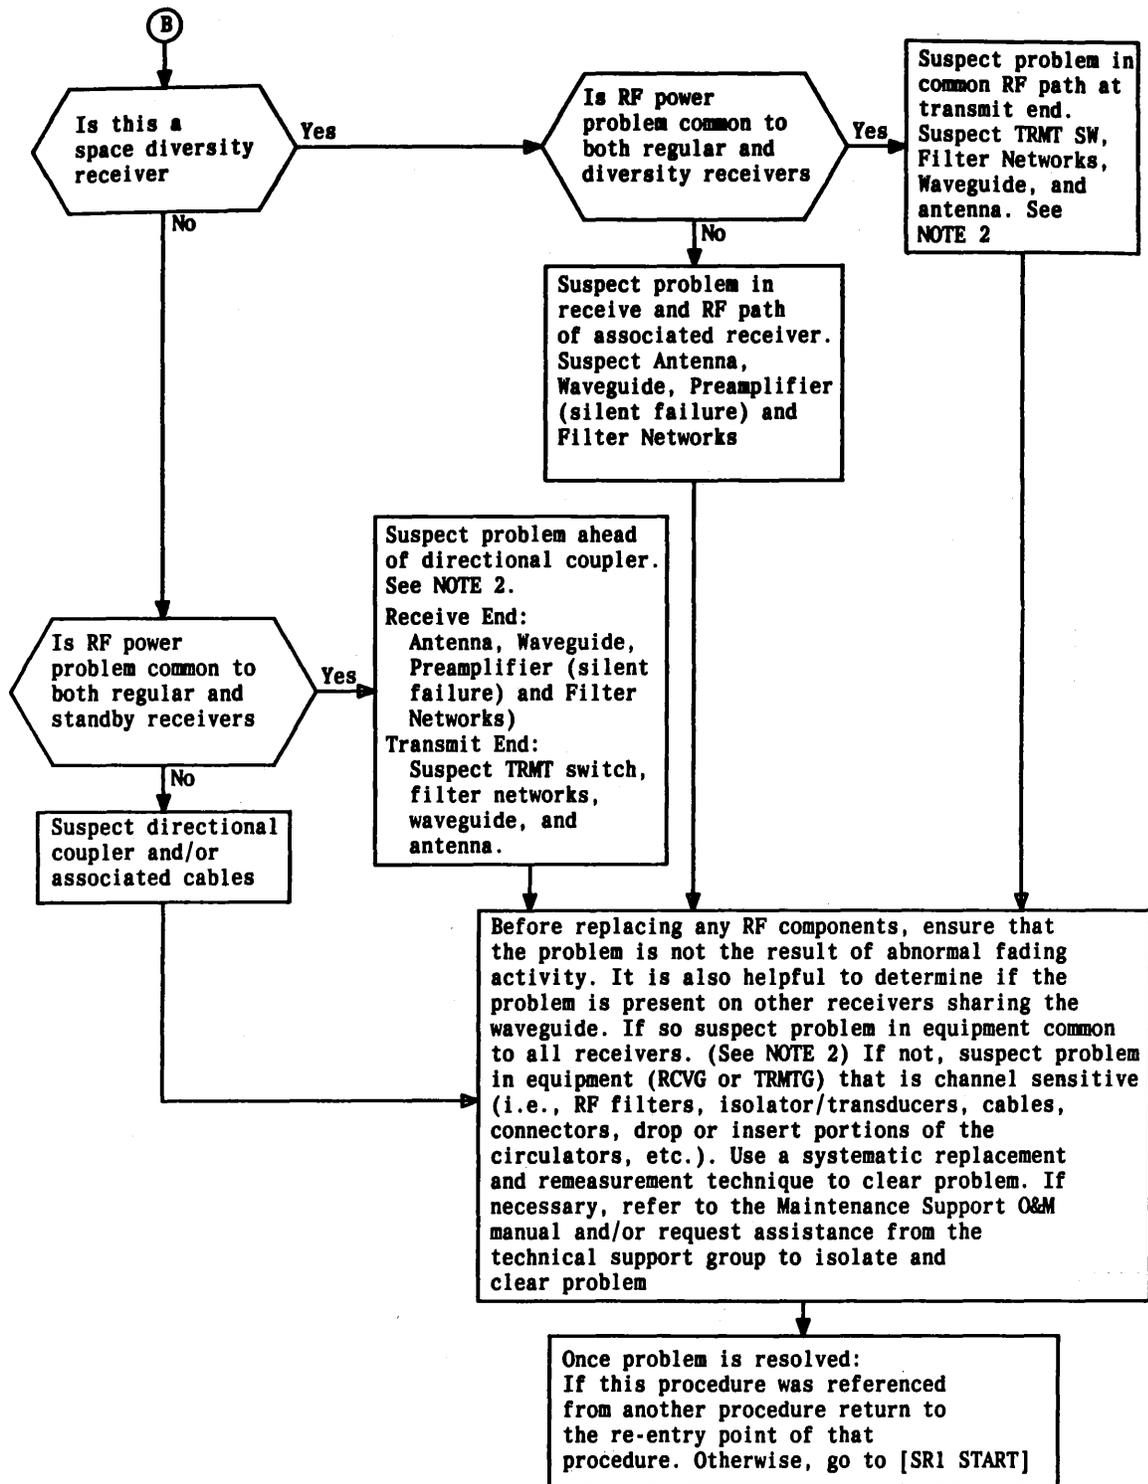
SR 3—Resolving RF-to-IF Loss Problem (Sheet 2 of 2)

See "Common Equipment Failure" information in "Service Protection" tab for additional diagnostic aid in isolating RF problems which are known to be common to both receivers.

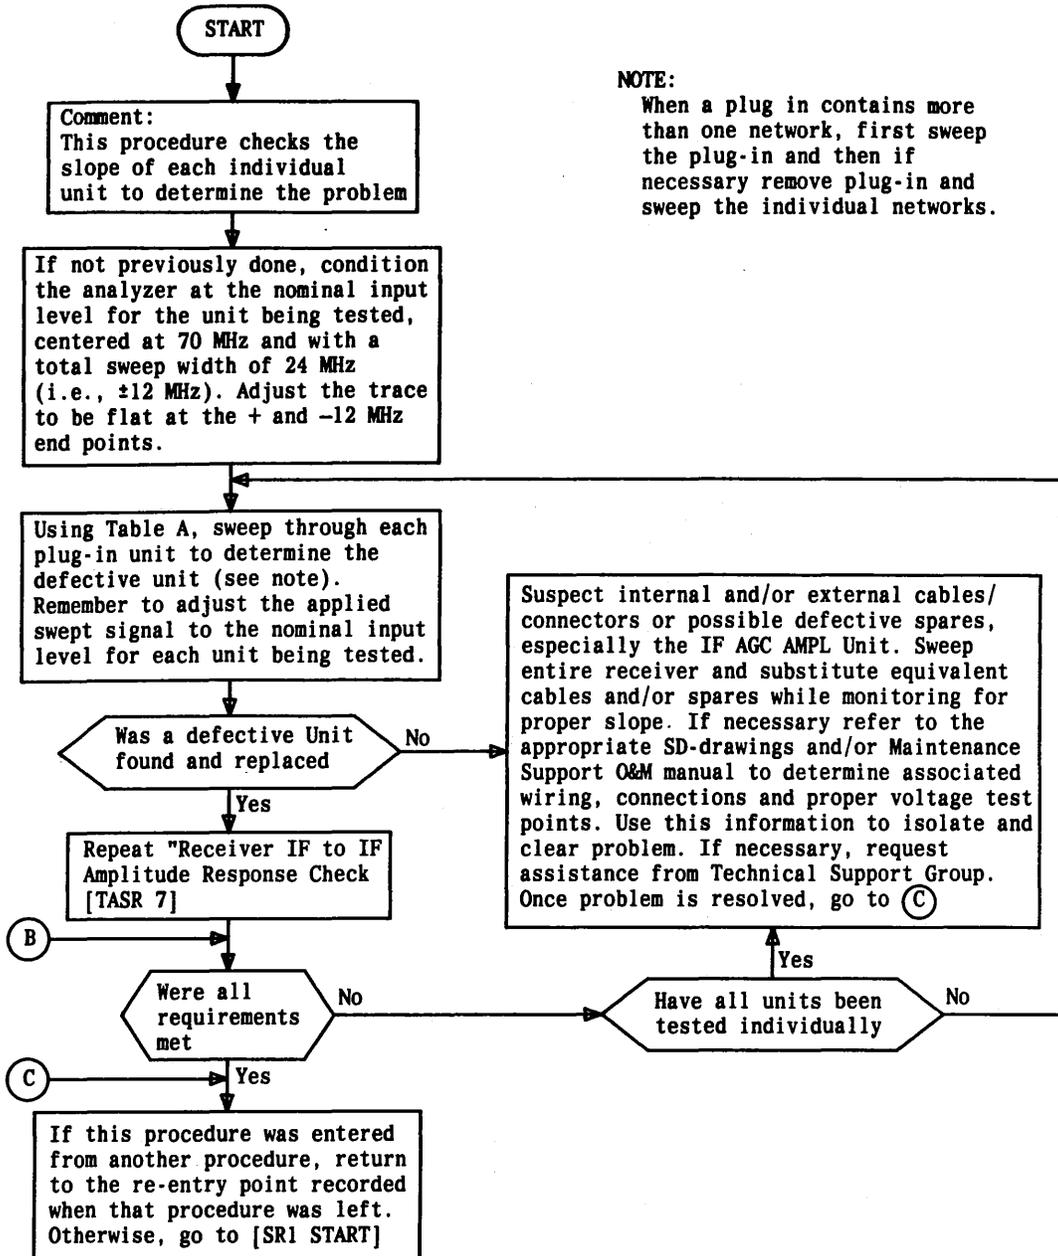
SR 4—Resolving IF Slope Problem (Sheet 1 of 2)

PREREQUISITE: Received IF to IF Slope measurement did not meet requirement

NOTE:
When a plug in contains more than one network, first sweep the plug-in and then if necessary remove plug-in and sweep the individual networks.

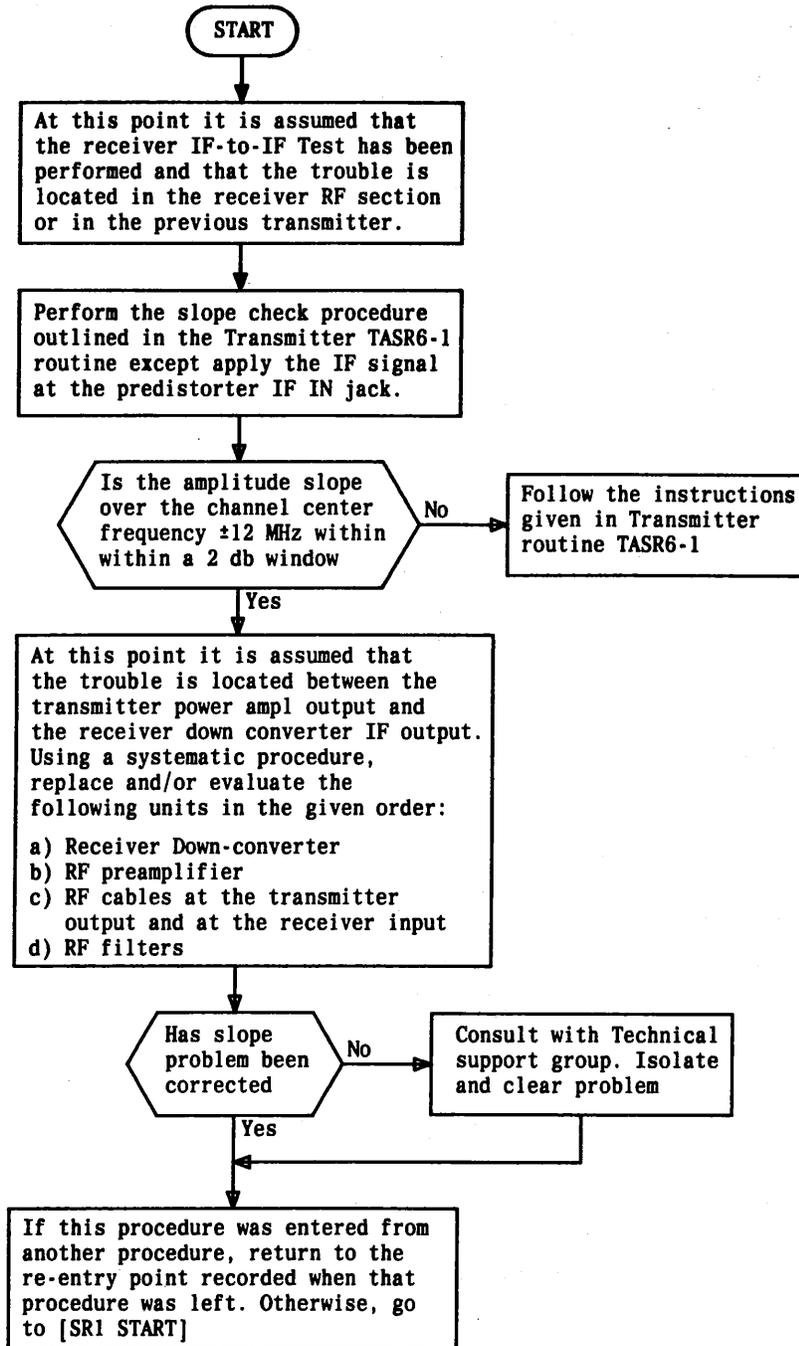
SR 5—Resolving RF Slope Problem

PREREQUISITE: Excessive IF slope exists at the RCVR CONV-IF OUT jack

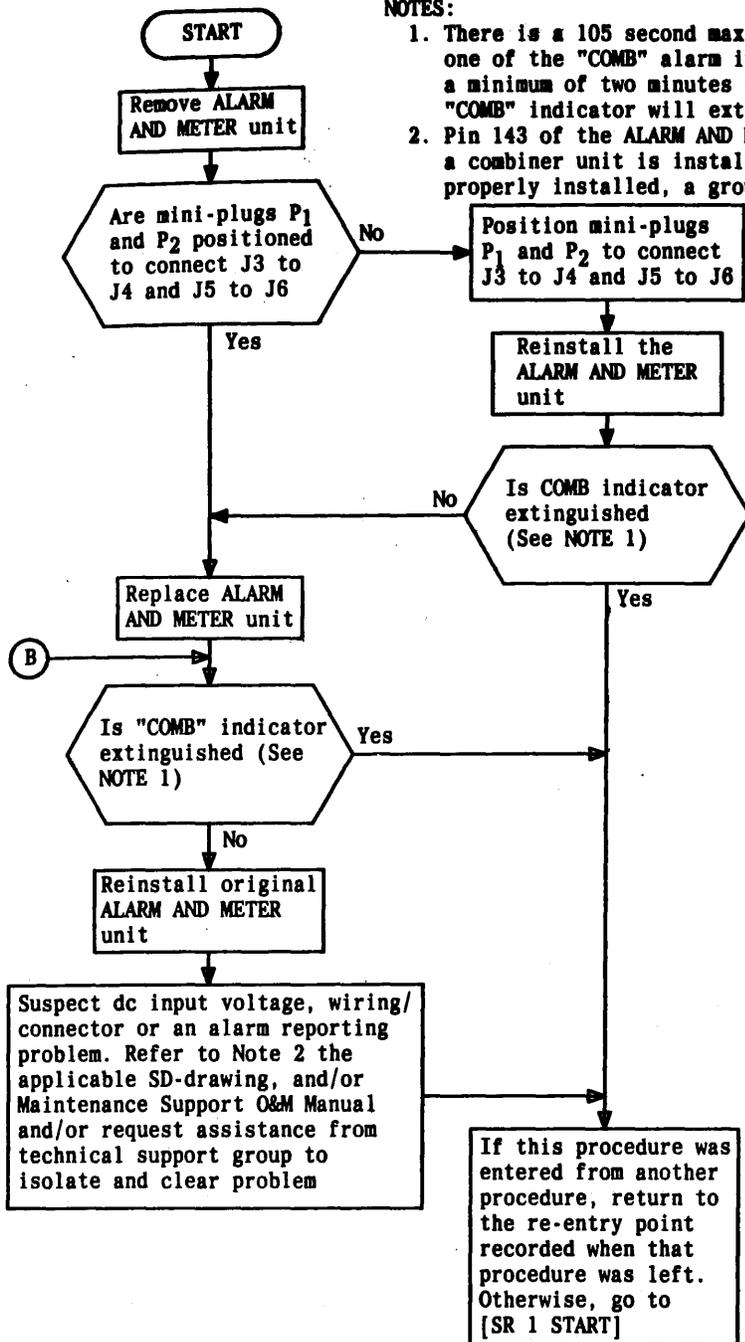
SR 6—Resolving Combiner Indicator Problem

PREREQUISITE: COMB indicator lighted on ALARM/ALARM and METER unit when IF COMBINER Unit is not equipped in receiver

1. There is a 105 second maximum delay associated with one of the "COMB" alarm inputs. Therefore, wait a minimum of two minutes to determine if the "COMB" indicator will extinguish.
2. Pin 143 of the ALARM AND METER unit is used to sense if a combiner unit is installed. If miniplugs P1 and P2 are properly installed, a ground on Pin 143 will cause an alarm.

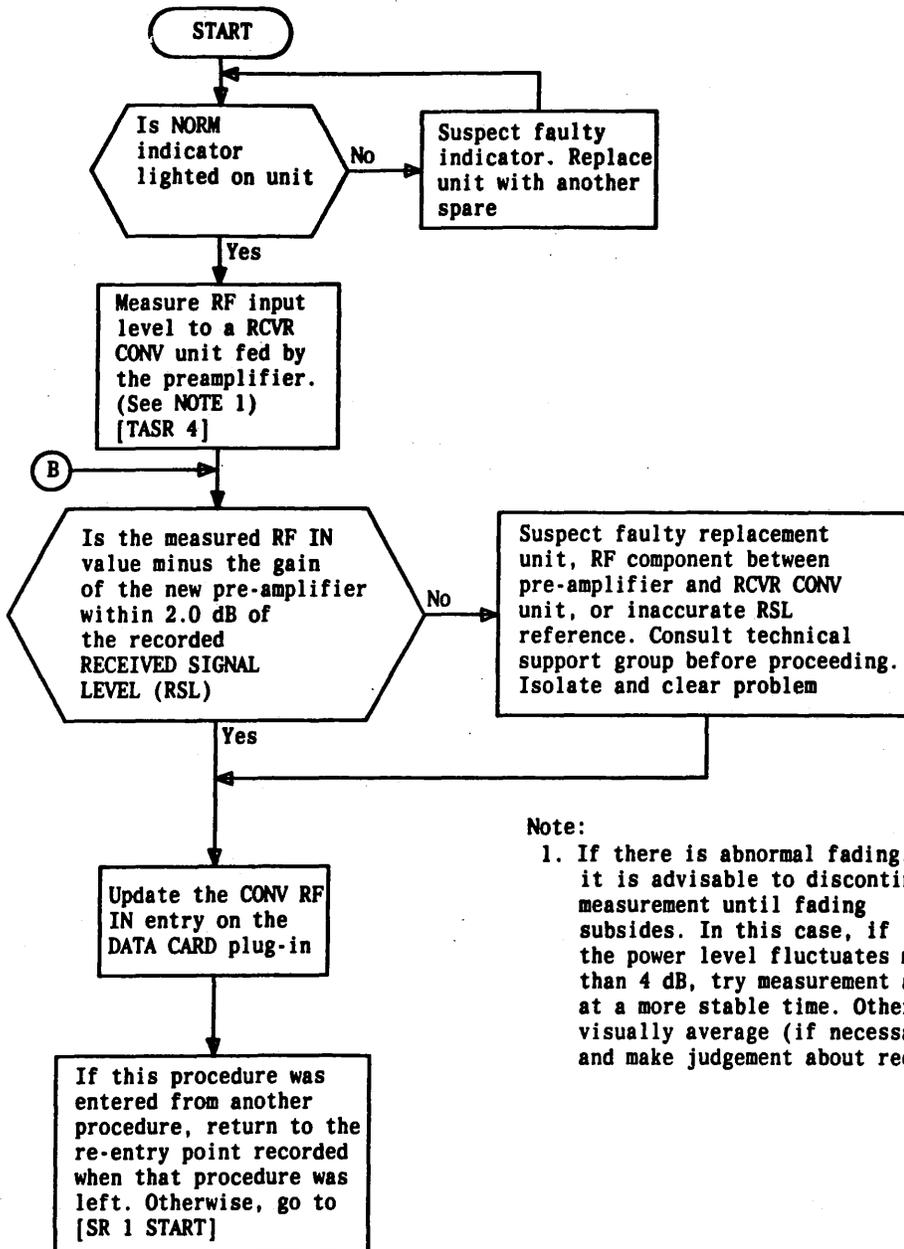
SR 7—RF Preamp Unit Initial Check

PREREQUISITES: 1. New RF Pre-amplifier just installed.
2. The dc input voltages to RF Preamplifier are good (+15V and -15V $\pm 0.4V$)

1. If there is abnormal fading, it is advisable to discontinue measurement until fading subsides. In this case, if the power level fluctuates more than 4 dB, try measurement again at a more stable time. Otherwise visually average (if necessary) and make judgement about requirement.

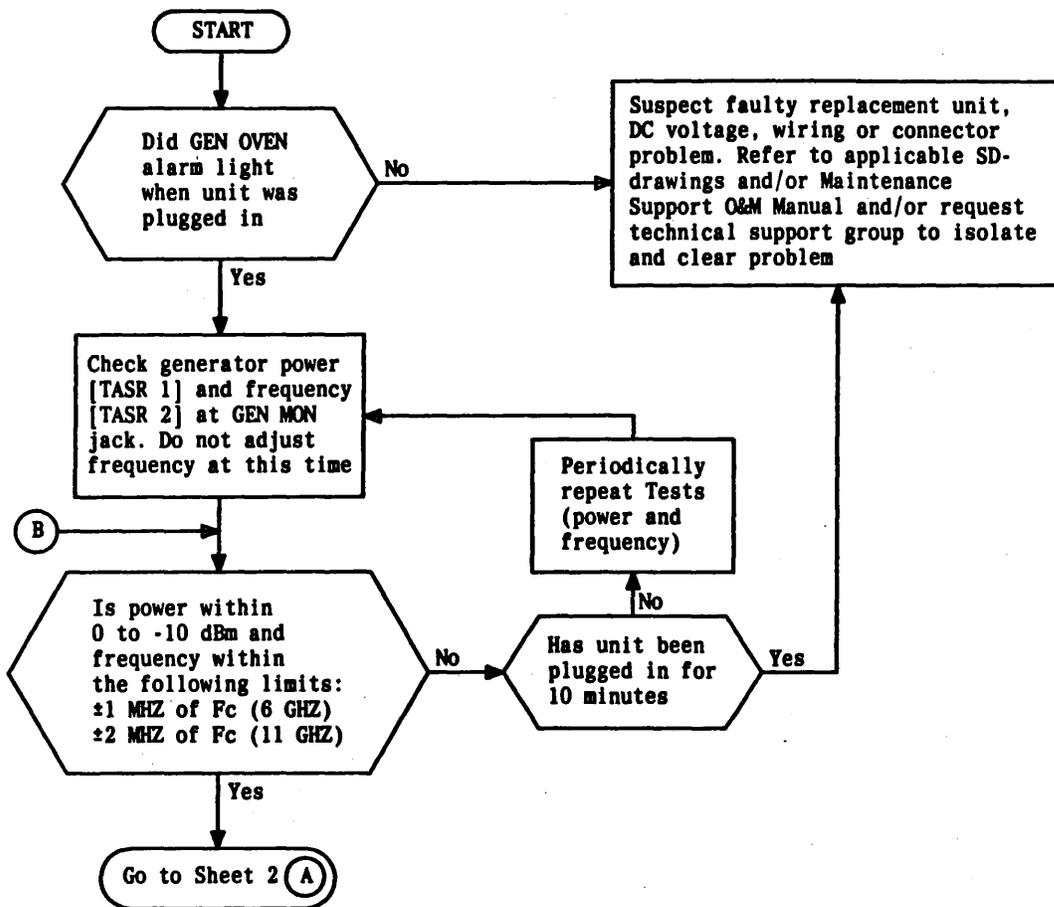
SR 8-RCVR CONV Unit Initial Check (Sheet 1 of 3)

PREREQUISITE: RCVR CONV unit just installed

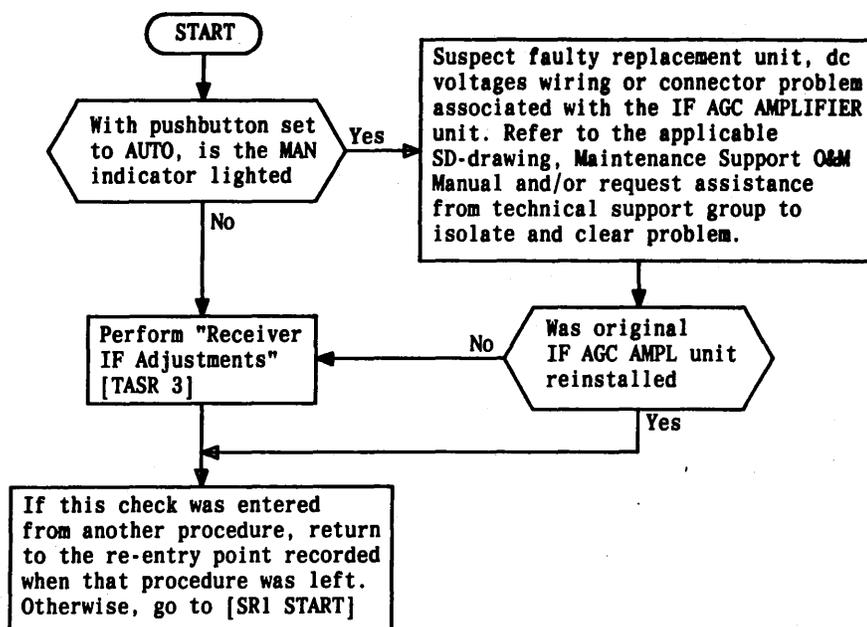
SR 9—IF AGC AMPL Unit Initial Check

PREREQUISITE: If AGC AMPL unit just installed.

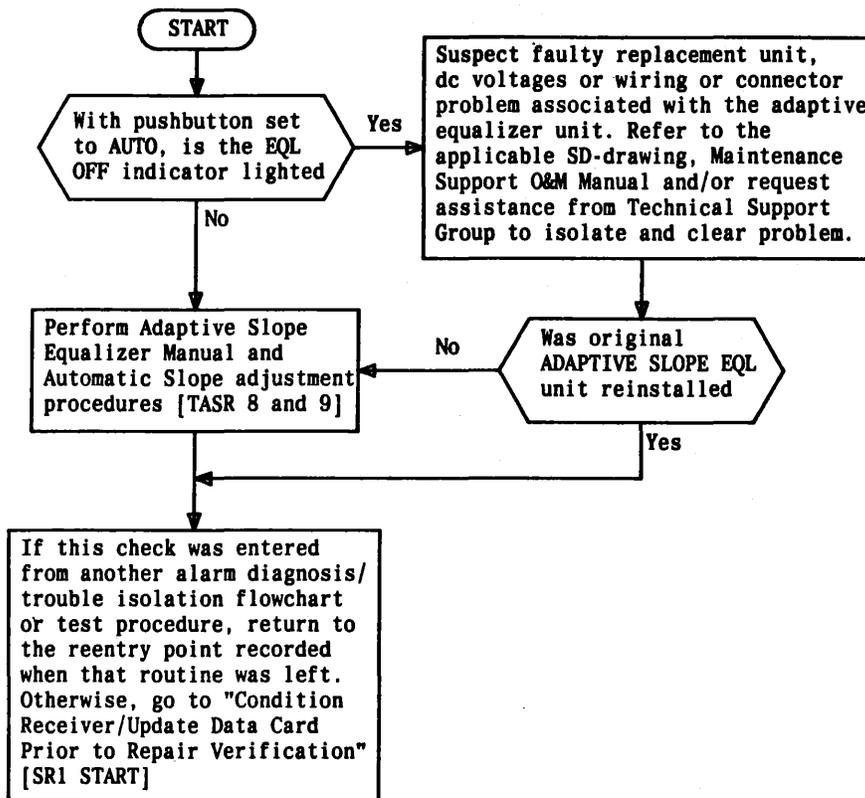
SR 10—Adaptive Slope Equalizer Unit Initial Check

PREREQUISITE: IF ADAPTIVE SLOPE EQL unit just installed.

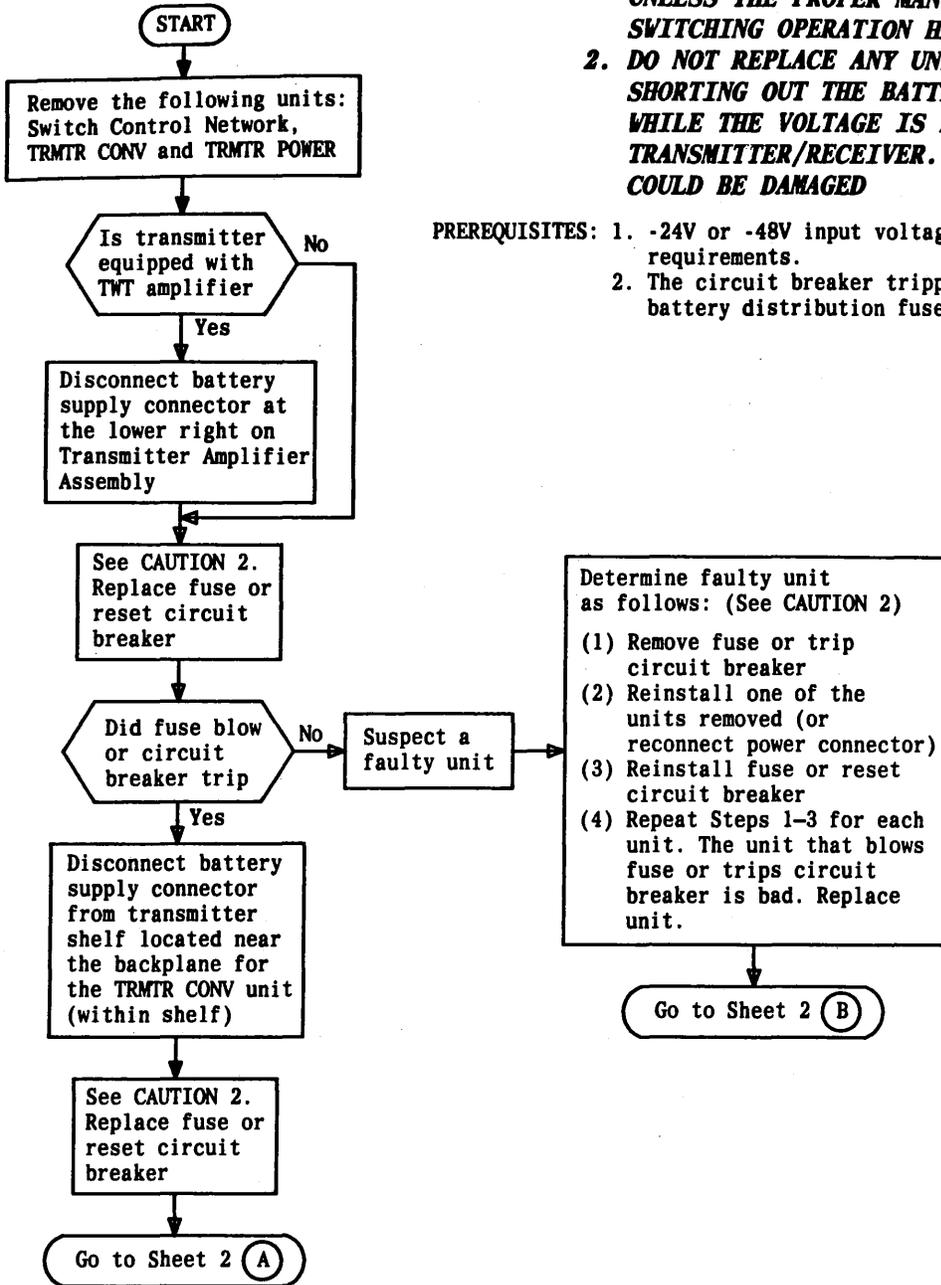
SR 11—Resolving Transmitter Shelf DC Input Problems (Sheet 1 of 2)

PREREQUISITES: 1. -24V or -48V input voltage does not meet requirements.
 2. The circuit breaker tripped/fuse blown at battery distribution fuse bay.

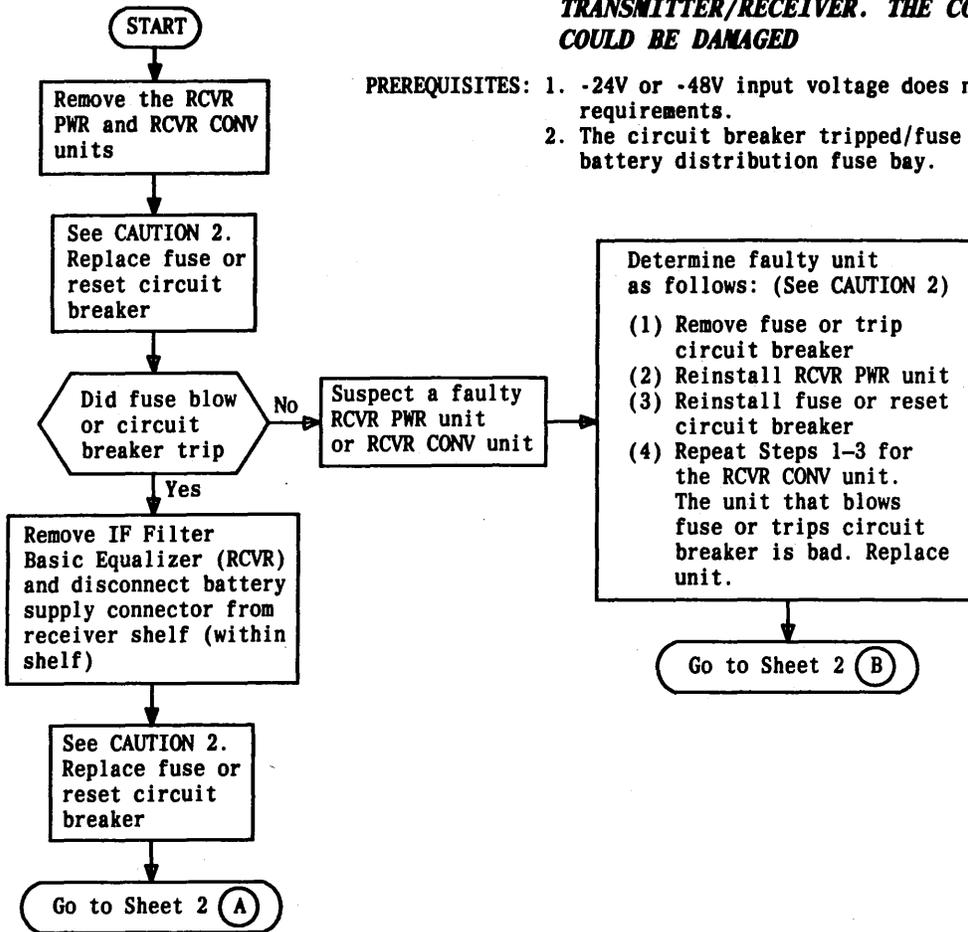
SR 12—Resolving Receiver Shelf DC Input Problems (Sheet 1 of 2)

PREREQUISITES: 1. -24V or -48V input voltage does not meet requirements.
 2. The circuit breaker tripped/fuse blown at battery distribution fuse bay.

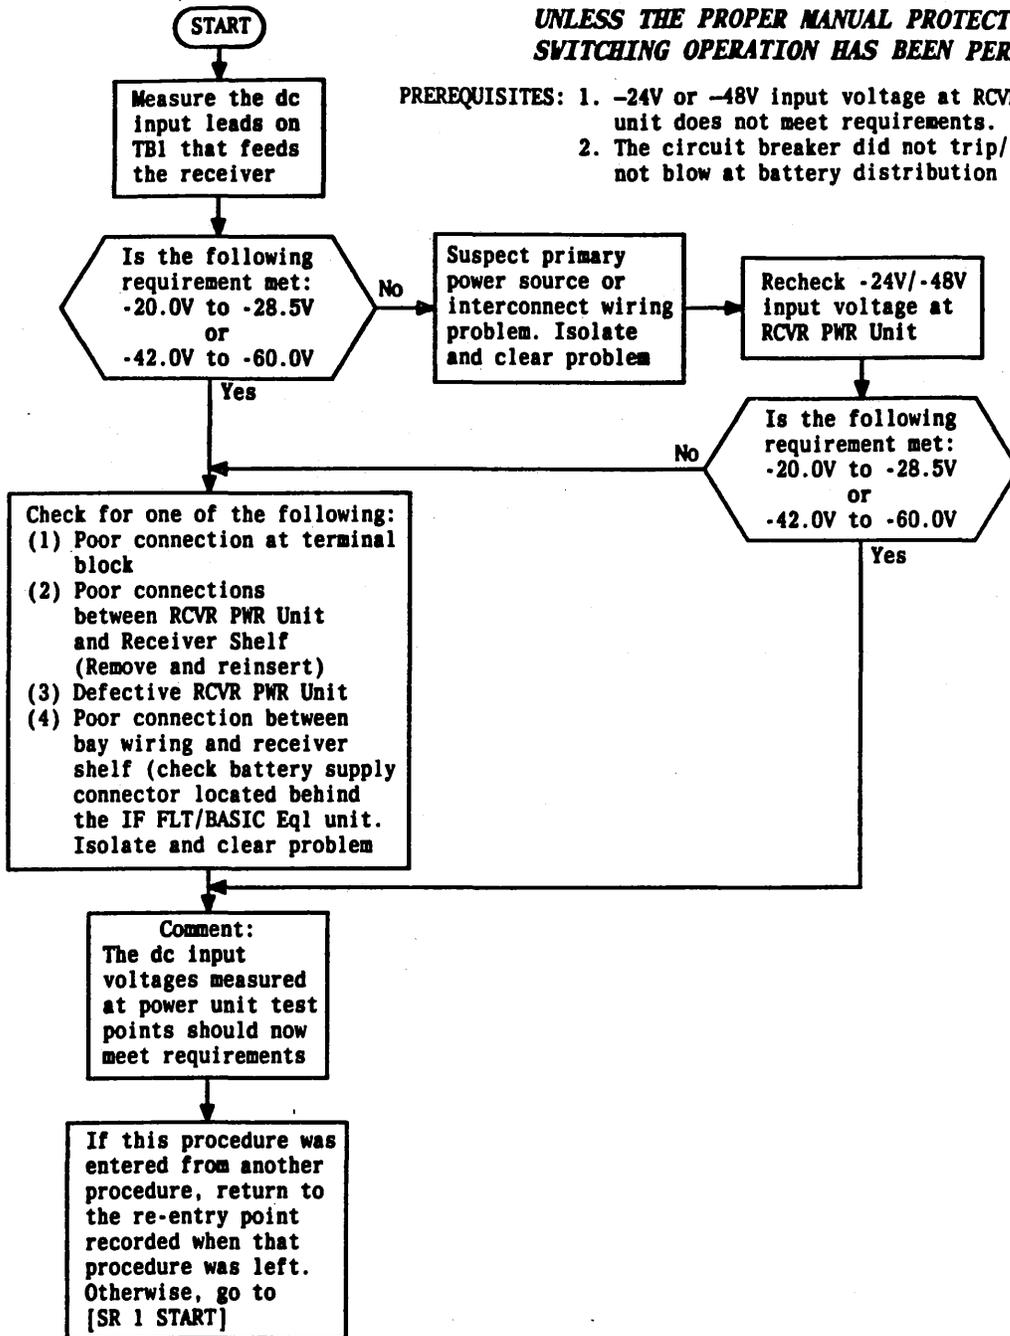
SR 13—Resolving DC Input Problems When Circuit Breaker and Fuse Did Not Blow/Trip

PREREQUISITES: 1. -24V or -48V input voltage at RCVR PWR unit does not meet requirements.
 2. The circuit breaker did not trip/fuse did not blow at battery distribution fuse bay.
