**DR 6/11-135A and 135EC
1×N Frequency Diversity
Operation and Maintenance
Terminal/Regenerator
Trouble Isolation**

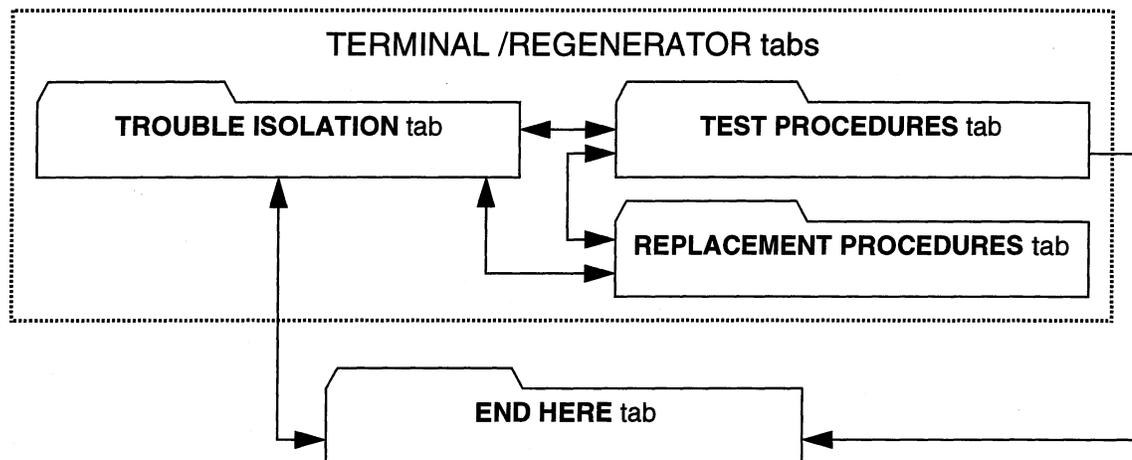
As you go through the trouble isolation process, you will be interacting with the test procedures and the replacement procedures as shown below:

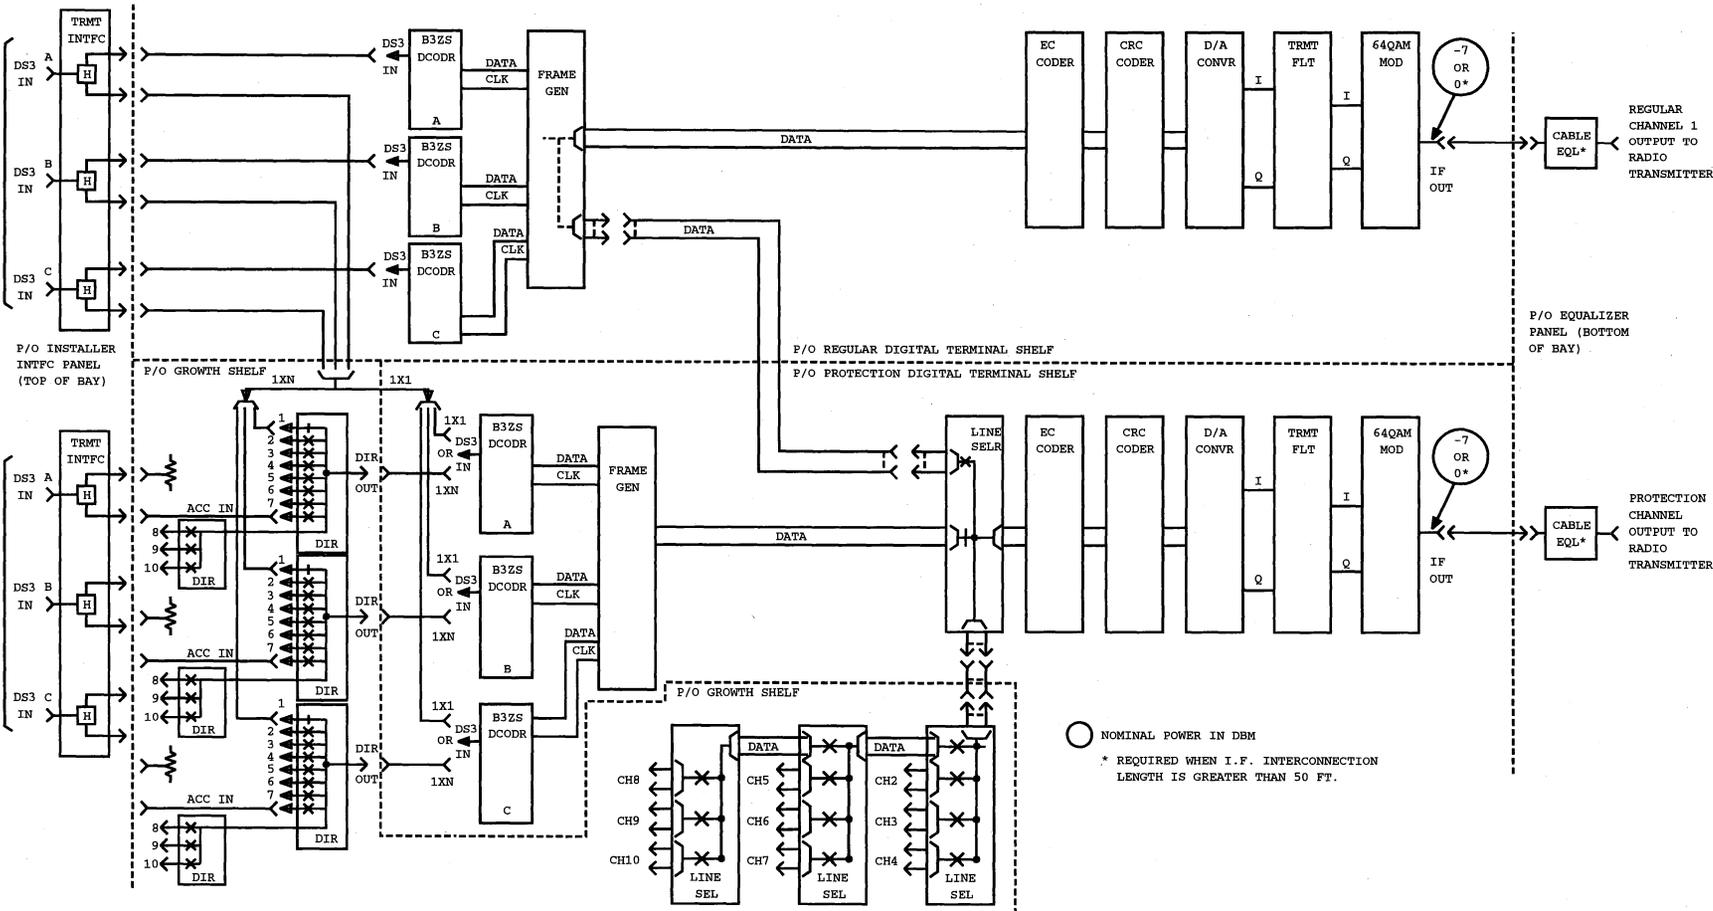
Figure 1. Terminal Transmitter Block Diagram
Page 8

A functional block diagram of a digital transmitter is shown in Figure 1. Functional block diagrams of a digital receiver equipped with analog transversal equalizers (ATE) and digital transversal equalizers (DTE) are shown in Figures 2 and 3, respectively. The diagrams show the transmission signal flow and the nominal input and output signal levels. All of the diagrams are for 135EC systems; 135A systems do not have the following plug-in units:

- EC CODER
- EC RECDR
- ERROR LOCTR
- ERROR CORR

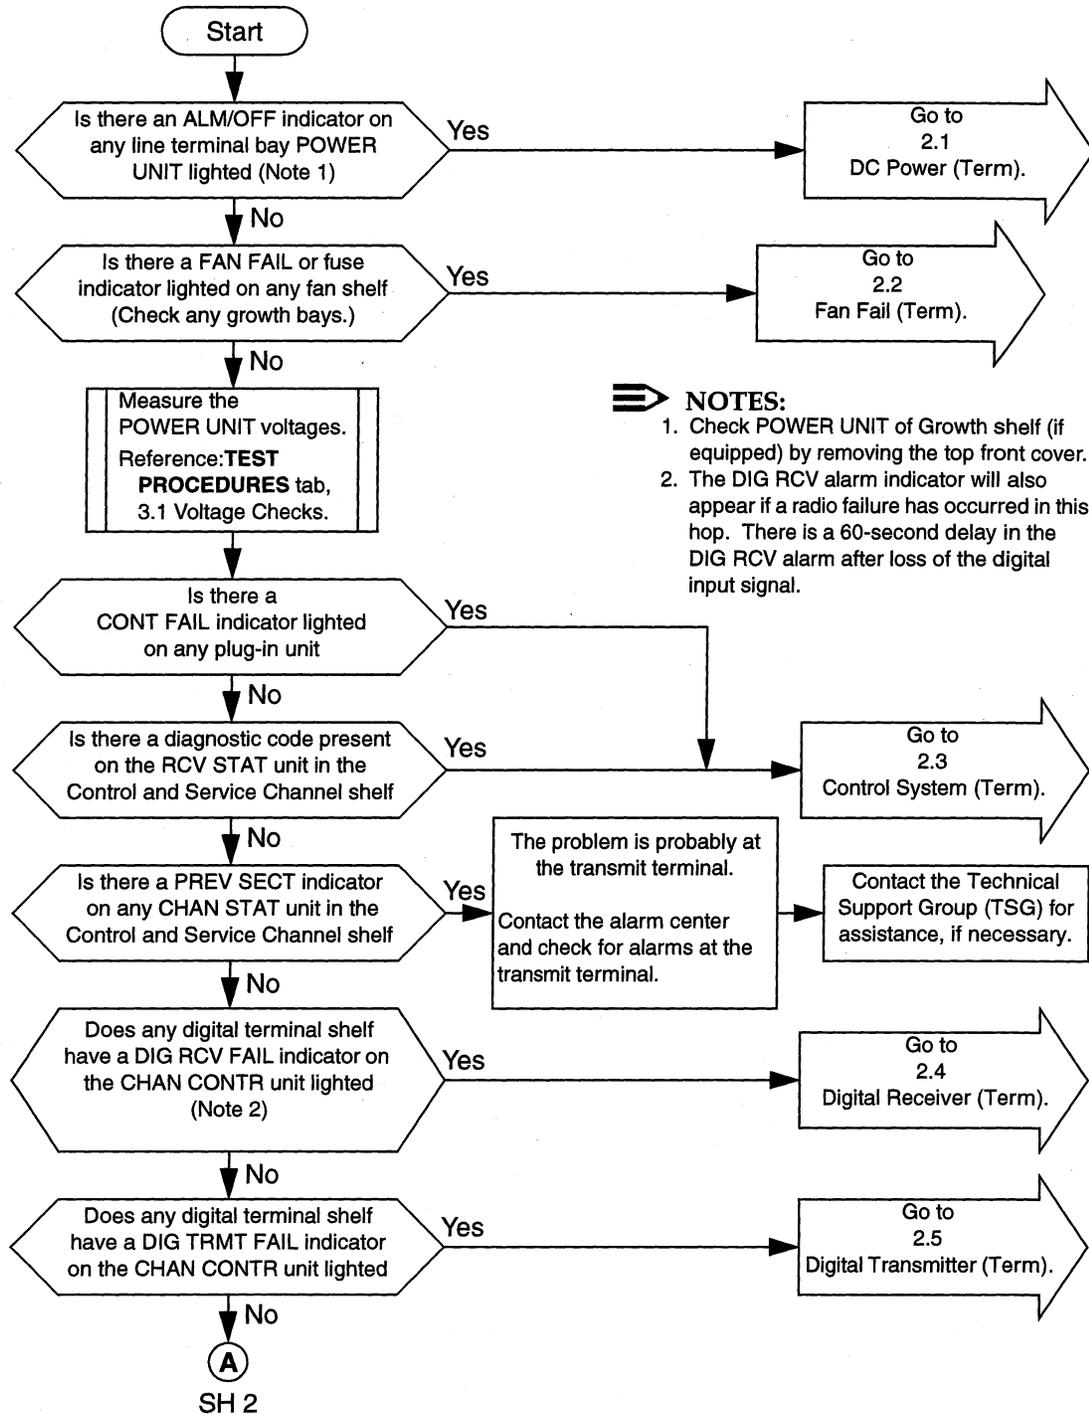
Flowchart 1. Terminal Bay Trouble Isolation (Sheet 1 of 2)

Flowchart 1, Terminal Bay Trouble Isolation, is the starting point for isolating and clearing alarmed conditions in a line terminal bay. It should be entered when directed by the **START HERE** tab or when referenced from one of the detailed terminal alarm-clearing flowcharts.

Any line terminal bay failure will light the COM ALARM indicator on the MSTR ALARM unit located in the Control and Service Channel Shelf of the initial line terminal bay. All transmission-related failures are centralized on the CHAN CONTR unit of the receiver shelf for each pair of shelves (transmitter and receiver). The resulting office alarm can be silenced by pressing the alarm cutoff (ACO) push button located on the right side of the terminal frame (if equipped). However, DC power failures cannot be silenced by the ACO push button.

Power unit troubles can cause false and misleading alarms. Check the power unit voltages before clearing an alarm. If an output voltage does not meet the requirement, the trouble is either a faulty power unit or an abnormal current demand by one or more of the units supplied by the power unit.

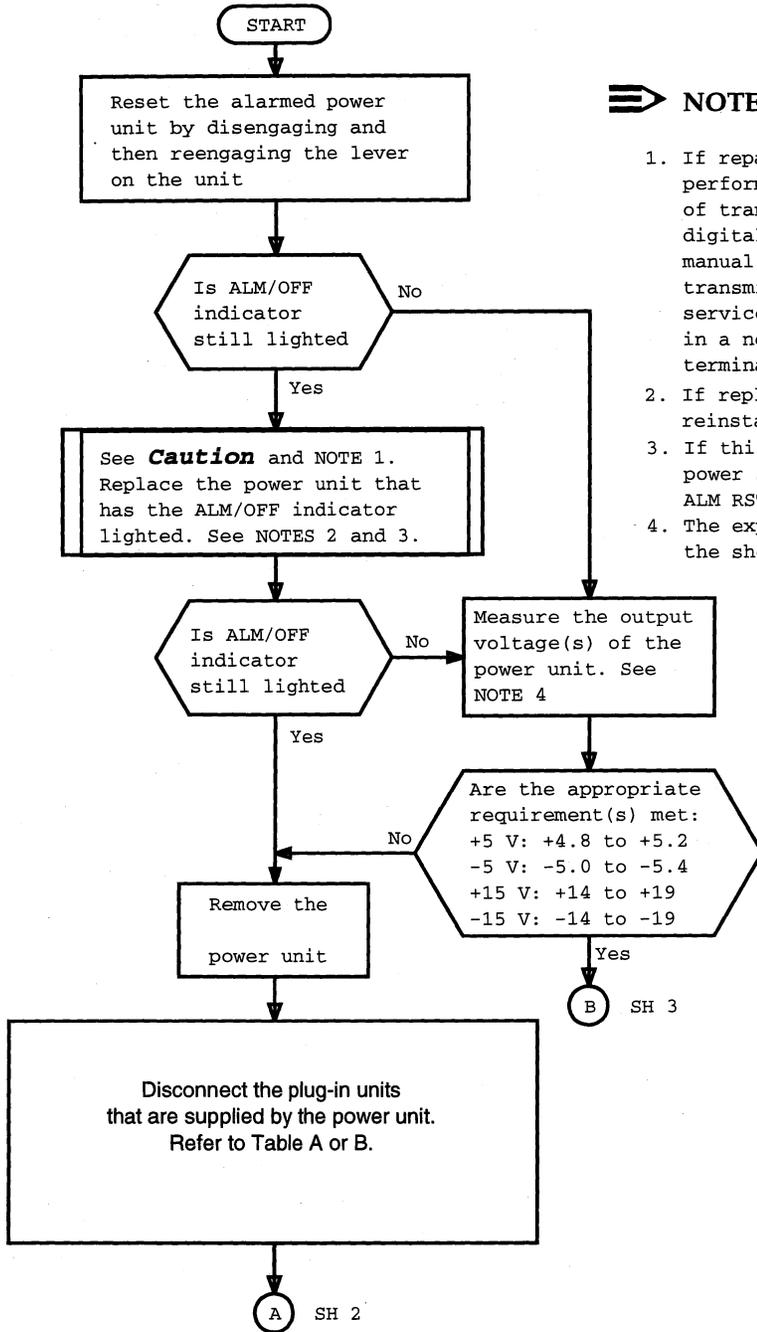
Flowchart 2. Terminal Bay DC Power Alarm-Clearing (Sheet 1 of 3)

Before using this flowchart, verify that the -24 V DC or -48 V DC input is good. A power failure in the line terminal bay is indicated by a lighted ALM/OFF indicator on the failed power unit. The power unit is shut down when the ALM/OFF indicator is lighted. It will remain shut down until it is reset by pulling the latch lever down, without disengaging the plug-in unit, and pushing it up again. The power unit voltages should always be measured with the load connected, that is, plug-in units installed.

- NOTES:**
1. If repairing a regular digital terminal shelf, perform a manual span switch for BOTH directions of transmission. If repairing the protection digital terminal or growth shelf, perform a manual protection lockout for BOTH directions of transmission. If repairing the control and service channel shelf, ensure that the system is in a normal, nonswitched state. Refer to the terminal replacement procedures.
 2. If replacement unit does not correct problem, reinstall original unit.
 3. If this is a control and service channel shelf power supply, it may be necessary to operate the ALM RST on the RCV STAT unit to clear any alarms.
 4. The expected output voltage(s) is identified on the shelf label below each power unit.

Flowchart 2 references local equipment indications and any necessary tests that will help determine the source of a power problem. When a unit has failed, refer to the **REPLACEMENT PROCEDURES** tab under the **TERMINAL / REGENERATOR** tab for information to replace the failed unit. If tests are necessary, refer to **TEST PROCEDURES** tab under the **TERMINAL / REGENERATOR** tab.

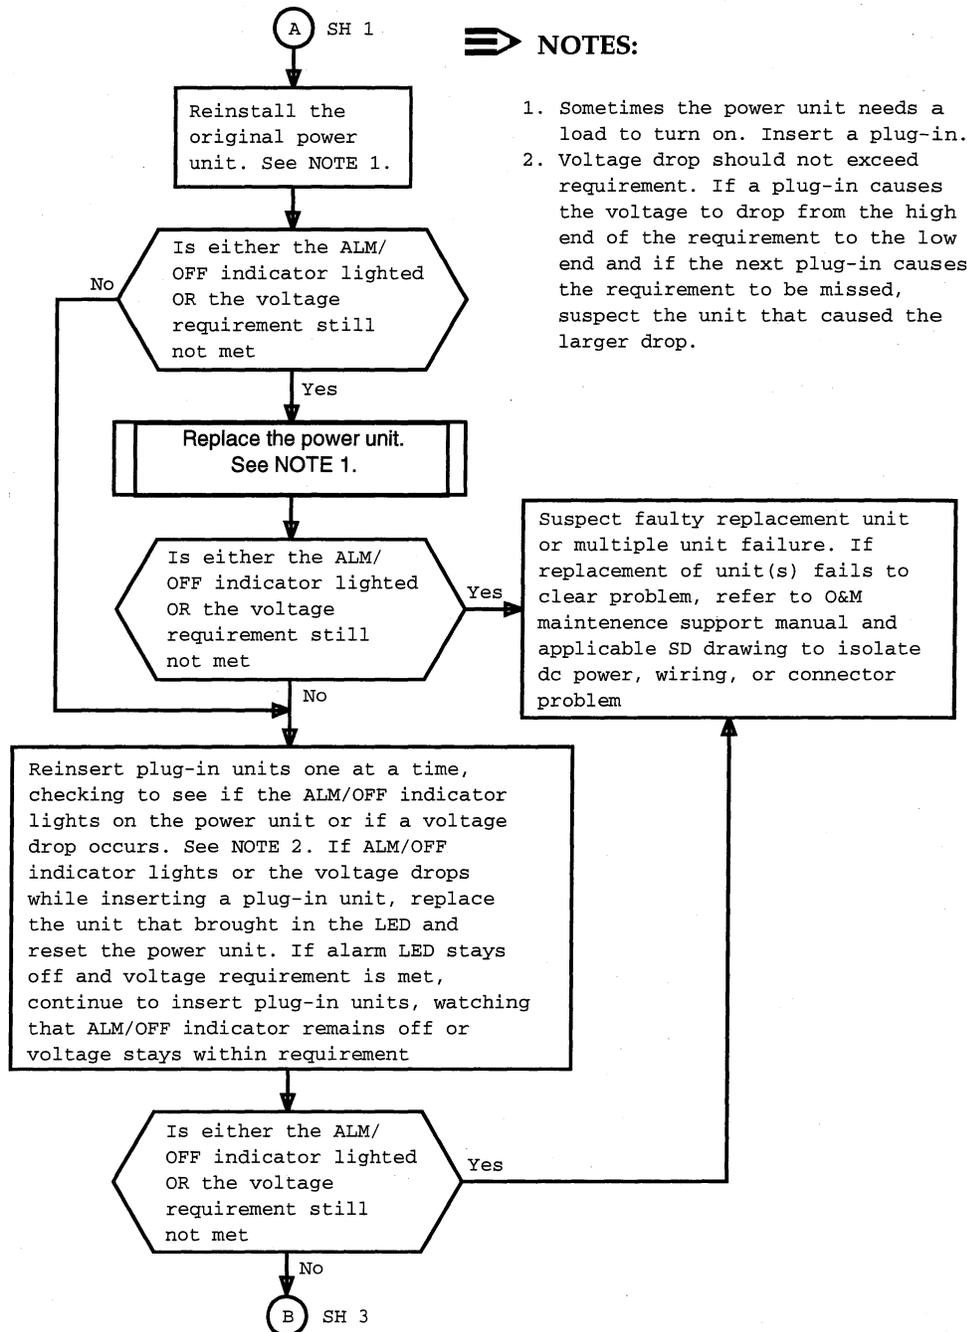
Flowchart 2. Terminal Bay DC Power Alarm-Clearing (Sheet 2 of 3)

1. Sometimes the power unit needs a load to turn on. Insert a plug-in.
2. Voltage drop should not exceed requirement. If a plug-in causes the voltage to drop from the high end of the requirement to the low end and if the next plug-in causes the requirement to be missed, suspect the unit that caused the larger drop.

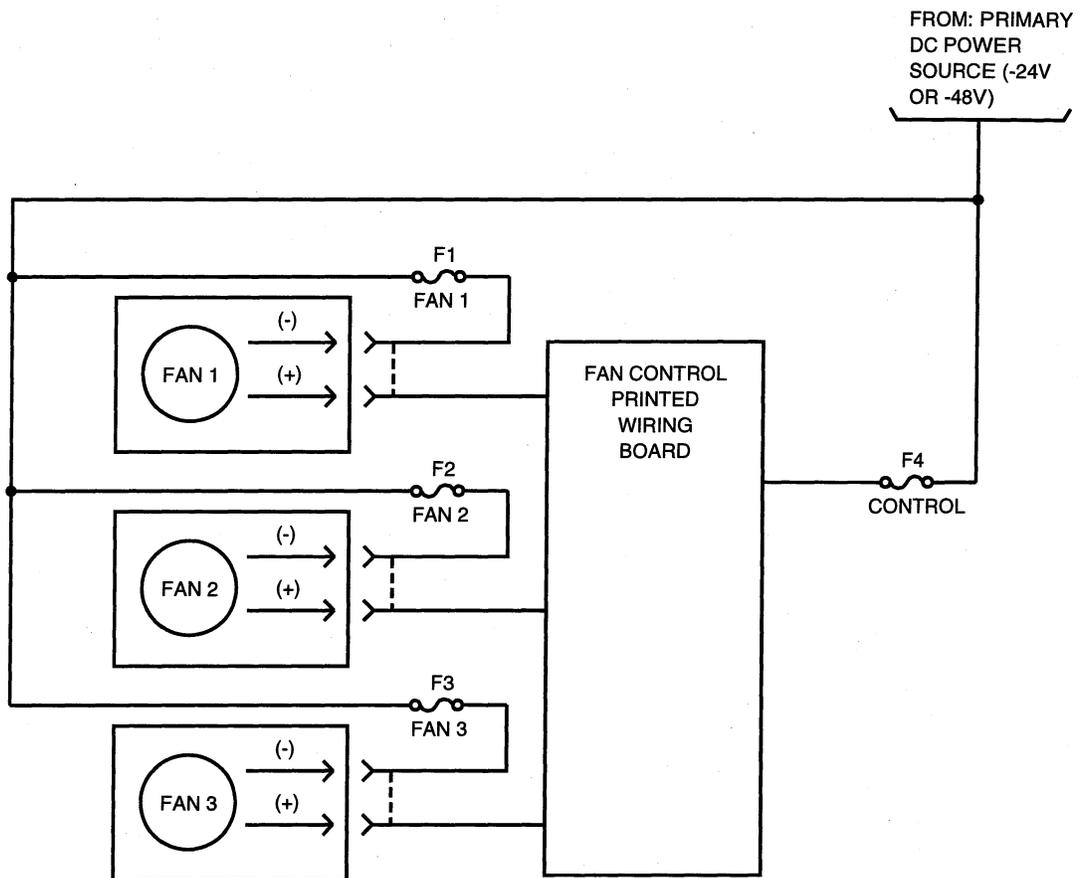
Figure 4. Bay Fan Fusing

Each of the three fans and the fan control printed wiring board (PWB) are protected by input fuses as shown in Figure 4. The fuses should always be checked before replacing any unit in the fan shelf.

An inoperative fan is indicated by the FAN 1, 2, or 3 FAIL indicator on the front of the fan shelf. If only one FAN FAIL indicator is lighted, assume that the associated fan or input fuse to the fan is defective and should be replaced. If fan replacement does not clear the alarm, if more than one FAN FAIL indicator is lighted, or if no FAN FAIL indicators are lighted, assume that a fan control PWB or its associated CONTROL input fuse is defective.

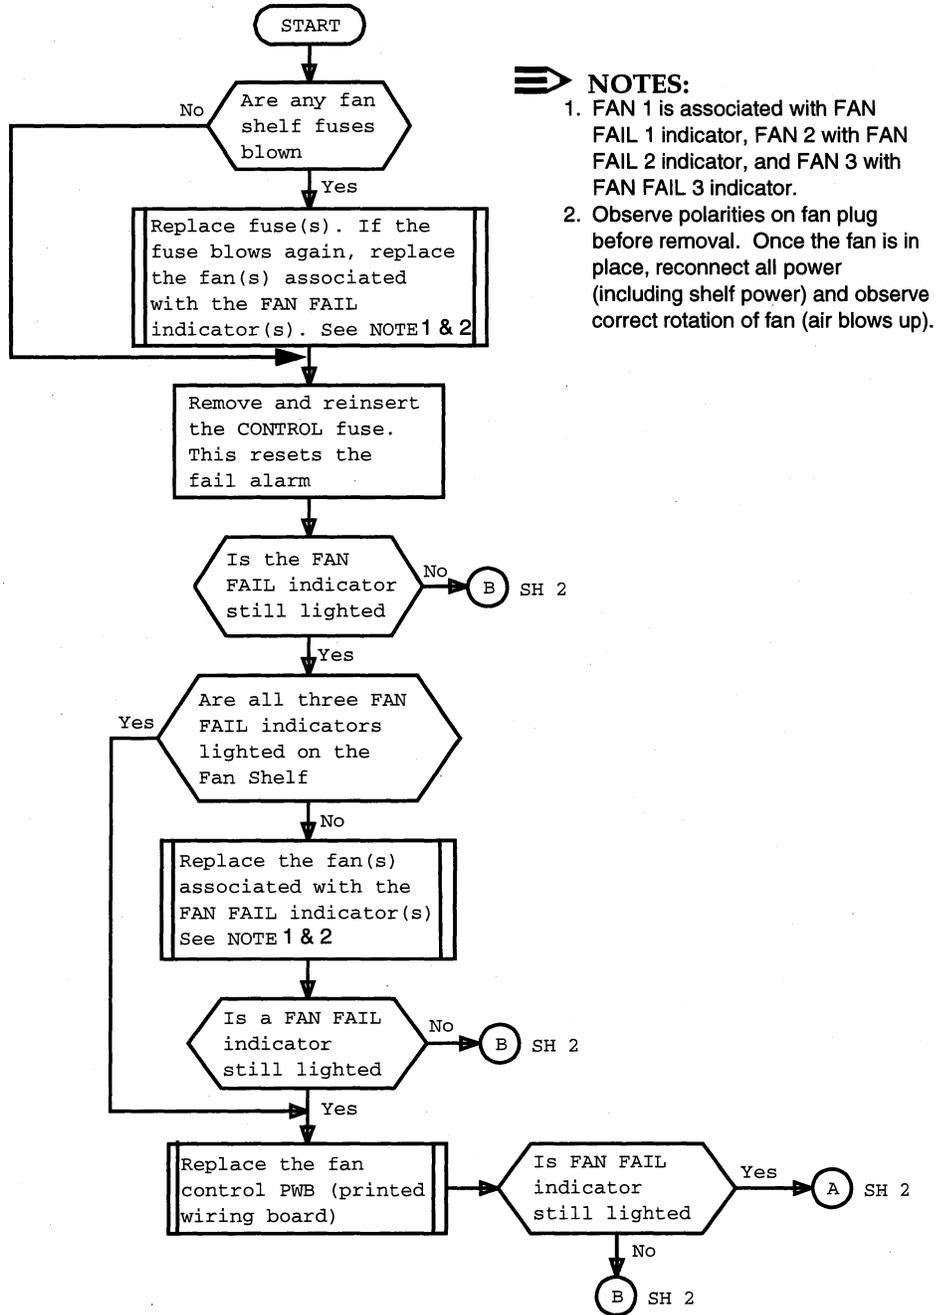
Flowchart 3. Bay Fan Fail Alarm-Clearing (Sheet 1 of 2)

- NOTES:**
1. FAN 1 is associated with FAN FAIL 1 indicator, FAN 2 with FAN FAIL 2 indicator, and FAN 3 with FAN FAIL 3 indicator.
 2. Observe polarities on fan plug before removal. Once the fan is in place, reconnect all power (including shelf power) and observe correct rotation of fan (air blows up).

Flowchart 3 is used to clear a FAN FAIL alarm indicator on the fan shelf. When a unit has failed, refer to the **REPLACEMENT PROCEDURES** tab under the **Terminal / Regenerator** tab to replace the unit.

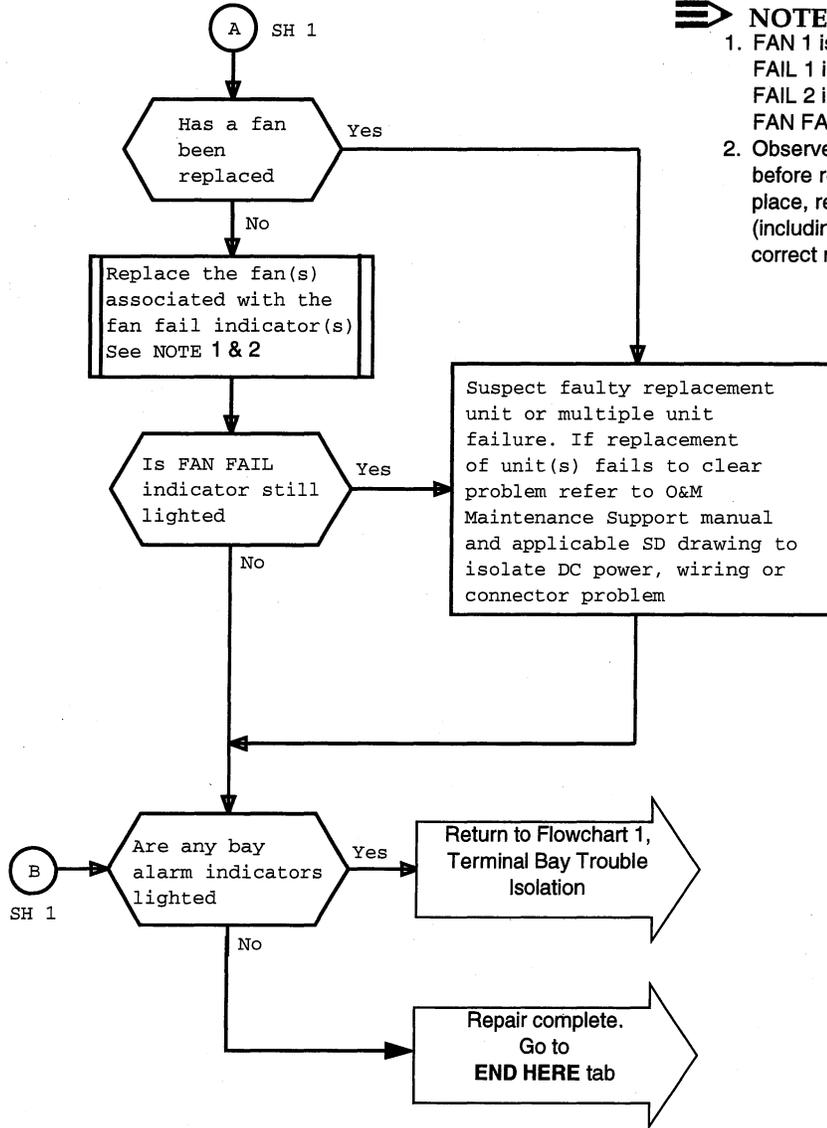
Flowchart 3. Bay Fan Fail Alarm-Clearing (Sheet 2 of 2)

- 1. FAN 1 is associated with FAN FAIL 1 indicator, FAN 2 with FAN FAIL 2 indicator, and FAN 3 with FAN FAIL 3 indicator.
- 2. Observe polarities on fan plug before removal. Once the fan is in place, reconnect all power (including shelf power) and observe correct rotation of fan (air blows up).

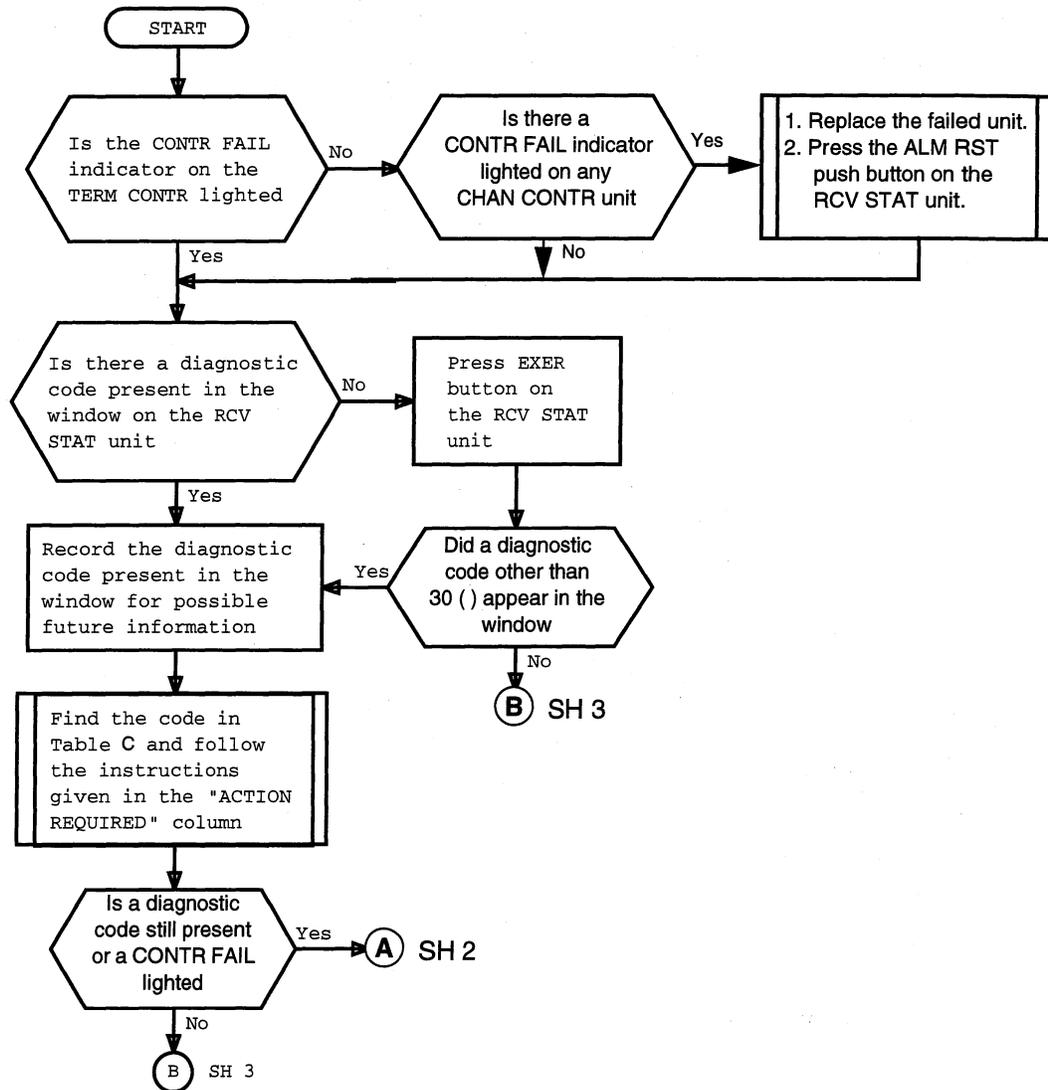
Flowchart 4. Terminal Bay Control System Alarm-Clearing (Sheet 1 of 3)

! CAUTION:
 Performing this procedure will release any manual or automatic protection switches that may exist. Any transmission alarm on a regular channel **must** be cleared before performing this procedure.

Flowchart 4 is used to clear any CONTR FAIL indicator and any DIAGNOSTIC CODE display. When a unit has failed, refer to the **REPLACEMENT PROCEDURES** tab under the **Terminal / Regenerator** tab to replace the unit.

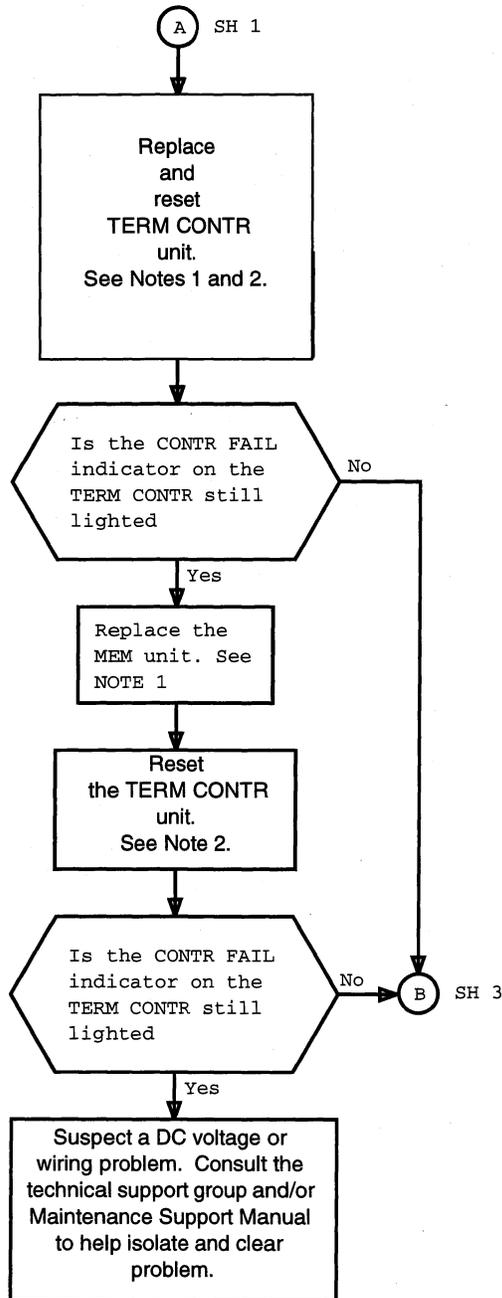
Flowchart 4. Terminal Bay Control System Alarm-Clearing (Sheet 2 of 3)

1. If replacement unit does not correct problem, reinstall original unit.
2. To reset the TERM CONTR unit:
Upon installing the TERM CONTR unit:
 - a. Before inserting unit, press and hold the CONTR RESET push button.
 - b. Insert unit while holding button in.
 - c. Release CONTR RESET push button.
 - d. Wait for indicator lights to clear.
 - e. Reset again by pressing and holding the CONTR RESET push button in until the CONTR FAIL indicator lights.
 - f. Release the CONTR RESET push button.
 - g. Manually run the exerciser (press and release the EXER push button on the RCV STAT unit).**For installed unit:**
 - a. Press and hold the CONTR RESET push button in until the CONTR FAIL indicator lights.
 - b. Release the CONTR RESET push button.
 - c. Manually run the exerciser (press and release the EXER push button on the RCV STAT unit).

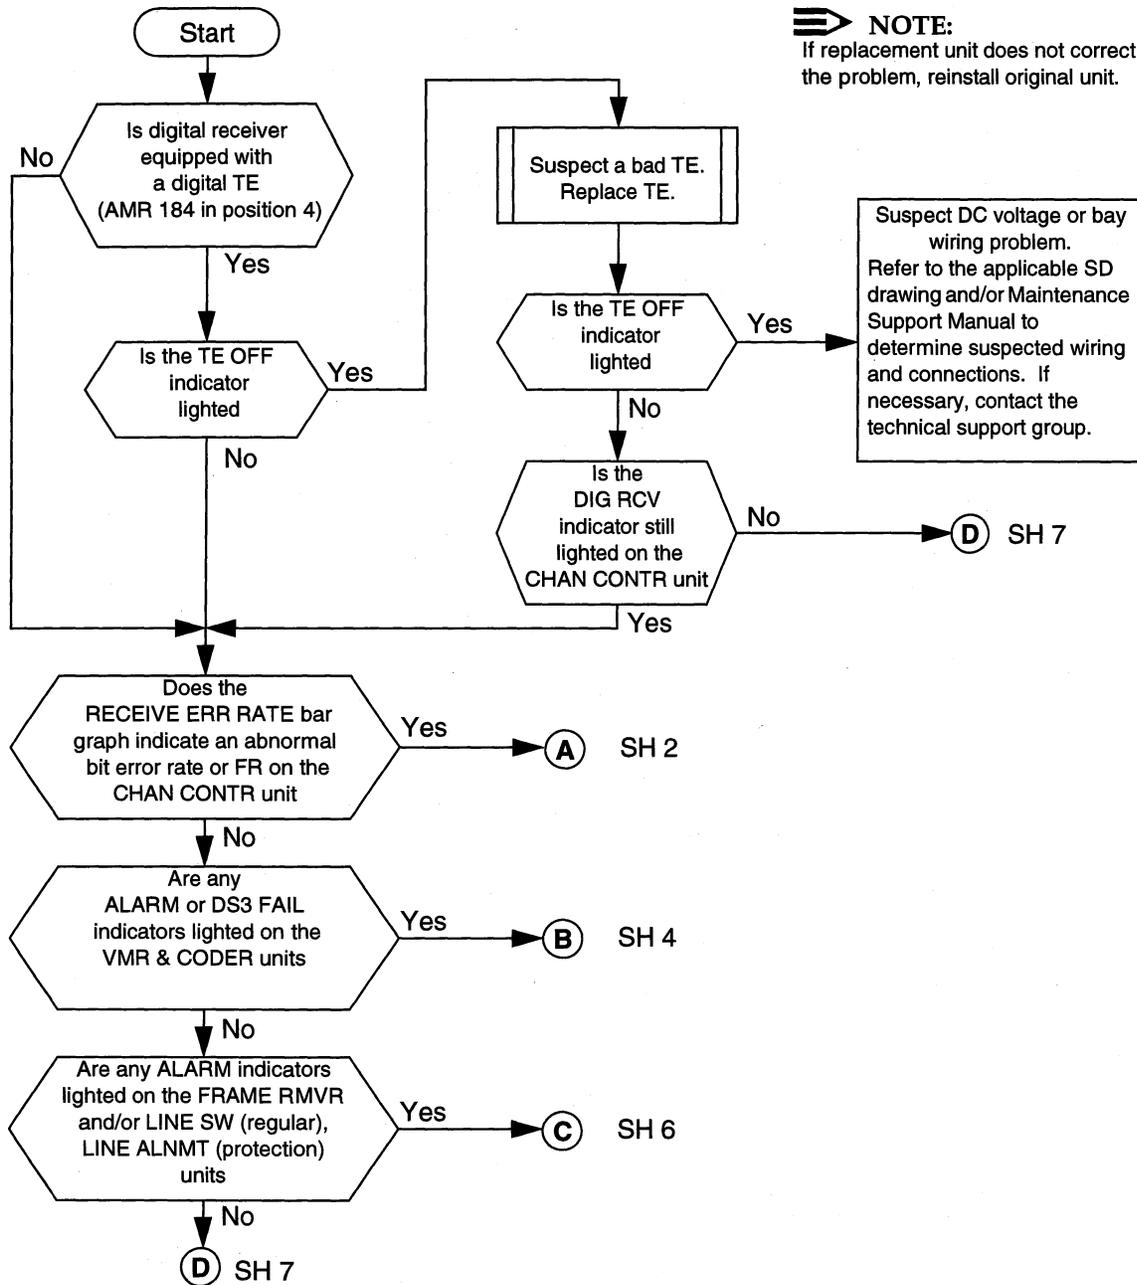
Flowchart 5. Terminal Bay Digital Receiver Alarm-Clearing (Sheet 1 of 7)

- Prerequisites:**
1. FAIL—DIG RCV indicator lighted on the CHAN CONTR unit.
 2. If digital TE, the TE NORMAL OFF push-button switch is set to NORMAL.
 3. Service is protected with a manual switch (lock out if protection).
 4. Fault locate and/or alarm indications isolate problem to this terminal receiver.

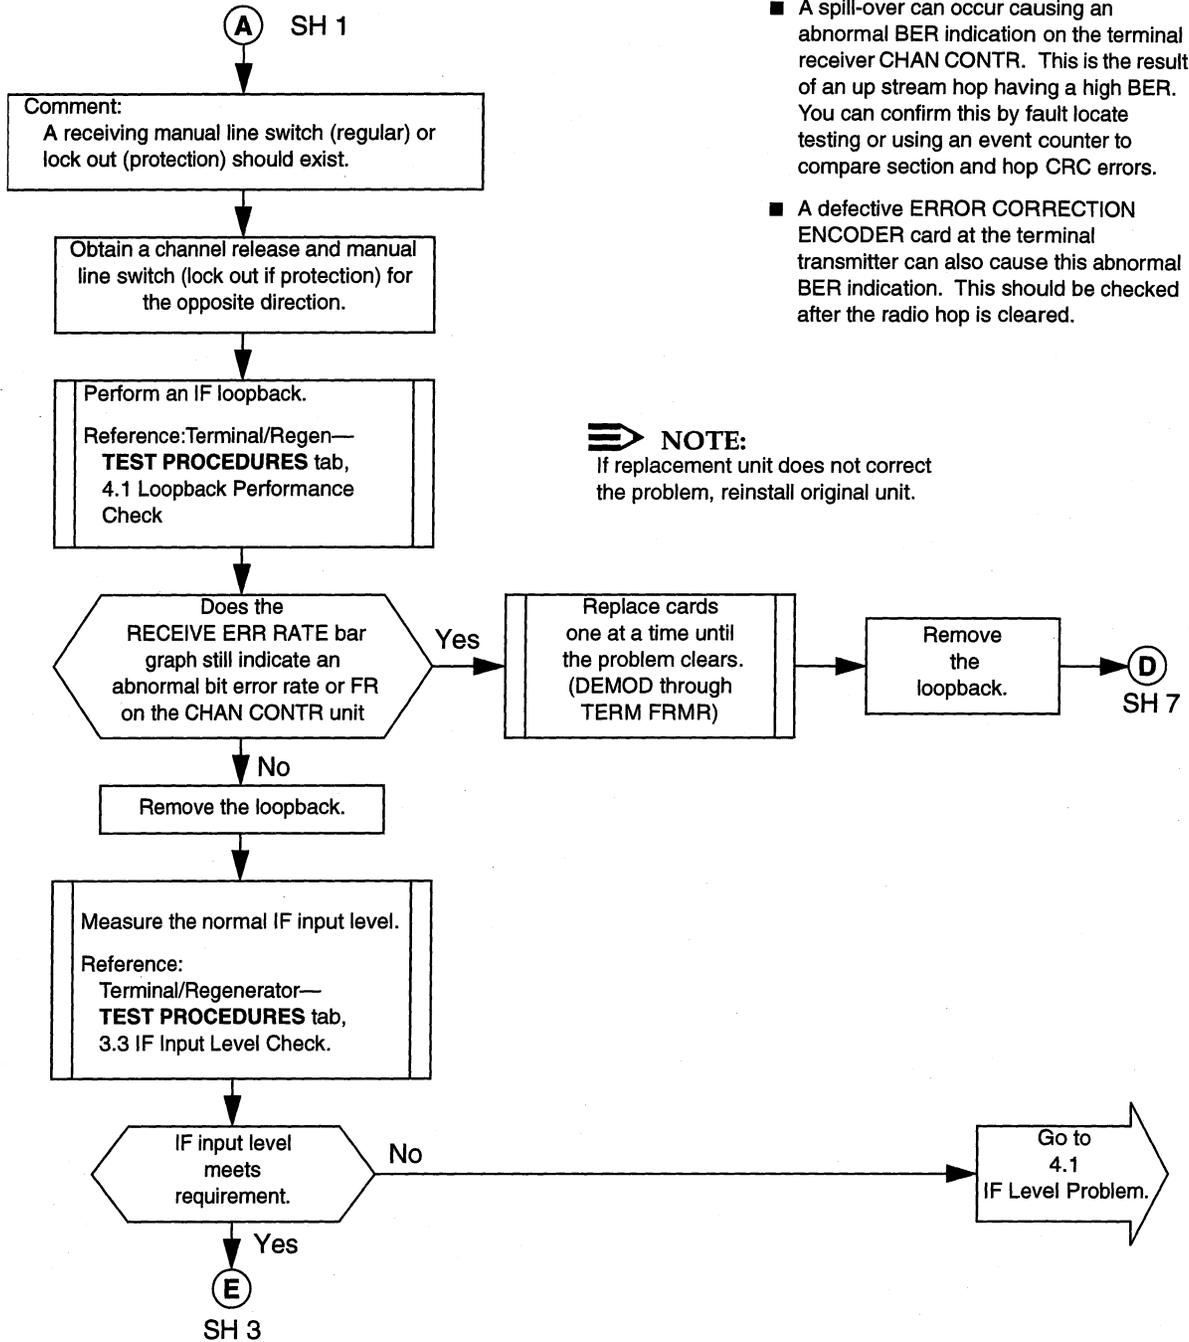
Flowchart 5. Terminal Bay Digital Receiver Alarm-Clearing (Sheet 2 of 7)

- A spill-over can occur causing an abnormal BER indication on the terminal receiver CHAN CONTR. This is the result of an up stream hop having a high BER. You can confirm this by fault locate testing or using an event counter to compare section and hop CRC errors.
- A defective ERROR CORRECTION ENCODER card at the terminal transmitter can also cause this abnormal BER indication. This should be checked after the radio hop is cleared.

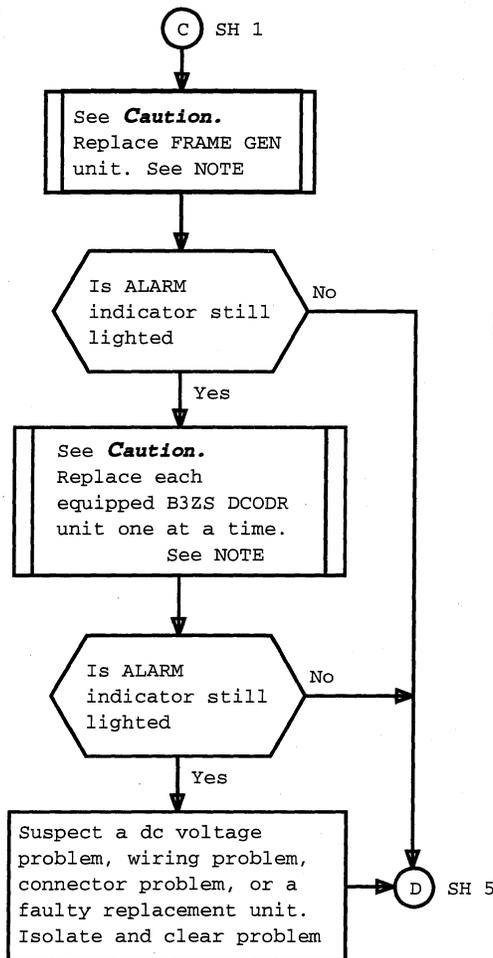
Flowchart 6. Terminal Bay Digital Transmitter Alarm-Clearing (Sheet 4 of 5)

Prerequisite: Alarm indicator on FRAME GEN unit lighted.

Caution: *THIS IS A SERVICE AFFECTING REPAIR FOR THE TRANSMITTING DIRECTION OF TRANSMISSION. If repairing a regular channel, perform a Manual Span Switch. If repairing the protection channel, perform a Protection Channel Lockout.*

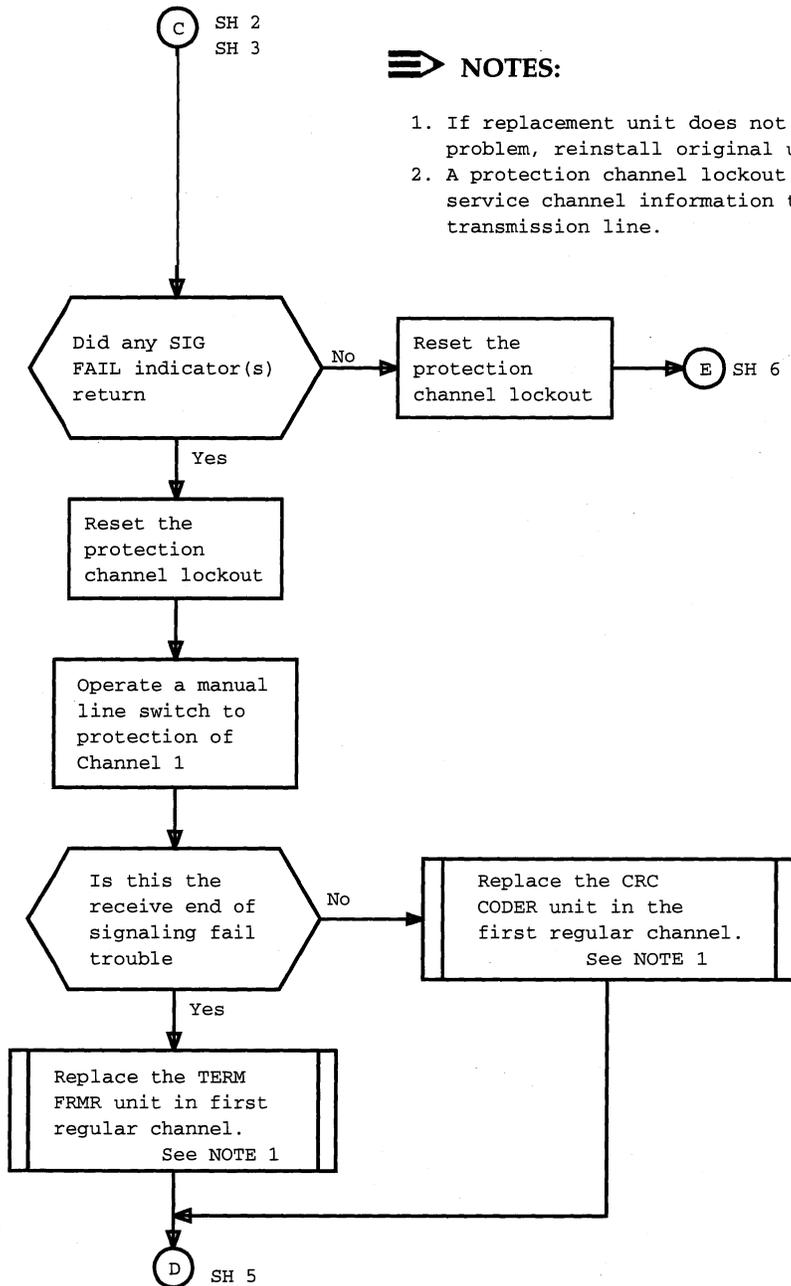
1. If replacement unit does not correct problem, reinstall original unit.
2. A protection channel lockout switches the service channel information to the CH1 transmission line.

- 3. In this case, the standby service channel path (CH1) is unavailable to carry signaling information if a protection channel transmission failure should occur.
- 4. The protection channel lockout should be released at all times except to check if CH1 has been repaired.

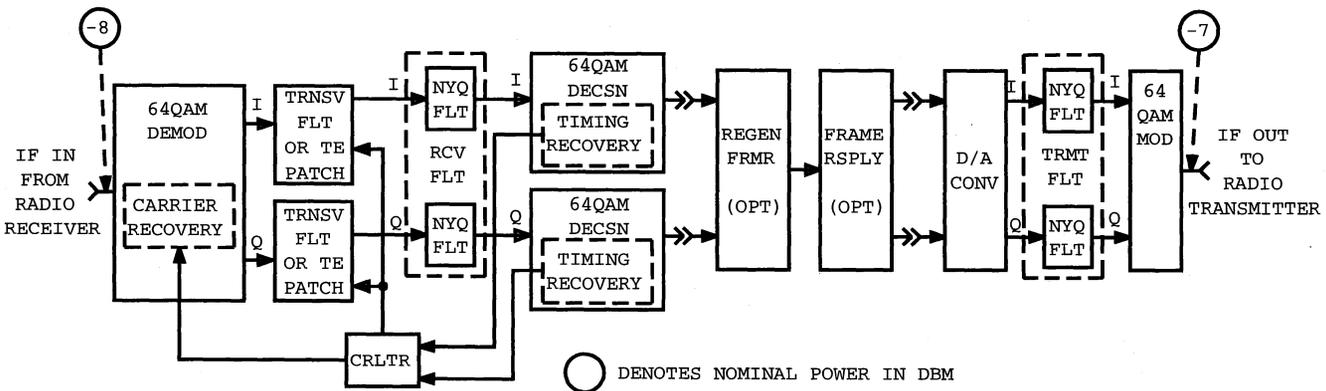
Figure 5. Regenerator (ATE) Block Diagram

Functional block diagrams of a regenerator equipped with analog transversal equalizers (ATE) and digital transversal equalizers (DTE) are shown in Figures 5 and 6, respectively. The diagrams show the transmission signal flow and the nominal input and output signal levels.

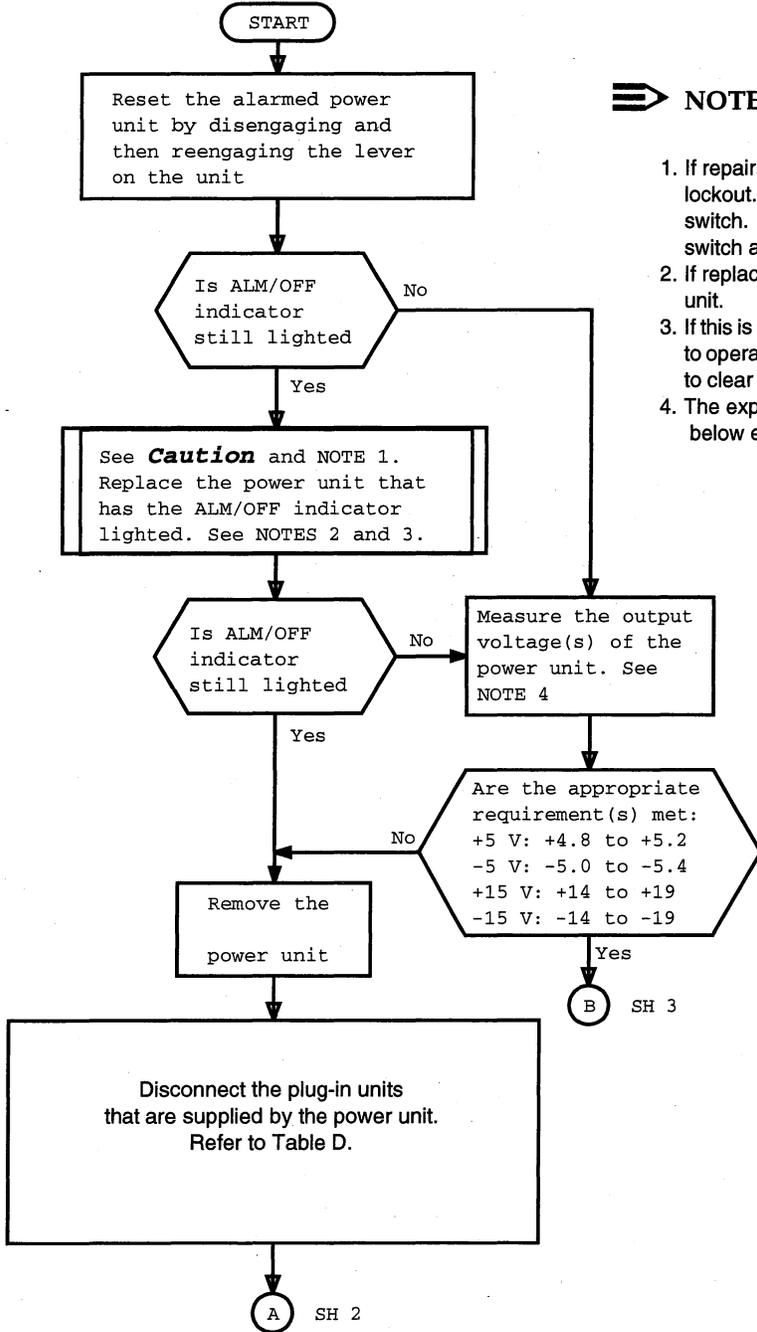
Before using this flowchart, verify that the -24 V DC or -48 V DC input is good. A power failure in the regenerator bay is indicated by a lighted ALM/OFF indicator on the failed power unit. The power unit is shut down when the ALM/OFF indicator is lighted. It will remain shut down until it is reset by pulling the latch lever down, without disengaging the plug-in unit, and pushing it up again. The power unit voltages should always be measured with the load connected; that is, plug-in units installed.

1. If repairing the protection channel, perform a protection channel lockout. If repairing a regular channel, perform a manual line switch. If repairing the Control and Service Channel shelf, no switch action is required.
2. If replacement unit does not correct problem, reinstall original unit.
3. If this is a Control and Service Channel shelf, it may be necessary to operate the ALM RST push button on the REGEN CONTR unit to clear any alarms.
4. The expected output voltage(s) is identified on the shelf label below each power unit.

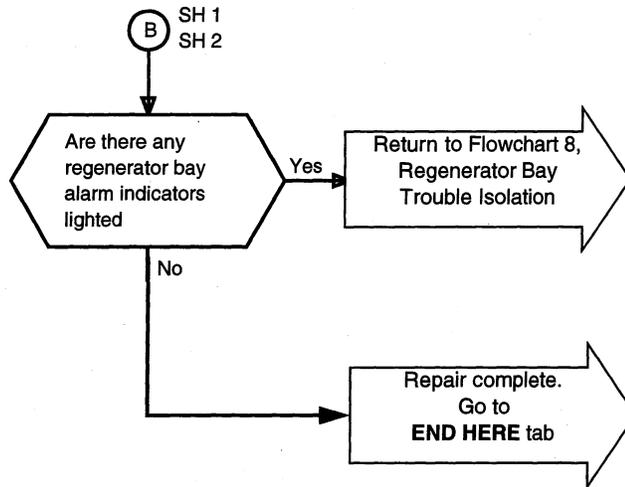
Flowchart 9. Regenerator Bay DC Power Alarm-Clearing (Sheet 2 of 3)

1. Sometimes the power unit needs a load to turn on. Insert a plug-in.
2. Voltage drop should not exceed requirement. If a plug-in causes the voltage to drop from the high end of the requirement to the low end and if the next plug-in causes the requirement to be missed, suspect the unit that caused the larger drop.

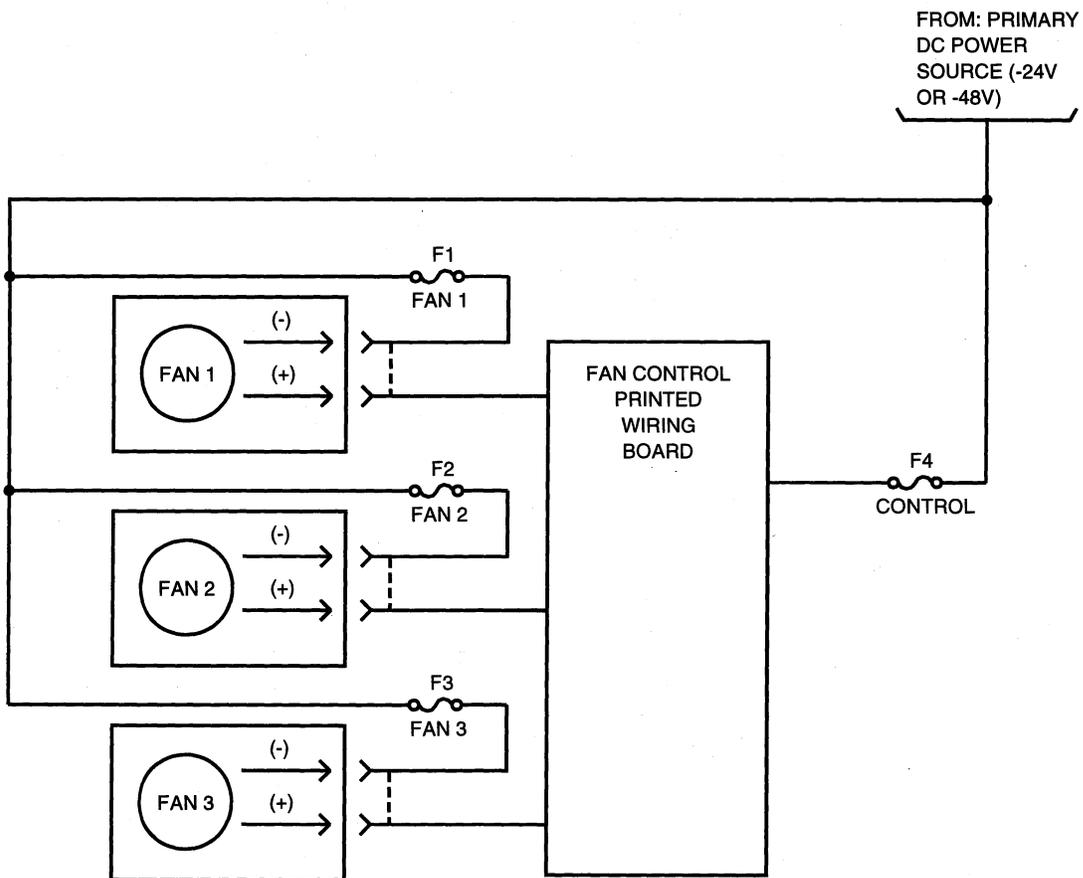
Figure 7. Bay Fan Fusing

Each of the three fans and the fan control printed wiring board (PWB) are protected by input fuses as shown in Figure 7. The fuses should always be checked before replacing any unit in the fan shelf.

An inoperative fan is indicated by the FAN 1, 2, or 3 FAIL indicator on the front of the fan shelf. If only one FAN FAIL indicator is lighted, assume that the associated fan or input fuse to the fan is defective and should be replaced. If fan replacement does not clear the alarm, if more than one FAN FAIL indicator is lighted, or if no FAN FAIL indicators are lighted, assume that a fan control PWB or its associated CONTROL input fuse is defective.

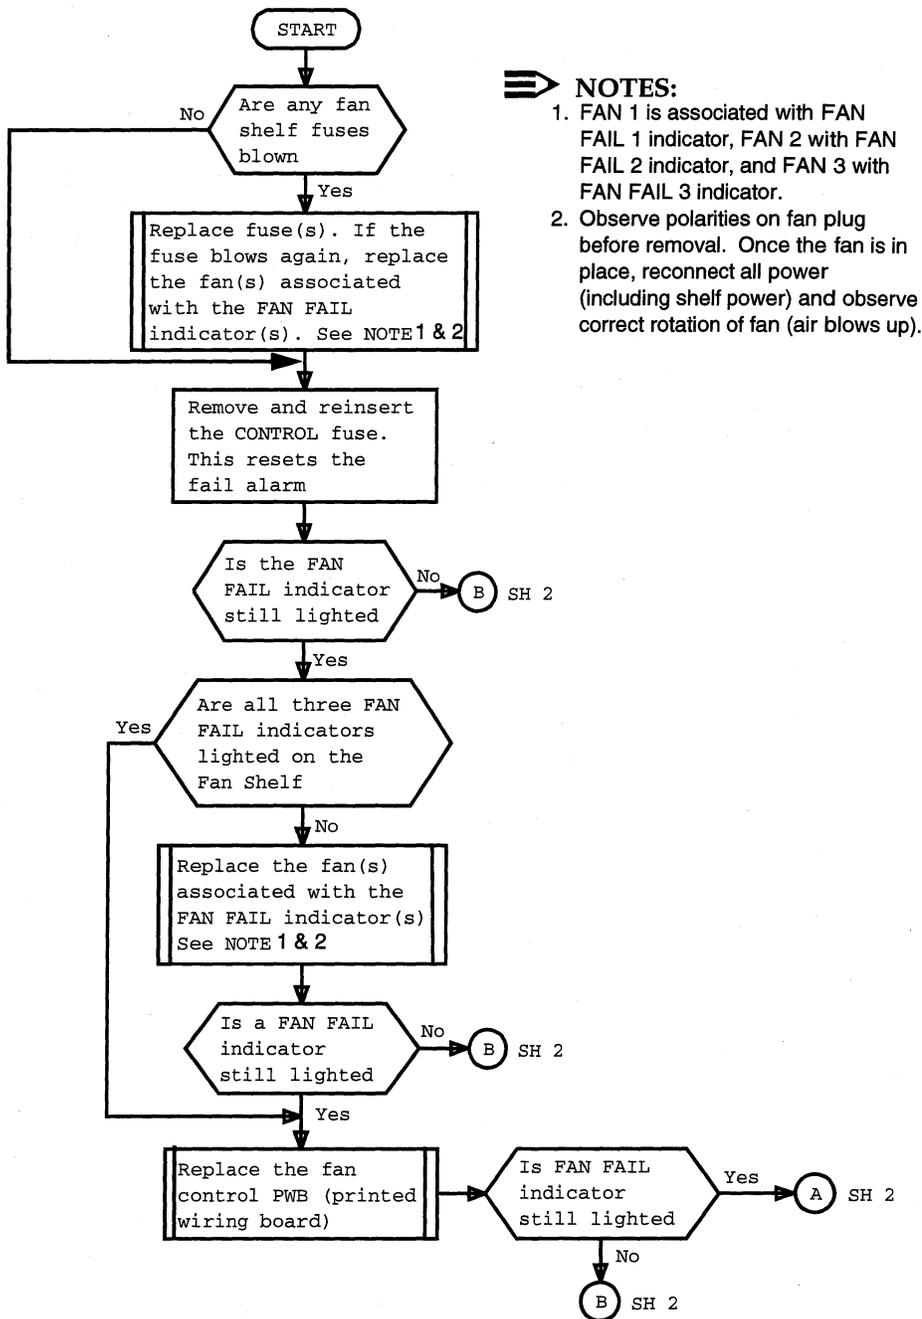
Flowchart 10. Bay Fan Fail Alarm-Clearing (Sheet 1 of 2)

- NOTES:**
1. FAN 1 is associated with FAN FAIL 1 indicator, FAN 2 with FAN FAIL 2 indicator, and FAN 3 with FAN FAIL 3 indicator.
 2. Observe polarities on fan plug before removal. Once the fan is in place, reconnect all power (including shelf power) and observe correct rotation of fan (air blows up).

Flowchart 10 is used to clear a FAN FAIL alarm indicator on the fan shelf. When a unit has failed, refer to the **REPLACEMENT PROCEDURES** tab under the **TERMINAL / REGENERATOR** tab to replace the unit.
