**DR 6/11-135A and 135EC
1×N Frequency Diversity
Operation and Maintenance
Terminal/Regenerator
Trouble Isolation**

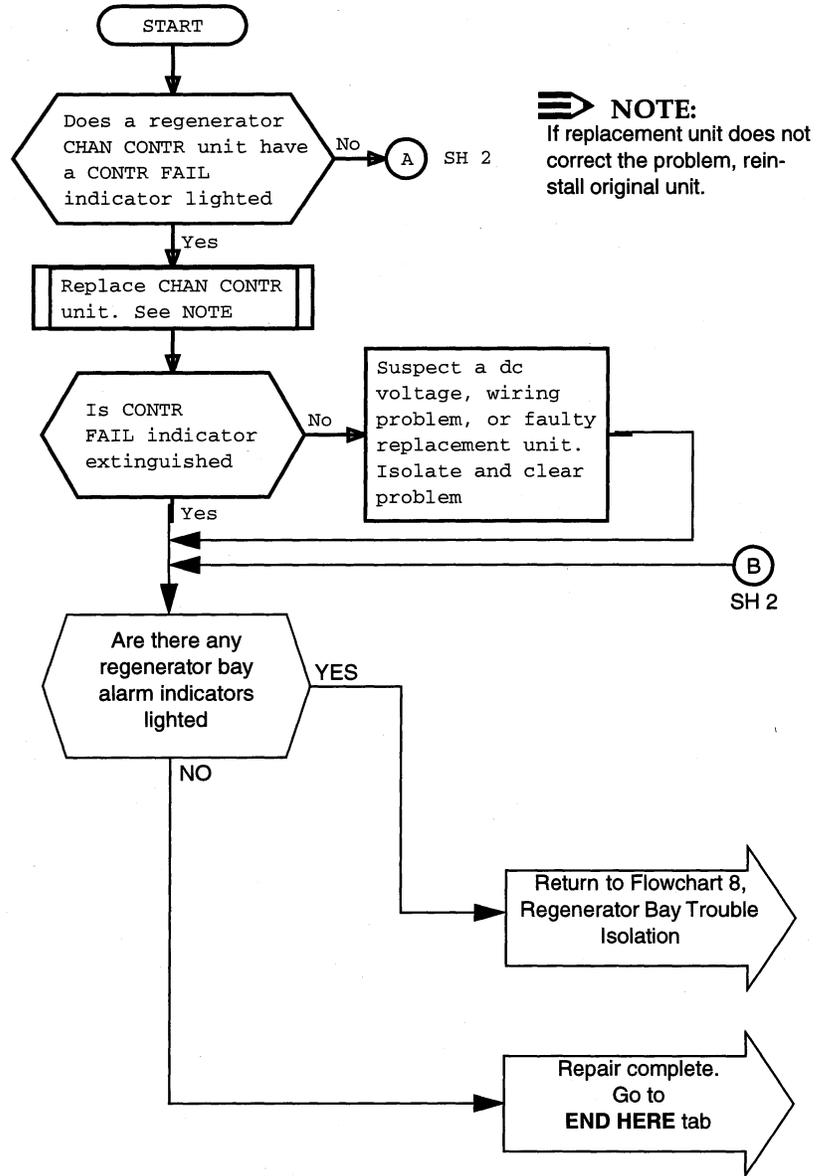
Flowchart 11. Regenerator Bay Control System Alarm-Clearing (Sheet 1 of 2)

NOTE:
If replacement unit does not correct the problem, re-install original unit.

Flowchart 11 is used to clear any CONTR FAIL indicator and the CONTR SIG ALARM indicator. When a unit has failed, refer to the **REPLACEMENT PROCEDURES** tab under the **TERMINAL / REGENERATOR** tab to replace the unit.

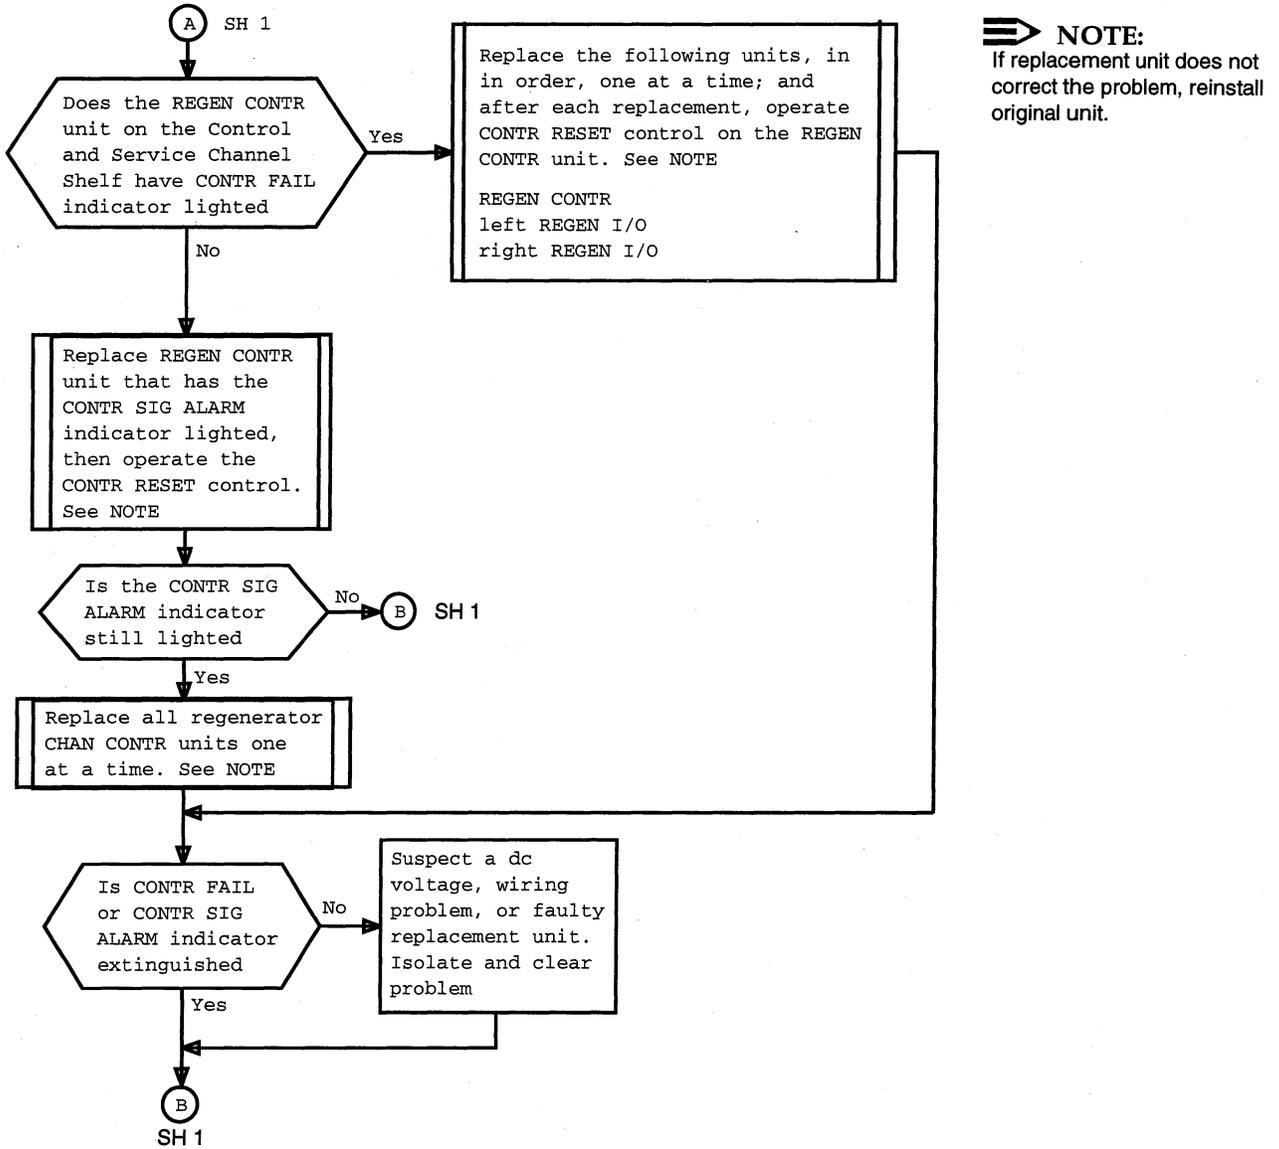
Flowchart 11. Regenerator Bay Control System Alarm-Clearing (Sheet 2 of 2)

NOTE:
If replacement unit does not correct the problem, reinstall original unit.

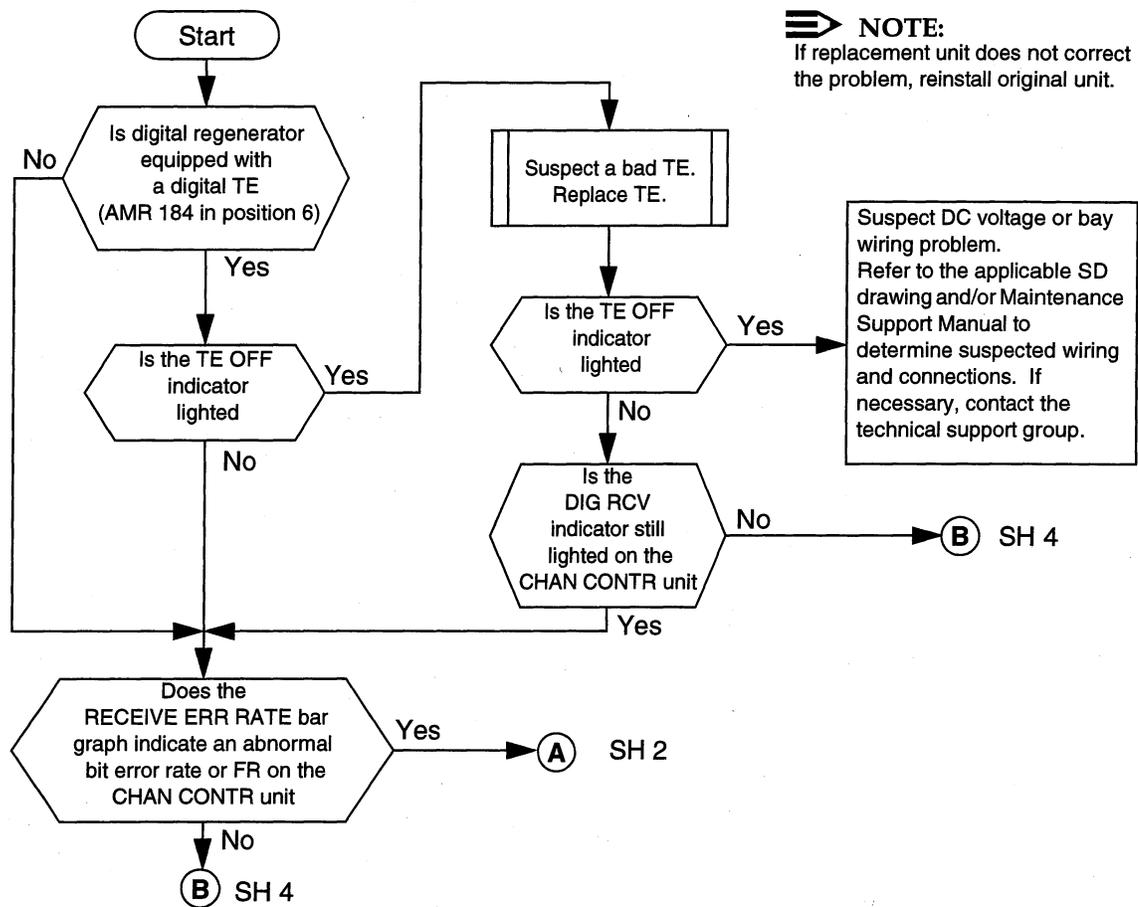
Flowchart 12. Regenerator Bay Digital Receiver Alarm-Clearing (Sheet 1 of 4)

- Prerequisites:**
1. FAIL—DIG RCV indicator lighted on the CHAN CONTR unit.
 2. If digital TE, the TE NORMAL OFF push-button switch is set to NORMAL.
 3. Service is protected with a manual line switch (lock out if protection channel).
 4. Fault locate and/or alarm indications isolate problem to this regenerator receiver.

Flowchart 12 is used to clear the DIG RCV FAIL alarm indicator on the CHAN CONTR unit. If this alarm indicator is ON, the associated regenerator has a failure in its receiving circuits or something is wrong with the incoming signal. Local indications and any necessary tests are referenced to isolate the problem.

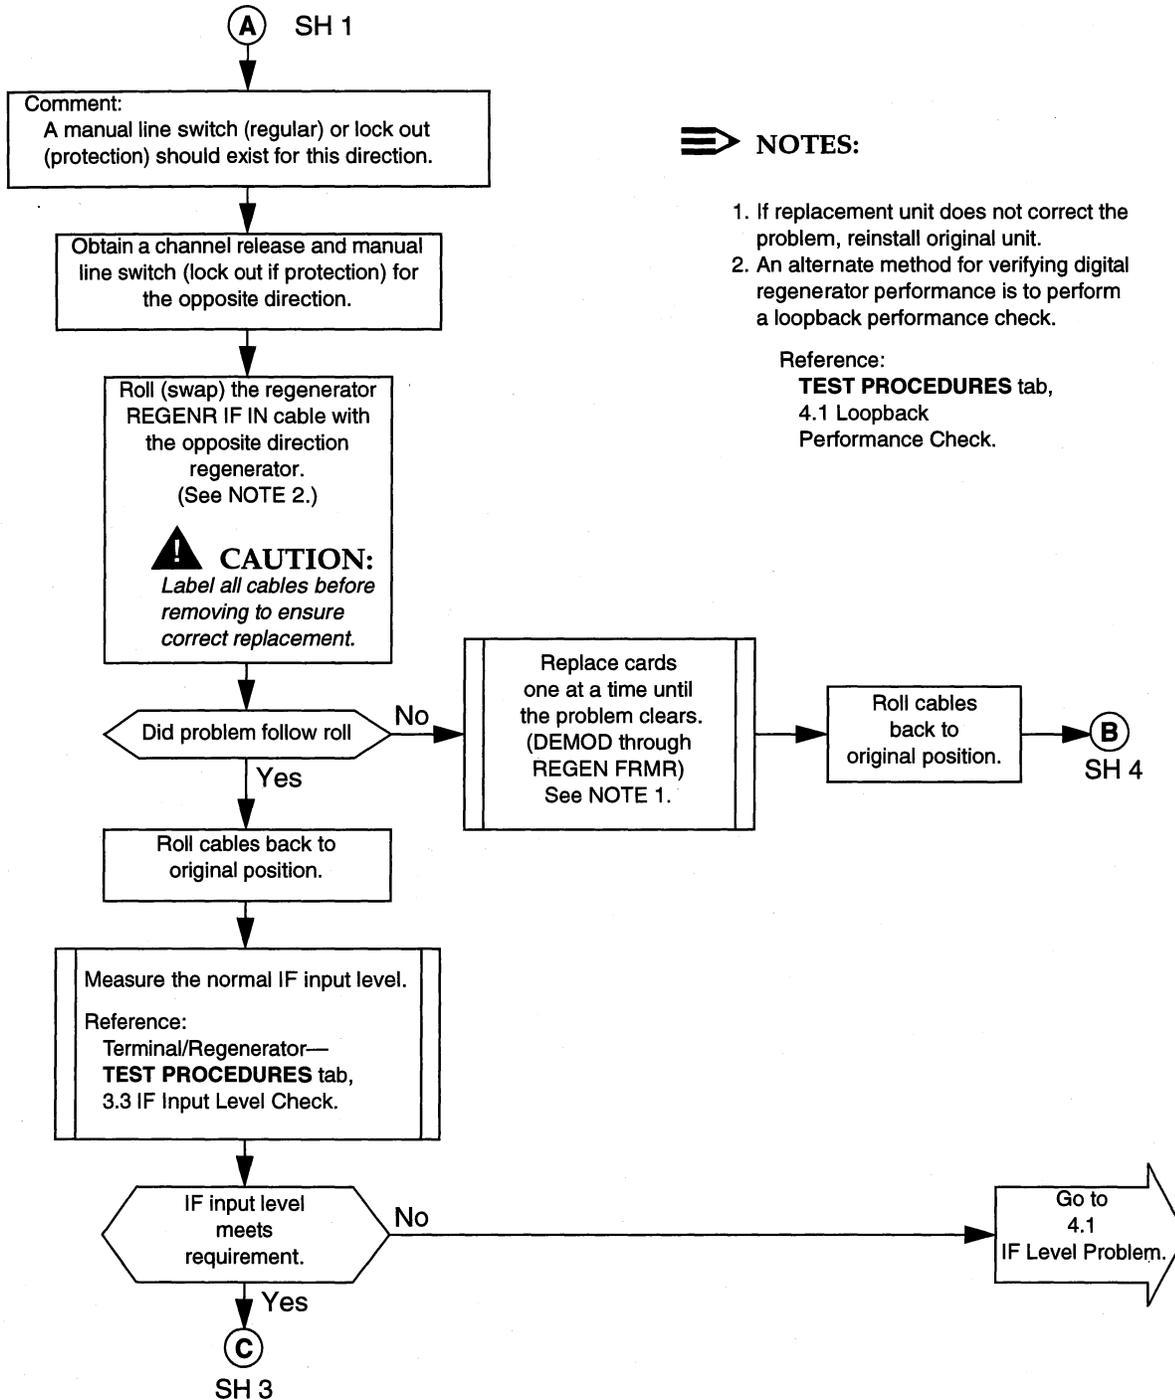
Flowchart 12. Regenerator Bay Digital Receiver Alarm-Clearing (Sheet 2 of 4)

Prerequisite: Bar graph on CHAN CONTR unit indicates an abnormal BER or FR.

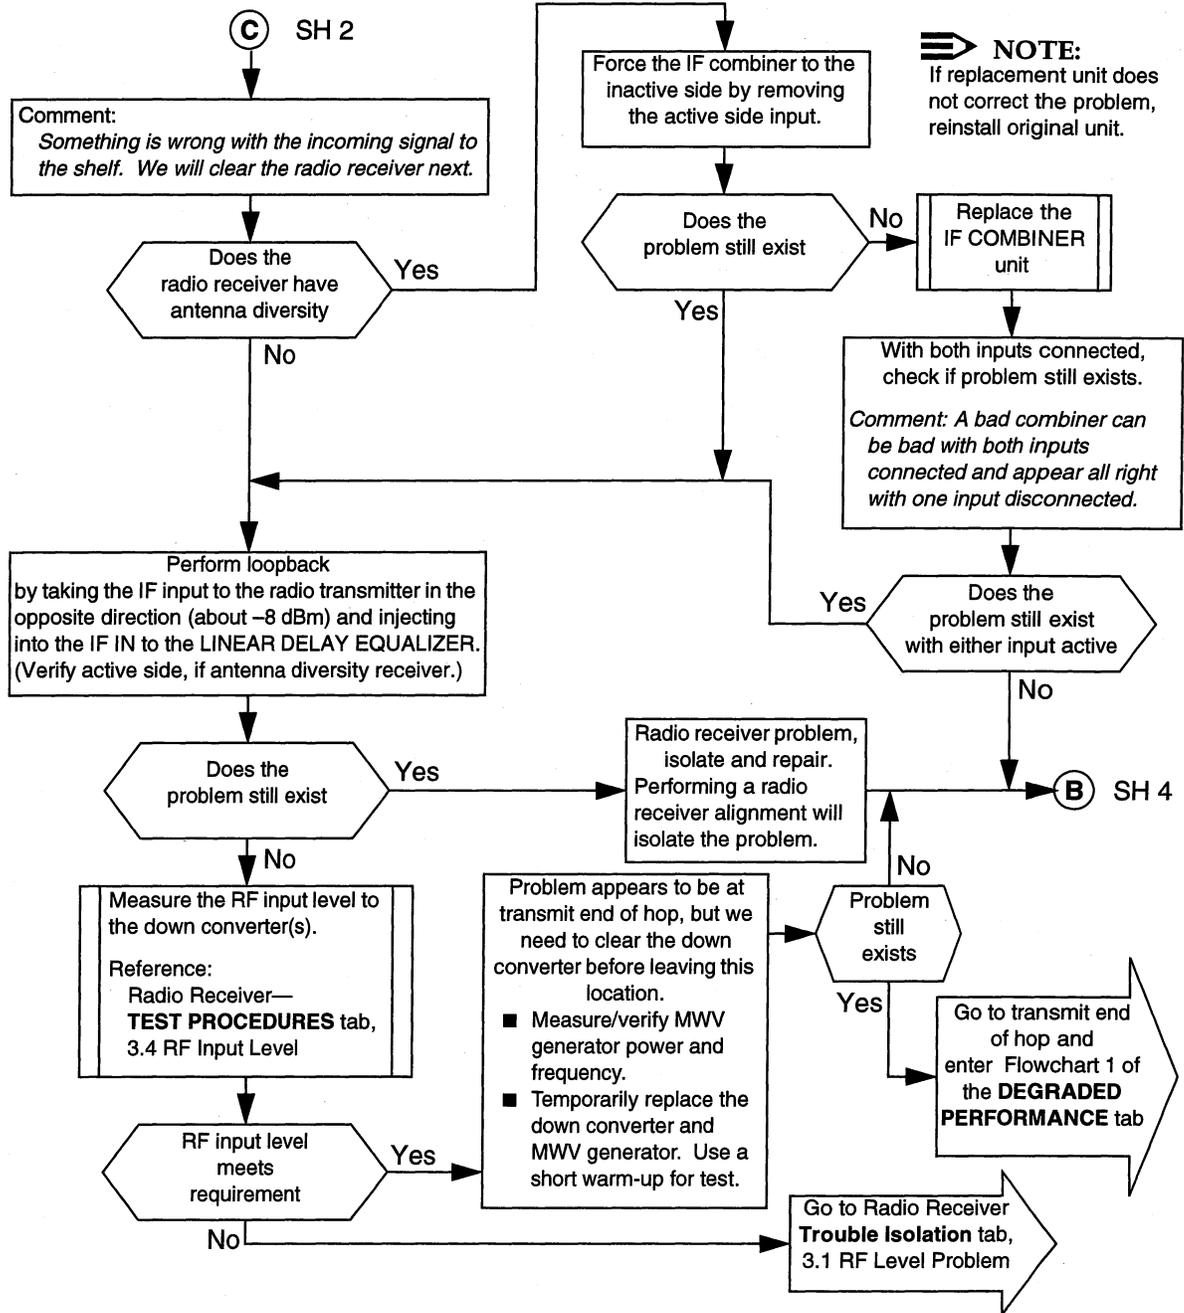
Flowchart 12. Regenerator Bay Digital Receiver Alarm-Clearing (Sheet 3 of 4)

- Prerequisites:**
1. Bar graph on CHAN CONTR unit indicates an abnormal BER or FR.
 2. Service is protected with a manual line switch (lock out if protection channel) in both directions.
 3. The IF input level to the digital shelf meets requirements.
 4. The digital regenerator is good per previous test.

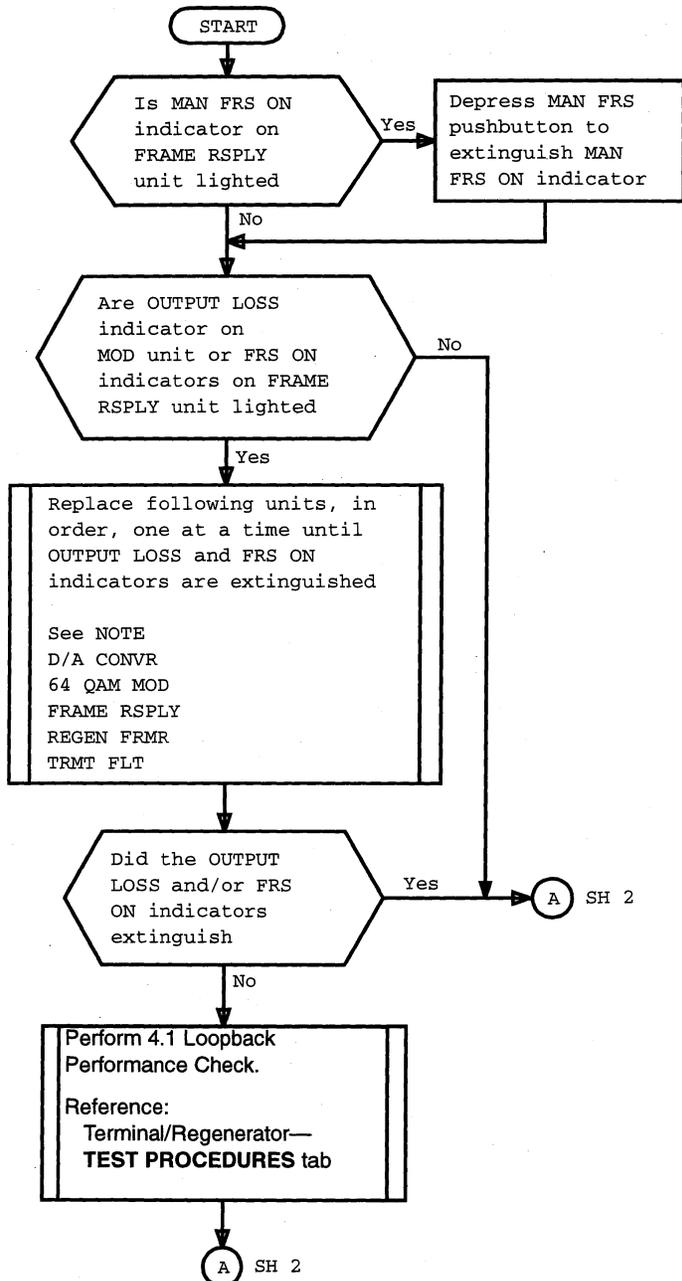
Flowchart 13. Regenerator Bay Digital Transmitter Alarm-Clearing (Sheet 1 of 2)

Prerequisite: Service is protected with a manual line switch (lock out if protection channel) in the direction of transmission.

NOTE:
If replacement unit does not correct the problem, reinstall original unit.

Flowchart 13 is used to clear the DIG TRMT FAIL alarm indicator on the CHAN CONTR unit. If this alarm indicator is ON, the associated regenerator has a failure in its transmitting circuits. Local indications and any necessary tests are referenced to determine the failed unit. When it has been determined which unit has failed, refer to the **REPLACEMENT PROCEDURES** tab under the **TERMINAL / REGENERATOR** tab to replace the unit. If tests are necessary, refer to the **TEST PROCEDURES** tab under the **TERMINAL / REGENERATOR** tab.

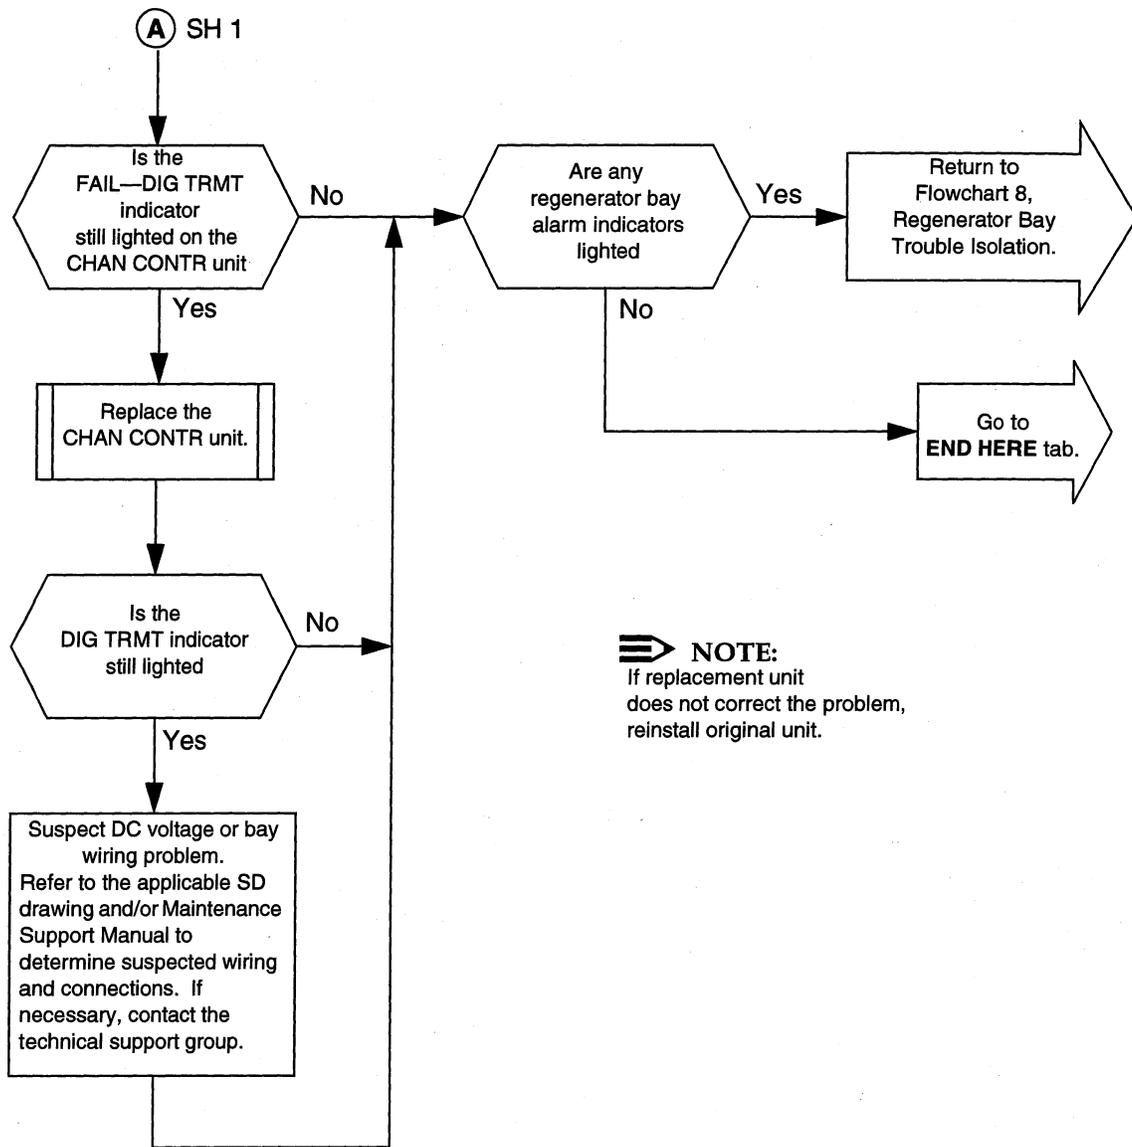
Flowchart 13. Regenerator Bay Digital Transmitter Alarm-Clearing (Sheet 2 of 2)

NOTE:
If replacement unit does not correct the problem, reinstall original unit.

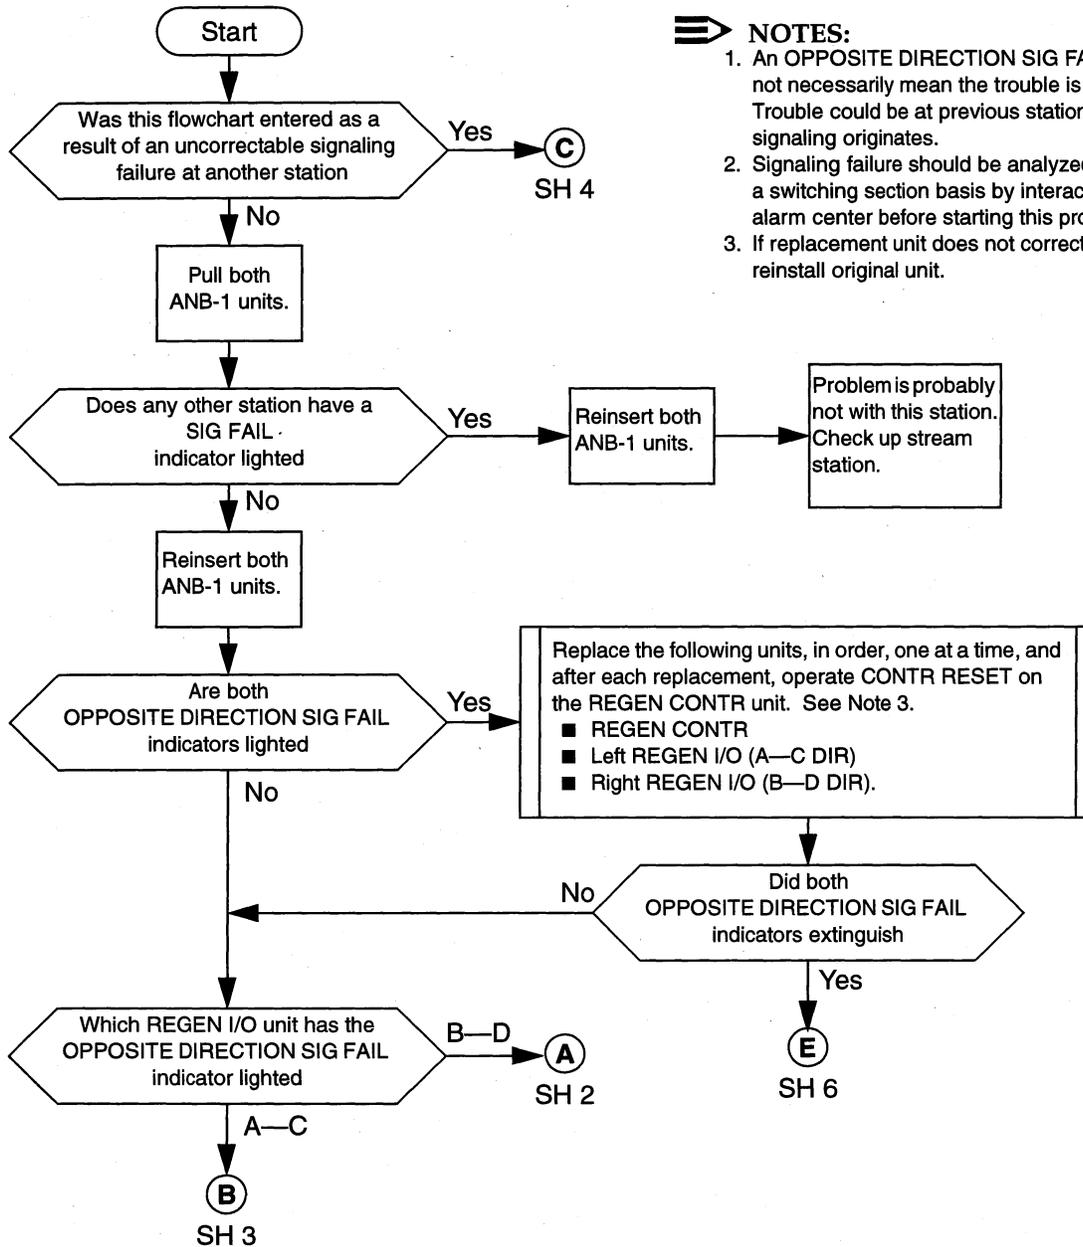
Flowchart 14. Regenerator Bay Signaling Fail Alarm-Clearing (Sheet 1 of 6)

- Prerequisites:**
1. Clear all other alarms in the switching section before clearing signaling fail alarm troubles.
 2. Clear all transmission alarms at this station before proceeding.
 3. Read Notes 1 and 2.

- NOTES:**
1. An OPPOSITE DIRECTION SIG FAIL indication does not necessarily mean the trouble is in this station. Trouble could be at previous station where the signaling originates.
 2. Signaling failure should be analyzed and localized on a switching section basis by interacting with the alarm center before starting this procedure.
 3. If replacement unit does not correct the problem, reinstall original unit.

Flowchart 14 is used to clear an OPPOSITE DIRECTION SIG FAIL indicator on a REGEN I/O UNIT. Local indications are referenced to determine the failed unit. When it has been determined which unit has failed, refer to the **REPLACEMENT PROCEDURES** tab under the **TERMINAL / REGENERATOR** tab to replace the unit.

The protection switch signaling is conveyed from one end of the switching section to the other as part of the internal system service channel. When no switches are operated, the service channel information is transmitted as part of the protection channel digital signal. If the protection channel is not available, the service channel will automatically switch to regular channel 1. In normal system operation, this switch will occur when the protection channel is locked out or if the protection channel has failed. The appropriate SRV CHAN SWITCHES indication will be lighted on the SC MULDEM unit to show which service channel direction has been switched. The SIG FAIL alarm condition will be reported when the service channel transmission path is failed or if a service channel unit is failed.

The service channel protection switching is controlled by the receiving end of a regenerative section. This means that reverse signaling is used to switch the transmitting end after the receiving end executes a service channel switch. Therefore, when the A-C direction (leftmost) REG I/O unit has an OPPOSITE DIRECTION SIG FAIL indicator lighted, the problem is most likely in the B-D direction plug-in units. When the B-D direction (rightmost) REG I/O unit has an OPPOSITE DIRECTION SIG FAIL indicator lighted, the problem is most likely in the A-C direction plug-in units.

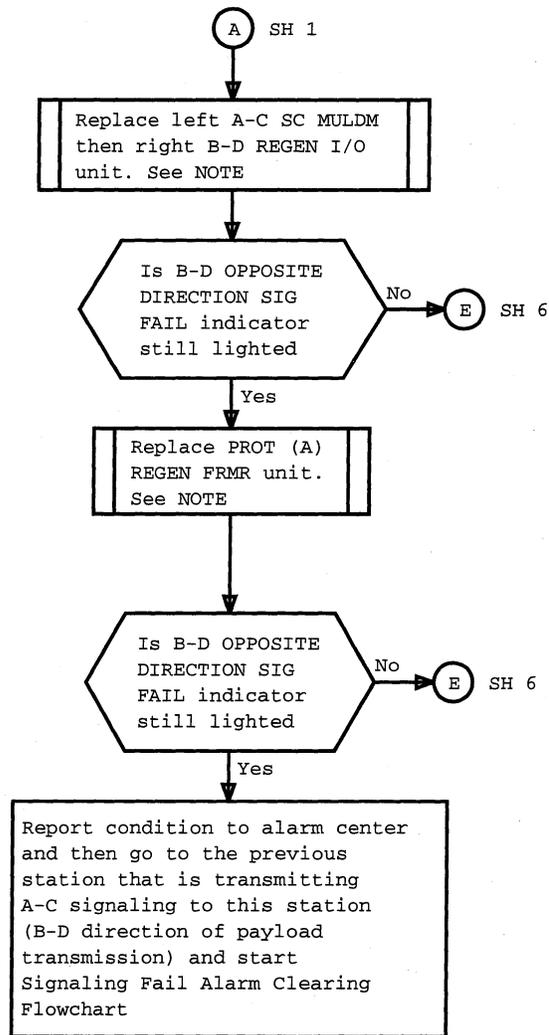
Flowchart 14. Regenerator Bay Signaling Fail Alarm-Clearing (Sheet 2 of 6)

If replacement unit does not correct problem, reinstall original unit

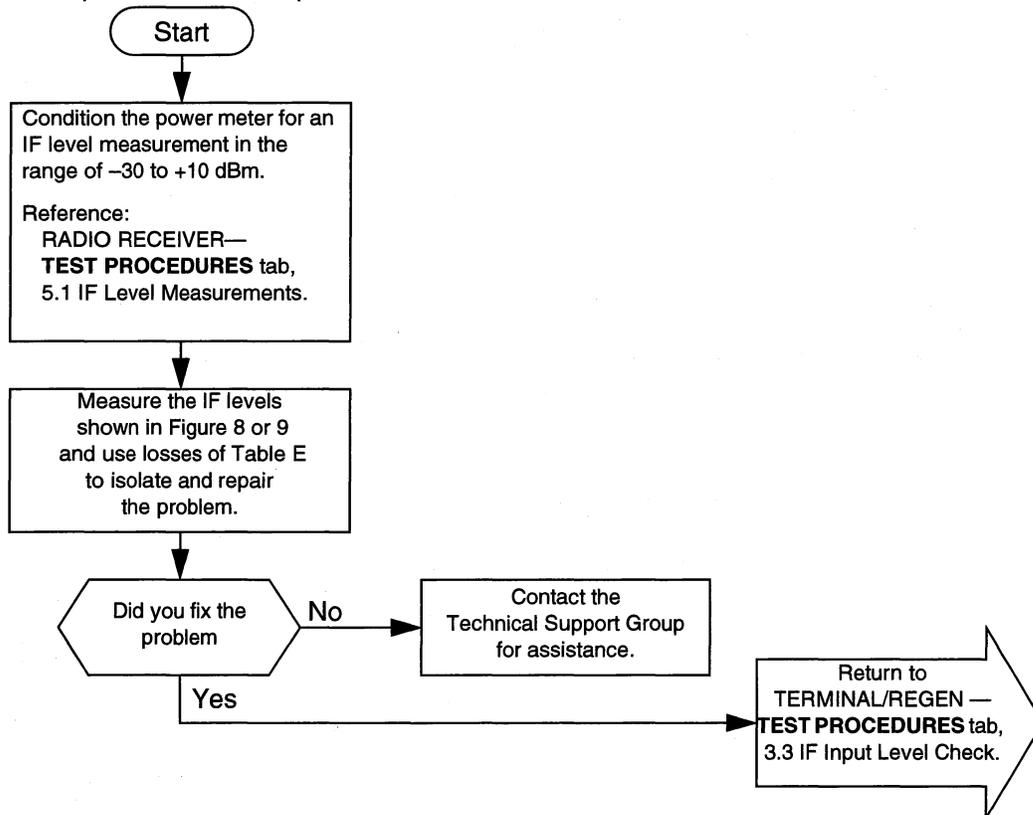
Flowchart 15. IF Level Problem Isolation

You were referred here from the **TEST PROCEDURES** tab, 3.3 IF Input Level Check, because the IF input level to a terminal receiver or regenerator does not meet requirements. The power meter should already be conditioned for an IF level measurement between -30 dBm and +10 dBm.

Use Flowchart 15 to isolate the level problem. A radio receiver alignment may be required to correct a problem isolated to the radio receiver.

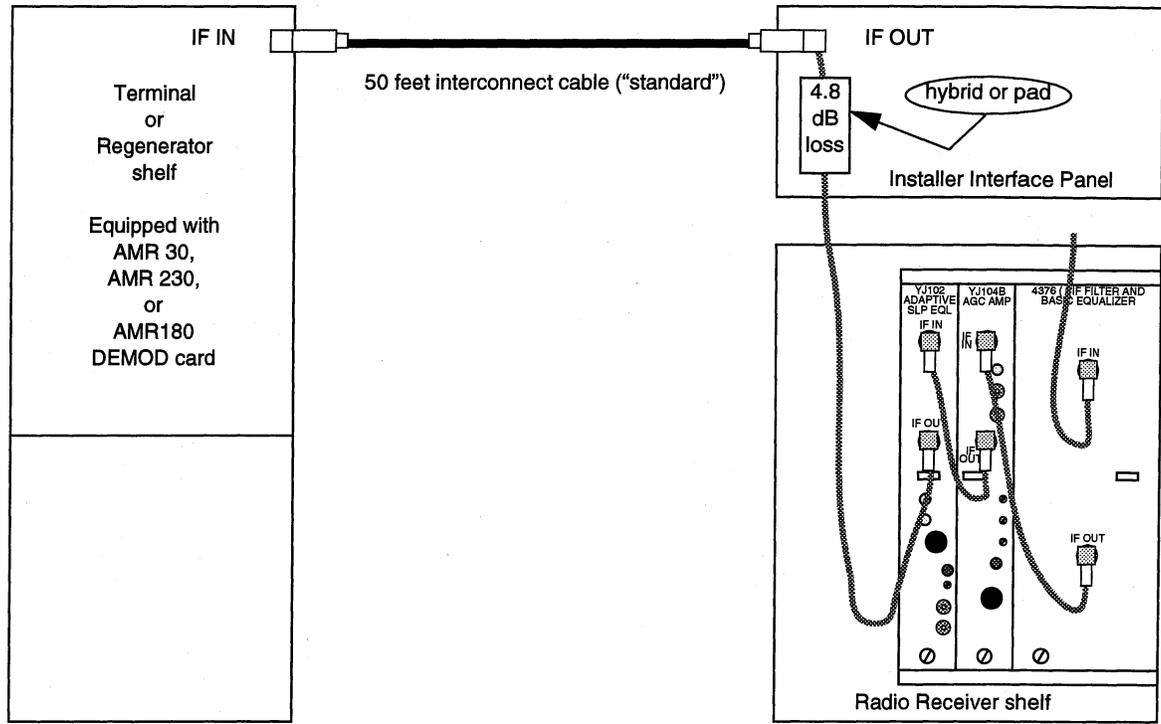
Figure 8. IF Level Problem Isolation—50 Feet Interconnect Cable

Terminal or Regenerator IF IN

Requirement: $-8.2 \text{ dBm} \pm 1.0 \text{ dB}^*$

*The AMR 180 64QAM DEMOD card will work with $-10.0 \text{ dBm} \pm 3.0 \text{ dB}$.
