**DR 6/11-135A and 135EC
1×N Frequency Diversity
Operation and Maintenance
Terminal/Regenerator
Trouble Isolation**

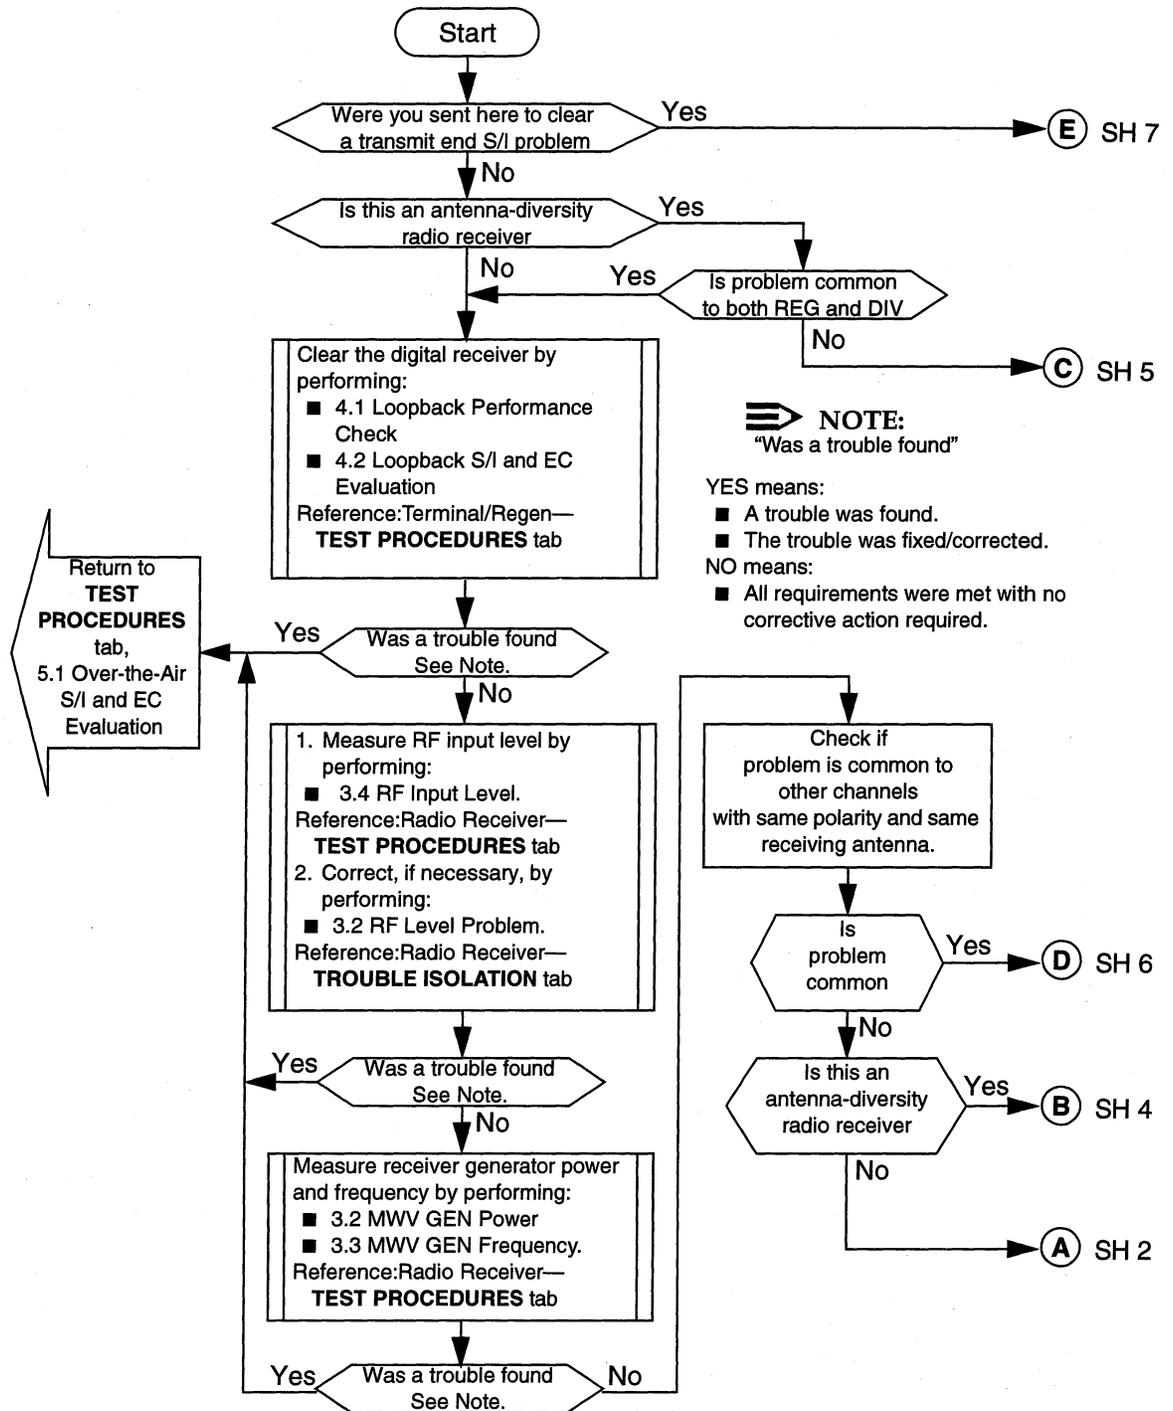
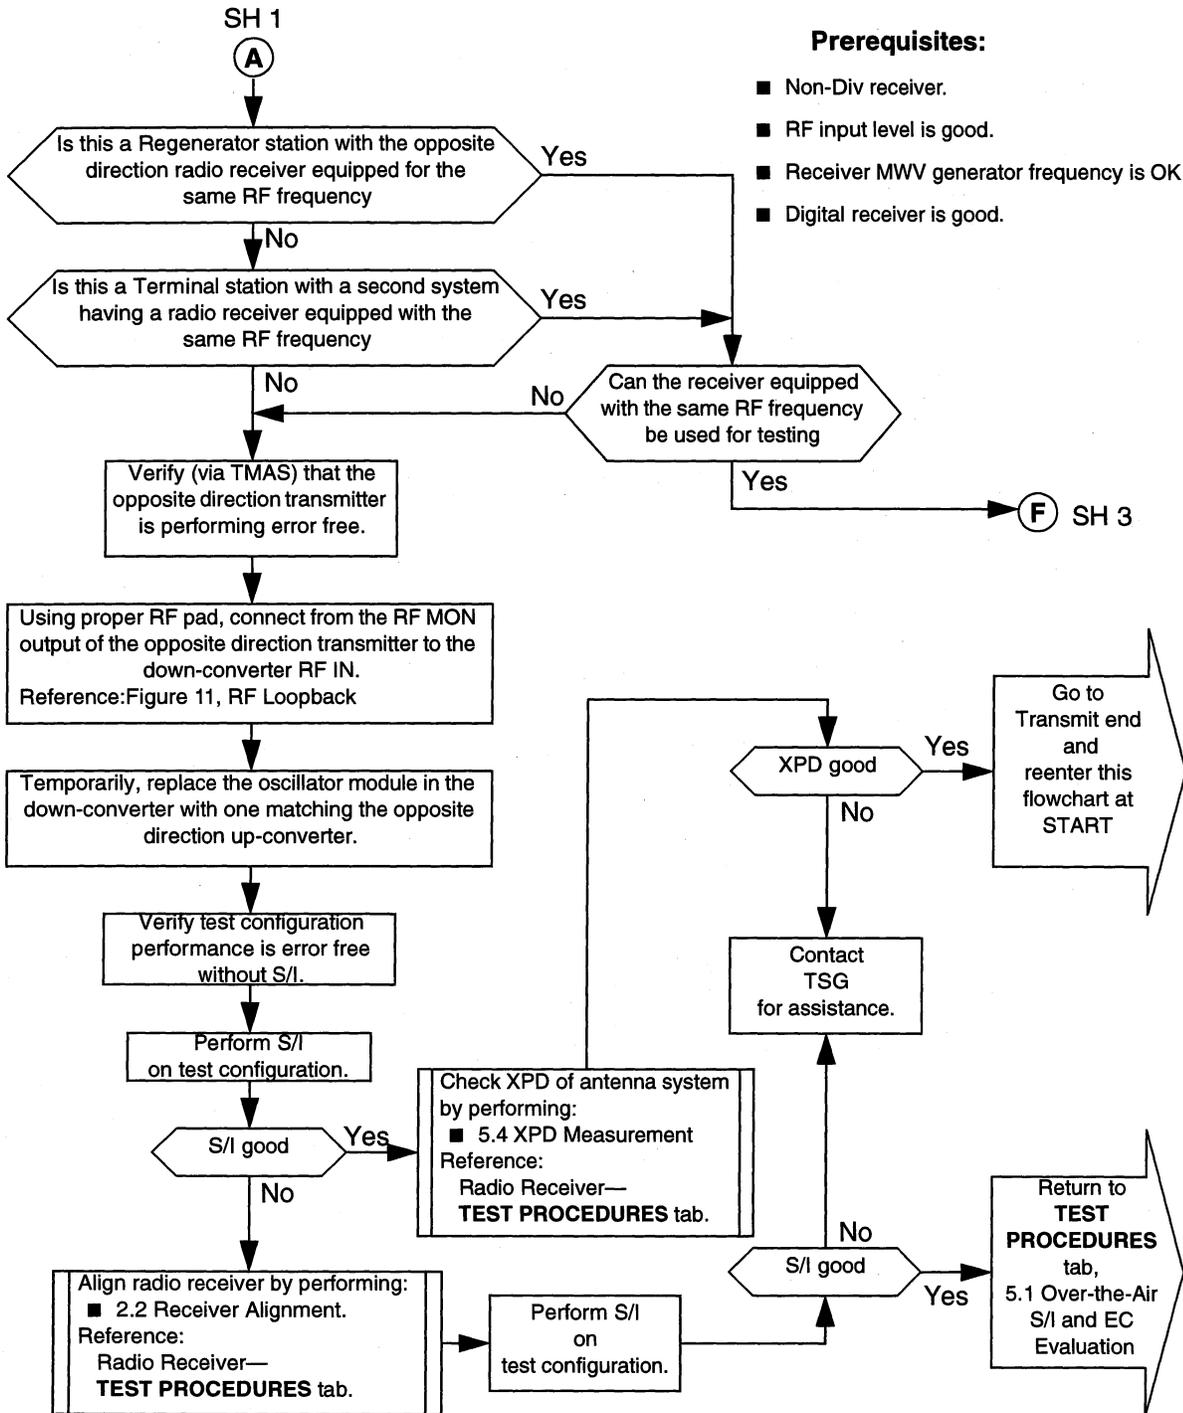
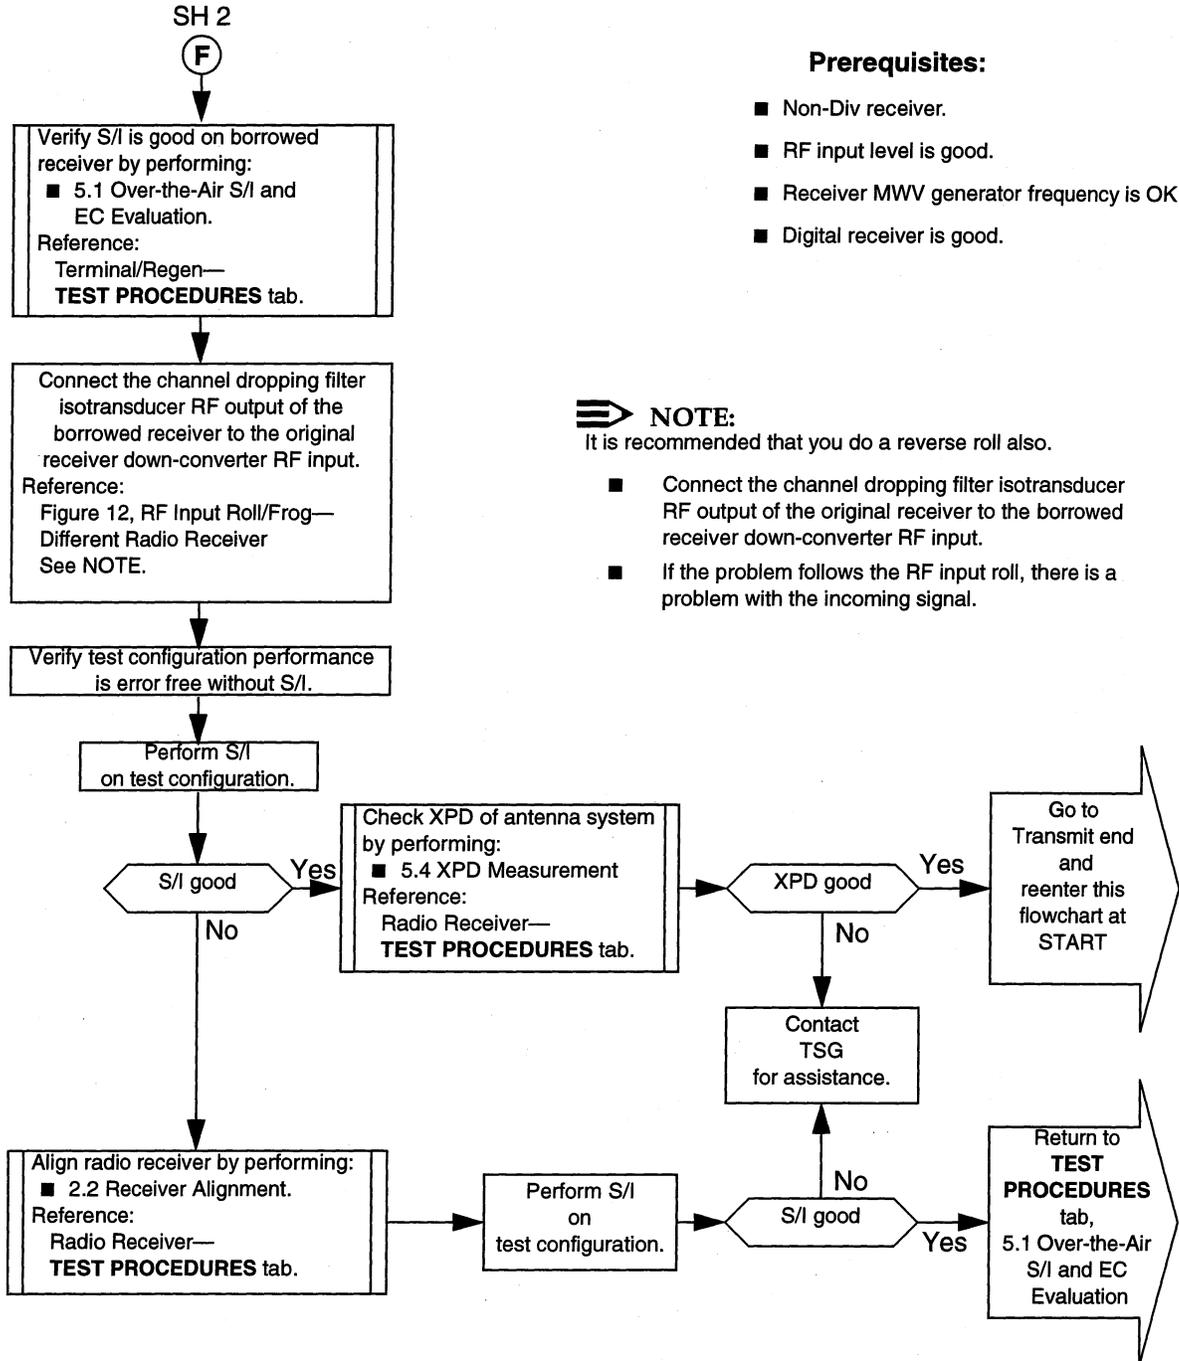
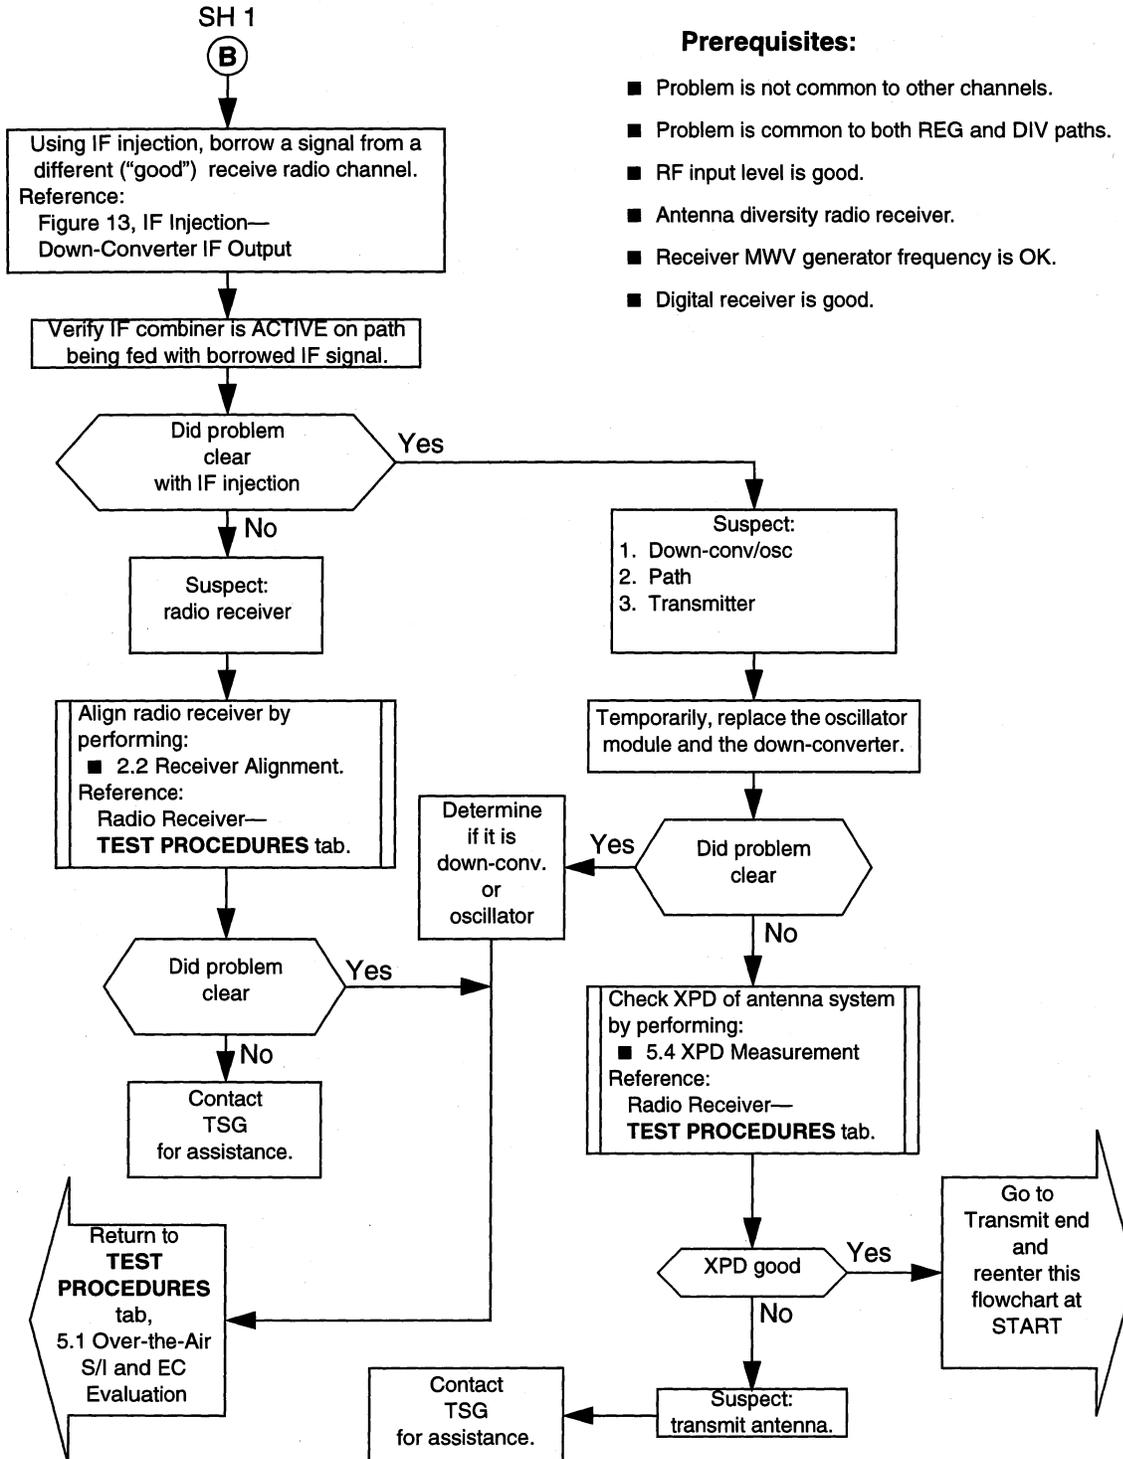
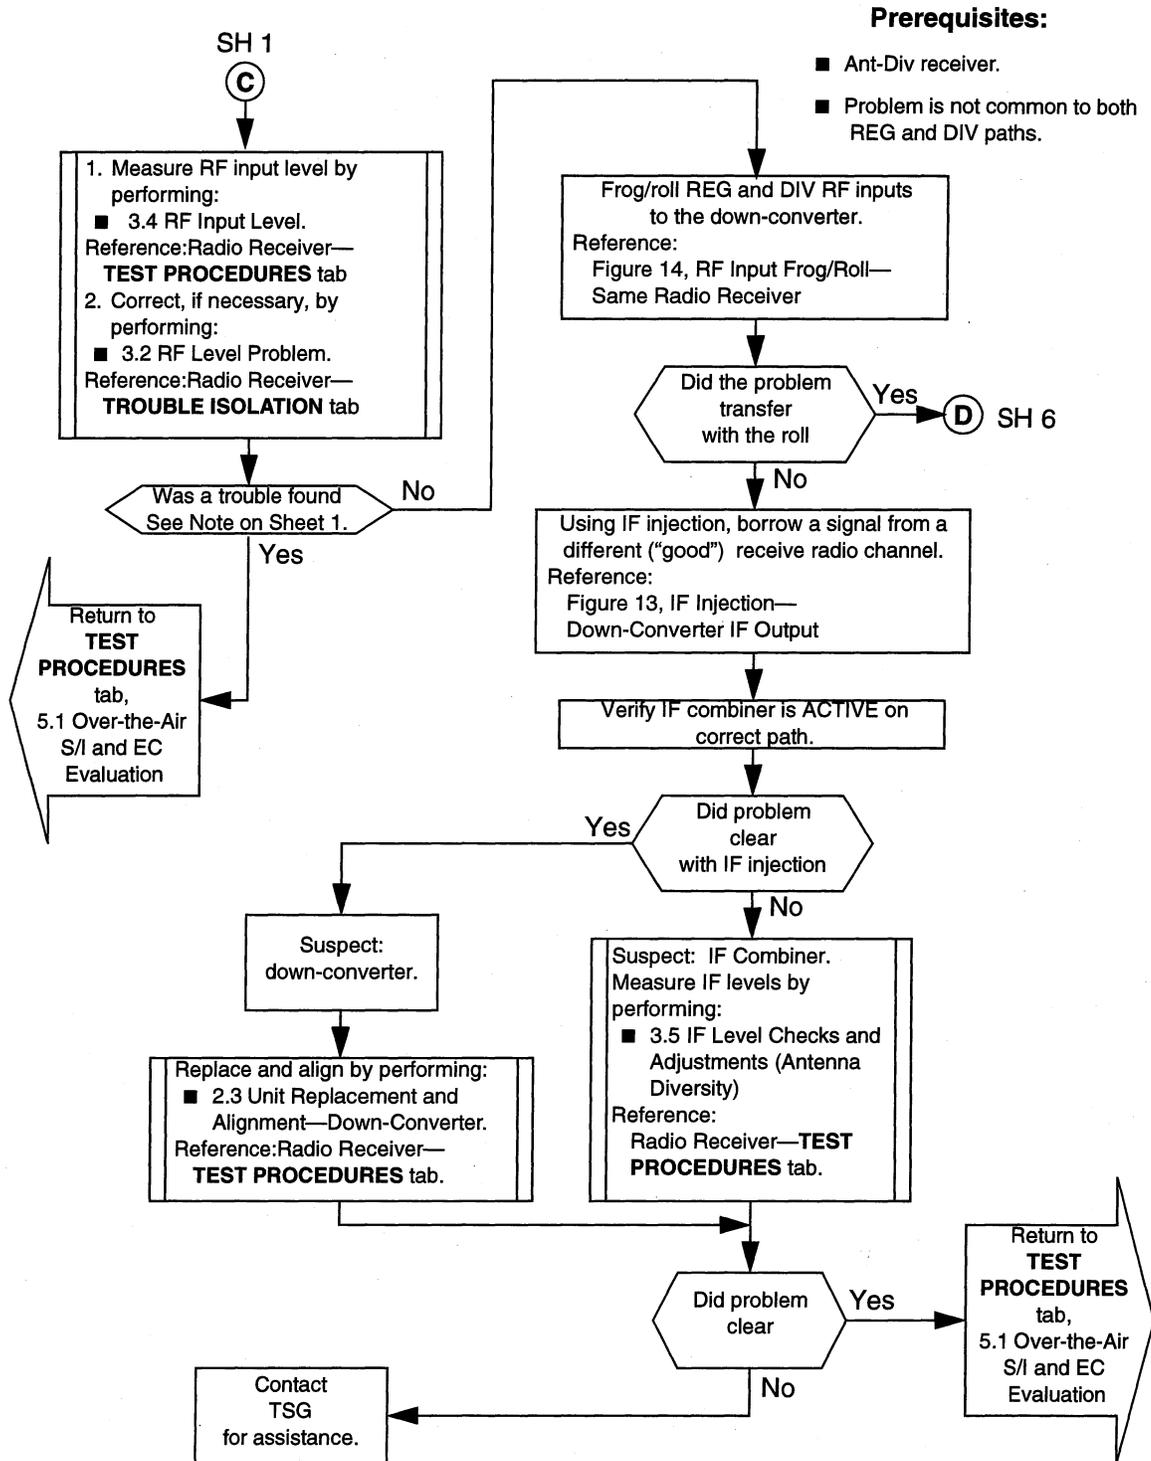
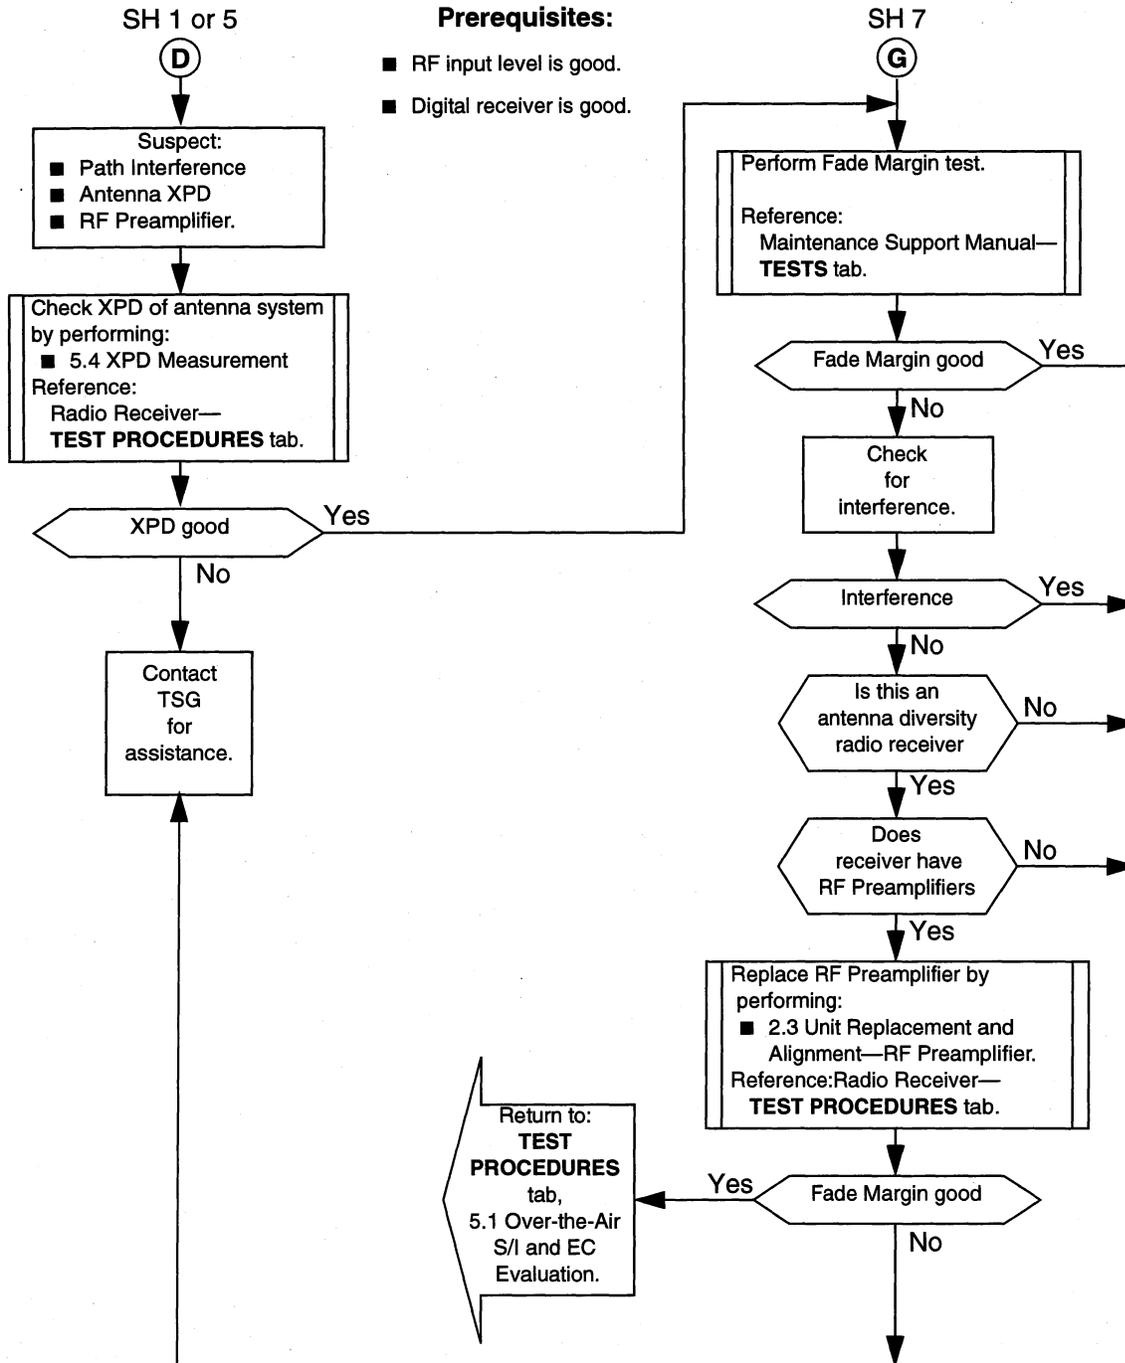
Flowchart 16. S/I Problem Isolation (Sheet 1 of 7)

- Prerequisites:**
- RF input level is good.
 - Digital receiver is good.

You were referred here from the **TEST PROCEDURES** tab, 5.1 Over-the-Air S/I and EC Evaluation, because the signal-to-interference (S/I) test did not meet requirements. The receiving error performance for this channel is good under normal (unstressed) conditions.

Use Flowchart 16 to isolate the problem.

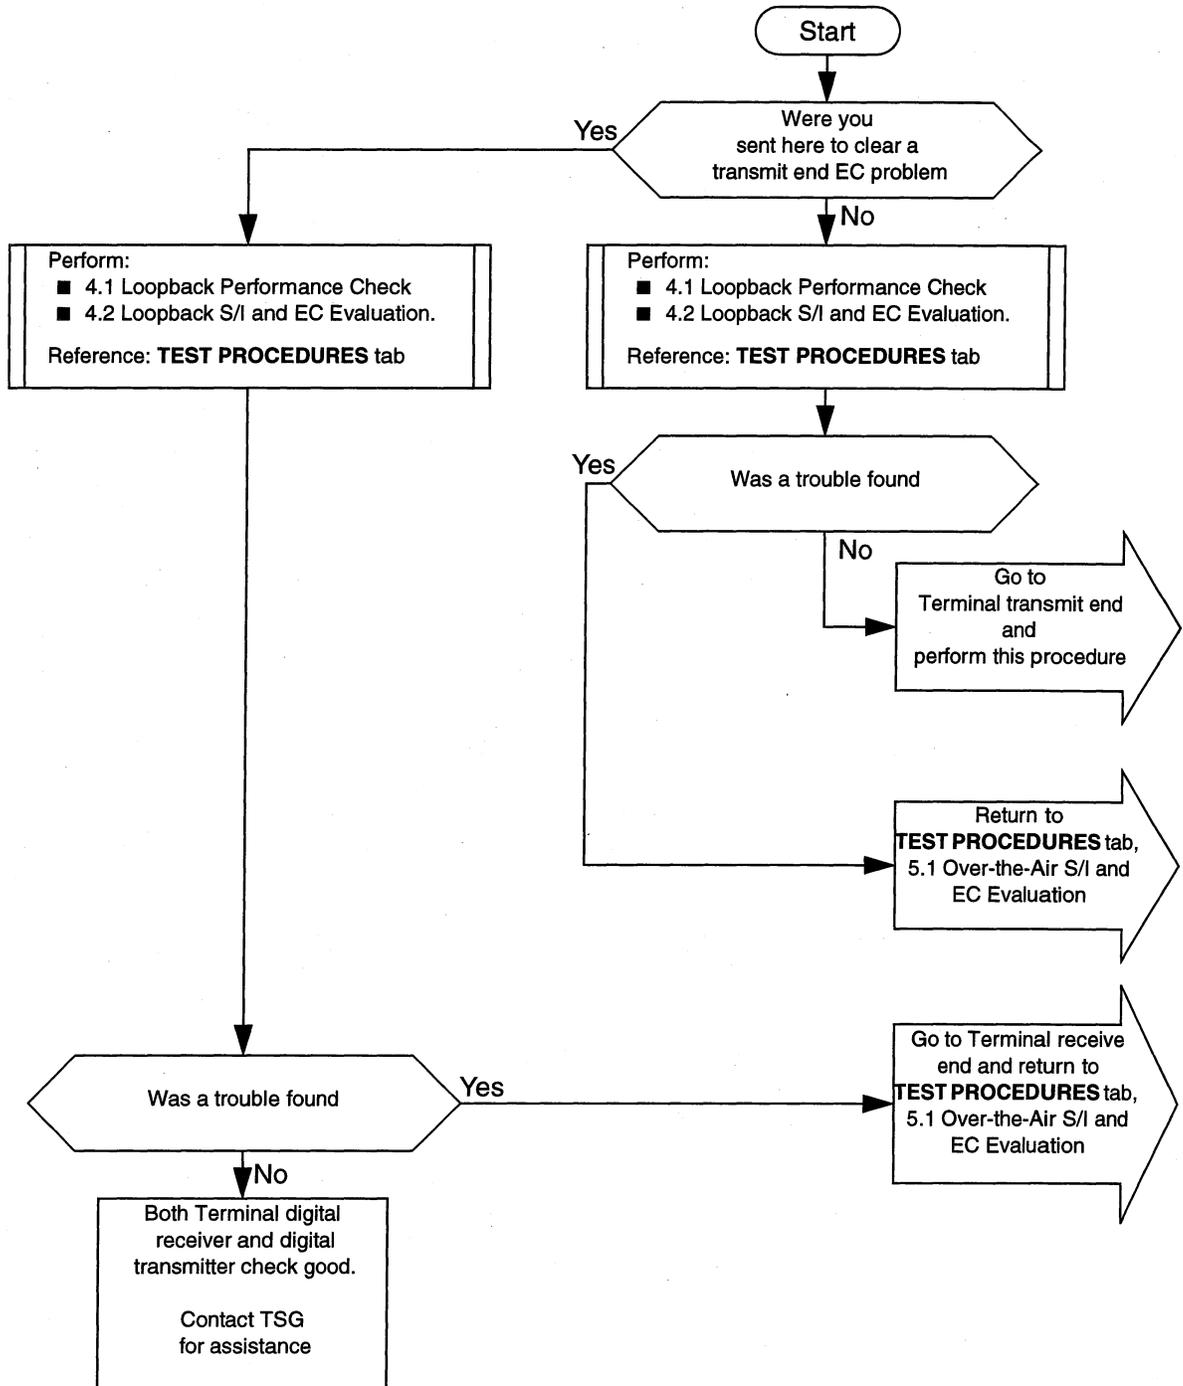
Flowchart 17. EC Problem Isolation

Use Flowchart 17 to isolate the problem.

You were referred here from the **TEST PROCEDURES** tab, 5.1 Over-the-Air S/I and EC Evaluation, because the error correction evaluation failed. The receiving error performance for this channel is good under normal (unstressed) conditions.

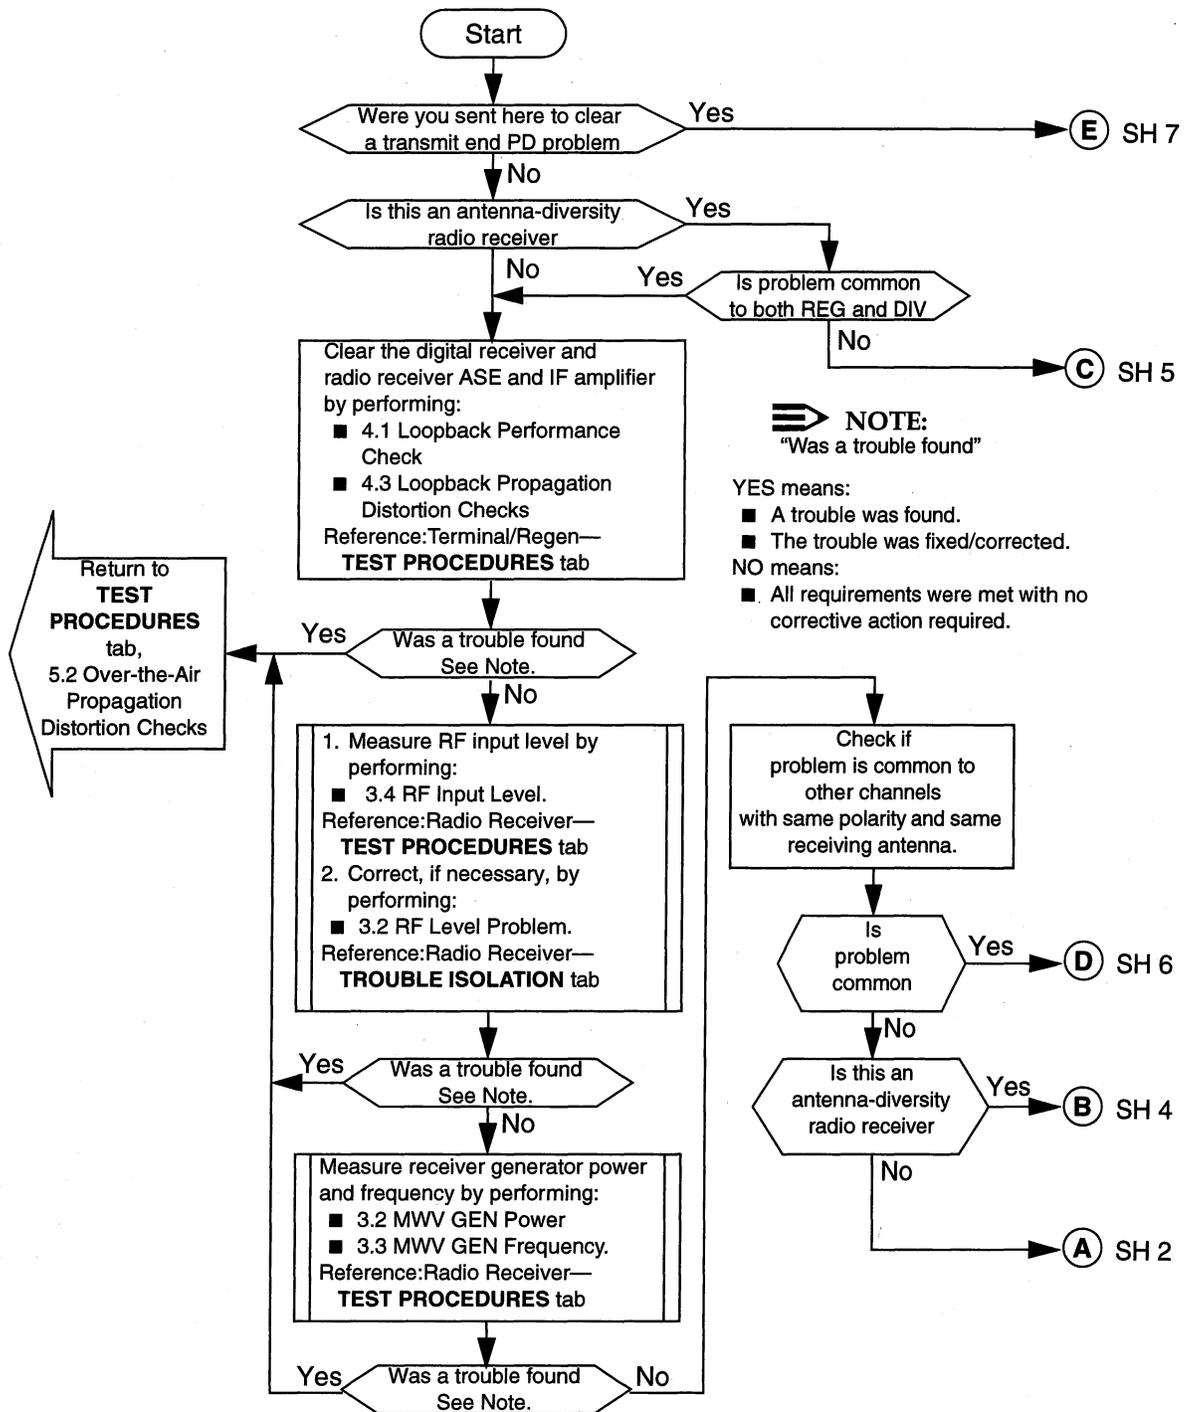
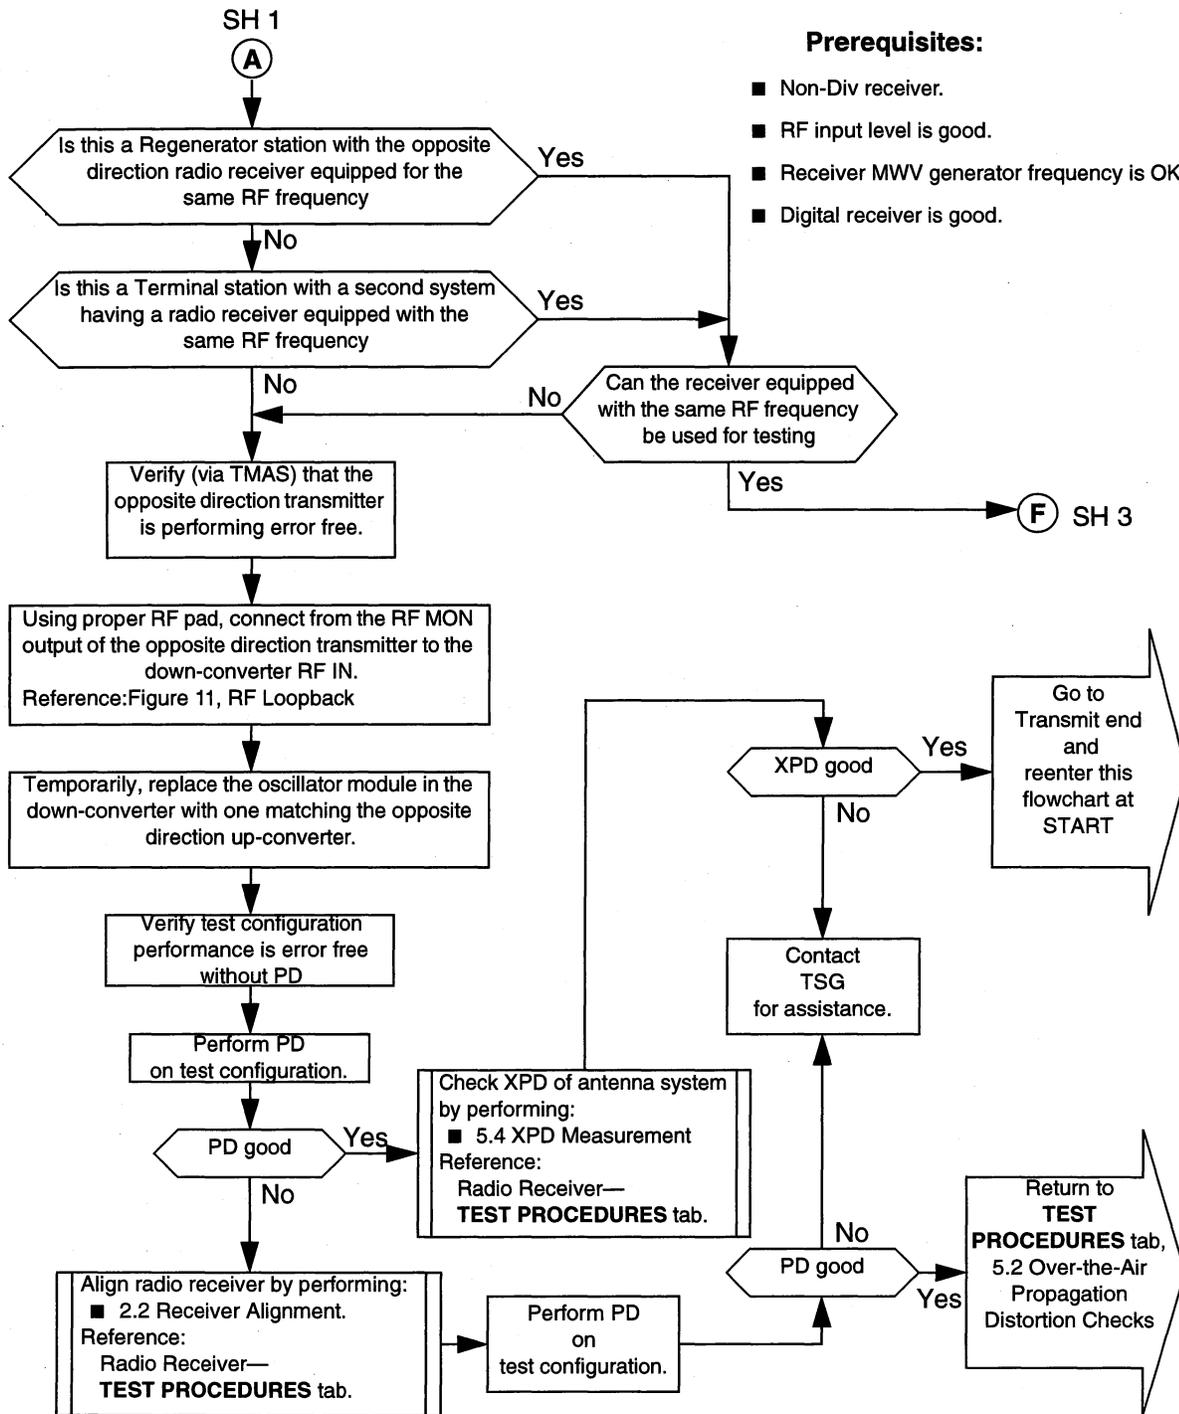
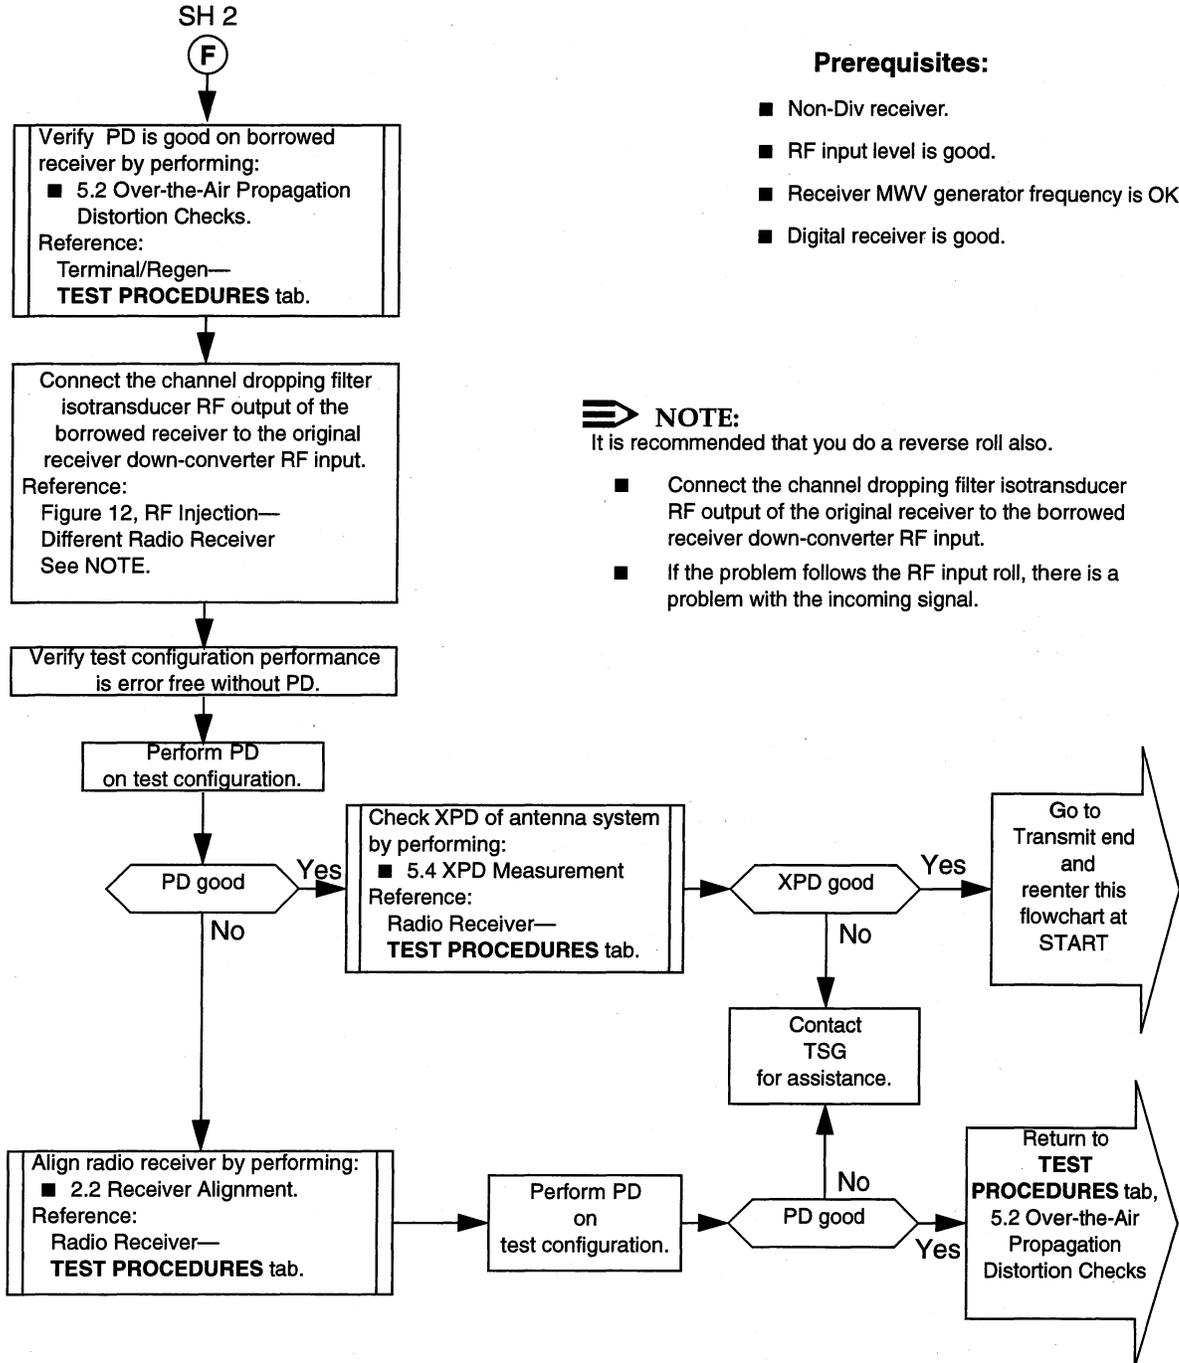
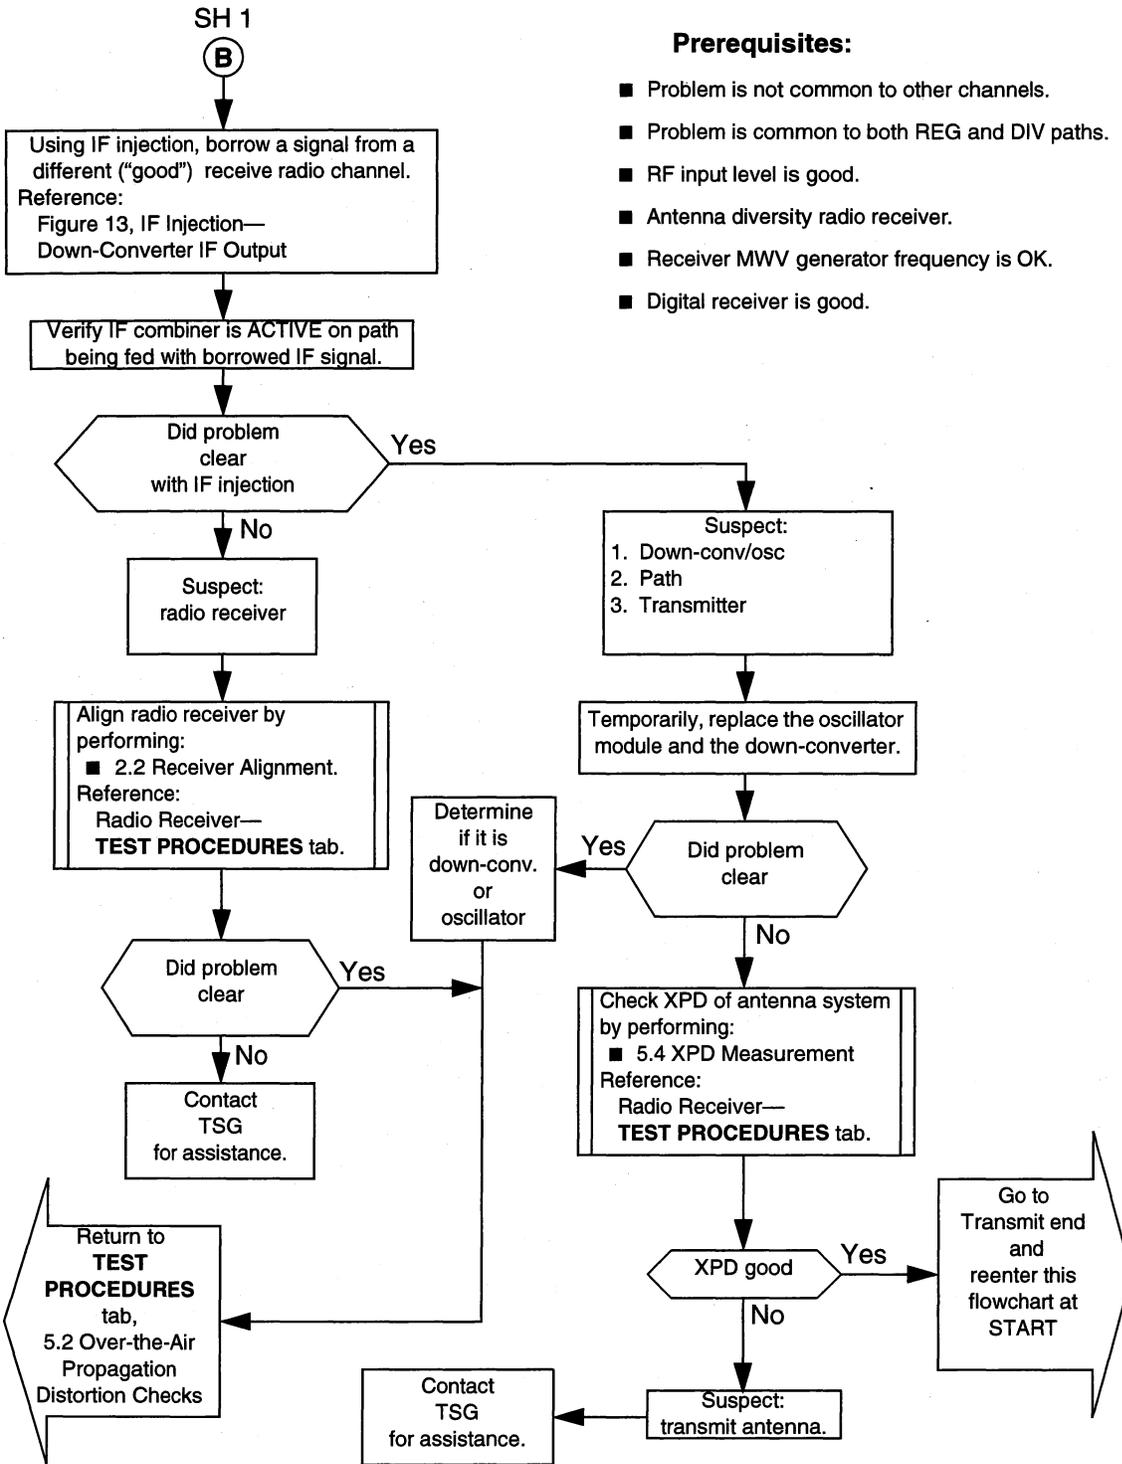
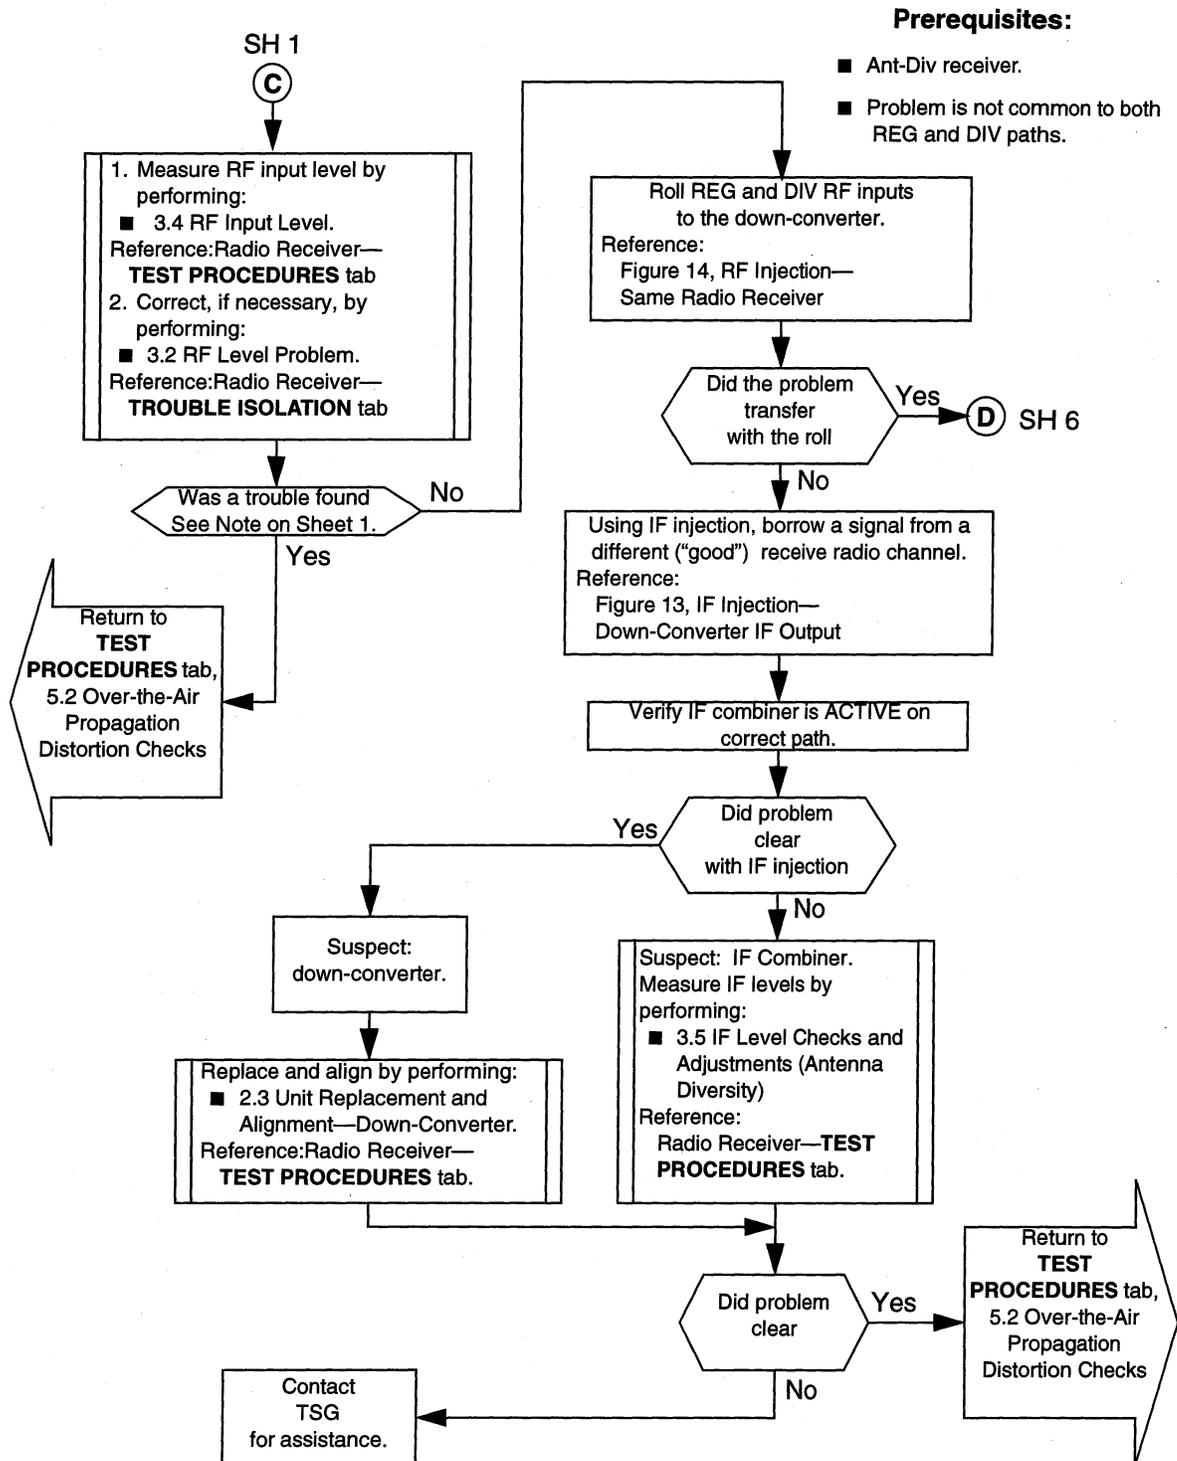
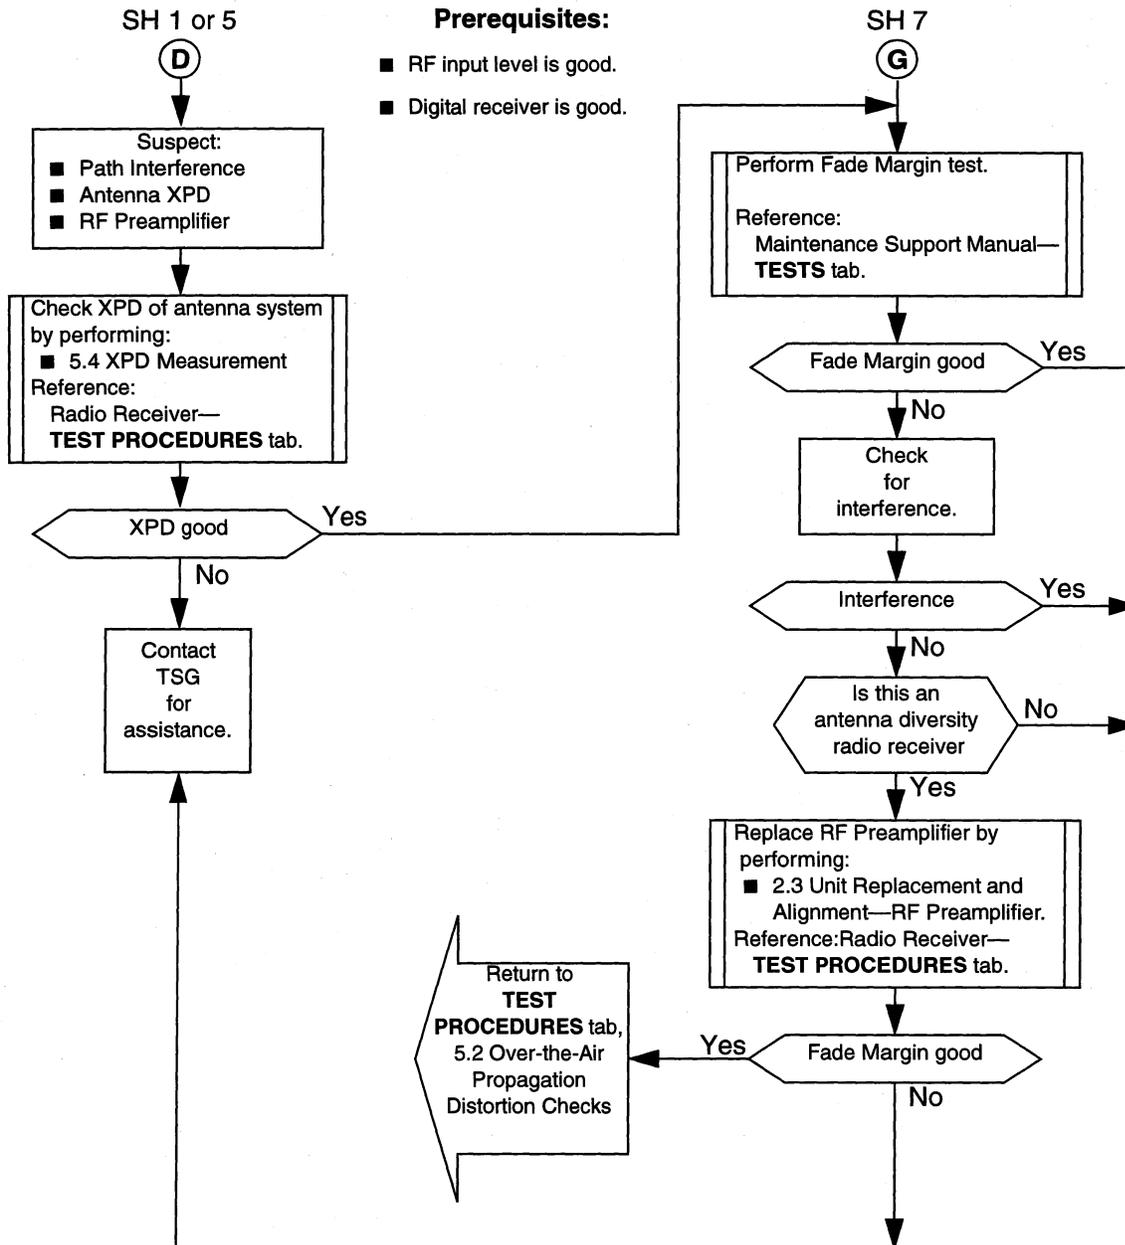
Flowchart 18. PD Problem Isolation (Sheet 1 of 7)

Some possible causes for the Adaptive Slope Equalizer (ASE) Test failure are:

- a. Adaptive Slope Equalizer (ASE) in radio receiver is defective or not adjusted properly.
- b. The radio channel has residual amplitude slope due to a problem.

Some possible causes for the Transversal Equalizer and Digital Receiver Recovery tests failures are:

- a. Transversal Equalizer in digital receiver is defective.
- b. A microwave generator is off frequency.
- c. An IF level problem into the digital receiver.
- d. A digital receiver problem.
- e. A digital transmitter problem.

Use Flowchart 18 to isolate the PD problem.

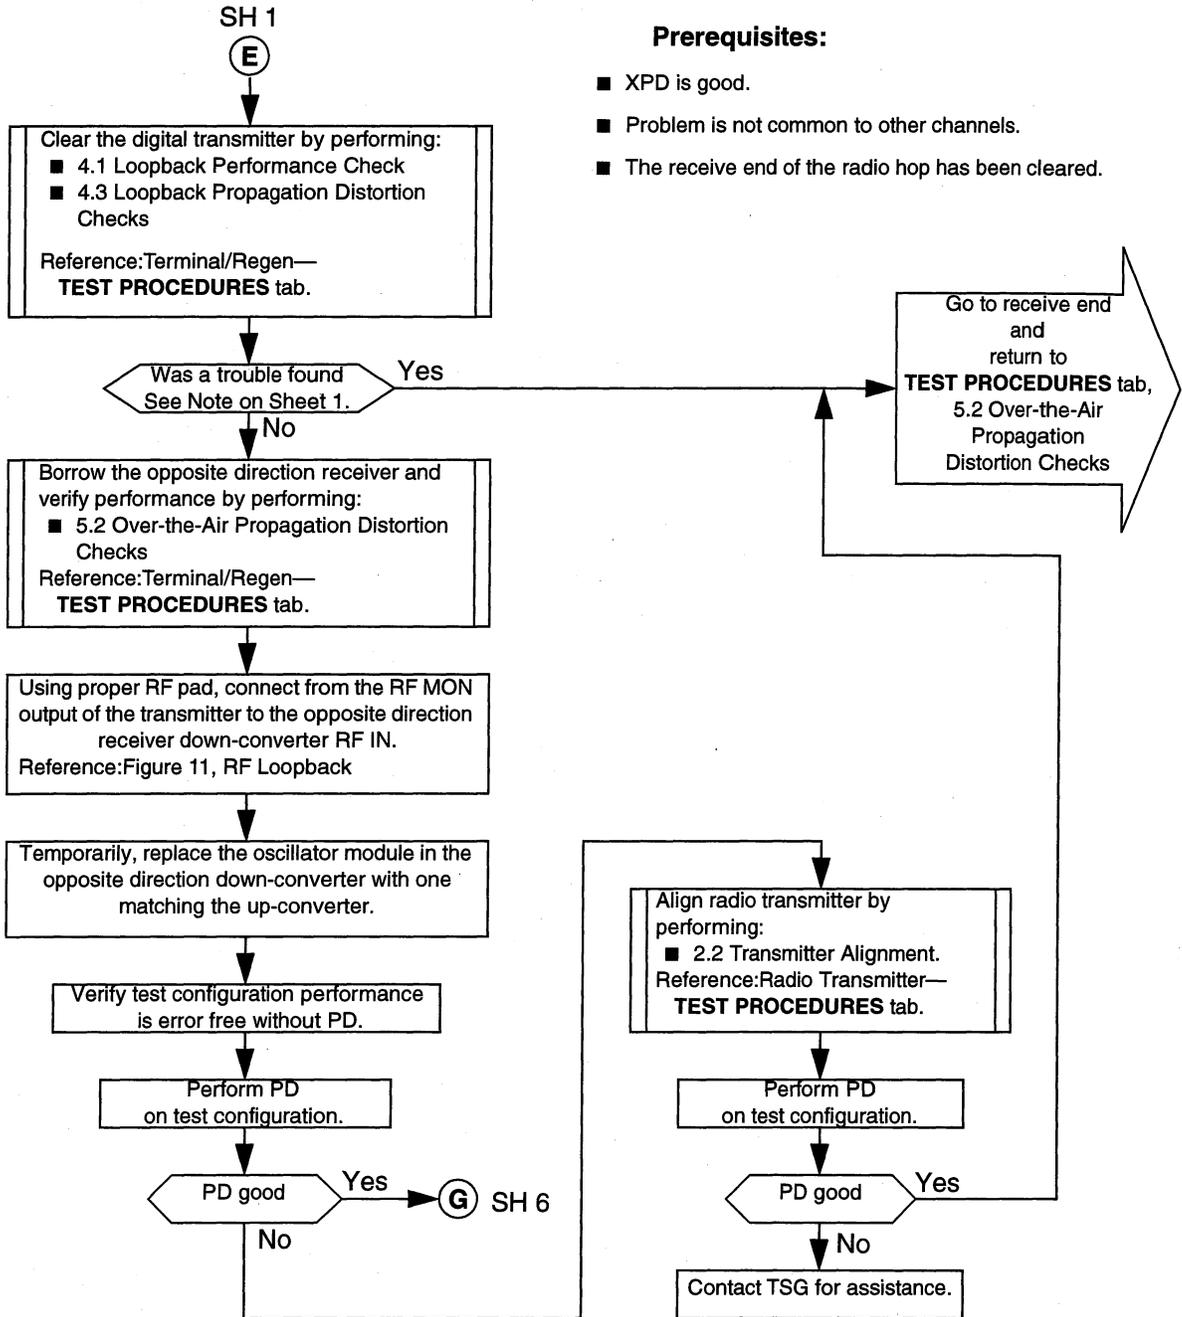
Flowchart 18. PD Problem Isolation (Sheet 7 of 7)

Prerequisites:

- XPD is good.
- Problem is not common to other channels.
- The receive end of the radio hop has been cleared.
