**DR 6/11-135A and 135EC
1×N Frequency Diversity
Operation and Maintenance
Terminal/Regenerator
Trouble Isolation**

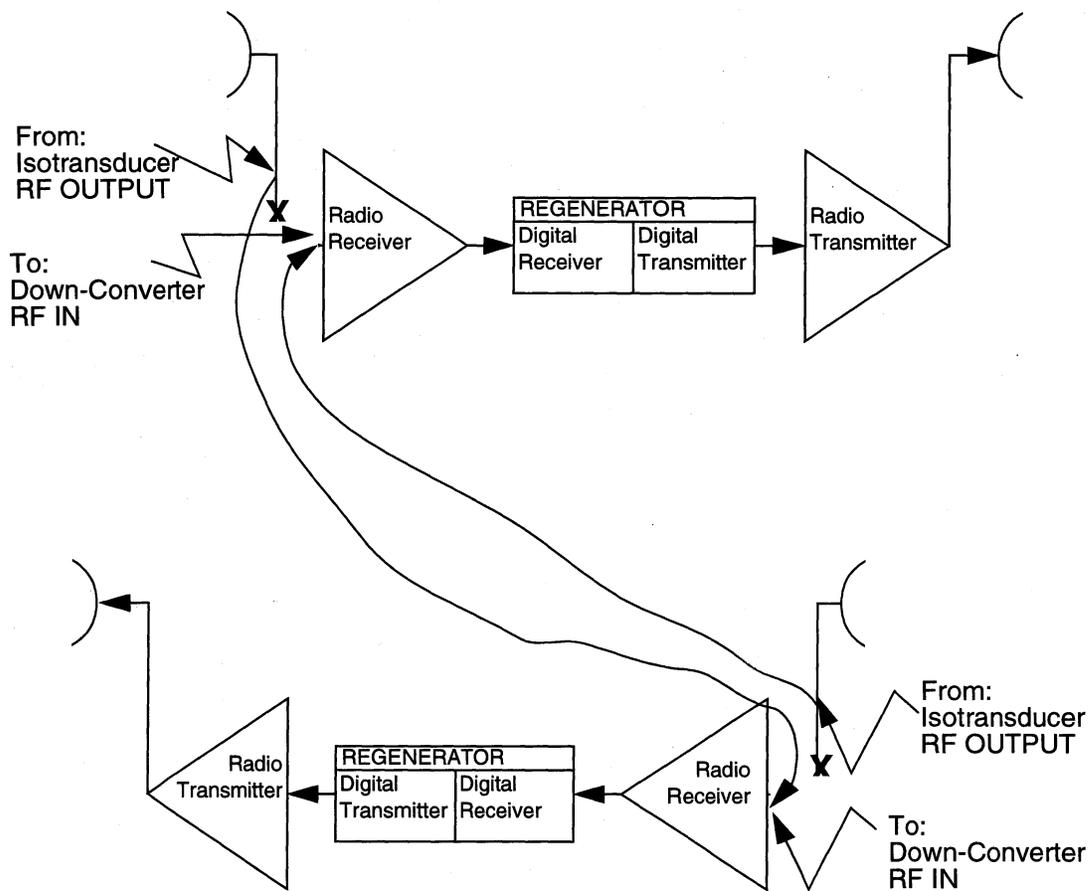
Figure 12. RF Injection—Different Radio Receiver

⇒ NOTE:
 Both radio receivers are equipped for the same RF center frequency.

Figures 10 through 14 are located at the end of this section. Figure 10 illustrates one two-way digital radio channel and Figures 11 through 14 show common test configurations which are referenced from several of the trouble isolation flowcharts.

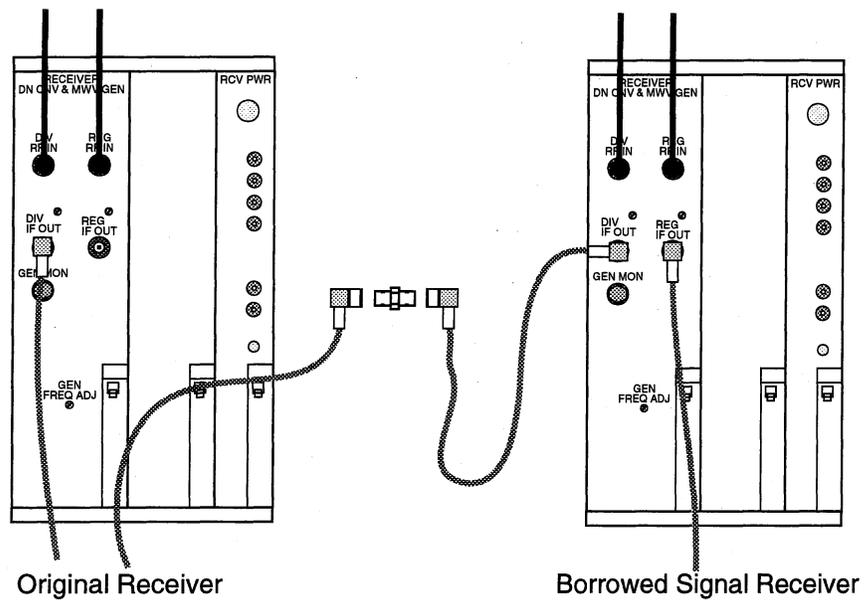
! **CAUTION:**
To prevent service interruptions, ensure that service is protected before removing cables.

Figure 13. IF Injection—Down-Converter IF Output

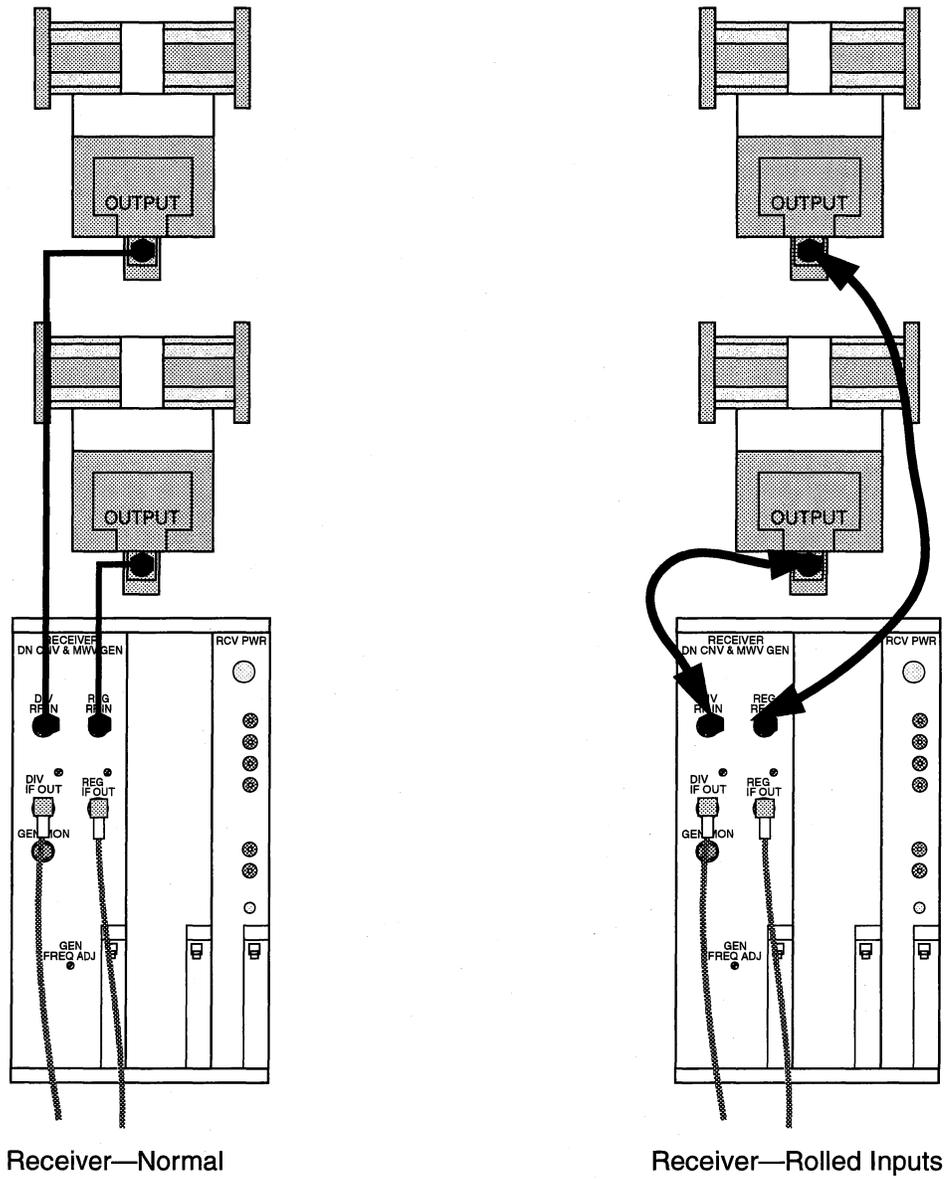
CAUTION:
To prevent service interruptions, ensure that service is protected before removing cables.

Figure 14. RF Injection—Same Radio Receiver
