## RINGERS—D1-TYPE MAINTENANCE

### 1. GENERAL

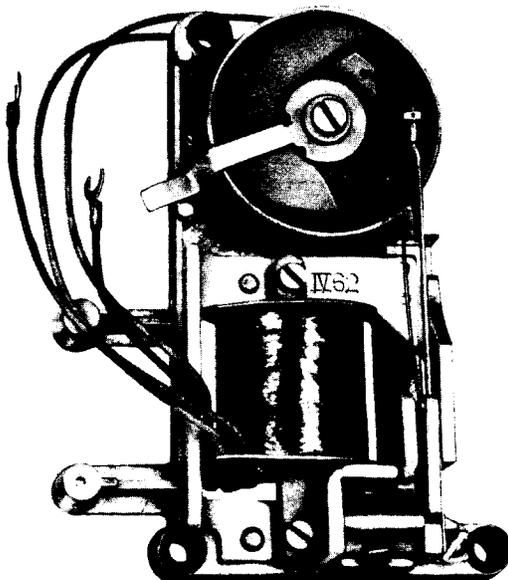
Fig. 1—D1C Ringer

2.01 Fig. 1 and 2 show typical D1-Type ringers and their component parts.
