## 1P2 KEY TELEPHONE SYSTEM

### TESTS AND MAINTENANCE

**1.01** This section provides tests and maintenance information in the form of Trouble Locating Tables and functional schematics for the following 1P2 Key Telephone System arrangements:

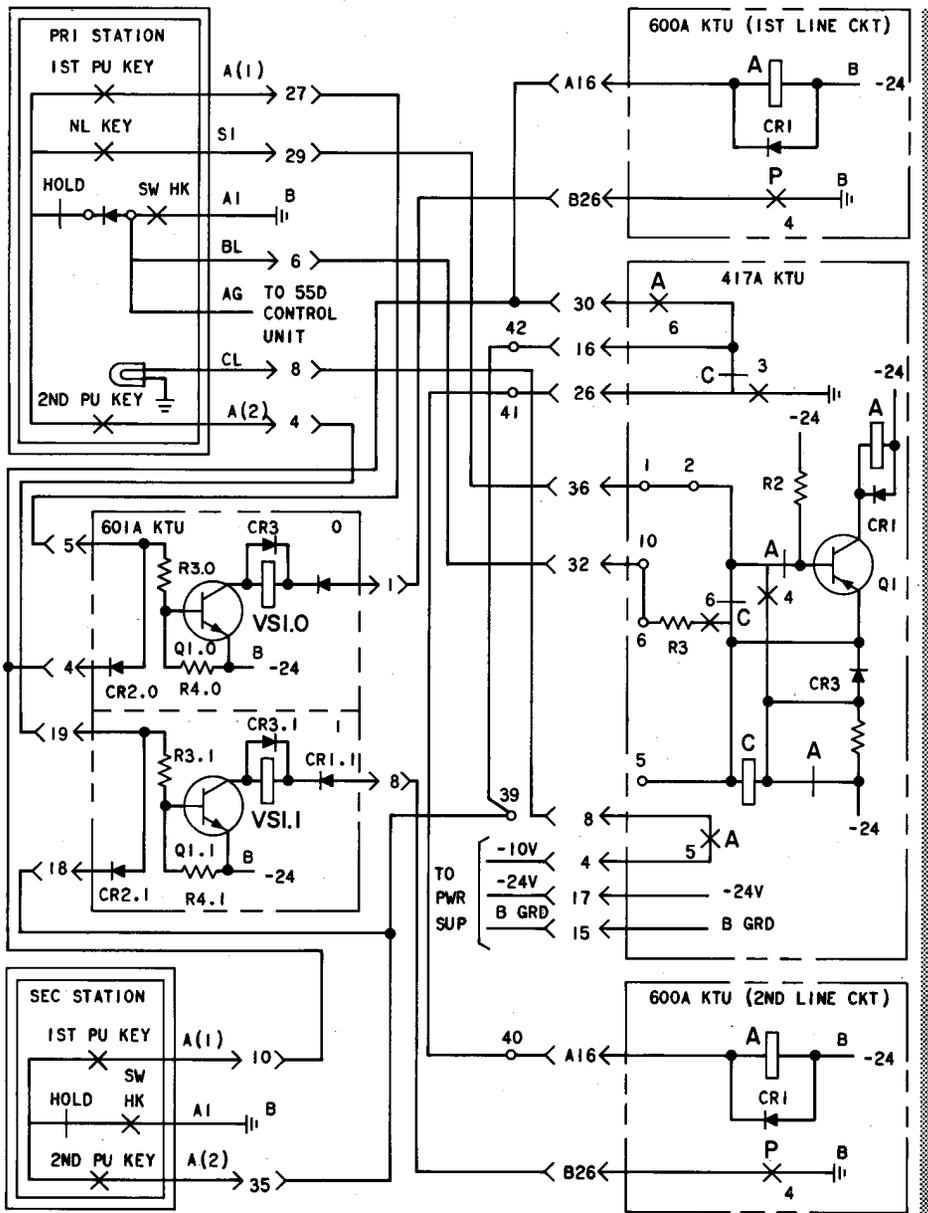
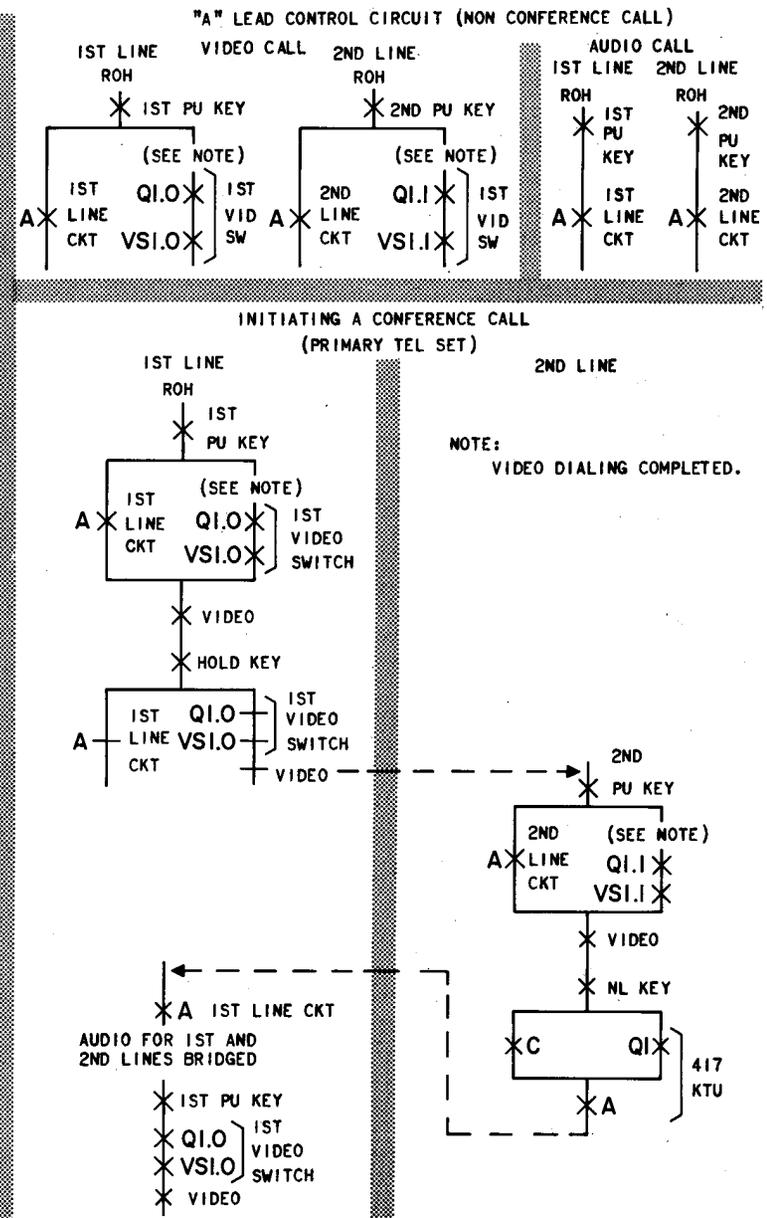
Fig. 1 - Single Group, A Lead and Add-on Conference Control

Fig. 1 — A Lead and Add-On Conference Control

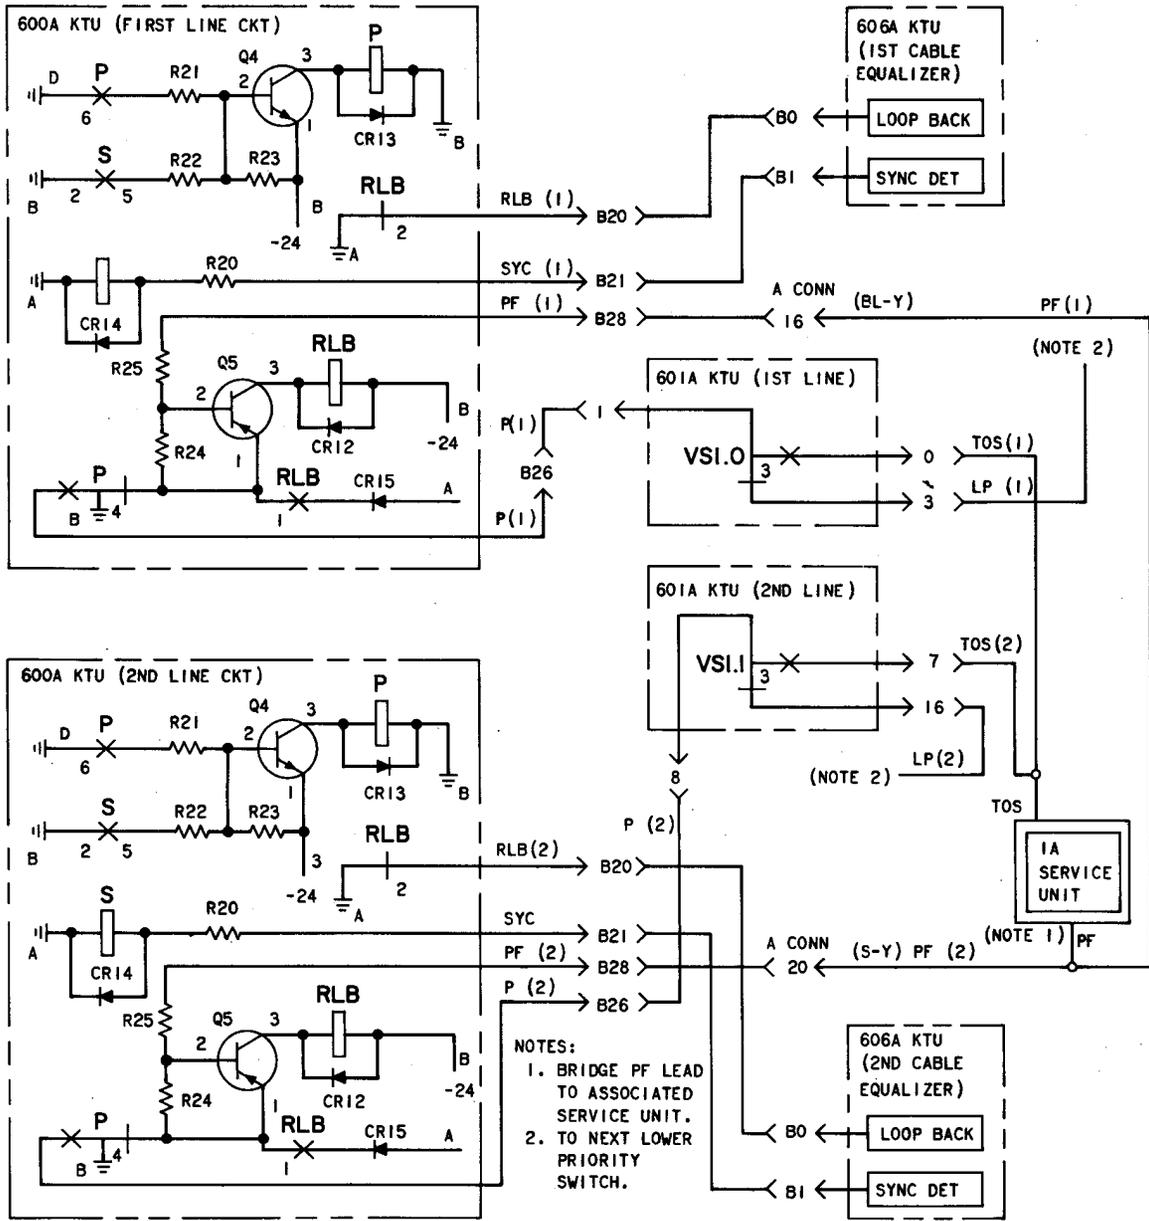
Fig. 2 - Single Group, Power Failure, Sync, Remove Loopback, and Turn-on-Set Control

Fig. 2 — Power Failure, Sync, Remove Loopback, and Turn-On-Set Control

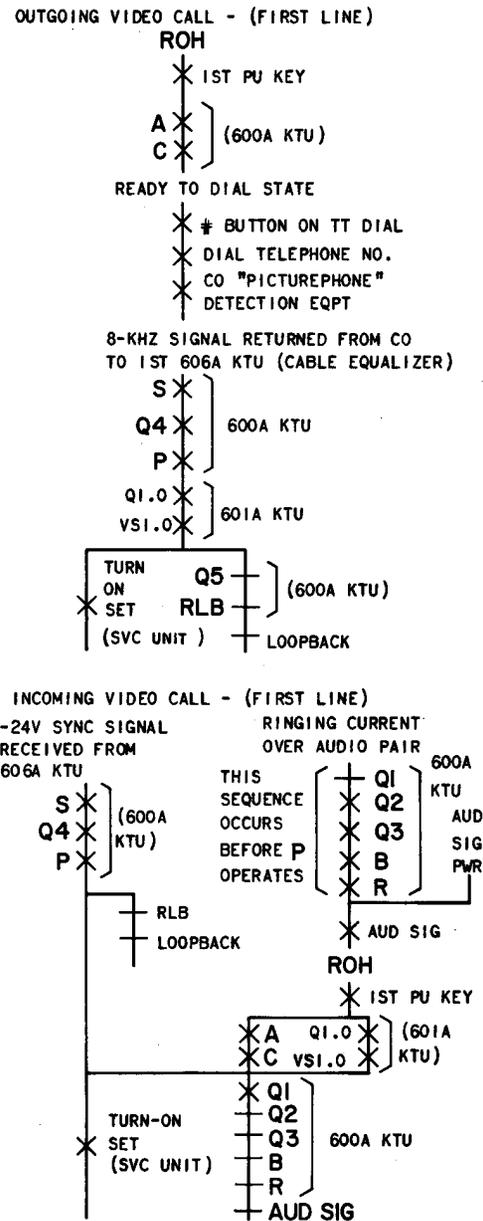
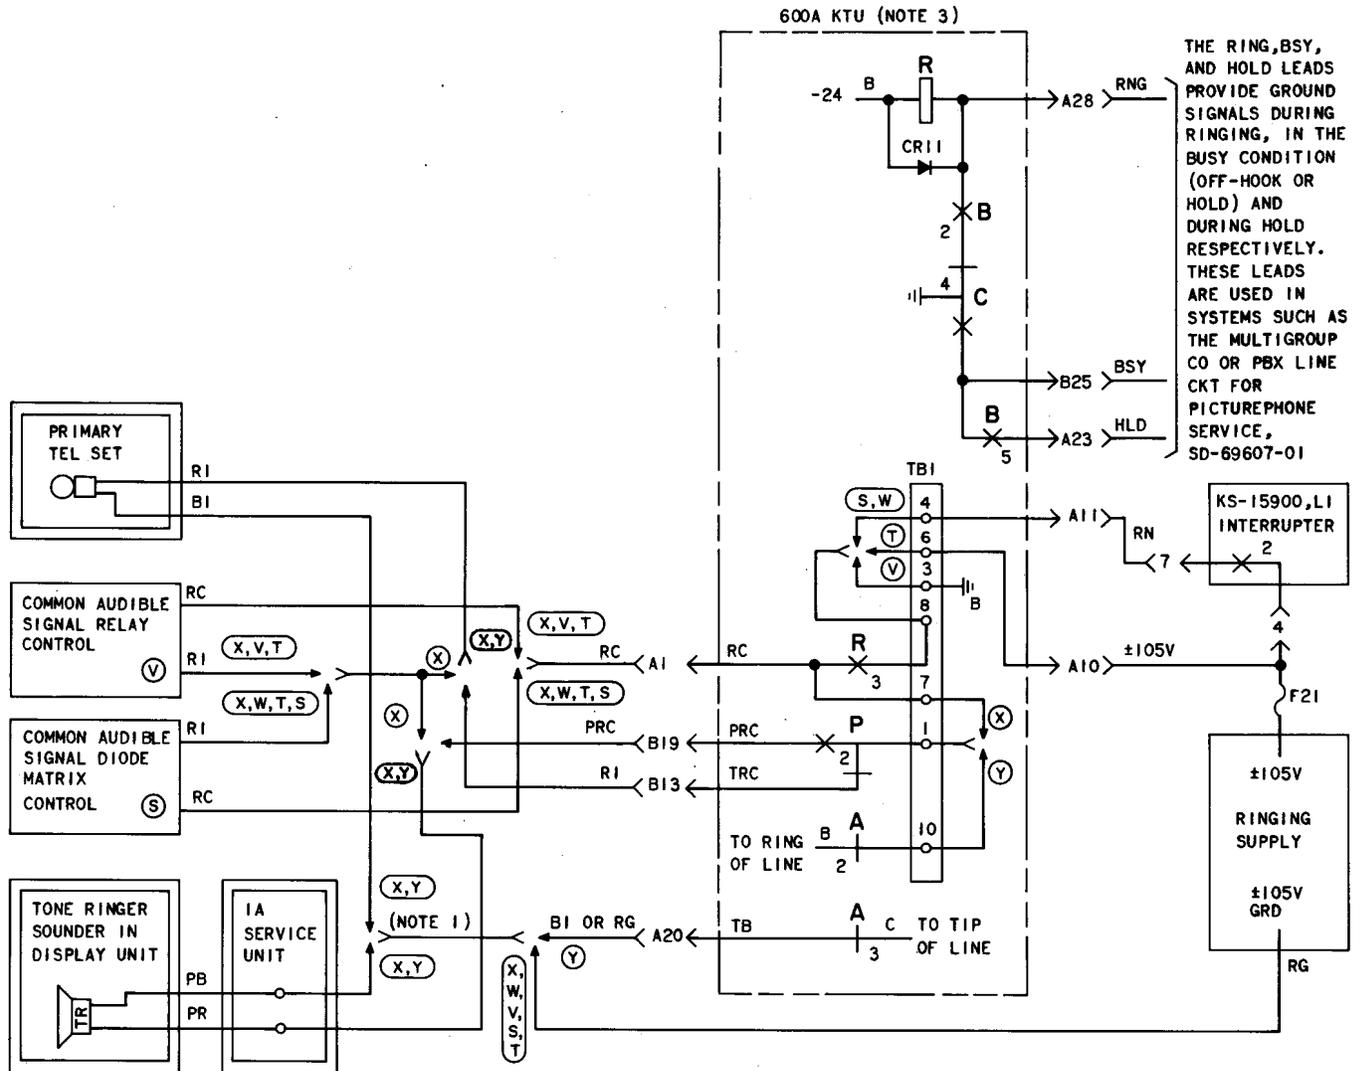
1. OPTIONS X OR Y PROVIDE FOR LINE RINGING ON EITHER TONE RINGER OR TEL SET RINGER OR BOTH.
2. REFER TO APPROPRIATE CONNECTION SECTION FOR OPTION STRAPPING TERMINAL ASSIGNMENTS ON CONNECTING BLOCK.
3. AUDIBLE SIGNAL OPTION STRAPS ON 600A KTU MUST BE PROVIDED BY INSTALLER.

AUDIBLE SIGNALING OPTIONS		
FEATURE OR OPTIONS		WIRING
LINE RINGING		Y
LOCAL RINGING		X
INTERRUPTED RINGING		W
COMMON AUDIBLE SIGNAL	RELAY CONTROL	V
	DIODE MATRIX CONTROL	S
STEADY RINGING		T

Fig. 3 - Single Group, Ringing Control

Fig. 3 — Ringing Control

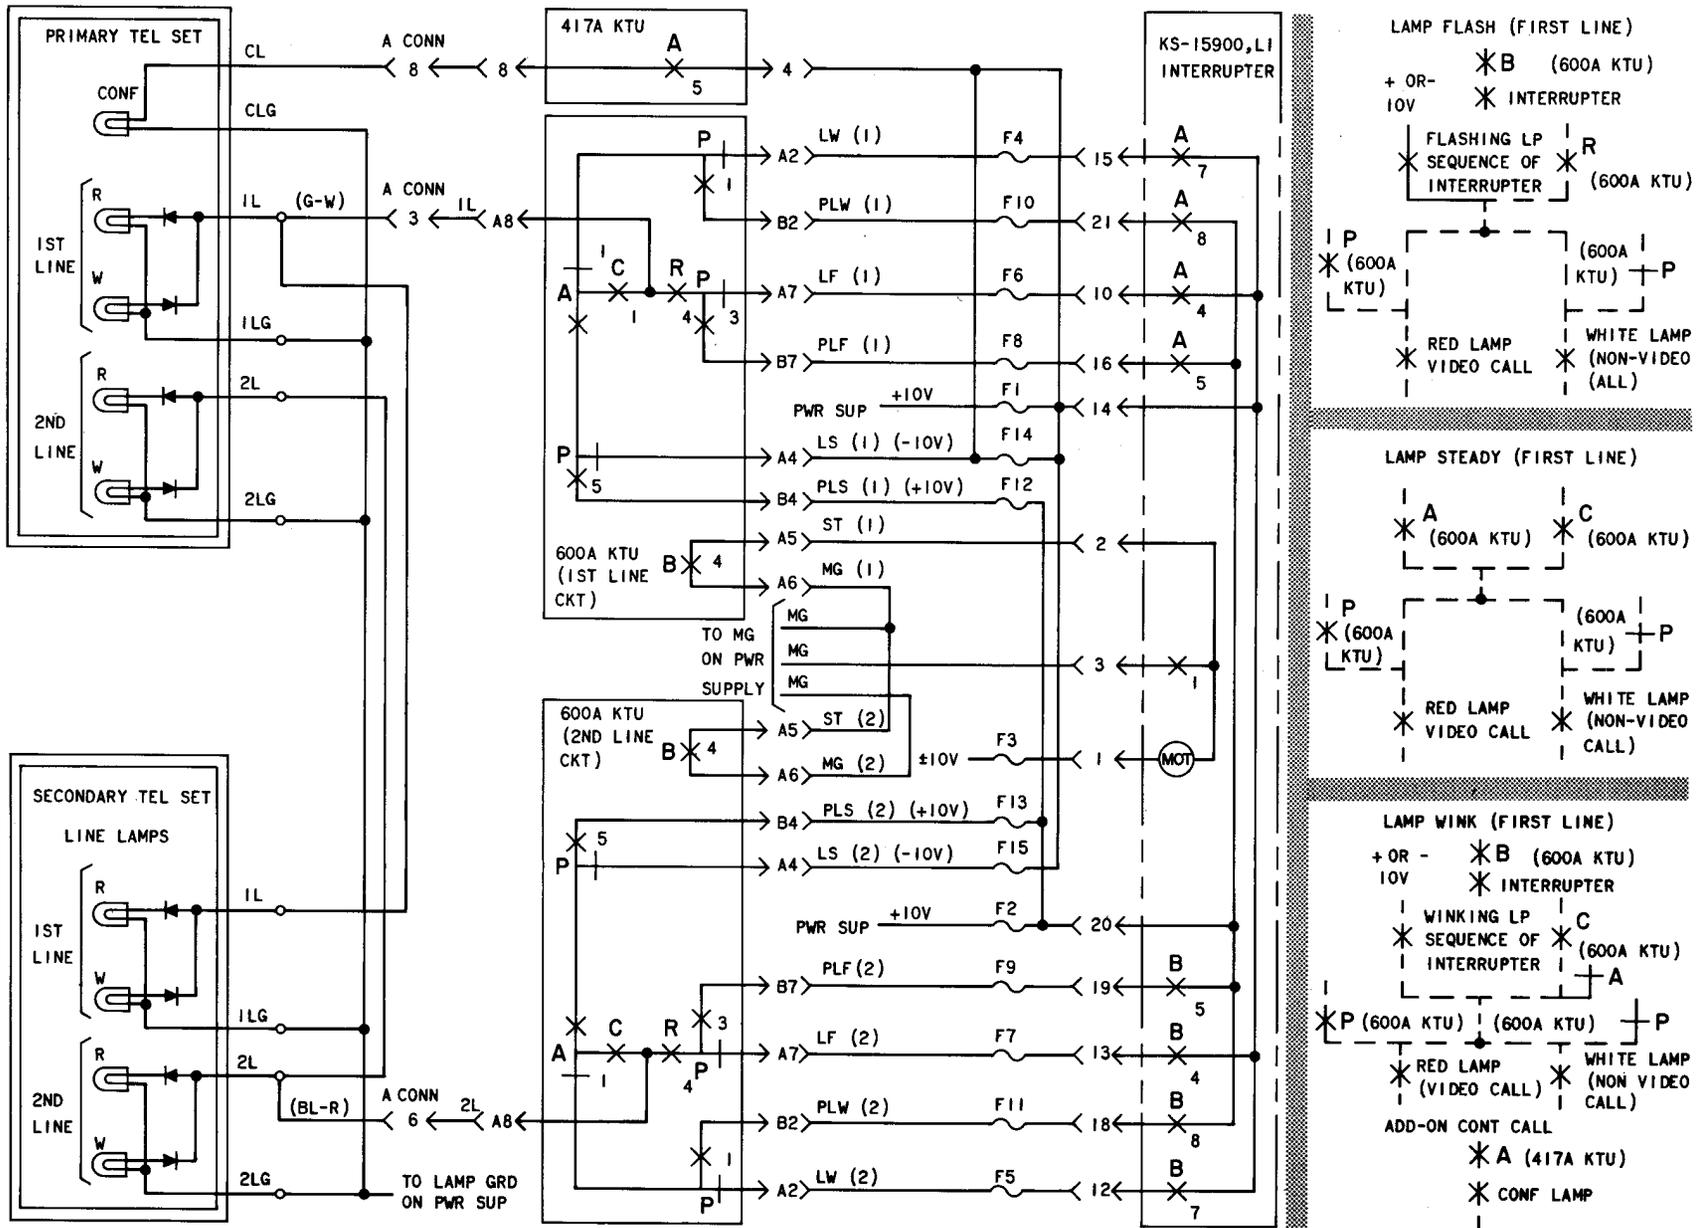
Fig. 4 - Single Group, Lamp Control

Fig. 4 — Lamp Control

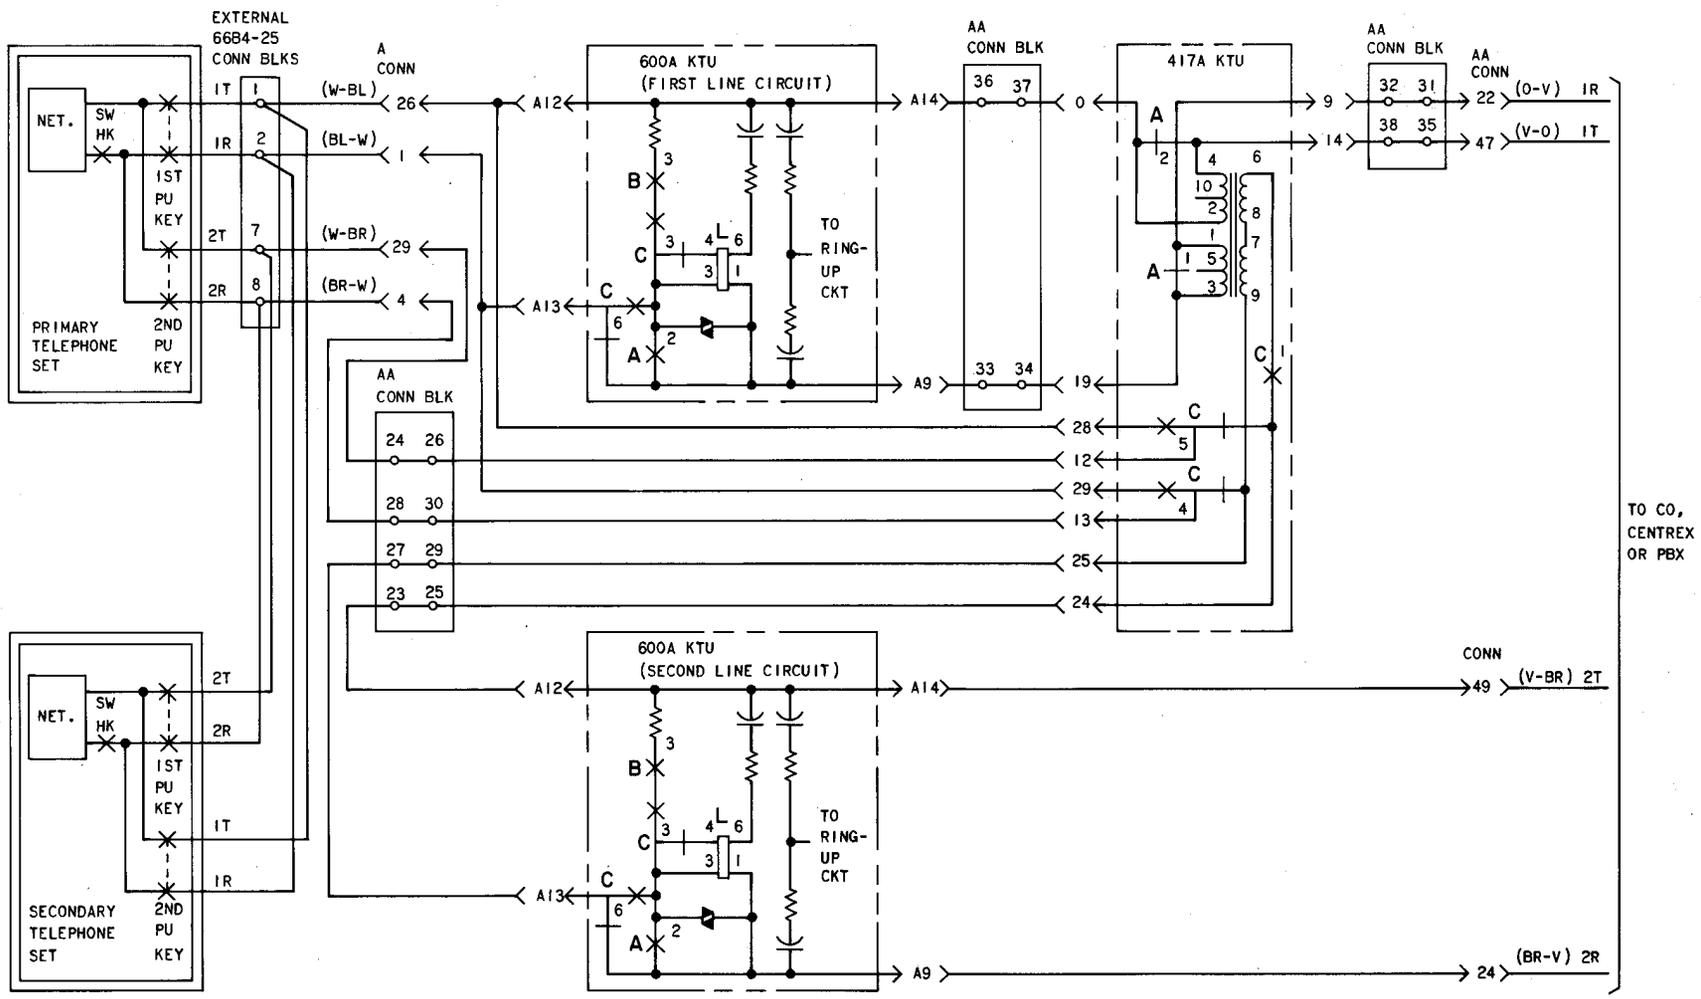
Fig. 5 — Single Group, Audio Transmission Path (With Add-on-Conference)

Fig. 5 — Audio Transmission Path (with Add-On Conference)

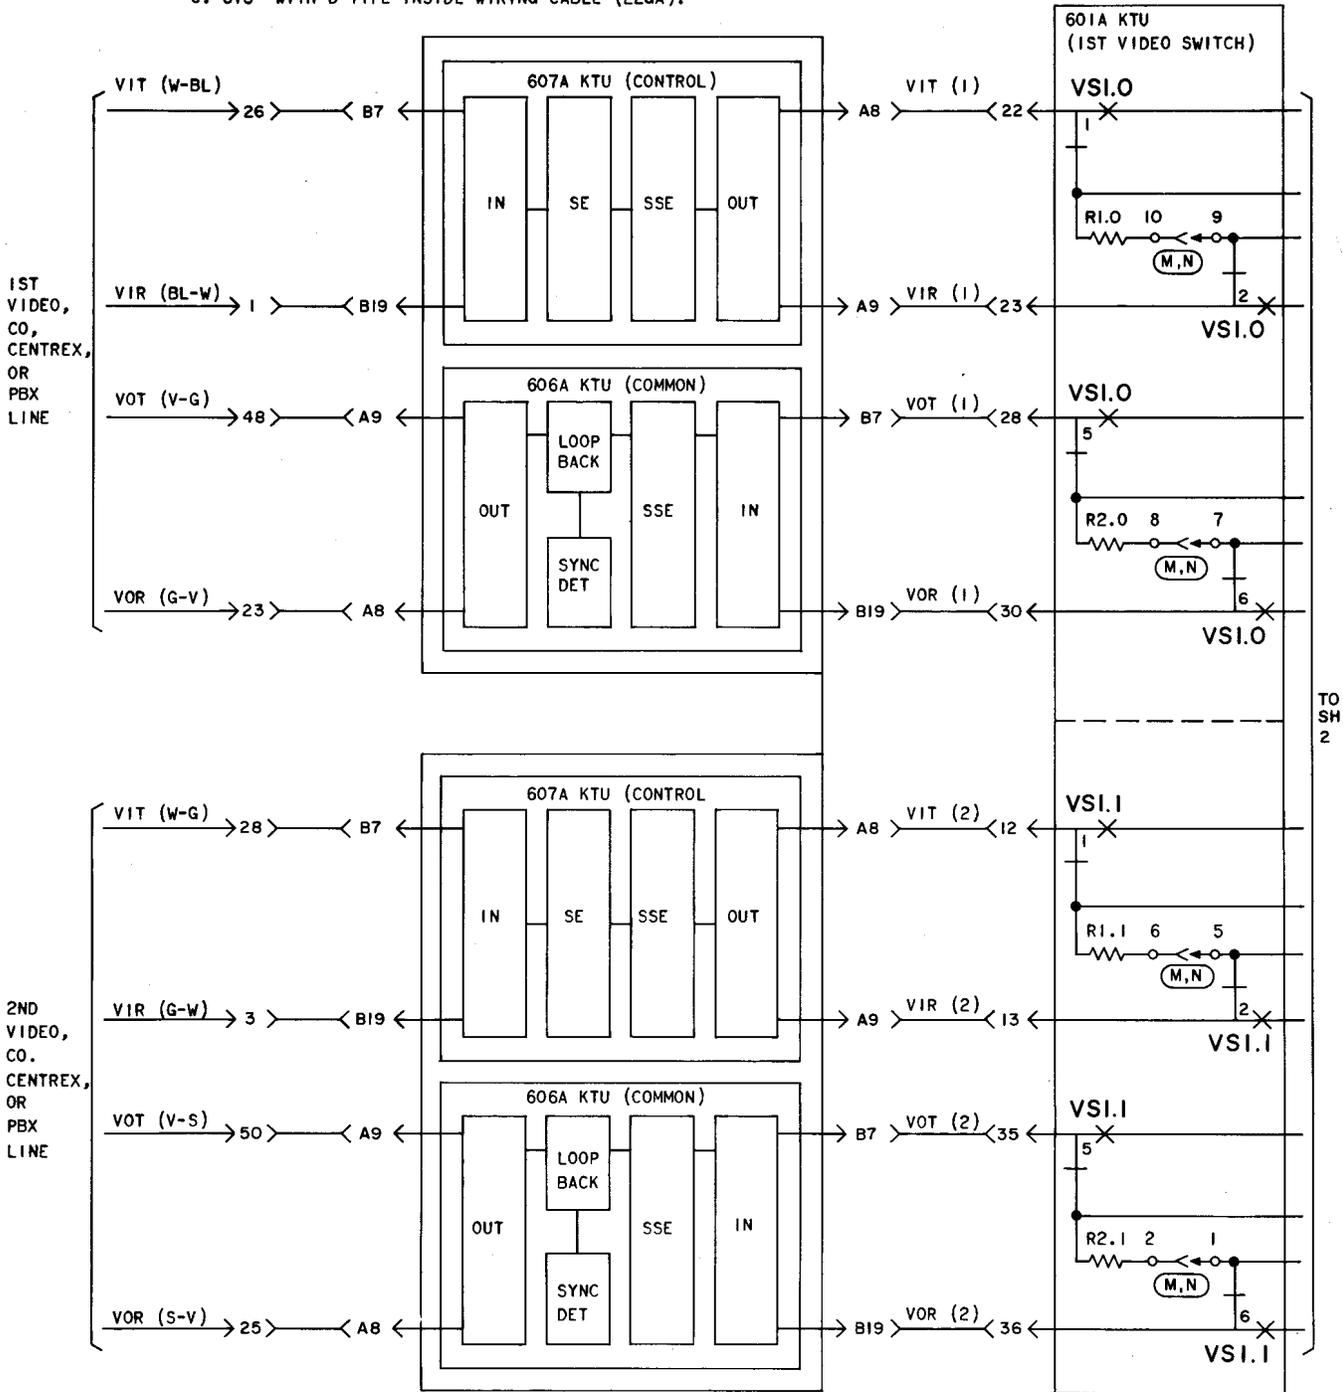
- (N) SINGLE STATION
- (M) LOWEST PRIORITY MULTIPLE STATION

Fig. 6 - Single Group, Video Transmission Path (Sheet 1)

Fig. 6 — Video Transmission Path

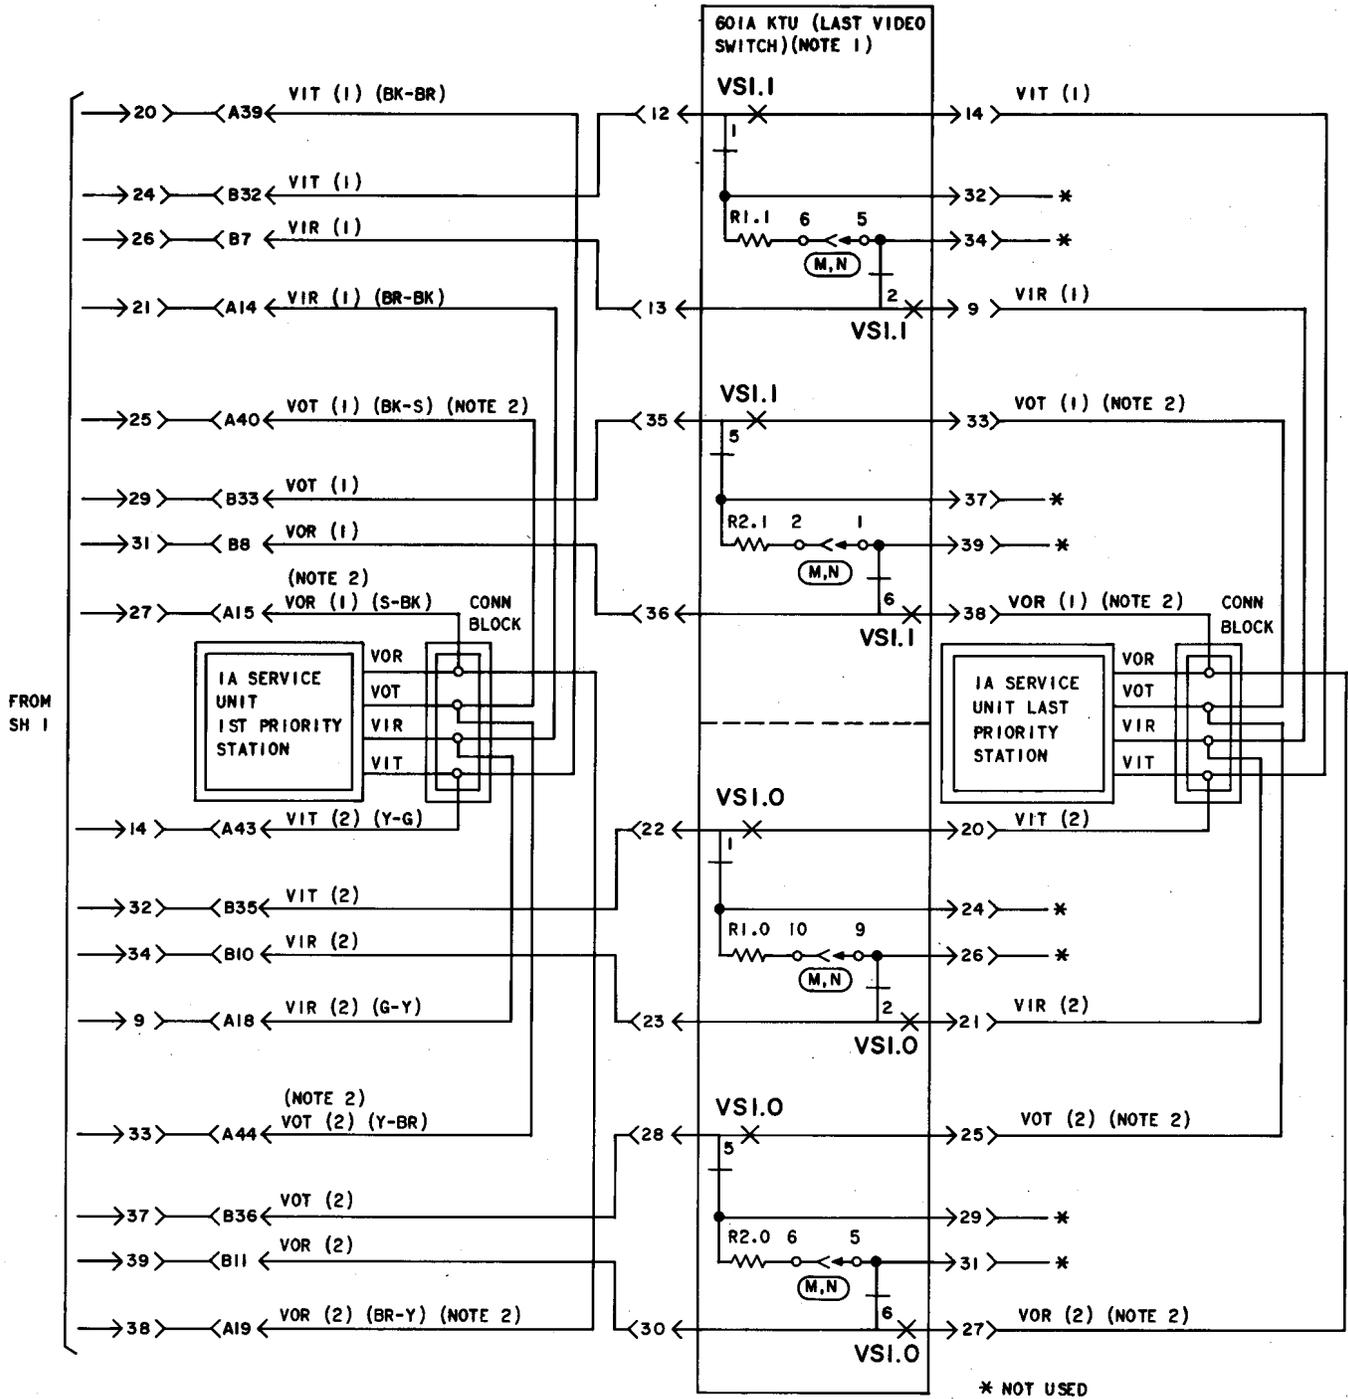
Fig. 6 - Single Group, Video Transmission Path (Sheet 2)

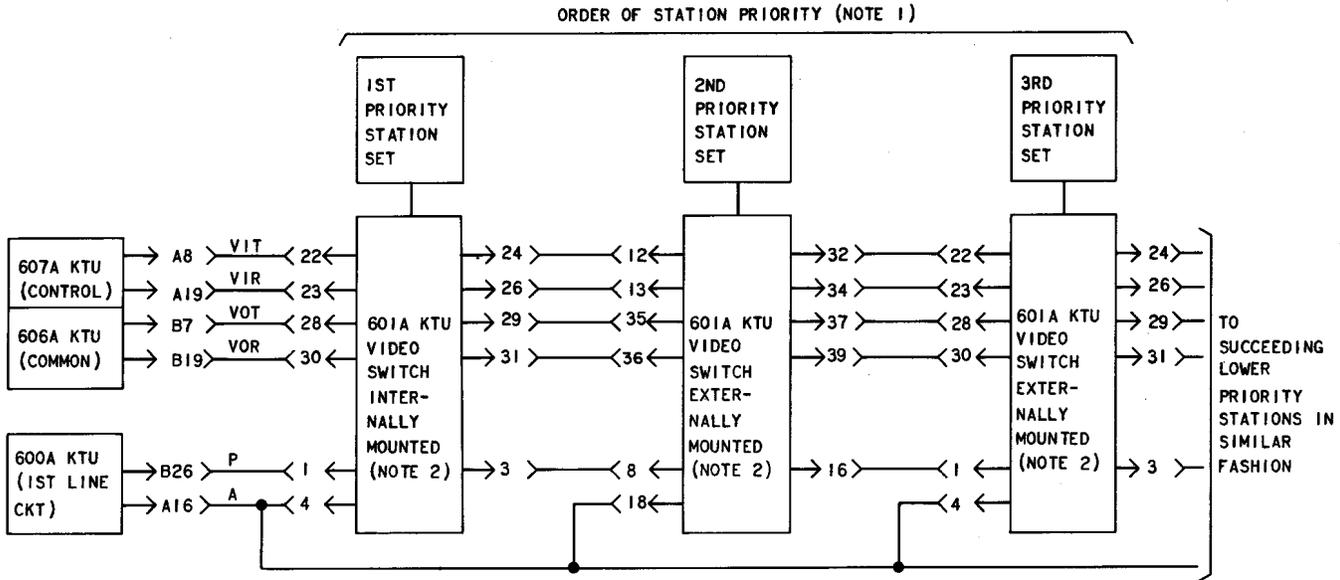
1. THE CASCADING OF VIDEO SWITCH CIRCUITS TO PROVIDE MULTI-STATION ACCESS UTILIZES A SEPARATE VIDEO SWITCH PER PICTUREPHONE STATION. THIS BLOCK DIAGRAM INDICATES THE WIRING ARRANGEMENT OF THE VIDEO TRANSMISSION PATHS ON A PRIORITY BASIS.
2. REFER TO FIG. 6 FOR SIMPLIFIED SCHEMATIC OF THE VIDEO TRANSMISSION PATH THROUGH THE VIDEO SWITCH.

Fig. 7 — Single Group, Connections to Provide Typical Station Priority

Fig. 7 — Connections to Provide Typical Station Priority

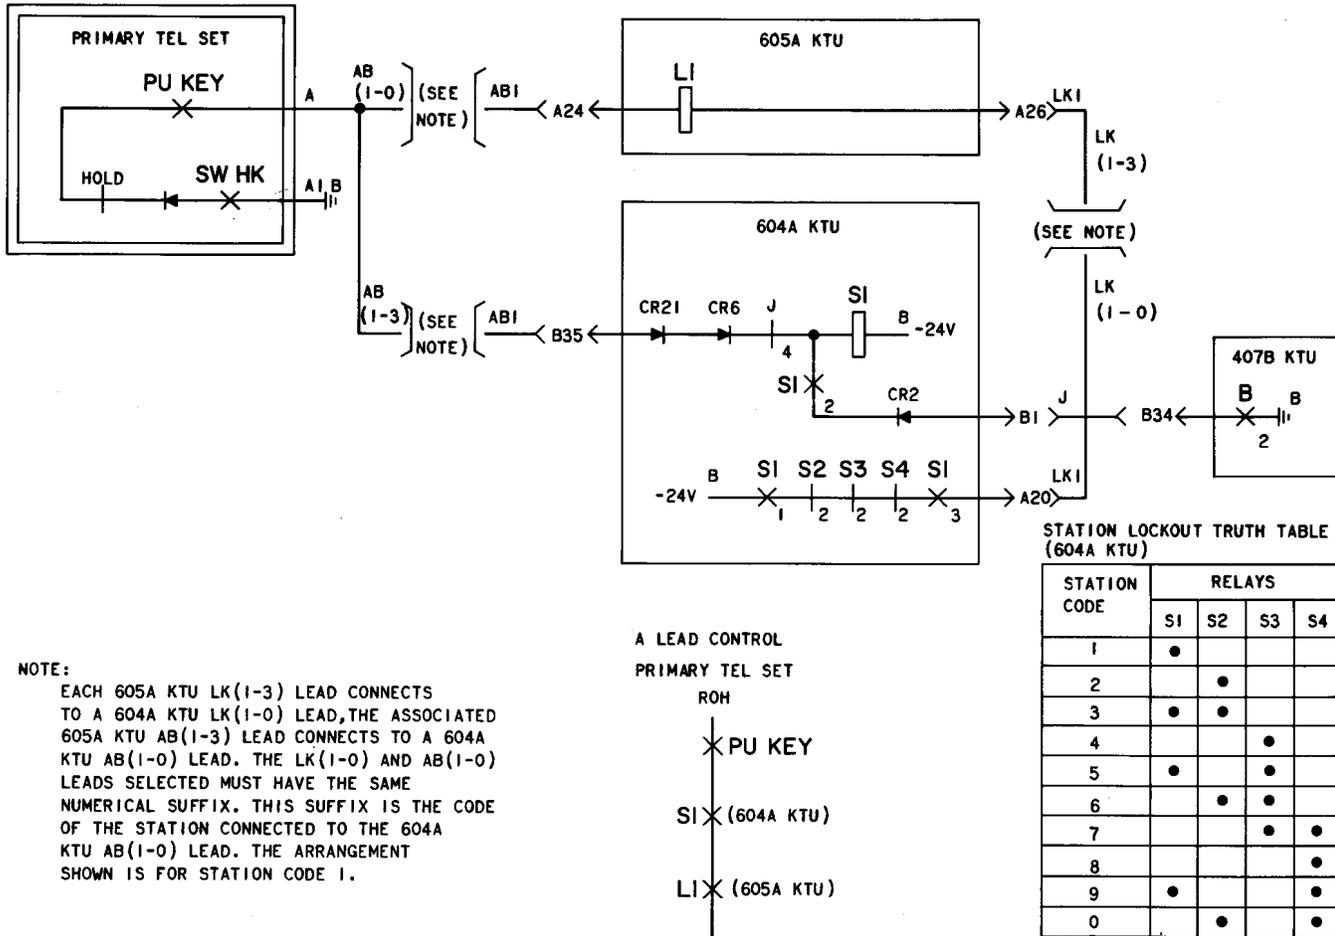
Fig. 9 — Single Link Intercom, A Lead Control (Primary Station)

**2.10** The four lamp observations made in 2.08 and 2.09 should be used in conjunction with Table D and the appropriate functional circuits (Figs. 9 through 25) provided in this section, to analyze probable causes of trouble. The suggested corrective action should then be followed when applicable. For instance, if the letter-number combinations recorded were A4, B4, C1 and D1, Table D indicates:

Fig. 9 — A Lead Control (Primary Station)

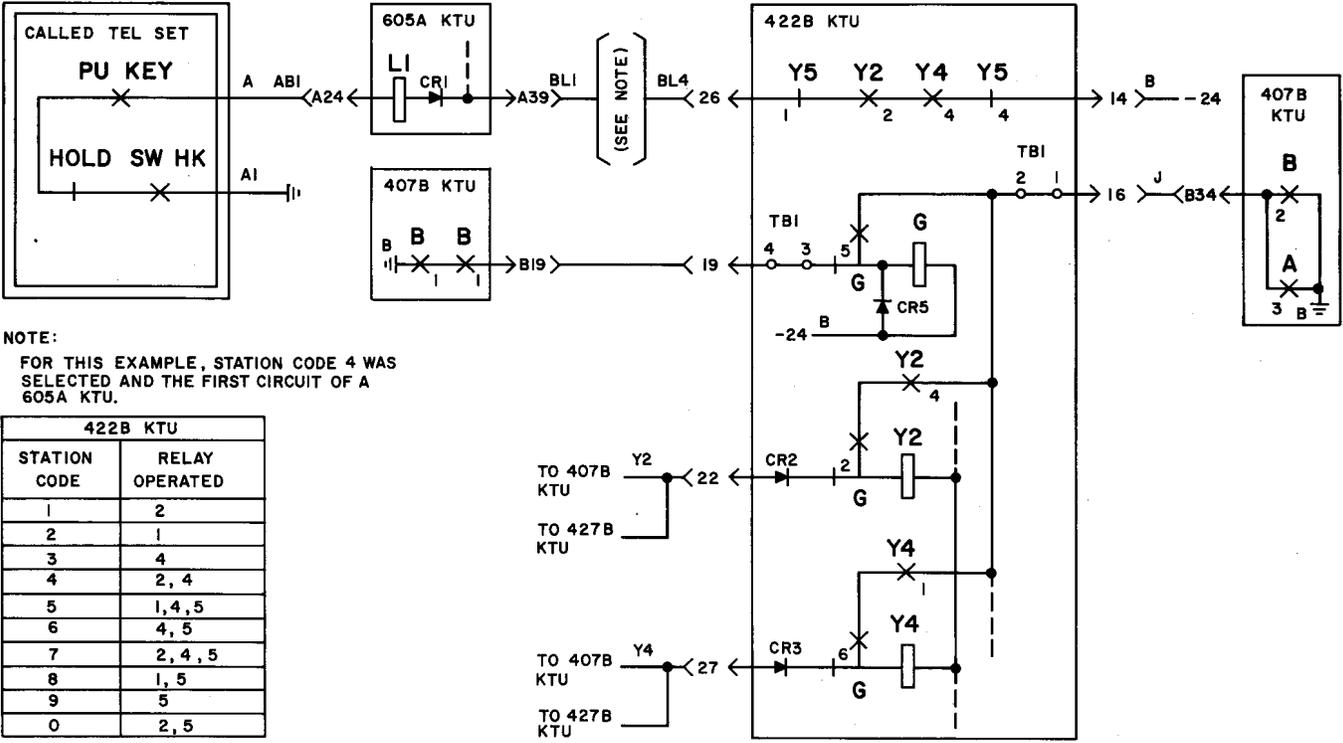
Fig. 10 – Single Link Intercom, Called Station Link Enable Circuit

Fig. 10 — Called Station Link Enable Circuit

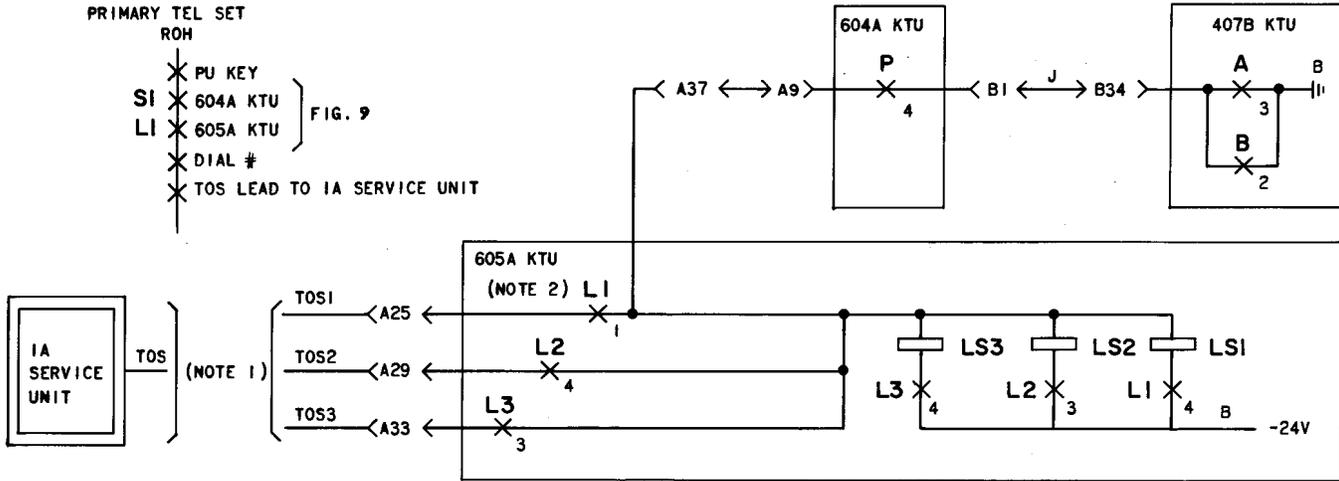
1. THE 605A KTU CONSISTS OF 3 IDENTICAL CIRCUITS. THE CIRCUITS SELECTED FOR CONNECTION TO A STATION SHOULD BE USED ONLY WITH THAT PARTICULAR STATION. THE 605A KTU TOS (1-3) LEAD MUST HAVE THE SAME NUMERICAL SUFFIX AS THE LK (1-3) AND AB (1-3) LEADS SELECTED FOR USE WITH THIS STATION.
2. SEE FIGURE ENTITLED "A LEAD CONTROL CIRCUIT FOR OPERATE PATH OF L(1-3) RELAYS.

Fig. 11 — Single Link Intercom, Turn-on Set (TOS)

Fig. 11 — Turn-On-Set (TOS)

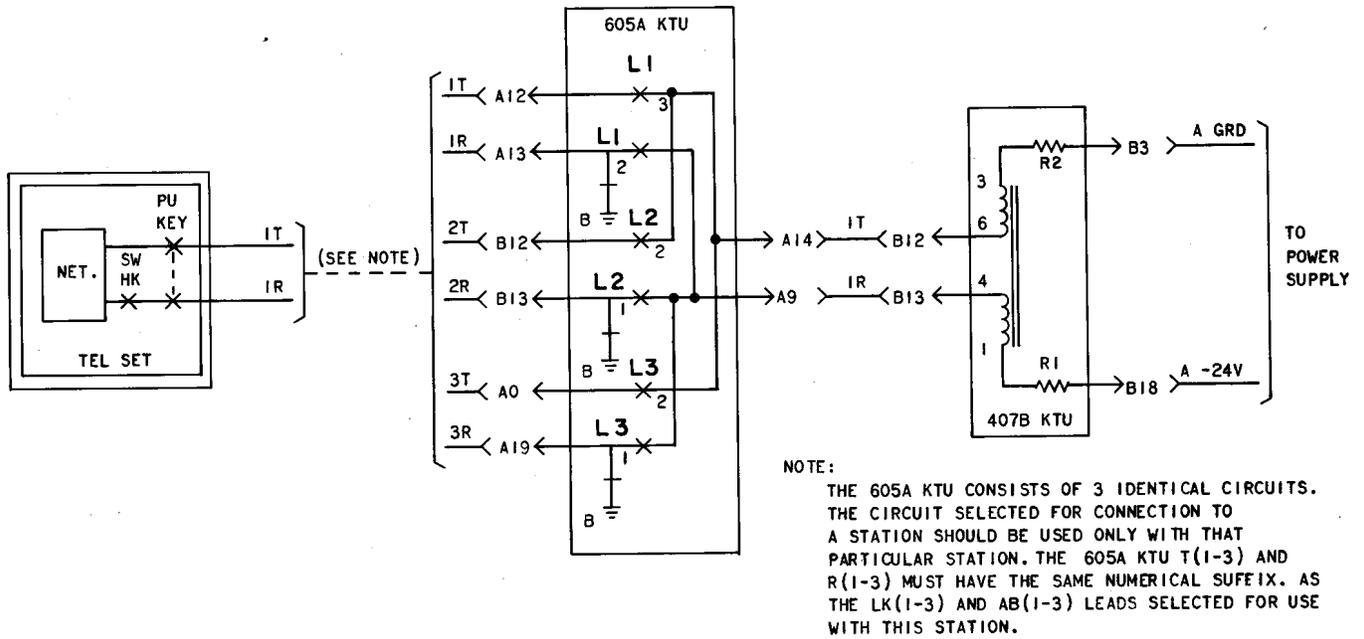
Fig. 12 — Single Link Intercom, Audio Transmission Path

Fig. 12 — Audio Transmission Path

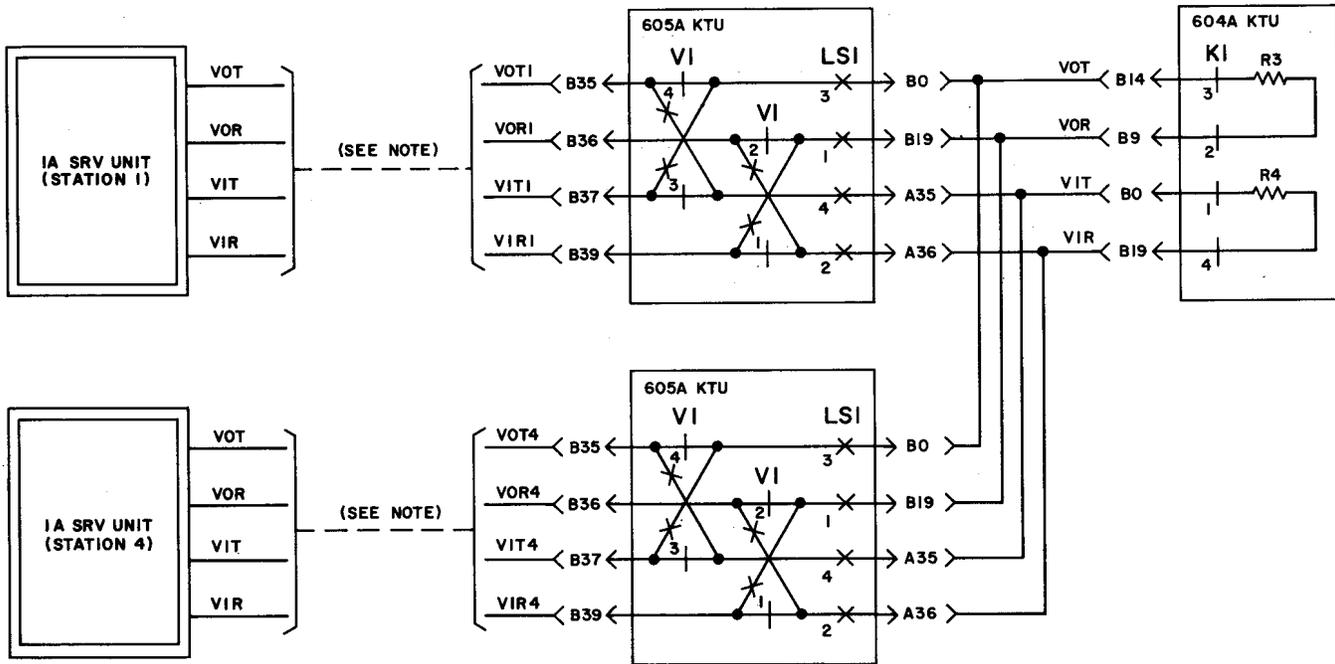
**NOTE:**  
 THE 605A KTU CONSISTS OF 3 IDENTICAL CIRCUITS. THE CIRCUIT SELECTED FOR CONNECTION TO A STATION SHOULD BE USED ONLY WITH THAT PARTICULAR STATION. THE 605A KTU VOT(1-3), VOR(1-3), VIT(1-3) AND VIR(1-3) LEADS MUST HAVE THE SAME NUMERICAL SUFFIX AS THE LK(1-3) AND AB(1-3) LEADS SELECTED FOR USE WITH THIS STATION. IN THIS EXAMPLE, THE 1ST CIRCUIT IN TWO DIFFERENT 605A KTU'S WAS SELECTED.

**Fig. 13 – Single Link Intercom, Video Transmission Path**

Fig. 13 — Video Transmission Path

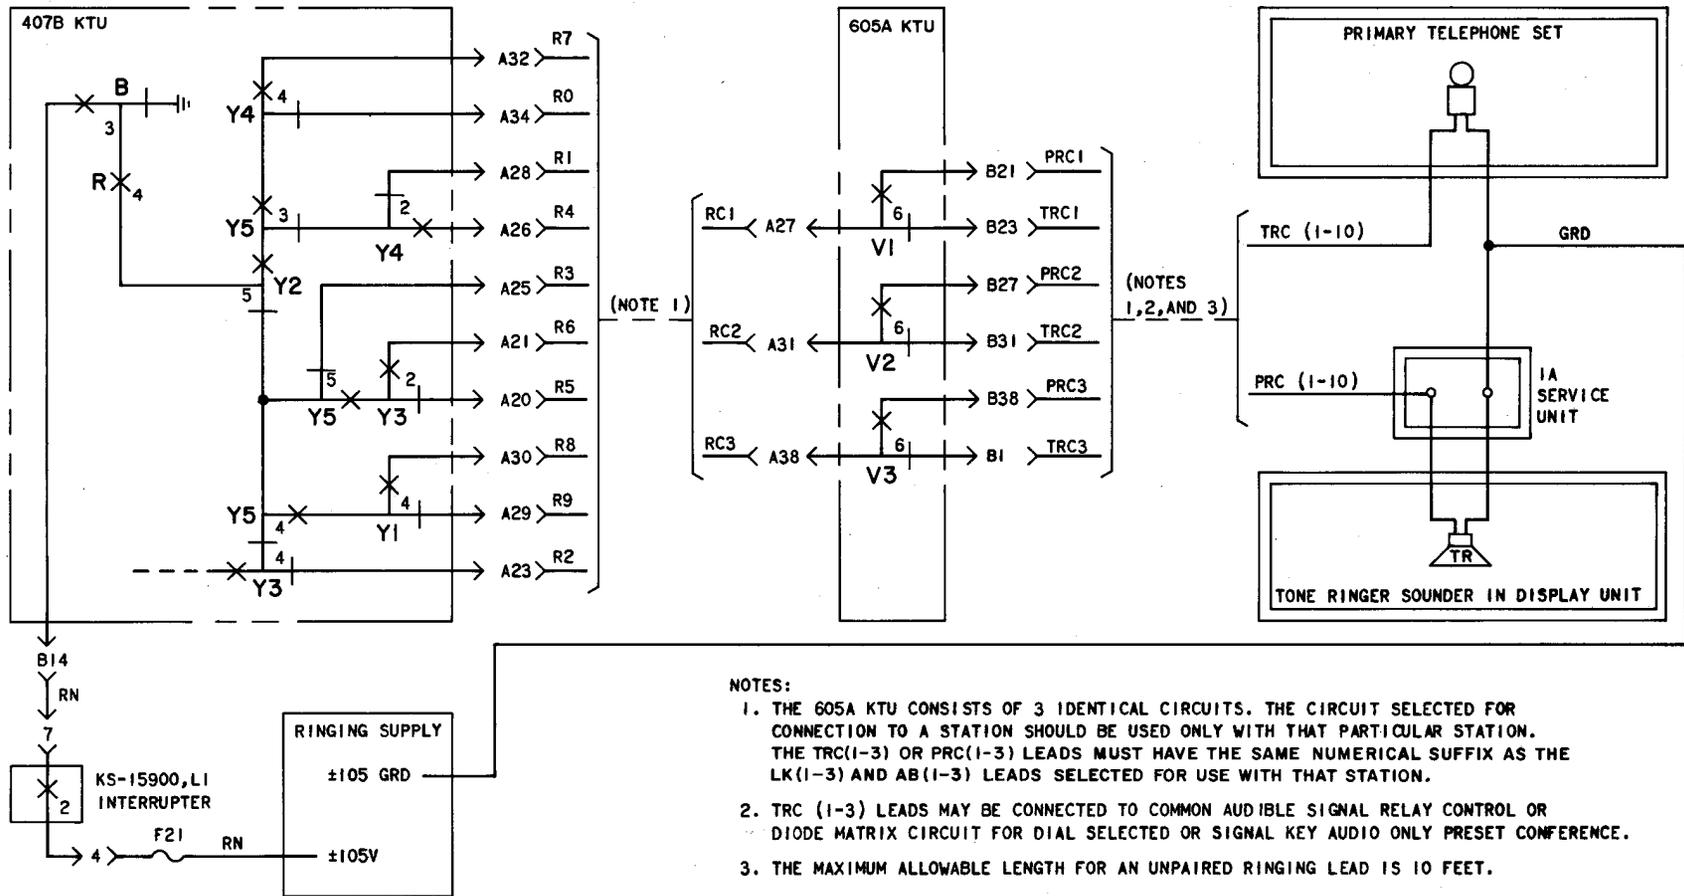
Fig. 14 — Single Link Intercom, Ringing Control

Fig. 14 — Ringing Control

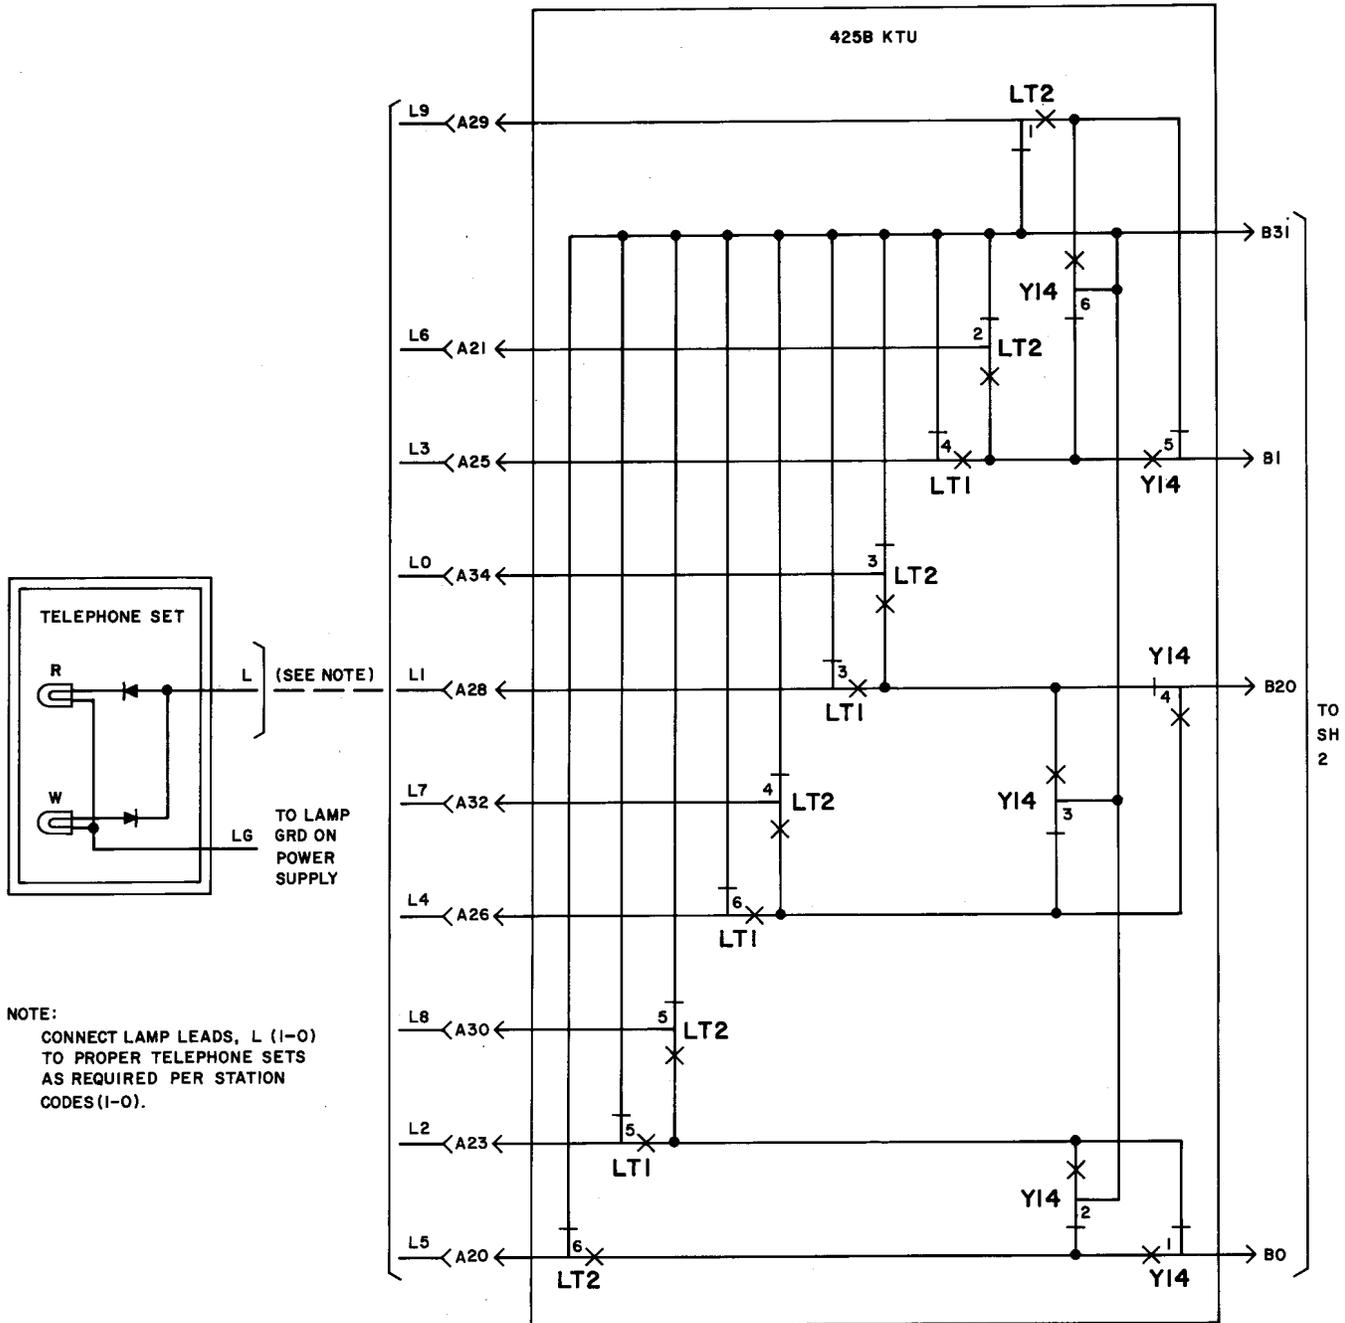
NOTE:  
CONNECT LAMP LEADS, L (1-0)  
TO PROPER TELEPHONE SETS  
AS REQUIRED PER STATION  
CODES (1-0).

Fig. 15 - Single Link Intercom, Lamp Control (Sheet 1)

Fig. 15 — Lamp Control
