## 1P2 KEY TELEPHONE SYSTEM

### TESTS AND MAINTENANCE

**1.01** This section provides tests and maintenance information in the form of Trouble Locating Tables and functional schematics for the following 1P2 Key Telephone System arrangements:

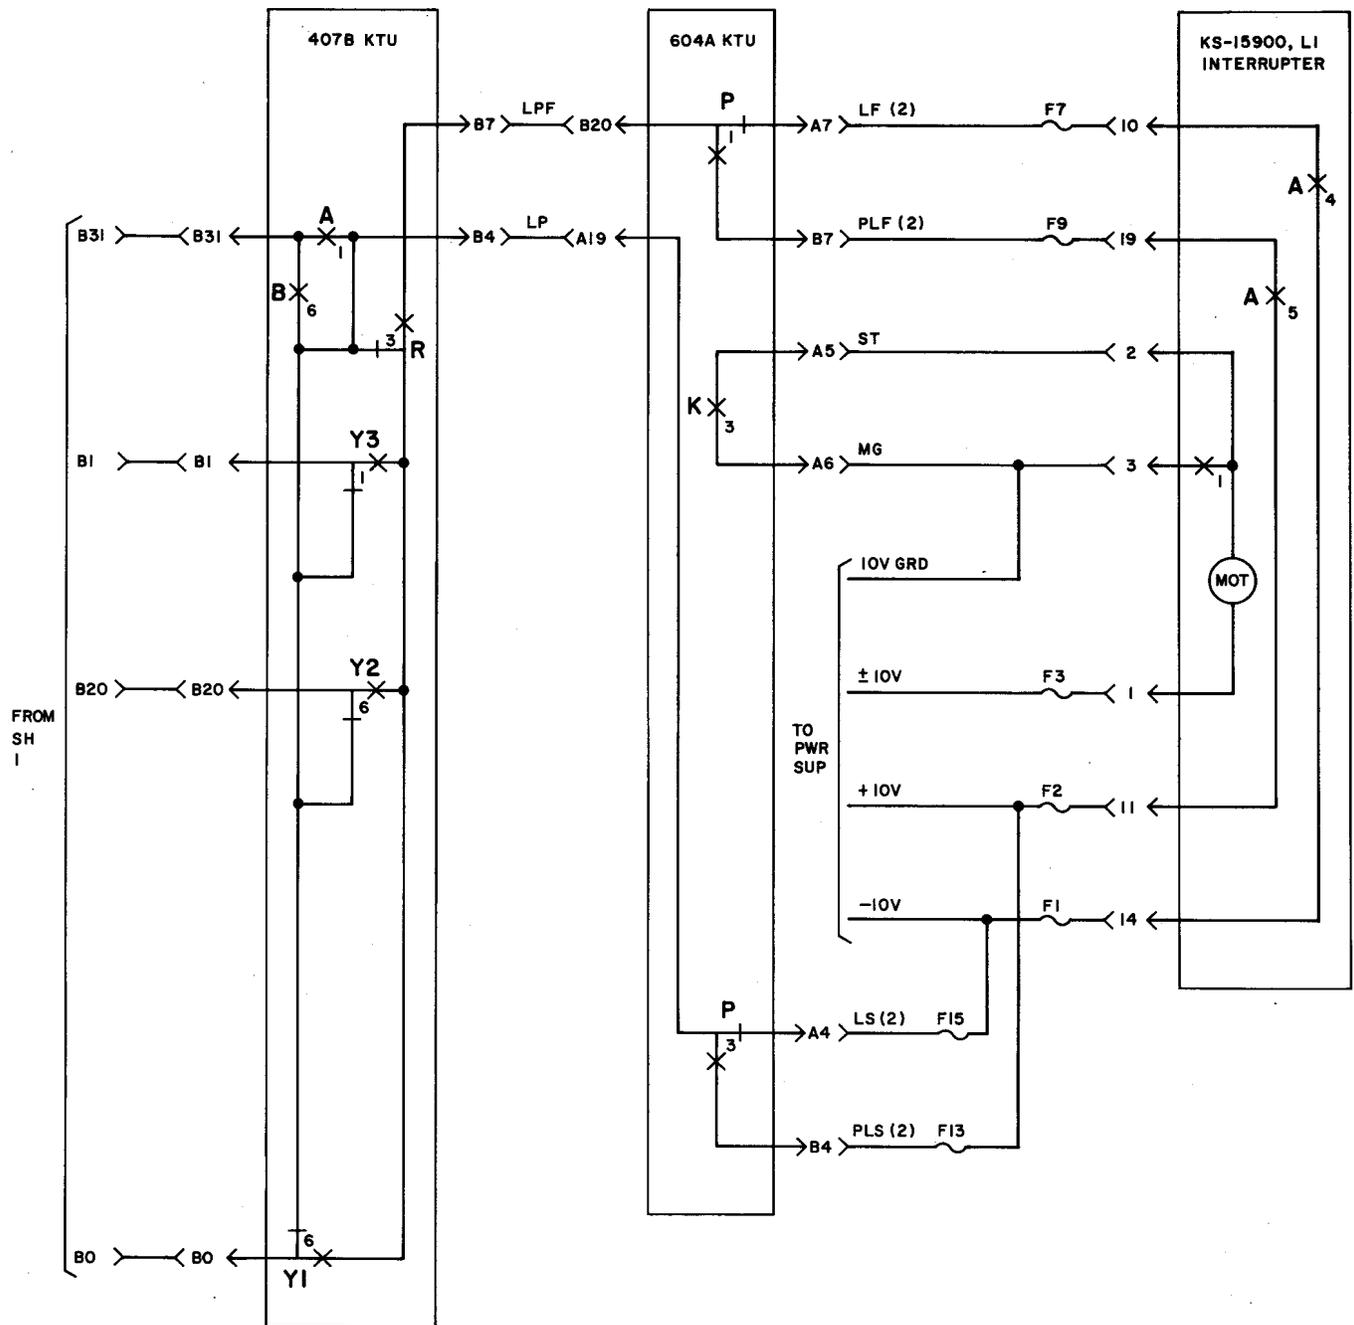
Fig. 15 — Single Link Intercom, Lamp Control (Sheet 2)

Fig. 15 — Lamp Control

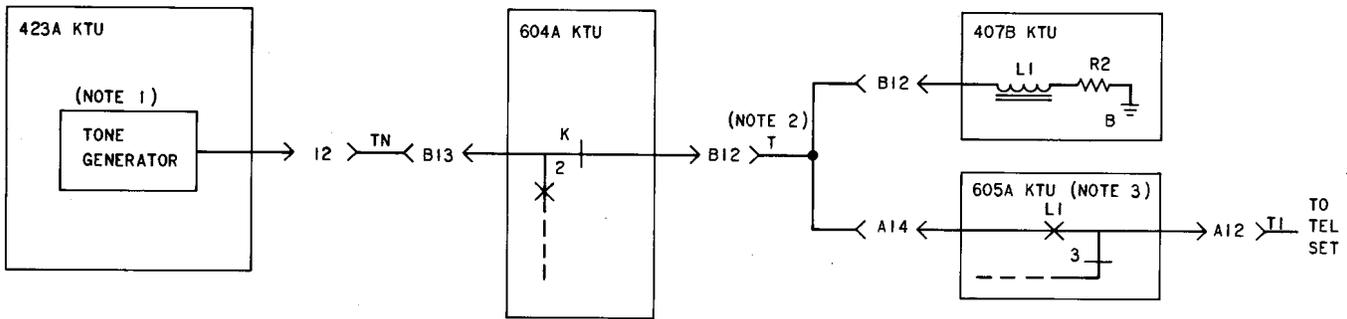
1. TONE GENERATOR IS ACTIVATED BY GROUND ON THE J LEAD FROM THE 407B KTU.
2. DIAL TONE IS APPLIED TO TIP SIDE OF LINE.
3. THE FIRST CIRCUIT OF A 605A KTU HAS BEEN SELECTED AS AN EXAMPLE.

Fig. 16 — Single Link Intercom, Dial Tone

Fig. 16 — Dial Tone

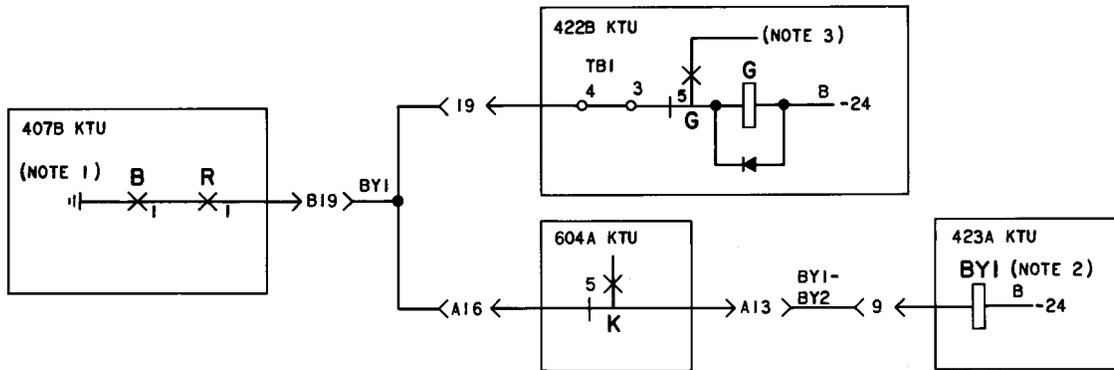
1. AT THIS POINT DIALING HAS JUST BEEN COMPLETED.
2. OPERATION OF BY1 RELAY (423A KTU) SETS TONE GENERATOR FOR AUDIBLE RINGBACK WHICH IS COUPLED TO THE TIP SIDE OF THE CALLING STATION LINE AS SHOWN IN FIG.14, DIAL TONE CIRCUIT.
3. OPERATION OF RELAY G COMPLETES THE LOCKUP PATH TO "J" GROUND FOR OPERATED Y RELAYS (422B KTU) AND THE G RELAY UNTIL ALL STATIONS DISCONNECT.

Fig. 17 — Single Link Intercom, Audible Ringback

Fig. 17 — Audible Ringback

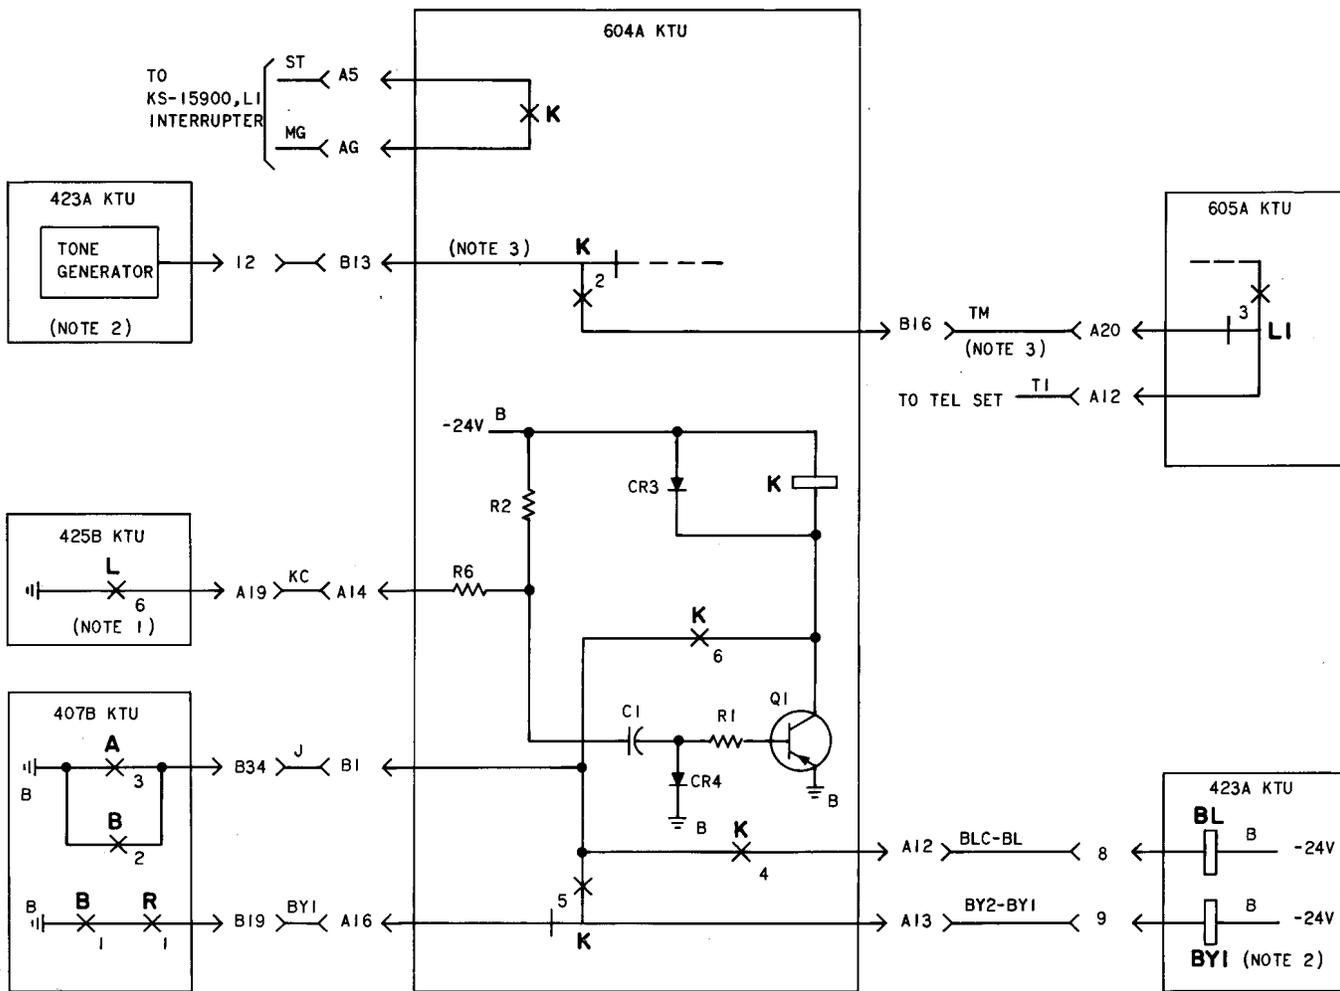
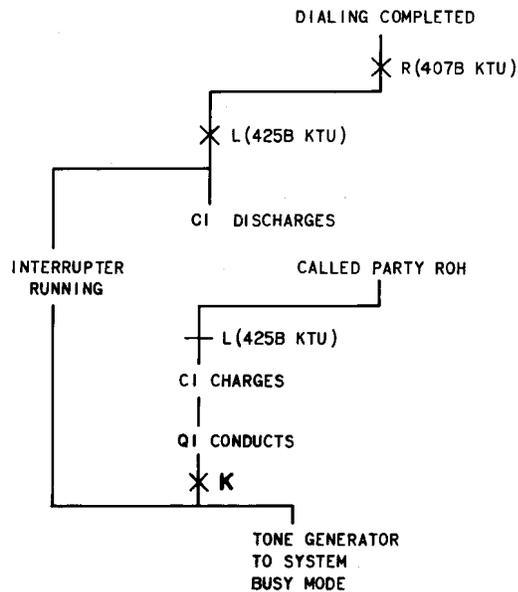
1. RELAY L WHICH OPERATES AT THE COMPLETION OF DIALING RELEASES UPON SECOND STATION DETECTION IN THE DSIC, OPENING THE DISCHARGE PATH FOR C1 CAPACITOR (604A KTU). TRANSISTOR Q1 TURNS ON MOMENTARILY OPERATING RELAY K WHICH LOCKS TO J GROUND.
2. OPERATED K RELAY SETS THE TONE GENERATOR TO THE BUSY TONE MODE BY HOLDING THE BY1 RELAY AND OPERATING THE BL RELAY (423A KTU).
3. OPERATED K RELAY COUPLES THE BUSY TONE SIGNAL TO THE MULTIPLIED TIP LEADS OF THE LOCKED OUT TELEPHONE SETS VIA THE TM LEAD AND INOPERATED L RELAYS (605A KTU).

Fig. 18 — Single Link Intercom, Busy Tone

Fig. 18 — Busy Tone

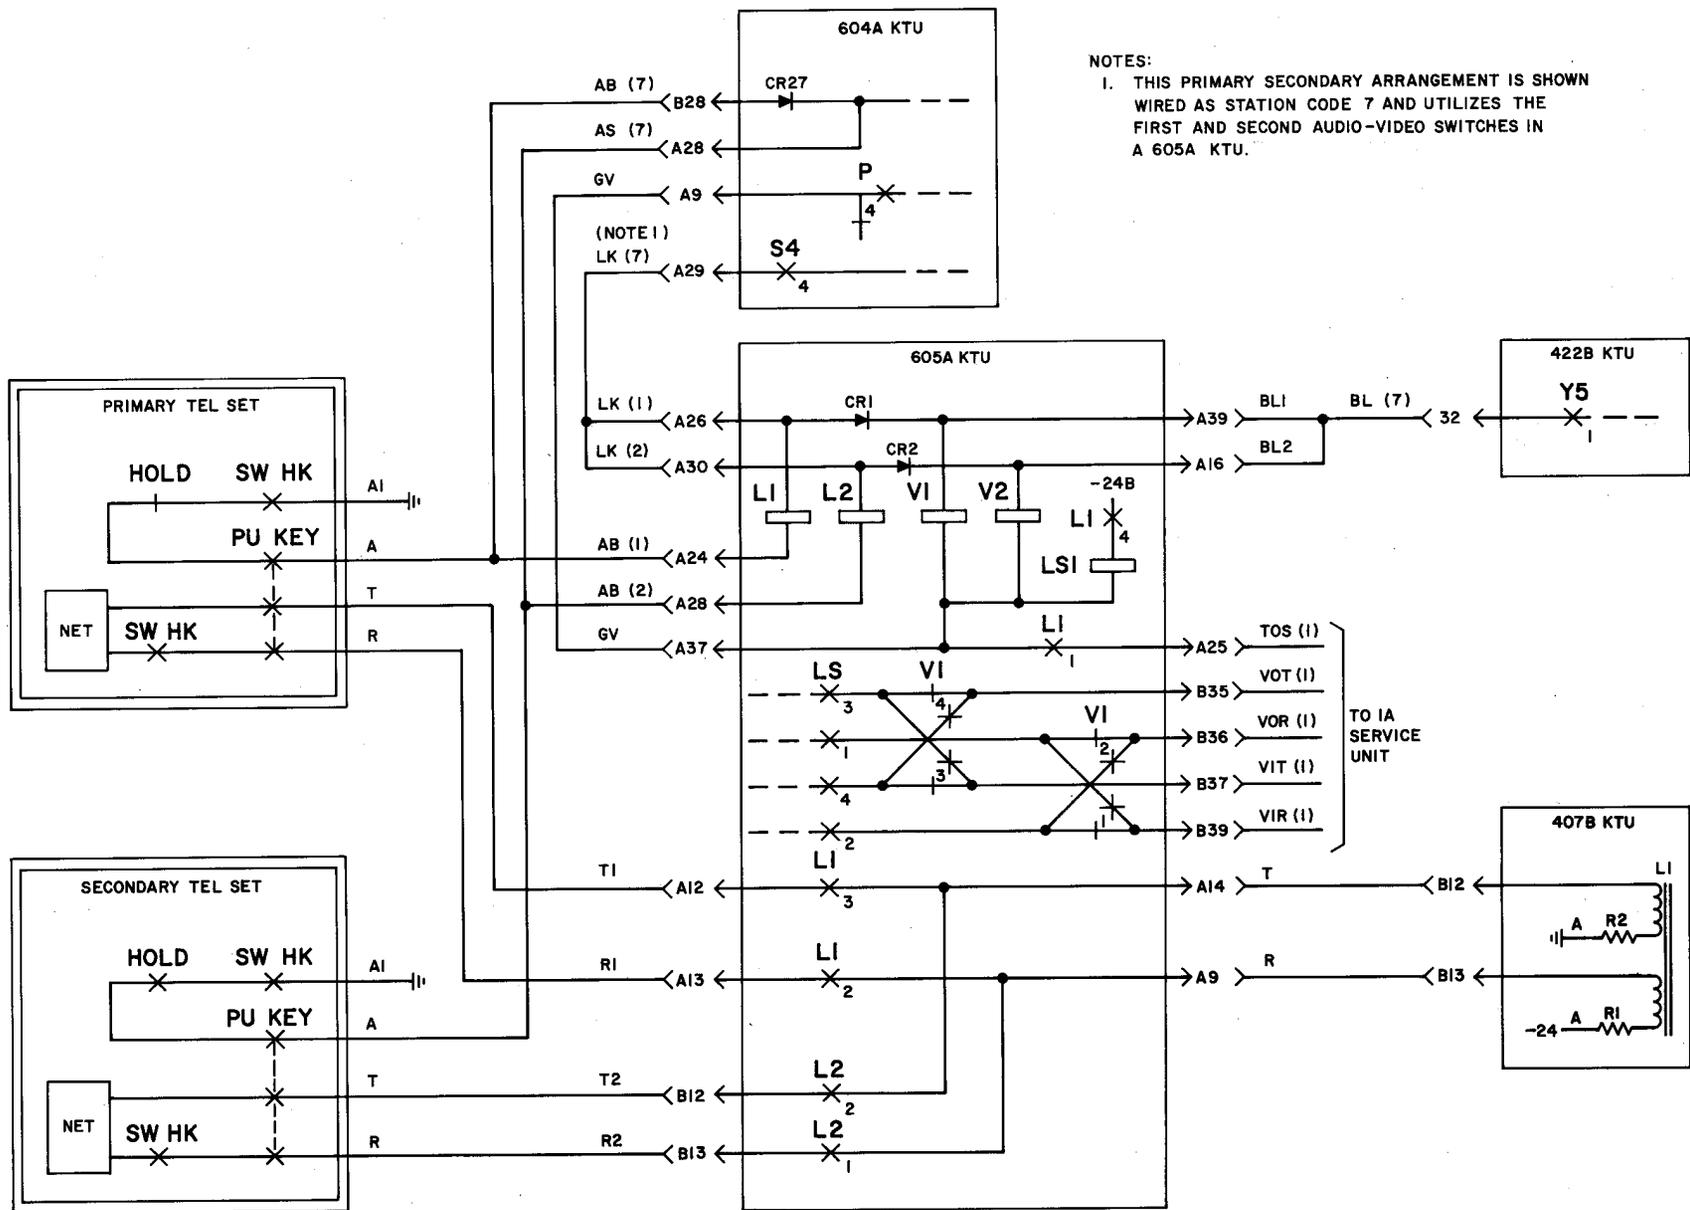
NOTES:  
 1. THIS PRIMARY SECONDARY ARRANGEMENT IS SHOWN WIRED AS STATION CODE 7 AND UTILIZES THE FIRST AND SECOND AUDIO-VIDEO SWITCHES IN A 605A KTU.

Fig. 19 - Single Link Intercom, Primary-Secondary Station Bridging

Fig. 19 — Primary-Secondary Station Bridging

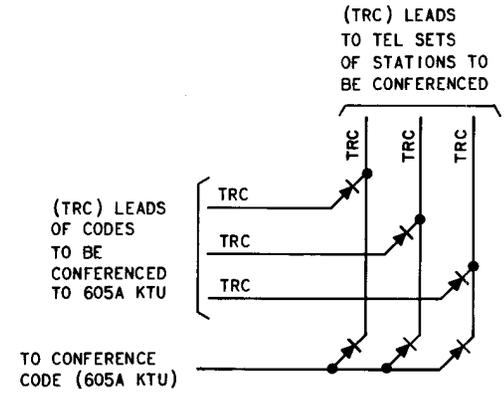
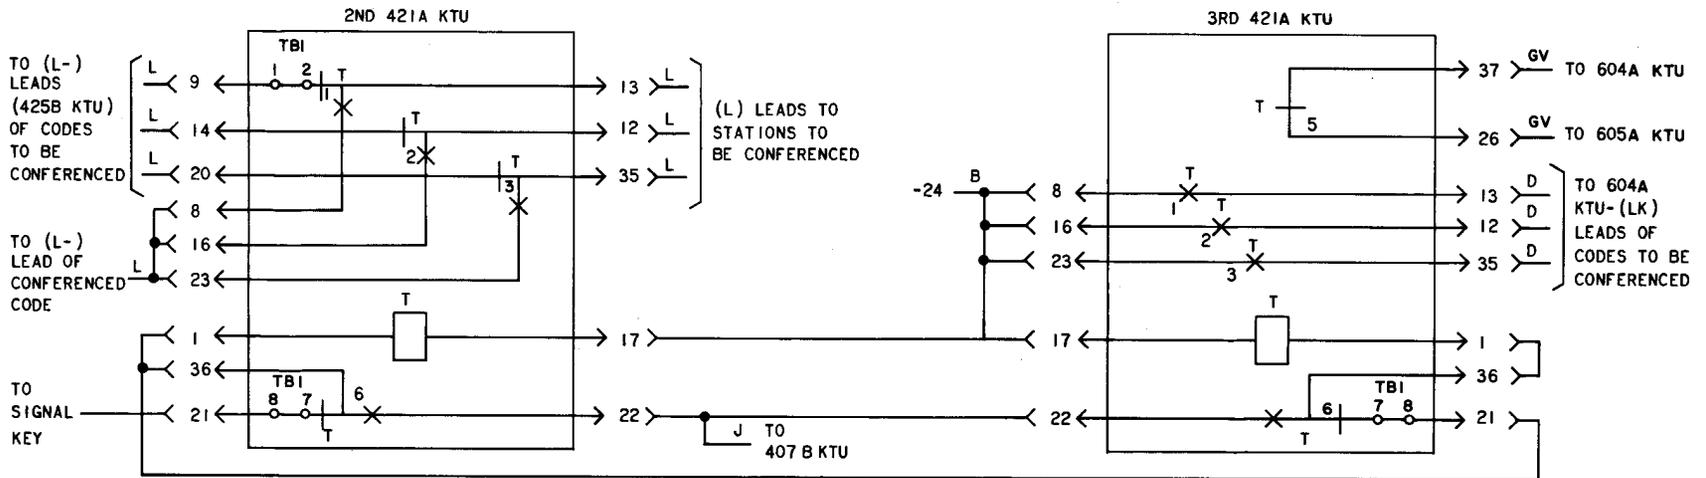
NOTE: THIS ARRANGEMENT REDUCES THE NUMBER OF STATION CODES AVAILABLE BY ONE PER CONFERENCE CODE.

Fig. 20 - Single Link Intercom, Signal Key Preset (Audio Only) Conference

Fig. 20 — Signal Key Preset (Audio Only) Conference

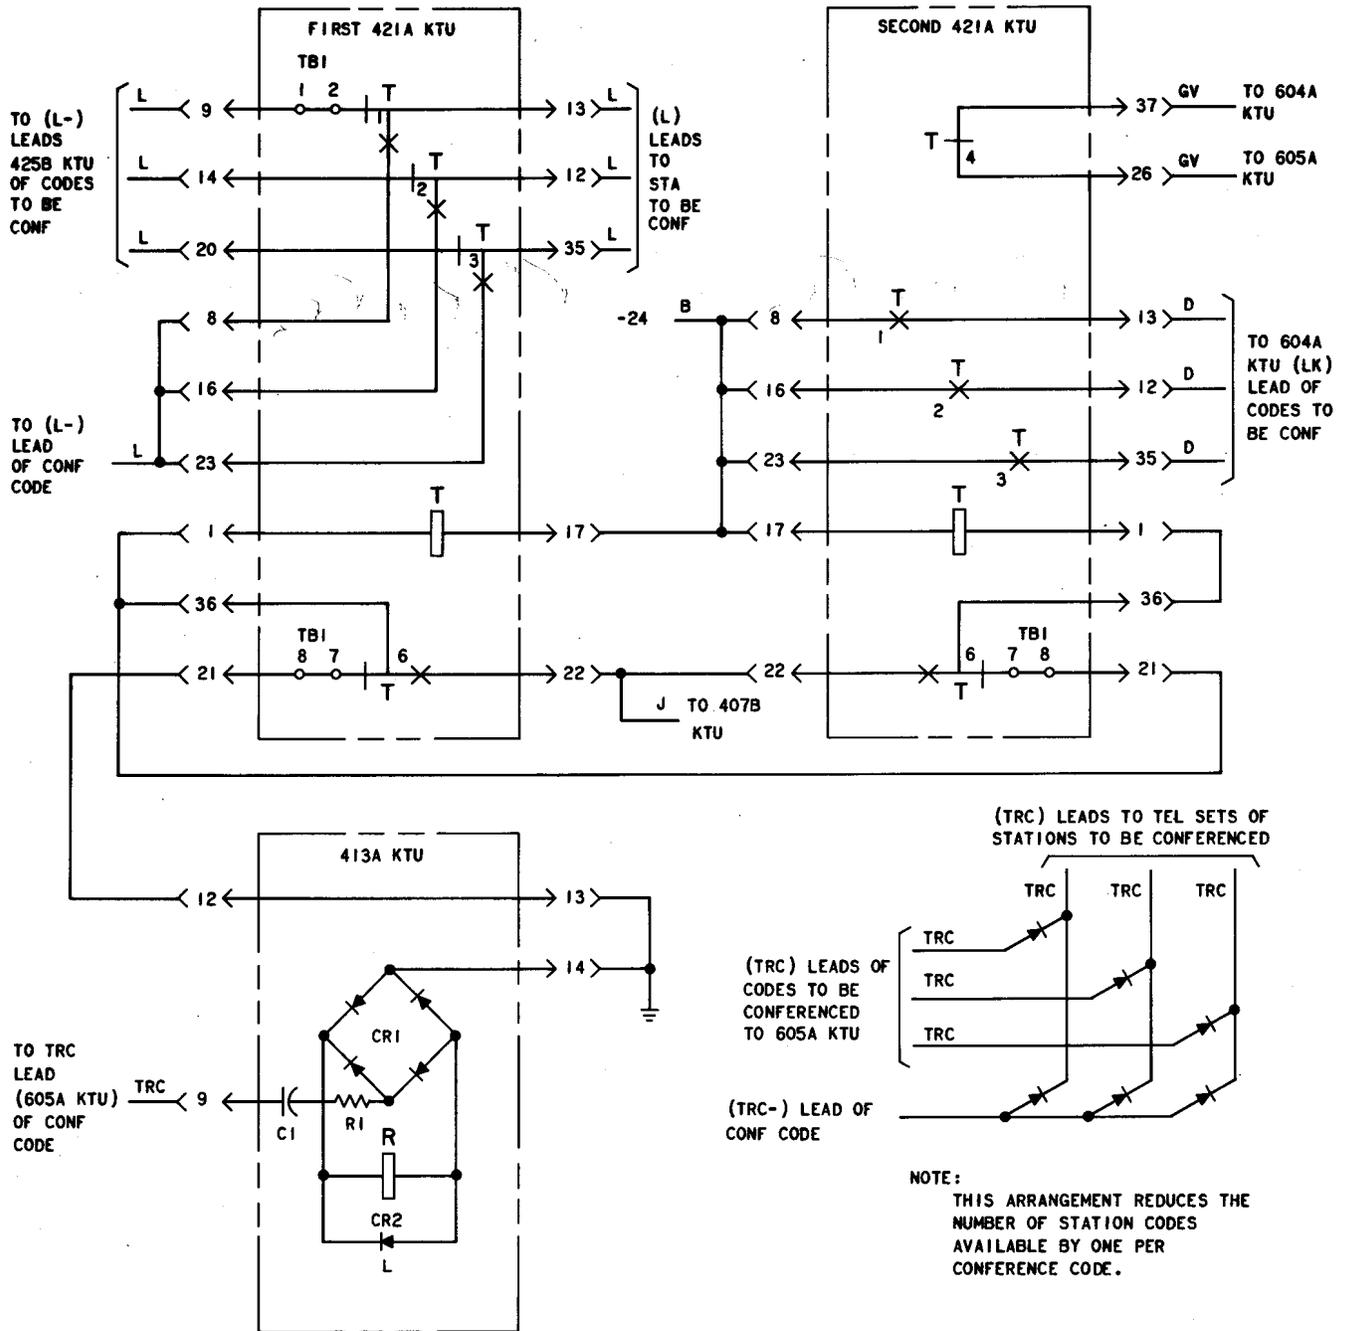
Fig. 21 – Single Link Intercom, Dial Selected Preset (Audio Only) Conference

Fig. 21 — Dial Selected Preset (Audio Only) Conference

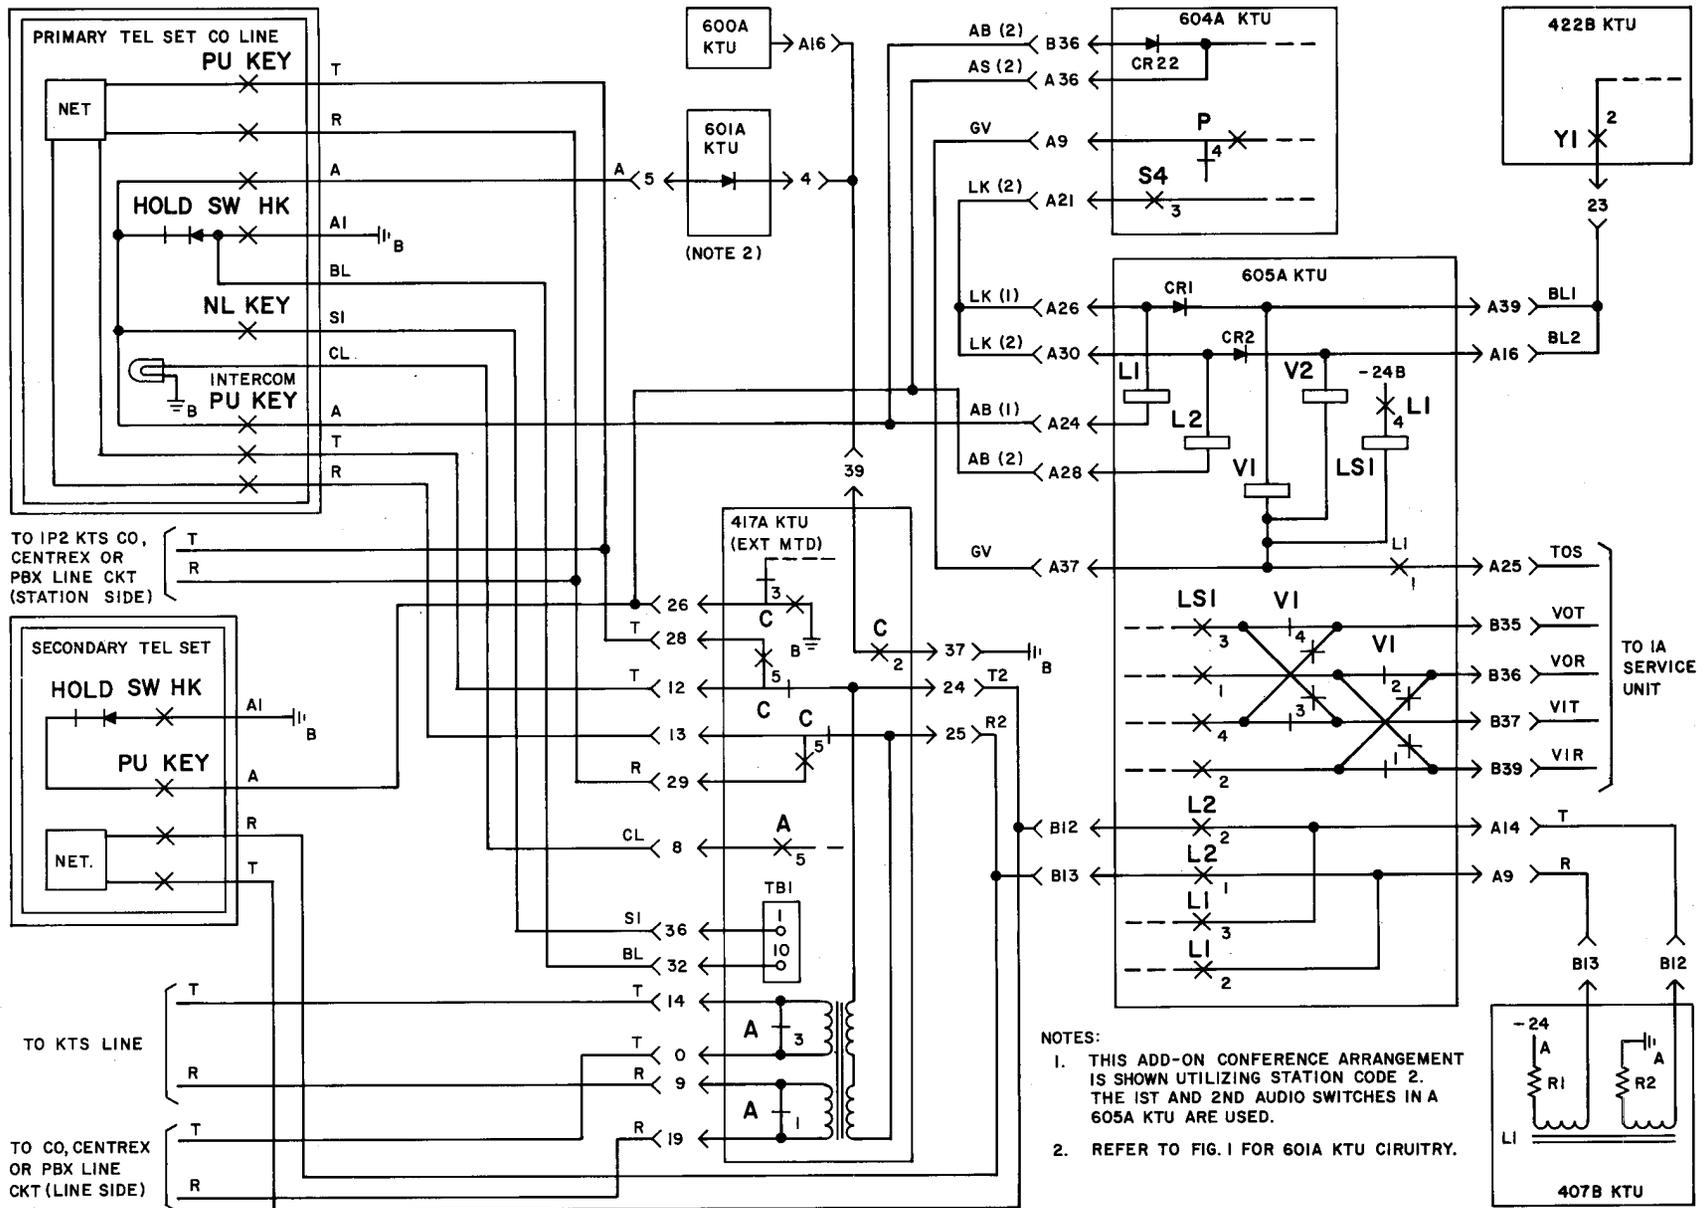
Fig. 22 - Single Link Intercom, Add-on Conference

Fig. 22 — Add-On Conference

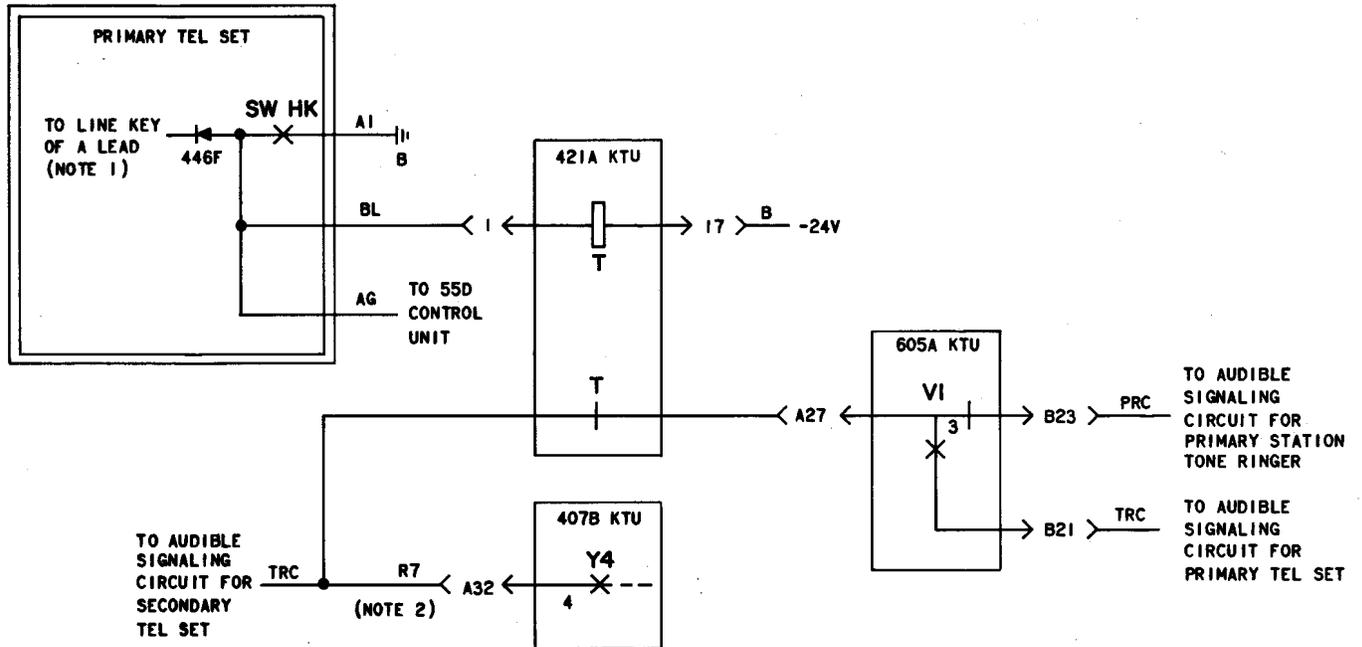
- NOTES:
1. A 446F DIODE MUST BE INSTALLED IN TEL SET AS SHOWN. REFER TO APPROPRIATE SECTION FOR TEL SET TO BE MODIFIED.
  2. THIS ARRANGEMENT IS WIRED FOR PRIMARY-SECONDARY STATION BRIDGING AND IS SHOWN WIRED AS STATION CODE 7 AND UTILIZES THE 1ST AUDIO-VIDEO SWITCH IN A 605A KTU TO ISOLATE THE RINGING CIRCUITS IN THE PRIMARY STATION.

Fig. 23 — Single Link Intercom, Bridged Hunting for One Station

Fig. 23 — Bridged Hunting for One Station

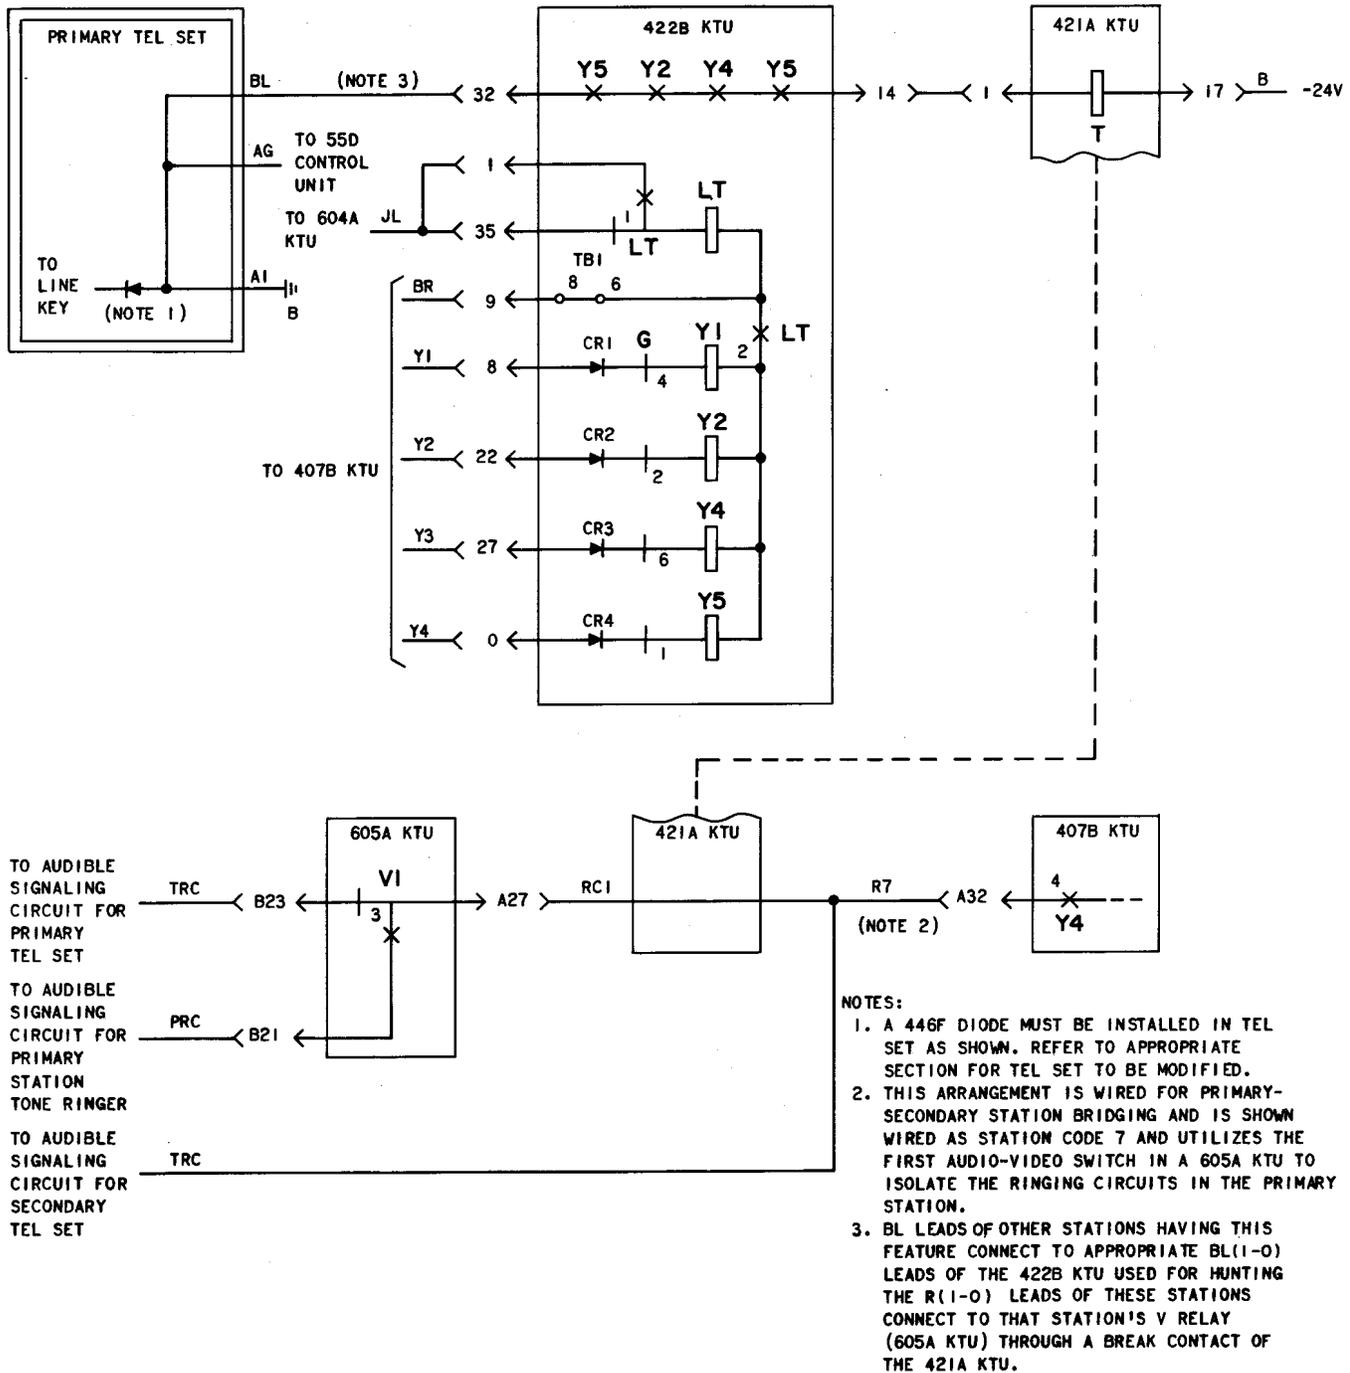
Fig. 24 —Single Link Intercom, Bridged Hunting for More Than One Station

Fig. 24 — Bridged Hunting for More than One Station

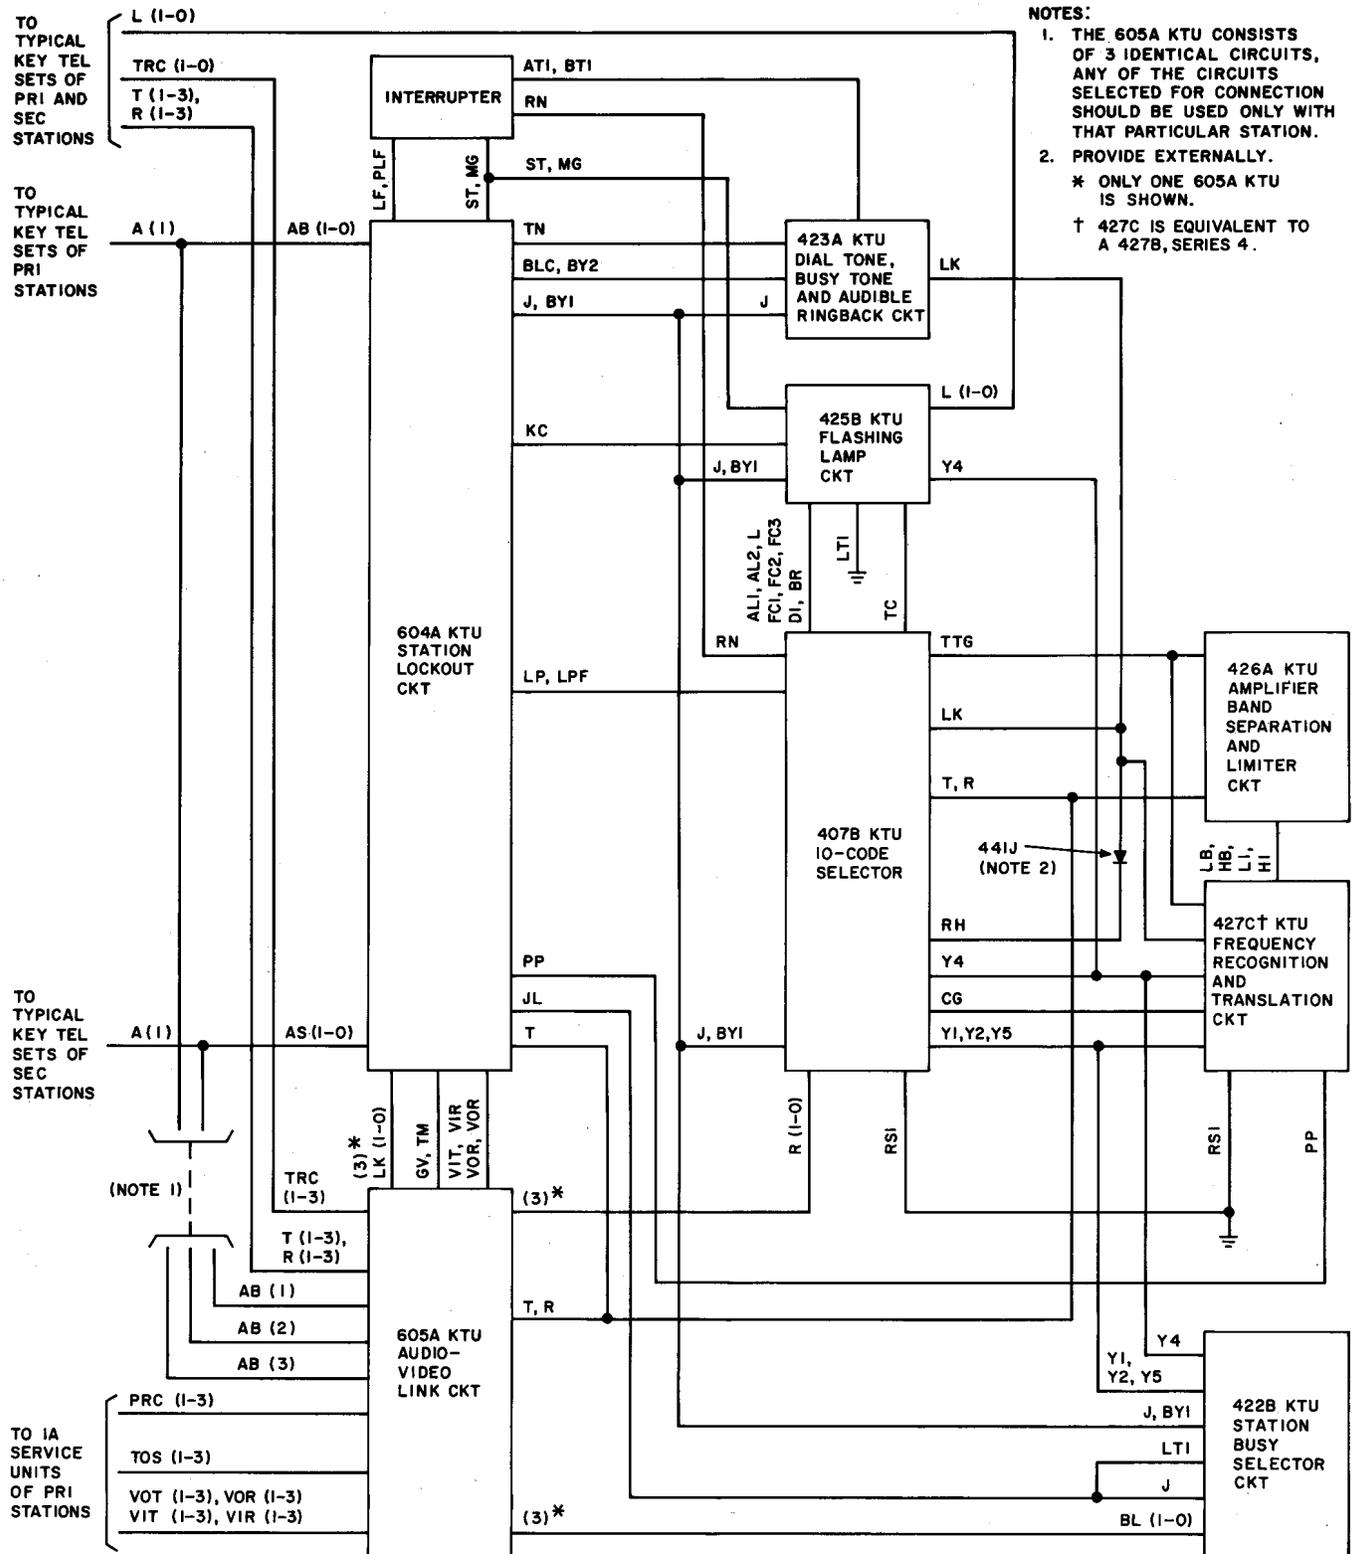
Fig. 25 - Single Link Intercom Arrangement, Block Diagram

Fig. 25 — Single Link Intercom Arrangement, Block Diagram

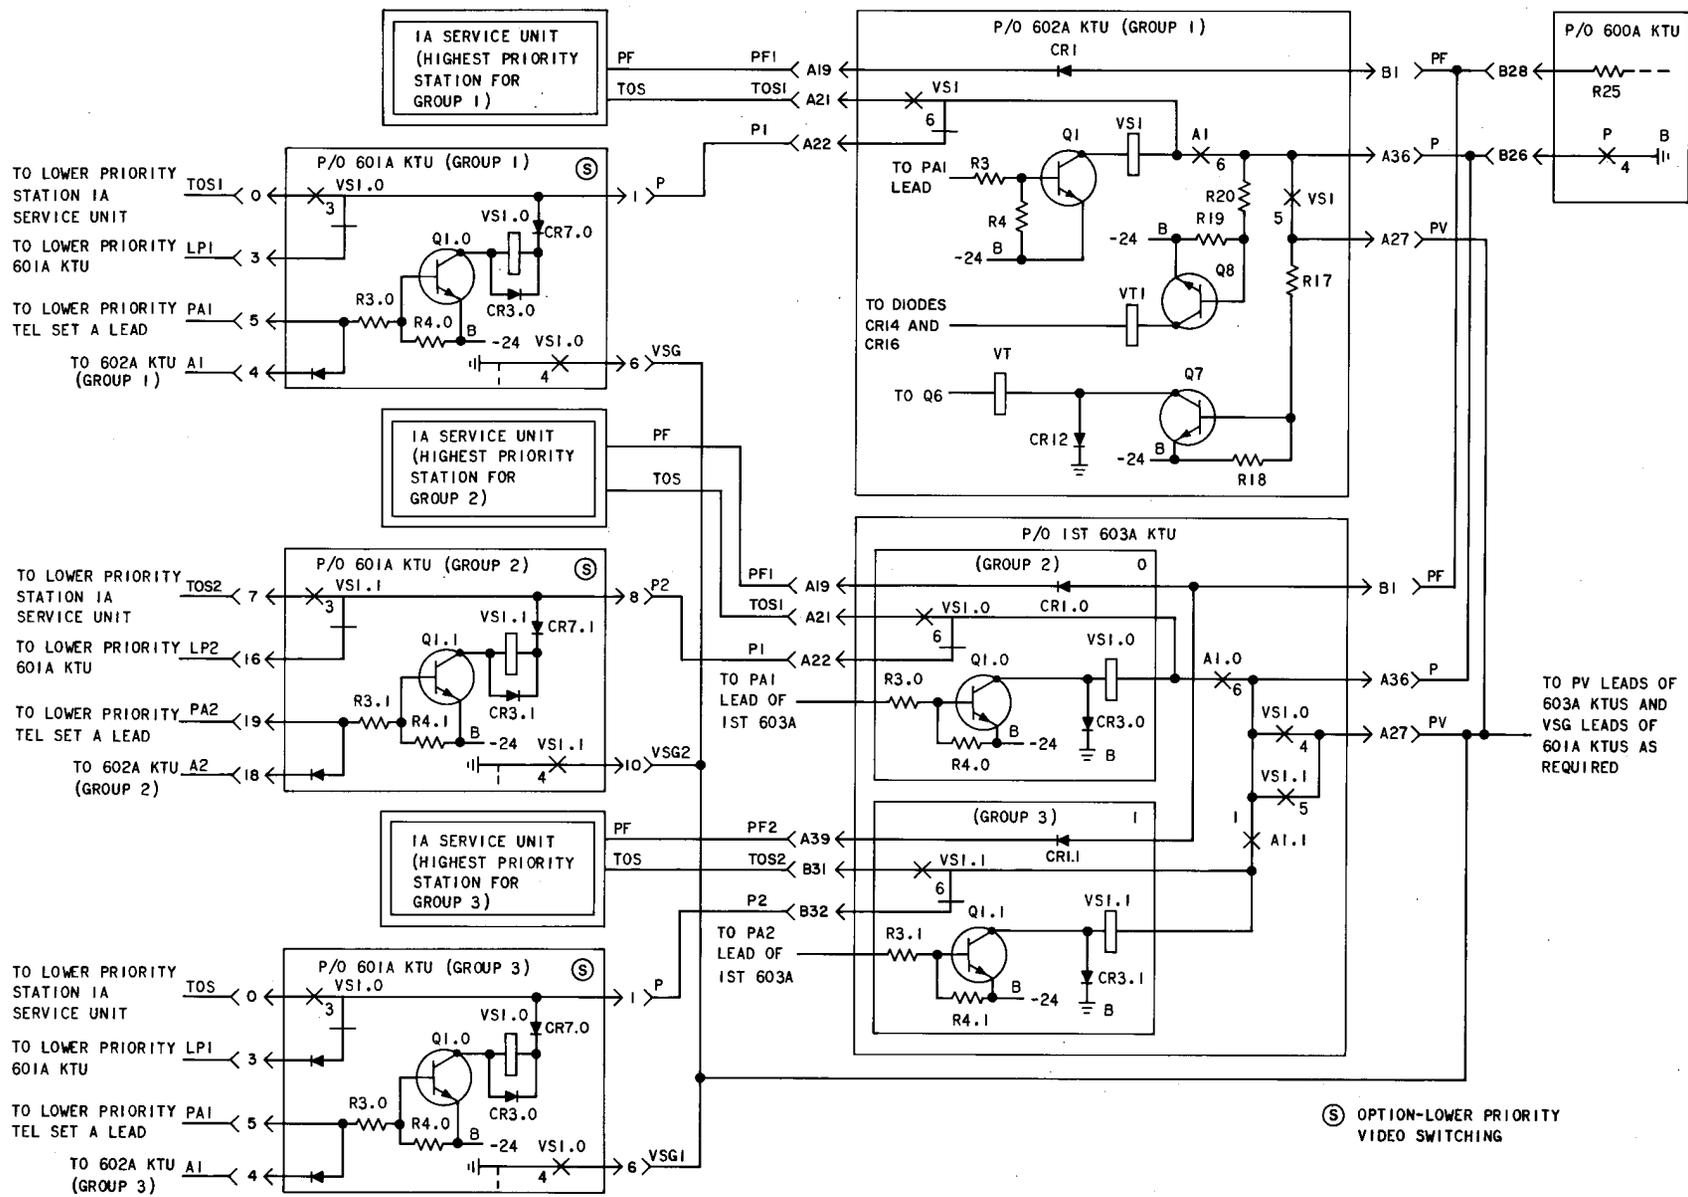
Fig. 27 - Multigroup, Video Control

Fig. 27 — Video Control

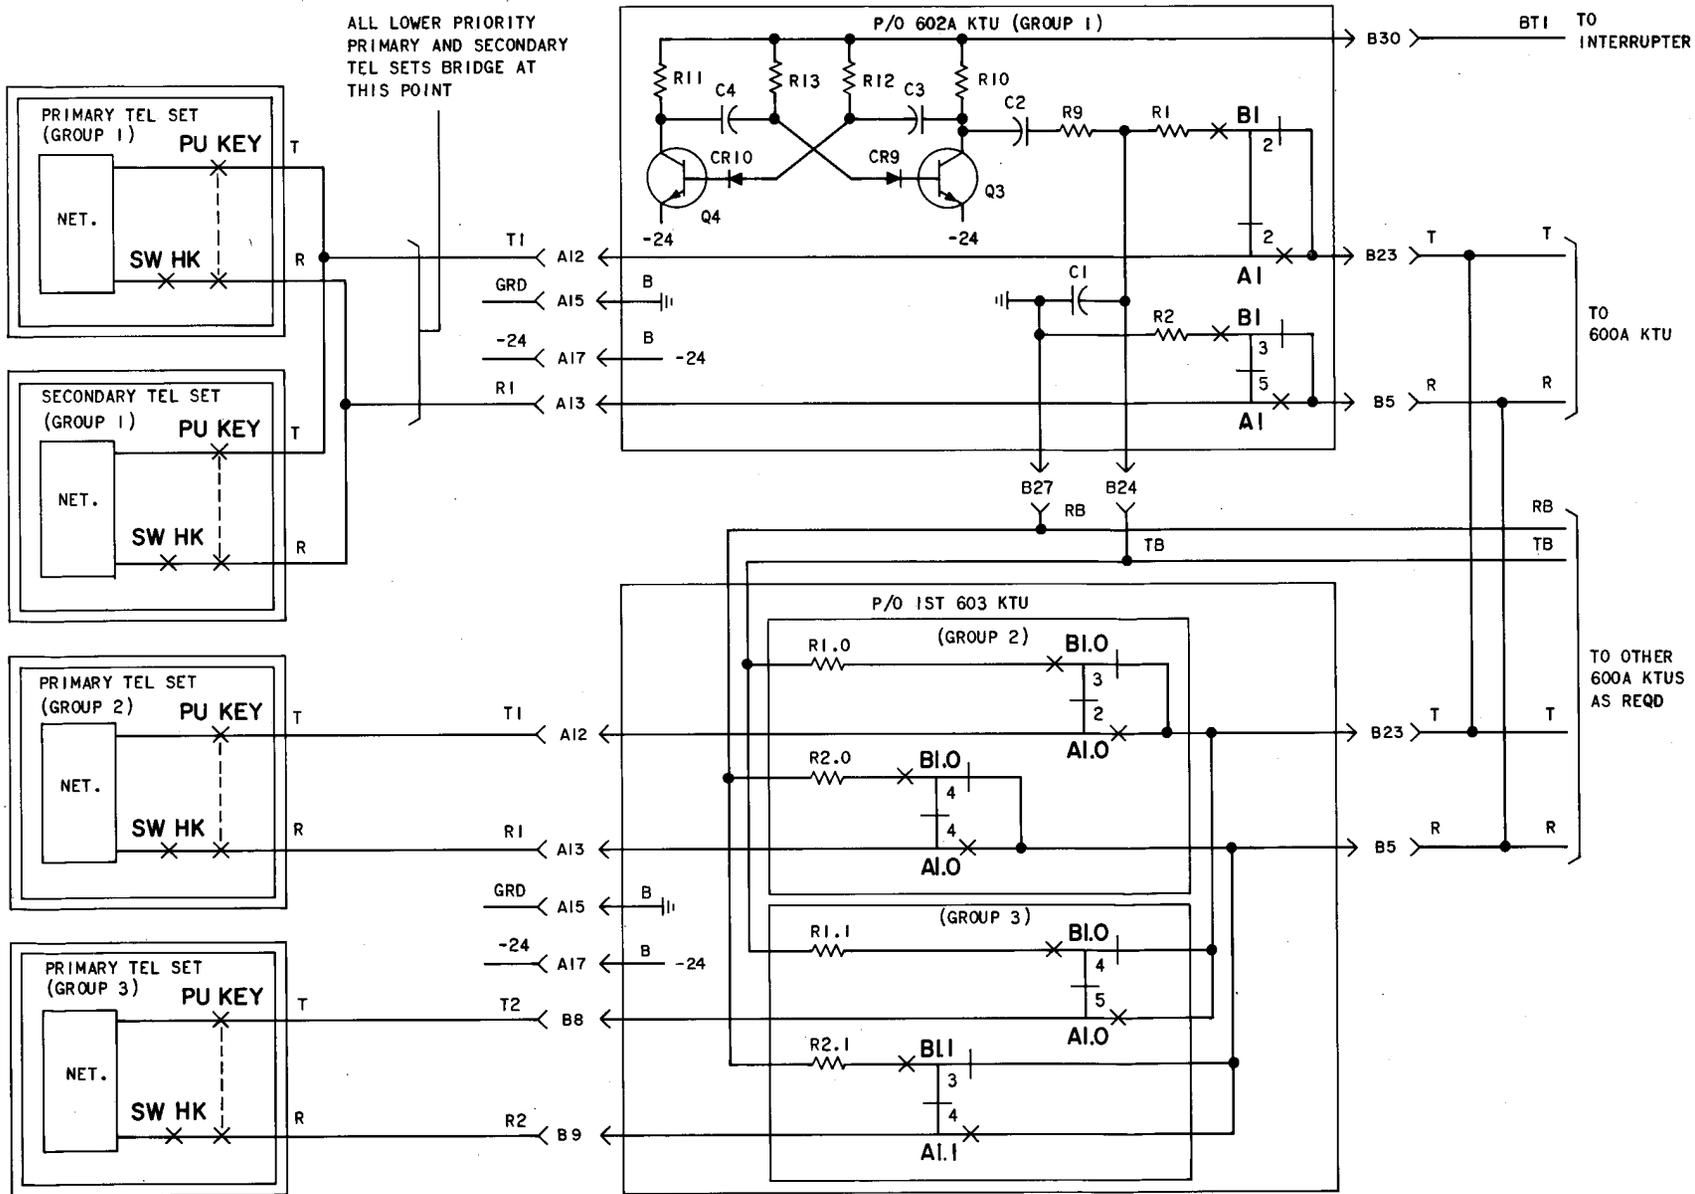
Fig. 28 - Multigroup, Audio Transmission Path and System Busy Tone

Fig. 28 — Audio Transmission Path and System  
Busy Tone

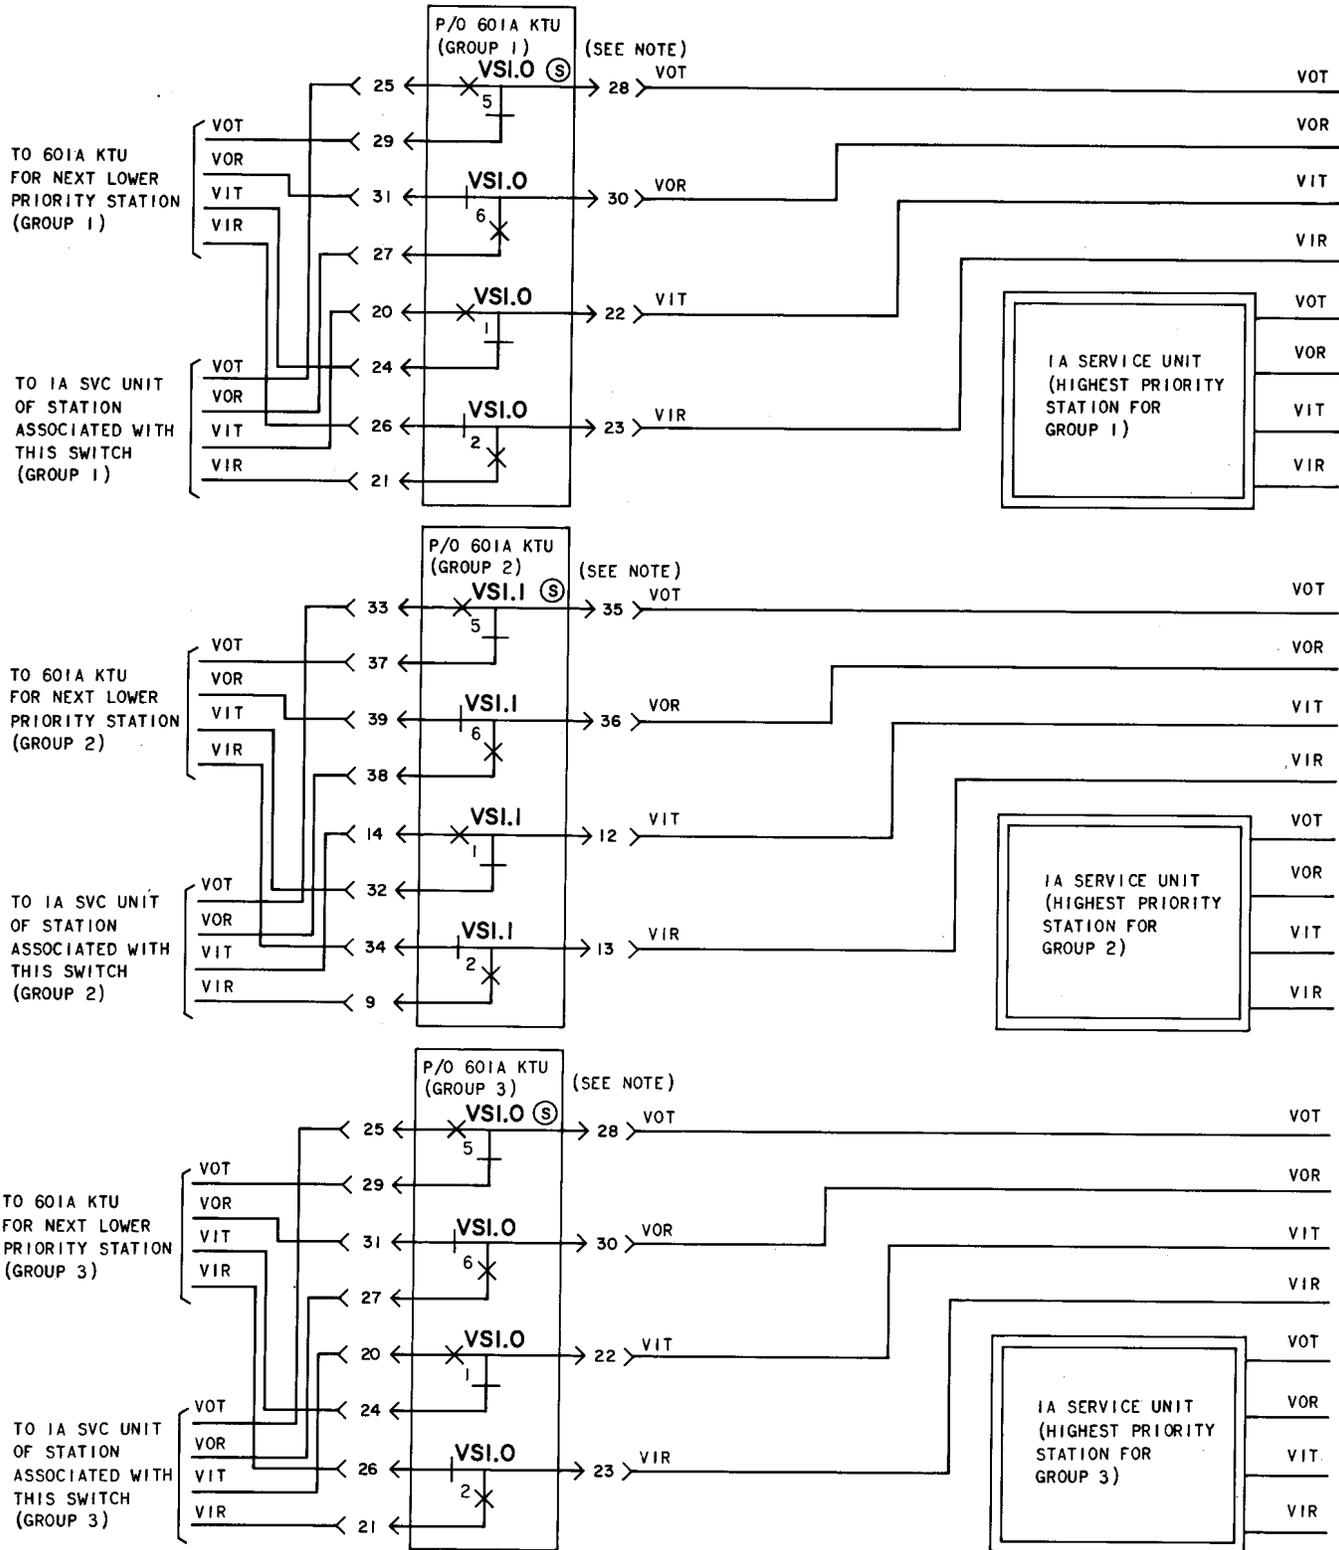
Fig. 29 - Multigroup, Video Transmission Path (Sheet 1)

Fig. 29 — Video Transmission Path
