## 1P2 KEY TELEPHONE SYSTEM

### TESTS AND MAINTENANCE

**1.01** This section provides tests and maintenance information in the form of Trouble Locating Tables and functional schematics for the following 1P2 Key Telephone System arrangements:

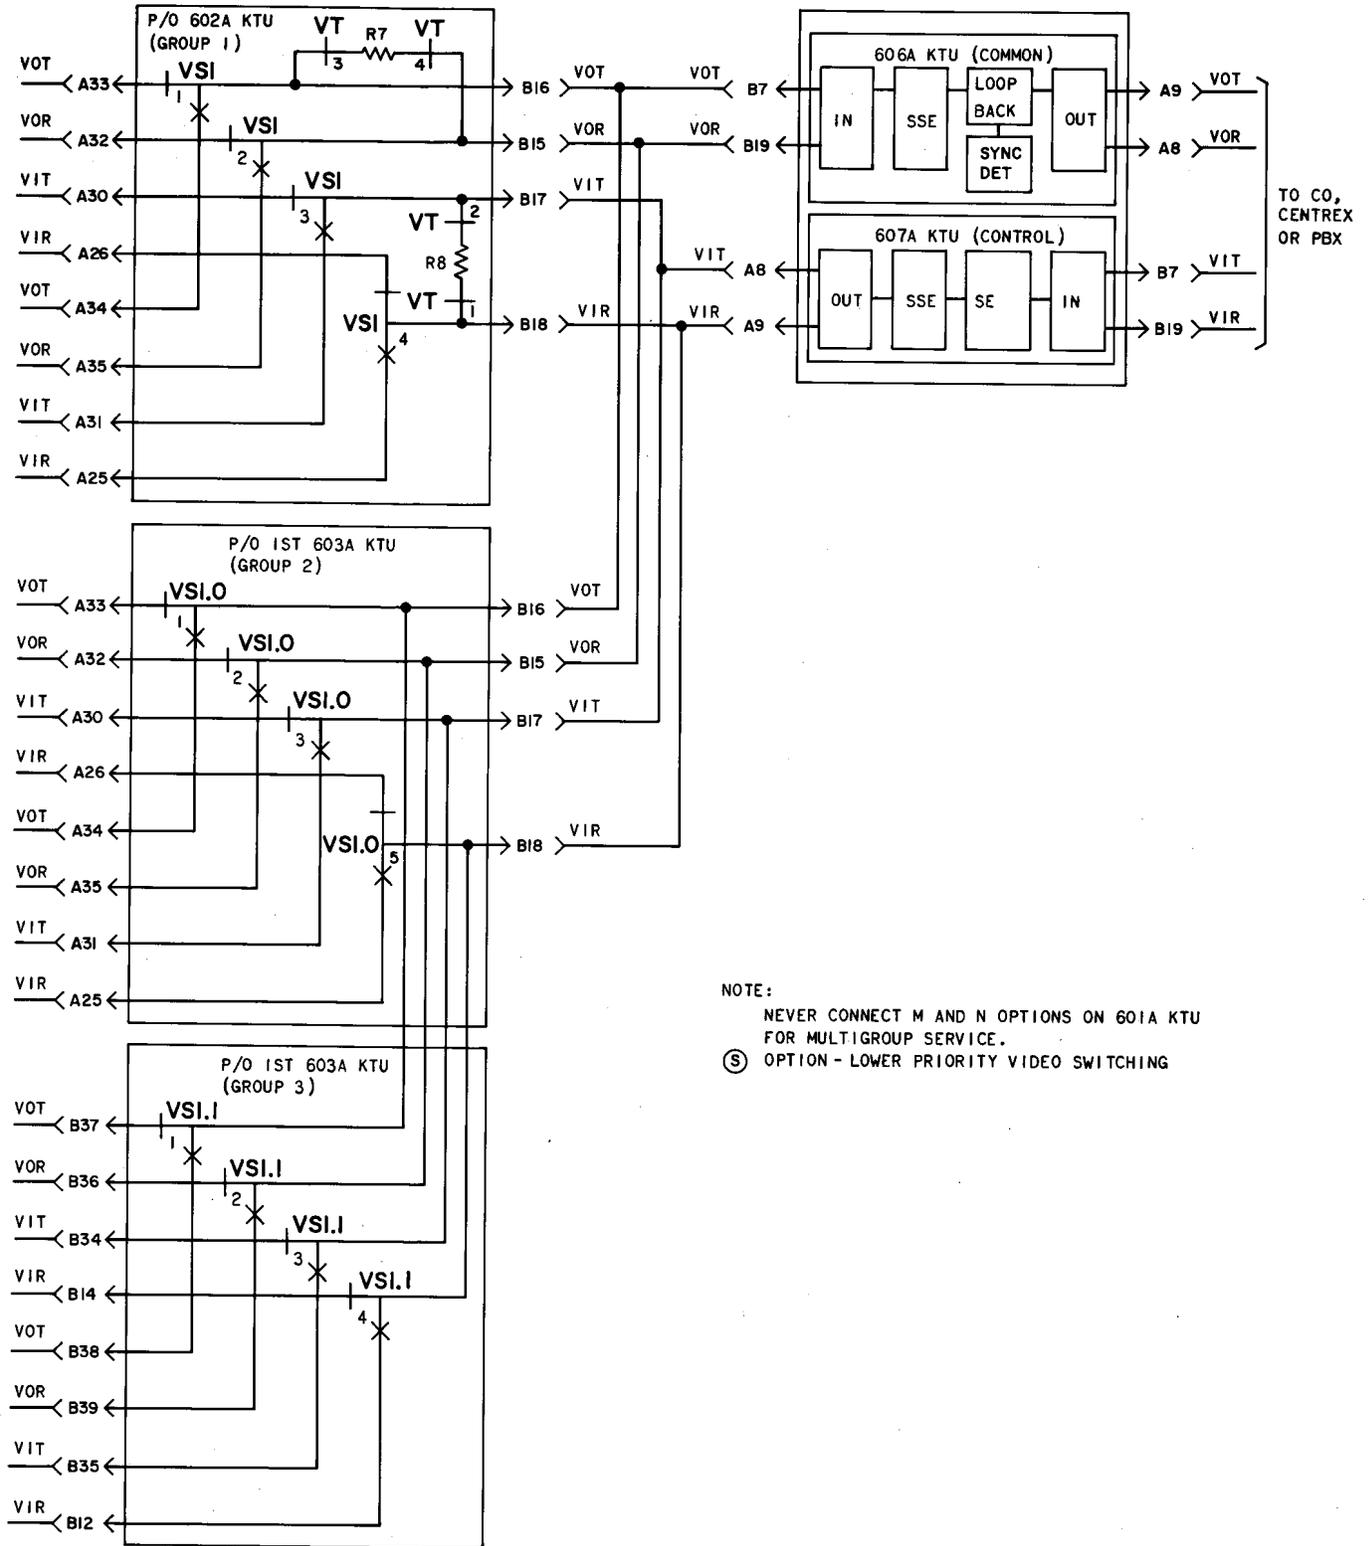
NOTE:  
 NEVER CONNECT M AND N OPTIONS ON 601A KTU FOR MULTIGROUP SERVICE.  
 (S) OPTION - LOWER PRIORITY VIDEO SWITCHING

Fig. 29 - Multigroup, Video Transmission Path (Sheet 2)

Fig. 29 — Video Transmission Path

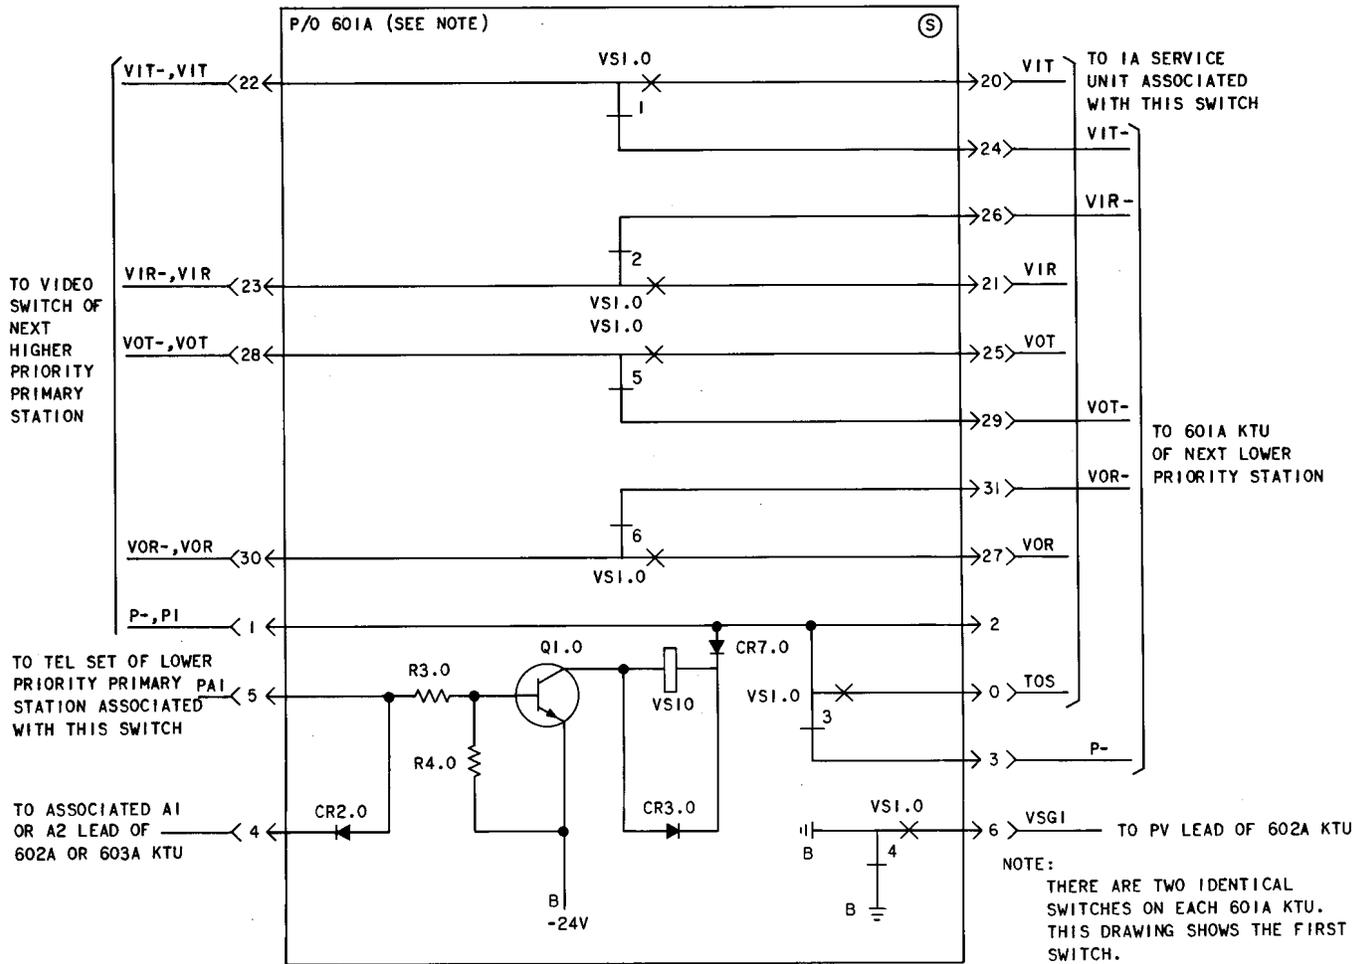
Fig. 31 – Multigroup, Video Switch (601A KTU, S Option) for Lower Priority Station

Fig. 31 — Video Switch (601A KTU, (S) Option)  
For Lower Priority Station

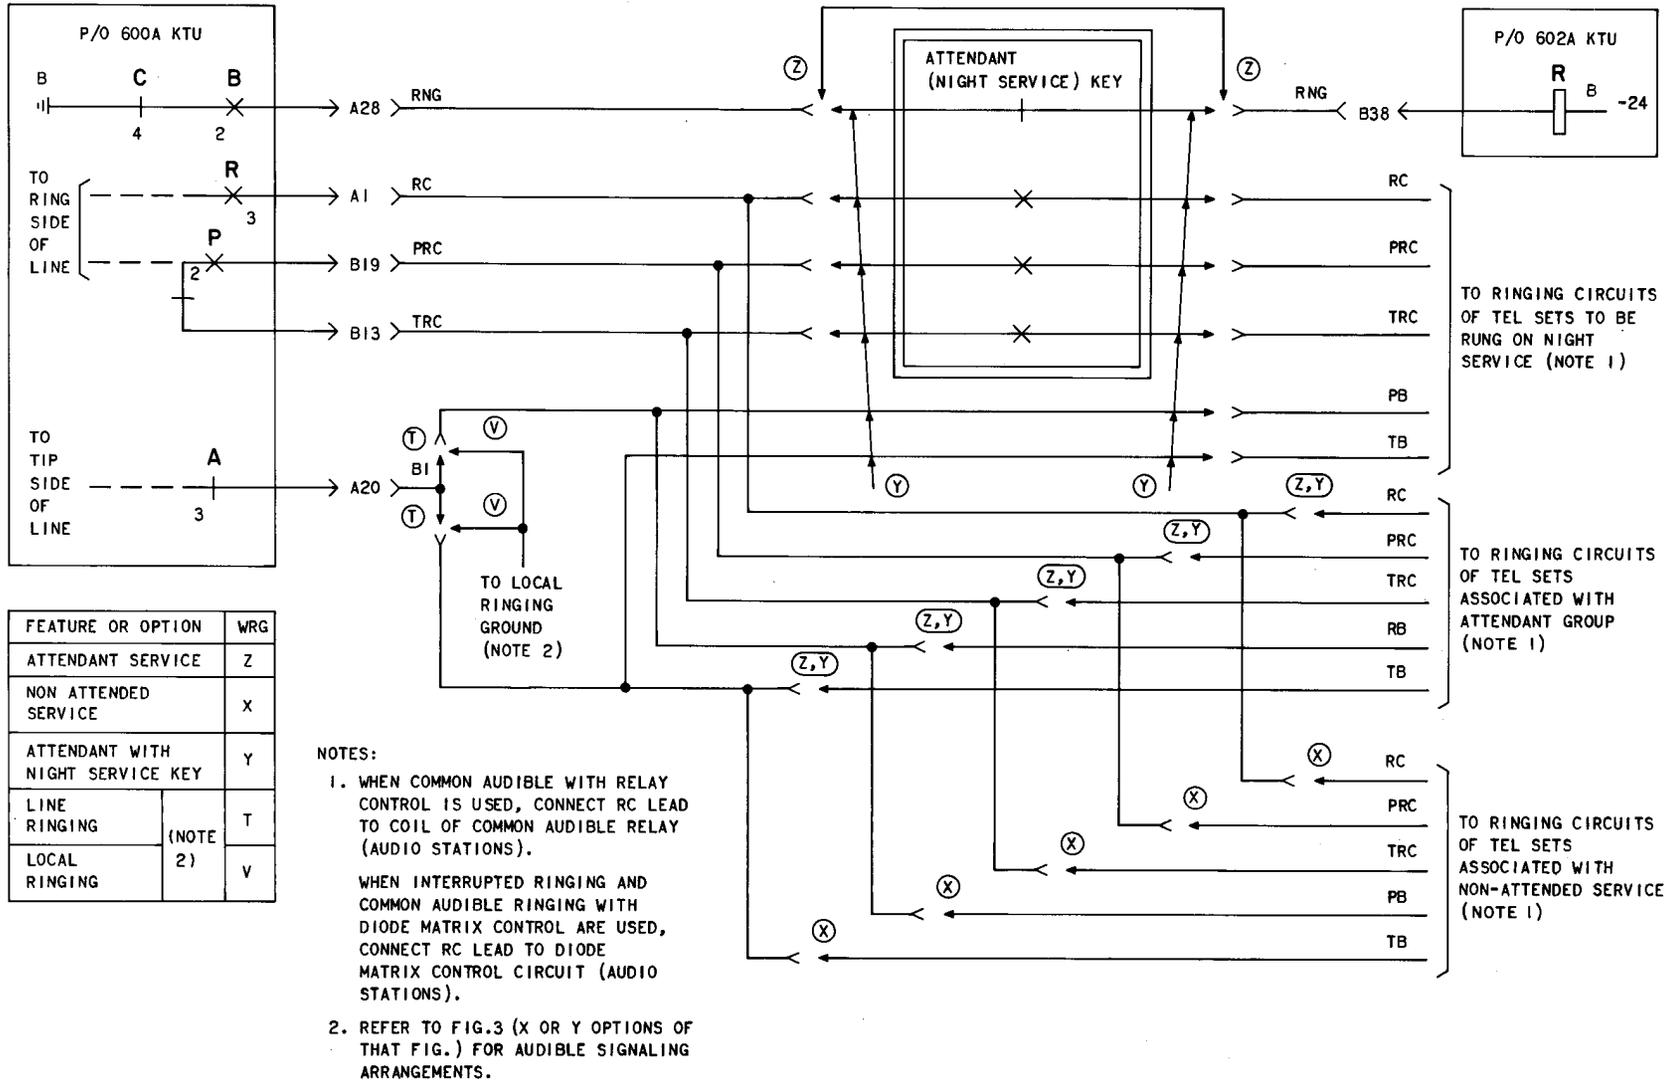
Fig. 32 — Multigroup, Attendant Service, Nonattended Service, or Night Service Key

Fig. 32 — Attendant Service, Nonattended Service,  
or Night Service Key

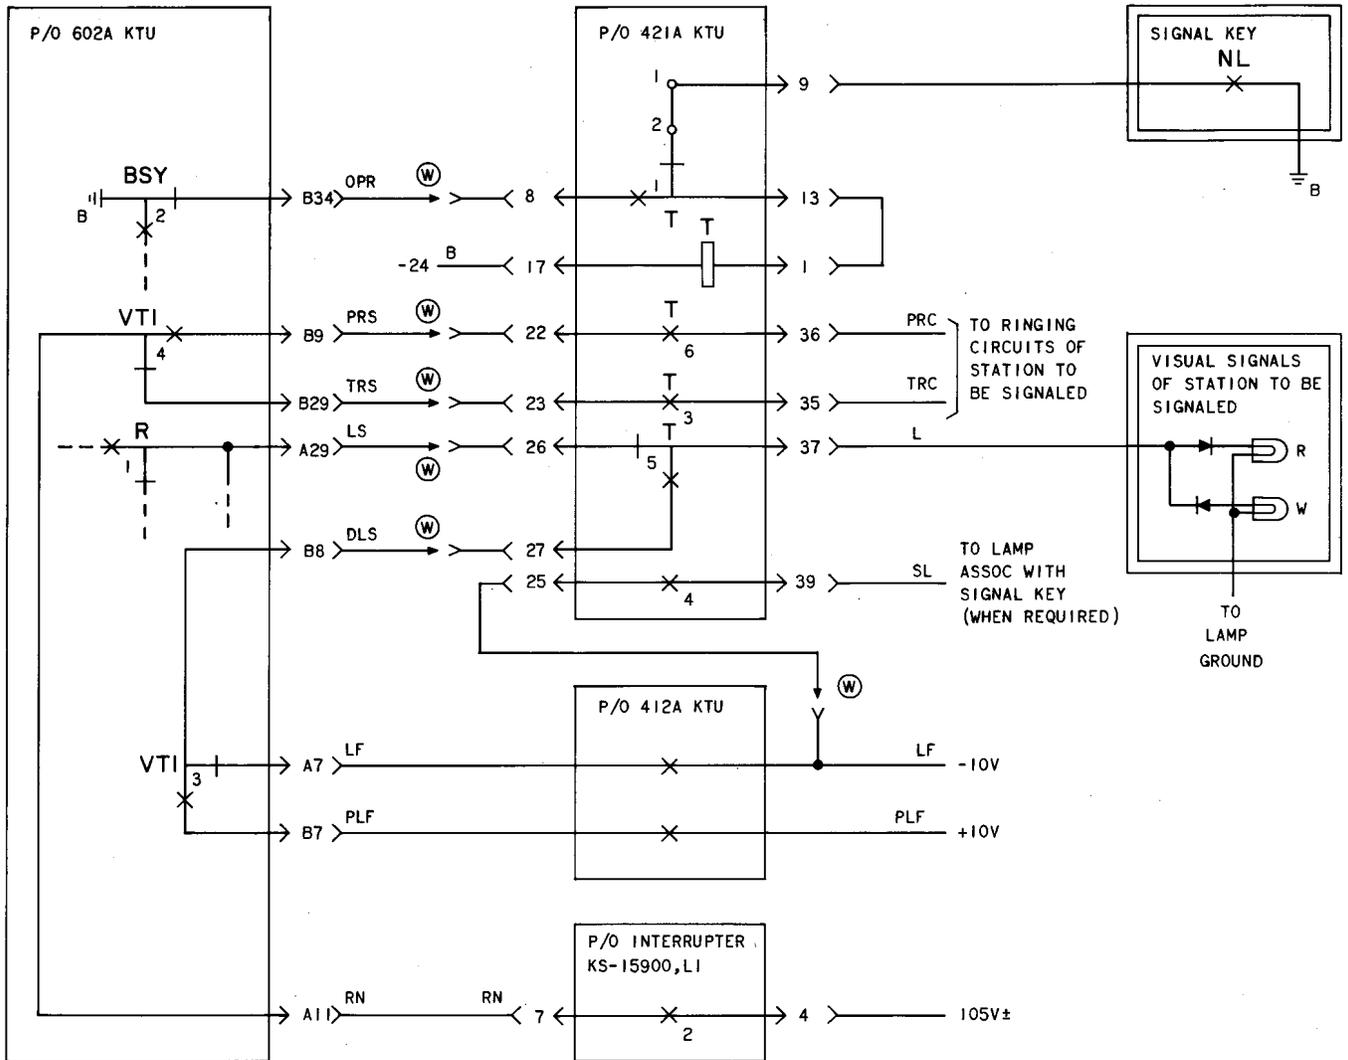
Fig. 33 — Multigroup, Directed Call Transfer (W Option)

Fig. 33 — Directed Call Transfer (W) Option

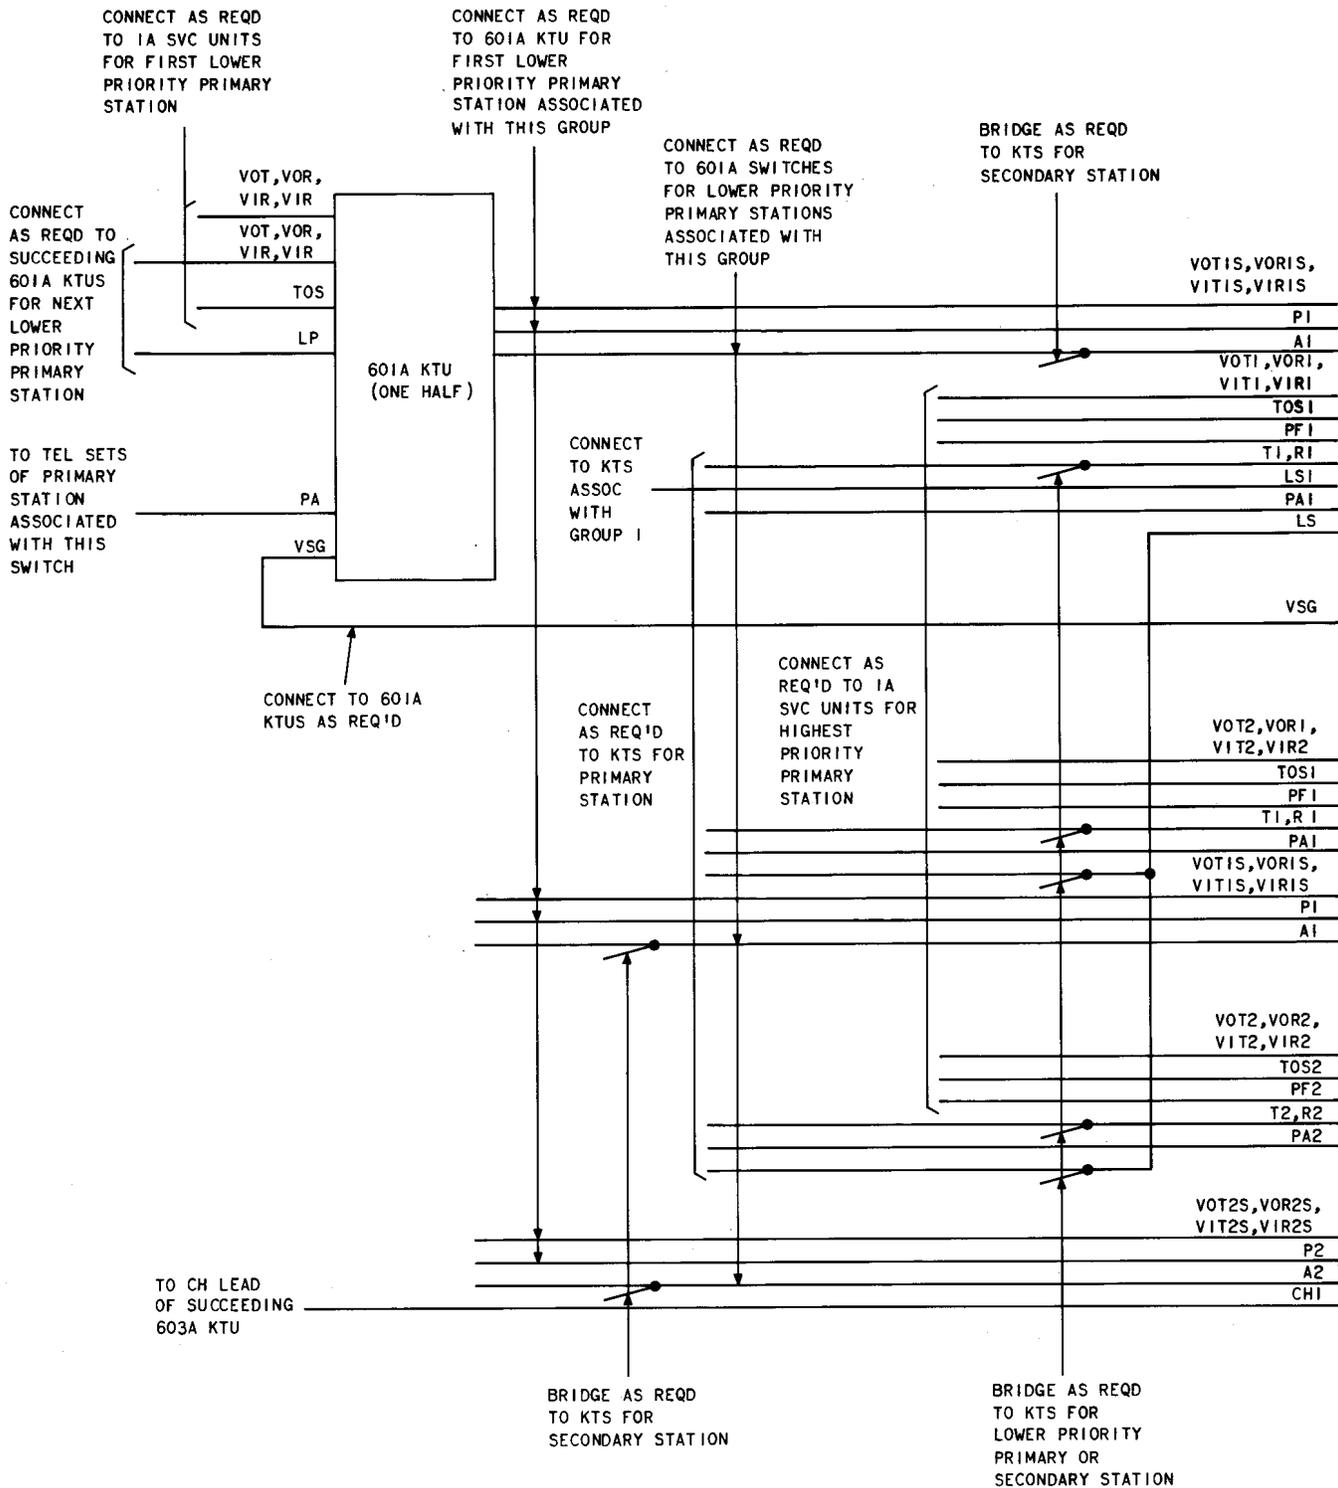
Fig. 34 - Multigroup Arrangement, Block Diagram (Sheet 1)

Fig. 34 — Multigroup Arrangement, Block Diagram

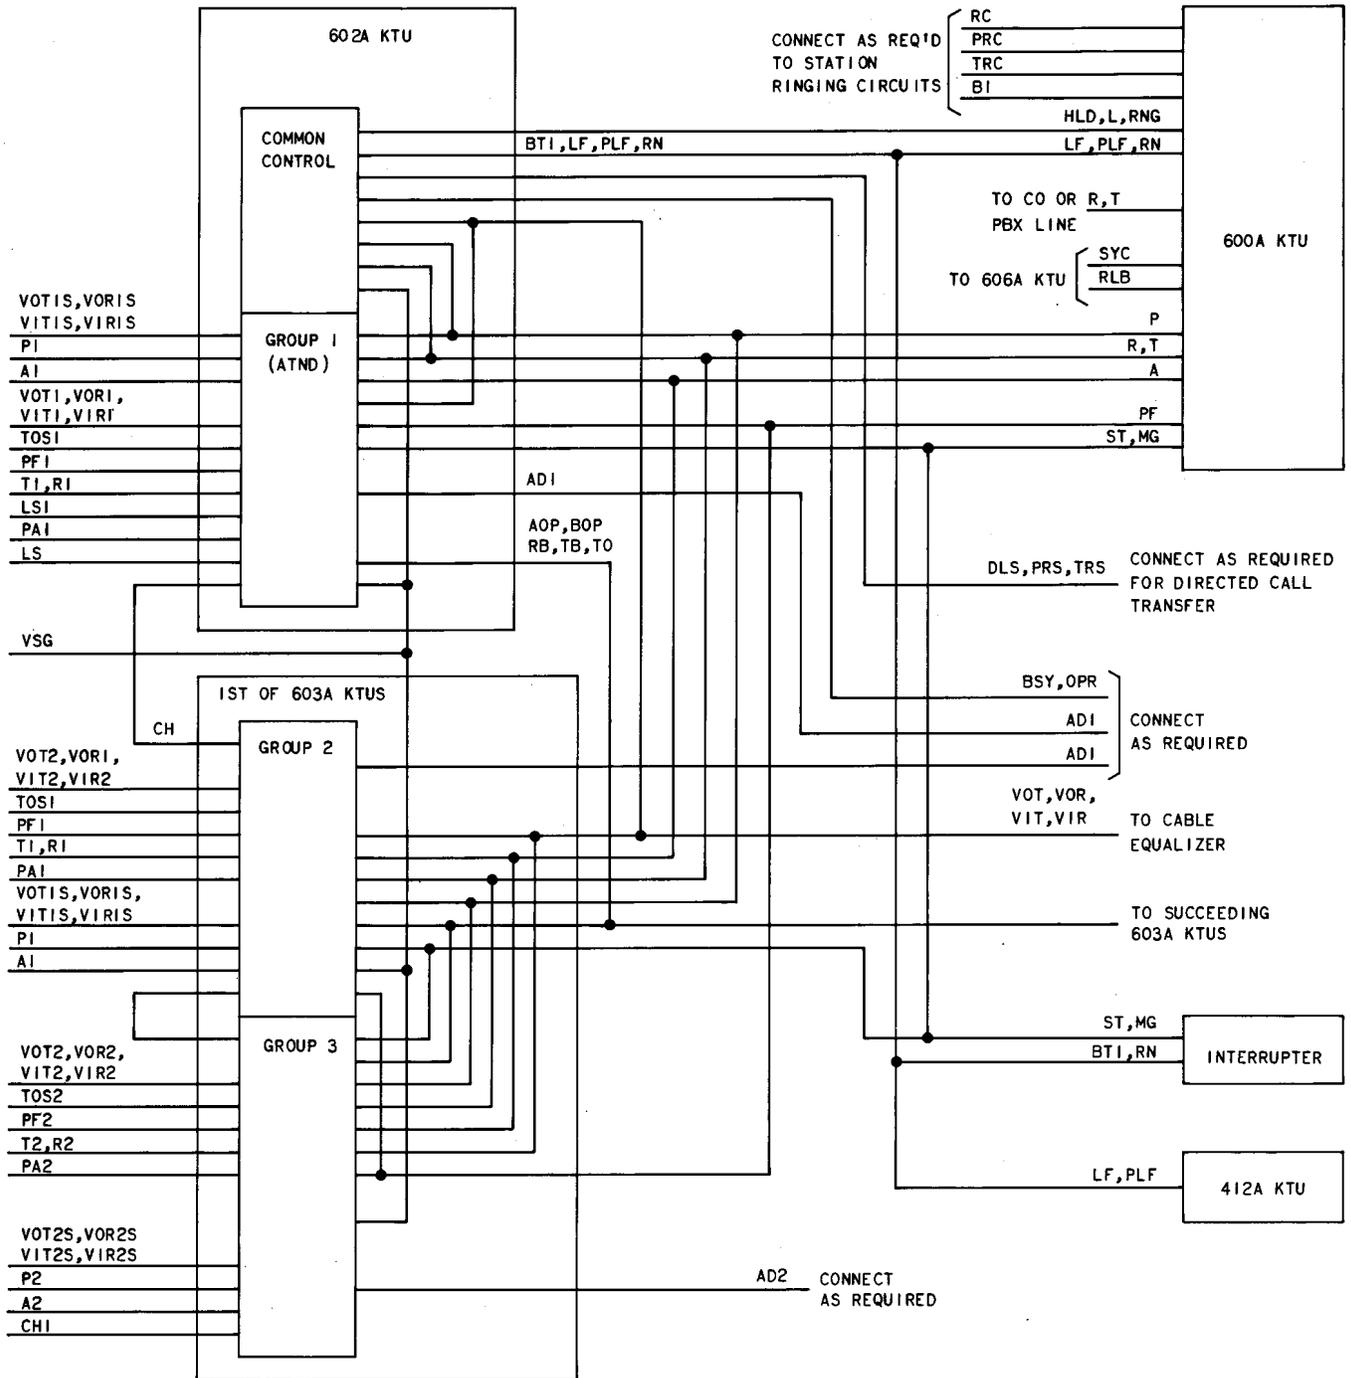
Fig. 34 - Multigroup Arrangement, Block Diagram (Sheet 2)
