Meridian 1

ISDN Basic Rate Interface

Maintenance

Document Number: 553-3901-500

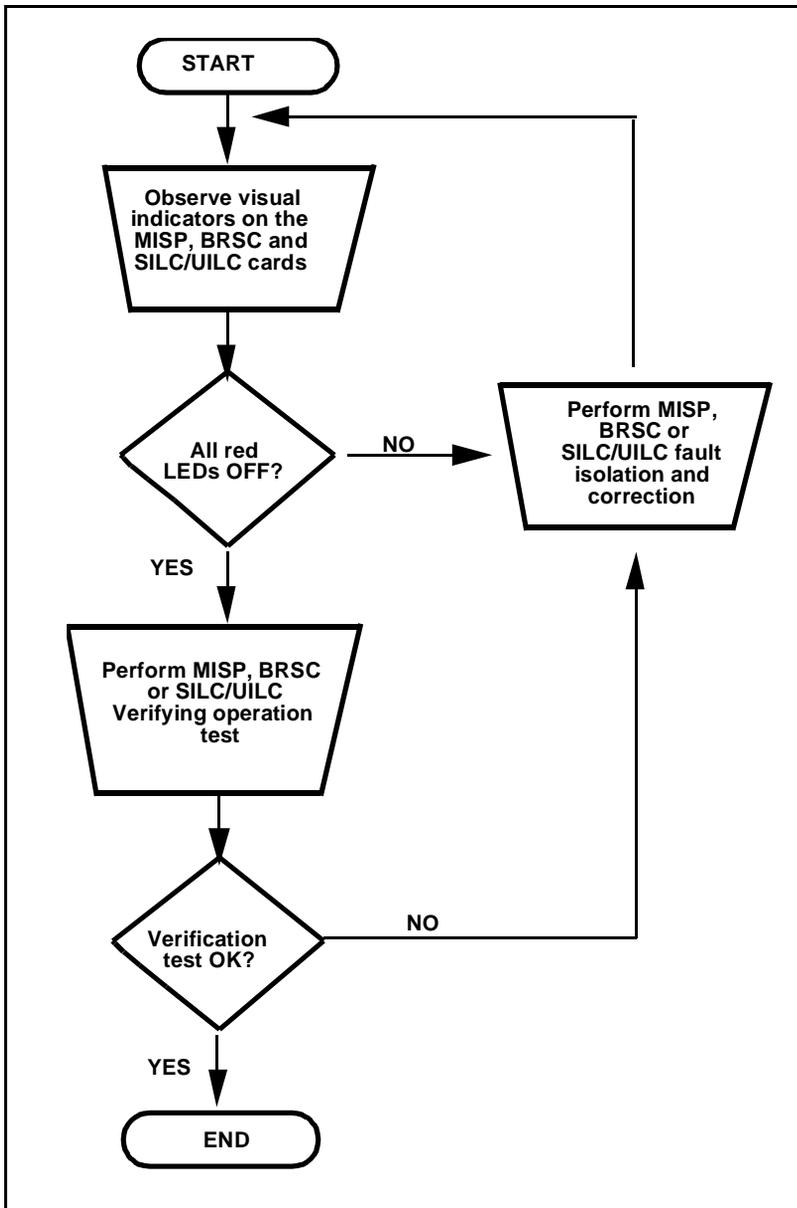
Figure 1
ISDN BRI fault isolation flowchart

Figure 1 presents a flowchart that deals specifically with ISDN BRI service problems. Based on the symptoms that these problems exhibit, the flowchart refers to the test procedures in this document that can resolve these problems.

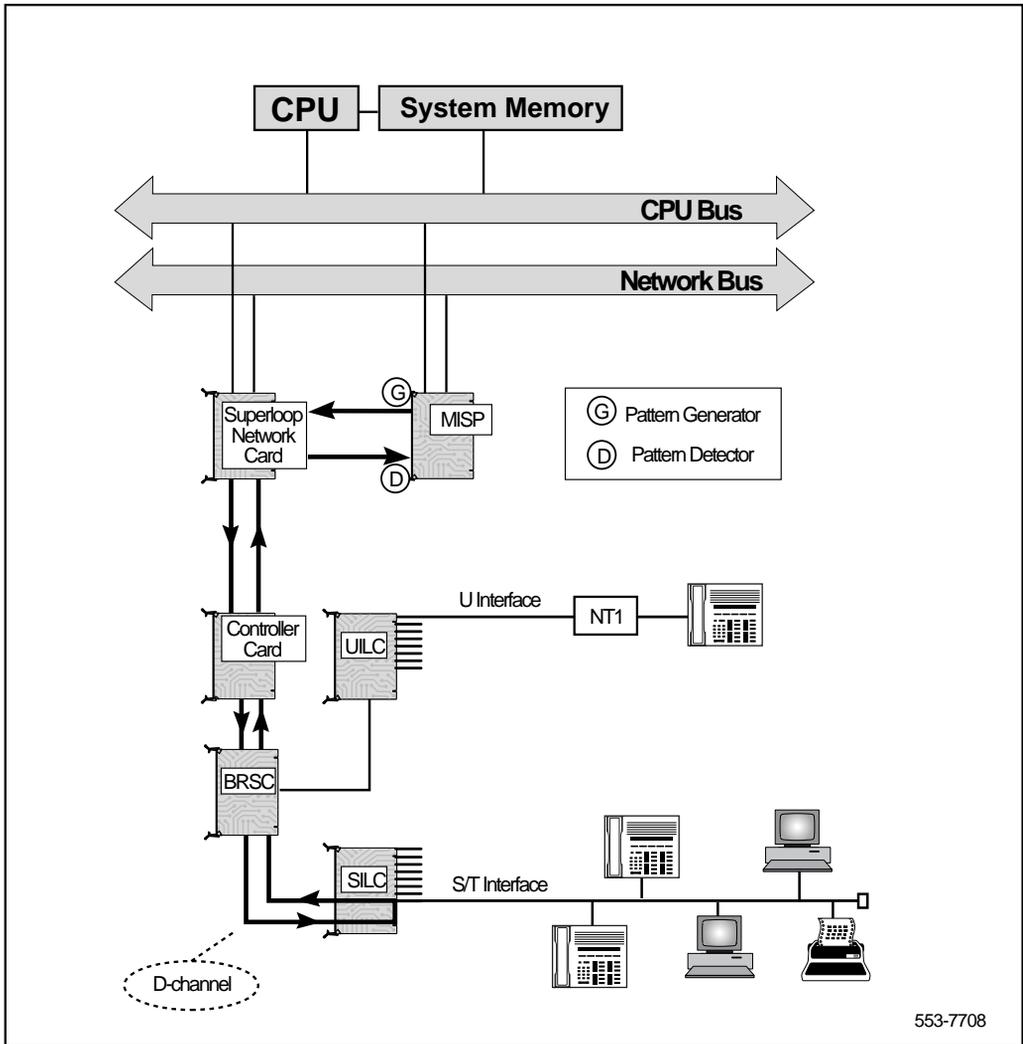
Figure 2
MISP loopback at a DSL interface

Figure 2 illustrates a DSL loopback path and the MISP as a test pattern generator and detector.

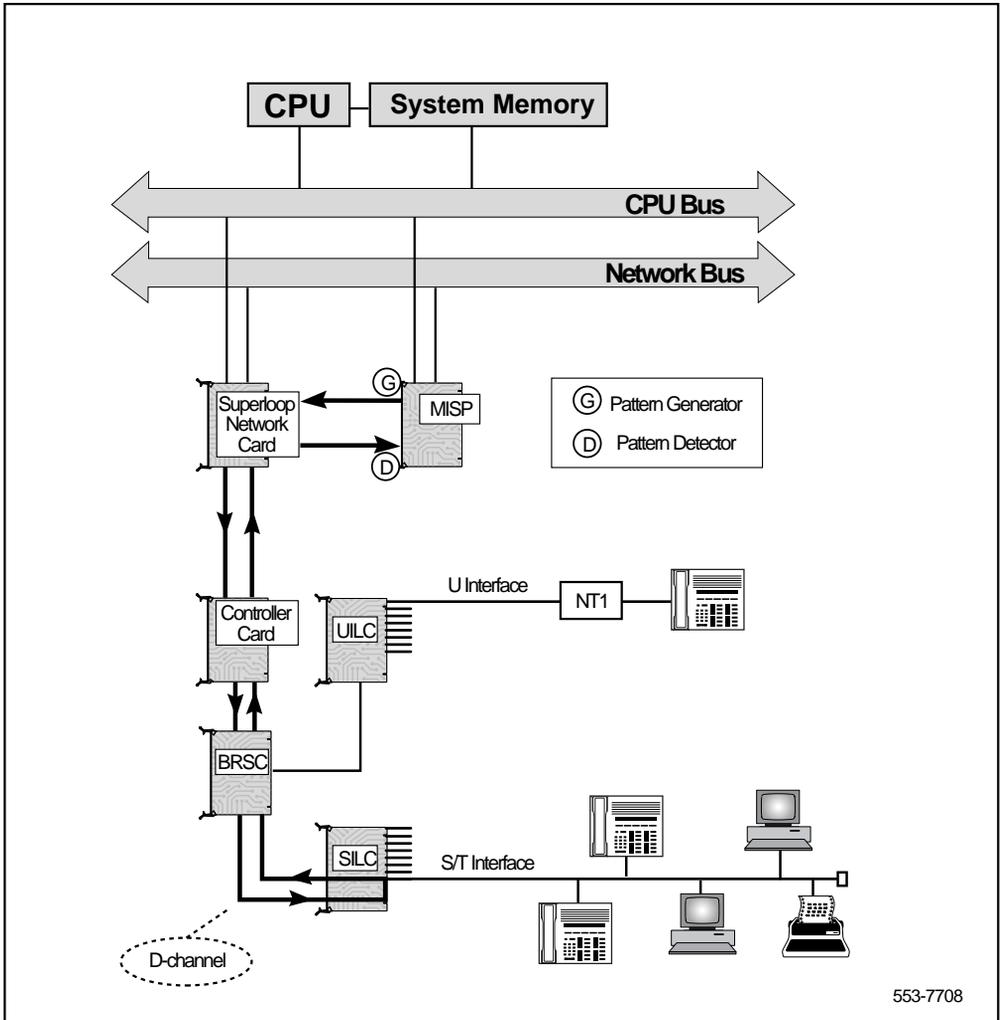
Figure 3
MISP loopback at the SILC or UILC peripheral bus interface

Figure 3 illustrates the SILC or UILC loopback path and the MISP as a test pattern generator and detector.

Before starting loopback testing at the SILC or UILC, disable the card to be tested; when the card is disabled, the system disconnects all the calls handled at the time by that card. Perform the following steps:

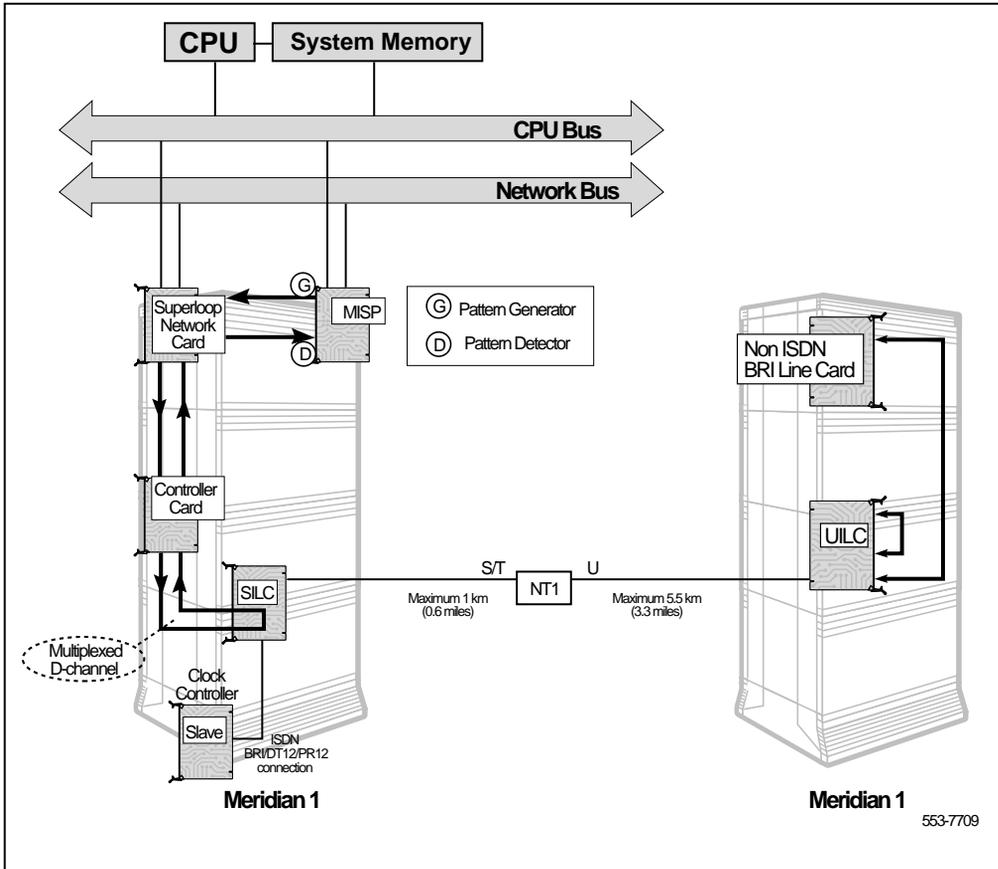
Figure 4
ISDN BRI trunk DSL remote loopback

Figure 4 illustrates a remote loopback test for an ISDN BRI trunk DSL provisioned as a MCDN Tie configuration; the Tie trunk connection is achieved by connecting two Meridian 1s through an NT1 device.

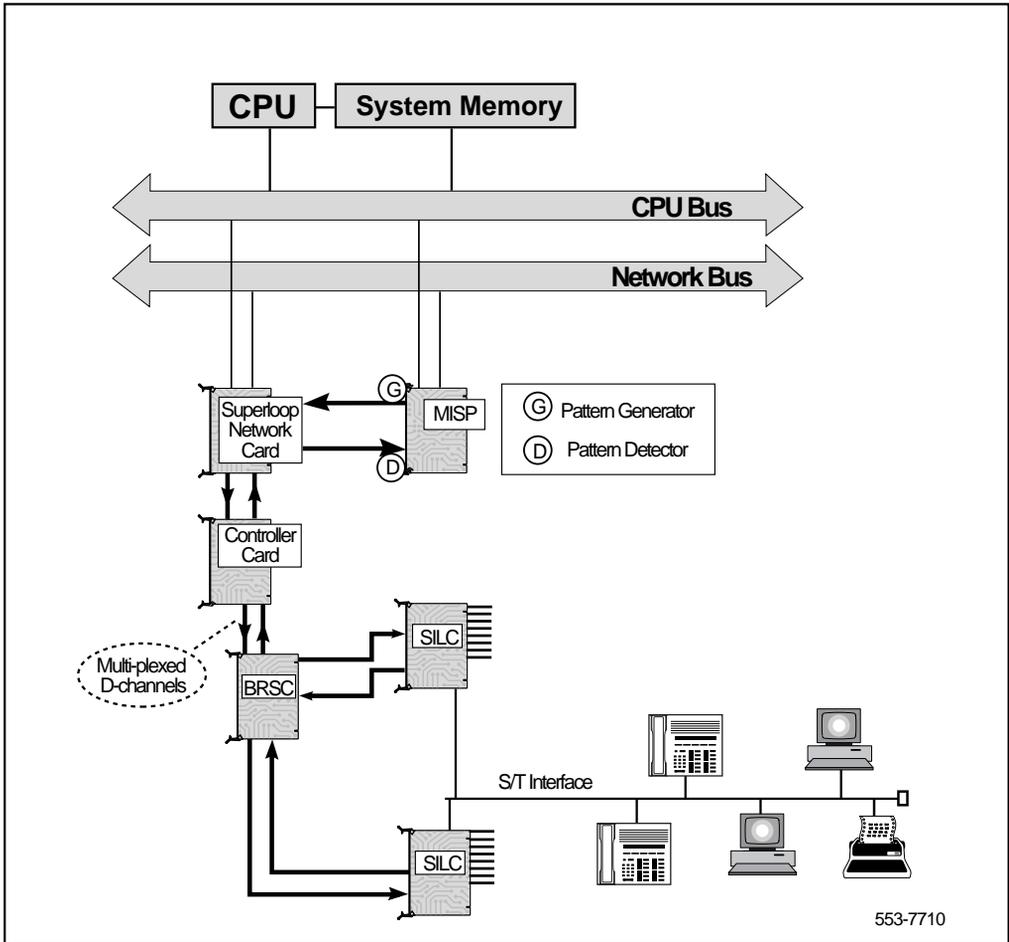
Figure 5
MISP to line card DSL loopback through the BRSC

- an MISP to line card DSL loopback through the BRSC. See Figure 5. This tests the entire D-channel signaling path. The MISP BRI line application generates and verifies the data through the path. The ISDN BRI application on the BRSC passes the data transparently.
- an MISP to line card loopback through the BRSC. See Figure 6. This tests the path from the MISP application through the BRSC to the line card. The ISDN BRI application on the BRSC passes the data transparently.

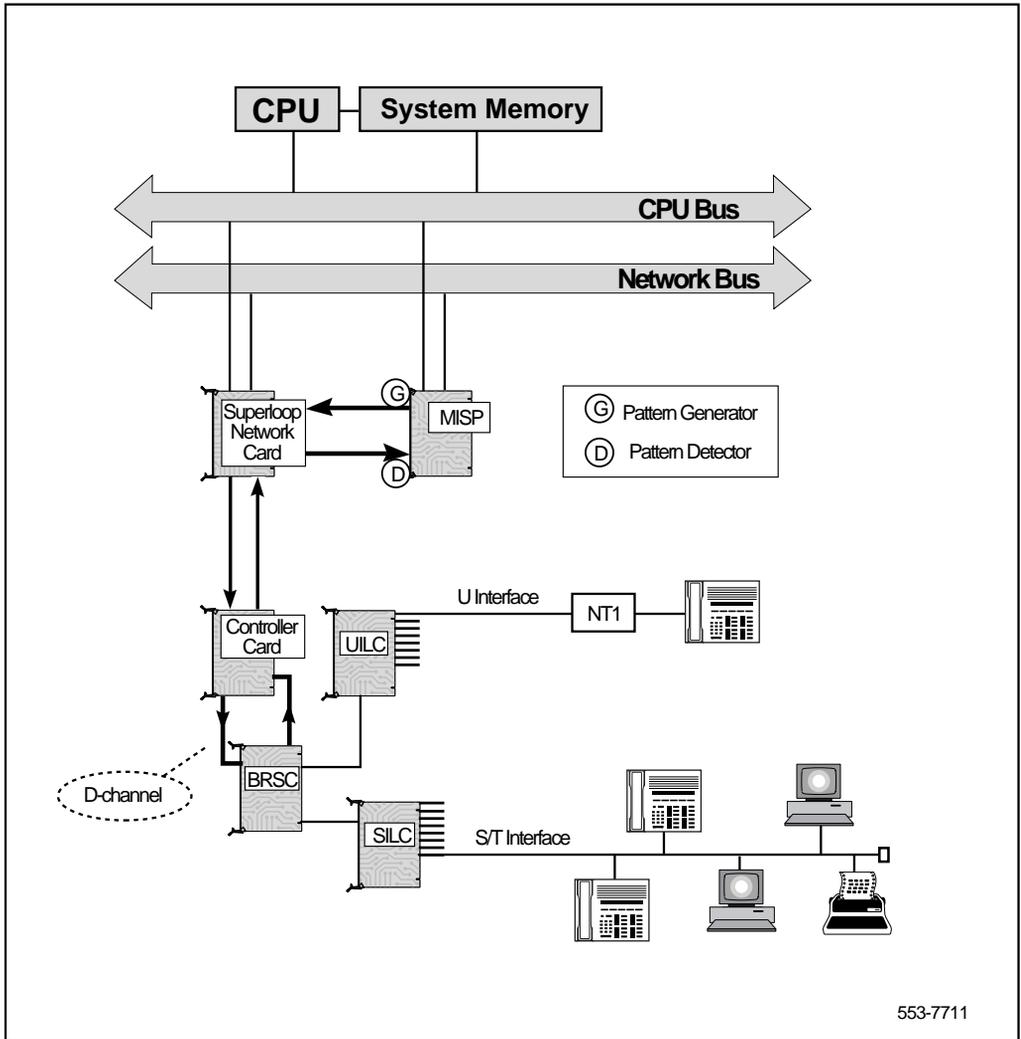
Figure 7
MISP to BRSC loopback test

If the BRSC self-test indicates that the BRSC is not faulty, perform the MISP to BRSC D-channel loopback tests; this tests the signaling channel between the MISP and the BRSC. See Figure 7. The BRSC card must be enabled and the BRSC application disabled to invoke this test.

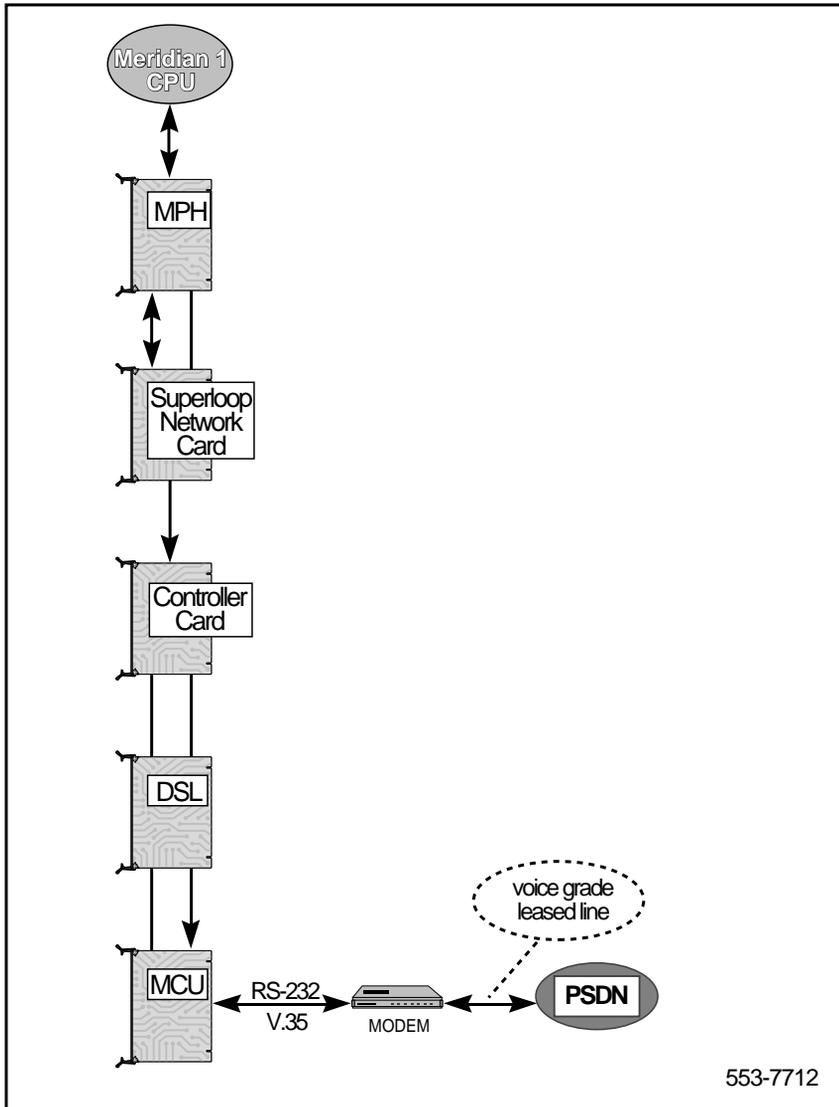
Figure 8
MPH to PSDN continuity test using MCU

Figure 8 illustrates this test which provides loopback testing between the MPH and PSDN through the MCU. The continuity check originates from the MPH through the Superloop network card, the Controller card, the line card, and then responds back at the MCU level. If the MCU was set up originally to operate in transparent mode (64 Kbps or 56 Kbps to the PSDN interface), the connection between the MPH and the MCU must be brought down and then reestablished. To perform this test, the dedicated connection between the MCU and the MPH must be in manually disabled state.

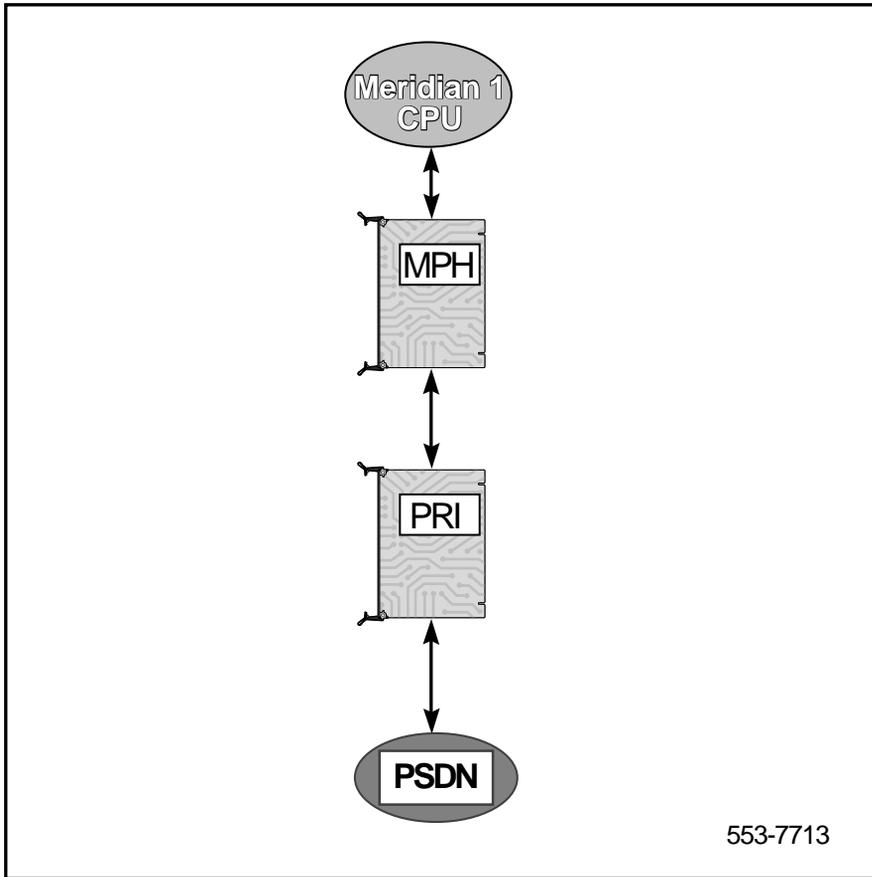
Figure 9
MPH to PSDN continuity test using MCU

Figure 9 also illustrates this test which provides loopback testing between the MPH and PSDN using a PRI connection. To perform this loopback test, the dedicated connection between the PRI and the MPH must be in manually disabled state.

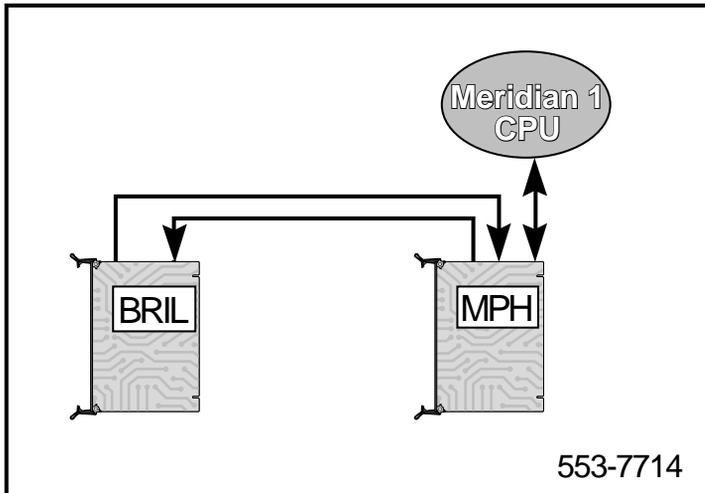
Figure 10
MPH to BRIL continuity test

Figure 10 shows the MPH to BRIL continuity test. The link interface between the MPH and the MISP is a direct path through the network bus without any intervening circuit pack. A test pattern frame is sent from the MPH to the MISP. The MISP, on receiving the test frame, retransmits back to the MPH. To perform this test, the dedicated connection between the BRIL and the MPH must be in manually disabled state.

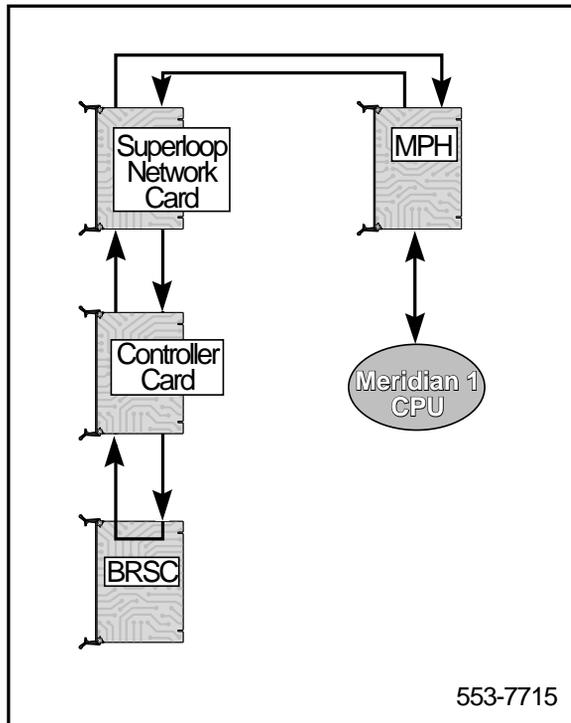
Figure 11
MPH to BRSC continuity test

Figure 11 illustrates the MPH to BRSC test. As in the MISP case, a test pattern frame is sent from the MPH through the Superloop network card to the Controller card and then to the BRSC. Upon receiving the frame, the BRSC retransmits it back to the MPH. To perform this test, the dedicated connection between the BRSC and the MPH must be in manually disabled state.

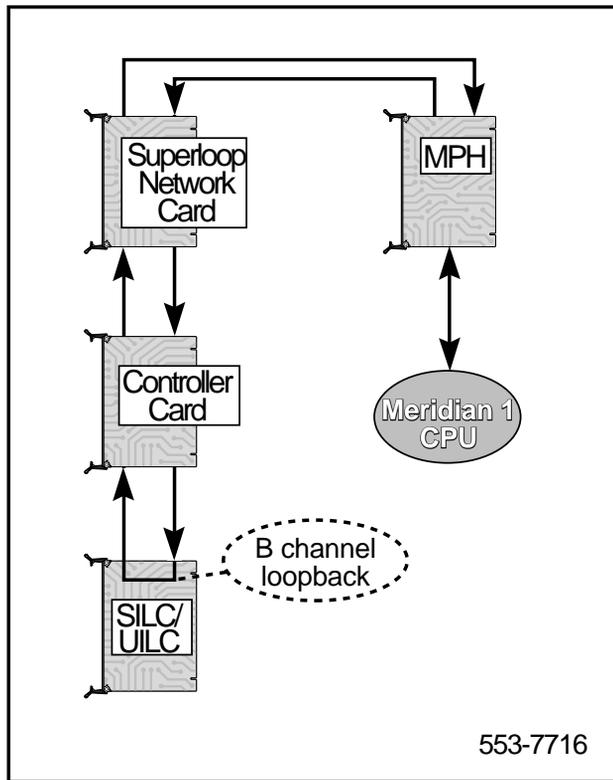
Figure 12
MPH to B-channel continuity test

Figure 12 illustrates the MPH to B-channel continuity test. In the MPH to B-channel continuity test, the Meridian 1 sends a message to the line card placing the B-channel in loopback mode. The continuity test pattern is then transmitted by the MPH, going through the Superloop network card and the Controller card, then looped back at the line card. For the MPH to B-channel test, the dedicated connection between the MPH and the B-channel must be in manually disabled state.

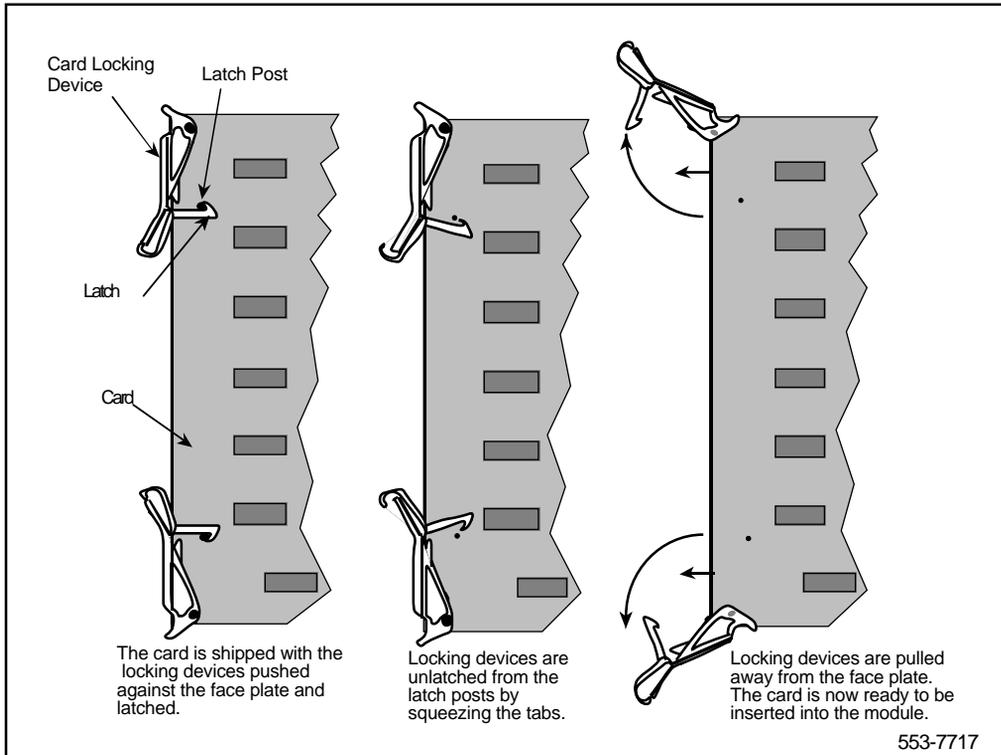
Figure 13
Unlatching the card-locking devices on a card

- 3 When the Type **DISL III** and press the ENTER key to disable the MISP loop, where **III** is the MISP loop number being disabled.
- 4 Unlatch the card-locking devices by squeezing the tabs and pulling the card-locking devices away from the card as shown in Figure 13
- 5 Pull the card out of the module and place it into an antistatic bag away from the work area.

- 3 Unlatch the card-locking devices by squeezing the tabs and pulling the devices away from the card as shown in Figure 13.
- 4 Pull the card out of the module and place it in an antistatic bag away from the work area.

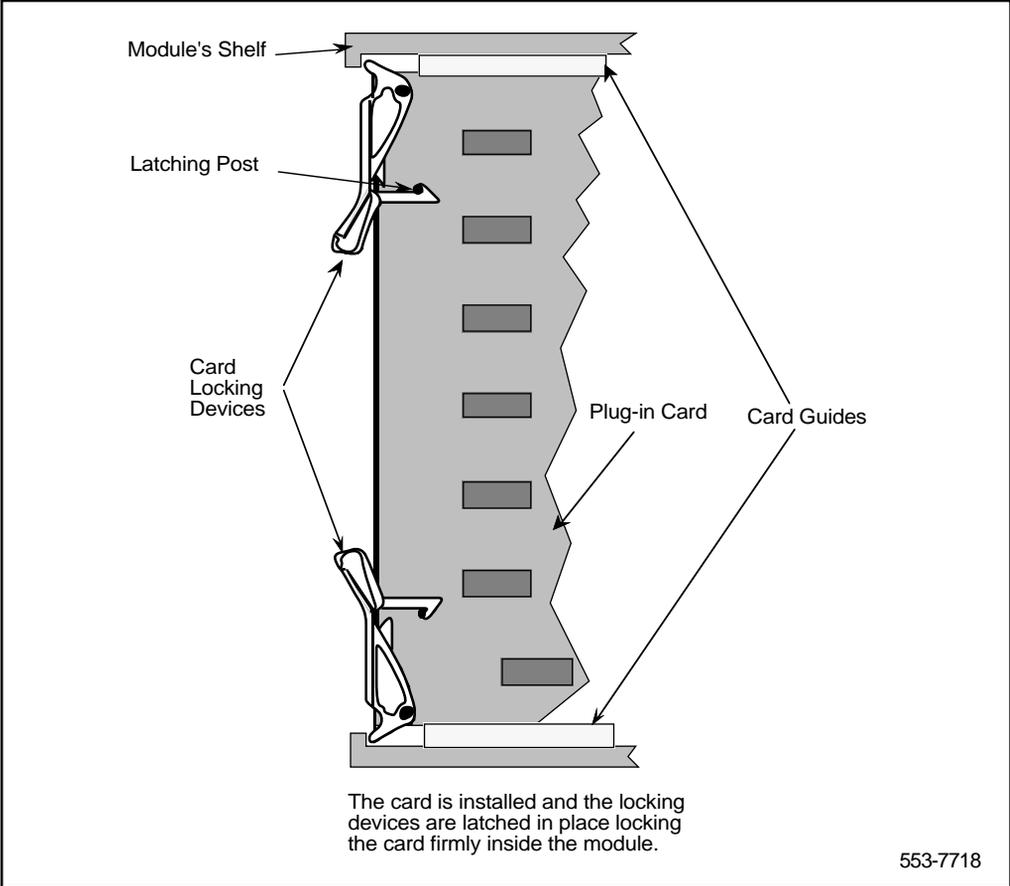
Figure 14
Latching the card-locking devices on a card

- 6 Hold the replacement card by the card-locking devices and insert it partially into the card guides in the module.
- 7 Pull the card-locking devices away from the card faceplate and firmly insert the card into the backplane connector. Press the card-locking devices firmly against the faceplate to latch the card inside the module, as shown in Figure 14. The MISP automatically starts the self-test.

- 5 Hold the replacement card by the card-locking devices and insert it partially into the card guides in the module.
- 6 Pull the card-locking devices away from the faceplate on the card and insert the card firmly into the backplane connector. Firmly press the card-locking devices against the faceplate to latch the card in the module, as shown in Figure 14. The card automatically starts the self-test.
