**Lucent Technologies**  
Bell Labs Innovations

**MultiPoint Control Unit  
(MCU)  
Release 4.0**  
Maintenance

555-027-724  
Comcode 107373193  
Issue 5  
April 1995

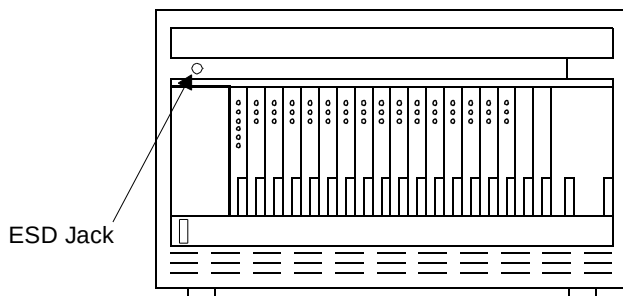
**Figure 5-1. ESD Wrist Strap Grounding Locations**

*Electrostatic discharge can destroy or severely damage integrated circuits or circuit packs. Always wear the ESD wrist grounding strap when handling circuit packs. Connect the wrist strap to one of the metal tabs located on the lower left or right side of one of the carriers.*

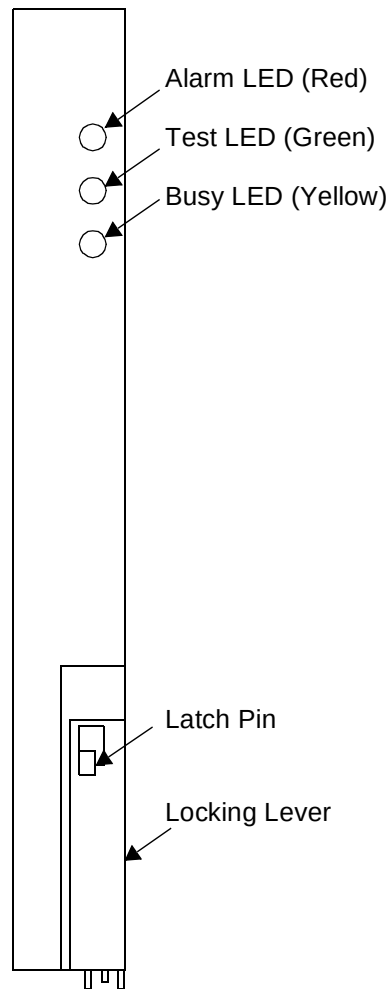
**Figure 5-2. Typical TN-Coded Circuit Pack**

1. Push the unseated circuit pack back into the backplane connector.
2. Lift the locking lever until the pin engages.

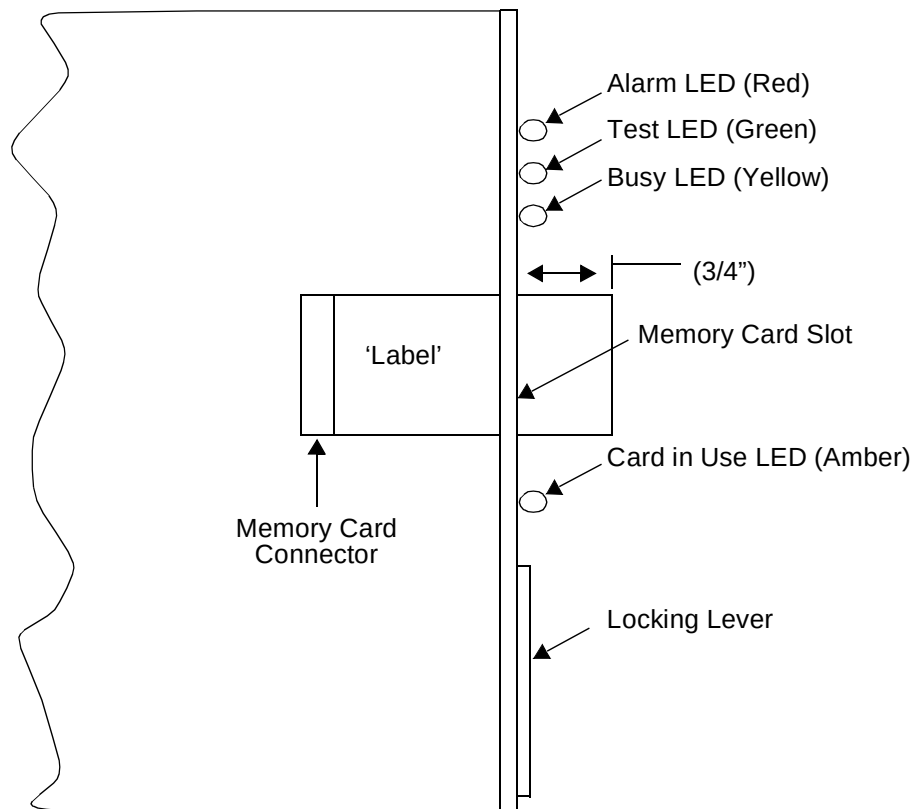
**Figure 5-3. Inserting a Memory Card**

3. Gently push the card forward until you feel some resistance at the opposite edge of the card.
4. When the card is fully inserted, about 3/4 inch of the card should still appear outside the memory card slot.
5. Confirm that as you are facing the circuit pack, the memory card label is facing to your left. If it is not, remove the card and start again.
6. Test the memory card by entering **test card-mem** (see CARD-MEM in Chapter 8, "Maintenance Object Repair Procedures").

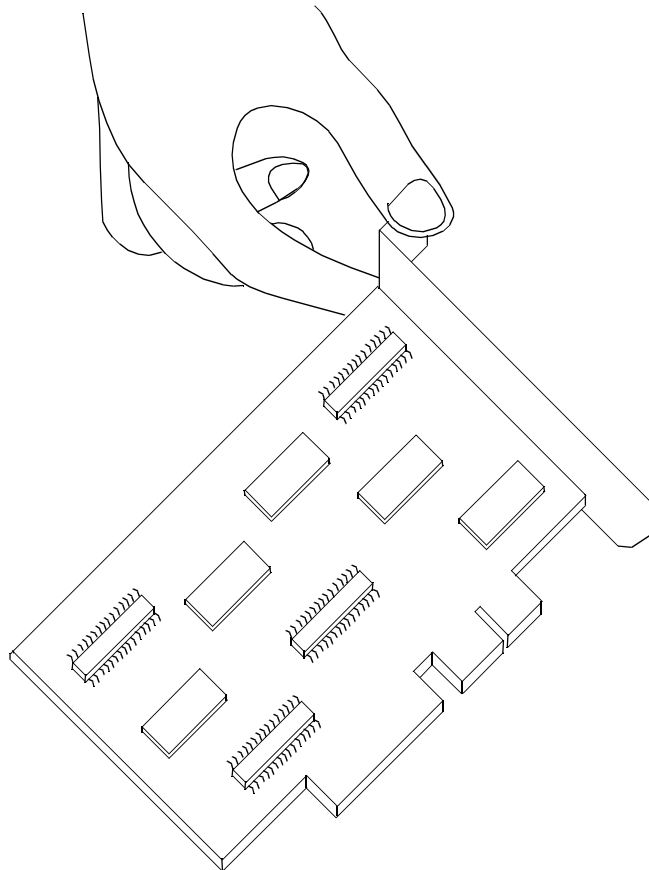
**Figure 5-6. Holding a Short Circuit Card**

- Handle ESD-sensitive circuit cards only after you attach a ground wrist strap to the bare skin of your wrist. Attach the other end of the wrist strap to a ground that terminates to the system ground, such as an unpainted metallic chassis surface.
- Handle a circuit card by the faceplate or side edges only. Do not touch components, leads or connector areas (gold finger pins).
- Hold a short circuit card by the faceplate only. See the following figure.

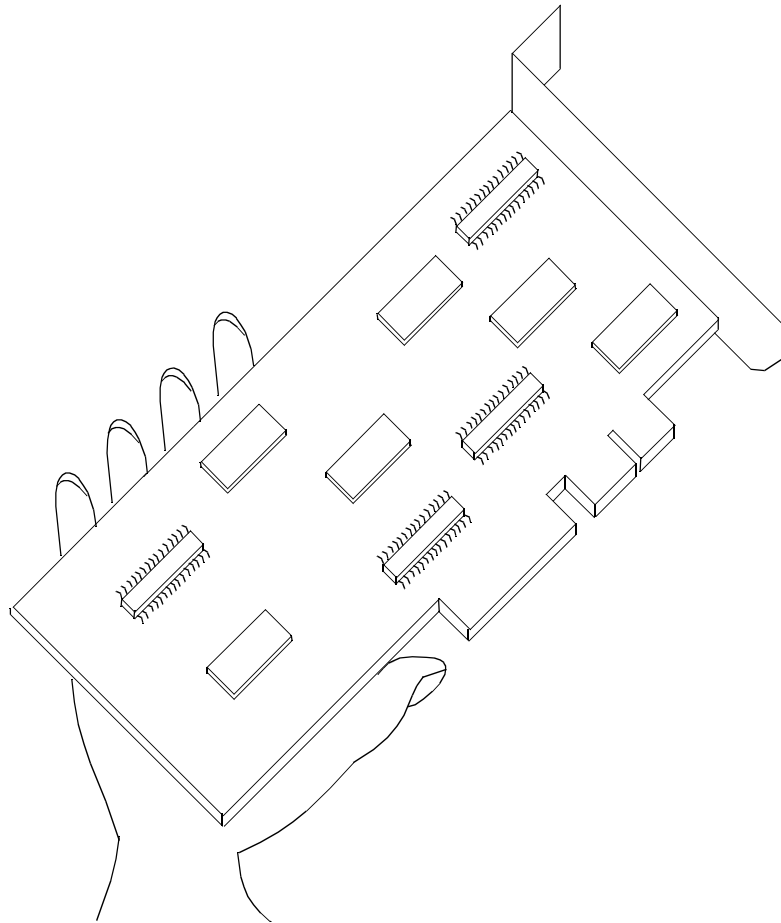
**Figure 5-7. Holding a Large Circuit Card**

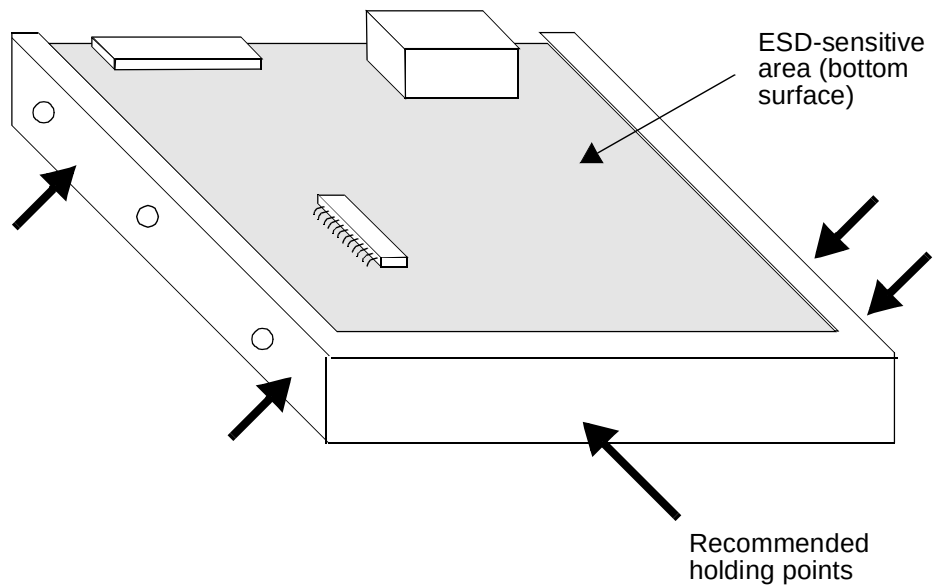
The ESD-sensitive area of these components is located on the bottom surface. Hold these drives on the areas recommended in the following figure.

**Figure 5-8. Electrical Component ESD-Sensitive Area**

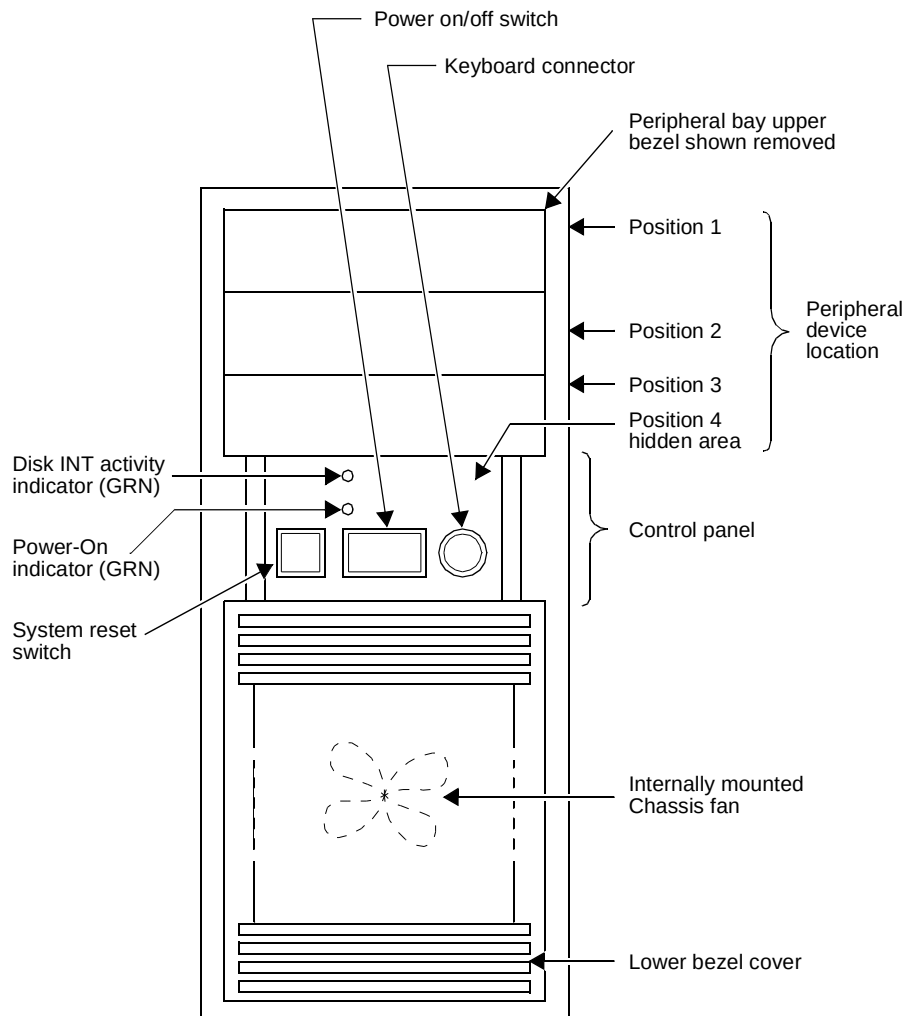
**Figure 5-9. Front View of the ESM**

| <b>Component</b> | <b>Location</b> | <b>Description</b> | <b>Function</b> |
|---|---|---|---|
| bezel cover | lower | — | covers air intake and holds air filter |

Even though a second keyboard receptacle is located on the rear of the chassis, the front receptacle is provided as an ease-of-use option.

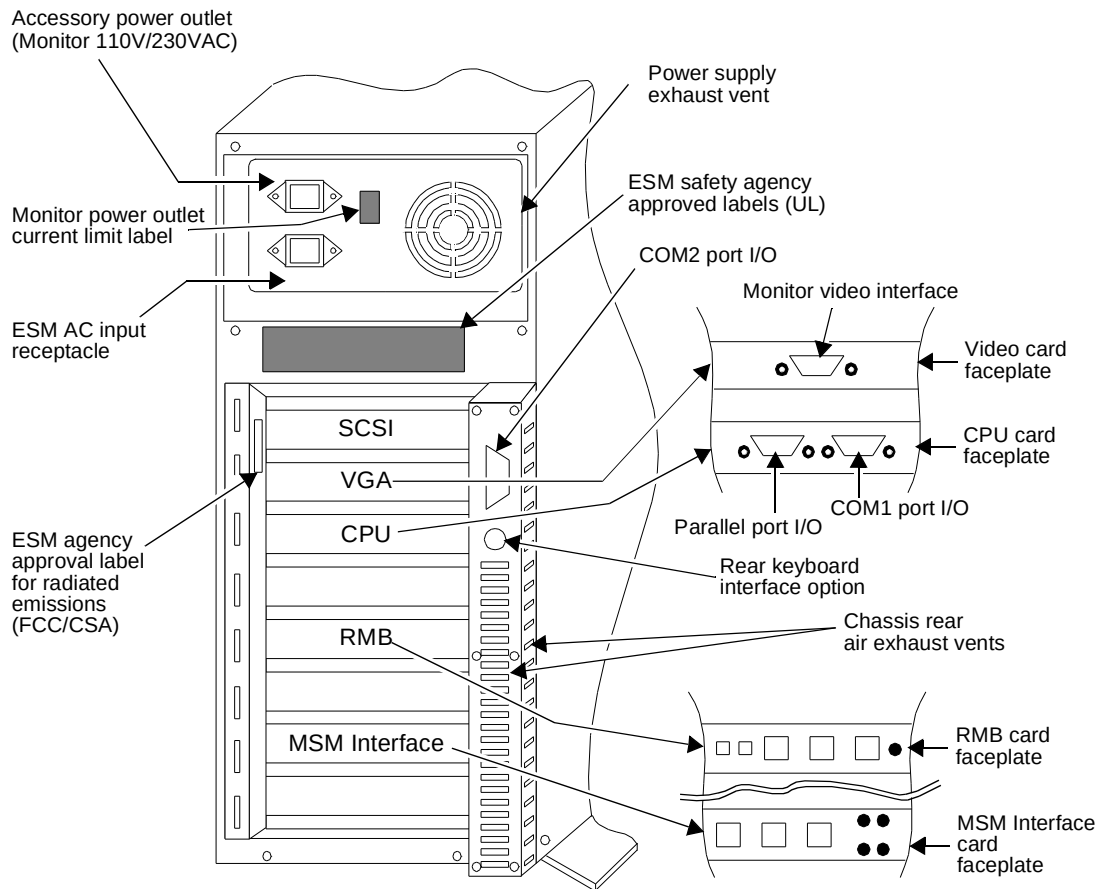
**Figure 5-10. Back View of an AC-Powered ESM**

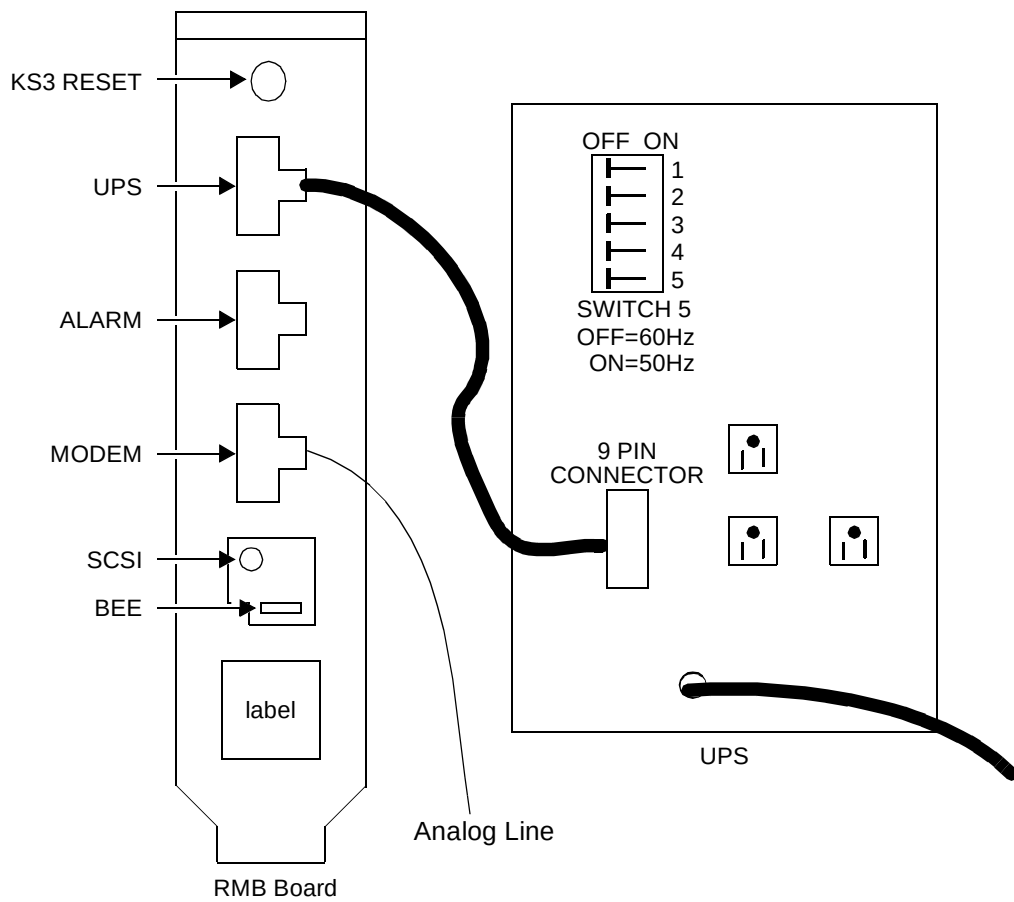
**Figure 5-11. Connection of RMB to UPS**

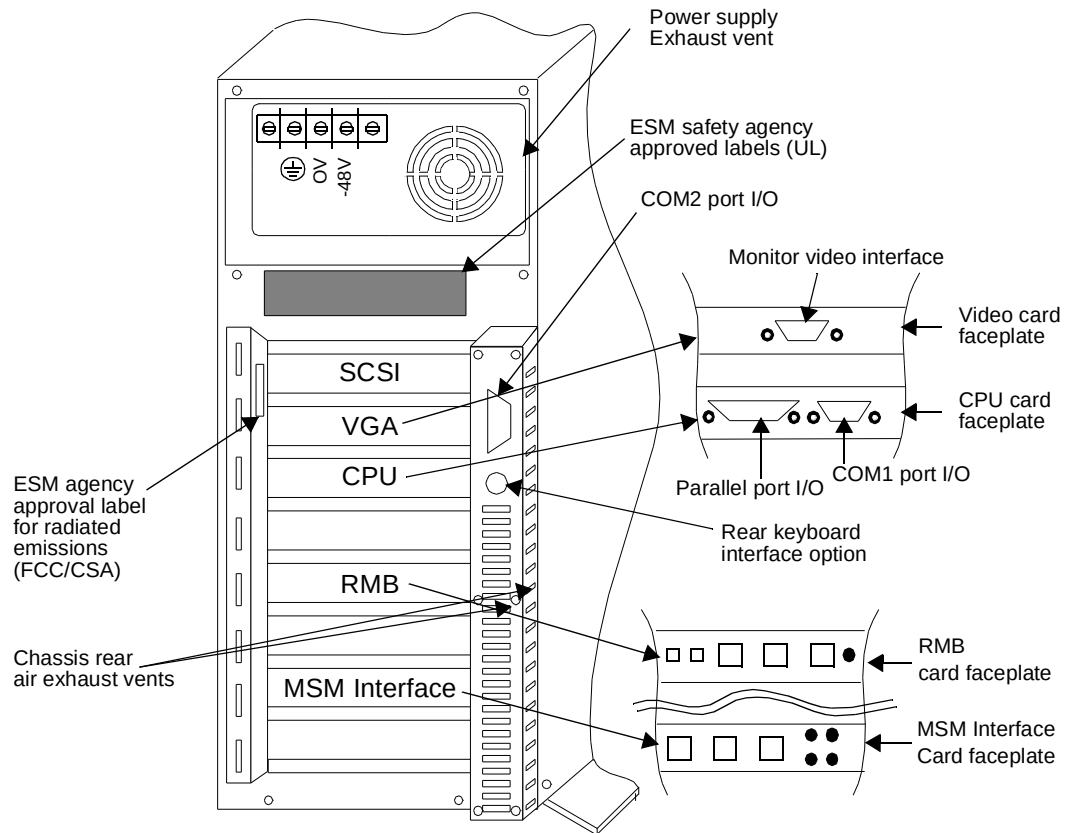
**Figure 5-12. Back View of a DC-Powered ESM**

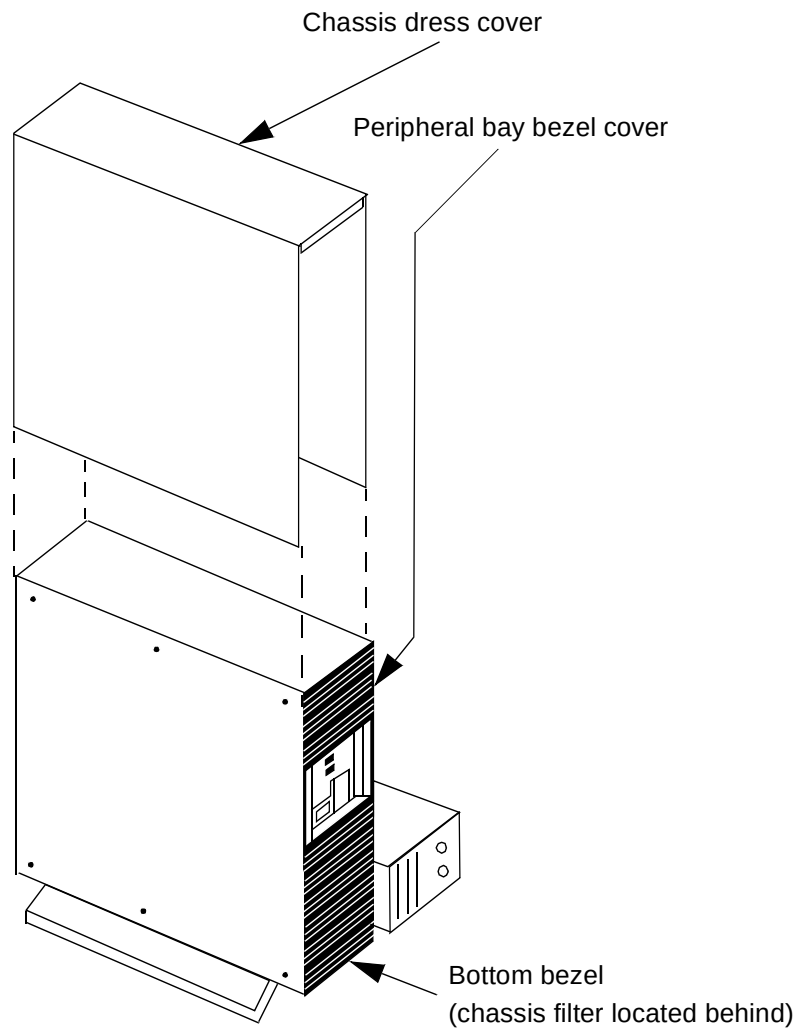
**Figure 5-13. Removing the Dress Cover**

1. In a tower configuration, keep the EMS in an upright, vertical position on the support base.
2. Locate the two screws on the left side and right side corners of the chassis cover.
3. Remove the two screws on the right side of the chassis, and remove the two screws on the left side of the chassis.
4. Place one hand on each side of the chassis, with the palm down toward the top edge.
5. Press inward slightly with your palms on both sides of the chassis and lift it up.
6. Be aware that, as more of the dress cover is removed, it may begin to collapse inward from the pressure of your hands. In such a case, move your hands downward on the dress panel to reduce the pressure of your lift.
7. Remove the dress cover.

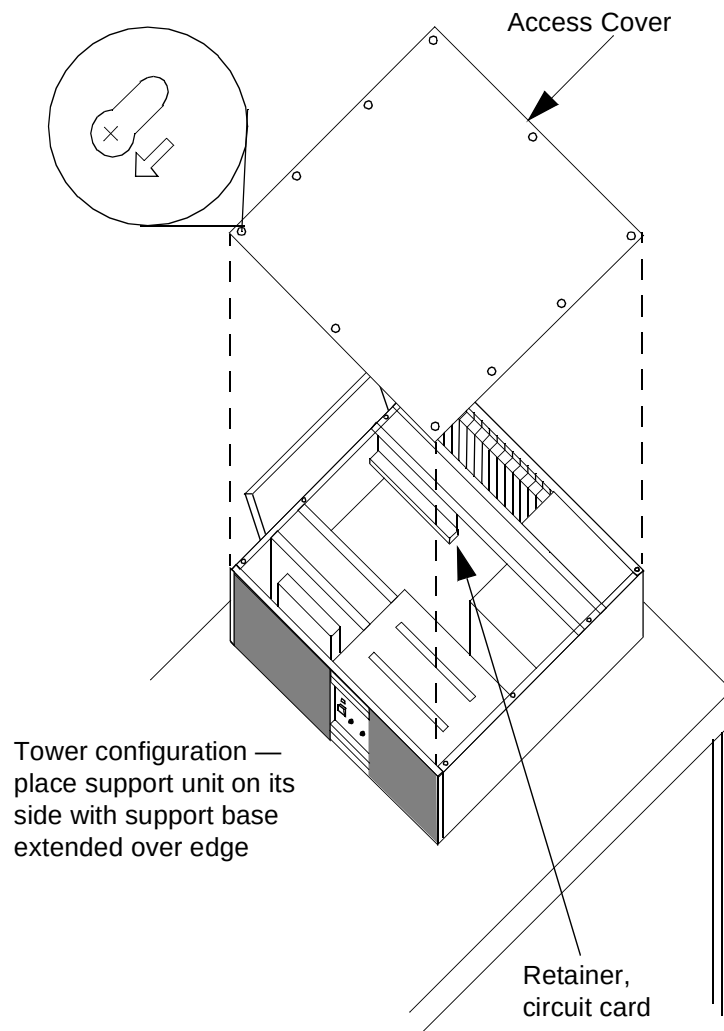
**Figure 5-14. Removing the Access Cover**

Adequate clearance only should be provided. It is *not* necessary to remove the screws.
3. Apply pressure gently with your hands, palms down on the access cover.
4. Push into the chassis with your palms and slide the access cover back toward the chassis area.
5. Lift up and remove the cover once you have cleared the Phillips screw heads.

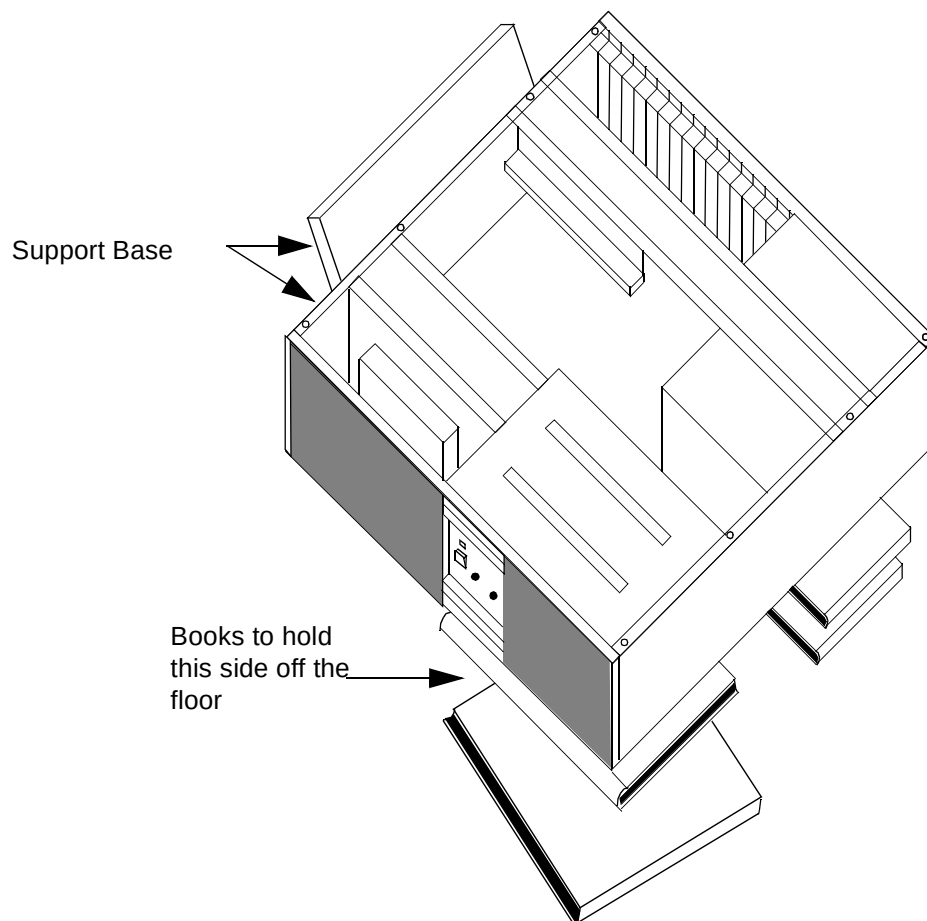
**Figure 5-15. Working Within the Card Cage**

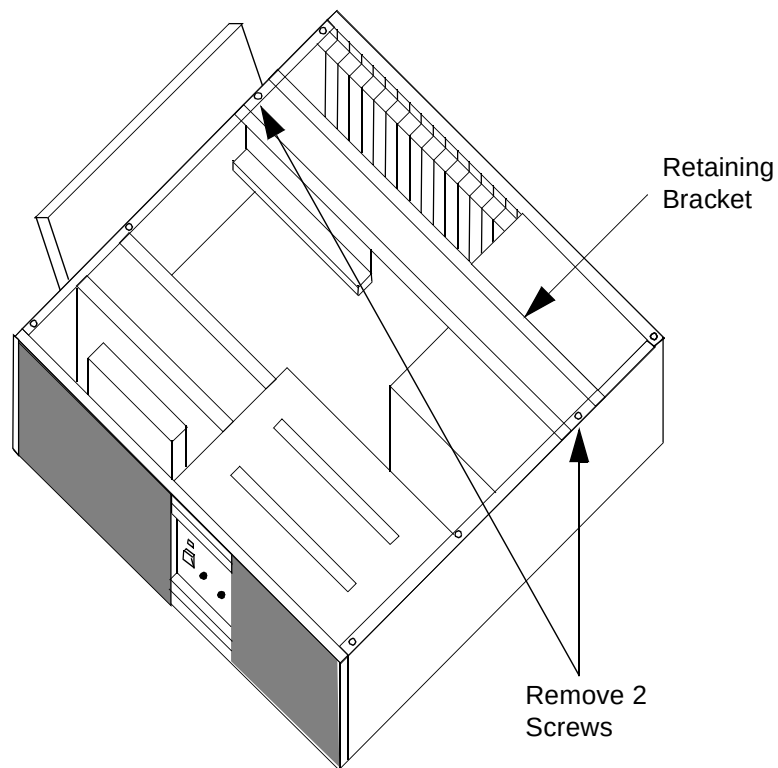
The manufacturer equips the ESM card cage with a retainer to reduce shipping and environmental vibrations that could damage the circuit cards. To remove the retaining bracket, use a #2 Phillips screwdriver to remove the two hold down screws in the retaining bracket. See the following figure.

**Figure 5-16. Removing Screw in Retaining Bracket**

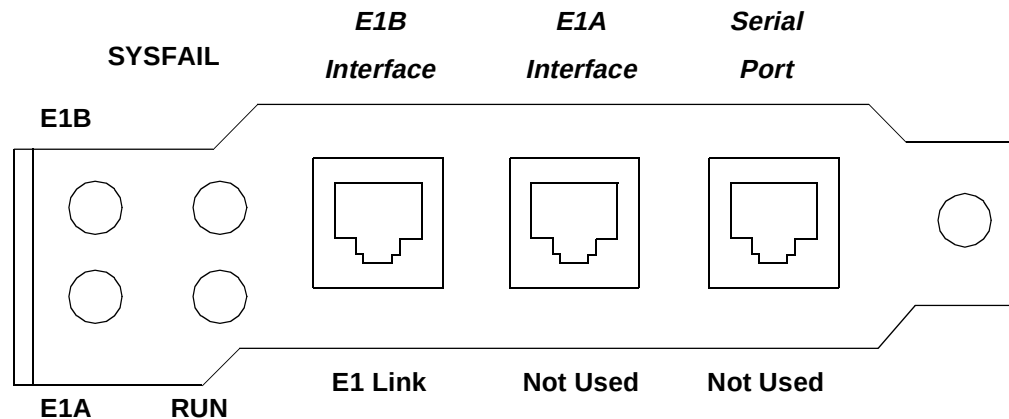
Figure 5-17. Rear Bracket of the MSM Interface Card

For more details on LEDs, refer to Chapter 7.

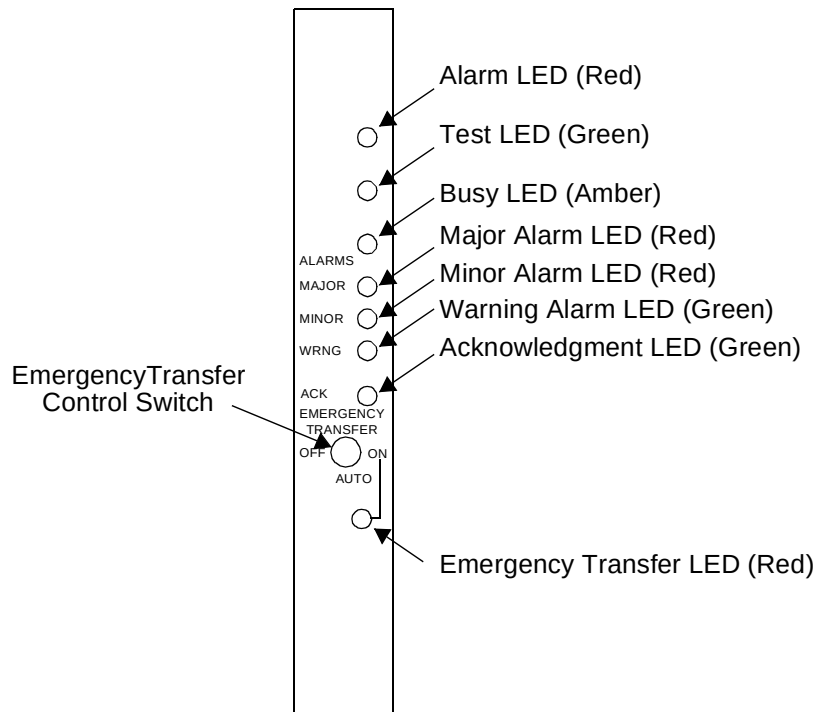
† Alarms on the PROCR, MEMORY, and PR-MAINT MOs are indicated by the first red LED on the processor circuit pack.

**Figure 7-1. LEDs on the Processor Circuit Pack**

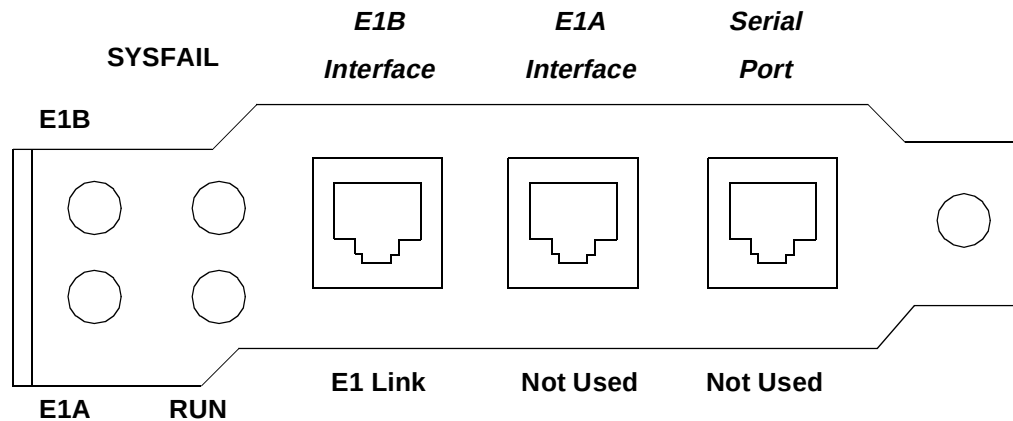
The following figure illustrates the LED arrangement on the back of the MSM Interface Card.

**Figure 7-2. Rear Bracket of the MSM Interface Card**

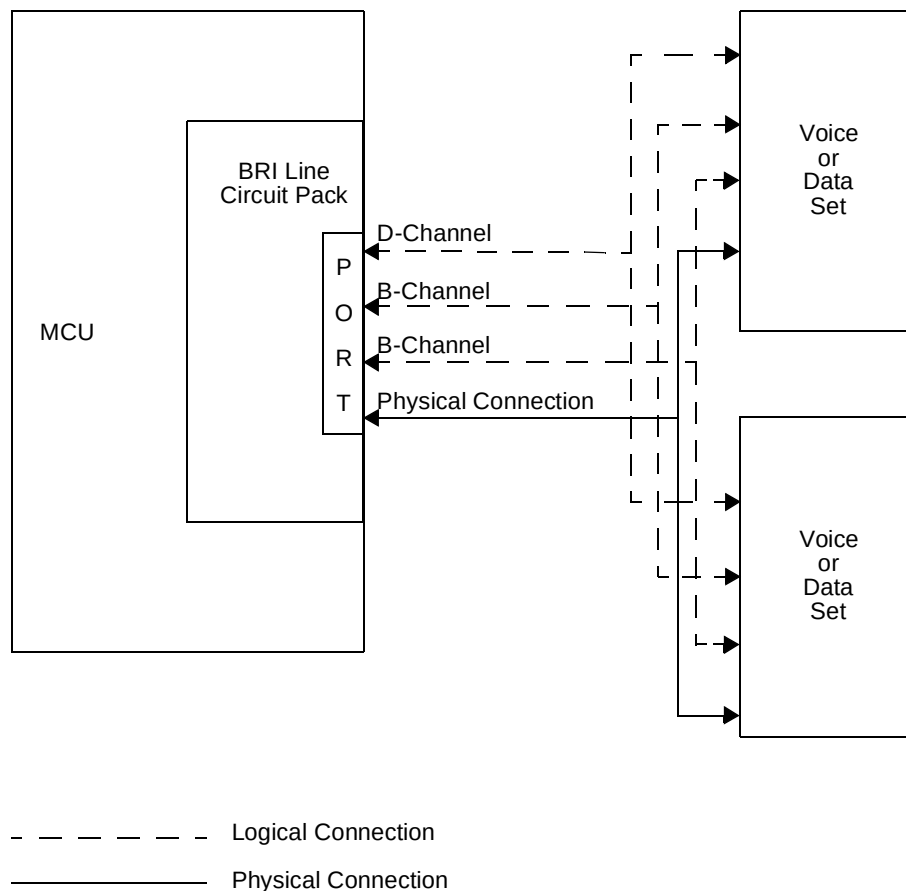
The following figure illustrates the physical connection (solid line) between an ISDN-BRI Port and its associated ISDN-BRI set(s). Each physical connection allows for two B-channels and one D-channel. Each ISDN-BRI circuit pack can support up to 12 of these *physical* connections to different voice and voice/data sets.

**Figure 8-1. ISDN-BRI Port Interactions**

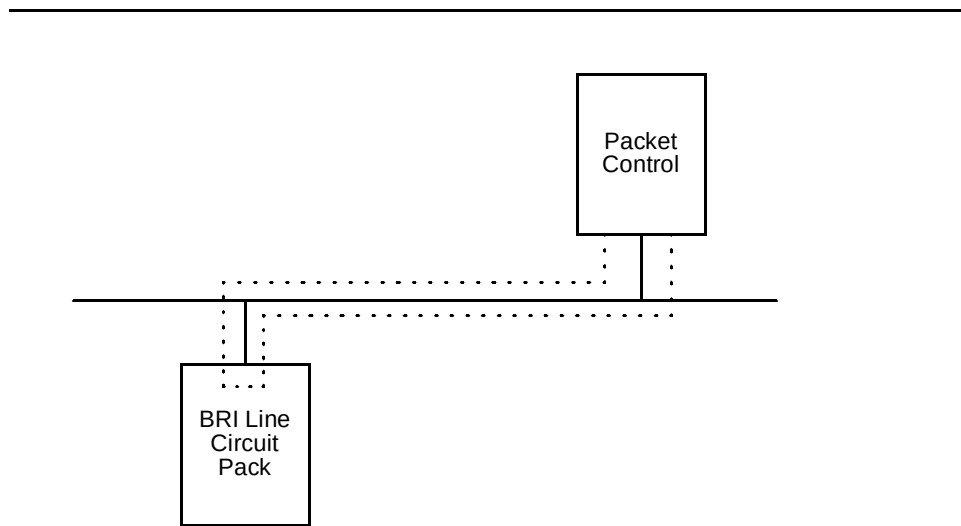
The dotted lines in the following figure show how a Loop-Around Test is performed across the Packet Bus for the D-channel.

**Figure 8-2. Path of the BRI Port LAN Loop-Around**

This test, which verifies the connectivity of a BRI port across the LAN Bus, executes only if the port is out-of-service. The test aborts if calls associated with the port are in-progress. Failures of this test indicate either on-board faults associated with the BRI-PORT hardware on the circuit pack, or problems with the LAN Bus, which is used to form connectivity between the switch and the BRI-PORT.

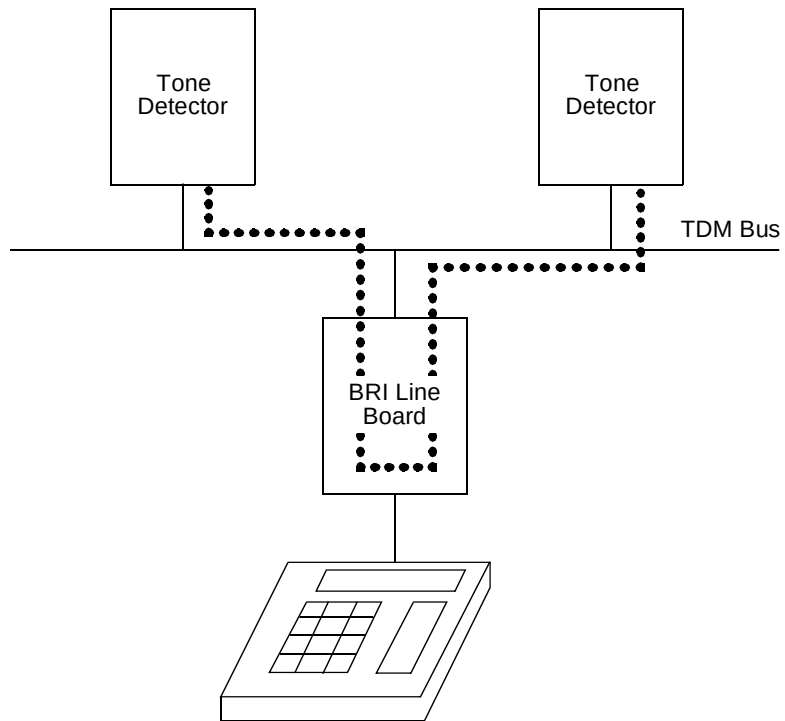
The dotted lines in the following figure show how a Loop-Around Test is performed for the B-channels.

**Figure 8-3. Path of the BRI Port Local TDM Loop-Around**

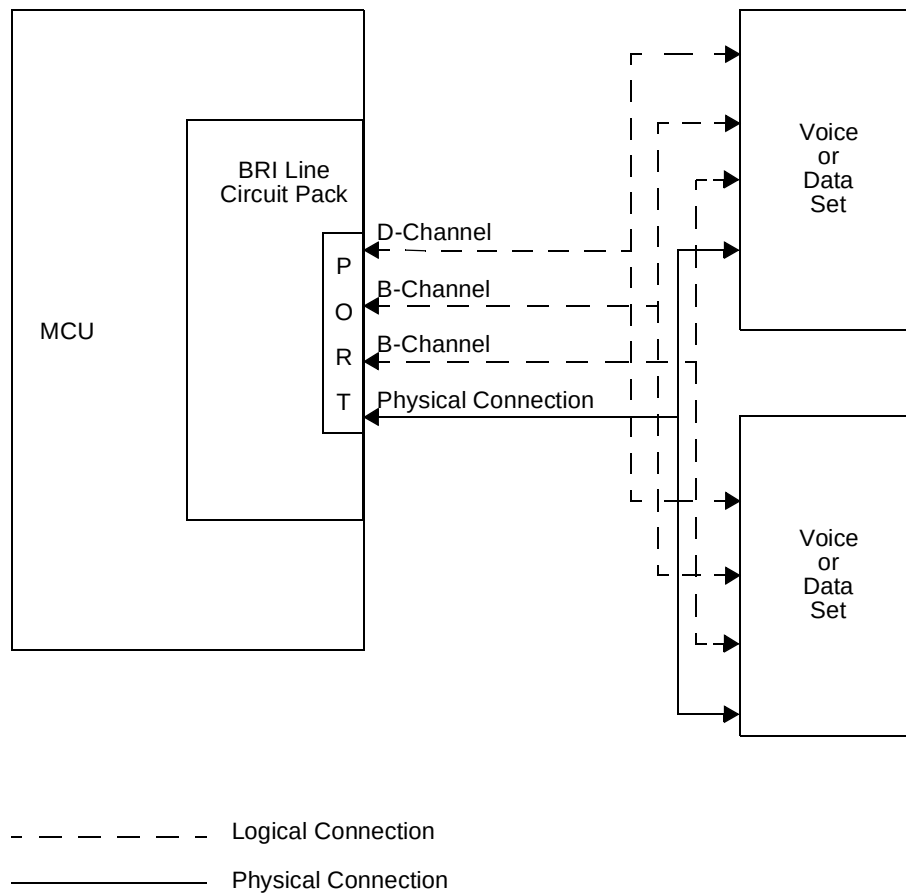
The following figure illustrates the physical connection (solid line) between an ISDN-BRI circuit pack and a voice or voice/data set. Each physical connection allows for two B-channels, as stated previously, plus one D-channel. Each ISDN-BRI circuit pack can support up to 12 of these physical connections to different voice and voice/data sets.

**Figure 8-4. ISDN-BRI Set Interactions**

ISDN-BRI endpoints come in a number of configurations. All endpoints require the D-channel to convey signaling information to the switch. A voice-only set requires only one B-channel. A voice and data-capable set requires both B-channels (one for voice and one for data). Therefore, each TN556 port can support either two voice-only sets or one voice and data-capable set.

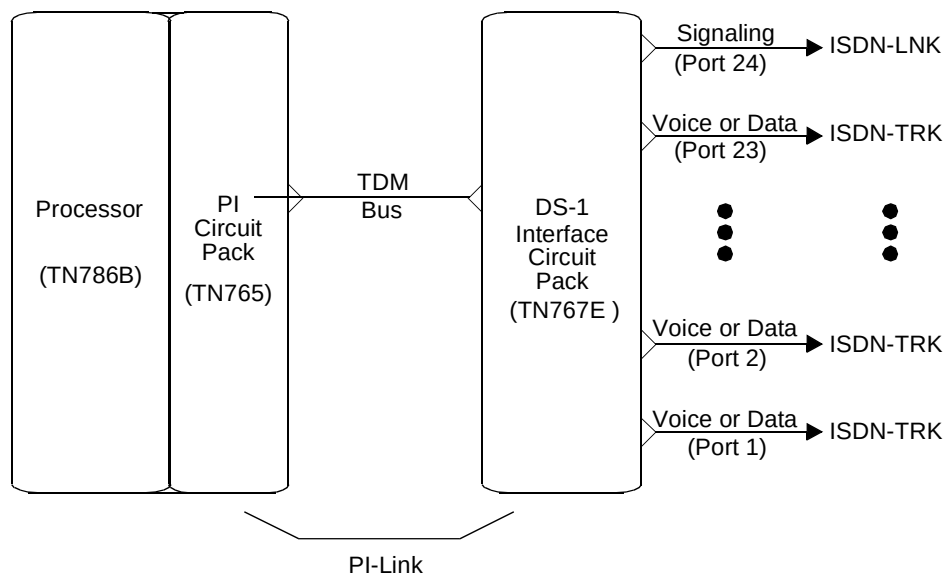
ISDN-LNK handles maintenance and recovery for the D-channel port on the DS1 (UDS1) carrying the signaling link. A problem with the ISDN-PRI Signaling Link Port (D-channel) affects all of the associated DS1 (UDS1) ISDN trunks (B-channels) since no call control information can be conveyed to the far-end switch without it. Stable calls may remain operational, but no new calls can be made.

**Figure 8-5. ISDN-PRI Signaling Link Port Interactions (24 Channels)**

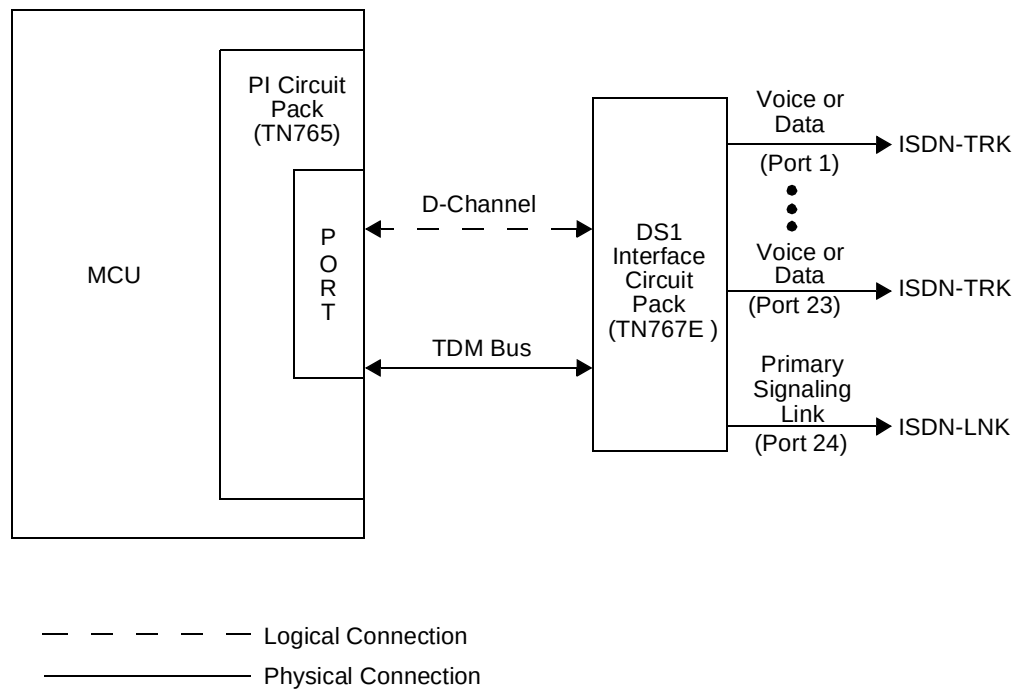
The figures following this section illustrate each of the configurations. In an FAS signaling group, the 24th port or the 15th port of the DS1 Interface circuit pack is always the D-channel that carries signaling information for other ports (B-channels) on the circuit pack.

**Figure 8-6. FAS ISDN-PRI Signaling Group (24 Channels)**

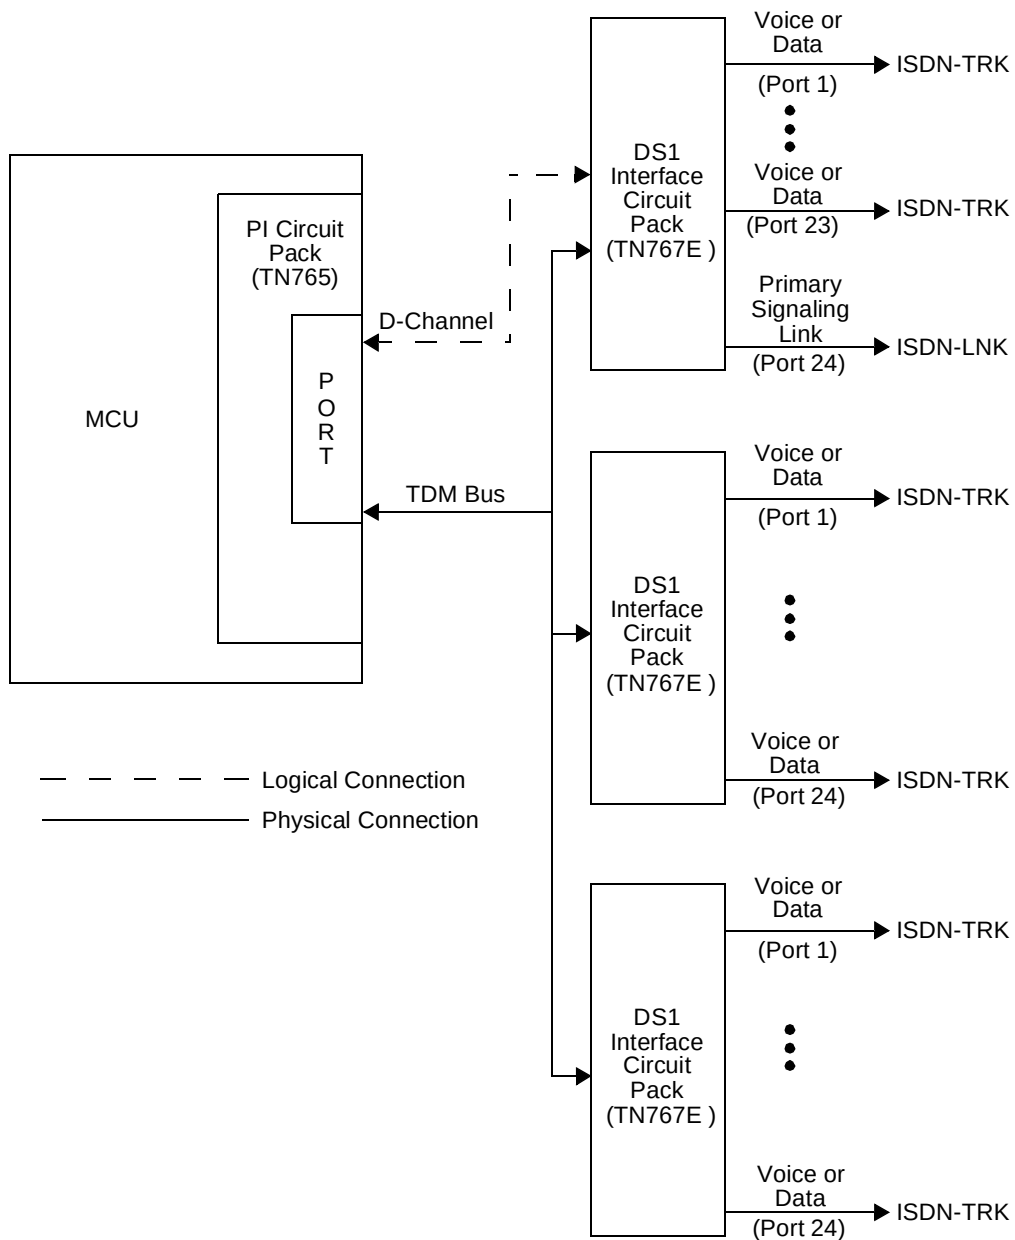
In an NFAS signaling group, the 24th port of a DS1 Interface circuit pack (for 24 channels) is administered as a D-channel. The D-channel carries signaling information for other ports (B-channels) on that circuit pack. That D-channel can also carry signaling information for any of the ports on other DS1 Interface circuit packs in the NFAS signaling group.

**Figure 8-7. NFAS Simplex ISDN-PRI Signaling Group (24 Channels)**

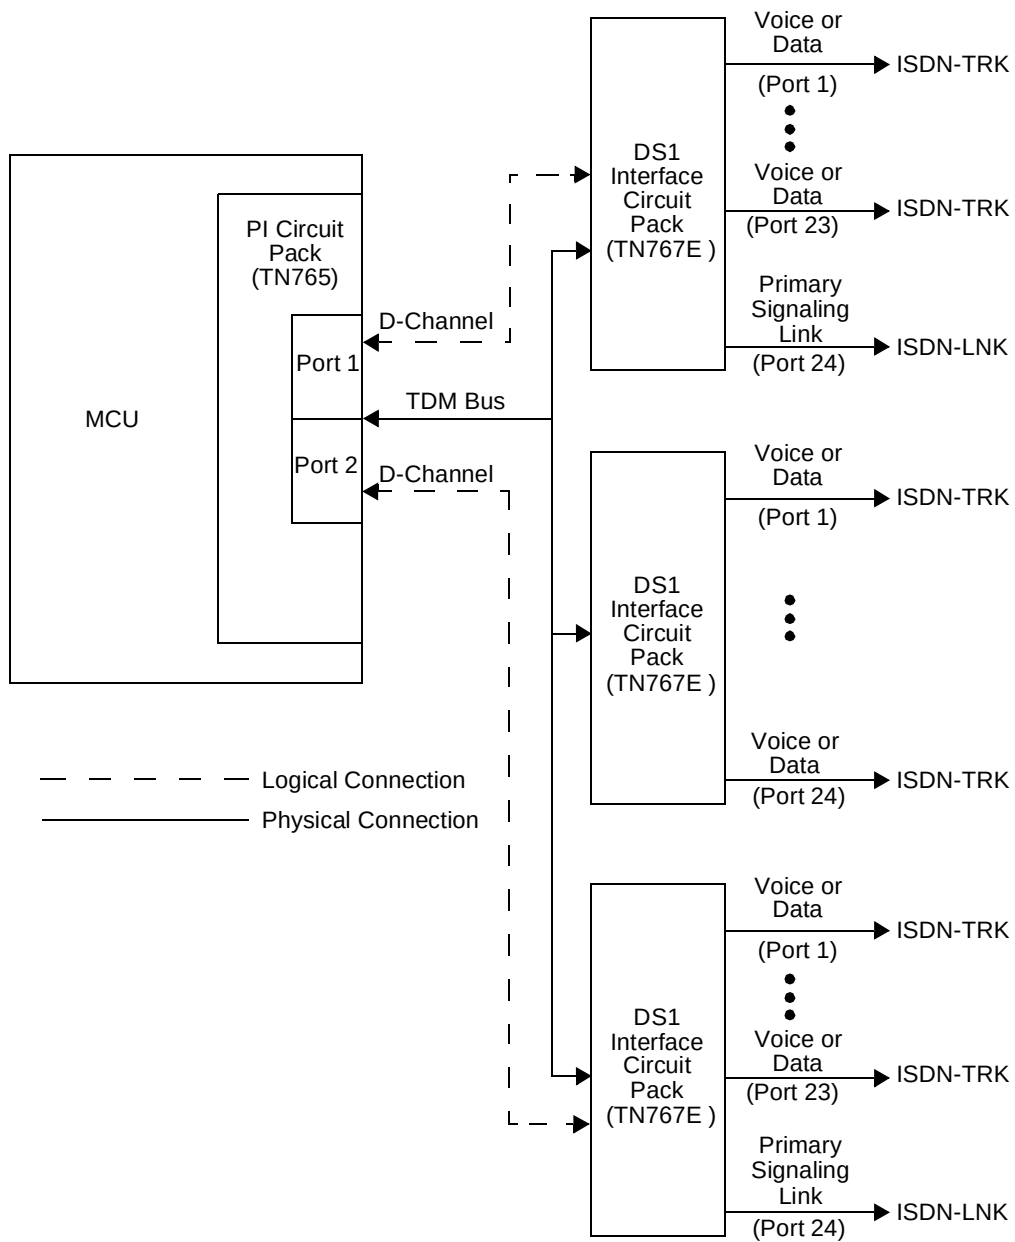
In addition to NFAS simplex, another type of NFAS group is called NFAS duplex. This provides the user with more reliability, which is desirable because NFAS permits the D-channel to signal for so many B-channels. NFAS duplex allows the administration of a backup D-channel, which remains in a standby state until the

active D-channel goes down. If the active D-channel does go down, the backup D-channel takes over and provides signaling for all the B-channels in the signaling group.

**Figure 8-8. NFAS Duplex ISDN-PRI Signaling Group (24 Channels)**

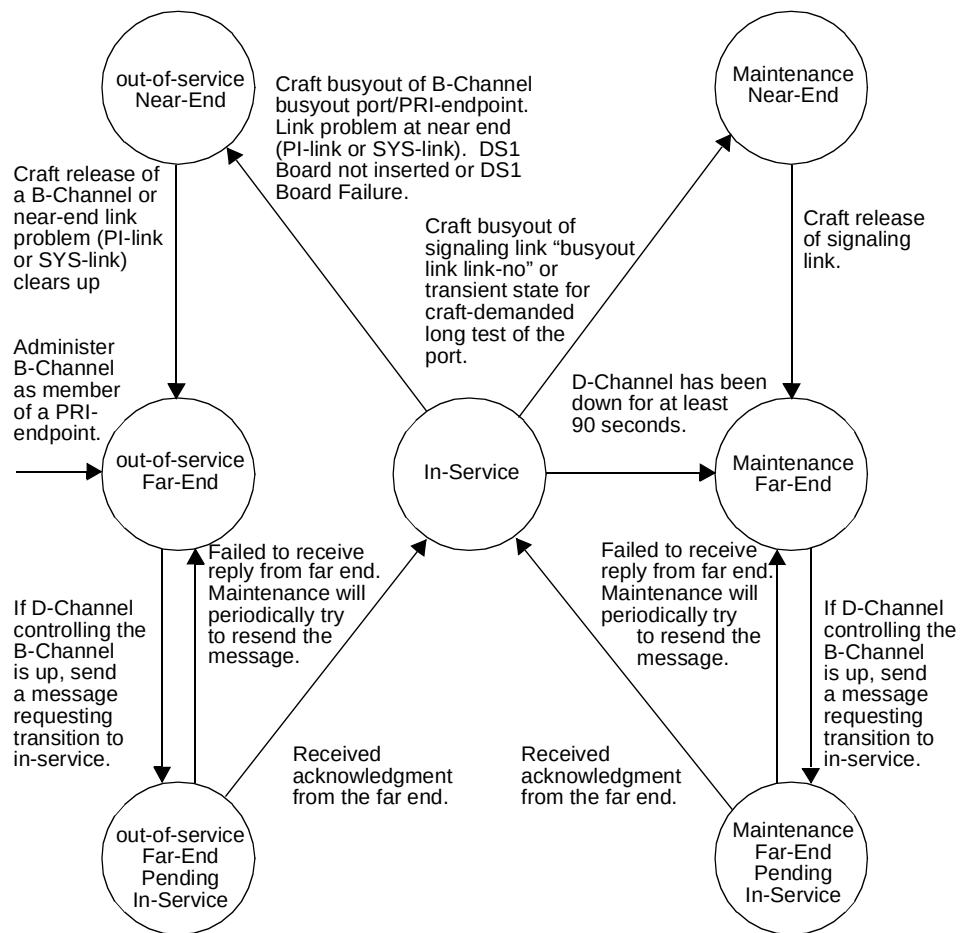
The following figure of the DS1 ISDN trunk service states shows the common progression from one service state to another and the event that caused the change of state.

**Figure 8-11. Common Progressions in Service States**

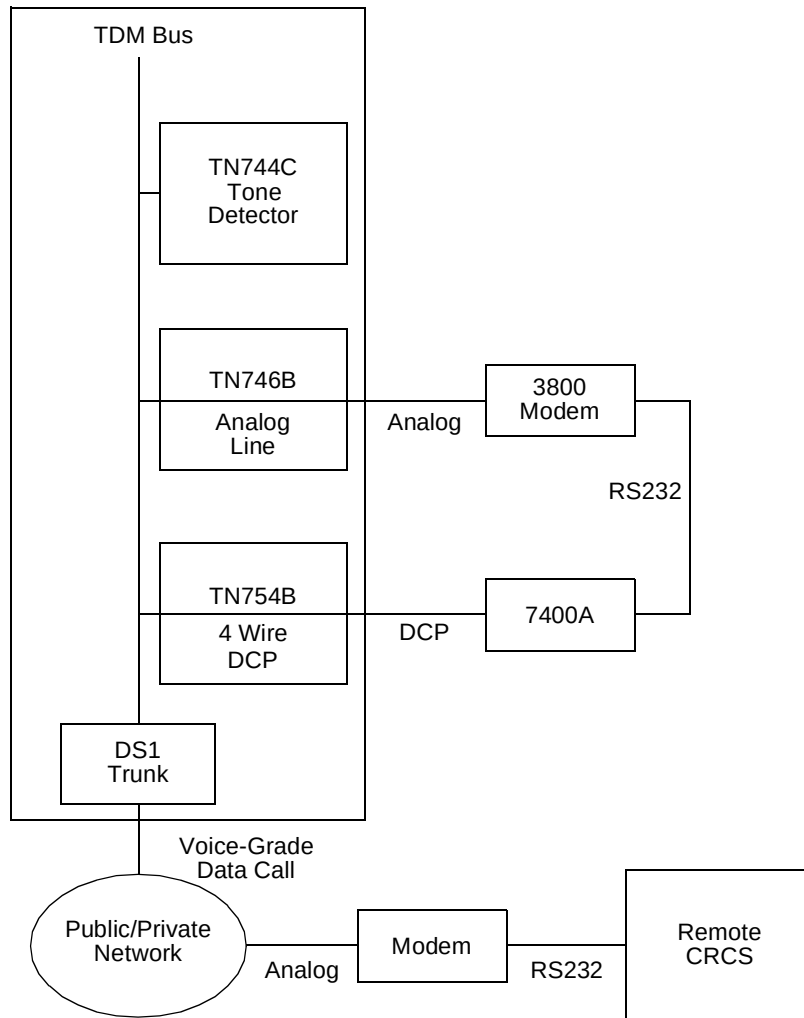
A number of modem pool conversion resources may be available in the MCU. Each such resource is assigned to one of five available Modem Pool Groups. Only one conversion resource is used per data connection. Whenever a local data call originates from an analog port normally used for voice service only and terminates on a digital port, a Data Origination access code must be dialed before the extension number for the Modem Pool conversion resource to be included in the connection.

**Figure 8-12. MCU/CRCS Combined Modem Pool Configuration**

Digital Line or Trunk port associated with the Data Module in the connection. The analog modem signals enter the analog port of the conversion resource in standard Pulse Code Modulation (PCM) format. Subsequently, they are converted to Data Communications Protocol (DCP) format before going to the Digital Line or trunk in the connection.

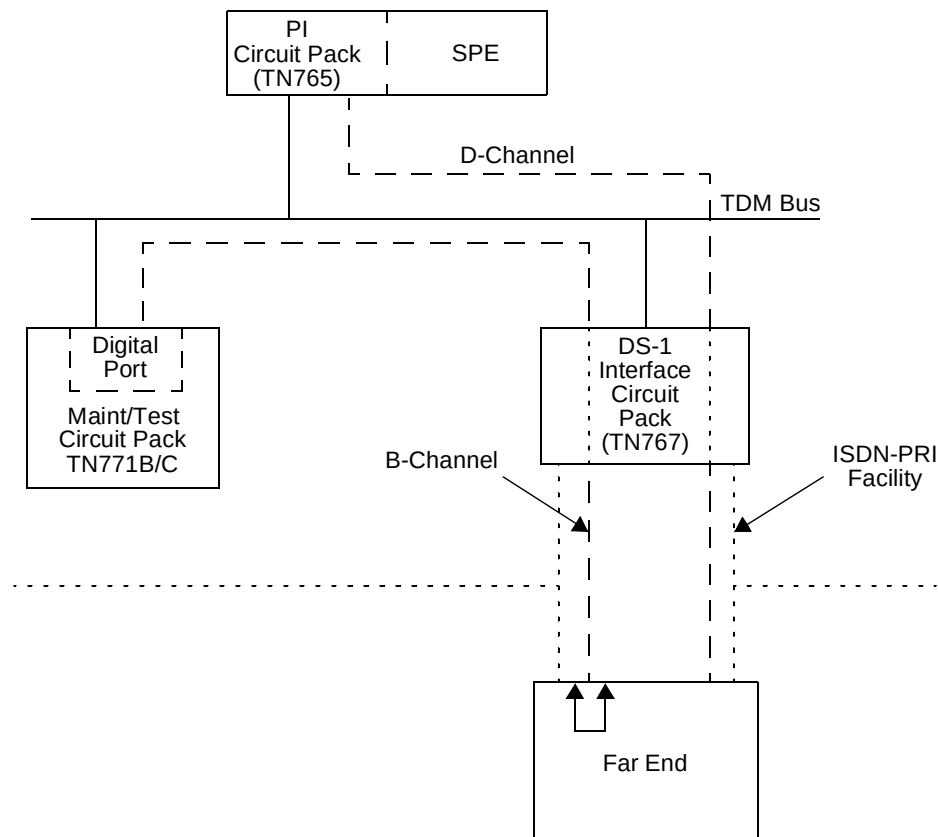
**Figure 8-13. ISDN-PRI Outgoing Test Call**

An alarm on the Maintenance/Test Digital Port reduces service, but it does not block service since the ISDN-TRK has other means to determine the health of the ISDN-PRI trunk facility. However, to measure the error performance accurately and to ensure accuracy of the health of the ISDN-PRI trunk, the Maintenance/Test circuit pack should be replaced when a new circuit pack is available.
