**Lucent Technologies**  
Bell Labs Innovations

**MultiPoint Control Unit  
(MCU)  
Release 4.0**  
Maintenance

555-027-724  
Comcode 107373193  
Issue 5  
April 1995

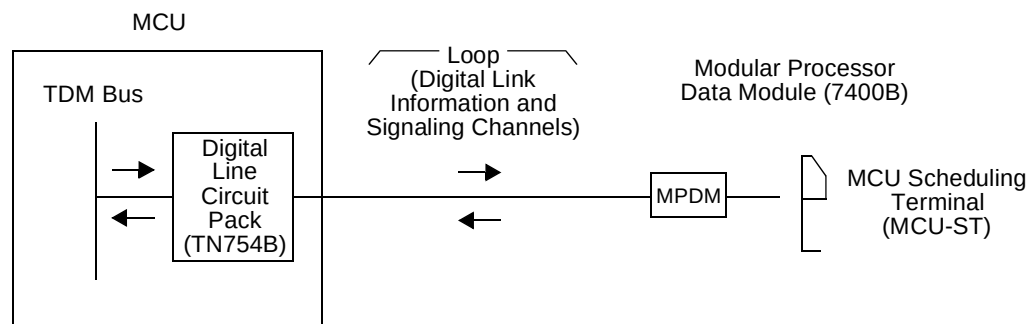
Data modules provide an interface between the system TN754B Digital Line circuit pack and data equipment, such as terminals, host computers, and modems. Data modules are used for both dial-up and permanent circuit-switched data calls.

**Figure 8-14. Typical Data Module Application**

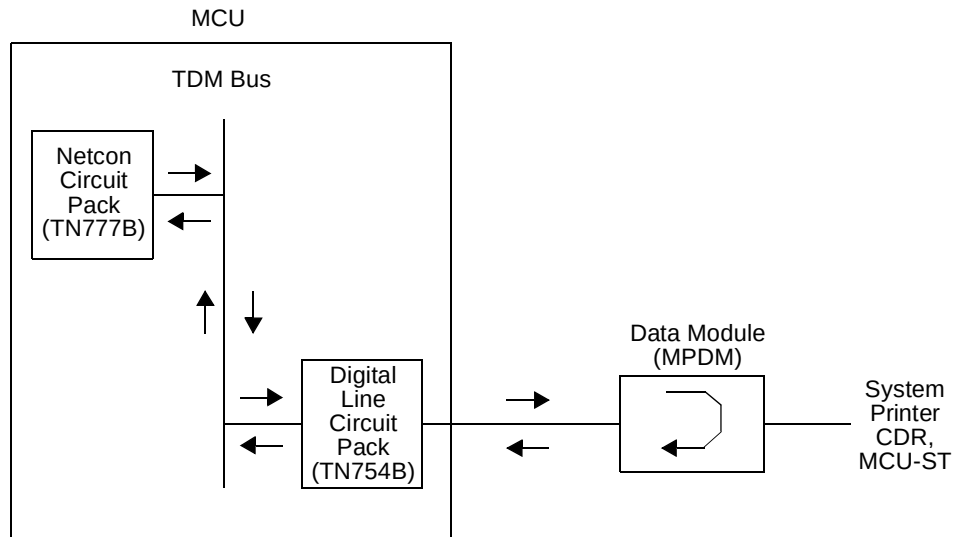
This test verifies that a data message can be sent from the MCU, through the building wiring, through an internal loop-around path in the data module under test, and back to the MCU. The following figure shows the hardware configuration used for this test.

**Figure 8-15. Internal Loop-Around Test**

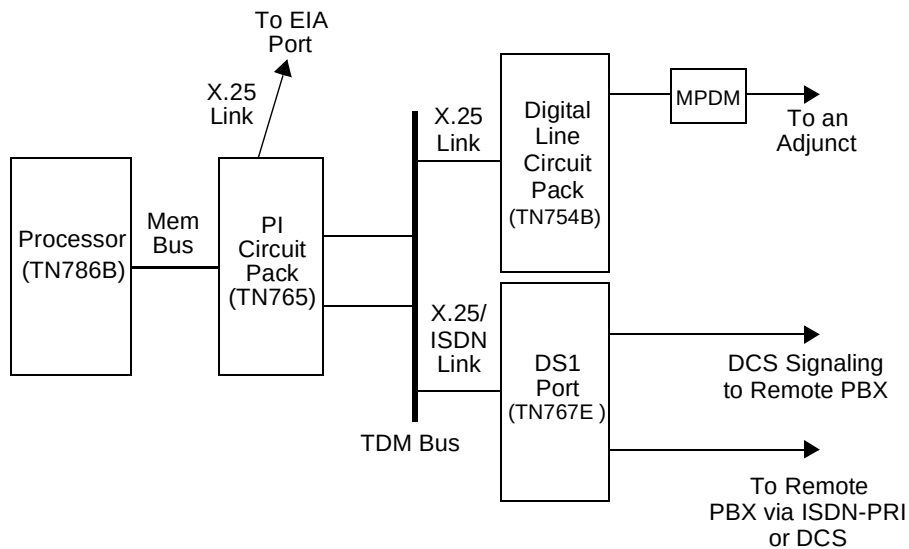
The following figure shows the Processor Interface Communications Link (PI-LINK) interactions.

**Figure 8-16. Processor Interface Link Communications Interactions**

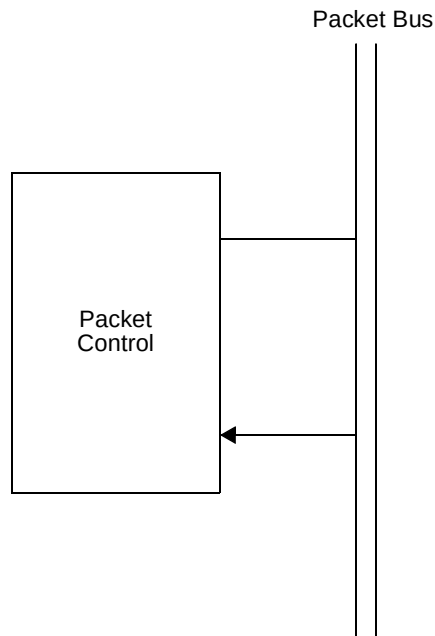
The TN778 Packet Control circuit pack is the hardware component that serves as the interface between the SPE and the Packet Bus. It terminates the Link Access Procedure D (LAPD) protocol and provides support for thousands of signaling links. As shown in the figure on the following page, a Packet Control link generally terminates on the Packet Control circuit pack and a packet endpoint that is connected to a Packet circuit pack. A TN556 circuit pack is an example of a Packet circuit pack. The following Packet circuit packs (packs that can connect to the Packet Bus) are available:

- TN556 ISDN-BRI Line Circuit Pack
- TN771 Maintenance/Test Circuit Pack
- TN778 Packet Control Circuit Pack

**Figure 8-17. Hardware Configuration**

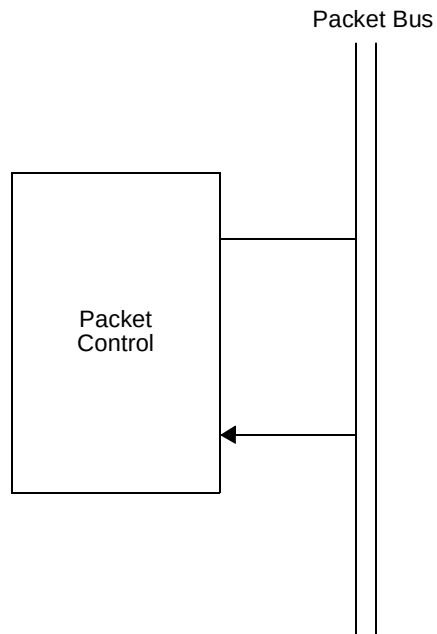
This test checks whether the Packet Control circuit pack can send and receive data correctly. The test performs the following major functions:

1. Establishes an LAPD link from the Packet Control circuit pack to itself (see the following figure).
2. Transmits and receives test data over the testing link.

**Figure 8-18. Test Configuration**

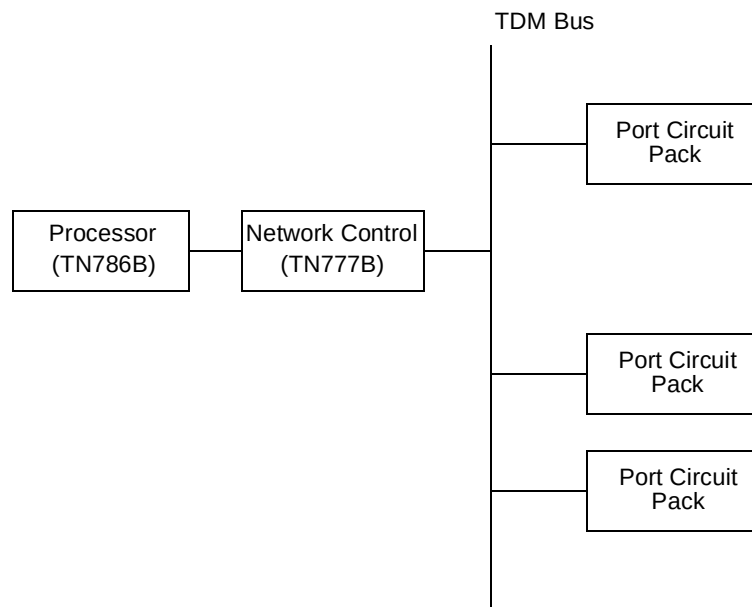
Switch Control is critical in the setup and takedown of all calls but is not involved in the voice or data transmission that takes place during established calls. Switch Control detects when port circuit packs are plugged into or removed from the cabinet. This information is then sent to the processor. The Switch Control monitors the health of the control channel on the TDM Bus and informs the processor when errors occur.

Switch Control contains the hardware time of Day (TIME-DAY) clock that the system uses for all its date and time information. In addition, Switch Control also contains hardware to monitor critical system timing signals and informs the processor when these signals fail. For example, if the timing signals from a Tone-Clock circuit pack in the cabinet fail, Switch Control informs the processor.

**Figure 8-19. Switch Control Connectivity**

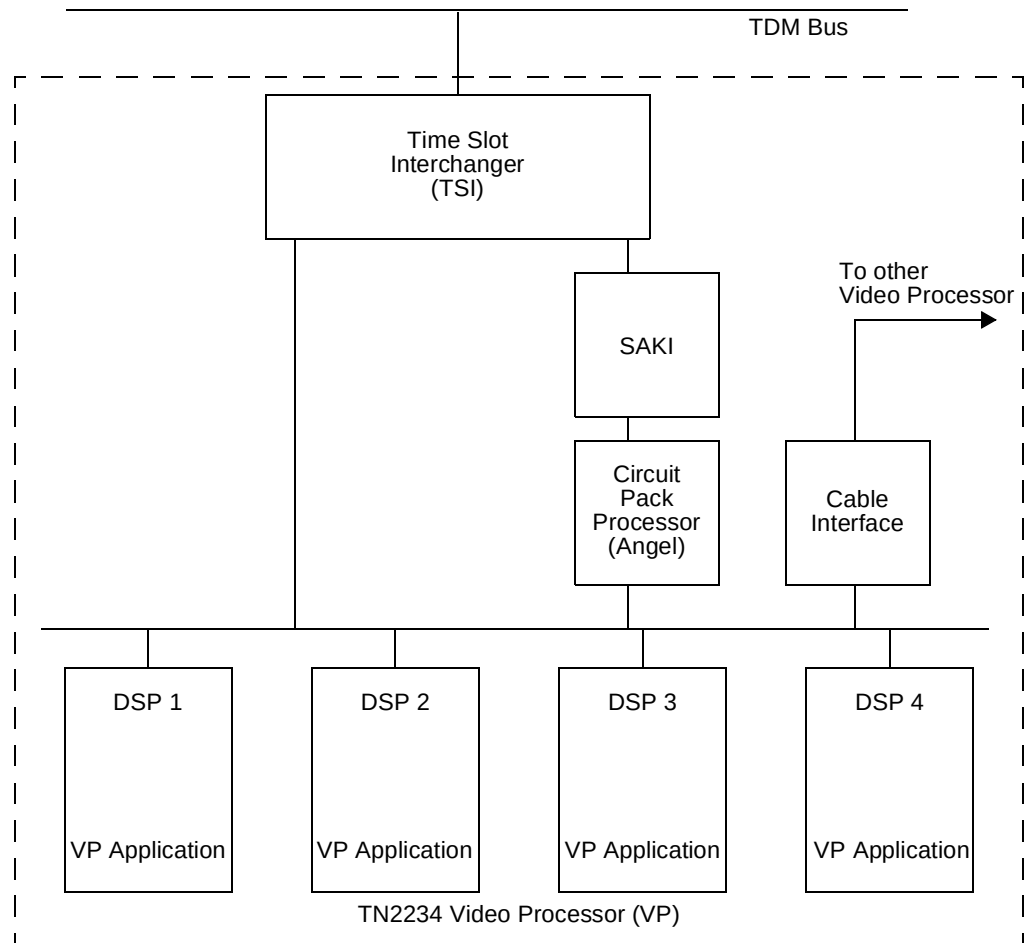
| Error Code | Test Result | Description | Recommendation |
|---|---|---|---|
| | PASS | The computed checksum matched the ROM checksum. The system continues to operate normally. | |

The TN2234 Video Application Processor circuit pack is used to implement Continuous Presence *Plus*. In Continuous Presence *Plus*, four H.261 video streams are mixed together and then rate adapted back to the bandwidth of the original video streams. This allows each endpoint in a multipoint conference to see up to four other conferees simultaneously.

Continuous Presence *Plus* requires two Video Application Processors per conference. The circuit packs are cabled together. One circuit pack performs the video mixing functionality; the other takes the resultant video stream and rate adapts it back to the bandwidth of the original video streams. A maximum of 10 Continuous Presence *Plus* complexes or 20 Video Application Processor circuit packs are supported. Each circuit pack in a Continuous Presence *Plus* complex is maintained separately. Also, each circuit pack supports a single port.

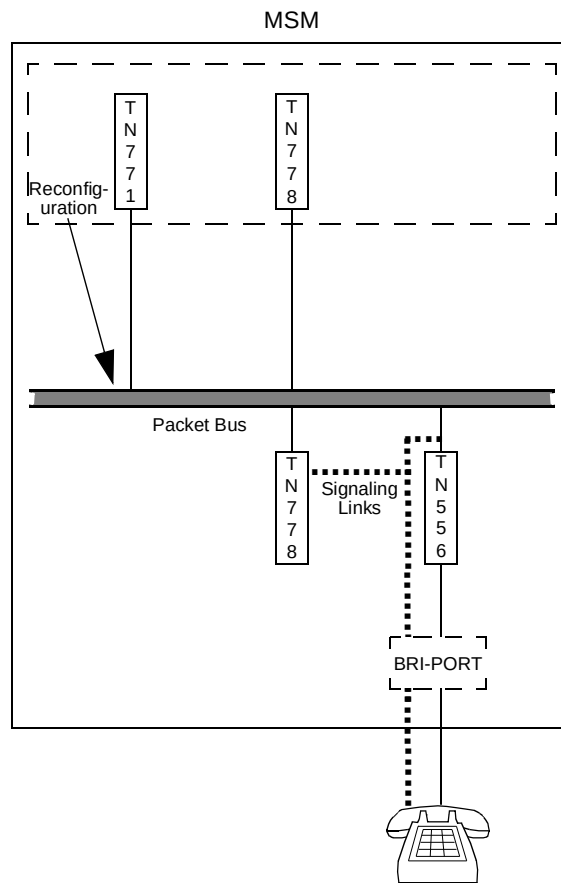
Figure 9-1 shows the various circuit packs that communicate on the Packet Bus. Logical and physical connections are illustrated. Connectivity with three port networks is similar.

**Figure 9-1. ISDN-BRI/Packet Bus Connectivity**

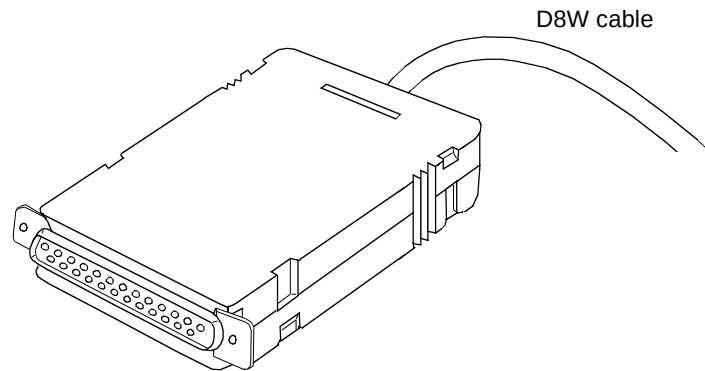
**Figure 9-2. 355A EIA-232 Adapter**

2. 355A EIA-232 Adapter (COMCODE 105 012 637). This adapter is illustrated in Figure 9-2.
3. 258B Six-Port Male Amphenol Adapter (COMCODE 103 923 025). This adapter is illustrated in Figure 9-3.

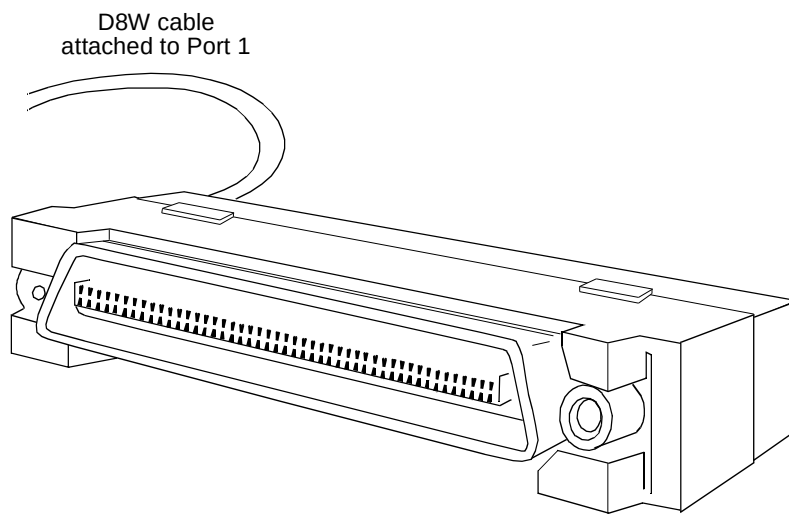
**Figure 9-3. 258B Six-Port Male Amphenol Adapter**

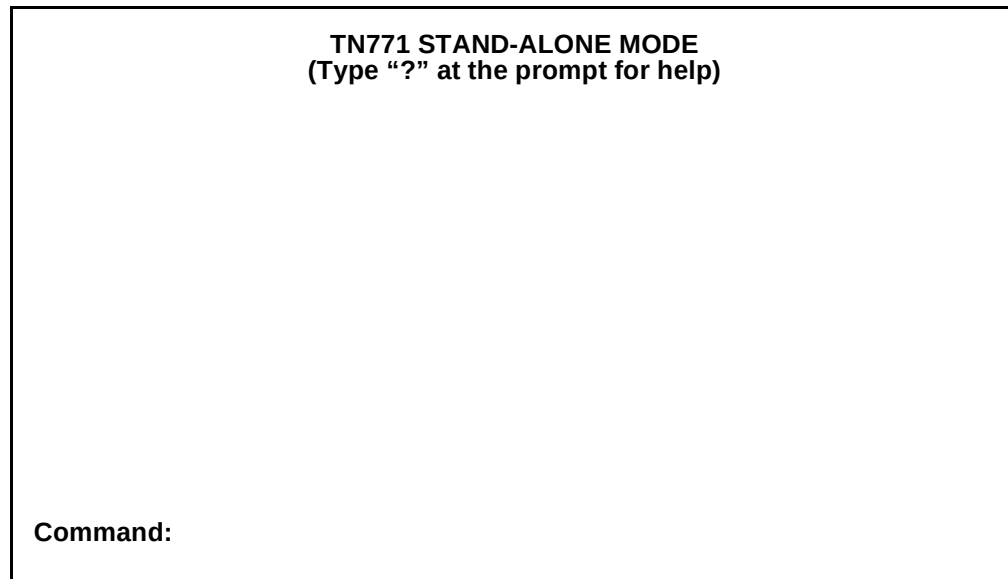
If the standalone mode is entered successfully, the following is displayed on the connected terminal:

**Figure 9-4. Normal Stand-Alone Mode Display**

*If the display in Figure 9-4 does not appear, be sure to check the wiring between the terminal and the TN771 circuit pack, and also the terminal parameters. If these are correct, the TN771 circuit pack may be defective. In such a case, follow the procedures to exit stand-alone mode (described in the next paragraph). Then test the Maintenance/Test circuit pack (refer to M/T-BD and M/T-PKT in Chapter 8, "Maintenance Object Repair Procedures").*

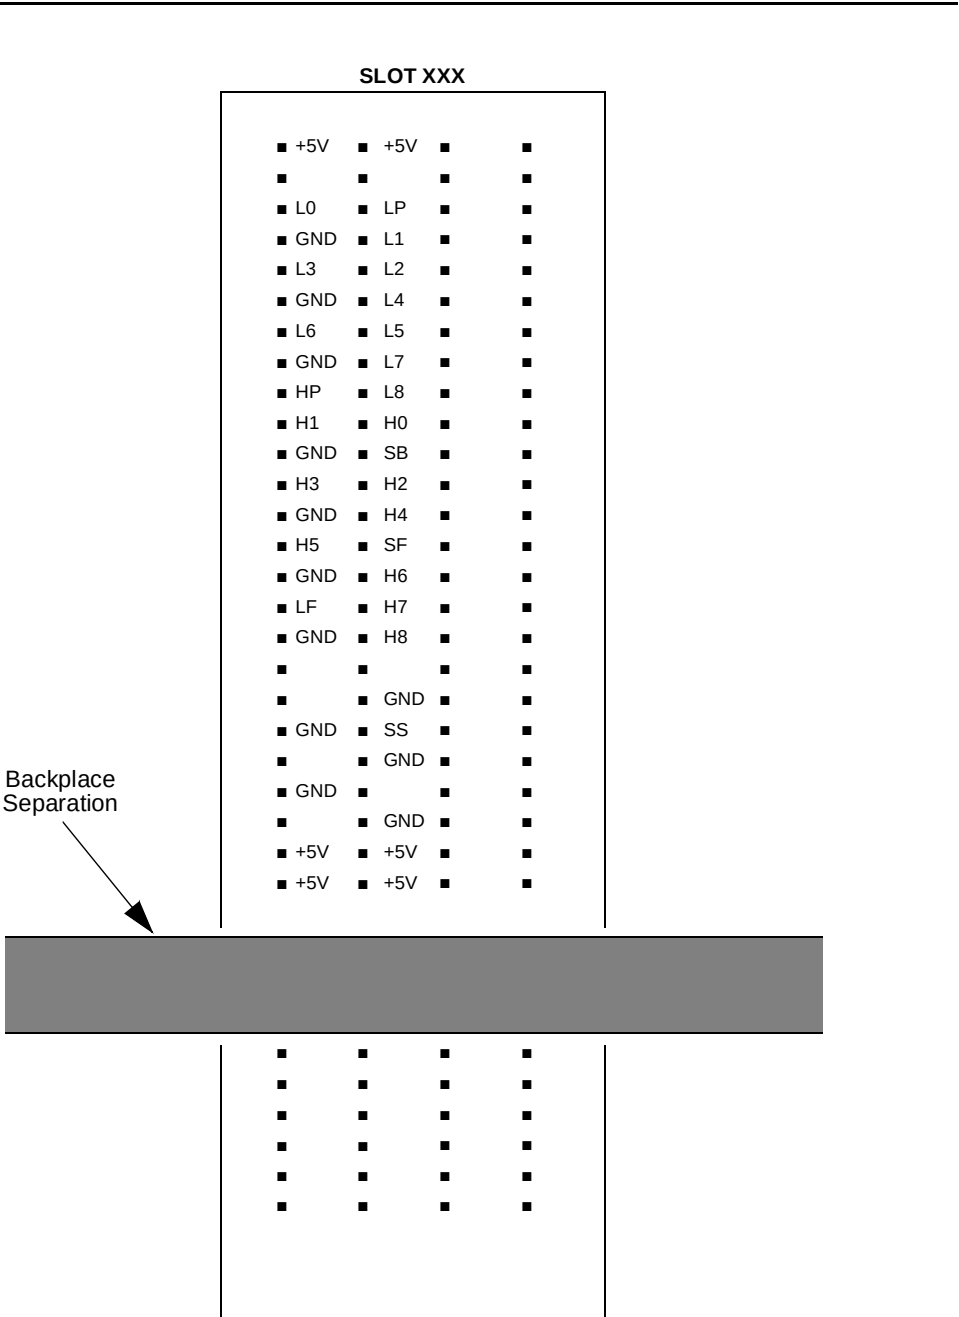
**Figure 9-6. Packet Bus Leads on the Backplane—Front View**

The information within a stand-alone mode display is used in the Packet Bus Fault Correction procedures that follow. The TN771 circuit pack display indicates the specific leads on the backplane to examine for bent or damaged pins. Figure 9-6 shows the location of the Packet Bus leads on the backplane as viewed from the front of the carrier, while Figure 9-7 shows the same slot as viewed from the back of the carrier.

2. Determine if the Packet Bus fault is still present.
3. If the Packet Bus fault is still present:
  - Determine if the backplane pins in the removed circuit pack's slot are bent. Use the output from the Maintenance/Test stand-alone mode and Figures 9-6 and 9-7.

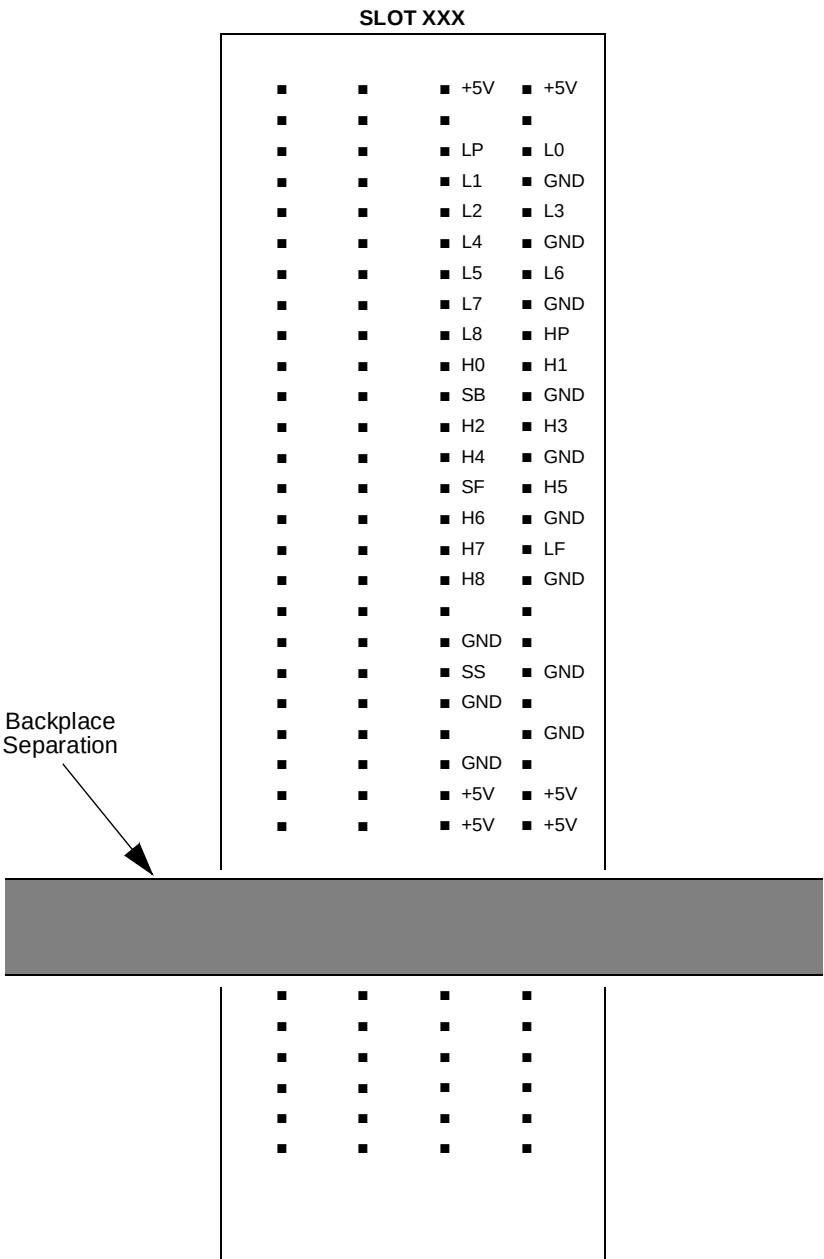
**Figure 9-7. Packet Bus Leads on the Backplane—Back View**

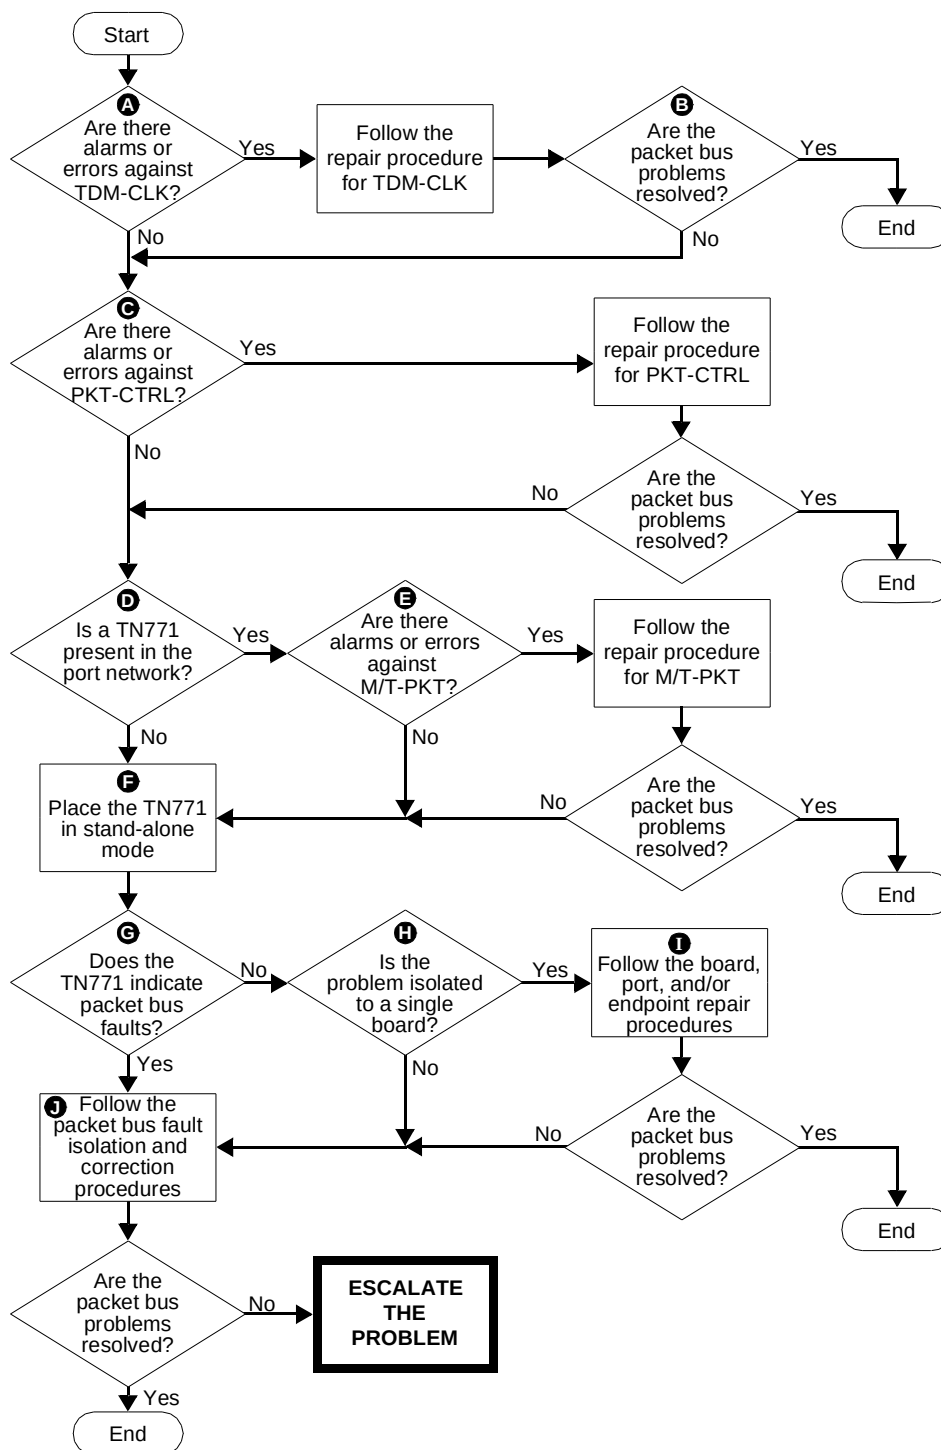
See the "Flowchart Description and Supplement" section following the flowchart for a description of the flowchart as well as for supplementary information, the availability of which is indicated by the uppercase letters in bold that appear within some of the circles and diamonds in the flowchart.

Figure 9-8. Processing of Packet Bus Problems

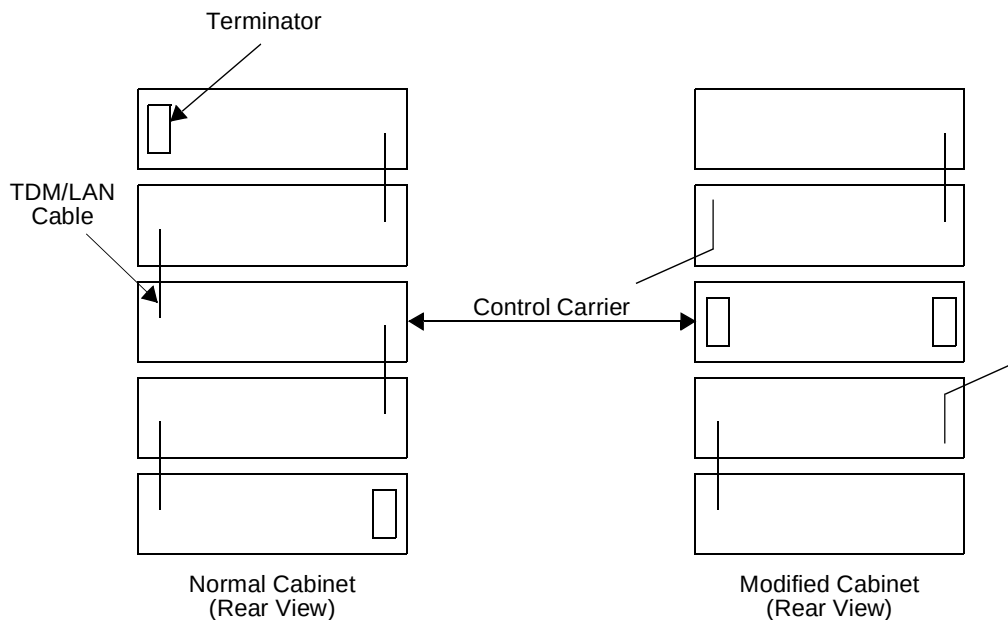
In Procedure 4, the TDM/LAN Cable Assemblies and TDM/LAN termination resistor packs are replaced. If this action does not resolve the Packet Bus fault, the carriers are reconfigured by moving the termination resistor packs in such a manner that certain carriers are disconnected from the bus. This is done by moving the termination resistors on the carrier backplanes. To terminate the Packet Bus at the end of a particular carrier, first unplug the cable that connects the carrier to the next carrier and then replace the cable with a termination resistor (see Figure 9-9). When the length of the Packet Bus is modified via this procedure, circuit packs that are essential to system operation (for example, Processor Complex, Tone-Clock) must still be connected to the new "shortened" Packet (and TDM) Bus. In addition, the Maintenance/Test circuit pack (in stand-alone mode) must be connected to the "shortened" bus.

**Figure 9-9. Carrier Rewiring Example**
