555-230-105  
Issue 5  
September 1996

# **DEFINITY Enterprise Communications Server Release 5 Maintenance for R5r**

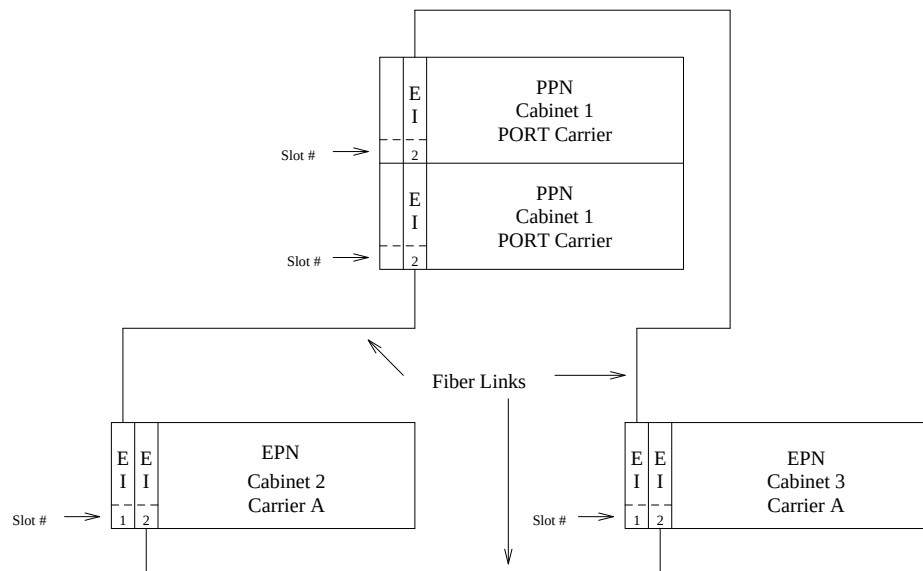
**Figure 1-1. Direct Connect PNC**

The PNC is provided in one of two different configurations: Direct Connect and Center Stage Switch (CSS). In either configuration the TN570 Expansion Interface (EI) board provides the interface to the data on the TDM/PKT busses. In the direct connect configuration up to 3 PNs are connected via hardware between each pair of PN EIs as illustrated below.

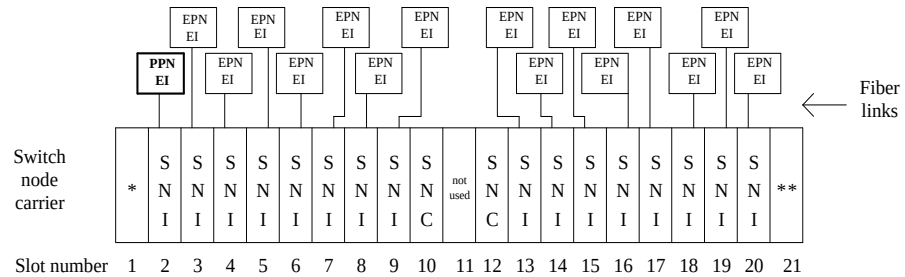
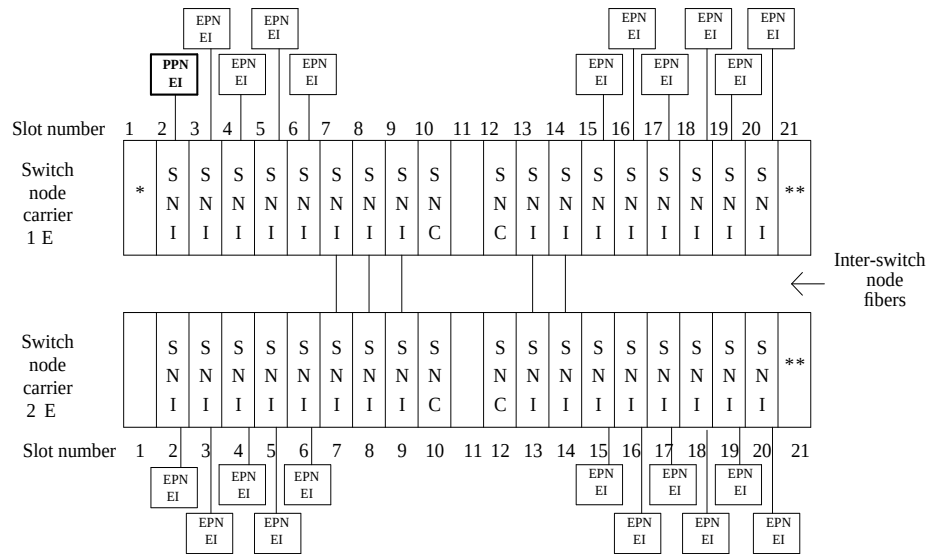
Figure 1-2. Center Stage Switch Configurations (Simplex Examples)

In the CSS configuration up to 16 PNs (including the PPN) can be connected to one switch node (SN). With two SNs, up to 22 PNs can be connected. Each SN consists of a carrier containing the following components (in Critical Reliability systems, each SN is duplicated on a second, identically configured carrier):

Figure 1-2 shows two examples of CSS configurations. Illustrations of the switch node carrier hardware appear in Chapter 2.

CSS with one switch node

CSS with two switch nodes

\* The PPN EI or a DS1C circuit pack may reside in this slot

\*\* A DS1C circuit pack may reside in this slot

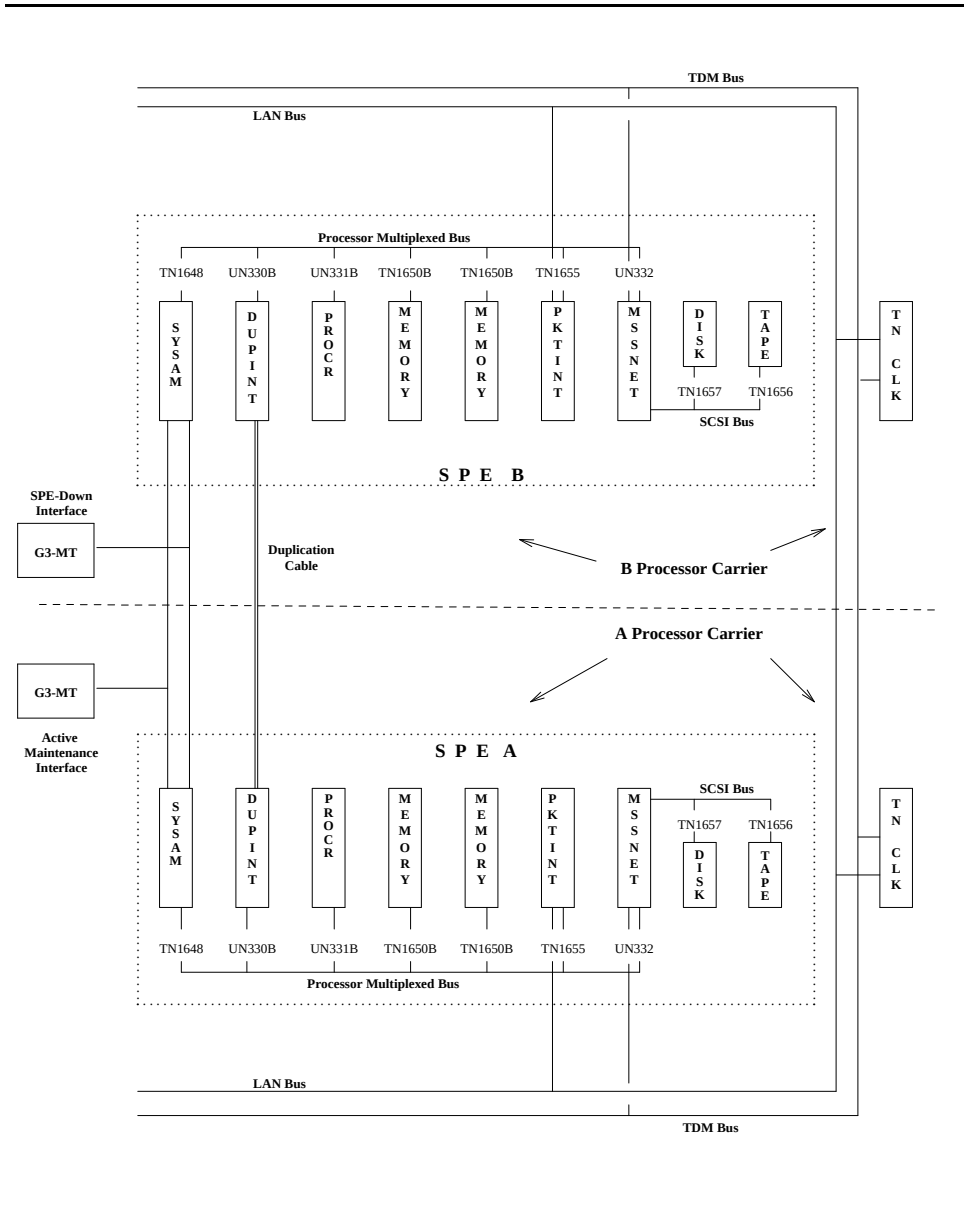
Figure 1-3. Duplicated SPEs — Hardware Configuration

System software running on both active and standby SPEs attempts to assure that the standby SPE is kept fully available in terms of the above factors. The health of both the active and standby is tracked as a State-of-Health (SOH) value.

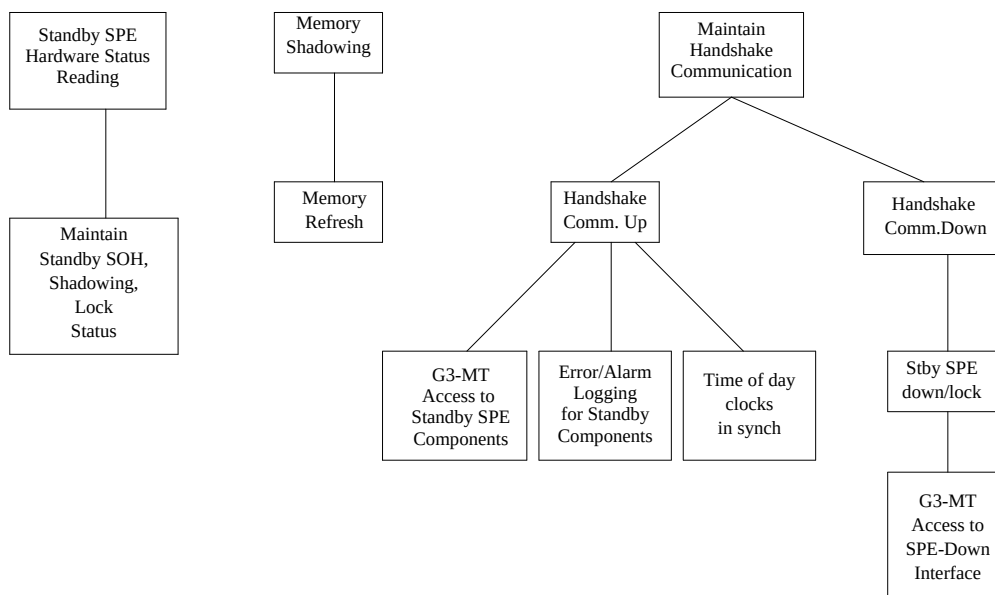
**Figure 1-4. Components of Standby Maintenance**

As illustrated below, all maintenance capabilities for the standby SPE are built upon these three.

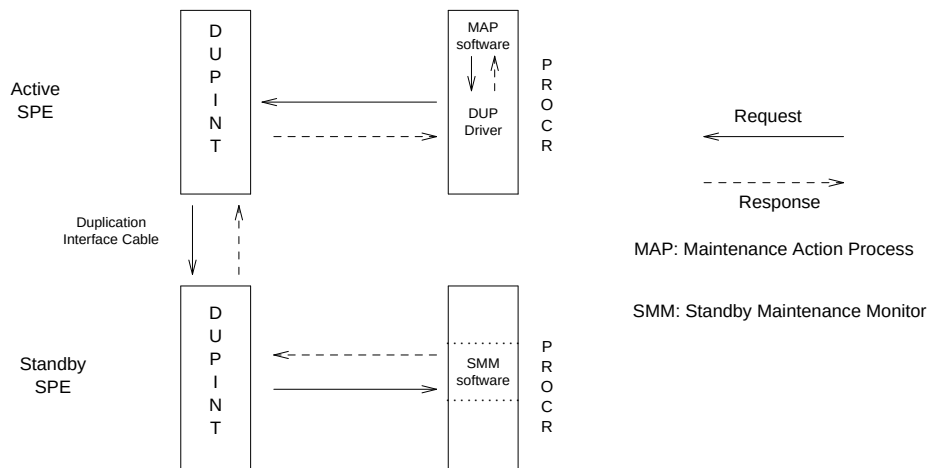
**Figure 1-5. Handshake Communication Path**

**configuration control.** Whenever handshake is down, this data may be out of date. Whenever handshake has been down and is restored, the active SPE requests standby SPE software to transmit the current version of this hardware configuration and vintage data. The data is then stored in active SPE memory. Failure to use the lock-and-power-down method for standby circuit pack replacement (see Chapter 5, "Responding to Alarms and Errors") can lead to incorrect standby component hardware configuration and vintage data.

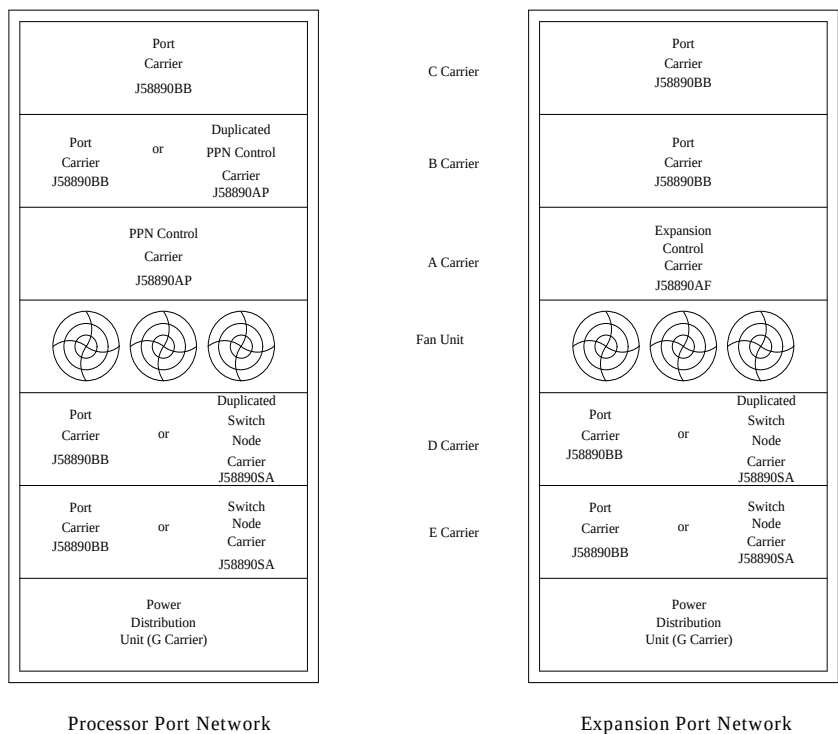
**Figure 2-1. Multicarrier Cabinet (J58890A) Configurations**

- 120V AC 60 Hz at 50A from a National Electrical Manufacturing Association (NEMA) 5-50R power outlet or equivalent
- Single phase 240V AC, or three phase 208V AC, 60 Hz at 30A from a NEMA L 14-30R power outlet or equivalent

- -48V DC battery plant
- Global MCC will use 50-60Hz 200-240VAC power source

When used for an EPN, the multicarrier cabinet supports one Port Network with a daisy-chained TDM/LAN bus, or, optionally, two separate PNs if the cabinet does not contain a Switch Node. A cabinet with two PNs has two separate TDM/LAN bus daisy-chains. One TDM/LAN bus between carriers in positions A, B and C supports the first PN, and another TDM/LAN bus between positions D and E supports the second PN. Figure 2-1 shows locations of carriers in EPN cabinets.

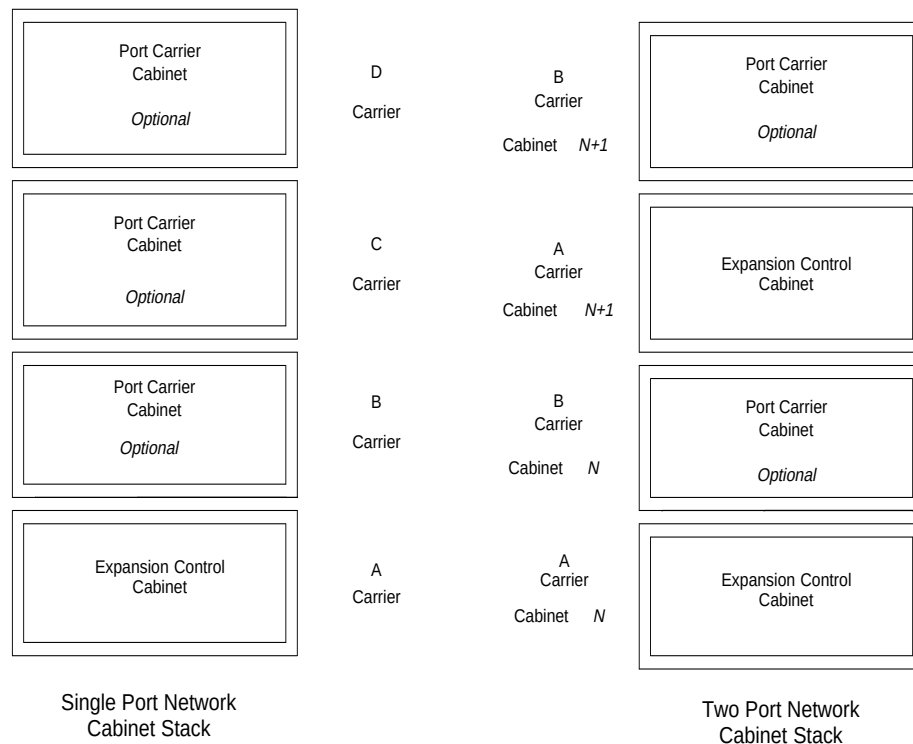
**Figure 2-2. Single-carrier Cabinet EPN Configurations**

Single-carrier cabinets may be used for remotely located EPNs. Figure 2-2 shows two examples of these configurations. Each EPN requires an Expansion Control Cabinet (ECC) (J58890N) which resides in the bottom, or A, position. From one to three Port Cabinets (J58890H) may be stacked on top of the ECC as needed, in the order B-C-D. For administration and maintenance purposes, each stack constituting a single EPN is identified with a single cabinet number.

Cabinet clips in the front of the cabinets electrically connect the cabinets together. At the rear of the cabinets, a ground plate connected between cabinets provides ground integrity.

One of two power sources can be used. A power cord with a three-prong plug on one end and a single connector on the other end connects the cabinet's power supply to a dedicated 50 Hz to 60 Hz 120 VAC power sources at 15A per single cabinet or 20A per pair of cabinets. The cabinet may optionally be powered by a dedicated -48 VDC 25A battery plant.

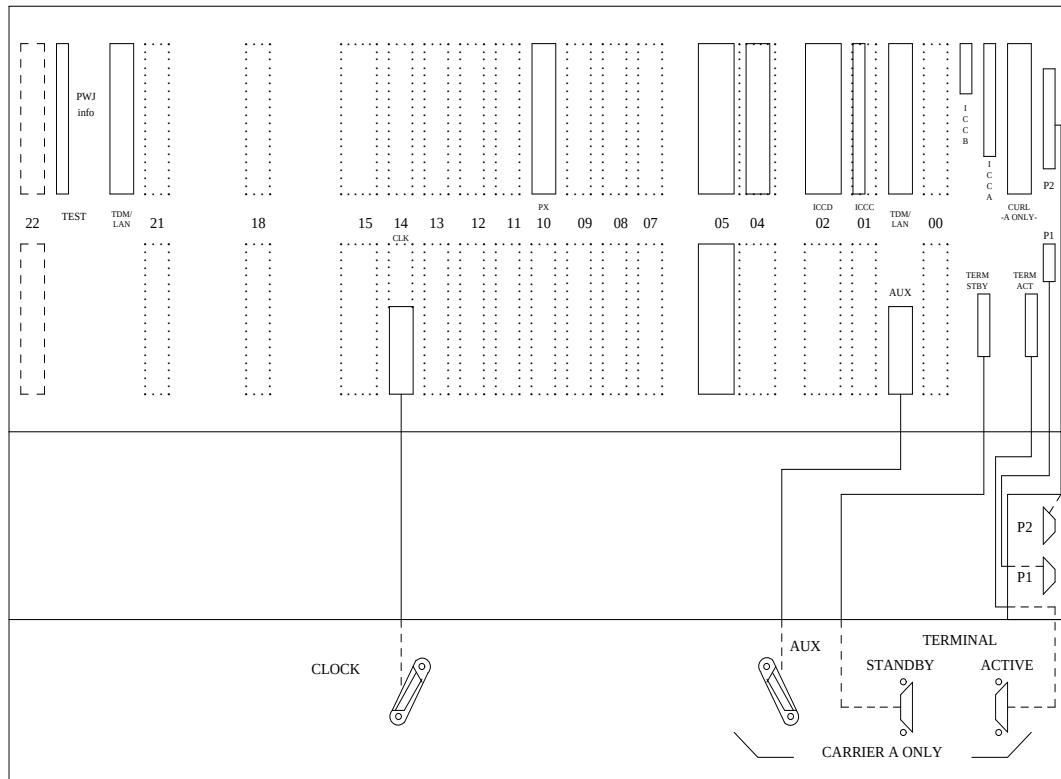
**Figure 2-4. PPN Control Carrier (J58890AP) — Rear View**

In Figure 2-4, the upper portion shows the pin fields on the backplane of the carrier with the I/O connector plate removed. The lower portion shows the connector plate which covers the lower pin fields and connects to them by cable.

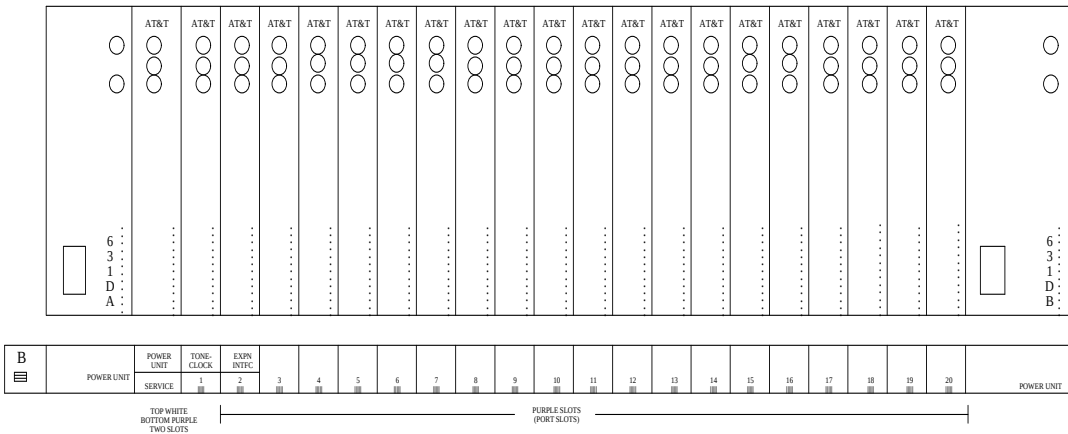
Figure 2-5. Port Carrier (J58890BB)

Figure 2-5 and Table 2-3 describe the function of each carrier slot.

On E-position Port Carriers, the TONE-CLOCK and EXPN INTFC slots are reversed.

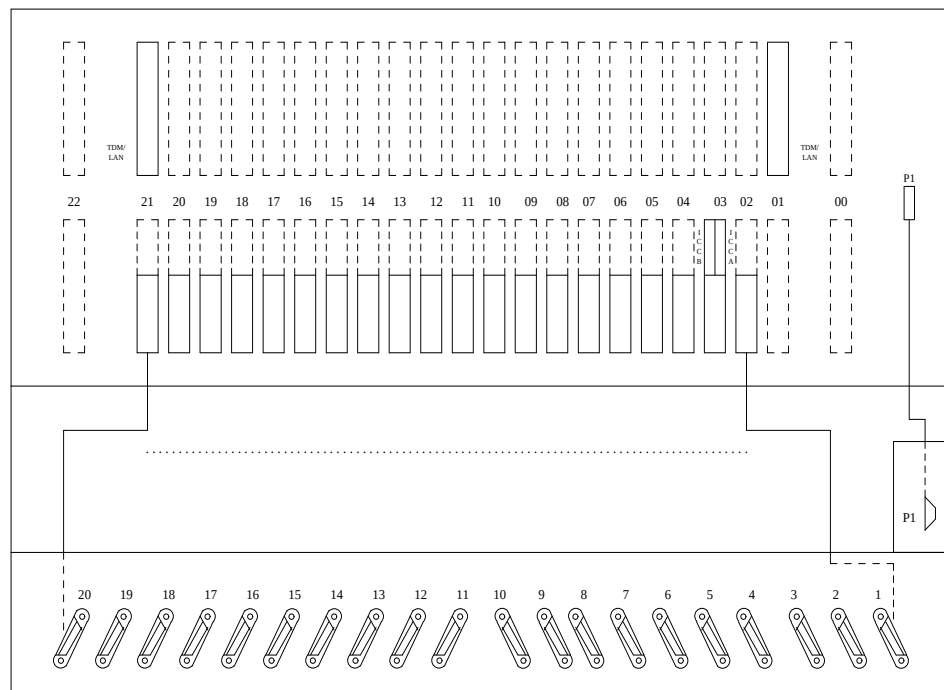
**Figure 2-6. Port Carrier — Rear View**

Figure 2-6 represents a *typical* port carrier. The upper portion shows the pin fields on the backplane of the carrier with the I/O connector plate removed. The lower portion shows the connector plate which covers the lower pin fields and connects to them by cable.

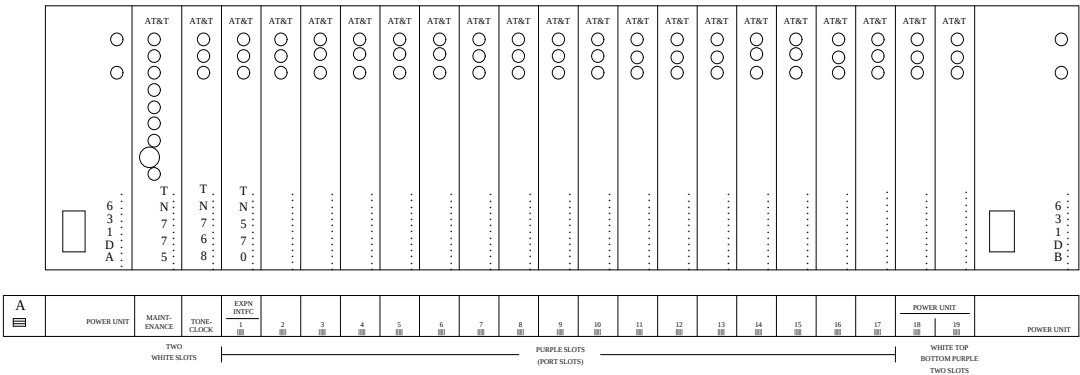
Figure 2-7. Expansion Control Carrier (J58890AF)

The Expansion Control Carrier is located in position A of each EPN. Figure 2-7 and Table 2-5 describe the function of each carrier slot.

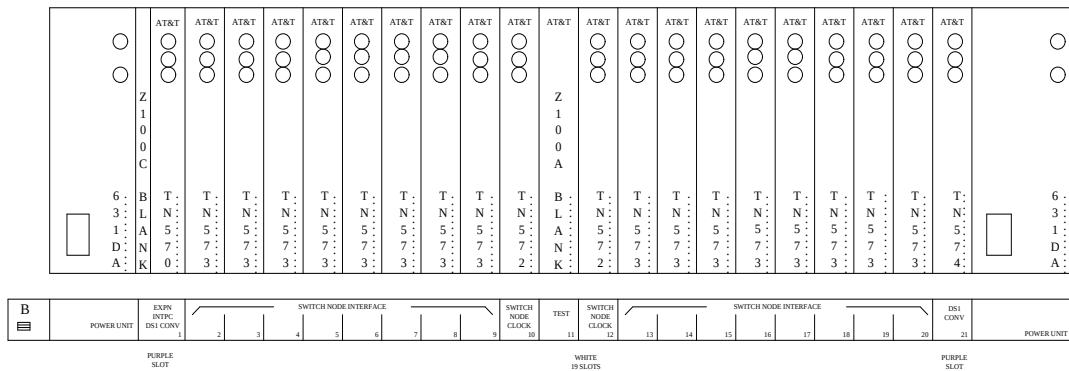
Figure 2-9. Switch Node Carrier (J58890SA)

Switch Node carriers house the components of a Center Stage Switch (CSS). The first switch node is located in carrier E of the PPN. If duplicated in a Critical Reliability configuration, its duplicate is located in carrier D of the PPN. The second switch node is located in carrier E of a non-remoted EPN. If duplicated in a Critical Reliability configuration, its duplicate is located in carrier D of the same EPN.

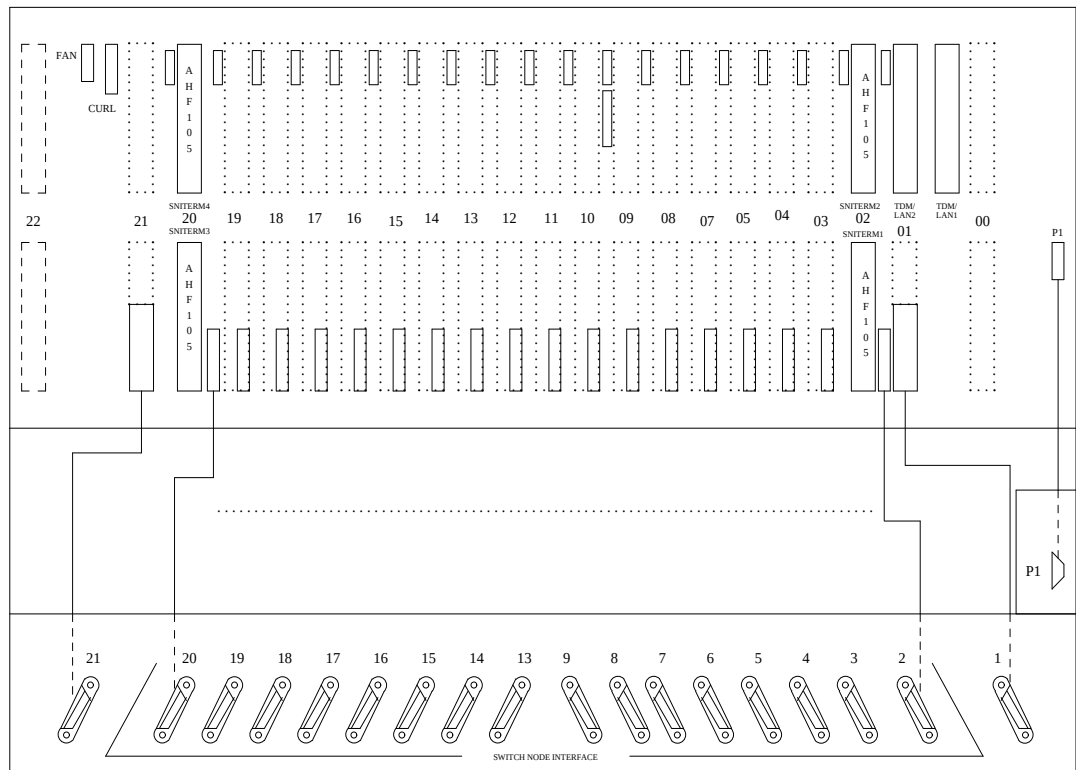
**Figure 2-10. Switch Node Carrier — Rear View**

In Figure 2-10, the upper portion shows the pin fields on the backplane of the carrier with the I/O connector plate removed. The lower portion shows the connector plate which covers the lower pin fields and connects to them by cable.

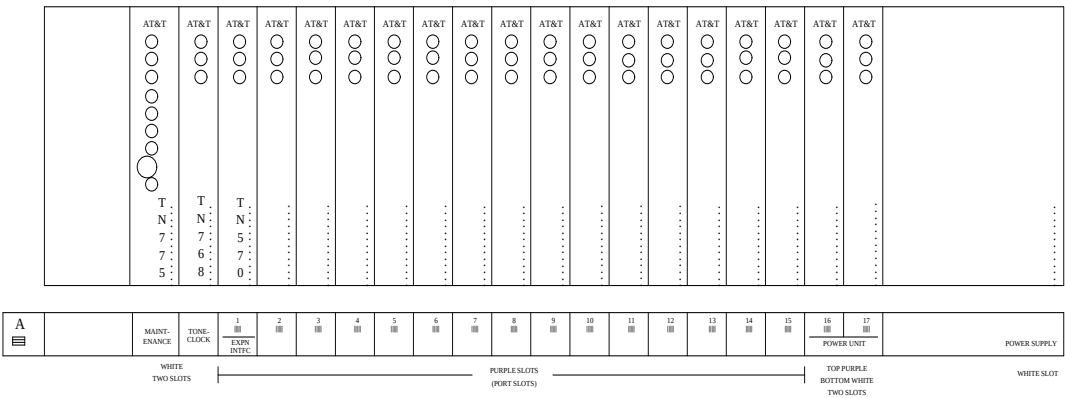
Figure 2-11. Expansion Control Cabinet (J58890N)

The Expansion Control Cabinet is the bottom and only required cabinet in a stack of single-carrier cabinets constituting a remote EPN. Figure 2-11 through Figure 2-14 and Table 2-9 through Table 2-12 explain the functions of the circuit pack slots.

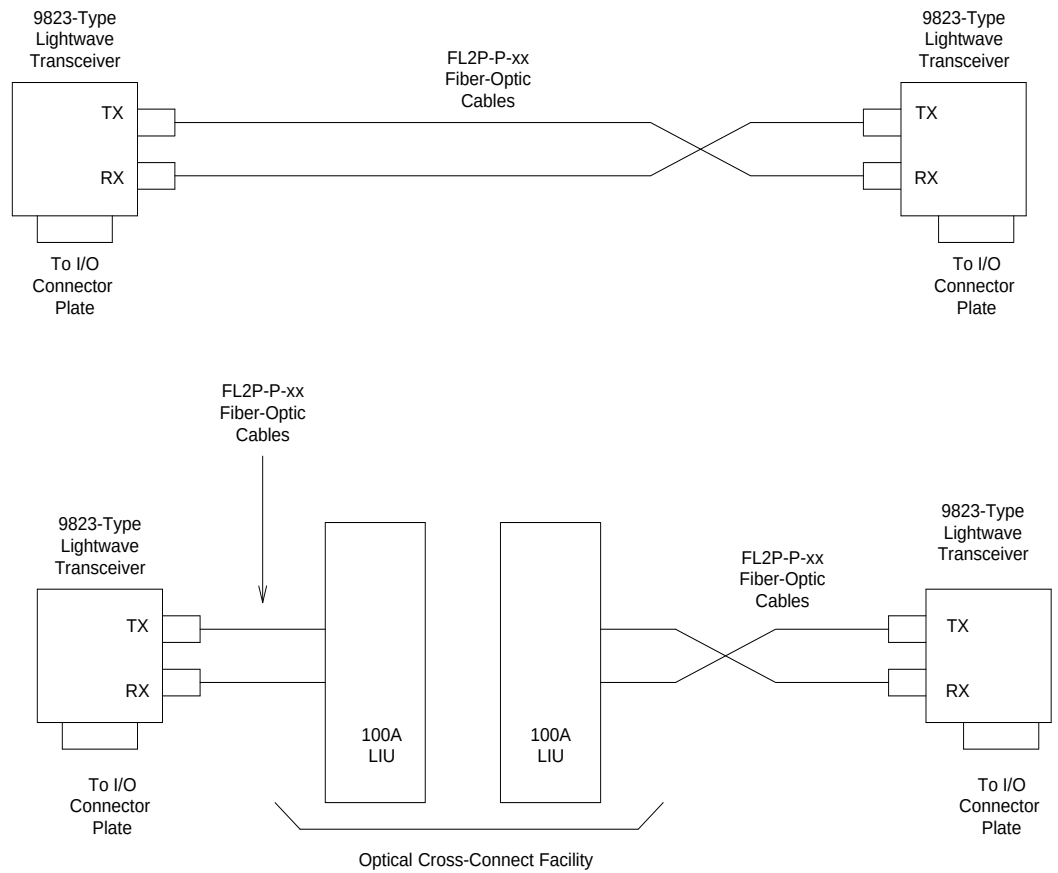
**Figure 2-15. Fiber Link Connection Hardware**

The lightwave transceivers are powered from I/O connector plate leads attached to TN570 Expansion Interface circuit pack or a TN573 Switch Node Interface circuit pack. The transceivers include loop-around capabilities to support fiber fault isolation. Either of two different 9823-type multi-mode transceivers may be used, depending upon the length of the fiber, as shown below or the 300A single mode fiber transceiver. The transceivers at each end of a given fiber should match. Figure 2-15 illustrates the interconnection of fiber-optic hardware.

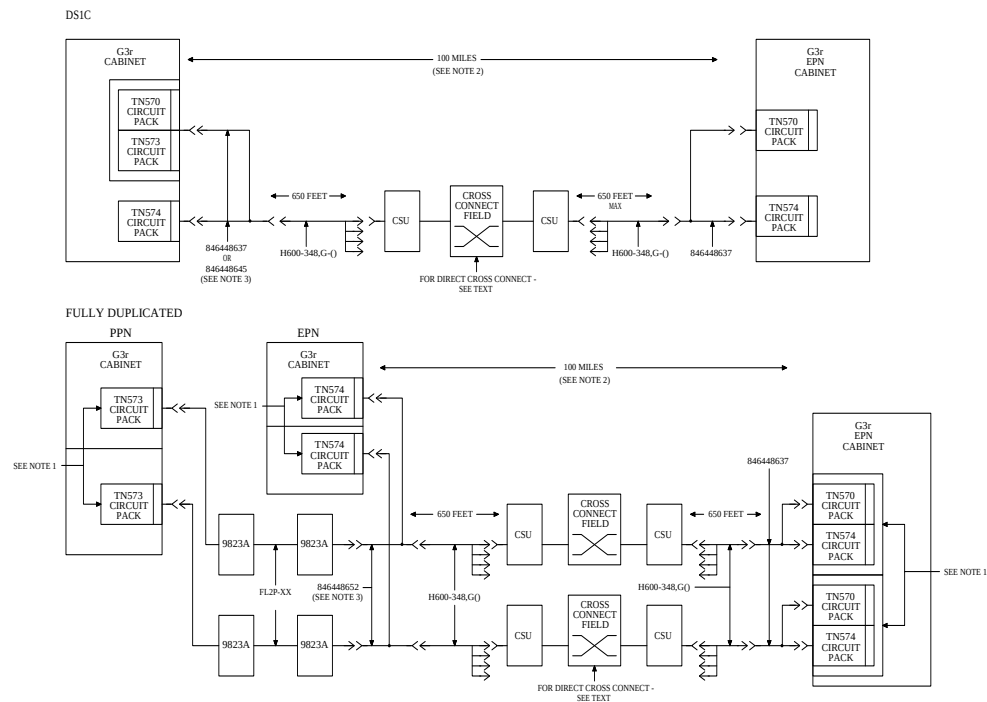
**Figure 2-16. Typical DS1CONV Connections to Remote EPNs**

1. Place duplicate pairs in different carriers.
2. When remoting two (2) or more, the maximum cable distance between any two (2) remoted end points is 100 miles. For example, if EPN is 75 miles from the PPN, then EPN 2 can only be 25 miles from the PPN.
3. 846447637 is used within a carrier for a TN574, for TN1654 within a carrier use a 847245750.

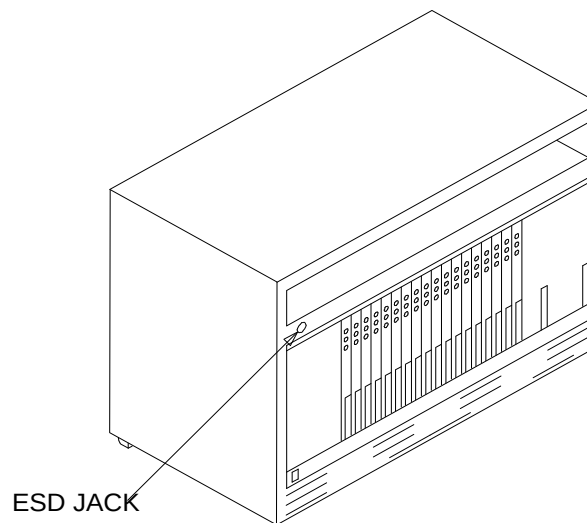
**Figure 5-1. Single Carrier Cabinet ESD Grounding Wrist Strap Jack**

Figure 5-1 and Figure 5-2 show the location of the grounding jacks.

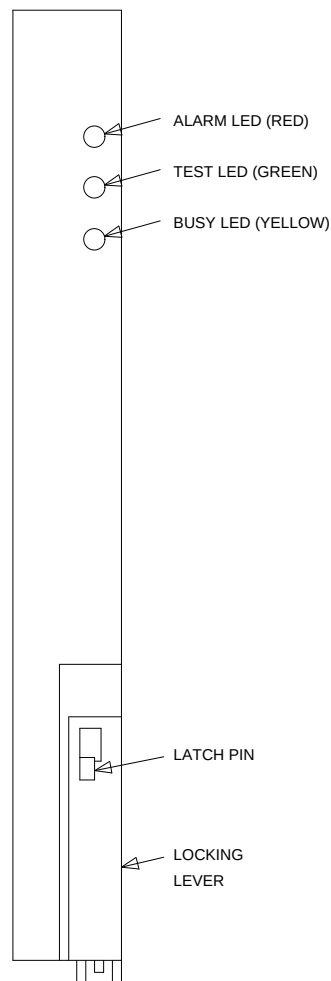
**Figure 5-3. Typical Circuit Pack**

1. Attach the grounding strap to the cabinet and your bare wrist.
2. Unlock the latch pin (see Figure 5-3).
3. Pull down on the locking lever until the circuit pack is disconnected from its socket.
4. Pull the circuit pack out just enough to break contact with the backplane connector. Use steady, even force to avoid disturbing the backplane. If the procedure you are following instructs you to simply reseat the circuit pack, then proceed to step 8.
5. Slide the circuit pack out of the slot, taking care not to disturb surrounding components.
6. When handling the circuit pack, touch only the edges. Touching components on the board can cause electrostatic or physical damage.
7. Insert the back edge of the circuit pack into the slot, making sure it is vertically aligned.

8. Slide the board into the slot until it engages the backplane connector. *Use extreme care in seating the backplane connectors. A bent pin can cause catastrophic problems.*
  9. Lift the locking lever until the latch pin engages.
  10. Verify that the board has made contact by observing the LEDs and continue the repair procedure.
-

1. Unlock the latch pin (See Figure 5-3 for location of the pin).
2. Pull down on the locking lever until the BIU or Rectifier moves forward and is disconnected from its socket.
3. Pull the BIU or Rectifier out just enough to break contact with the backplane connector. Use steady even force to avoid disturbing the backplane.
4. Carefully slide the BIU or Rectifier out of slot.

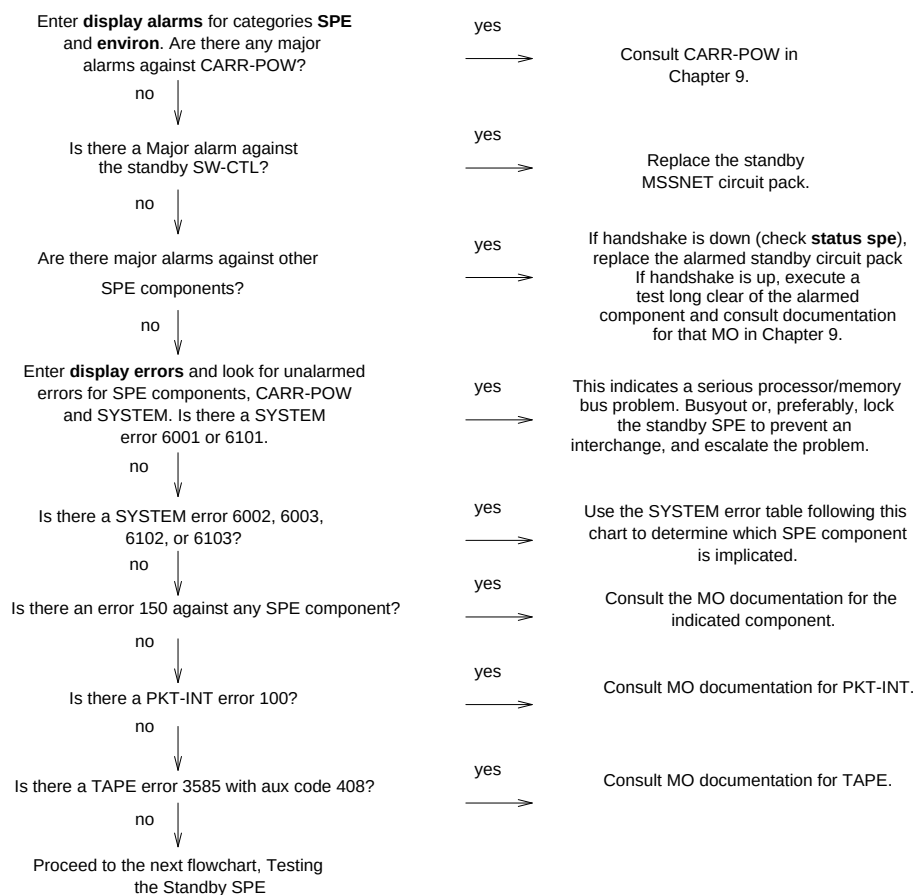
**Figure 5-4. Determining the Cause of an SPE Interchange**

The system may have had time to log alarms or errors against the fault the caused the interchange. Proceed through the steps summarized in the following flowchart. Examine only major alarms with a timestamp near the time of interchange, and whose carrier designation is the current standby SPE (the SPE interchanged out of). Include any resolved alarms meeting this description.

All relevant alarms must be timestamped at or near the time of interchange.

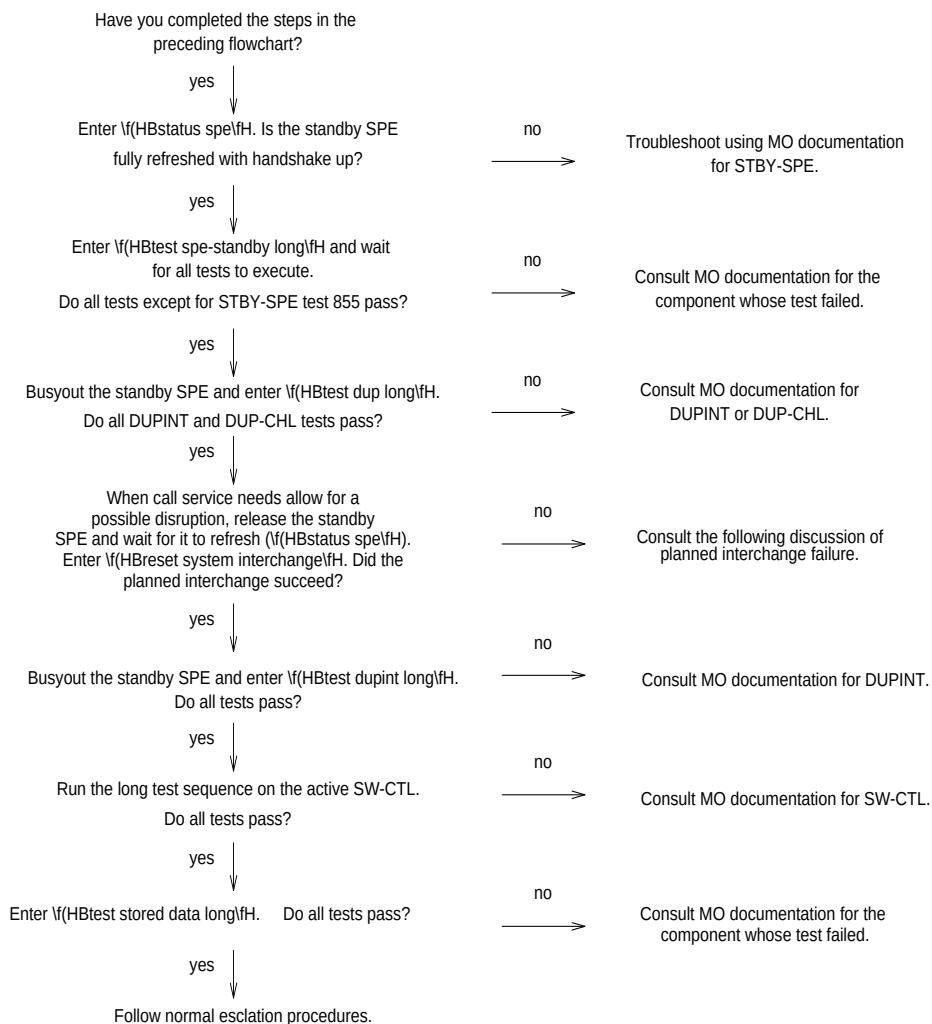
**Figure 5-5. Testing the Standby SPE**

The system may not have had time to log errors against the failed component that caused the spontaneous interchange. If you've progressed through the preceding flowchart without determining the cause of interchange, test the standby for faults by proceeding through the following steps.

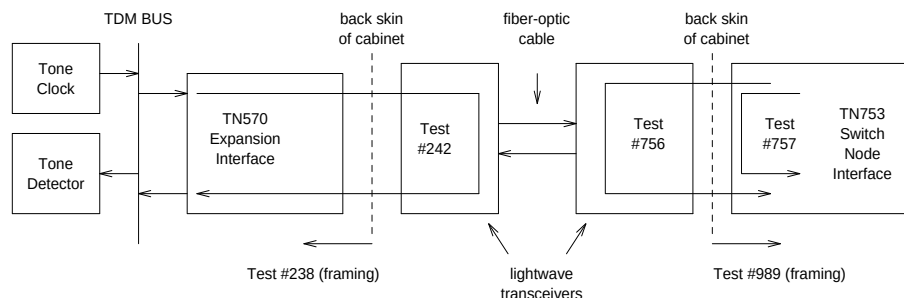
**Figure 5-6. Fiber Fault Isolation Tests**

Test 242 can be run as part of the **test board UUCSS long** command for an Expansion Interface circuit pack. Besides testing on-board components, this test

is helpful for isolating problems between a circuit pack and the lightwave transceiver. The loopback shown in this diagram shows only part what test 242 does. If no lightwave transceiver is connected to the Expansion Interface circuit pack, an on-board loopback is performed on the Expansion Interface circuit pack. For more information about test 242, see the EXP-INTF section in Chapter 9, "Maintenance Object Repair Procedures".

Did test 788 pass and test 789 fail? If yes, replace the DS1C and lightwave transceiver (if present) at the other end of the DS1C complex. (See Figure 5-6 and Figure 5-7.)

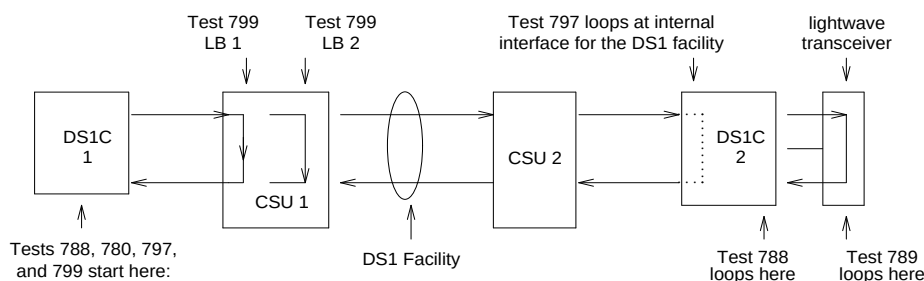
**Figure 5-7. DS1C Loopbacks**

Figure 5-7 illustrates the loopbacks performed on the SNI circuit pack for test 756 and test 757. Test 756 reports the result of the off-board loopback; test 757 reports the result of the on-board loopback. Test 756 and test 757 can be run individually or as part of the **test boardUUCSSlong** command for an SNI circuit pack.

If DS1Cs exist on the fiber link (check with **list fiber-link**), then additional DS1C loopback tests can be run to further isolate the problem. The DS1C loopback tests are shown in Figure 5-7, *DS1C Loopbacks*. For more information about DS1C loopback tests 788 and 789, see the DS1C-BD section in Chapter 9, "Maintenance Object Repair Procedures". For more information about DS1 facility loopback tests 797 and 799, see the DS1-FAC section in Chapter 9, "Maintenance Object Repair Procedures".

This test requires manually altering the external connections of the DS1 facility. Place the loopbacks at as many points as your CSU capabilities will allow (see Figure 5-7).

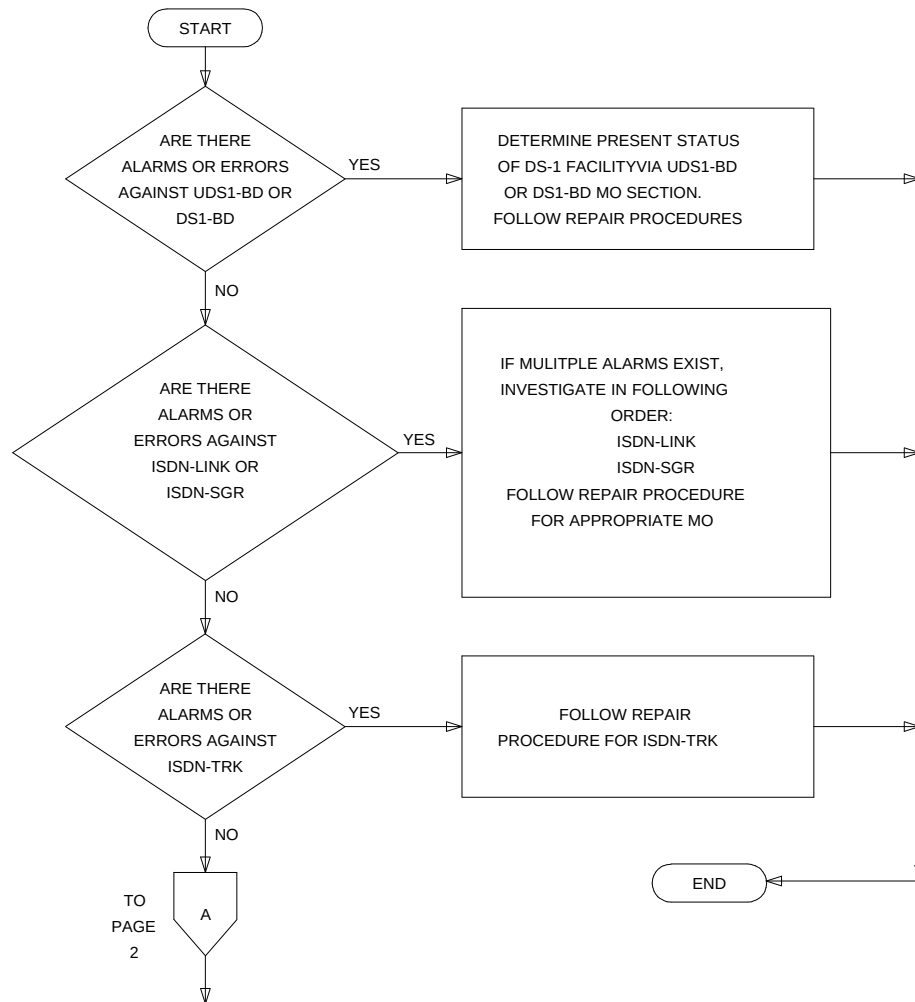
**Figure 5-8. Troubleshooting ISDN-PRI (Page 1 of 2)**

The following flow chart defines a layered approach when troubleshooting ISDN-PRI problems. Since a problem at a lower layer affects upper layers, layers are investigated from low to high. In the flowchart, the DS1 facility is layer 1, the ISDN-PRI D-channel is layer 2, and the ISDN trunks are layer 3. Transient problems are diagnosed on Page 2 of the flowchart. For problems with PRI endpoints (wideband), see the following section.

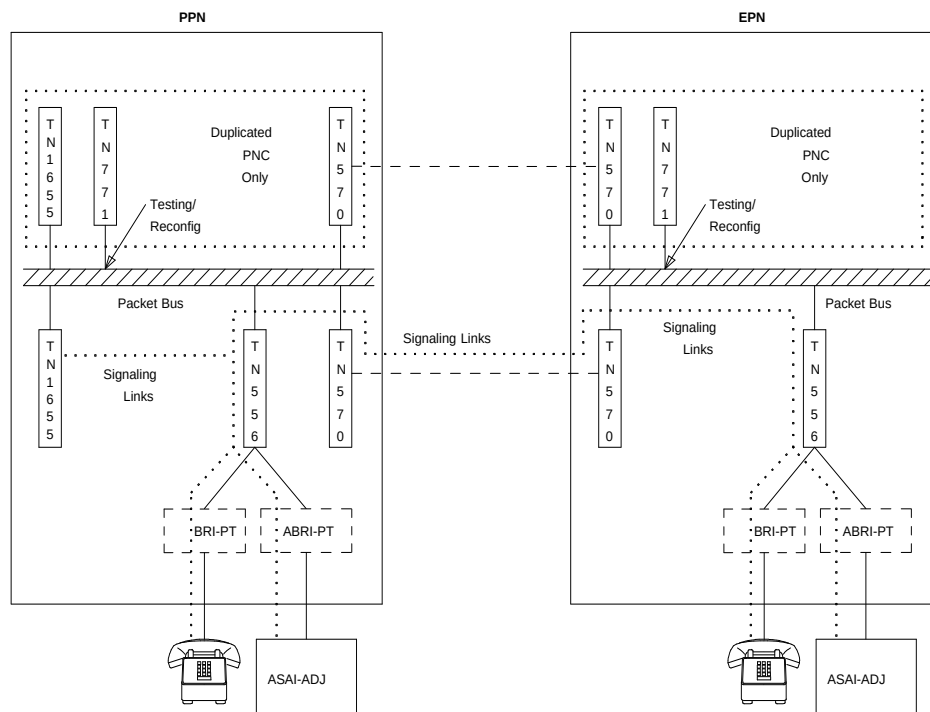
**Figure 5-10. ISDN-BRI/ASAI Connectivity**

Troubleshooting ISDN-BRI/ASAI problems can be a complex and involved procedure. The reason for this is that ISDN-BRI devices communicate with the SPE over the Packet Bus, as opposed to the TDM Bus. Therefore, it is possible for failures of other Packet Bus-related system components to cause problems with ISDN-BRI devices. Figure 5-10 shows the connectivity of the Packet Bus as it applies to ISDN-BRI signaling.

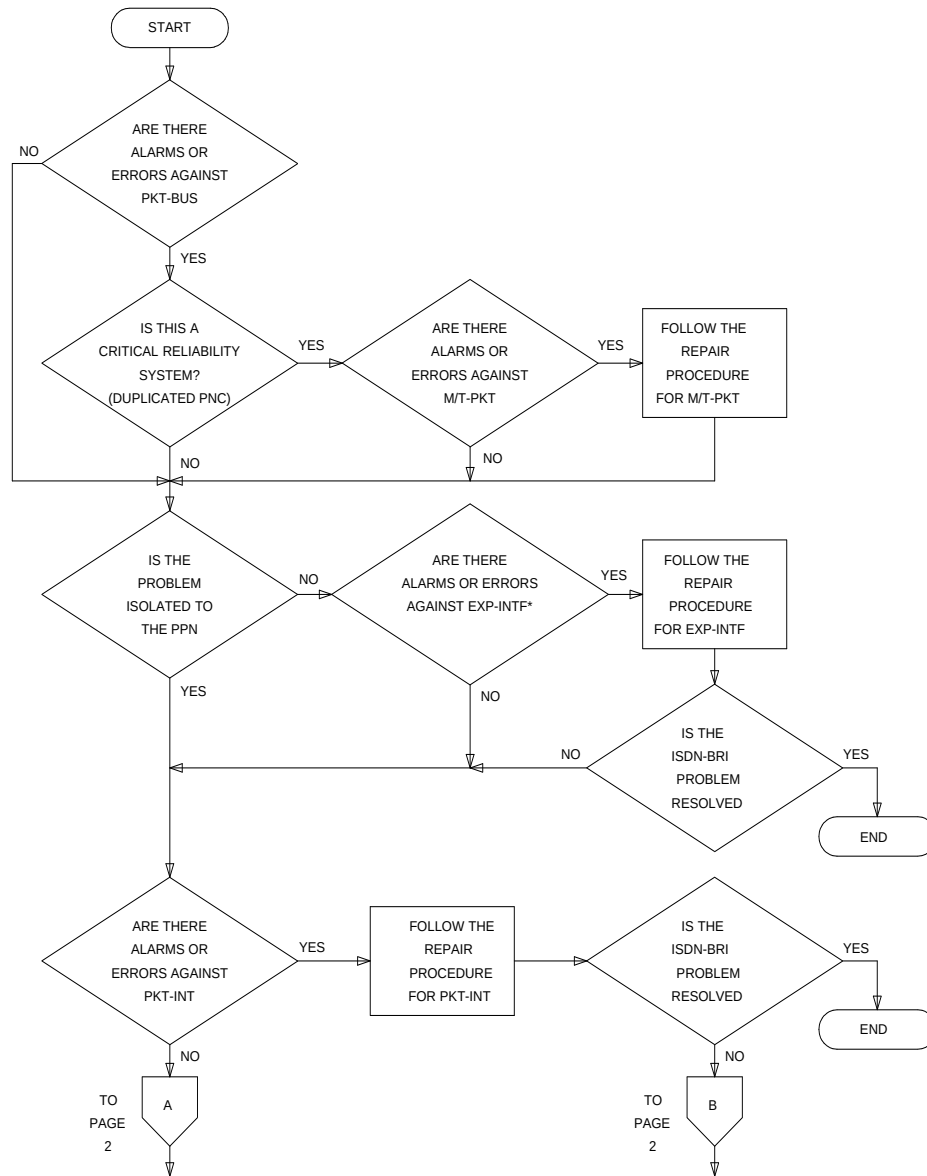
Figure 5-11. Troubleshooting ISDN-BRI Problems (Page 1 of 2)

The flowchart in Figure 5-11 describes the steps that should be taken to isolate and resolve ISDN-BRI problems. The order in which you should examine the maintenance objects is determined by looking at how wide-spread the failure is. For example, since all ISDN-BRI devices communicate with the TN1655 Packet Interface circuit pack, this MO should be examined early in the sequence. On the other hand, a failure of a TN570 circuit pack may cause ISDN-BRI failure in an EPN, but could not be the cause of a failure in the PPN.

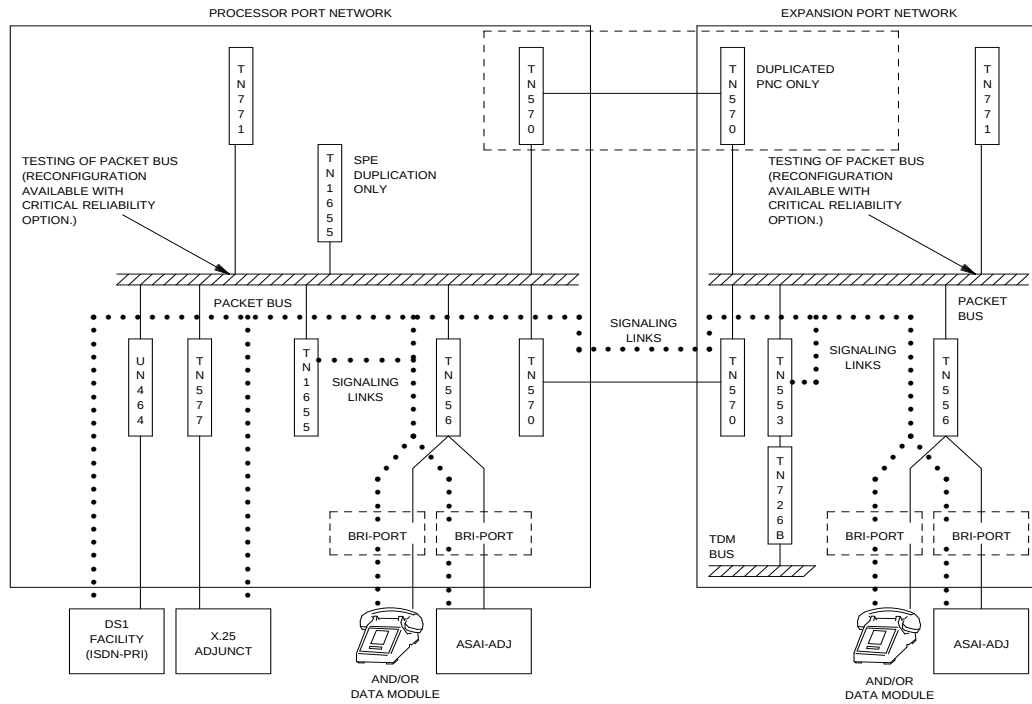
**Figure 5-13. Packet Bus Connectivity**

Figure 5-13 shows the circuit packs that communicate on the packet bus. Logical and physical connections are illustrated. Connectivity with multiple expansion port networks is similar.

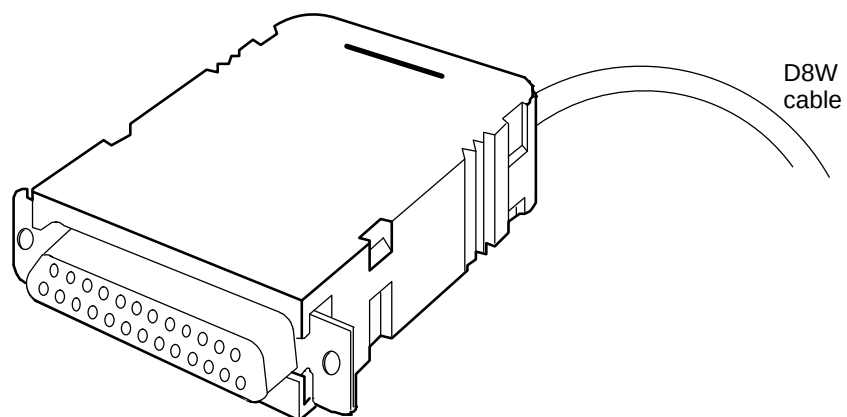
**Figure 5-14.** 355A EIA-232 Adapter

- D8W 8-wire modular cable of an appropriate length to connect the 258A on the back of the cabinet to the 355A adapter. The relevant COMCODE is determined by the length of the cable, as follows:

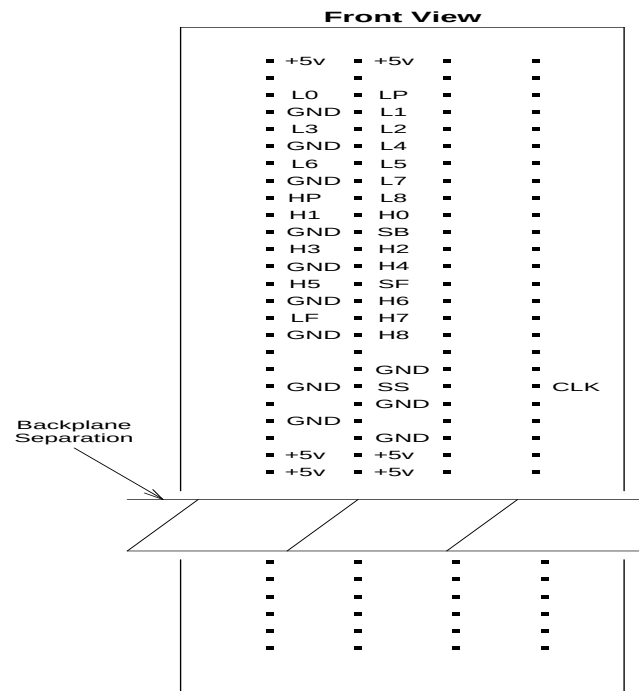
**Figure 5-16. Packet Bus Leads on the Backplane**

The packet bus is a set of 24 leads in the backplane of each Port Network. Twenty of these leads are data leads, three are control leads, and one lead is a spare. This distinction is important only for understanding why some circuit packs are able to detect only certain faults; the distinction does not affect fault isolation and repair. Each Port Network has its own packet bus and there is one packet bus maintenance object (PKT-BUS) in each port network. The packet bus is not duplicated as is the TDM Bus. There are however several spare leads on the packet bus and, in Critical Reliability systems (duplicated PNC), these spare leads are used to recover from some failures on the packet bus.

Figure 5-16 shows the location of the packet bus leads for a given slot as seen from the front and back of the carrier.

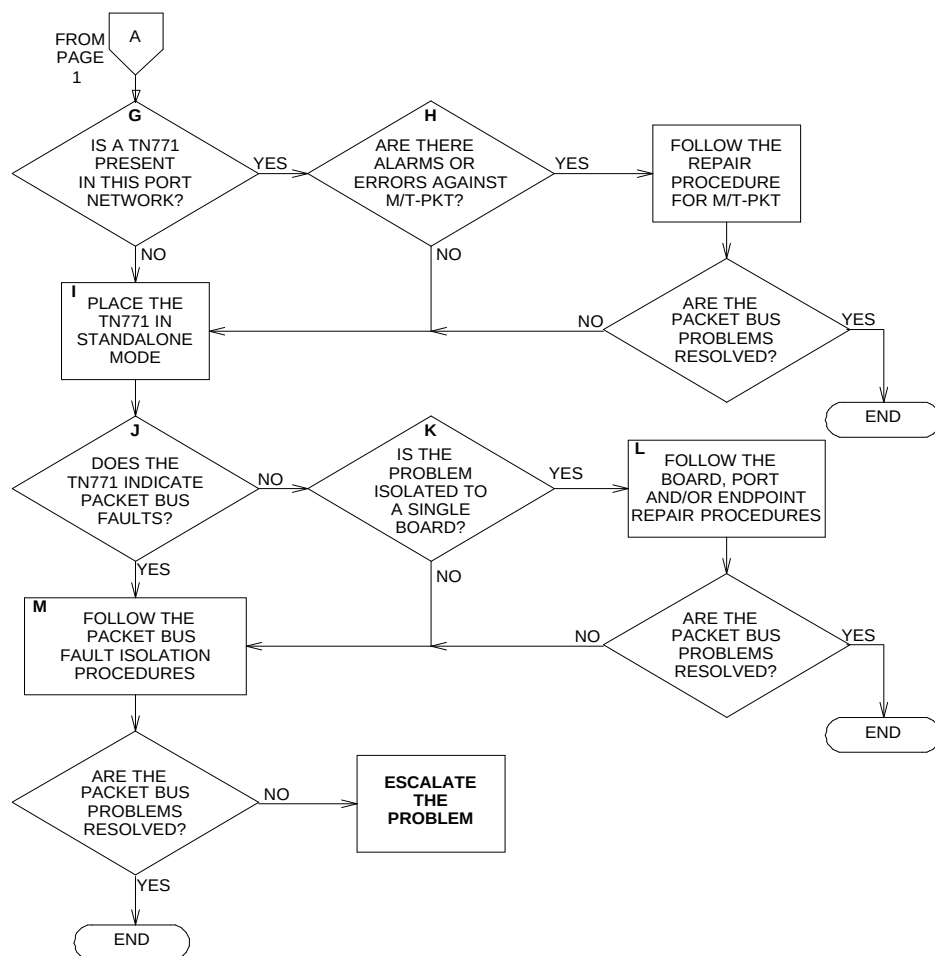
**Figure 5-19. Troubleshooting Packet Bus Problems (Page 2 of 2)**

Boldface letters in the flowchart refer to paragraphs in the explanatory section that follows.
