555-230-105  
Issue 5  
September 1996

# **DEFINITY Enterprise Communications Server Release 5 Maintenance for R5r**

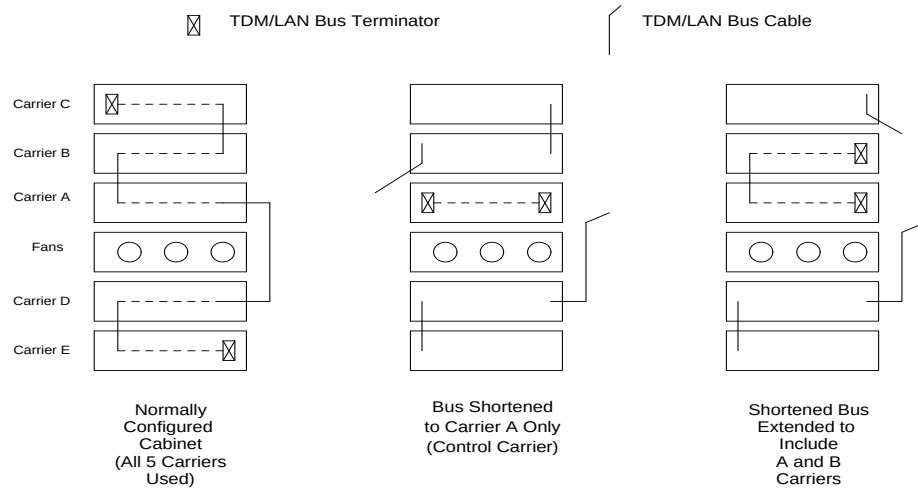
**Figure 5-20. Carrier Rewiring Example—Rear View of Multicarrier Cabinet**

In Procedure 4, the TDM/LAN Cable Assemblies and TDM/LAN termination resistor packs are replaced. If this action does not resolve the packet bus fault, the carriers are reconfigured by moving the termination resistor packs on the carrier backplanes in such a manner that certain carriers are disconnected from the bus. To terminate the packet bus at the end of a particular carrier, unplug the cable that connects the carrier to the next carrier and replace the cable with a TDM/LAN terminator resistor pack (see Figure 5-20). When the length of the packet bus is modified with this procedure, circuit packs that are essential to system operation (and the TN771 Maintenance/Test in standalone mode) must still be connected to the new 'shortened' packet and TDM busses.

Procedure 4 consists of two parts. Part 1 attempts to clear the packet bus fault by replacing all the bus cabling and terminators within a port-network. Part 2 attempts to isolate the fault to a particular carrier by extending the packet bus from the control carrier to additional carriers one at a time.

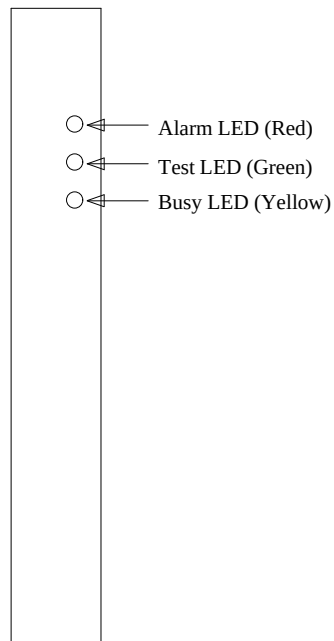
**Figure 7-1. Circuit Pack LEDs**

| Yellow | Busy | The circuit pack is currently in use by the system. |

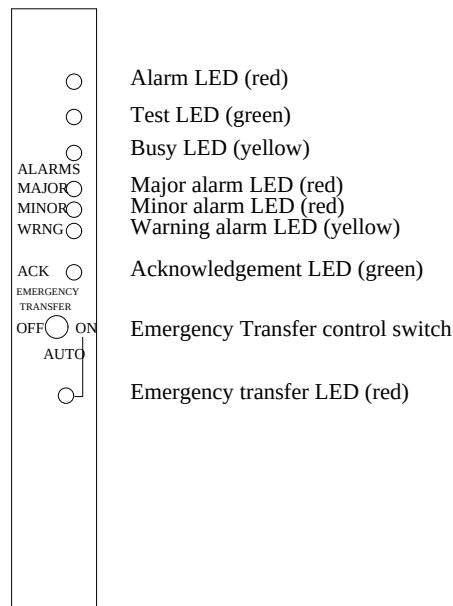
**Figure 7-2. SYSAM and EPN Maintenance Circuit Pack LEDs**

| EMERGENCY TRANSFER (red) on | Emergency transfer has been invoked. This occurs upon power-up as well as during disabling failures. |

These LEDS are illustrated on the following page.

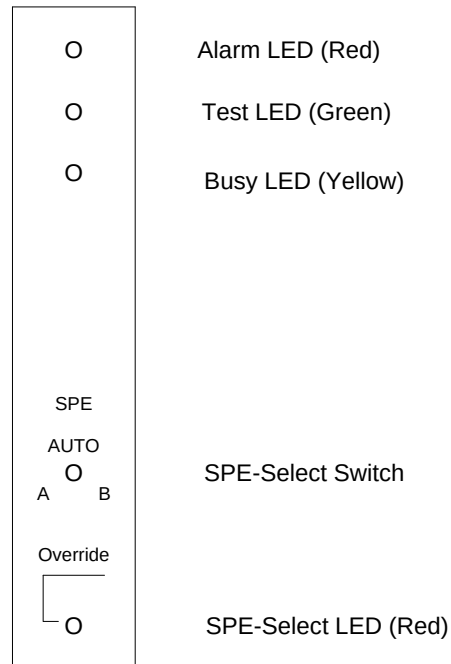
**Figure 7-3. Duplication Interface Circuit Pack LEDs**

In systems with duplicated SPEs, (High Reliability and Critical Reliability), there are two Duplication Interface UN330B circuit packs. One is located in carrier A and one in carrier B of the PPN. Each circuit pack has four LEDs. The top three have the traditional function of indicating the status of the pack.

The LED located at the bottom of the faceplate directly beneath the SPE Select switch is labeled **OVERRIDE**. Under normal operating conditions, the SPE Select switch is in the **AUTO** (center) position, and the **OVERRIDE** LED remains unlit. This means that the system controls which SPE is active. System selection of the active SPE can be manually overridden by moving the SPE Select switches from the **AUTO** position to either the "A" position or the "B" position on both Duplication Interface circuit packs. At this time, the red **OVERRIDE** LEDs on both Duplication Interface circuit packs will light steadily to indicate that one SPE is locked Active and the system is not duplicated. If both SPE Select switches are not in the same position, the system software retains control of Active SPE selection, and the **OVERRIDE** LED remains unlit. When control of the SPE selection is returned to the system by returning the SPE Select switches on both Duplication Interface circuit packs to the **AUTO** position, the **OVERRIDE** LED will go dark. Forced SPE selection should be undertaken only after consulting the appropriate sections in Chapter 9, "Maintenance Object Repair Procedures".

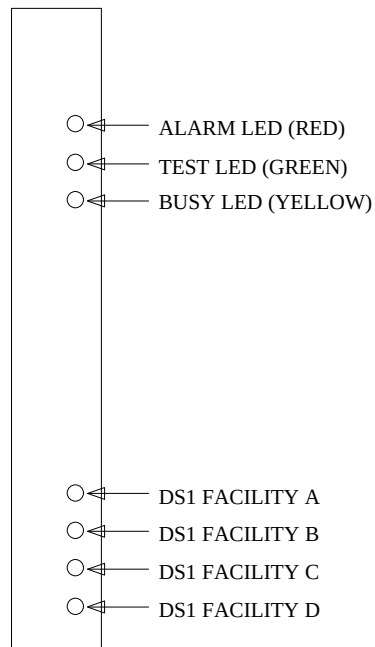
**Figure 7-4. TN574 DS1C Circuit Pack LEDs**

Below the three standard LEDs on the DS1C circuit pack are four green LEDs used to indicate whether a receive signal is present for each of the four DS1 facilities. Figure 7-4 shows which facility (A, B, C, or D) corresponds to each LED. If a green LED is off, there is a Loss of Signal condition on the DS1 facility associated with that LED. The presence of a signal does not guarantee that the signal is using the correct framing format or line coding; an Alarm Indication Signal indicating that the opposite end of the DS1C complex is out of service may be present.

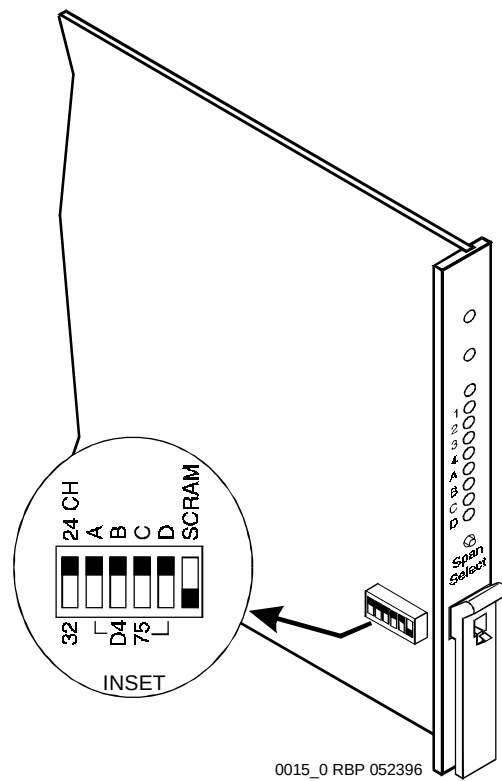
**Figure 7-5. TN1654 DS1CONV Circuit Pack**

The next four LEDs on the TN1654 DS1CONV board are labeled STATUS LEDs and are for future use. These LEDs will not be lit.

The bottom four LEDs on the TN1654 board are labeled SPAN LEDs. These LEDs are under firmware control. If the facility is not administered, then the LED is not lit. The LED is lit amber if the facility is running alarm free. If the facility is detecting either a red alarm (loss-of-signal or loss-of-frame), a yellow alarm (remote frame alarm) or a blue alarm (AIS signal) then the LED is lit red. The SPAN SELECT Switch on the TN1654 faceplate is for future use. Pushing the switch will have no affect on the board. See the following FIG. for a view of the face plate on the TN1654 DS1CONV circuit pack

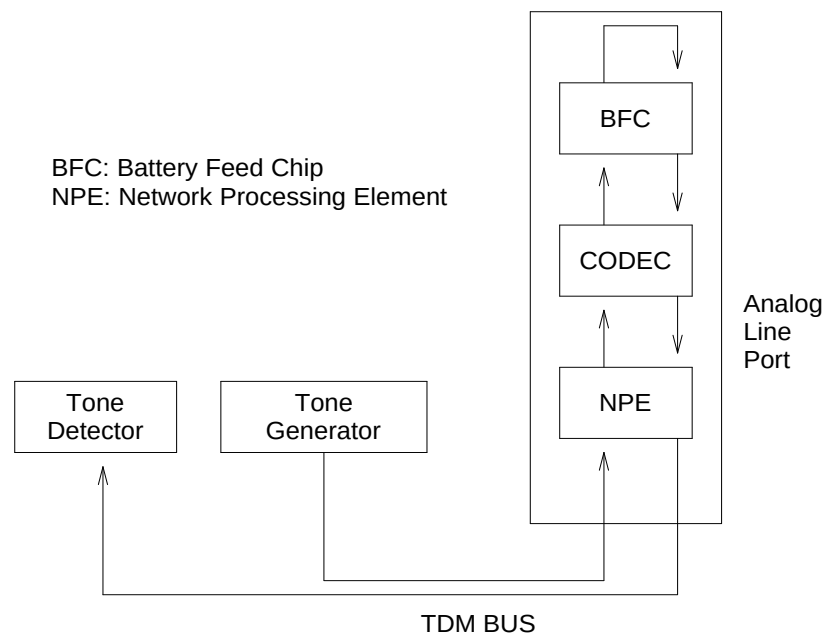
**Figure 9-1. Analog Loop Around Test**

This test is designed to check the on-board transmission capabilities of the NPE, the codec, and the battery feed chip of the analog port. A Tone Detector and a Tone Generator talk and listen on the same pair of time slots as the Analog Port. The Analog Port is then instructed to go into loop around mode (see Figure 9-1). The test passes if the signal measured by the Tone Detector is within acceptable limits.

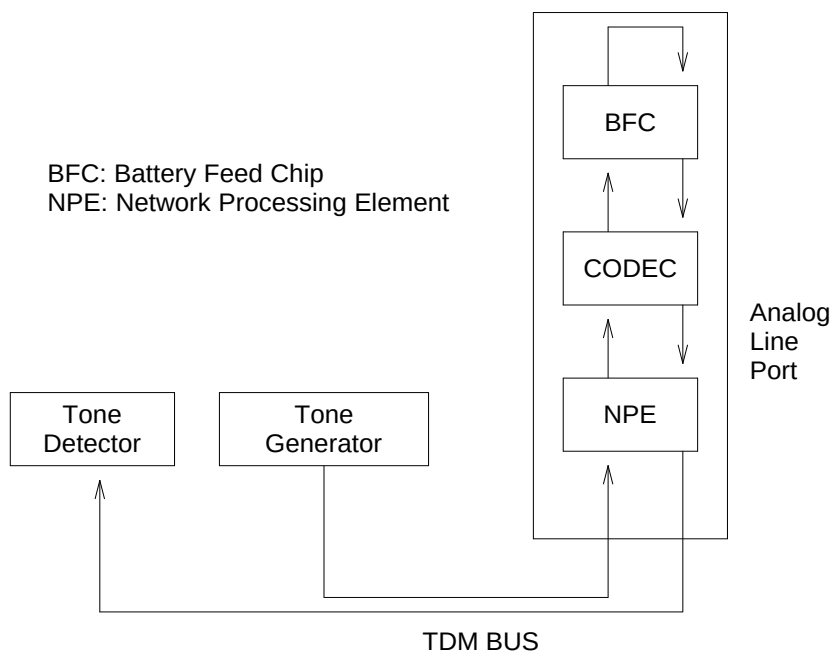
**Figure 9-2. Analog Loop Around and Conference Test**

This test is designed to check the on-board transmission capabilities of the NPE, the codec, and the battery feed chip of the Analog Port. A Tone Detector and a Tone Generator talk and listen on the same pair of time slots as the Analog Port. The Analog Port is then instructed to go into loop around mode (see Figure 9-2). The test passes if the signal measured by the Tone Detector is within acceptable limits.

This Loop Around Test is sensitive to the length of the loop, the equipment in the loop, or the equipment terminating the loop, such as off-premises stations. If this test is causing a false alarm, then disable the test by changing the Tests field to "no" using the **change station** command for this station.

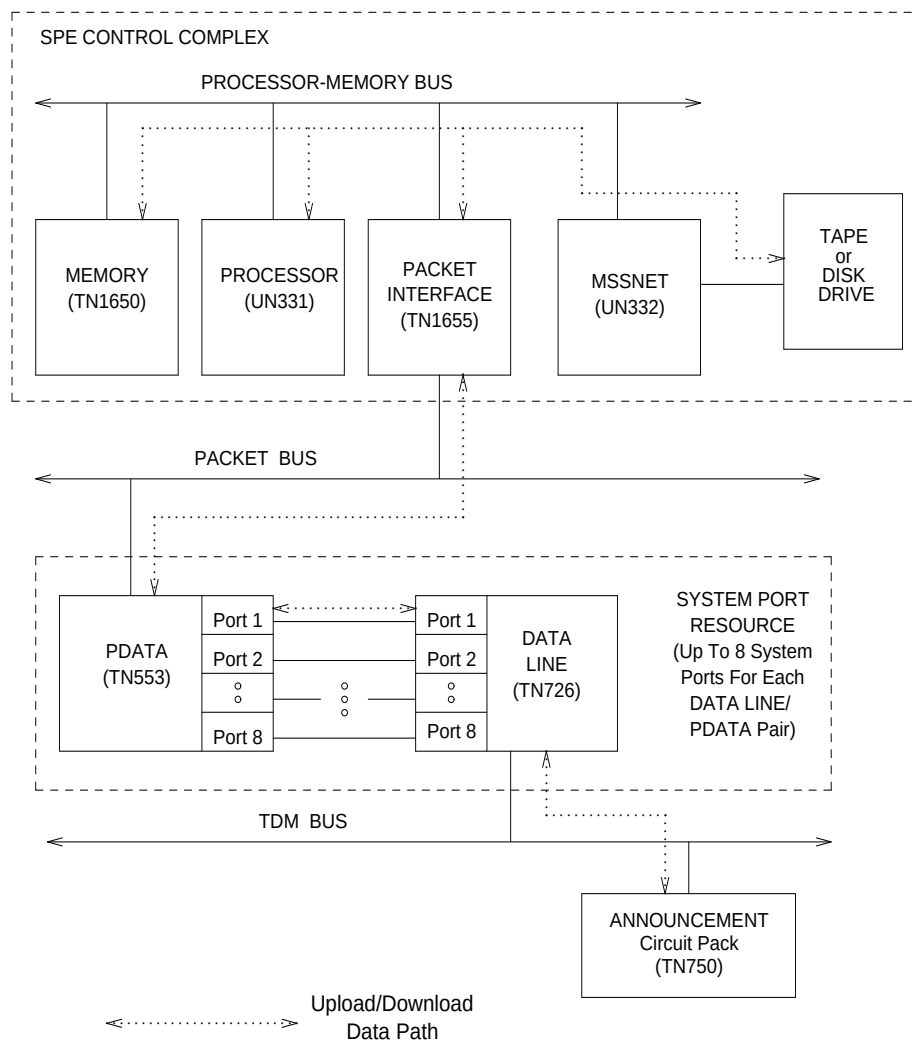
**Figure 9-3. Announcements Upload/Download Connectivity**

Figure 9-3 illustrates connections between the Announcement circuit pack and the system. To save or restore announcements, an ANNOUNCEMENT Data Extension must be administered, and at least one System Port must be in the *in-service/idle* state.

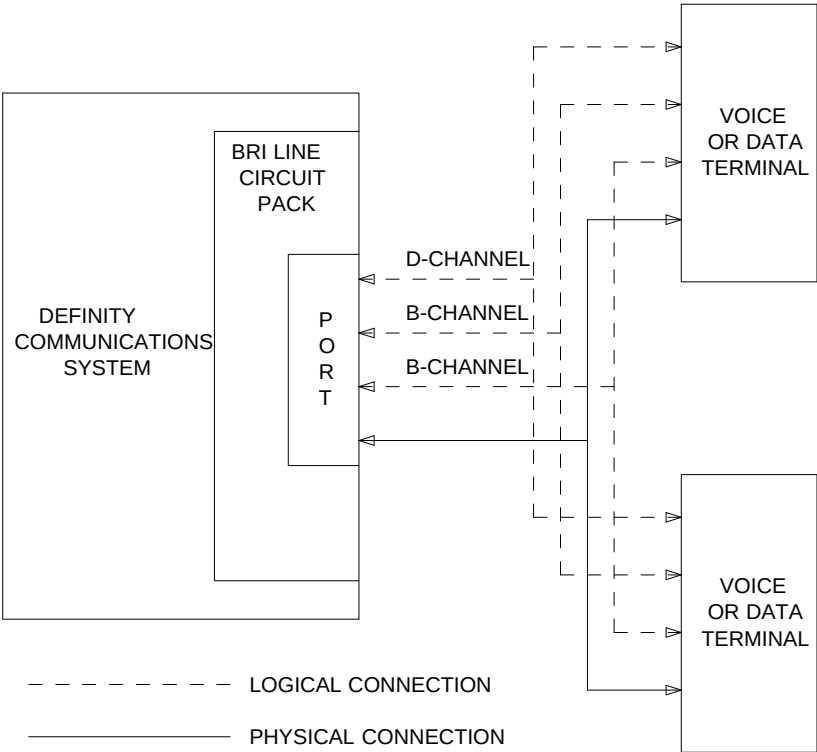
**Figure 9-4. ISDN-BRI Port Interactions**

Figure 9-4 illustrates the physical connection (solid line) between an ISDN-BRI Port and its associated ISDN-BRI set(s). Each physical connection allows for two B-channels and one D-channel. Each ISDN-BRI circuit pack can support up to 12 of these *physical* connections to different voice and voice/data sets or ASAI or AT&T adjuncts. On a TN2198 each ISDN-BRI circuit pack can support up to 12 *physical* connections to a NT1 which in turn connects to 2 terminals.

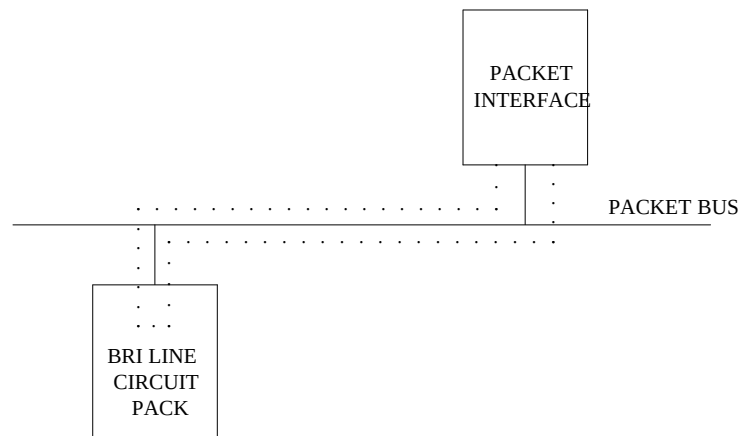
**Figure 9-5. Path of the BRI Port Local LAN Loop Around**

This test, which verifies the connectivity of a BRI port across the LAN Bus, executes only if the port is out-of-service. The test aborts if calls associated with the port are in-progress. Failures of this test indicate either on-board faults associated with the BRI-PORT hardware on the circuit pack, or problems with the LAN Bus, which is used to form connectivity between the switch and the BRI-PORT.

The dotted lines in Figure 9-5 show how a Loop Around Test is performed across the Packet Bus for the D-channel.

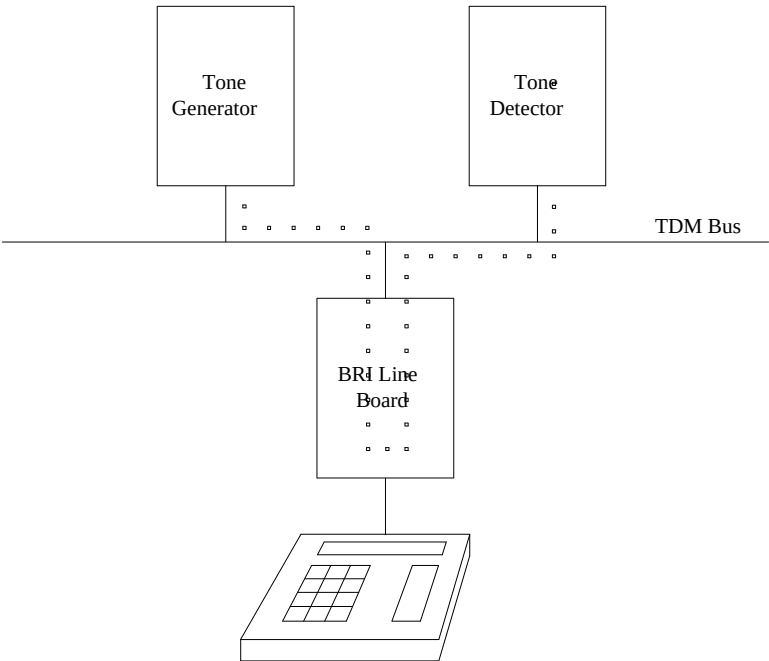
**Figure 9-6. Path of the BRI Port Local TDM Loop Around**

The dotted lines in Figure 9-6 show how a Loop Around Test is performed for the B-channels. The figure shows a terminal connected to a BRI line board using a TN556. If a TN2198 is used the terminal would be connected to a NT1, and the NT1 to the BRI board.

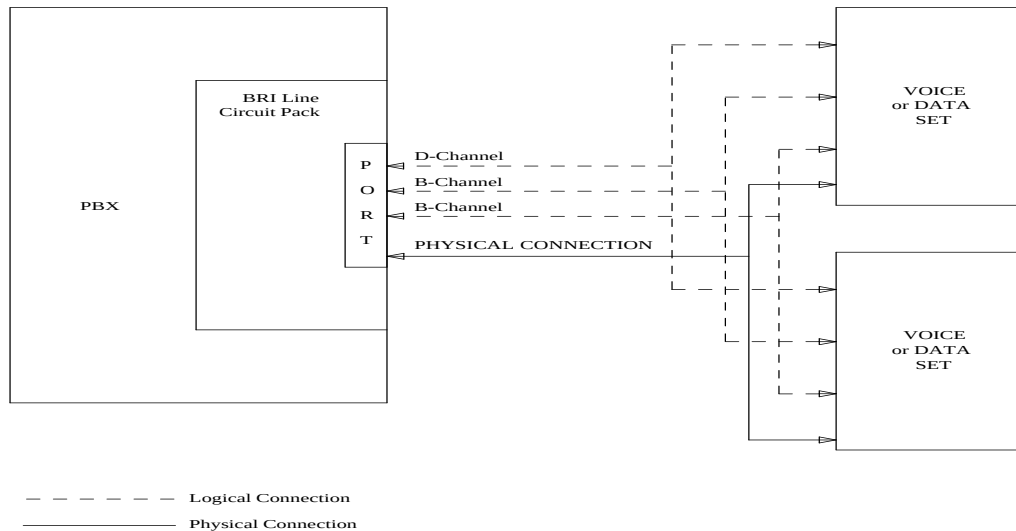
**Figure 9-7. ISDN-BRI Set Interactions**

Figure 9-7 illustrates the physical connection (solid line) between an ISDN-BRI Circuit Pack and a voice or voice/data set. Each physical connection allows for two B-channels, as stated above, plus one D-channel. Each ISDN-BRI circuit pack can support up to 12 of these PHYSICAL connections to different voice and voice/data sets or ASAI and AT&T adjuncts.

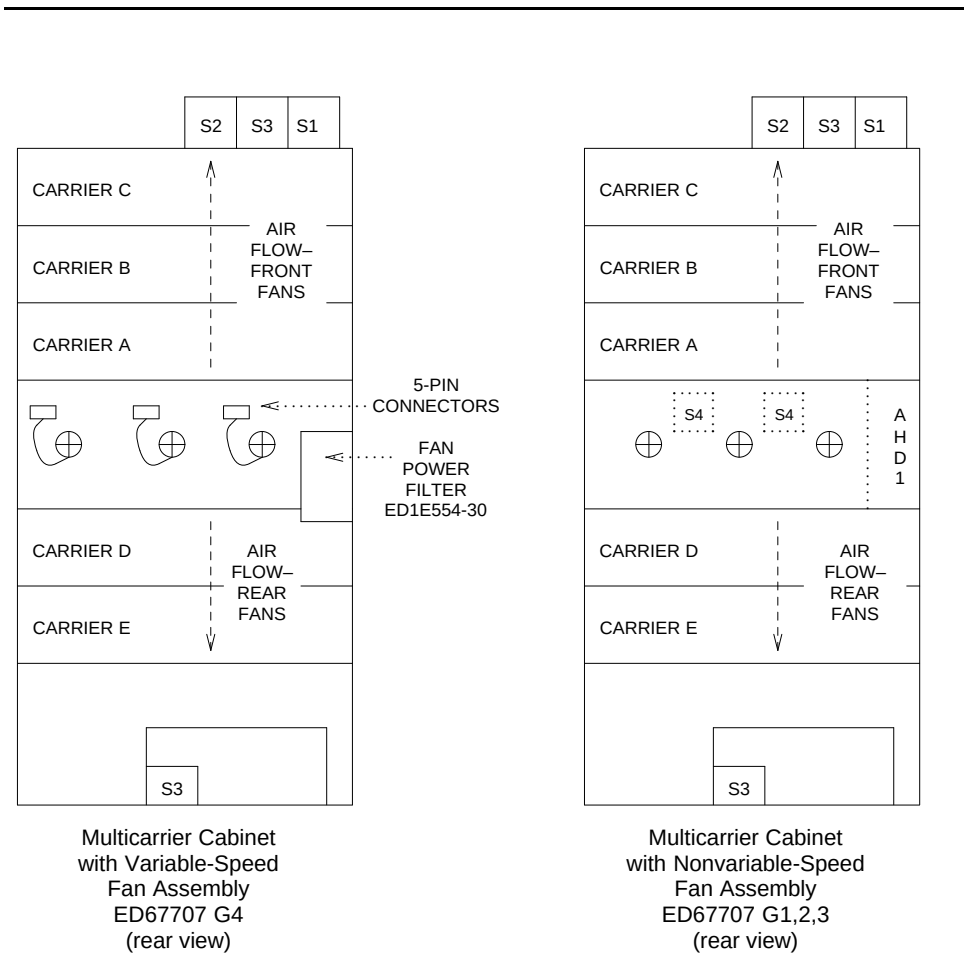
**Figure 9-8. CABINET Maintenance Object Components**

You will find one of two different fan assemblies and associated control hardware on G3r systems. New systems are equipped with variable-speed fans. In older or upgraded cabinets, you may find nonvariable-speed fans. See Figure 9-8 and descriptions to determine which fan assembly is present in the cabinet you are working on.

A variable-speed fan is identified by the following features (see also Figure 9-8):

Nonvariable-speed fan and air filter assemblies, found on some upgraded cabinets, are identified by the following (see also Figure 9-8):

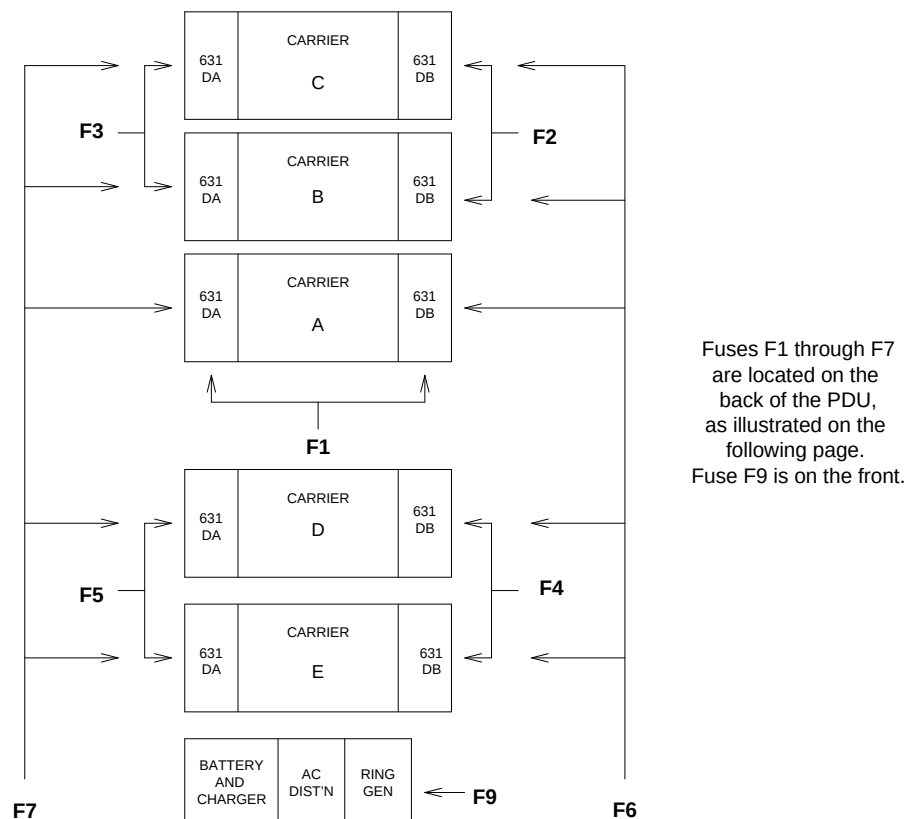
**Figure 9-9. Fuse Assignments for AC-Powered Systems (PDU 58890CE-1)**

In AC powered cabinets, the Power Distribution Unit, or PDU (58890CE-1), distributes 120/208V AC from a wall outlet through a set of fuses (F1-F7) to the Off-Line Switchers (OLSs). (During emergency backup in a system so equipped, 144 VDC is supplied.) Each carrier in the cabinet is equipped with two OLSs; the 631OLS DA and the 631OLS DB, which together supply the required voltages to the carrier.

Loss of the 631OLS DB Carrier Port Power Supply in the active PPN control carrier drops the G3-MT login. In a system with duplicated SPEs CARR-POW alarms do not cause an interchange, but loss of power to PROC, MEM-BD, SW-CTL, SYSAM, and PKT-INT maintenance objects (powered from the left side of the active control carrier) will reduce the SPE state of health, possibly causing an interchange. Loss of power on the right side of the active control carrier will cause the HOST-ADAPTER, DISK, and TAPE maintenance objects to fail, these failures will not cause an SPE interchange. Figure 9-9 through Figure 9-12 show which carriers are protected by each circuit breaker.

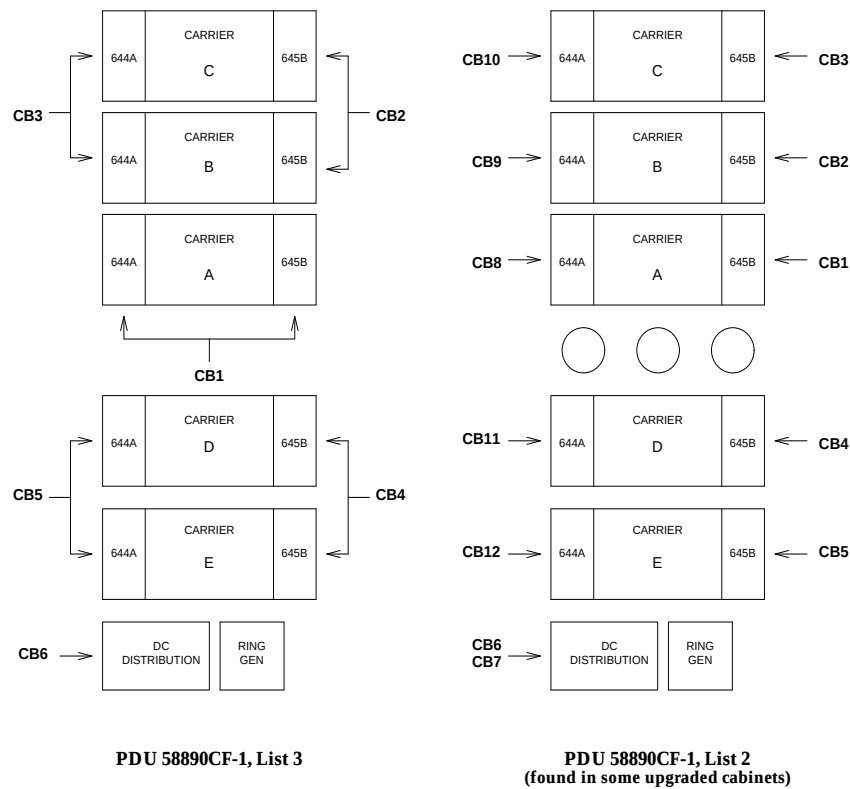
**Figure 9-13. Circuit Breaker Assignments for DC-Powered Systems**

On both units, the Ring Voltage Generator is protected by a fuse located next to the main circuit breaker on the front of the PDU.

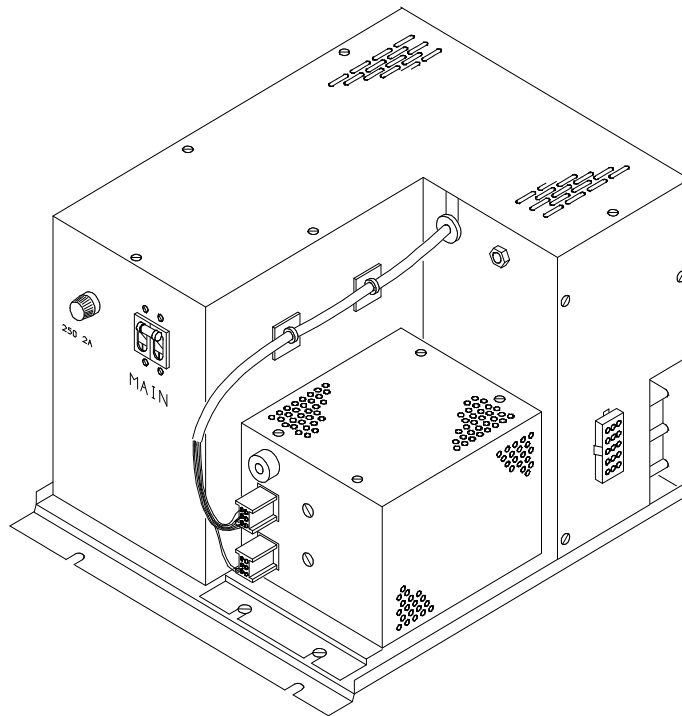
**Figure 9-14. Multi-Carrier Cabinet DC Power Distribution Unit, Front View**

The ringing voltage generator is protected by a fuse located next to the MAIN circuit breaker.

These two Power Distribution Units are illustrated on the following pages.

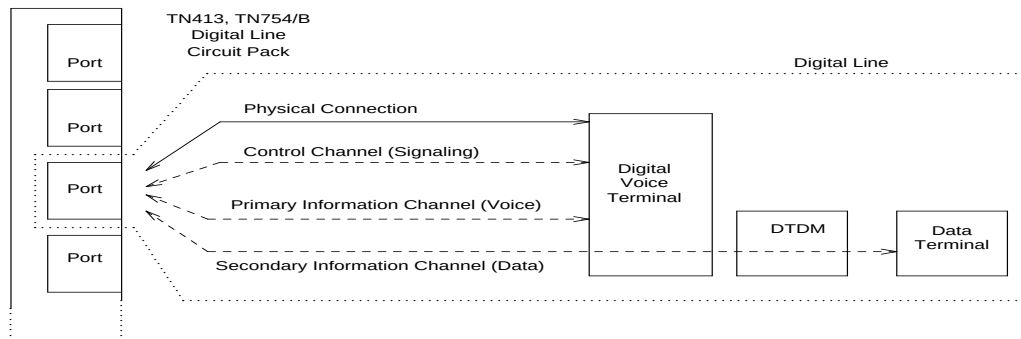
**Figure 9-18. Digital Line Connectivity**

other devices currently supported by Digital Line circuit packs communicate on the primary information channel. Figure 9-18 shows examples of digital line connectivity.

It should be noted that TN2181 and TN2224 supports both modes as shown in Figure 9-18 and Figure 9-19.

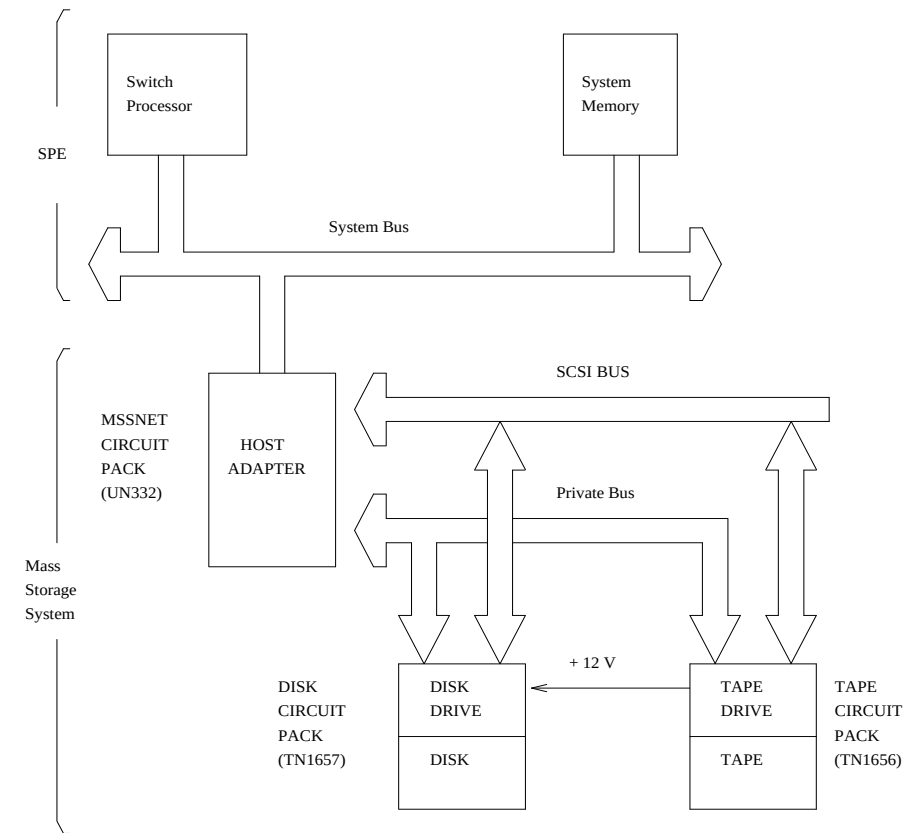
**Figure 9-20. Mass Storage System Interactions**

The TN1657 Disk circuit pack is part of the Generic 3r Mass Storage System (MSS). The MSS provides non-volatile storage for system software, translation data, announcement data and program update data. As shown in Figure 9-20, the MSS consists of a Host Adapter circuit on the UN332 MSS-Network Control circuit pack (MSSNET), a Small Computer System Interface (SCSI) bus, a TN1656 Tape circuit pack and the TN1657 Disk Drive circuit pack. The Disk Drive acts as the primary storage device and the Tape Drive serves as a backup device.

A -48V to +12V converter circuit on the Tape circuit pack provides power for both the Tape Drive and the Disk Drive. The presence of +12V on these circuit packs is monitored separately by maintenance software so that a failure of the +12V converter on the Tape circuit pack can be identified or ruled out as the source of the problem when the Disk Drive loses +12V power.

The Host Adapter Circuit, Tape circuit pack, and Disk circuit pack are treated as separate, but related, maintenance objects (H-ADAPTER,TAPE, and DISK). Since the Disk circuit pack is controlled by SCSI commands which are generated by the Host Adapter, problems with the Host Adapter can prevent communications with the Disk. Whenever the Host Adapter is taken out of service by the **busy-out host-adapter** command, or due to failure of a critical Host Adapter test, the Tape and Disk maintenance objects are also placed in a maintenance busyout state.

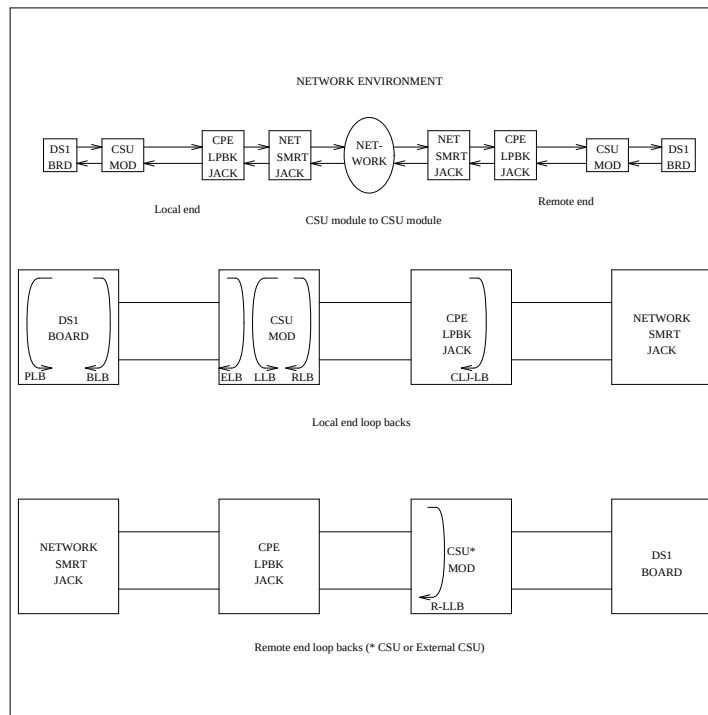
The TN767E and 120A1 CSU Module support on-demand loopback tests that assist in the detection of faults between the TN767E circuit pack and the CSU Module, between the Integrated CSU and the optional Customer Premises Loopback Jack, or between the Integrated CSU and remote CSU. These loopback tests are explained in detail later in this DS1-BD section, but Figure 9-21 gives a high level overview of the loopback points.

**Figure 9-21. High Level Overview Of Loopback Points**

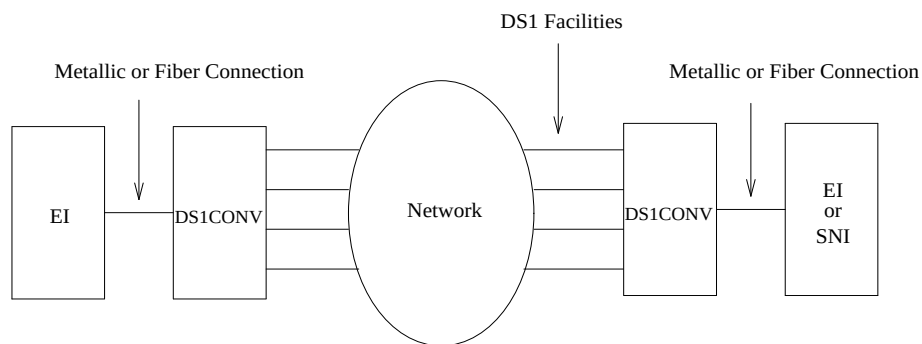
DS1CONV circuit packs are connected to the Expansion Interface (EI) circuit packs (TN570) and the Switch Node Interface (SNI) circuit packs (TN573) as shown in Figure 9-22.

**Figure 9-22. DS1CONV Complex and the DS1 Facilities**

The DS1CONV Complex can replace fiber links between two EIs and fiber links between an EPN EI and an SNI. Fiber links between two SNIs and fiber links between the Processor Port Network (PPN) and the Center Stage Switch (CSS) cannot be replaced by a DS1CONV Complex.

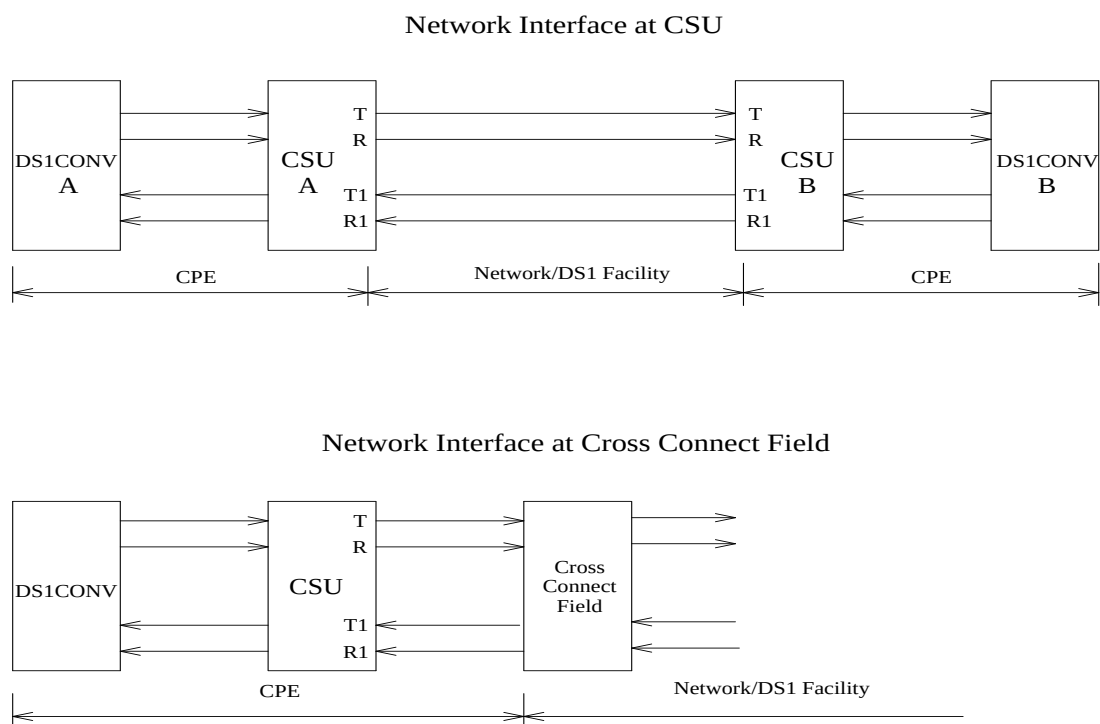
The DS1 facility line signal is pre-equalized at the transmitter on the DS1CONV circuit pack so that DS1 line pulses have correct amplitude and shape when they reach the Network Interface (see Figure 9-23). The amount of equalization necessary is determined by the distance to the Network Interface and also by the type of wiring used to connect to the Network Interface. If the equalization is not set to the correct value, potentially high error rates (errored seconds) will be observed on the DS1 facility. Equalization values are determined as follows:

**Figure 9-23. DS1 Facility Connections**

For the following repair procedure, refer to Figure 9-23 and the diagrams in the related test descriptions.

1. Check the loopback LEDs on both CSU A and CSU B as shown in Figure 9-23 to see if a CSU is in a loopback mode. Also check to see if the CSUs have been manually hard-wired into a loopback mode. Remove detected loopbacks.

To isolate a problem, set the loopback first at the loopback point **LB 1**, and then at the loopback point **LB 2**, see Figure 9-26 and *Figure 9-23*. Place the loopbacks at as many points as your CSU capabilities will allow. Hard-wired loopbacks at the far end are not desirable, because the equalization level adjustments may cause problems.

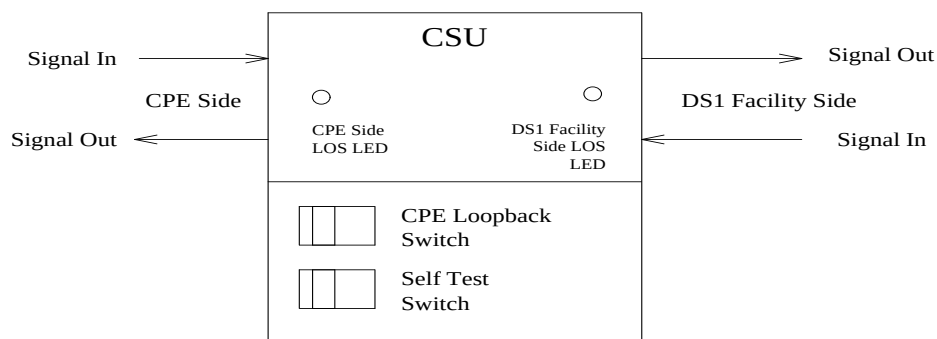
Fault isolation for this problem may be different depending on the capabilities of the CSU device that is being used. Typically, CSUs provides an LED that is useful for fault isolation (see Figure 9-24). This is the "16 Zeros" LED. This LED is momentarily lit when a string of 16 consecutive zeros is detected in the DS1 signal from the DS1CONV. Zeros on a DS1 link are represented by an absence of a pulse. Thus, an active 16 Zeros LED indicates a LOS alarm from the DS1CONV.

**Figure 9-24. Typical CSU Maintenance Capabilities**

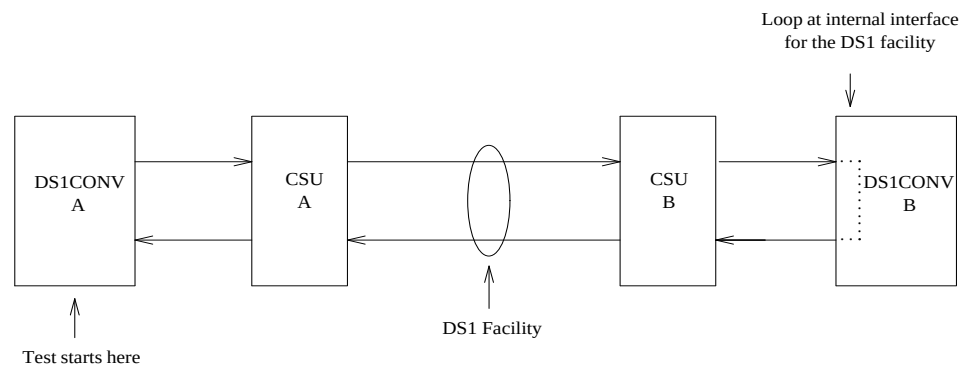
If the test passes on a TN1654 DS1 facility, the *round trip delay time* will be displayed in milliseconds in the *Error Code* field. The round trip delay time is defined as the length of time in milliseconds it takes for the firmware to receive the test pattern after it has been sent.

**Figure 9-25. Far-End Internal Loopback Test (#797)**

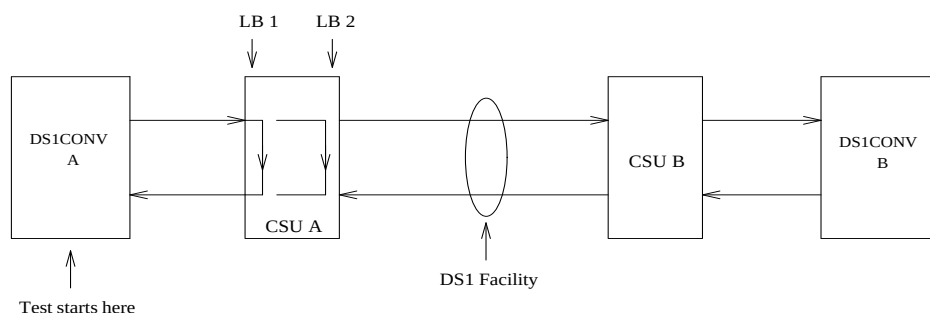
If the test passes on a TN1654 DS1 facility, the *round trip delay time* will be displayed in milliseconds in the *Error Code* field. The round trip delay time is defined as the length of time in milliseconds it takes for the firmware to receive the test pattern after it has been sent. This measurement is taken on the last DS1 channel tested.

**Figure 9-26. Loopback Points for Test #799**

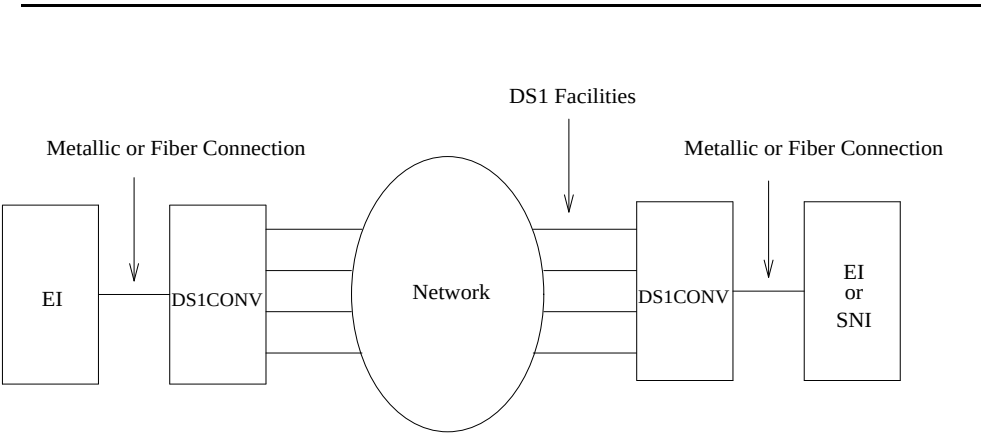
DS1CONV circuit packs are connected to TN570 Expansion Interface (EI) circuit packs and TN573 Switch Node Interface (SNI) circuit packs via metallic cables as shown in Figure 9-27. A fiber link cable can be used instead of the metallic cable if it is necessary to locate the DS1CONV far from the connected EI or SNI circuit pack, for example, in an adjacent cabinet.

Figure 9-27. DS1CONV connection to EIs and SNIs

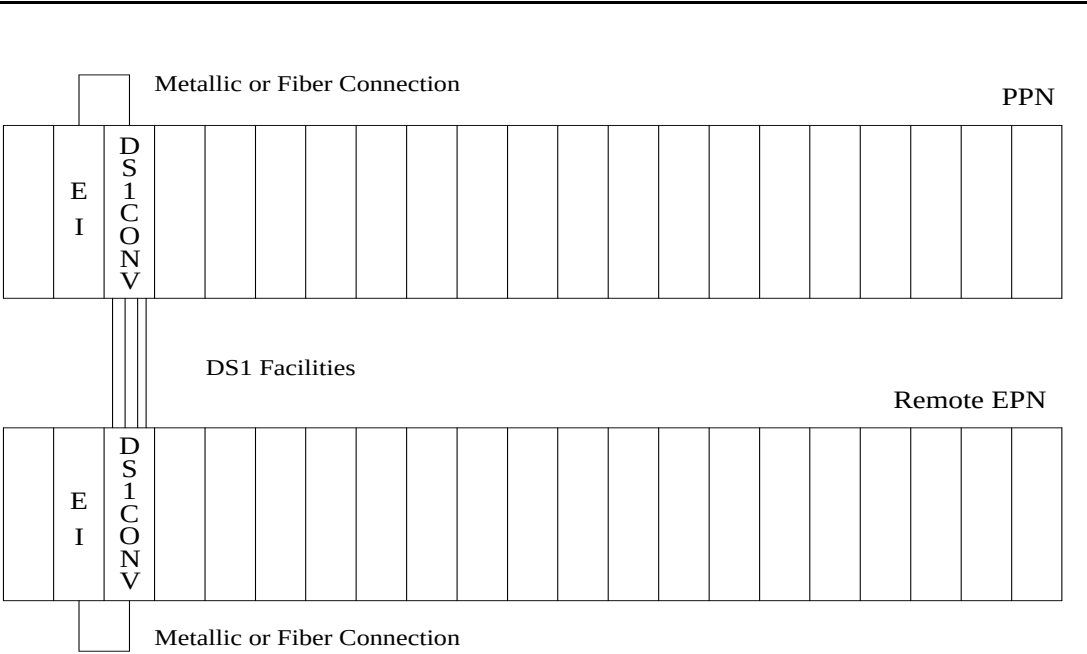
Figure 9-28. DS1CONV Complex in Direct Connect PNC

Figure 9-28 and Figure 9-29 show DS1CONV connections in a direct connect PNC configuration and between the CSS and an EPN in a Critical Reliability System configuration (duplicated PNC).

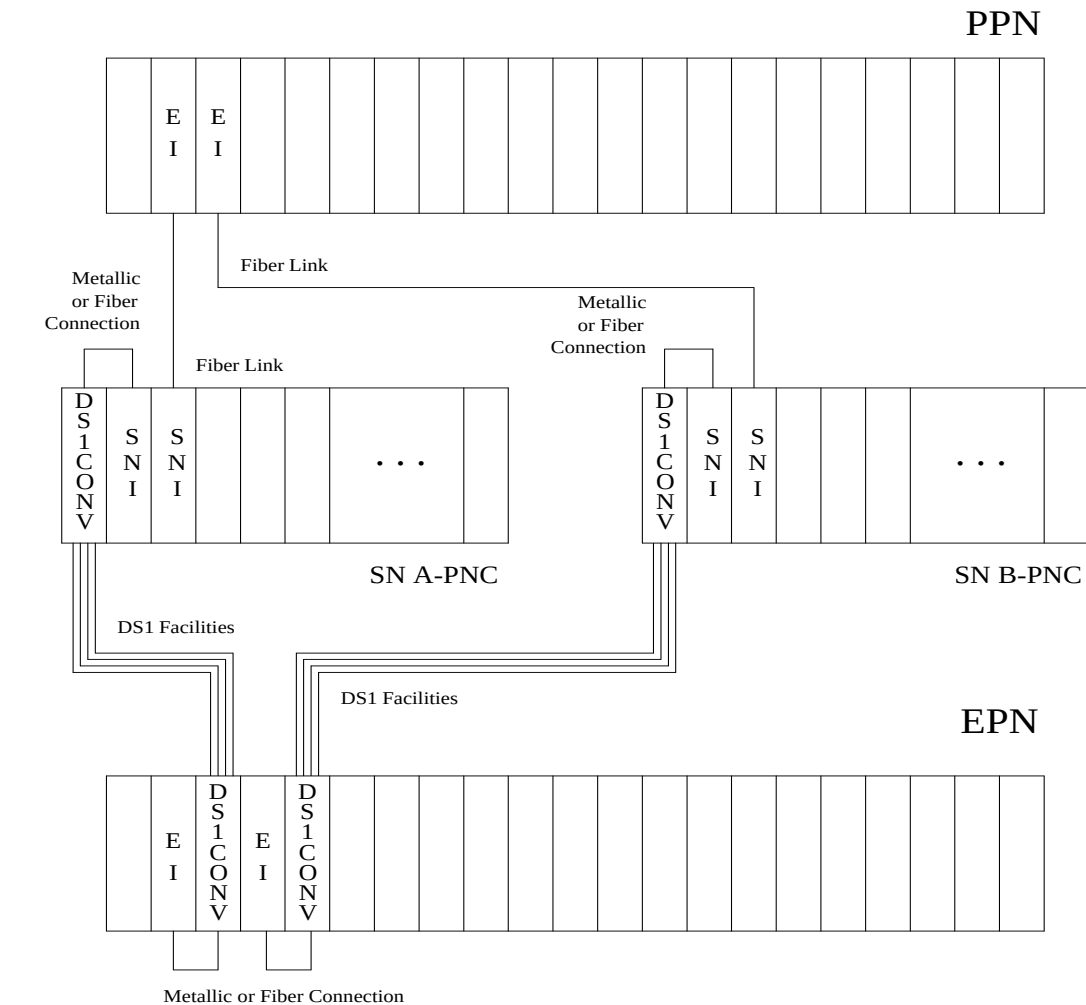
**Figure 9-29. DS1CONV Complex in Duplicated PNC with 1 SN**

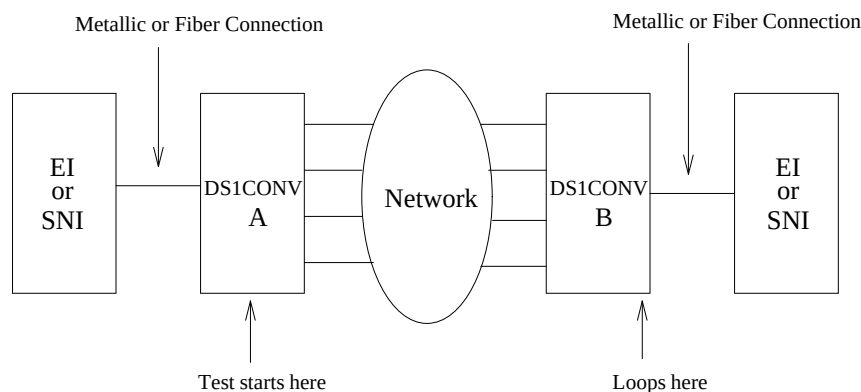
Every part of this test is executed under firmware control and the result is sent back to the maintenance software. Test is executed by sending digital data through every administered DS1 facility channel. Two different test patterns are used, these are hexadecimal values 55 and AA.

**Figure 9-30. Far-end DS1CONV Loopback Test (#788)**

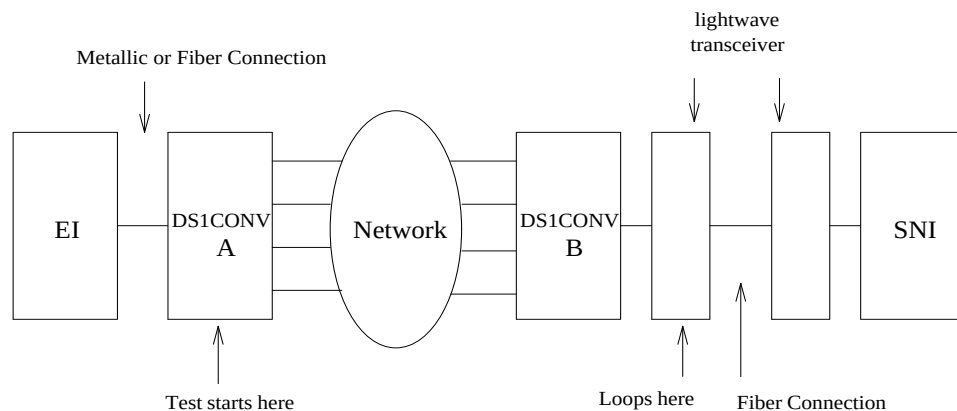
Every part of this test is executed under firmware control and the result is sent back to the maintenance software. Test is executed by sending digital data through every DS1 facility channel. Two different test patterns are used, these are hexadecimal values 55 and AA.

**Figure 9-31. Far-end Lightwave Transceiver Loopback Test**

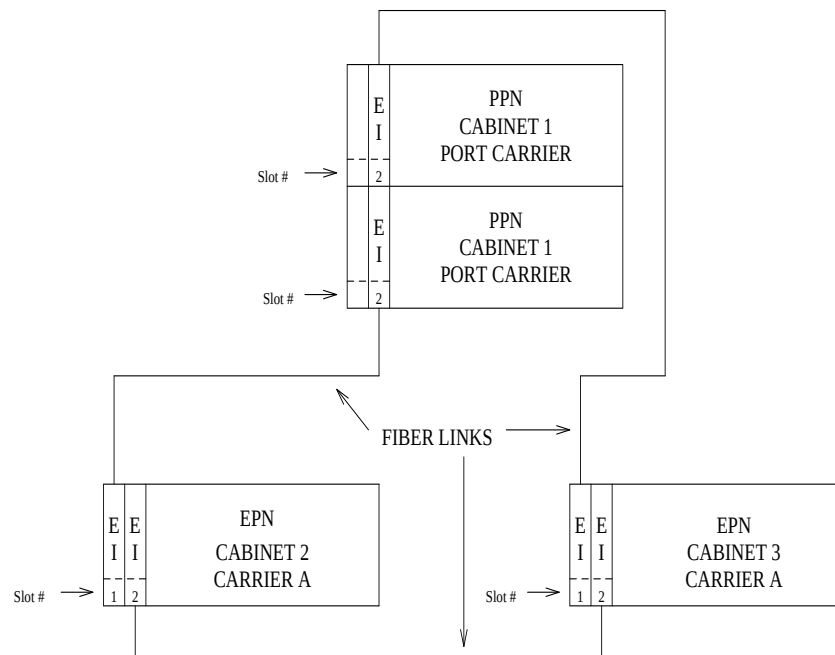
Figure 9-32 shows the location of the EI circuit packs in a typical simplex PNC, direct connect configuration.

**Figure 9-32. Direct Connect Configuration with Simplex PNC**

Each Port Network in direct connect configurations must be connected to each other port network via a fiber link. Each EPN has one EI that functions as an archangel. This EI must be connected, via fiber, to an EI located in the PPN. If an EI is functioning as an archangel (bus master), its yellow led will be flashing at a rate of 2 seconds on and 200 ms off.

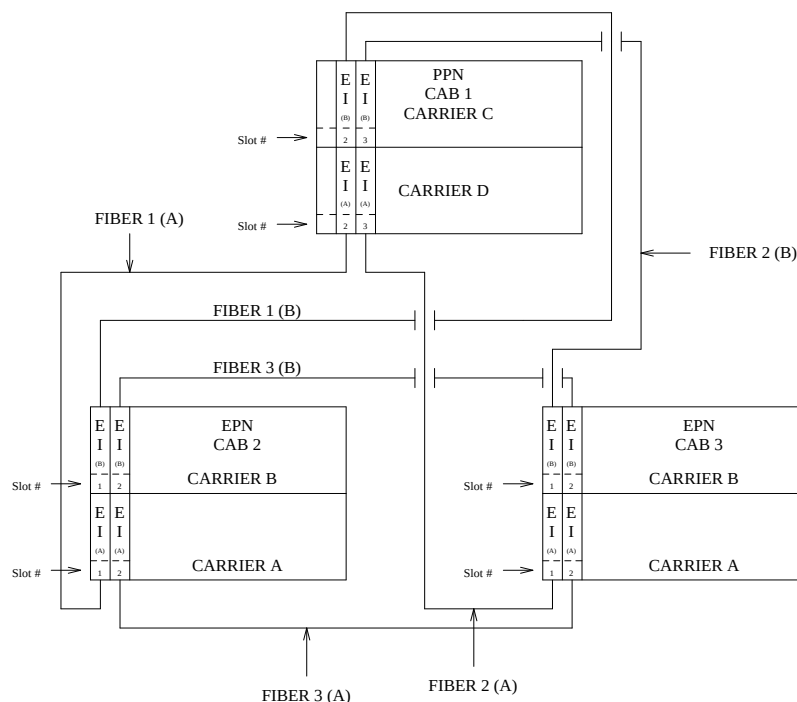
Figure 9-33 shows the location of EI circuit packs in a typical duplicated PNC, direct connect configuration.

**Figure 9-33. Direct Connect Configuration with Duplicated PNC**

In a duplicated PNC there is an A-side PNC and a B-side PNC. All EIs in this diagram are labeled with an A or a B to designate which PNC they are a part of. Note that the PNC designation (A or B) does not relate directly to carrier location. Again, only one of the EIs in an EPN can function as an archangel (TDM Bus Master). The EI that is on the active PNC and that is connected to the PPN is the only one that can function in this mode. In normal operation, its yellow LED should be blinking at a rate of 2 seconds on and 200 ms. off.

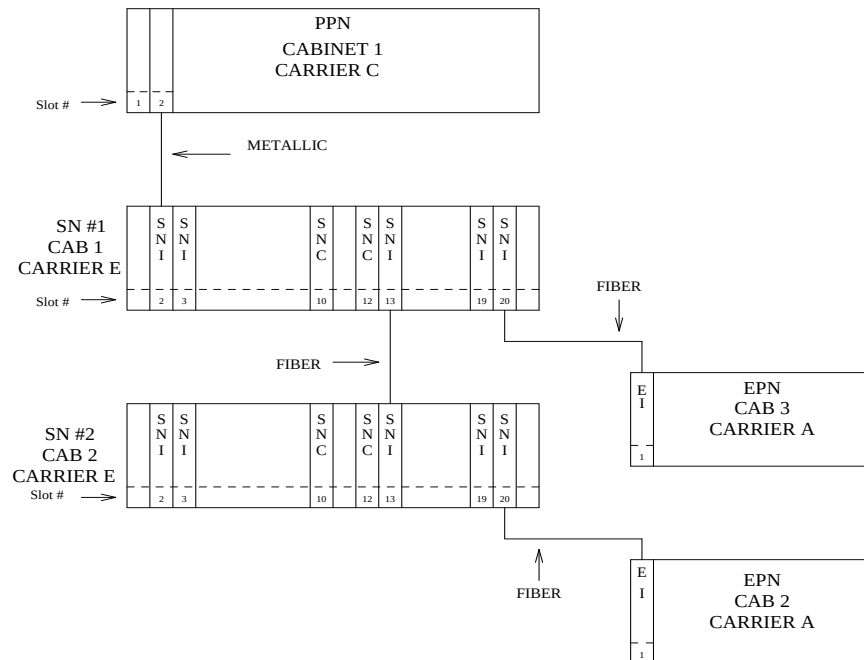
Figure 9-34 shows the location of EI s in a typical center stage switch configuration with simplex PNC.

**Figure 9-34. Center Stage Switch Configuration with Simplex PNC**

In a simplex stage switch configuration, only one EI is needed in each port network. Notice that there is no direct connection between the EPNs, rather all inter-EPN connections are made through the stage switch. Each SNI in the switch node carriers can be connected to an EPN through an EI circuit pack.
