555-230-105  
Issue 5  
September 1996

# **DEFINITY Enterprise Communications Server Release 5 Maintenance for R5r**

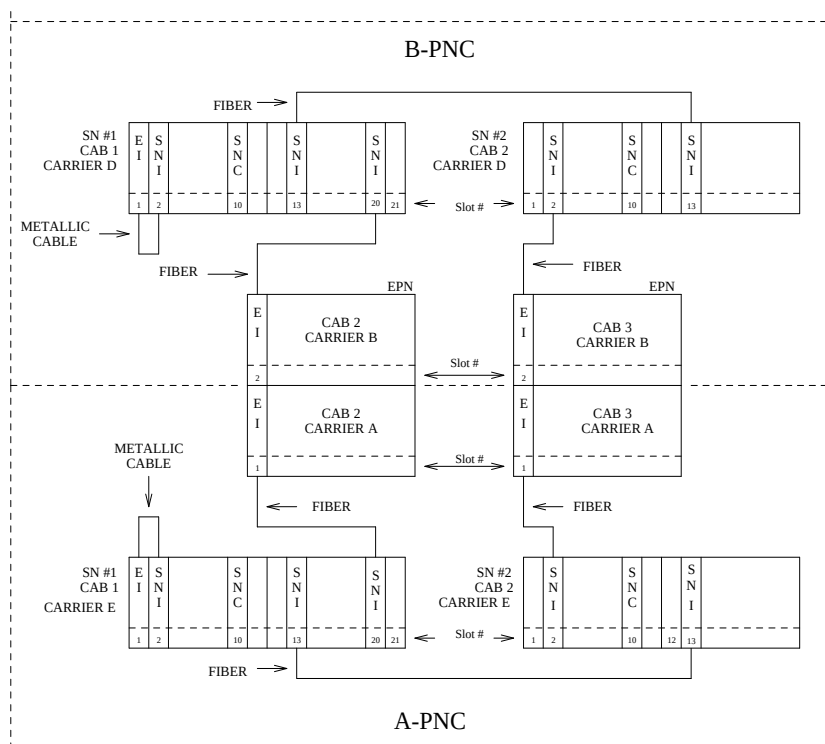
Figure 9-35 shows the location of EIs in a typical two Switch Node Center Stage Switch configuration with duplicated PNC.

**Figure 9-35. Center Stage Switch Configuration with Duplicated PNC**

In a duplicated center stage switch configuration, two EIs are needed in each port network. One is located on the A-side PNC and the second one is located on the B-side PNC. Note that PNC designation (A or B) does not relate directly to carrier location. The EI that is on the active PNC will be the one that is acting as the archangel (TDM Bus Master) for the EPN. This is the EI that should have its yellow led blinking at a rate of 2 seconds on and 200 ms. off. The standby PNC EI should have its yellow led off. The PPN EI circuit packs are located in the first slot of the switch node carriers, although they may be located in port carriers.

In a Center Stage Switch configuration with duplicated Port Network Connectivity, the PPN Expansion Interface circuit pack may be located in the Switch Node Carrier (see Figure 9-35). In these cases, the Expansion Interface circuit pack and Switch Node Interface circuit pack may be connected via a metallic cable instead of an optical fiber link. In diagnosing problems with an Expansion Interface circuit pack that may be related to fiber link problems, the metallic cable should be treated in the same manner as the optical fiber in regards to testing and replacement.

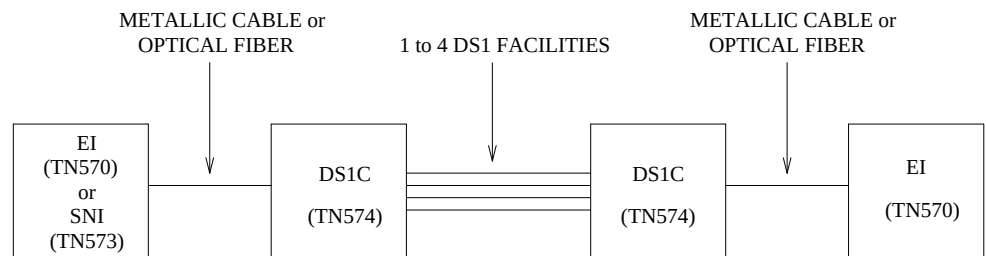
An EPN (and thus, the EIs contained in that EPN) can be remoted via a DS1 converter complex. This requires that the associated fiber link which provides connectivity to the remoted EPN, be administered with a DS1 converter complex. The DS1 converter complex consists of two TN574 DS1 converter (DS1C) circuit packs connected by from 1 to 4 DS1 facilities. Figure 9-36 shows where the DS1 converter complex fits into an EI to SNI, or EI to EI fiber link. For more information, refer to the DS1C circuit pack Maintenance documentation.

**Figure 9-36. Fiber Link with DS1 Converter Complex**

A PPN-EPN connection can be extended via a DS1C Complex. (See Figure 9-36). When discussing problems that may be related to fiber link problems, the DS1C will be considered part of the fiber link. If diagnosis of the problem points to the fiber connectivity, and a DS1C circuit pack is part of this connectivity, problems with the DS1C circuit pack should be investigated (See DS1C-BD Maintenance documentation). The DS1C circuit pack enters into diagnostics for the Expansion Interface circuit pack via such tests as the Neighbor Query Test (#237), the Fiber Out-of-frame Test (#238), the Two-way Transmission Test (#241), and the Packet Transmission Test (#589).

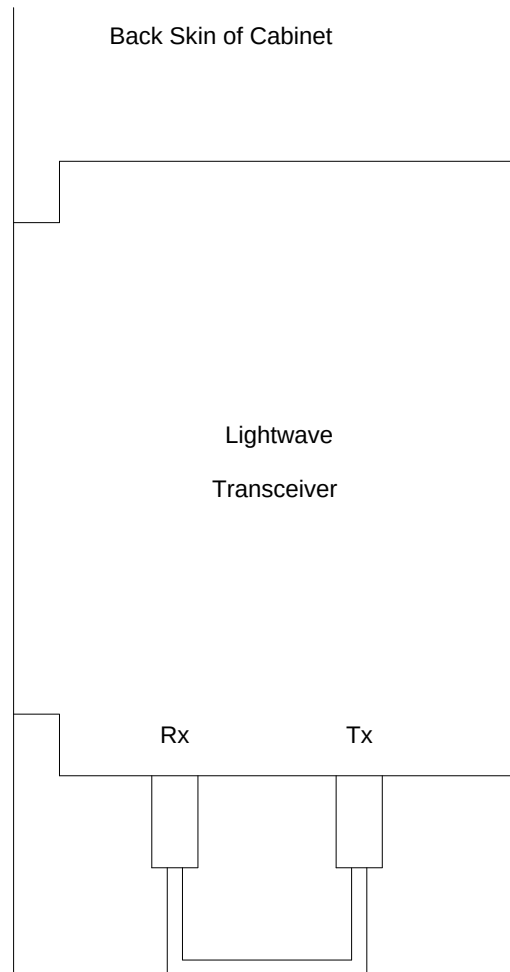
**Figure 9-37. Interconnection of Lightwave Transceiver Transmit/Receive Jacks**

1. Busyout the circuit pack (Expansion Interface or Switch Node Interface) using the **busyout board UUCSS** command.  
command.
2. Disconnect the transmit and receive fiber pair from the lightwave transceiver on the back of the circuit pack (Expansion Interface or Switch Node Interface) slot. *Note which is the transmit fiber and which is the receive fiber for proper re-connection at the end of this procedure. The fiber connected to the transmit side of the lightwave transceiver on one Expansion Interface circuit pack should be connected to the receive side of the lightwave transceiver on the circuit pack on the opposite end of the fiber.*
3. Using a fiber jumper cable, interconnect the transmit and receive jacks of the lightwave transceiver as shown in Figure 9-37.

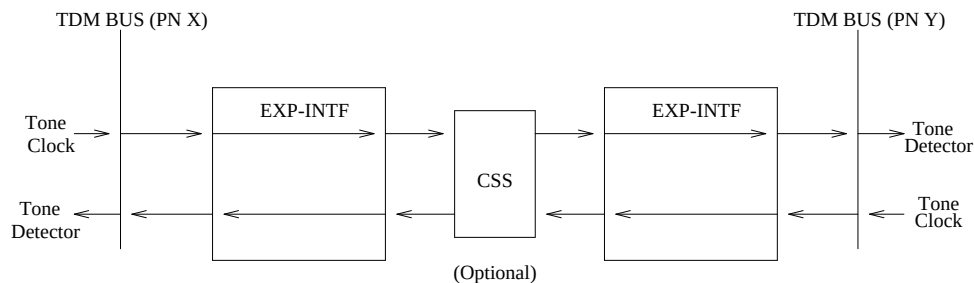
The EI 2-way transmission test is a basic connectivity test between two Port Networks. The test first sends dialtone from the cabinet of the Expansion Interface circuit pack under test through the Center Stage Switch (if so equipped), through the DS1C circuit packs (if so equipped), and through another Expansion Interface circuit pack to a tone detector in the other cabinet. The connections are then reversed and the tone is passed in the opposite direction. If the system is equipped with a Center Stage Switch, and this test either fails or aborts with the above connection, a second Port Network will be chosen (if one is available and the Expansion Interface circuit pack is In-Service) and the same test is run on this new connection. This helps in the isolation of the fault. Since two Expansion Interface circuit packs are involved in the connection, either one of them could be at fault and this repeated test can help determine which is actually at fault.

The path used in this test is represented in Figure 9-38.

**Figure 9-38. Two-Way Circuit Switch Transmission Test**

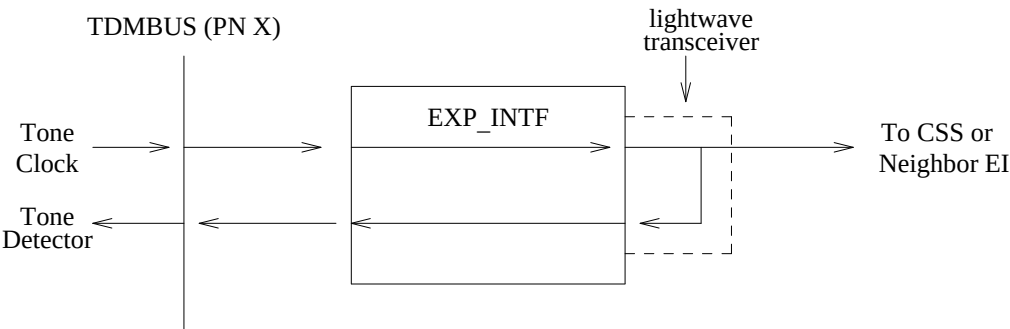
This is a two part connectivity test. In the first part of the test, a digital count is transmitted from the cabinet of the Expansion Interface circuit pack under test, through the Expansion Interface circuit pack under test, out to its lightwave transceiver. The connection then loops back into the lightwave transceiver through the same Expansion Interface circuit pack again and into the originating cabinet. If the test tone is detected by a tone detector, the first part of the test passes. The path used for this part of the test is represented in Figure 9-39.

Figure 9-39. TDM BUS Lightwave Transceiver Loop Around

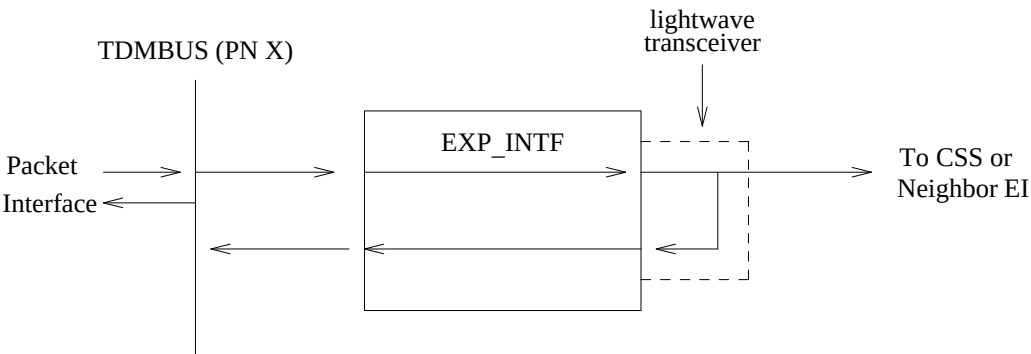
Figure 9-40. Packet BUS Lightwave Transceiver Loop Around—PPN only

The path used for this test if the Expansion Interface is located in the PPN is represented in Figure 9-40.

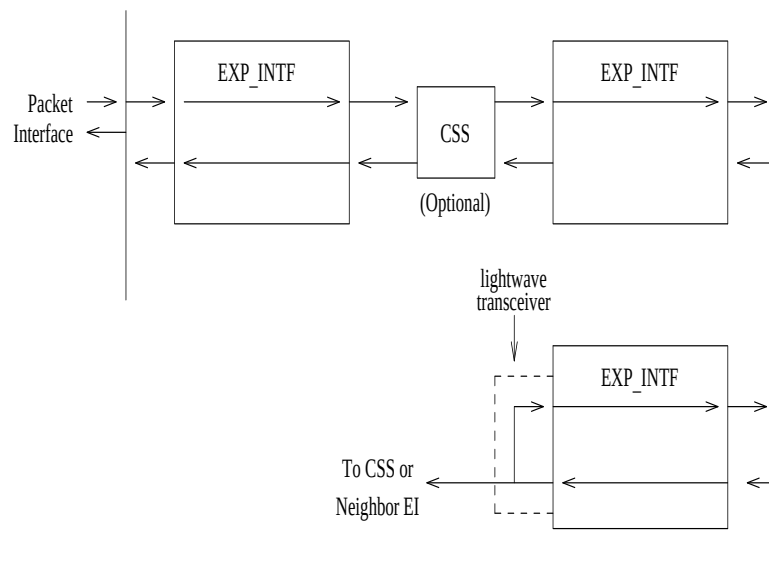
**Figure 9-41. Packet BUS Lightwave Transceiver Loop Around—EPN only**

The path used for this test if the Expansion Interface is located in an EPN is represented in Figure 9-41.

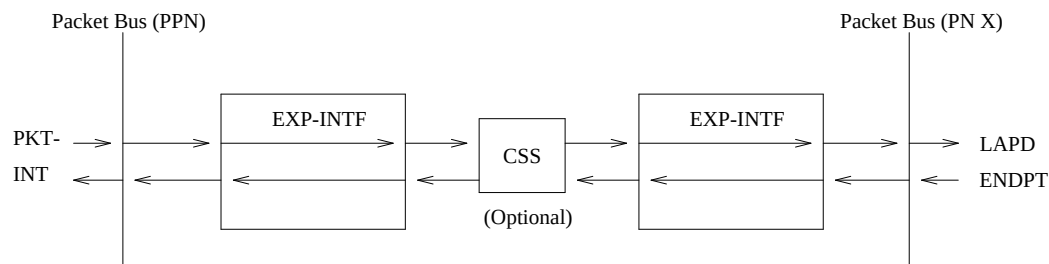
**Figure 9-42. Expansion Interface Packet Interface Test—Packet Endpoint Loop**

The path shown in Figure 9-42 is used when testing an EPN EI that is on the active PNC.

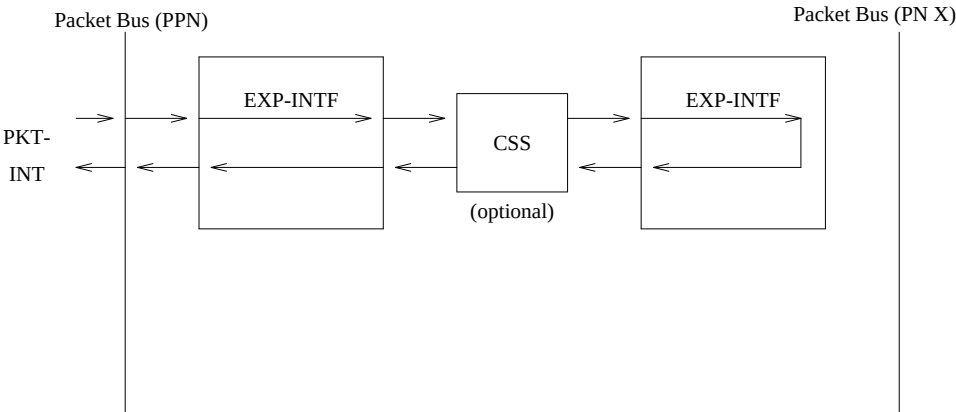
**Figure 9-43. Expansion Interface Packet Interface Test—PPN to EPN loop**

In a Center Stage configuration the path shown in Figure 9-43 is used when testing an EPN EI that is on the standby PNC. In a Direct Connect configuration, this path is used on any PPN EI or on an EPN EI that is on the standby PNC.

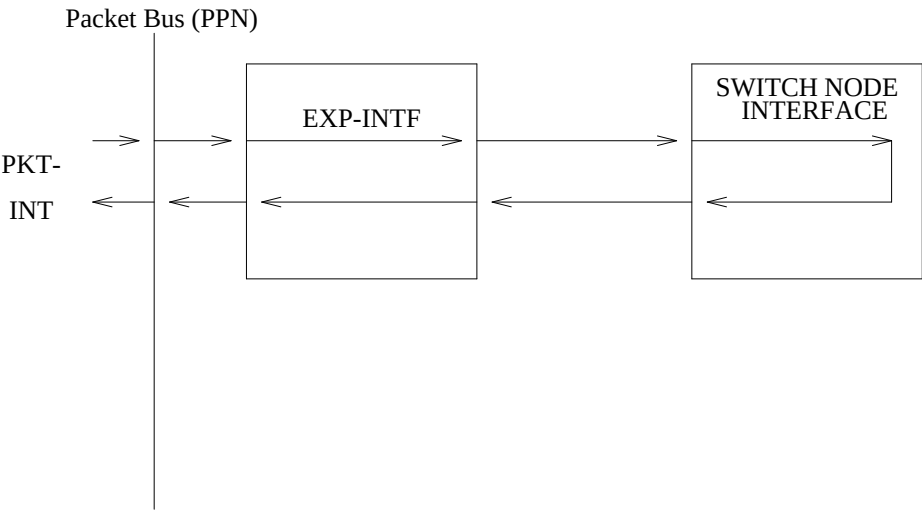
**Figure 9-44. Expansion Interface Packet Interface Test—PPN to CSS Loop**

The path shown in Figure 9-44 is used when running the test on a PPN EI in a Center Stage configuration.

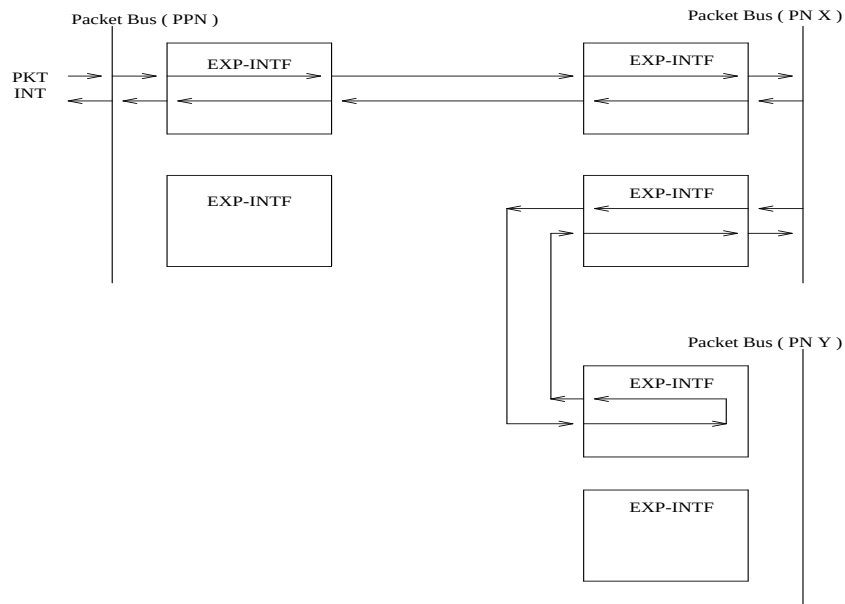
**Figure 9-45. Expansion Interface Packet Interface Test-EPN to EPN link**

The path shown in Figure 9-45 is used when the EI under test is one that provides connectivity between the two EPN s in a Direct Connect configuration.

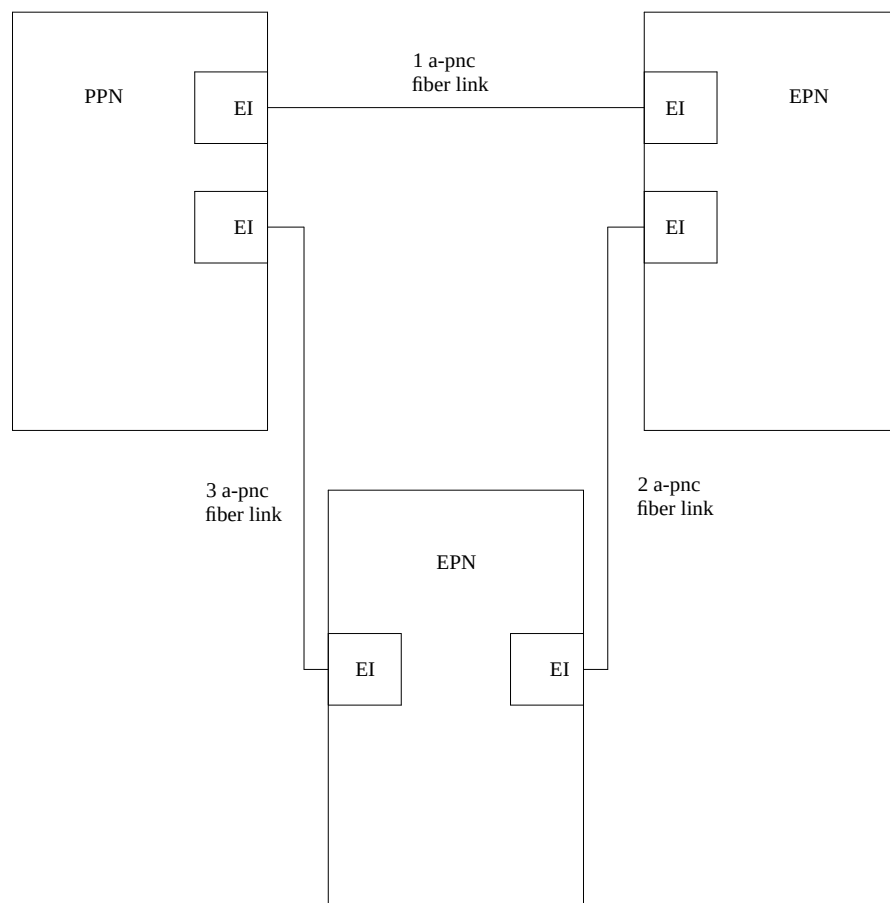
**Figure 9-46. Direct Connect Configuration with Simplex PNC**

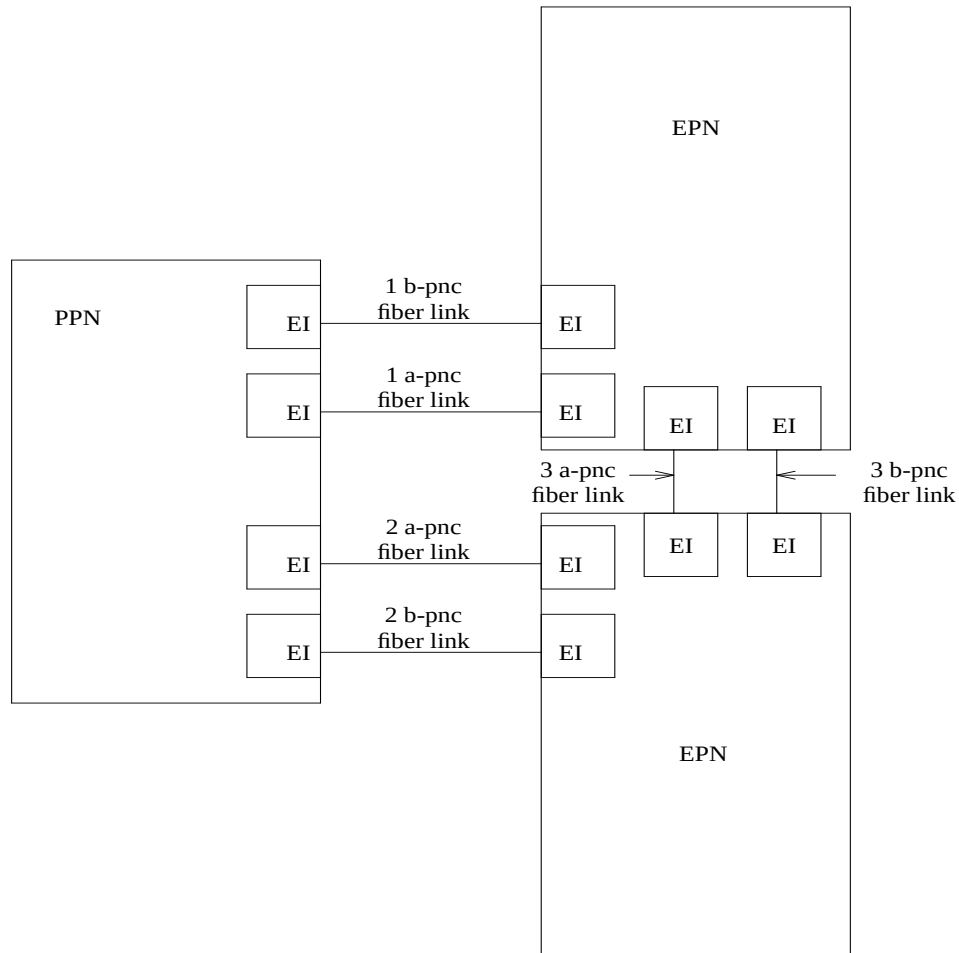
**Figure 9-47. Direct Connect Configuration with Duplicated PNC**

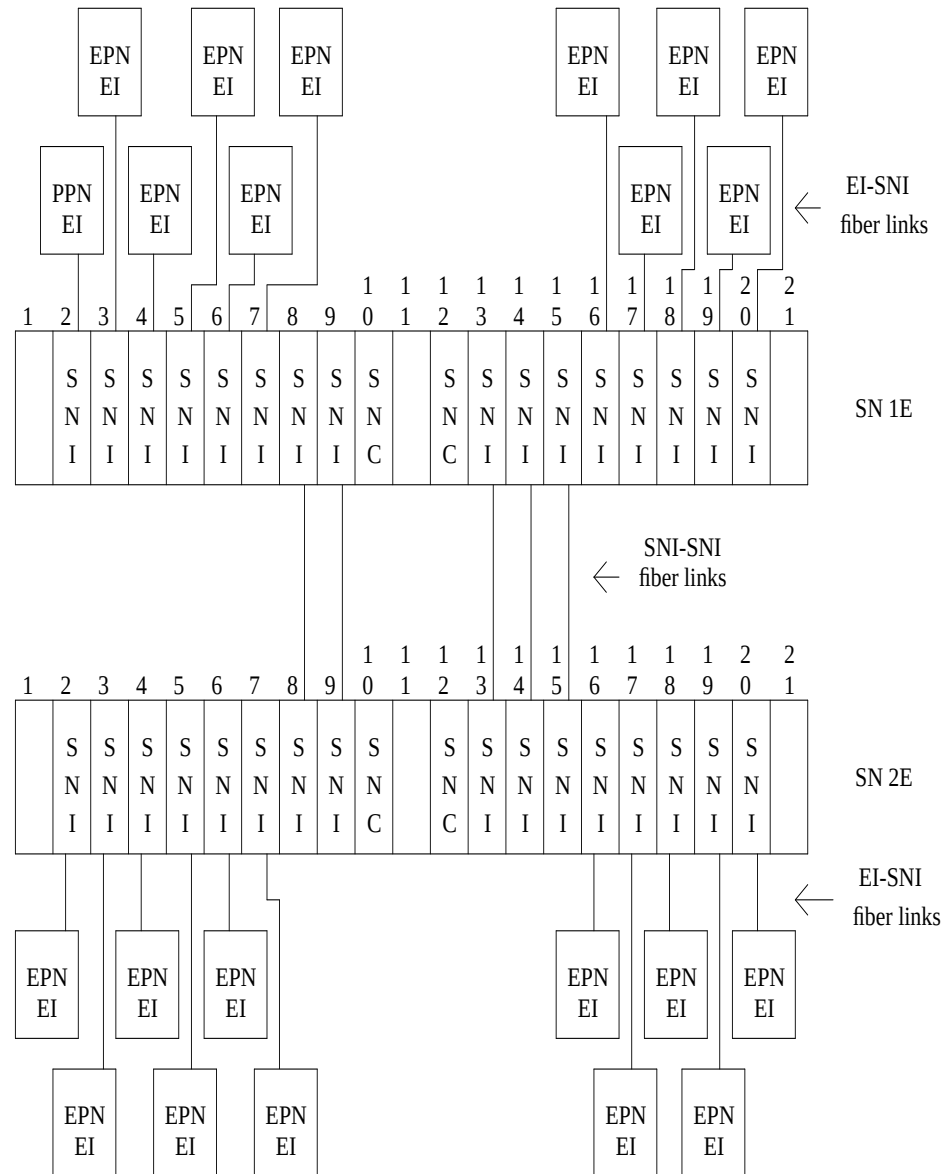
**Figure 9-48. CSS Configuration with Simplex PNC and 2 Switch Node Carriers**

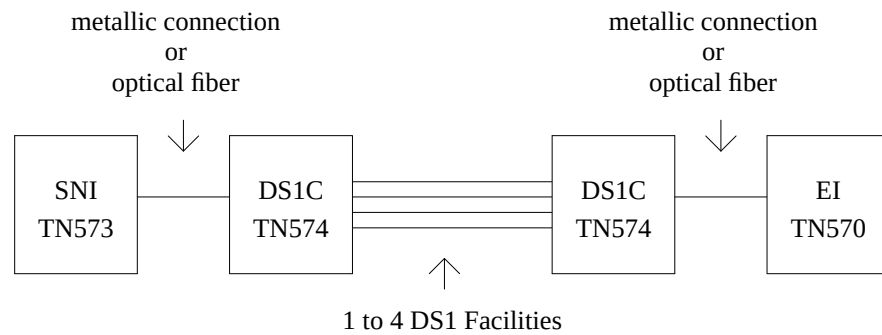
**Figure 9-50. EI-SNI Fiber Link with a DS1 Converter Complex**

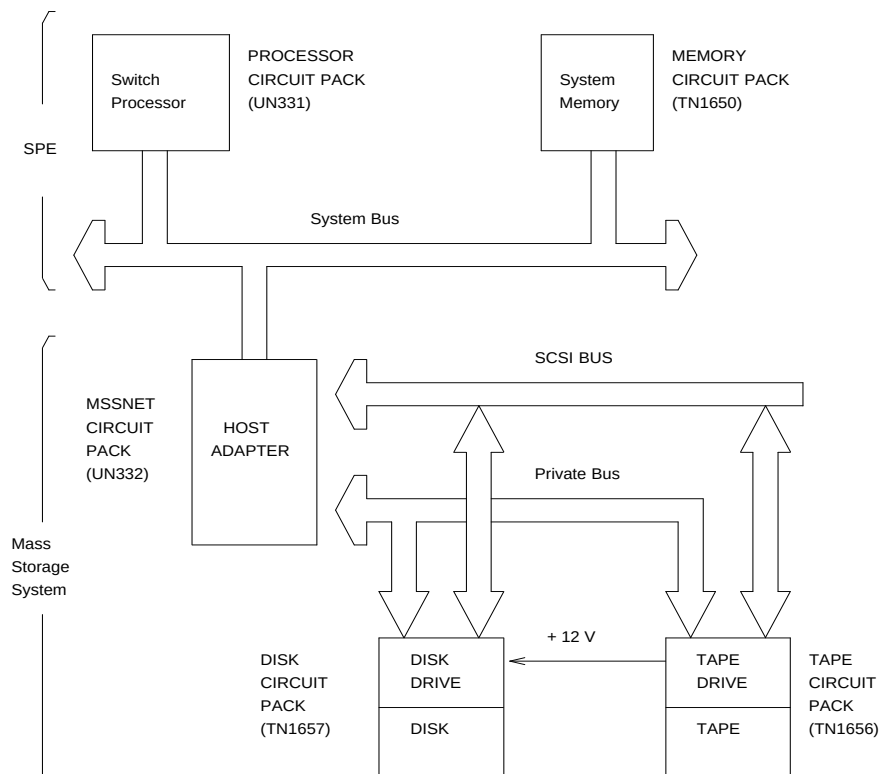
**Figure 9-51. Mass Storage System Interactions**

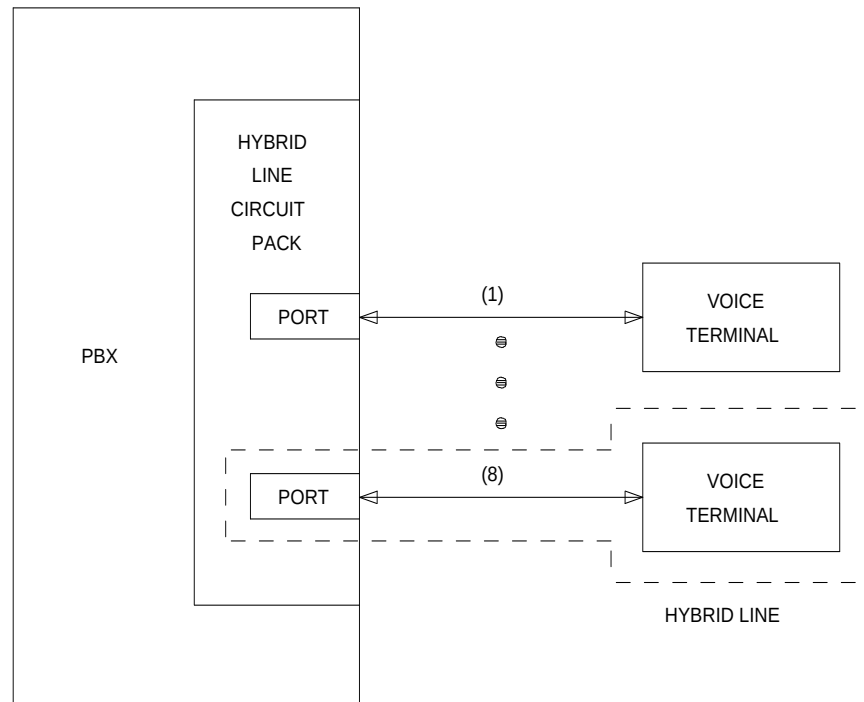
The TN762B Hybrid Line circuit pack supports eight of these multifunction analog telephone sets, as shown in Figure 9-52. The Hybrid Line sets use three pairs of wires: an analog voice pair, a transmit/receive pair, and a power pair.

**Figure 9-52. Hybrid Station Interactions**

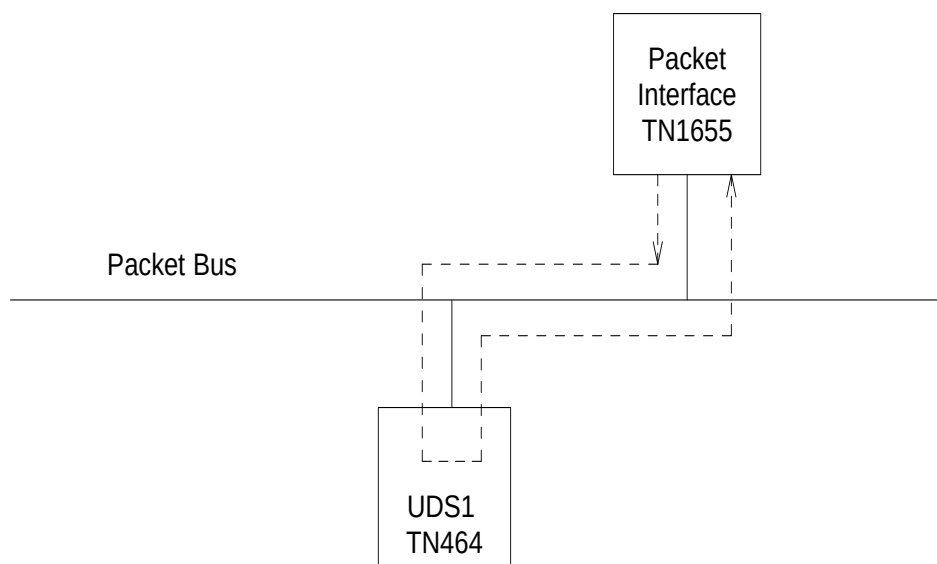
This test verifies the connectivity of an ISDN-PRI signaling port (D-channel) across the LAN bus, also known as the packet bus. It will execute only if the port is out-of-service. Failure of this test indicates a fault associated with the port hardware on the circuit pack.

**Figure 9-53. Signaling Port LAN (Packet Bus) Loopback**

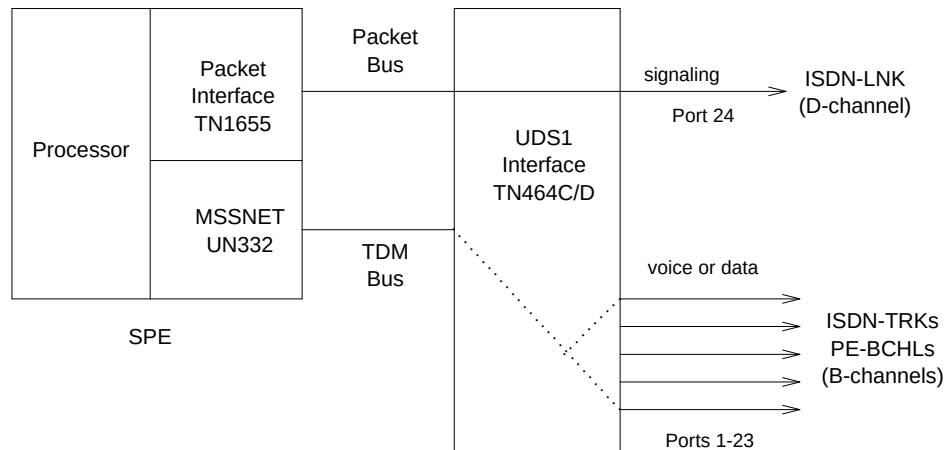
**Figure 9-54. 24-Channel FAS ISDN-PRI Signaling Group**

framing. Figure 9-54 through Figure 9-59 illustrate each type of signaling and interface combination.

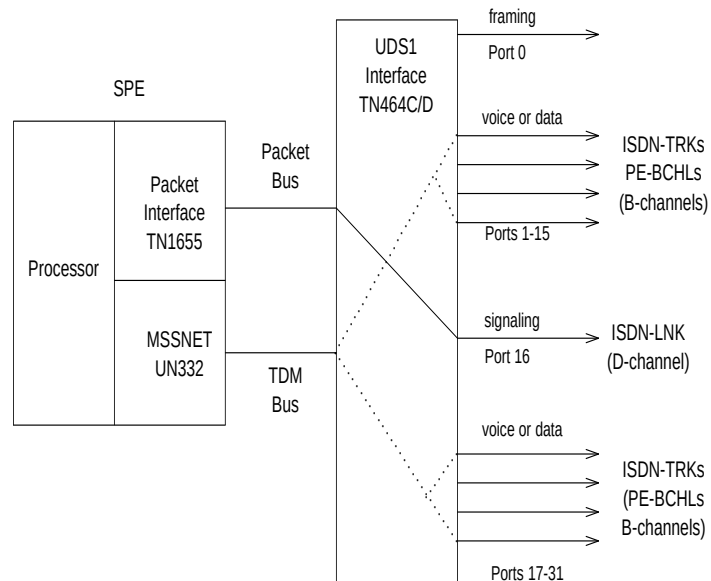
**Figure 9-55. 32-Channel FAS ISDN-PRI Signaling Group**

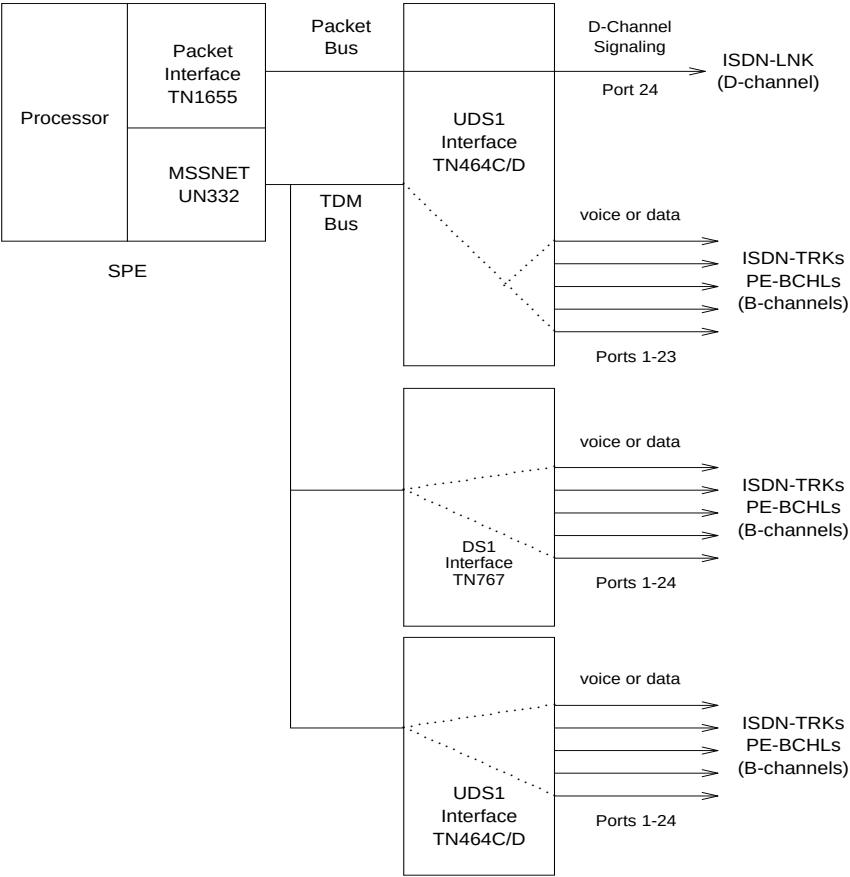
Figure 9-56. 24-Channel NFAS Simplex ISDN-PRI Signaling Group

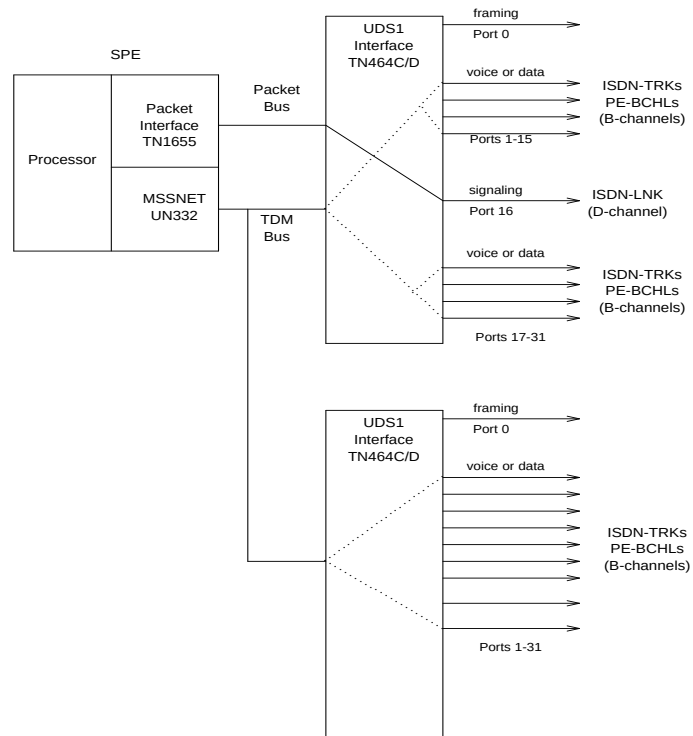
**Figure 9-57. 32-Channel NFAS Simplex ISDN-PRI Signaling Group**

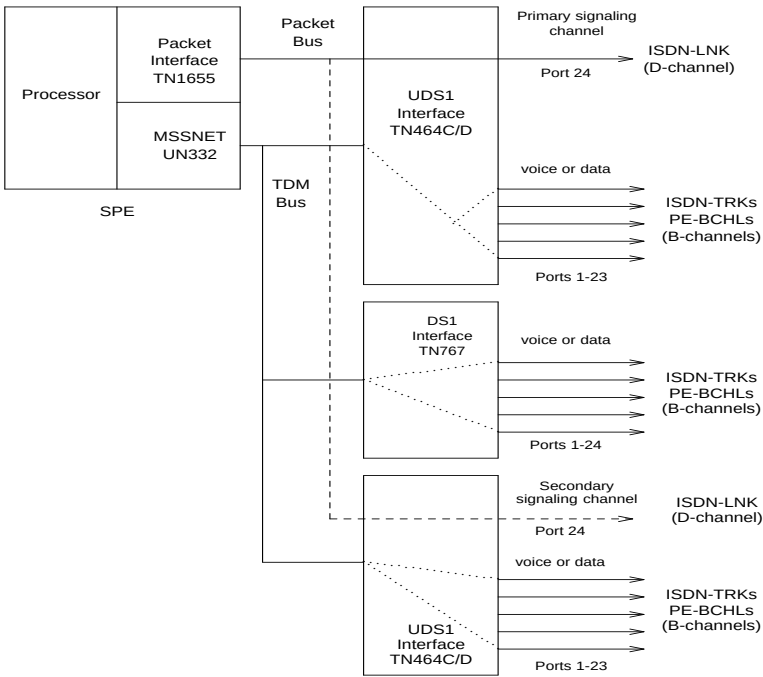
Figure 9-58. 24-Channel NFAS Duplex ISDN-PRI Signaling Group

NFAS duplex signaling provides increased reliability, which is highly desirable since NFAS permits the D-channel to signal for many more B-channels. NFAS Duplex allows the administration of a backup D-channel which remains in a standby state until the active D-channel goes down. If the active D-Channel does go down, the backup D-Channel takes over and provides signaling for all the B-channels in the signaling group.

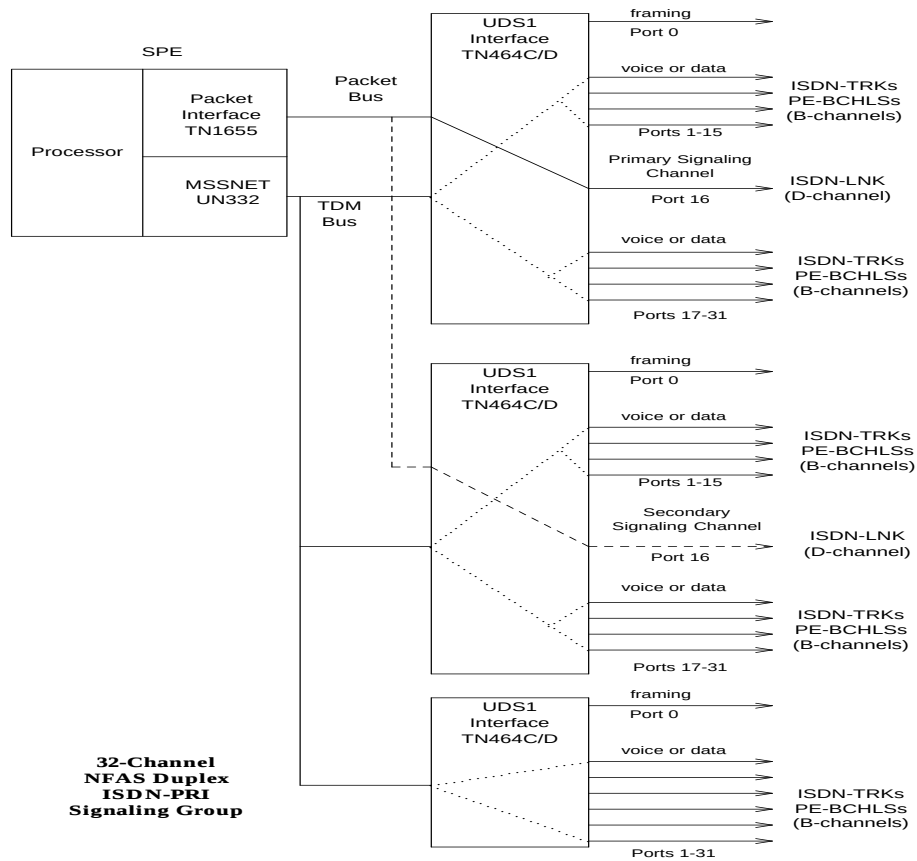
**Figure 9-59. 32-Channel NFAS Duplex ISDN-PRI Signaling Group**

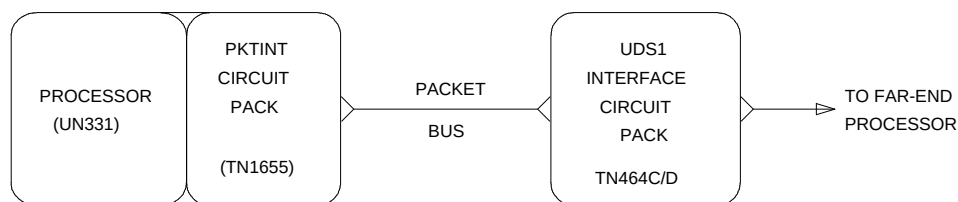
Tests #639 and #636 check the health of the D-channels and DS1/UDS1 Interface Circuit Packs. As shown in Figure 9-60, this test goes one step further by checking the communication path from the processor from the processor, through the TDM/Packet Bus and DS1/UDS1 Interface circuit pack, and on to the far-end switch or terminal adapter. A special ISDN message is sent to the far-end switch or terminal adapter, which must respond within a specified amount of time. This test is designed to ensure that the communication path between the switch and the far-end is up and operational, and that the two endpoints can properly exchange ISDN control messages.

**Figure 9-60. Remote Layer 3 Query (Test #637)**

Figure 9-60 illustrates a UDS1 Interface Circuit Pack located in the PPN. When the UDS1 board is located in an EPN, there is additional Port Network Connectivity hardware connecting the packet busses of the PPN and EPN. Examples of such hardware are the Center Stage Switch and fiber-optic cables.

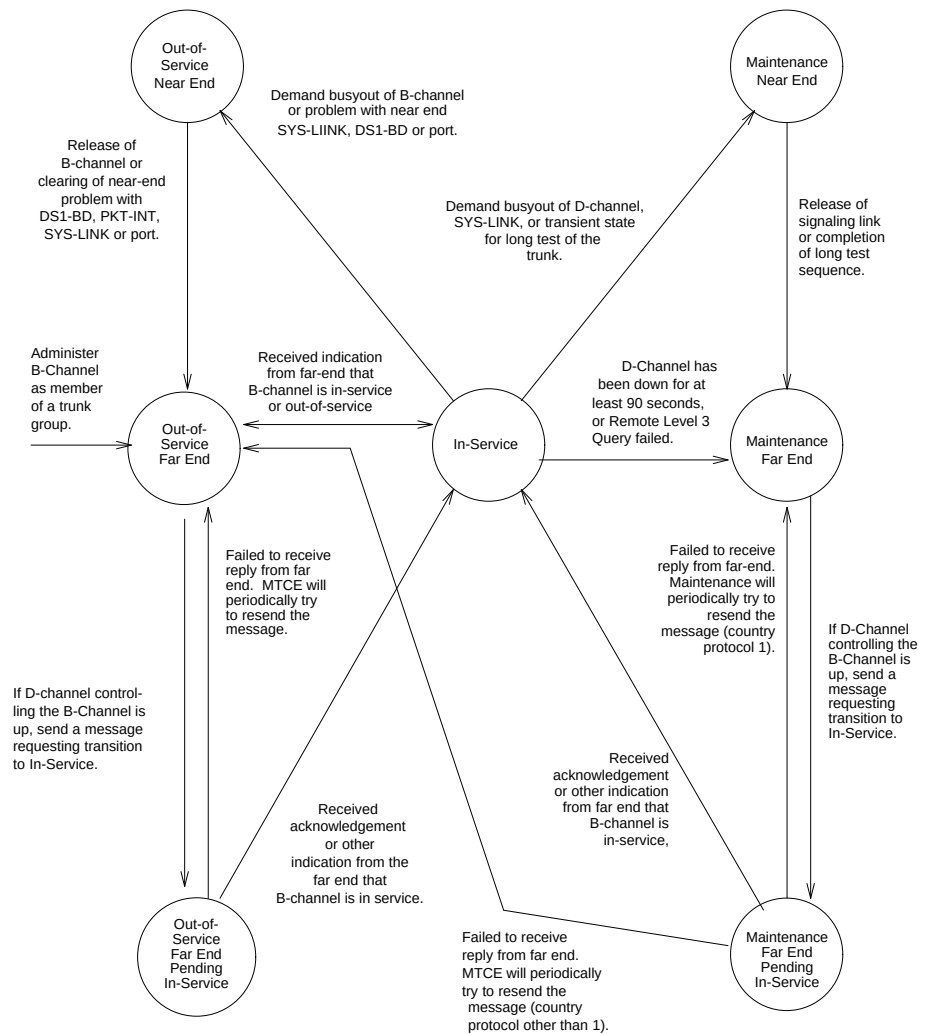
**Figure 9-61. Common Progressions in Service States**

The **status trunk** command displays the following possible service states for ISDN trunks. Table I-9 gives recommended procedures for each state. Figure 9-61 that shows typical progressions from one service state to another.

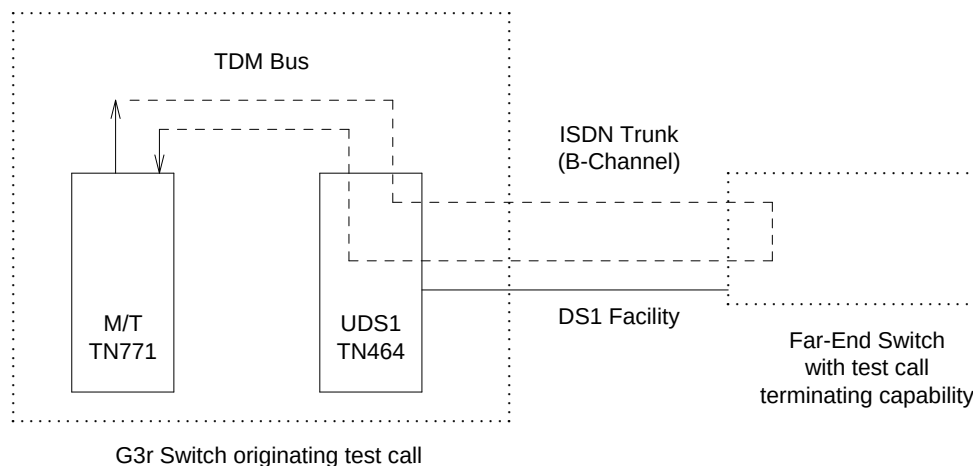
A test call connection is established to a far-end switch over the ISDN trunk to be tested. The digital port on a TN711D Maintenance/Test circuit pack generates a test-pattern bit stream which is sent to the far-end switch and echoed back. The received pattern is then compared to the sent pattern and checked for errors that indicate a loss of integrity on the communications path.

**Figure 9-62. Outgoing ISDN-PRI Test Call**

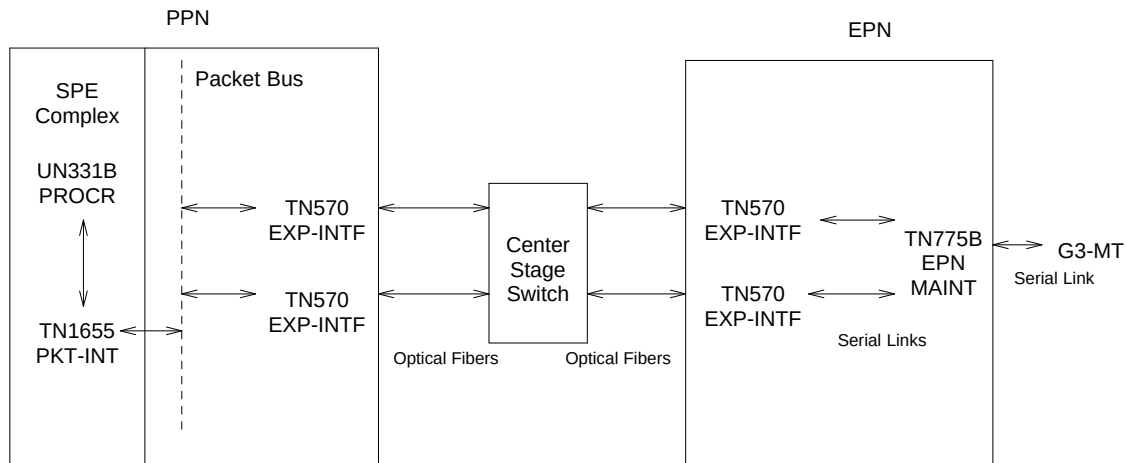
The PPN communicates with the EPN Maintenance circuit pack via the following path; uplink messages from the EPN Maintenance circuit pack to the PPN take exactly the reverse path. Messages flow from the UN331B Processor circuit pack in the SPE to the TN1655 Packet Interface circuit pack, over the Lan Bus to the Active PPN Expansion Interface circuit pack, across the fiber link to the Active EPN Expansion Interface circuit pack, and over a serial link to the EPN Maintenance circuit pack. Figure 9-63 illustrates this path in a system with a Center Stage Switch and duplicated PNC.

**Figure 9-63. EPN Maintenance Circuit Pack Message Flow**

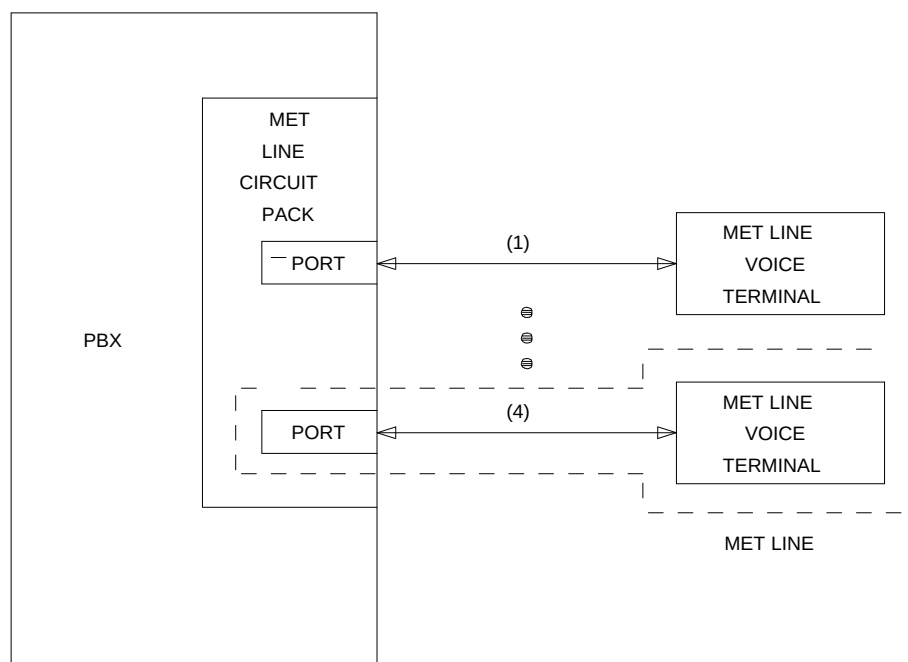
The TN735 MET Line circuit pack supports four of these Multifunctional Electronic Sets as shown below. Each MET set uses three pairs of wires: an analog voice pair, a transmit pair, and a receive pair. Power is sent over the transmit and receive pairs. The MET Line circuit pack supports all 10-, 20-, and 30-button sets.

**Figure 9-64. ISDN-BRI Port Interactions**

MET Line interactions are shown in Figure 9-64.

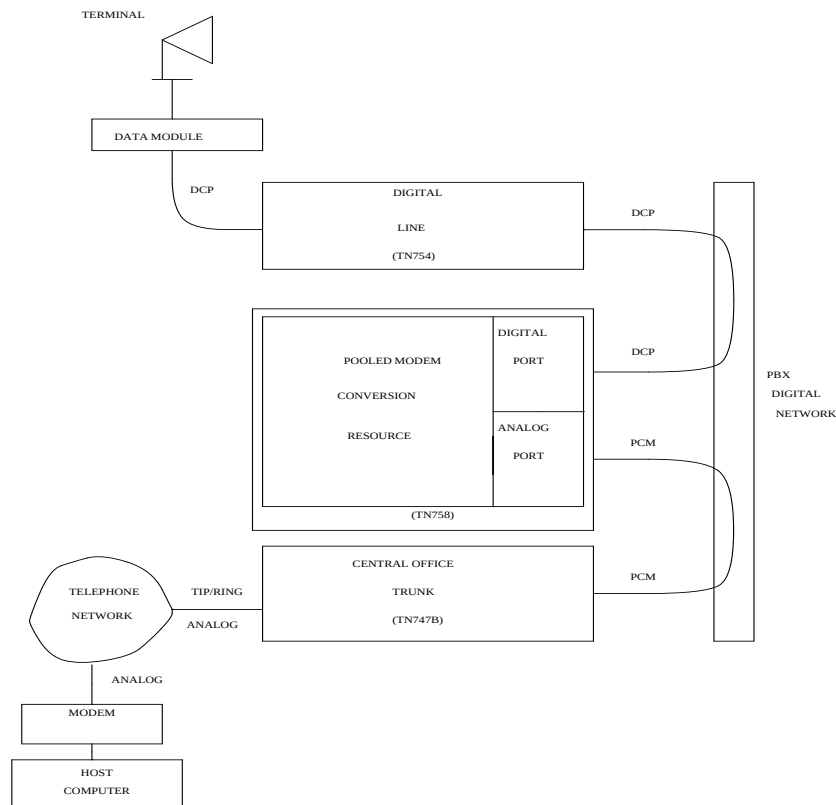
PBX digital network: an analog port and a digital port. The analog port is connected through the PBX network to the analog line or trunk port containing the analog modem signals. The digital port connects through the PBX network to the digital line or trunk port in the call. The figure below shows a typical end-to-end connection using a conversion resource on the integrated Pooled Modem circuit pack.

**Figure 9-65. Typical Modem Pool Switched Connection with Integrated Pooled Modem**

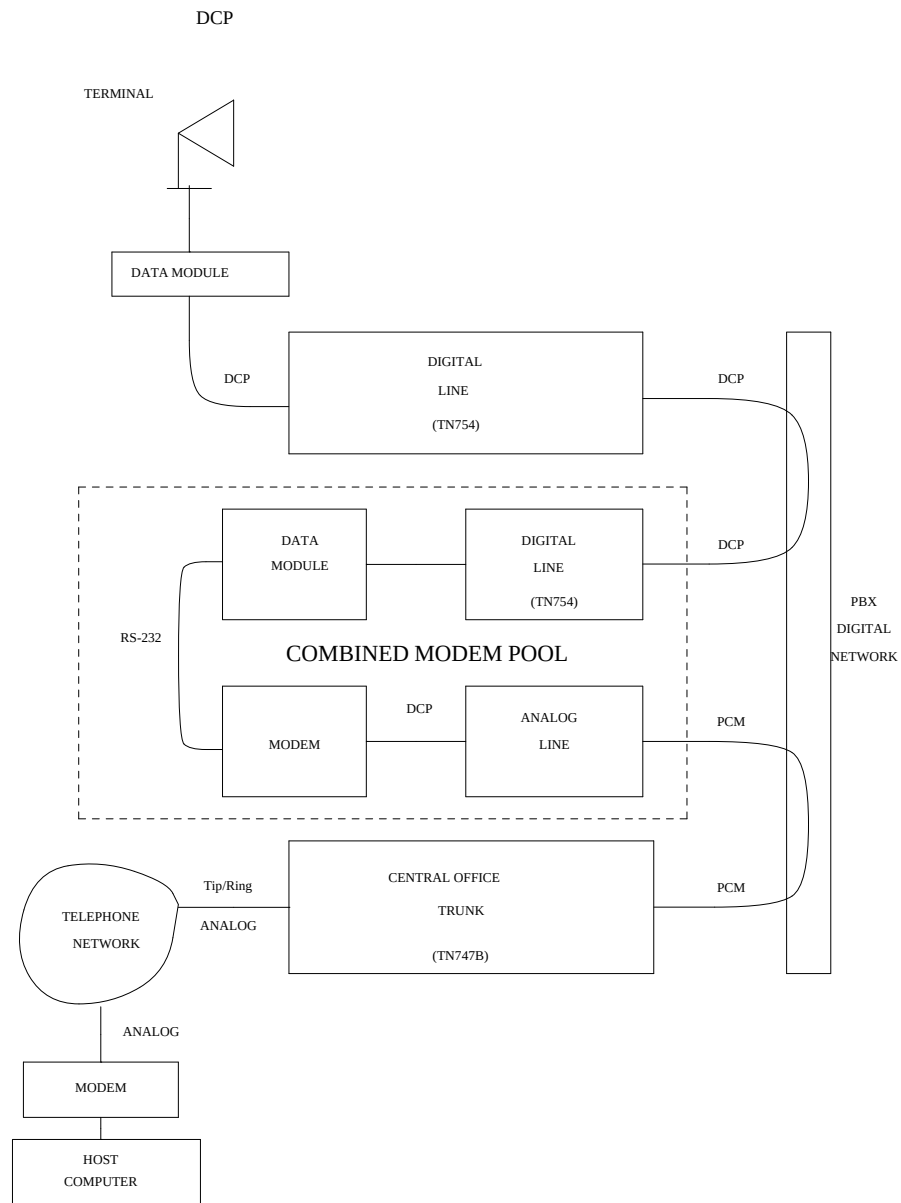
The Combined Modem Pool conversion resource is the second type available. The function served by the Combined Modem Pool is similar to that of the integrated Pooled Modem circuit pack, but the physical implementation is much different. It has the advantage of supporting any speed the external modem can support. The integrated Pooled Modem circuit pack can only support 300 or 1200 baud transmission rates. The Combined Modem Pool conversion resource consists of a port on an Analog Line circuit pack, an external modem, a Data Module, and a port on a TN754 Digital Line circuit pack. The tip and ring interface of the Analog Line is connected to the modem, the RS-232C interface of the modem connects to the Data Module, and the DCP interface on the Data Module is connected to the Digital Line port.

The analog modem signals pass through the Analog Line port to the modem. The modem converts these to RS-232C signals which are passed on to the Data Module. The Data Module further converts the signals to the DCP protocol for the Digital Line port which passes the signals on to the PBX network.

**Figure 9-66. Typical Modem Pool Switched Connection with Combined Modem Pool**

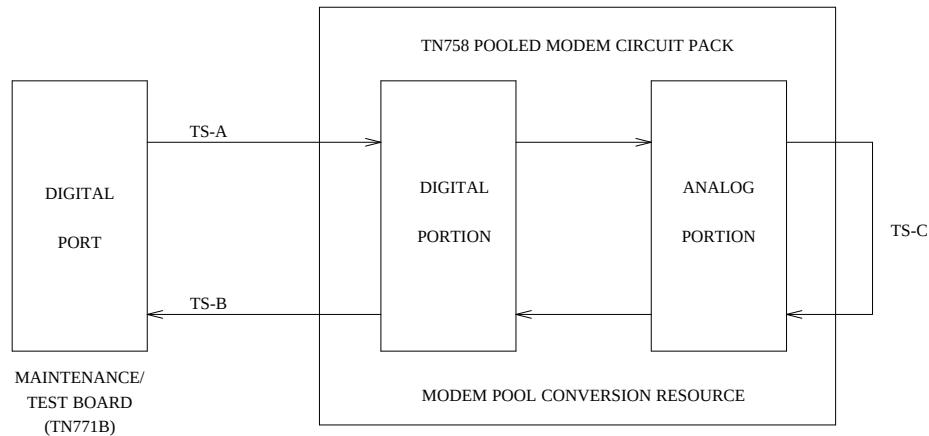
**Figure 9-67. Modem Pool Conversion Resource Loop-Around**

Test data patterns are transmitted from a Maintenance/Test Board digital port over network time slot A through the digital port on the conversion resource, looped around through the analog port via time slot C back to the Maintenance/Test Board digital port circuit via time slot B where the patterns are checked for accuracy. Finally, the test forces a disconnect by breaking the connection between the Maintenance/Test Board digital port and the Modem Pool Port (time slot A) and verifying that the Maintenance/Test Board digital port and Modem Pool Port go on-hook within the proper time. This test attempts to allocate a Maintenance/Test Board digital port, Modem Pool Port, and other internal resources. If any of these allocation attempts fail, the test cannot be completed and a specific abort error is reported.

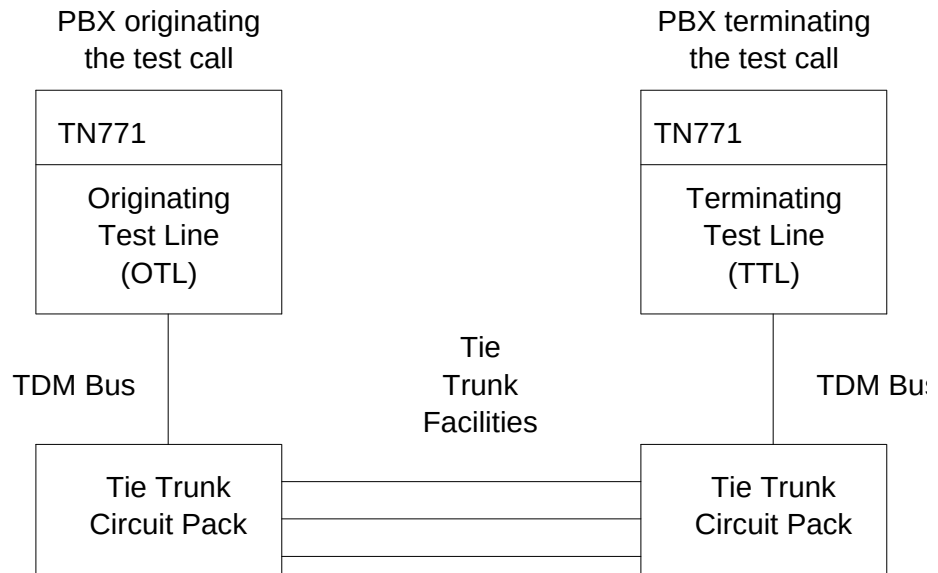
**Figure 9-68. ATMS Tie Trunk Test Call**

The Maintenance/Test Analog Port is port number 1 on the TN771 Maintenance/Test circuit pack. This port is used by the Automatic Transmission Measurement System (ATMS) as an Originating Test Line (OTL) or Terminating Test Line (TTL) for test calls over analog trunks. For more details, see "Automatic Trunk Transmission System" in Chapter 6, "Additional Maintenance Procedures". Figure 9-68 shows a typical ATMS configuration.

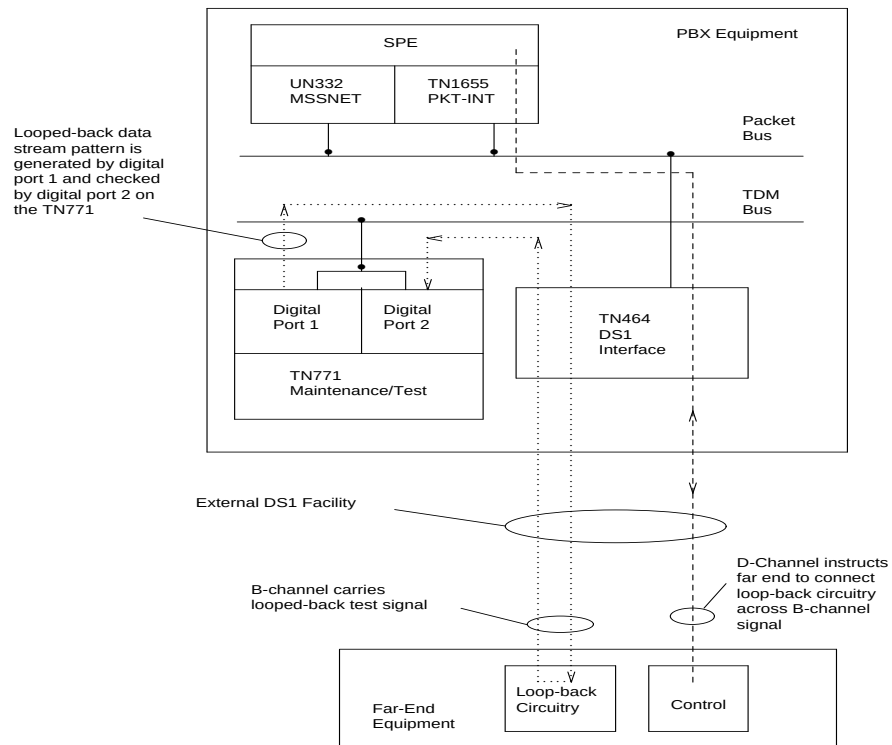
**Figure 9-69. ISDN-PRI Outgoing Test Call**

The Maintenance/Test Digital Port is a port on the TN771D circuit pack. Ports 2 and 3 are Digital Ports. The Maintenance/Test Digital Port provides the ability to perform digital (i.e., ISDN-PRI) trunk testing via the TDM Bus. For an ISDN-PRI test call, connections are set up in the system as shown in Figure 9-69.
