555-230-105  
Issue 5  
September 1996

# **DEFINITY Enterprise Communications Server Release 5 Maintenance for R5r**

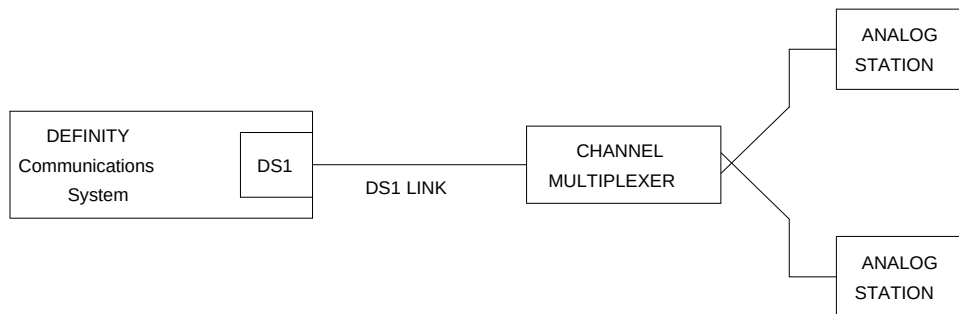
**Figure 9-70. DS1 OPS Line Interactions**

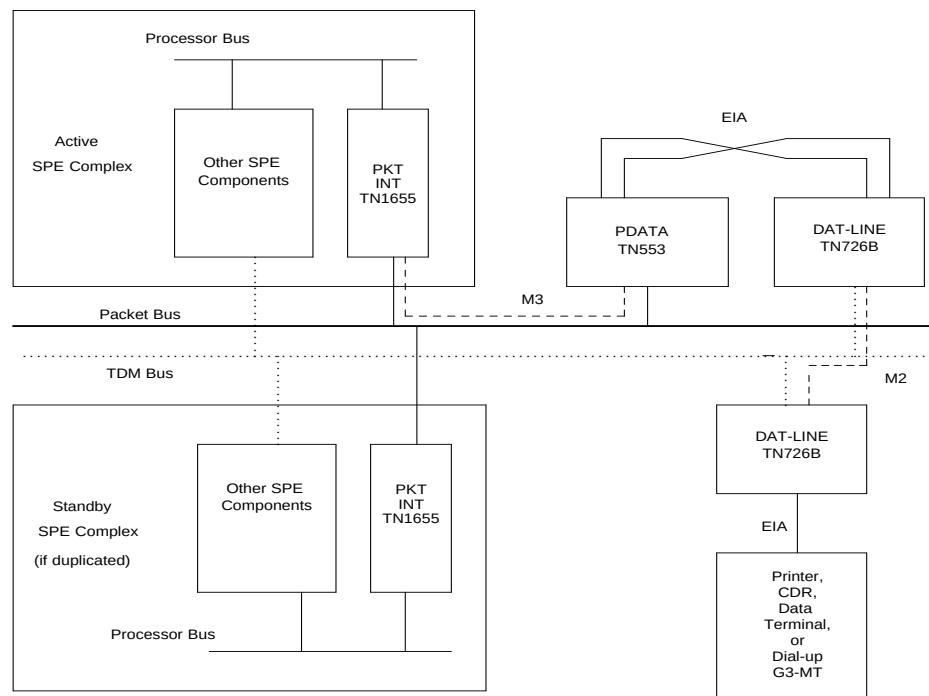
As part of each data application, the SPE connects itself to the application device through a system port. The application device may be an external terminal, printer, or data-module, or it may be circuitry internal to the switch, as is the case for the Announcement Circuit pack data-module used to save and restore recorded announcements. The figure below is an example of a system port connection using a second Data Line circuit pack (DAT-LN-BD) port to provide dial-in access for a remote terminal.

**Figure 9-71. Typical System Port Connection**

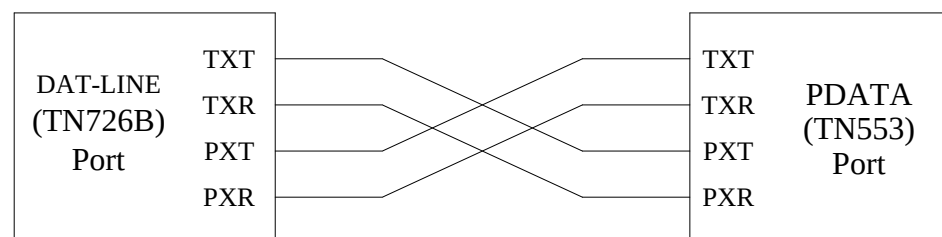
If you find that you are having trouble with a PDATA port and you do not know which extensions are being affected or which Data Line port is attached, enter **display port** UUCSSpp with the PDATA port number to display the extension of the System Port. With this extension you can run **display data-module** ext, which will in turn identify the Data Line port. The PDATA and Data Line ports are wired together in a manner similar to a null-modem. The figure below illustrates the wiring scheme for the EIA ports. The subsequent table gives the full wiring sequence for eight Data Line ports attached to eight PDATA ports.

Figure 9-72. System Port Wiring Scheme

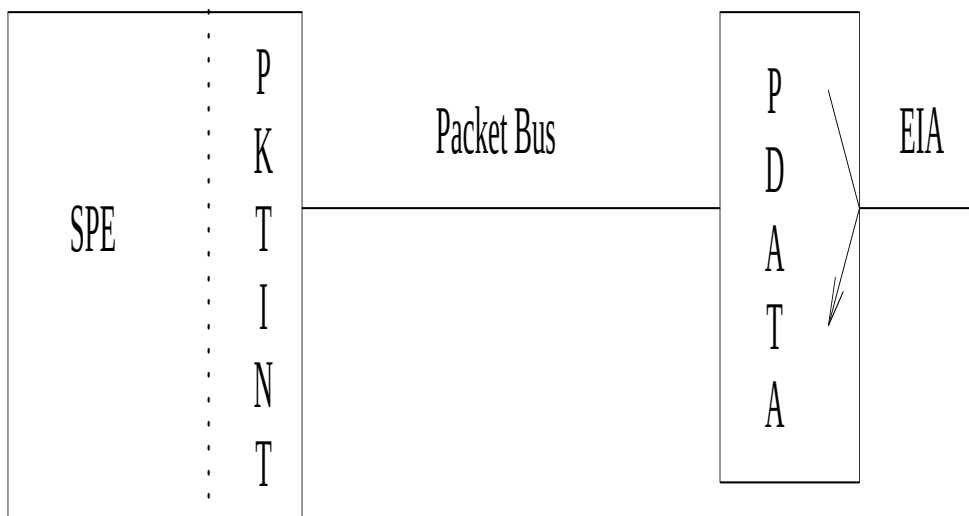
This is a connectivity test which checks if a specific PDATA port is capable of establishing a Level 2 LAPD link. The SPE will assign a LAPD bearer link between the SPE Packet Bus interface (i.e. the Packet Interface, also called PKTINT, TN1655) and the PDATA port. The SPE will send a test packet from the PKTINT to the PDATA port and it will expect to receive a reply from the PDATA port. Failure of this test may indicate an on-board fault associated with the port hardware on the PDATA circuit pack.

**Figure 9-73. Configuration for LAPD Connectivity Test**

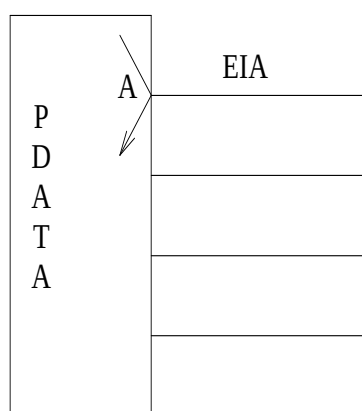
This test verifies the per port circuitry on the PDATA circuit pack. This test is executed by the PDATA circuit pack on command by the switch. The loop-back is done internal to the circuit pack at point "A" in the figure. Failure of this test indicates an on-board fault associated with the port hardware on the circuit pack.

Figure 9-74. Configuration for Port Local Loop-Around Test

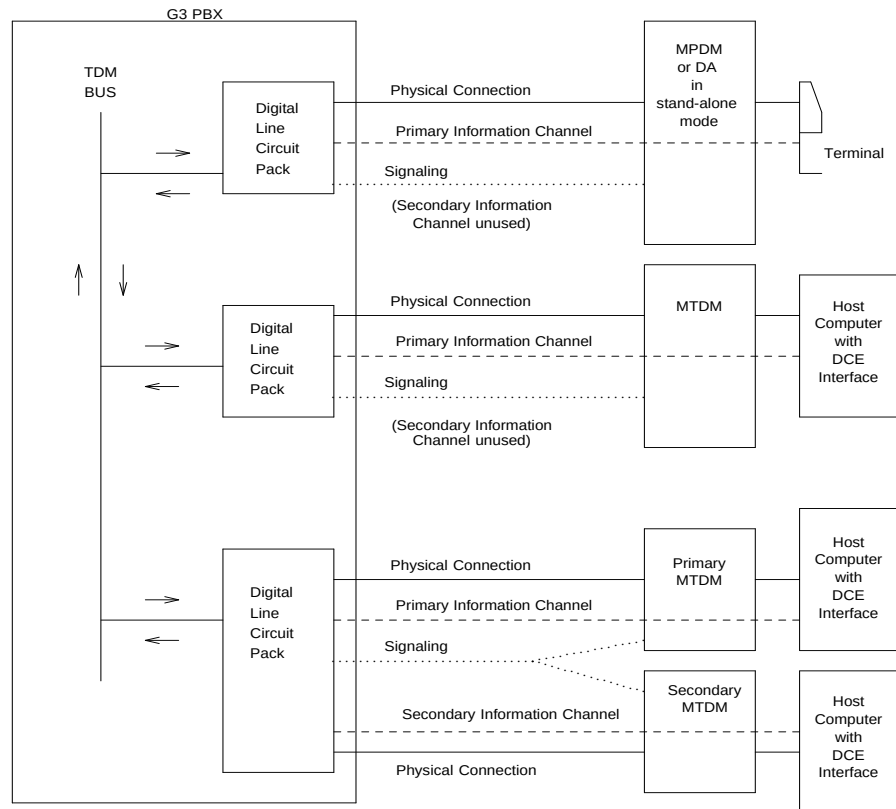
**Figure 9-75. Typical Data Module Configurations**

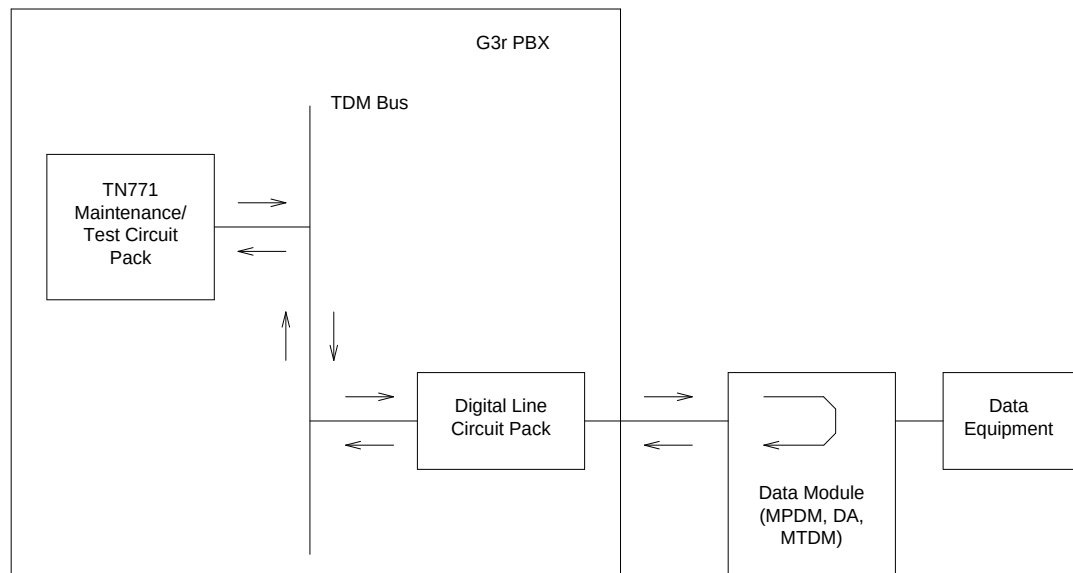
**Figure 9-76. Internal Loop Around Test**

For this test to run, the "Remote Loop-Around Test" field on the Data Module administration form must be set to "y," indicating that the data module endpoint supports the test.

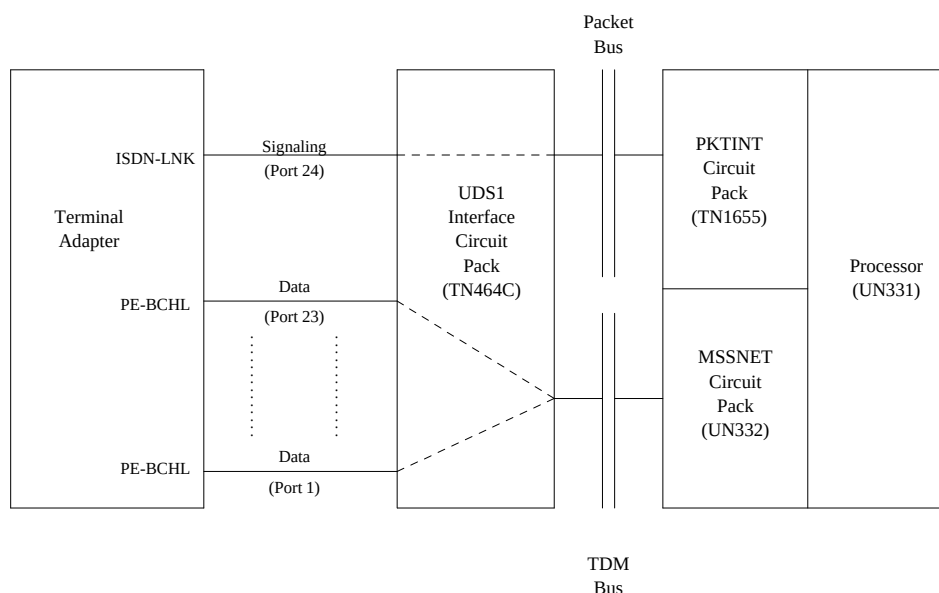
A PRI endpoint port is a port on a UDS1 interface circuit pack and thus depends on the health of the circuit pack for proper operation (see the following figure). A problem on the associated ISDN-PRI Signaling Link Port D-channel (ISDN-LNK) can also affect the PRI endpoint. The ISDN-PRI Signaling Link Port in turn

depends on the SYS-LINK (System Link) to the Packet Interface. Keep this hierarchy of dependencies in mind when diagnosing problems.

**Figure 9-77. PRI Endpoint Port Interactions**

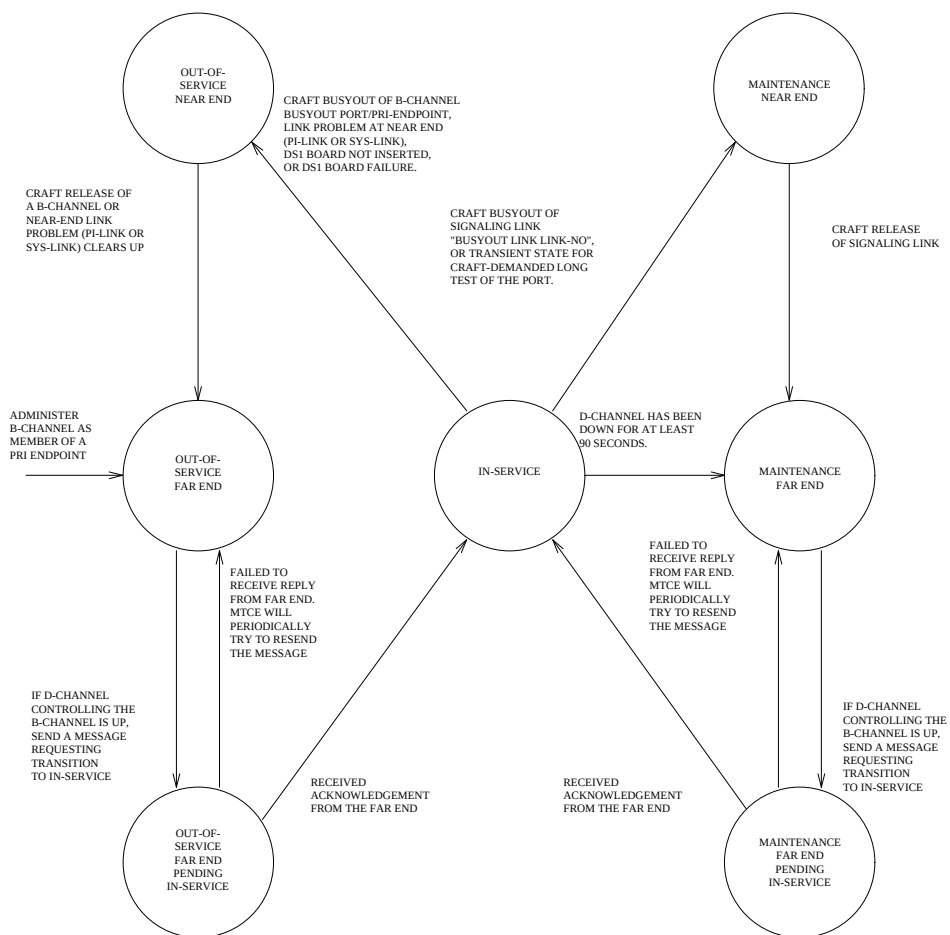
**Figure 9-78. Common Progressions in PRI Endpoint Service States**

The **status pri-endpoint** extension command displays the following possible service states for PRI endpoint ports. The table that follows gives recommended procedures for each state. The figure following that shows typical progressions from one service state to another. Refer also to *Troubleshooting Wideband Problems* in Chapter 5, "Responding to Alarms and Errors" for a layered approach to addressing PRI endpoint problems.

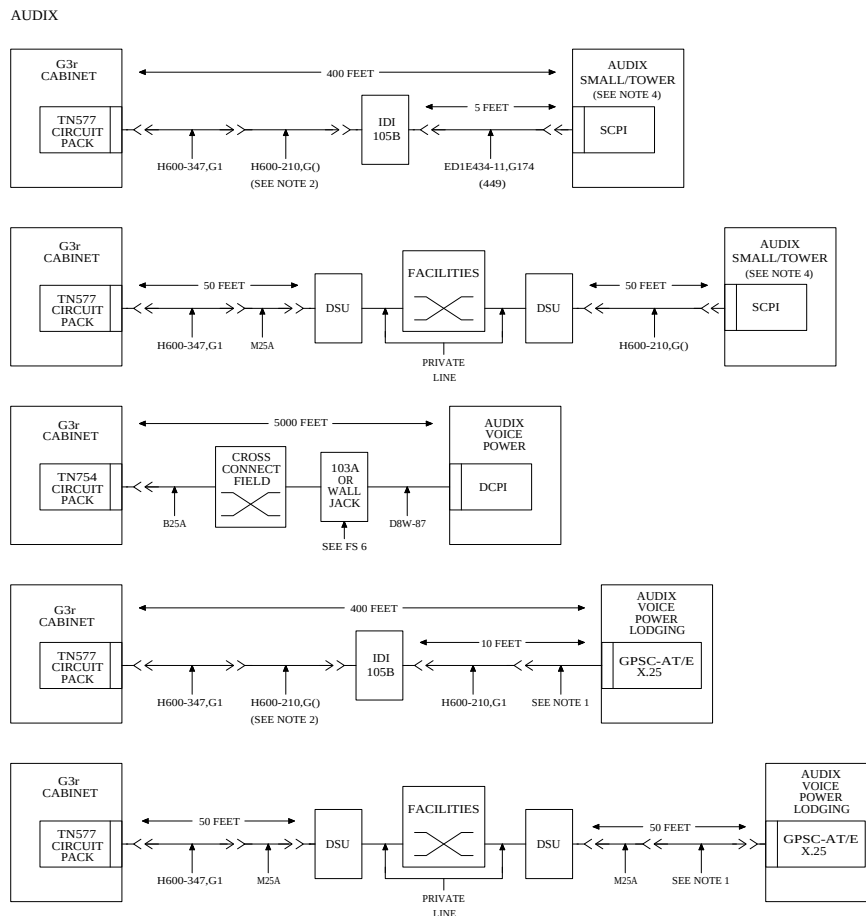
**Figure 9-79. Typical Direct Connections to Adjuncts**

The following figures show typical configurations utilizing Packet Gateway circuit packs. Not shown in the diagrams is the fact that X.25 links connect to the SPE via the packet bus and the TN1655 Packet Interface circuit pack. In addition to the configurations shown, a long distance modem can be connected directly to one of the external ports on the Packet Gateway circuit pack to connect to data networks including private lines, Dataphone II networks, and Digital Data Service (DDS) networks. Disregard the references to notes in the following figures.

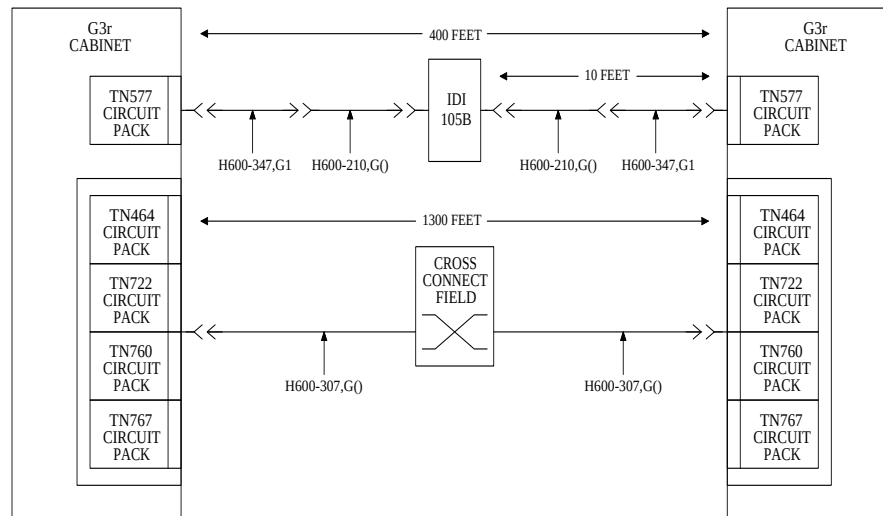
**Figure 9-81. Typical G3r-to-G3r DCS Connections Using BX.25 Signaling**

In this configuration, the BX.25 link is switched over the TDM bus to a DS1 port and over a DS1 facility to another G3r switch. The Packet Gateway can use only DMI Mode 1 on the TDM bus.

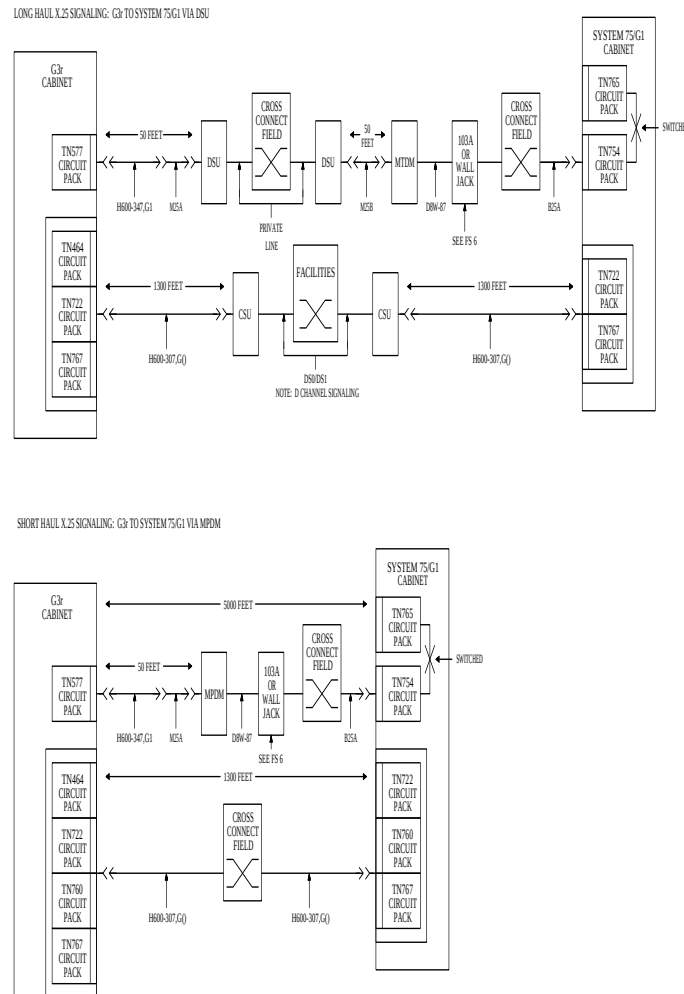
**Figure 9-82. Typical G3r-to-System 75/G1 DCS Connections Using BX.25 Signaling and Mode Conversion**

To connect a DCS signaling link to a System 75/G1 or System 85/G2 a DS1 facility, the BX.25 link data must be converted for transmission using DMI Mode 2. This is accomplished by using an MPDM and a Digital Line circuit pack. The link is then switched over the TDM bus to a DS1 port.

This method is also used for connecting to remote adjuncts. The channel on the DS1 facility is switched via hop channel on the switch connected to the adjunct.

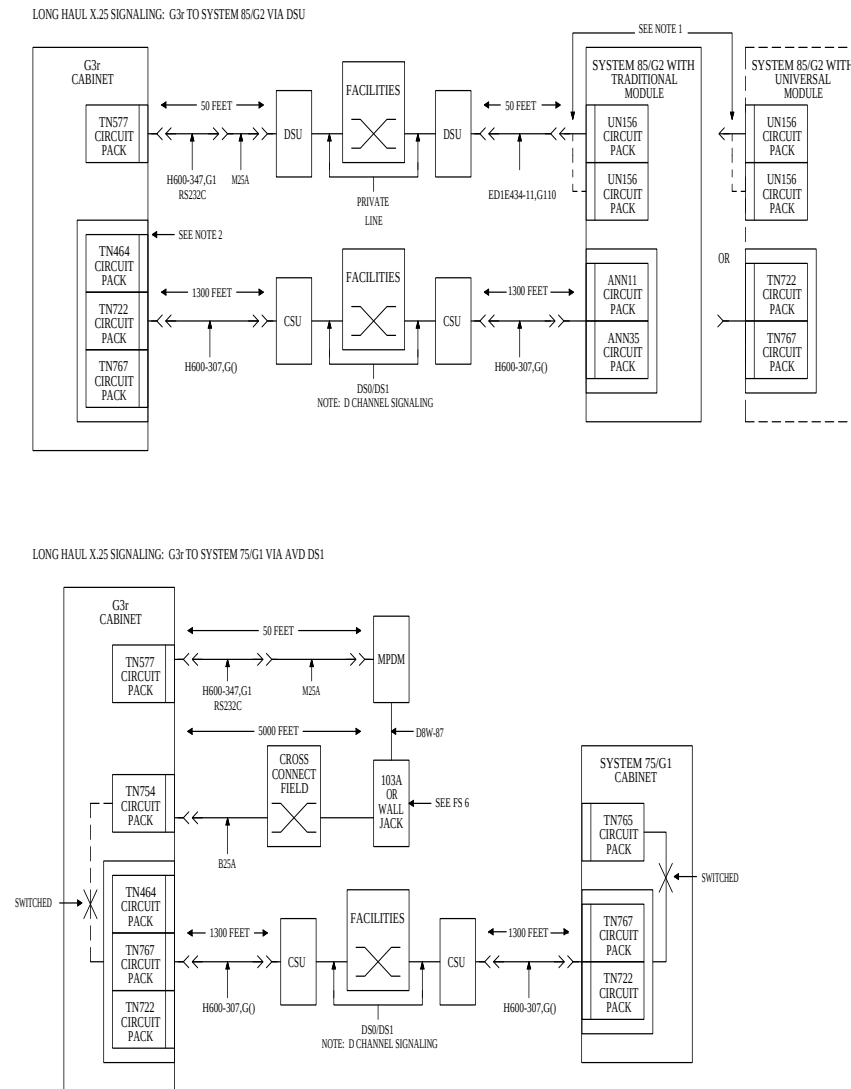
**Figure 9-83. Typical G3r-to-G1/G2 DCS Connections Using BX.25 Signaling and Mode Conversion**

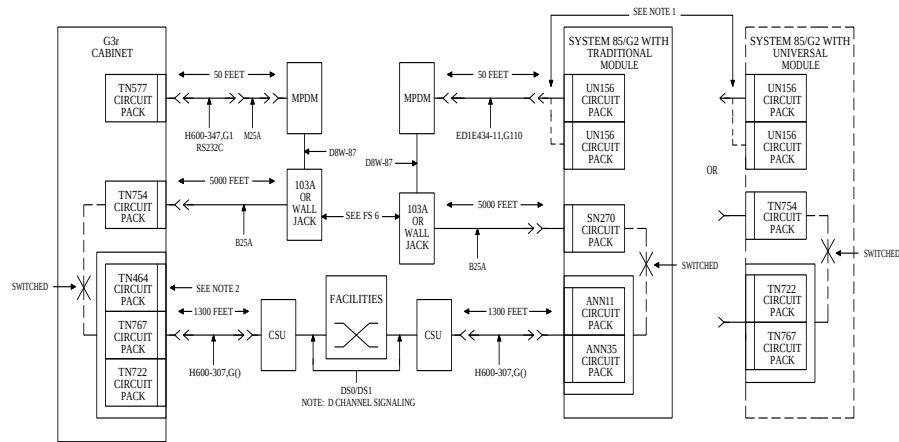
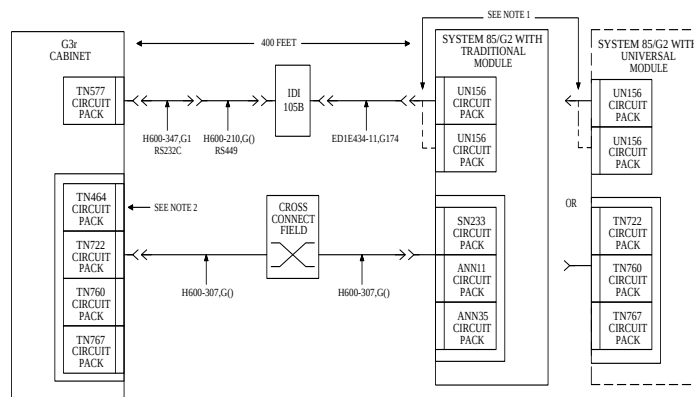
SHORT HAUL X.25 SIGNALING: G3r TO SYSTEM 85/G2 - DIRECT VIA IDI (ISOLATING DATA INTERFACE)

**Figure 9-84. Typical G3r-to-System 85/G2 DCS Connections Using BX.25 Signaling and Mode Conversion**

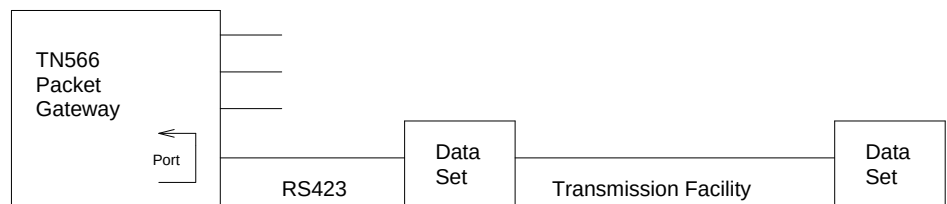
This test verifies the functionality of a port circuit on the Packet Gateway circuit pack. When the switch sends the test request, the Packet Gateway circuit pack automatically loops back the signal at the port as shown in the figure below. Failure of this test indicates the existence of a fault in the port hardware on the circuit pack.

**Figure 9-85. Packet Gateway Port Local Loop-Around Test**

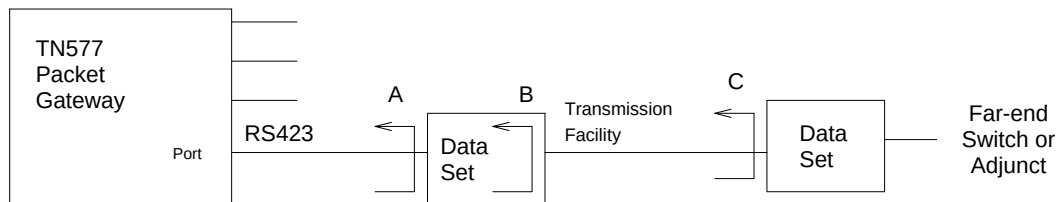
This test checks the integrity of cabling and devices external to the Packet Gateway port hardware. Packet Gateway firmware executes this test on demand by sending a test frame which is looped back to the Packet Gateway by a loop-around that has been externally activated or installed at one of several points in the external connectivity (see loopbacks A, B and C in the figure below). The test passes when the sent and received test frames are identical. The test fails if the sent and received test frames do not match, or if no test frame is received prior to a time out.

If you suspect a problem in cabling or external devices, then repeat this test at points that are progressively further from the PGATE port until either a failure point is identified or the integrity of the entire path is verified. Certain site configurations may require teamwork with those who maintain the off-site transmission facilities.

**Figure 9-86. Packet Gateway Port Remote Loop-Around Test**

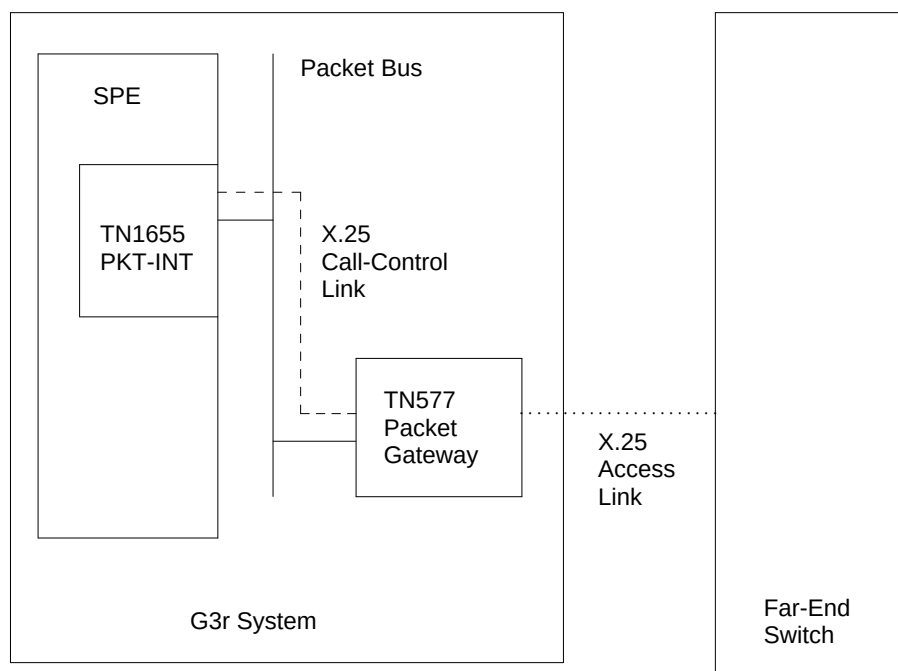
This test determines if the X.25 Access Link is connected or disconnected. The switch determines the state of the X.25 Access Link by sending a query to the Packet Gateway circuit pack. This test passes if the X.25 Access Link is connected and fails if it is disconnected.

**Figure 9-87. Packet Gateway Links**

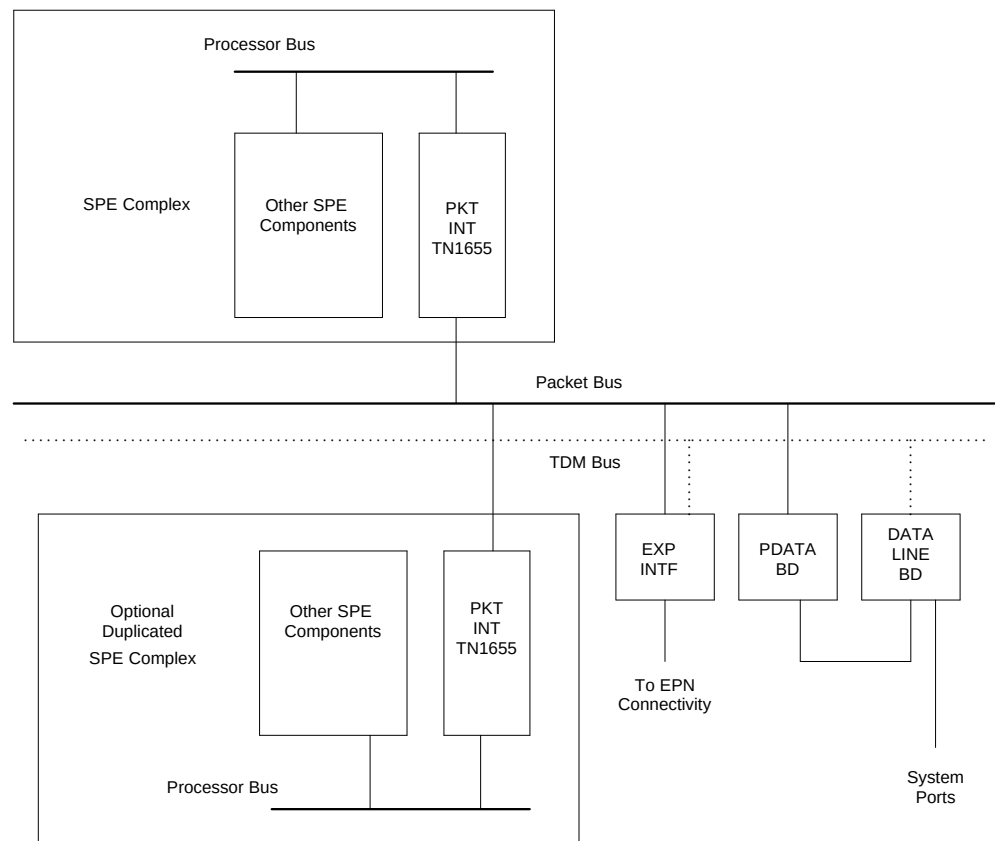
The PBX has been designed for a maximum of three Packet Interface circuit packs but only one Packet Interface circuit pack is required for the current PBX hardware configuration. The Packet Interface circuit pack will normally be inserted in the first Packet Interface slot provided in the control carrier although it will operate in any one of the three slots provided. If more than one Packet Interface circuit pack is inserted, an alarm will be generated. For a system equipped with duplicated SPEs, the slot used for the Packet Interface circuit pack on the standby SPE must be the same slot position as that used on the active SPE or an alarm will be generated against the Packet Interface circuit pack in the standby SPE.

**Figure 9-88. Packet Interface Connectivity**

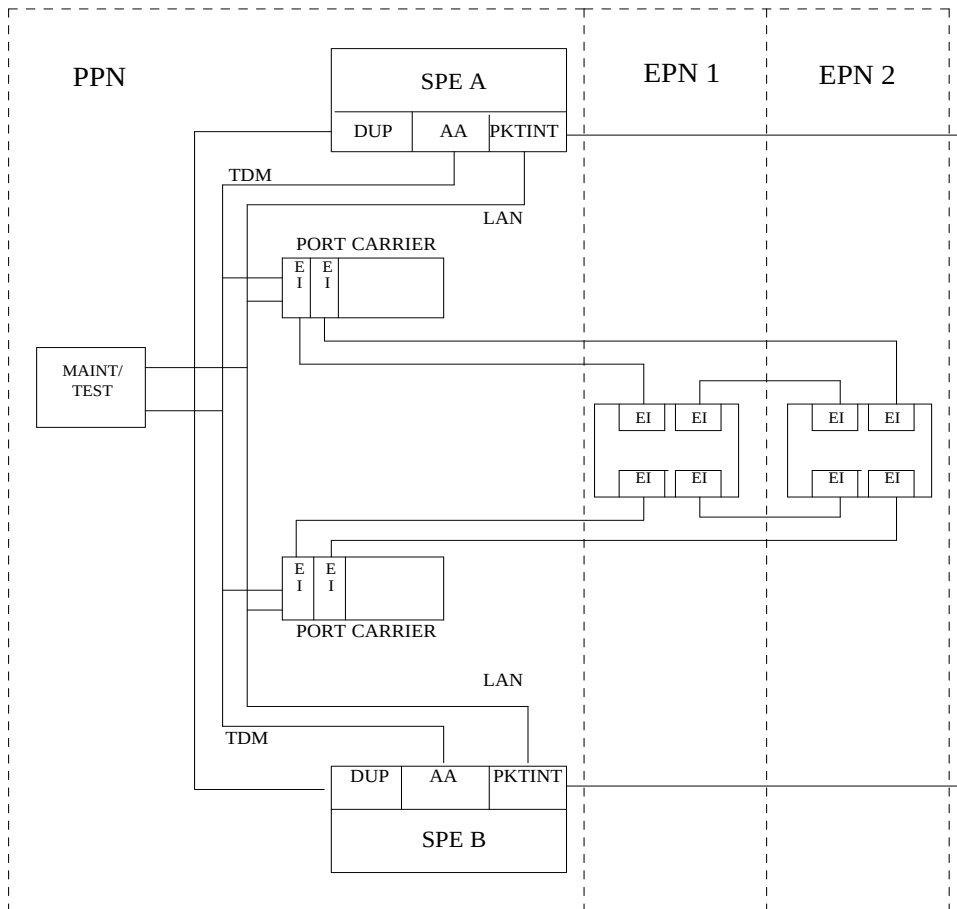
**Figure 9-89. Duplicated Direct Connect PNC Connectivity**

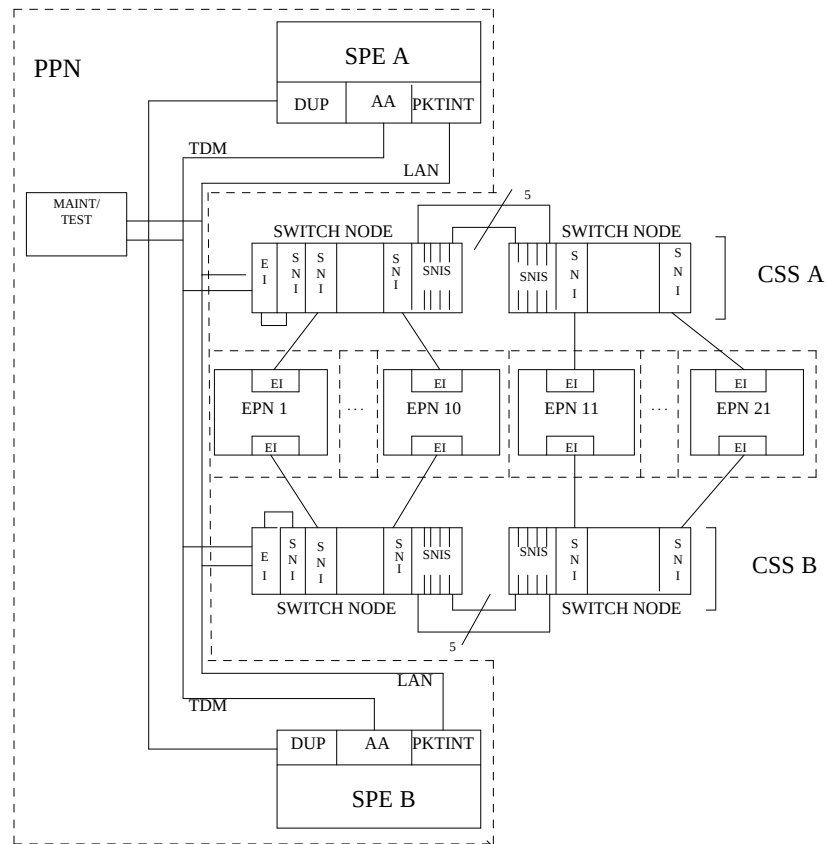
**Figure 9-90. Duplicated PNC with Center Stage Switch**

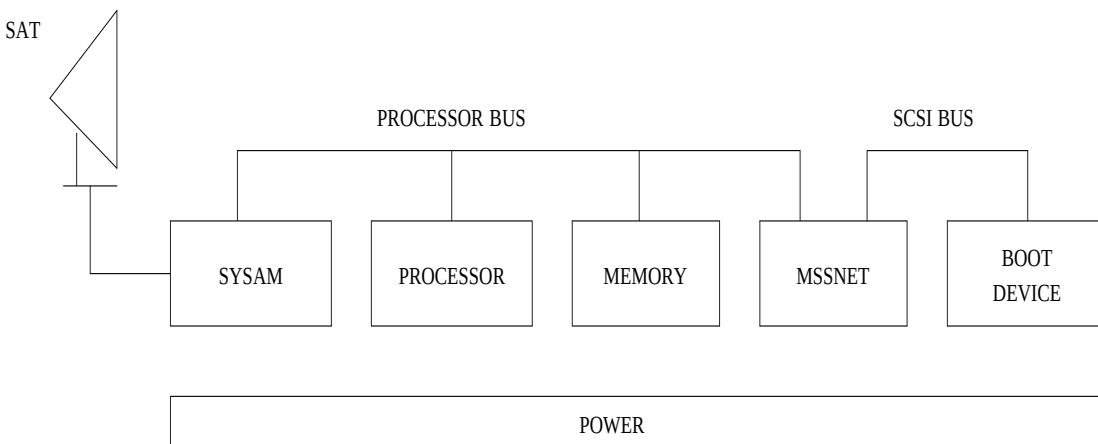
Full system operation depends on nearly every circuit pack in the SPE. However, the ability to load and run the maintenance software by the Processor circuit pack depends only on correct Memory, Processor Bus, Tape-Disk-MSSNET and SYSAM operation (see the following figure). The Memory contains all of the instructions and data required for software execution. The Processor Bus connects the Processor circuit pack and other components of the SPE together. The Tape-Disk-MSSNET complex provide the mass storage for program and translation data that is loaded into memory when the system is started up. SYSAM provides the user terminal access and remote alarm reporting functions needed for Processor circuit pack maintenance.

**Figure 9-91. SPE Components Required for Maintenance Software Operation**

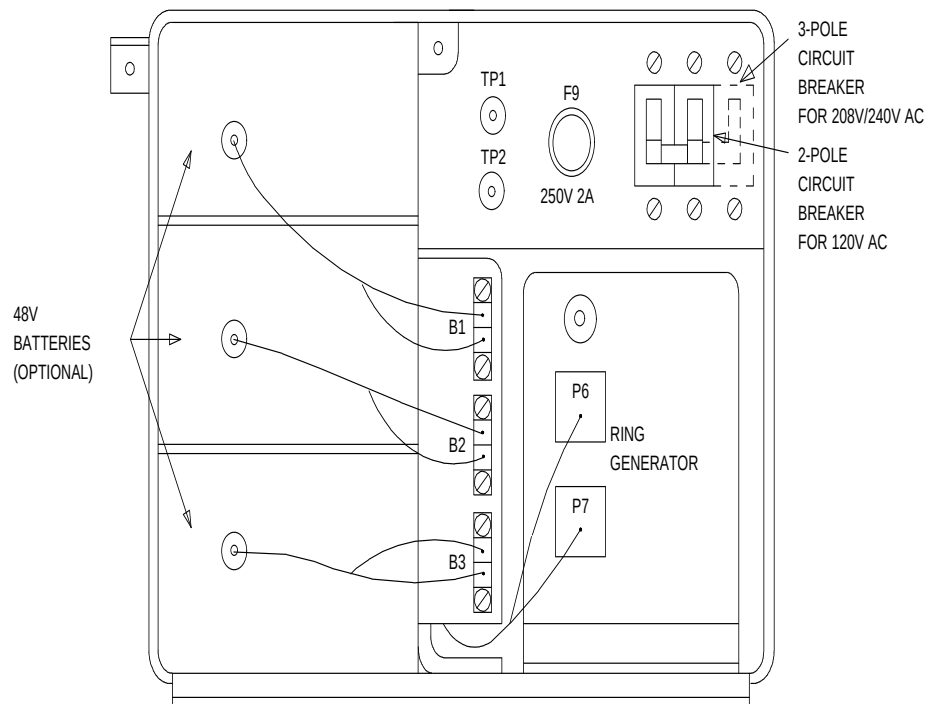
**Figure 9-92. Multicarrier Cabinet AC Power Distribution Unit, Front View without Cover**

Analog phones must be provided with a voltage that allows them to ring. The Analog Ring Generator maintenance object represents the device that provides the ringing voltage for all analog phones associated with a given cabinet. In a multicarrier cabinet, the Analog Ring Generator resides in the Power Distribution Unit (PDU). It is protected by a fuse located next to the main circuit breaker on the front of the PDU (labeled F9 in AC-powered cabinets). See Figure 9-92 and Figure 9-93. In single-carrier cabinets, the Analog Ring Generator is part of the WP-91153 power supply. Failure of the ring generator results in loss of ringing on analog phones. Ringing on digital and hybrid phones is not affected.

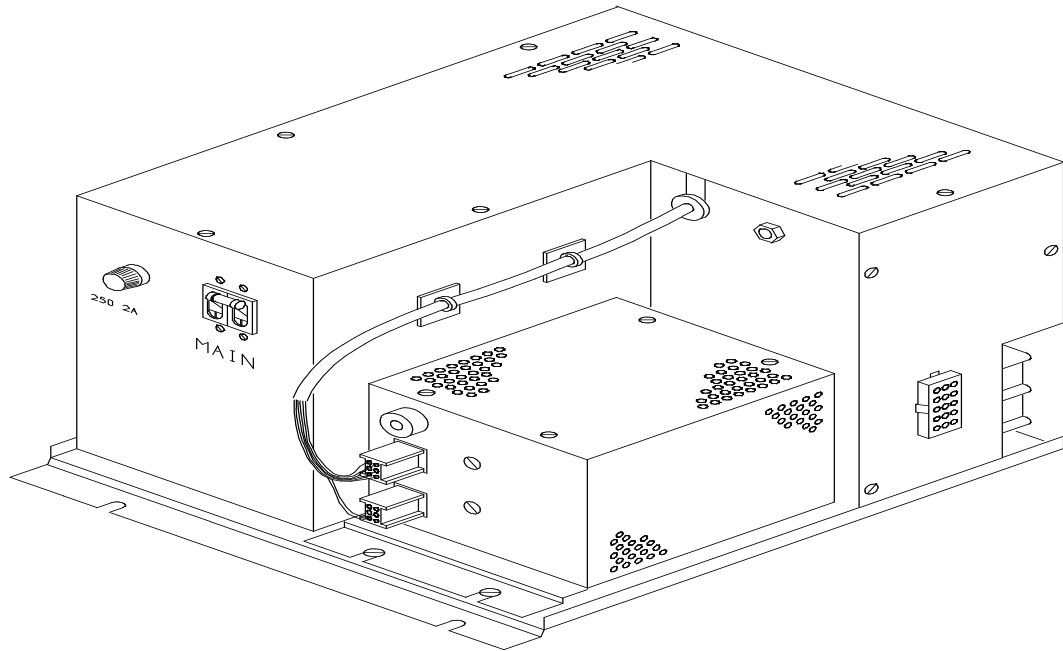
**Figure 9-93. Multicarrier Cabinet DC Power Distribution Unit, Front View without Cover**

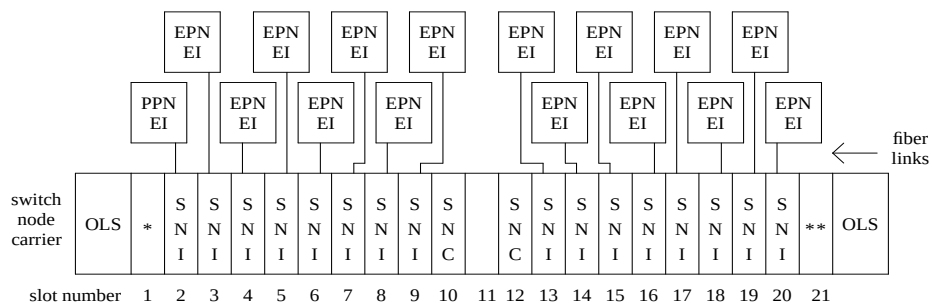
**Figure 9-94. A Center Stage Switch Configuration**

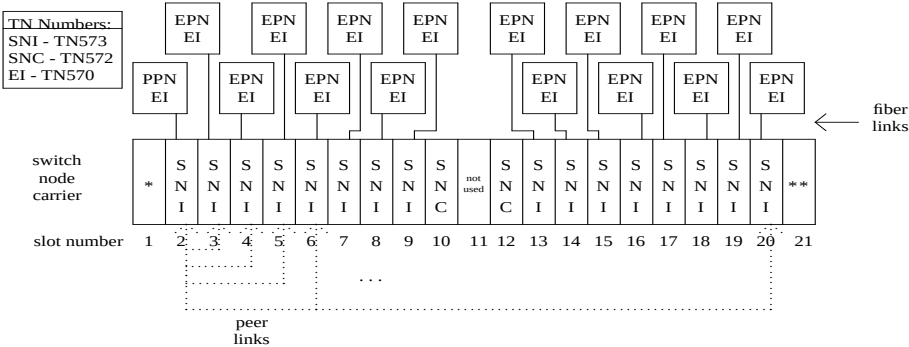
\* = An EI or a DS1C circuit pack may reside in this slot  
\*\* = A DS1C circuit pack may reside in this slot

Figure 9-96. CSS Configuration with Simplex PNC and 1 Switch Node Carrier

Figure 9-96 shows an unduplicated CSS with one switch node. A single switch node can accommodate up to 16 port networks, including the PPN. A system with two switch nodes can accommodate up to 22 port networks. Figure 9-97 shows a two-switch node CSS with duplicated PNC (four switch node carriers). In this configuration, each PNC (A and B) contains two switch nodes. The cabinet numbers for the switch node carriers are typical cabinet numbers. The EPNs and PPN on the top half of the figure (PNC A) are the same as the EPNs and PPN on the bottom half of the figure (PNC B).

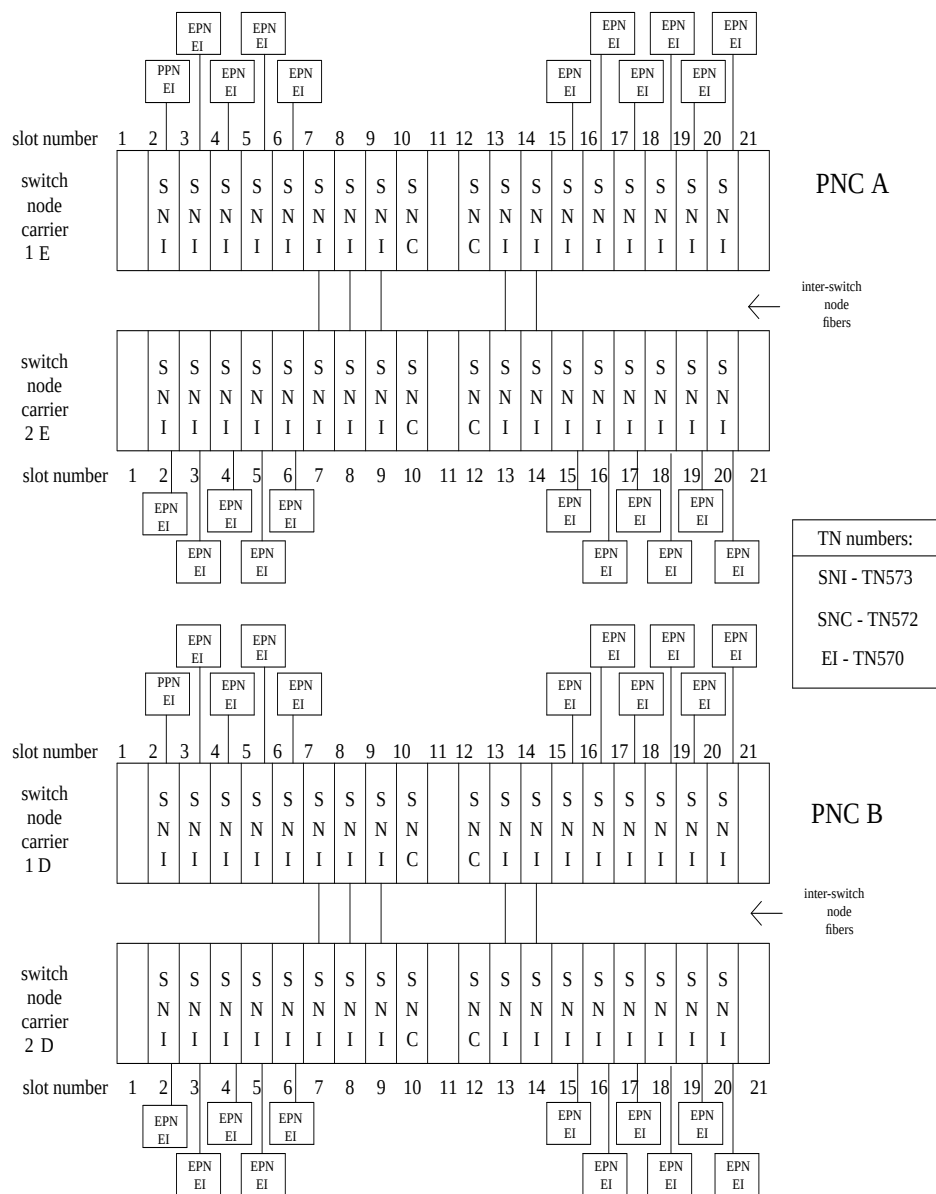
**Figure 9-97. CSS Configuration with Duplicated PNC and 4 Switch Node Carriers**

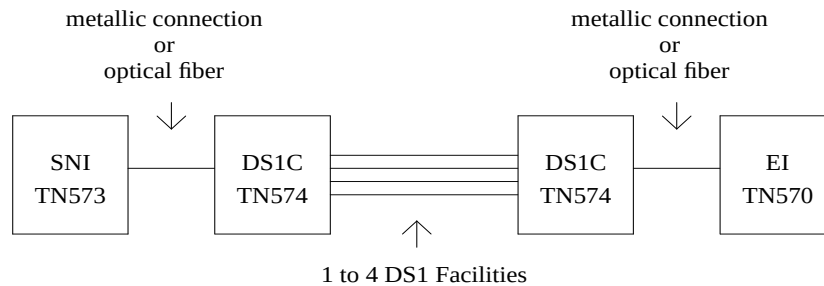
A DS1 converter complex can be used to provide connectivity to a remotely located port network. The DS1 converter complex consists of two TN574 DS1 converter (DS1C) circuit packs connected by 1 to 4 DS1 facilities. The DS1C complex is administered as a fiber link.

**Figure 9-98. Fiber Link over a DS1 Converter Complex**

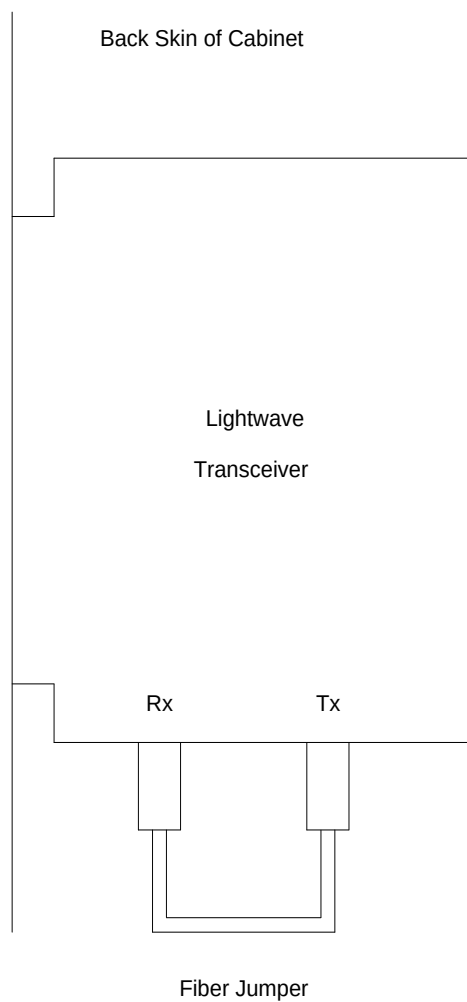
**Figure 9-99. Interconnection of Lightwave Transceiver Transmit/Receive Jacks**

3. Using a spare fiber jumper cable, interconnect the transmit and receive jacks of the lightwave transceiver as shown in Figure 9-99.

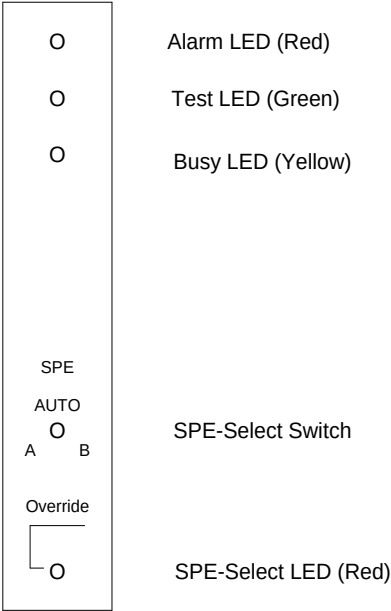
**Figure 9-100. Duplicator Interface Circuit Pack**

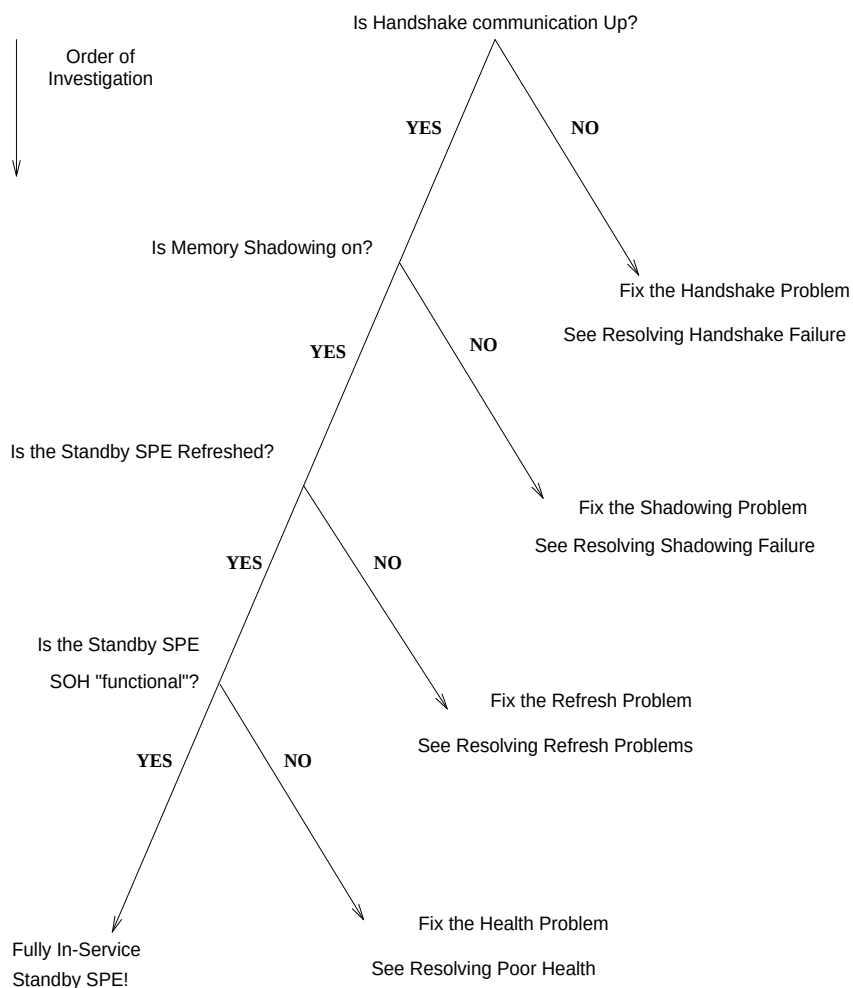
A hierarchical approach is recommended in the above order. Follow the steps presented in the following diagram.

**Figure 9-101. Resolving Standby-SPE Errors**

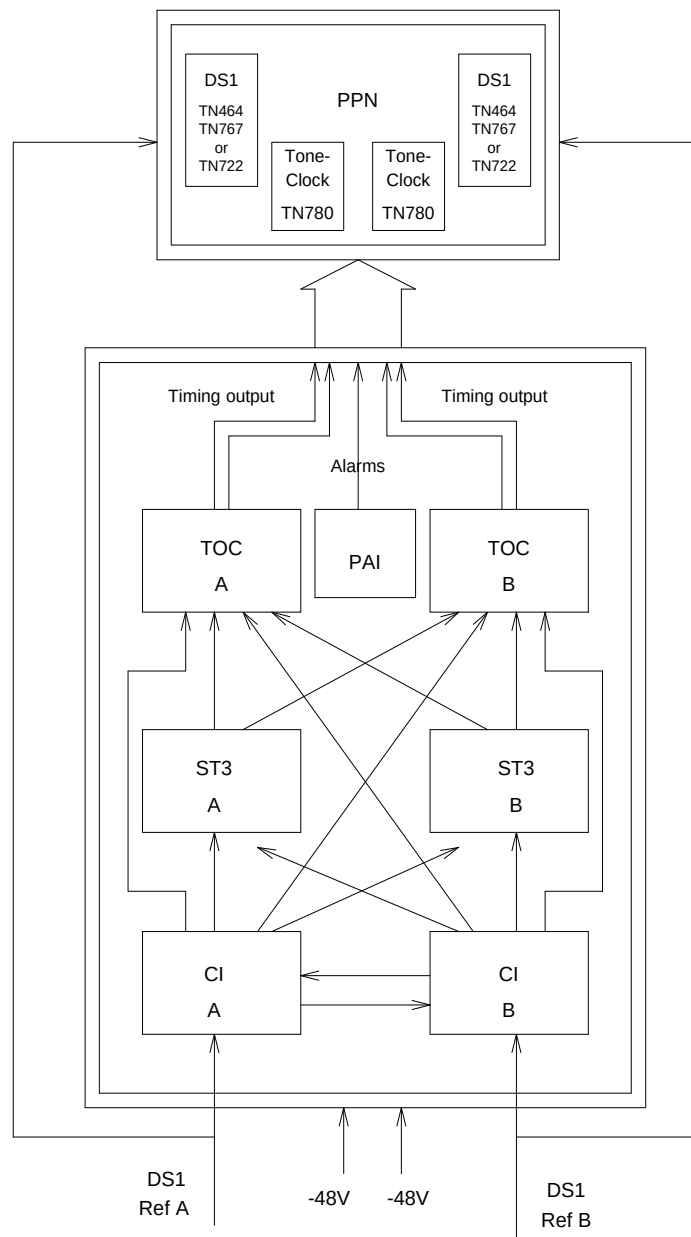
**Figure 9-102. Stratum 3 Clock Hardware Configuration**

In the system, the Stratum 3 clock has been implemented as an external which follows the specification in PUB 60110 for Stratum 3. The only external Stratum 3 clock that is supported is the Telecom Solutions Digital Clock Distributor™ for Customer Premise Timing (DCD-CPT) Stratum 3 clock. Figure 9-102 shows how

the Stratum 3 hardware configuration provides clock and alarm signals to the TN780 Tone-Clock circuit pack(s). The reference DS1 facilities are connected directly to the Stratum 3 clock for timing purposes, but the DS1 data may be routed into the switch by using a Y connector (H-600-274 G1 for the 50 pin DS1 end or H-600-274 G2 for the 15 pin DS1 end).

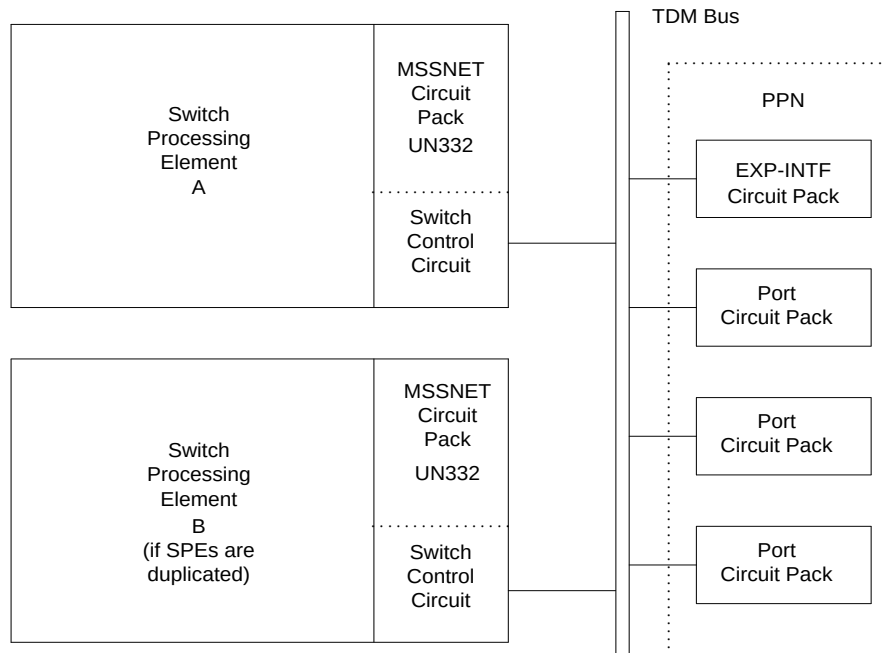
**Figure 9-103. Switch Control Connectivity**

The Switch Control sends control information between the SPE and port circuit packs on the Processor Port Network (PPN) as shown in Figure 9-103. This control information is sent via the PPN cabinet's TDM (Time Division Multiplexed) bus. The portion of the TDM bus used to transmit control messages is called the control channel. The control channel can be on either TDM bus A or TDM bus B, but only one of the two buses is used for the control channel at any give time.

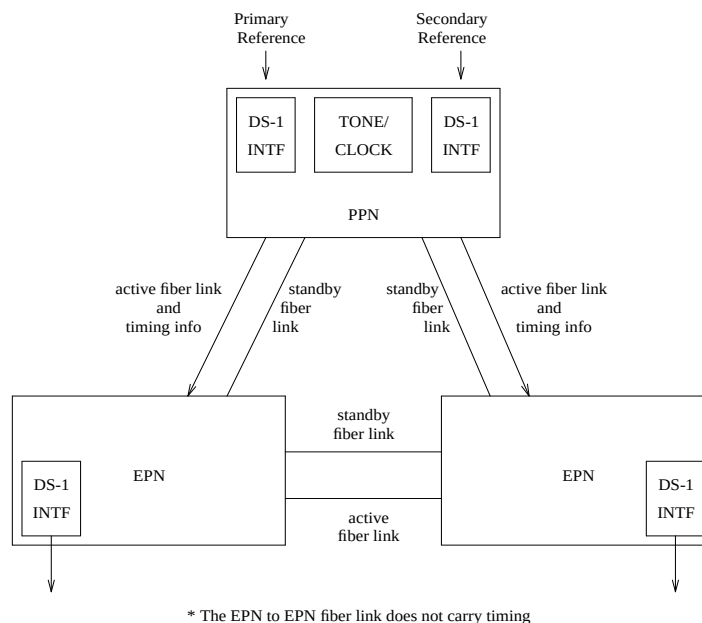
If the primary synchronization reference is not providing a valid timing signal, the system will automatically switch to the secondary synchronization reference. With the primary synchronization reference invalid if the secondary reference does not provide a valid timing signal or is not administered as a synchronization reference, a Tone-Clock circuit pack will provide the system timing source. If the system is using the local oscillator as the system timing source because the primary and secondary references are providing invalid timing signals, when either the primary or secondary reference becomes valid again, the system will switch back to the primary or secondary source. When both the primary and secondary source become valid, the system will switch to the primary source since the primary source is always preferred over the secondary source when both sources are equally healthy. The following diagram should assist in understanding Stratum 4 Synchronization Maintenance components within the system. This diagram depicts a possible duplicated direct connect configuration.

**Figure 9-104. Duplicated Direct-Connect Stratum 4 Synchronization**

If the primary synchronization reference, in the above diagram, is providing a valid timing signal, then the flow of system synchronization would travel from the DS1 interface circuit pack in the PPN across the active PPN to EPN fiber links to the two EPNs. The PPN DS1 interface circuit pack provides a timing signal for the PPN Tone-Clock circuit pack and the PPN Tone-Clock circuit pack provides timing for all circuit packs in the PPN. Each PPN Expansion Interface circuit pack uses the timing generated by the Tone-Clock circuit pack to clock data from the fiber links to the Expansion Interface circuit packs in the two EPNs. The active EPN Expansion Interface circuit pack uses the received data stream to generate a timing signal. The Tone-Clock circuit packs in the EPNs use this signal to generate timing for all the circuit packs in their respective EPNs. The PPN, in the above mentioned scenario, is designated the *master* port network and the EPNs are called *slave* port networks. The *master* port network is defined as the port network that contains the system synchronization source. If the primary synchronization reference does not provide a valid timing signal, Synchronization Maintenance will switch to the secondary reference. *Both the primary and secondary references must reside in the same port network, which may be any port network. The PPN is the recommended location.*
