555-230-105  
Issue 5  
September 1996

# **DEFINITY Enterprise Communications Server Release 5 Maintenance for R5r**

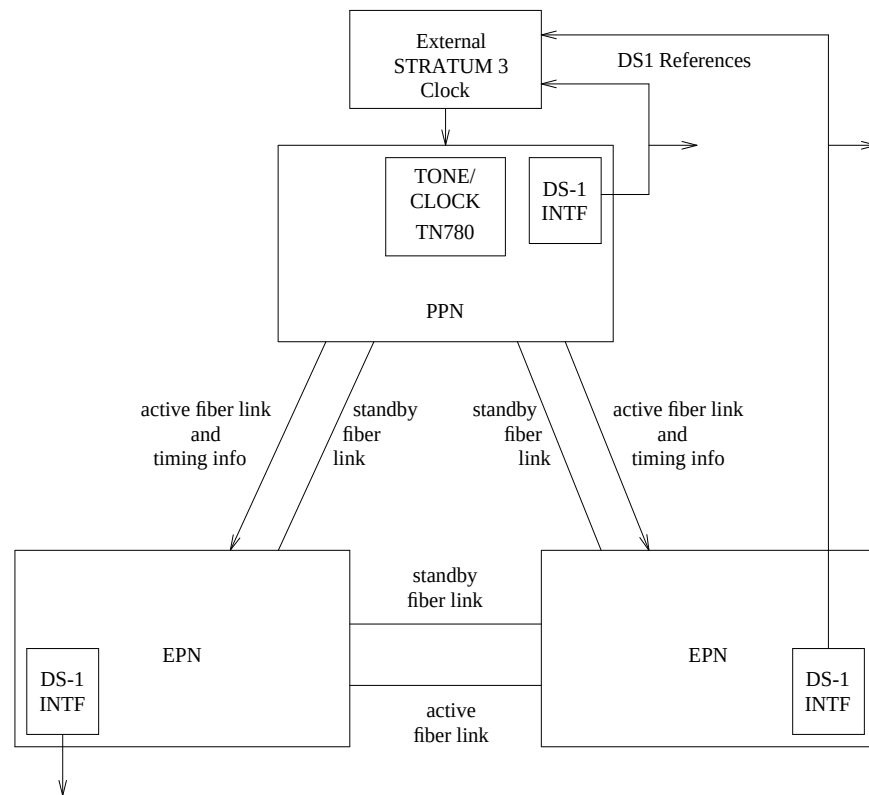
The following diagram illustrates one possible configuration of Stratum 3 synchronization.

\* The EPN to EPN fiber link does not carry timing

**Figure 9-105. Typical Duplicated Direct Connect Stratum 3 Synchronization Configuration**

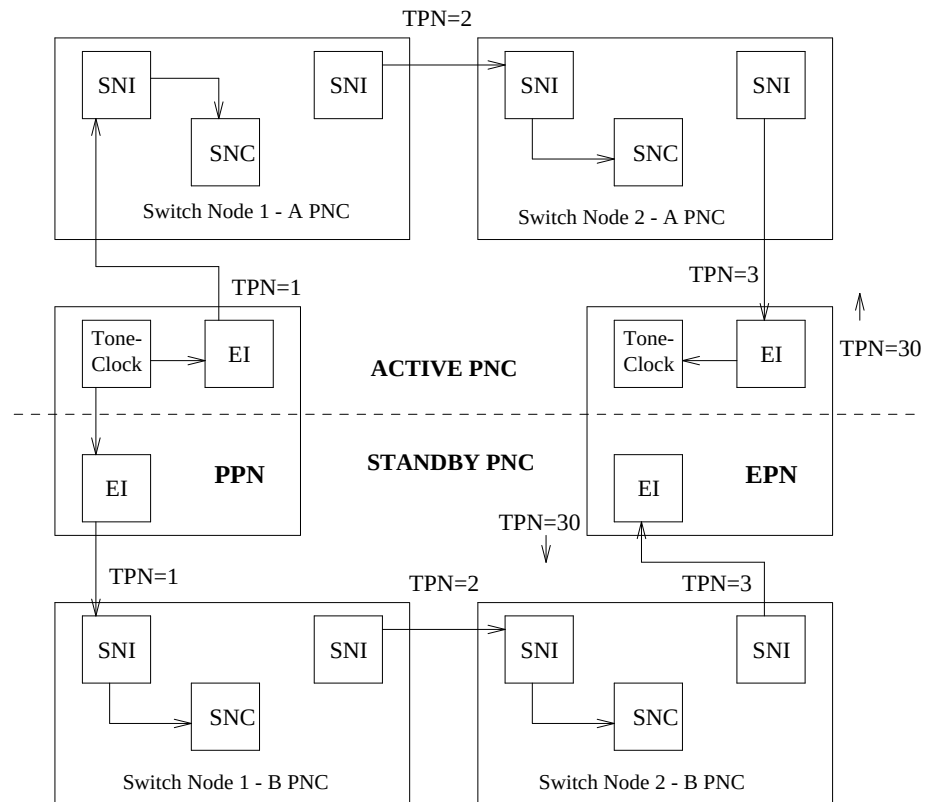
In the following typical duplicated Center Stage Switch (CSS) configuration, the timing signal from the *master* port network, the PPN in this diagram, is sent to all circuit packs in its network. The timing signal is sent from the Expansion Interface (EI) circuit packs in the PPN to the Switch Node Interface (SNI) circuit packs in the switch node carriers. The EIs in the *master* port network also sends out a timing priority number (TPN) of 1. Every *slave* port network EI sends out a TPN of 30. The active Switch Node Clock (SNC) circuit pack in each switch node carrier decides which SNI is providing the timing signal that the switch node carrier should synchronize to by looking at each SNI's incoming TPN. The SNC chooses the SNI with the lowest numbered TPN to synchronize to. The SNC then sends the timing signal to all SNIs and the standby SNC, if a standby SNC is present, in the switch node carrier. The SNC also sends out a TPN equal to 1 plus the lowest incoming TPN. Each SNI in the switch node sends the timing signal received from the SNC and the TPN from the SNC out on its associated fiber.

Timing information is sent through both the active and standby PNCs, but the EPNs normally derive timing from the EIs on the active PNC.

**Figure 9-106. Typical Center Stage Switch Synchronization Configuration -Two Switch Nodes, Duplicated PNC**

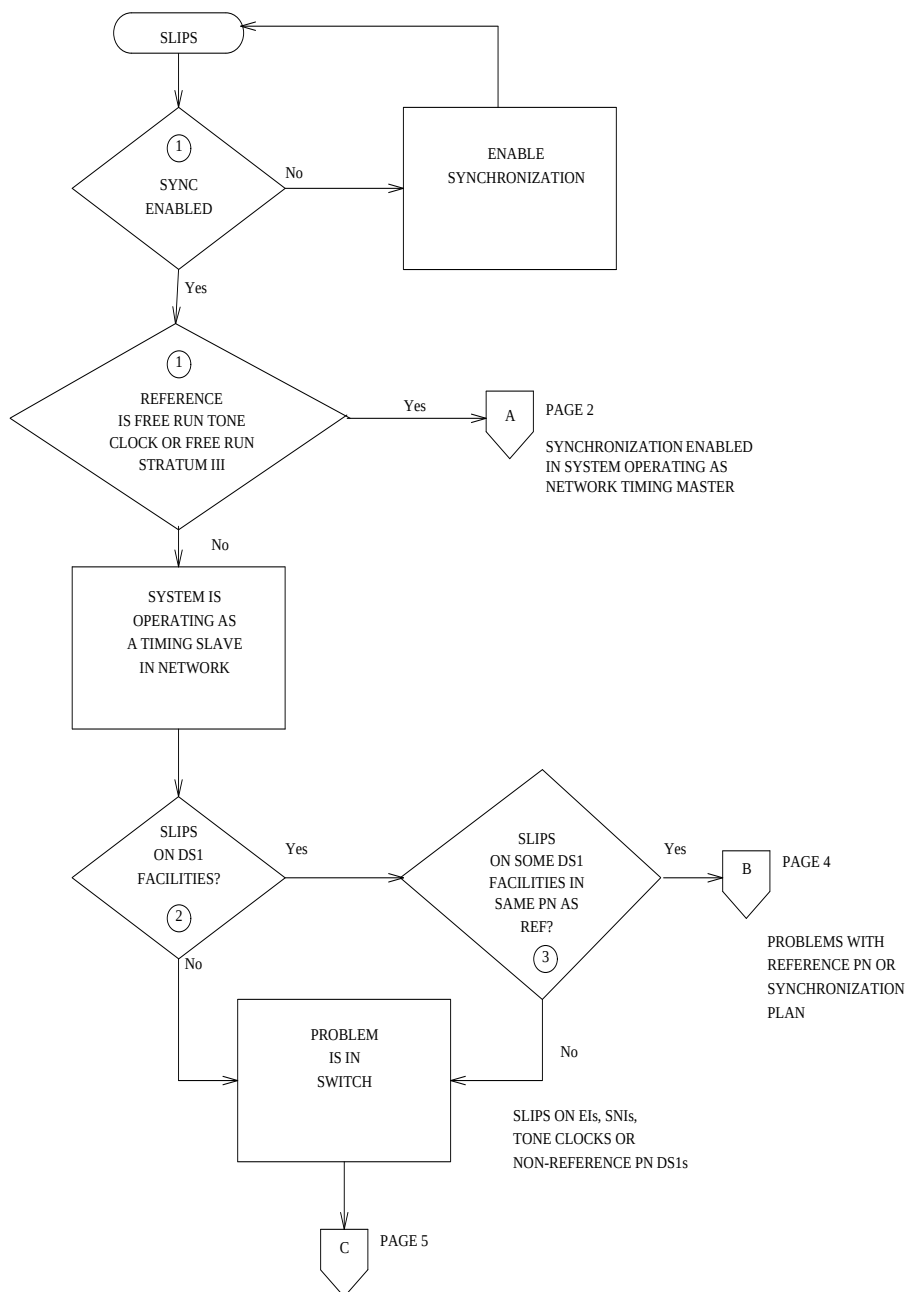
The following flow chart presents a logical approach to troubleshooting synchronization problems in conjunction with the background information presented above. Explanatory notes follow the charts.

Figure 9-107. Synchronization Troubleshooting, Page 1 of 6

Notes for Sheet 1 through Sheet 6 flowcharts (when checking for slip errors, use the table above, *Error Log Entries for Slip Errors*):

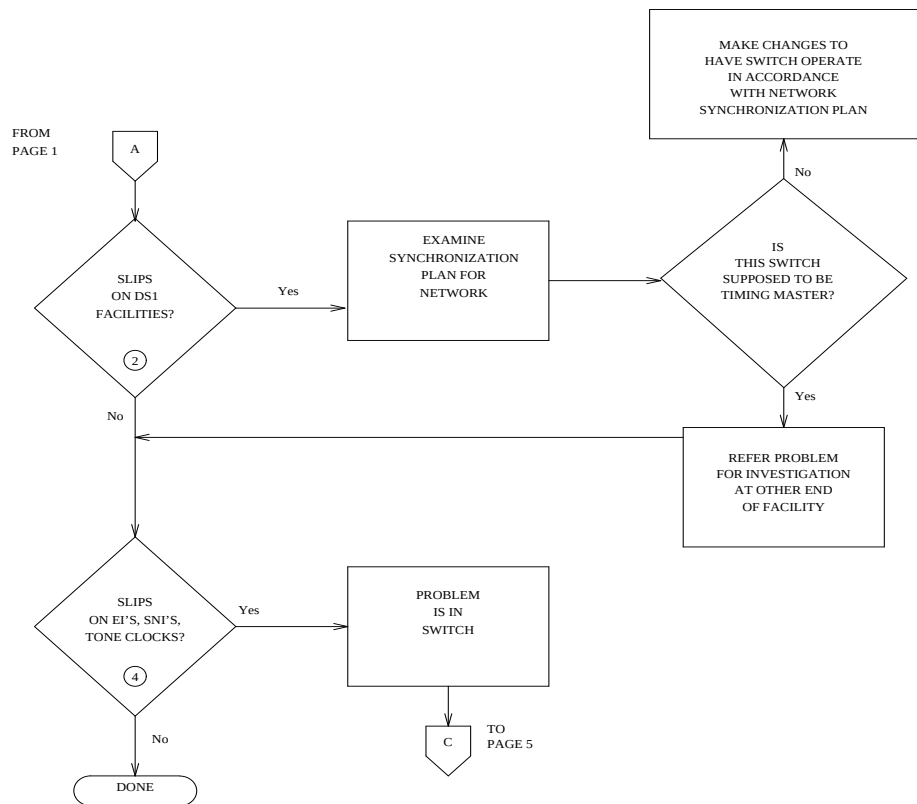
**Figure 9-108. Synchronization Troubleshooting, Page 2 of 6**

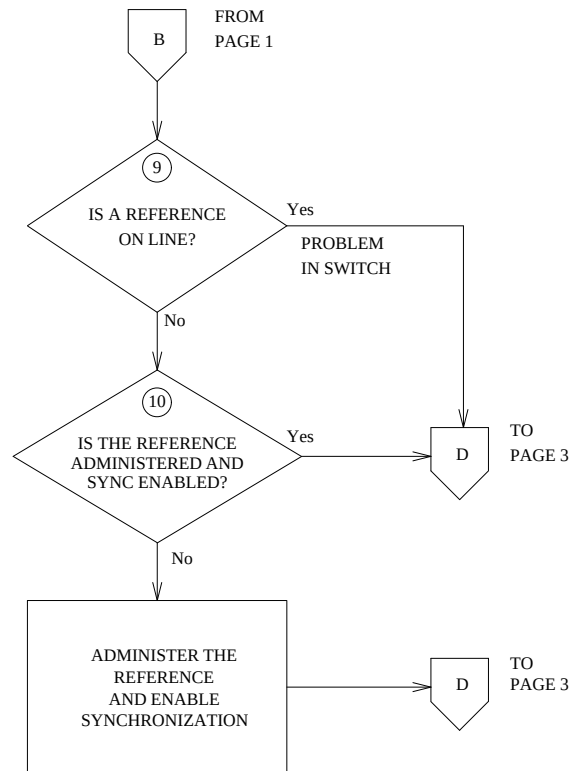
**Figure 9-110. Synchronization Troubleshooting, Page 4 of 6**

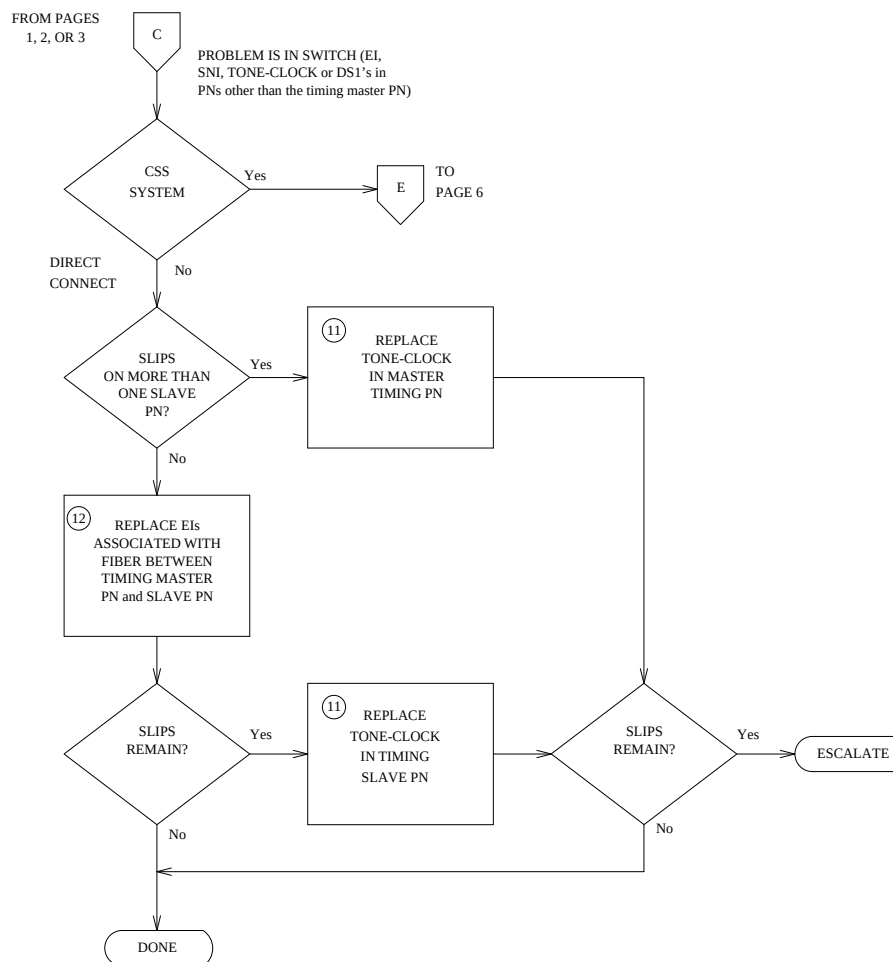
**Figure 9-111. Synchronization Troubleshooting, Page 5 of 6**

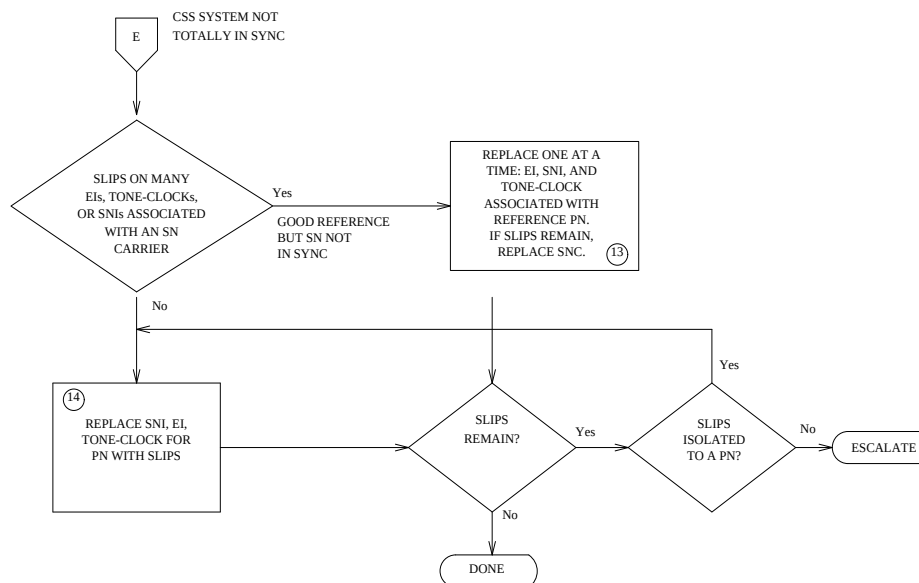
**Figure 9-112. Synchronization Troubleshooting, Page 6 of 6**

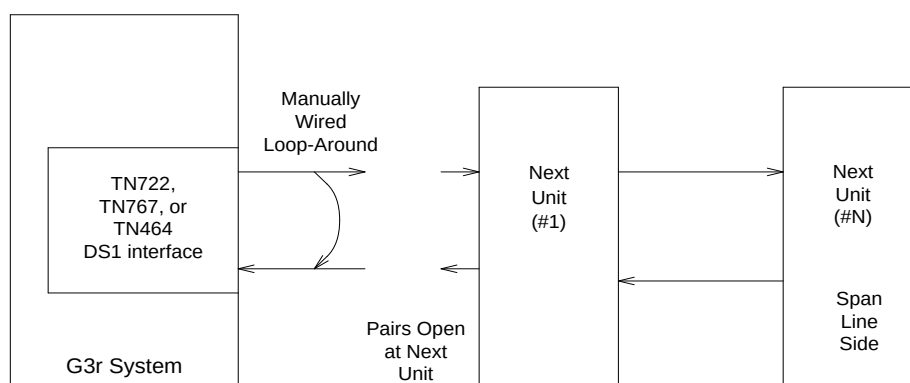
Figure 9-113 shows a sequence of units (1 through n) that may be connected as the on-site equipment. A typical example is the case where the only on-site equipment is channel-terminating equipment designated Unit #1. A more complex, less typical example might have a DACS as Unit #1, a protection switch as Unit #2, and a DS-1-level microwave radio system as Unit #3.

**Figure 9-113. Manual Looparound for Facility Fault Sectionalization**

Remove the transmit signal from the TN722, TN767, or TN464 circuit pack inputs and outputs and loop it around to the receive signal going toward the TN722, TN767, or TN464 circuit pack at the first unit wired to the TN722, TN767, or TN464 circuit pack. (See Figure 9-113).

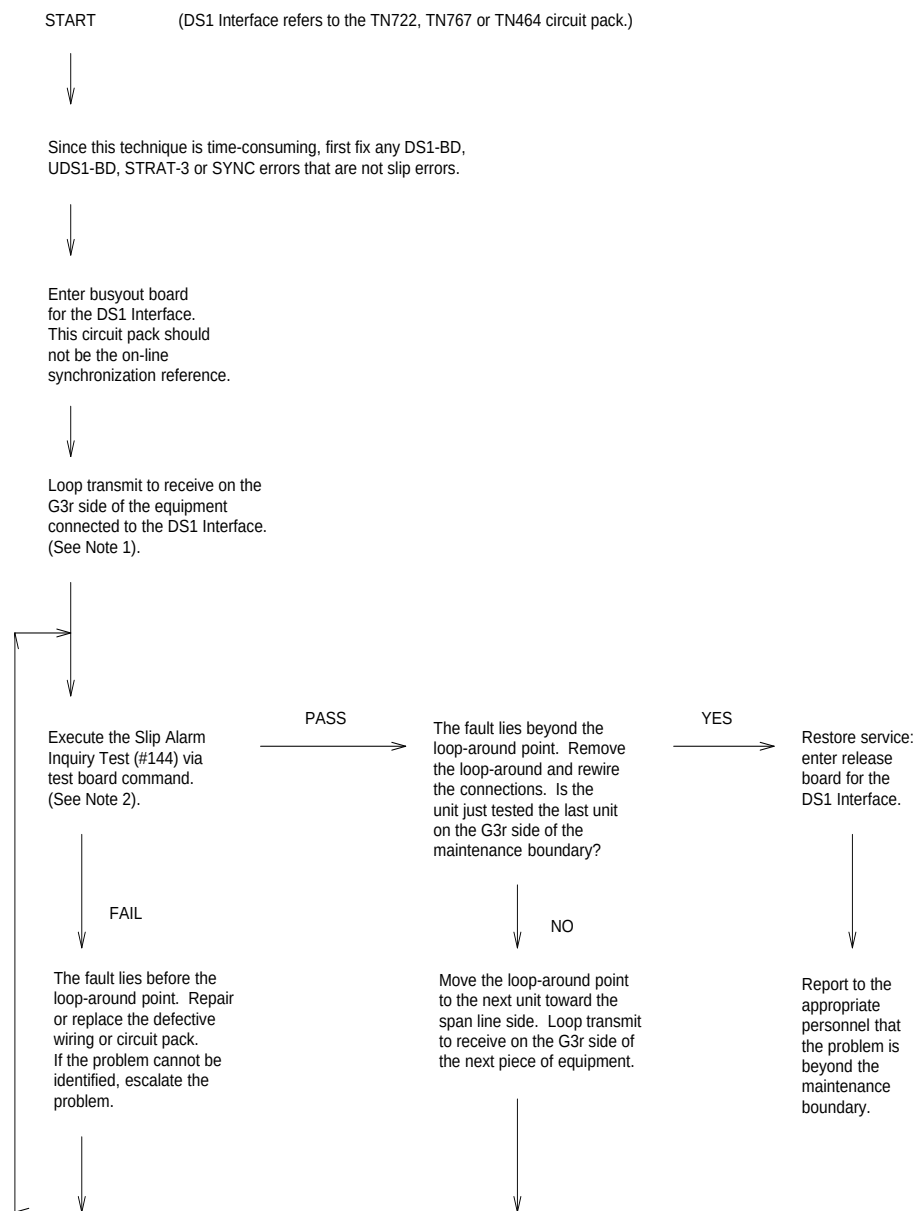
The flowchart in Figure 9-114 gives an overview of the facility fault sectionalization technique. It is important that you know the configuration and wiring of the equipment for the problem facility in order to support this technique.

**Figure 9-114. Facility Fault Sectionalization**

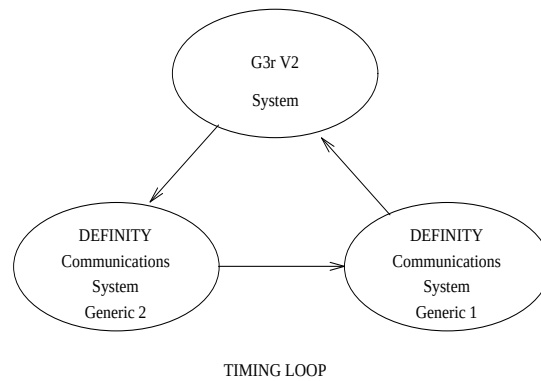
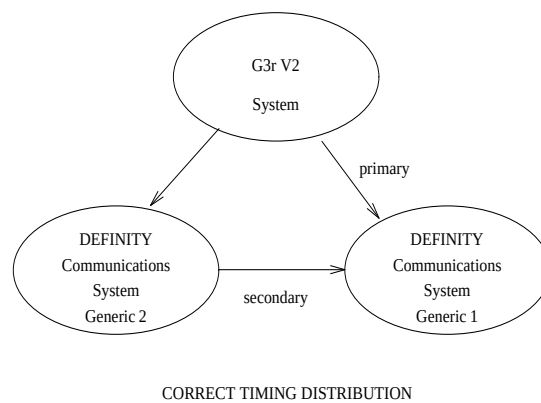
A timing loop exists whenever a system receives timing from another system whose timing reference is directly or indirectly derived from itself. The system synchronization planner *must avoid creating a timing loop* when administering the synchronization references in a system. Timing loops can lead to loss of digital data between systems that are exchanging data with any system within the loop. An invalid timing signal will also be generated by any system within the loop, thus propagating the invalid timing signal to any system(s) using a system within the loop as a synchronization reference. Figure 9-115 shows a timing loop and a correct distribution of timing between the systems.

NOTE:  
→ Synchronization Reference

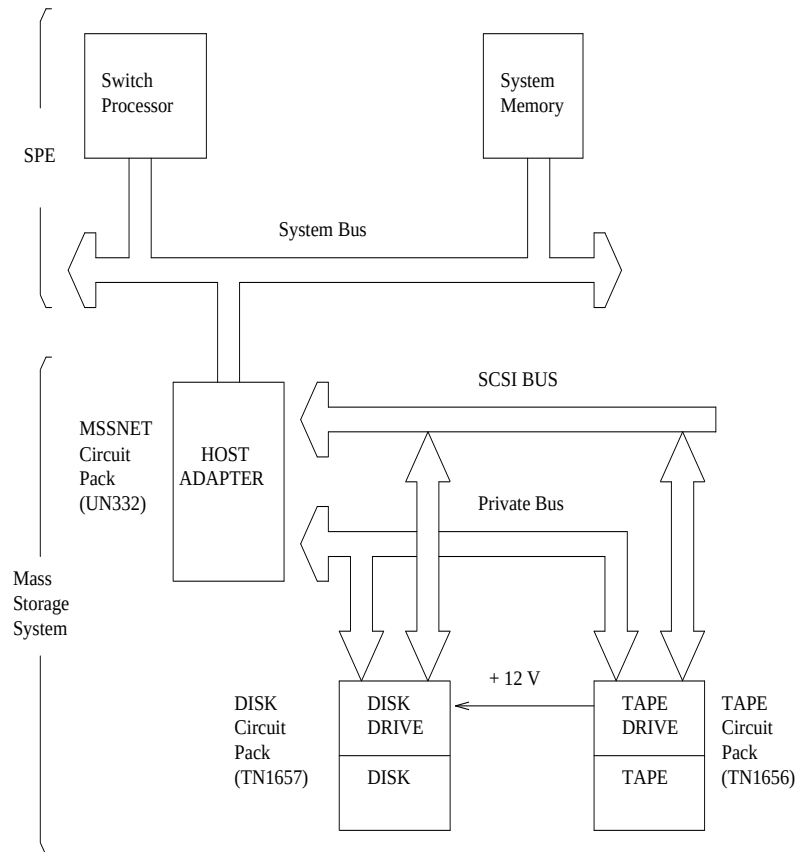
The TN1656 Tape circuit pack is part of the Mass Storage System (MSS). The MSS provides non-volatile storage for system software, translation data, announcement data and program update data. As shown in Figure 9-116, the MSS consists of a Host Adapter circuit on the UN332 MSS-Network Control circuit pack (MSSNET), a Small Computer System Interface (SCSI) bus, a TN1656 Tape circuit pack and the TN1657 Disk Drive circuit pack. The Disk Drive acts as the primary storage device. The Tape Drive serves as a backup device and as a removable medium for system data.

**Figure 9-116. Mass Storage System Interactions**

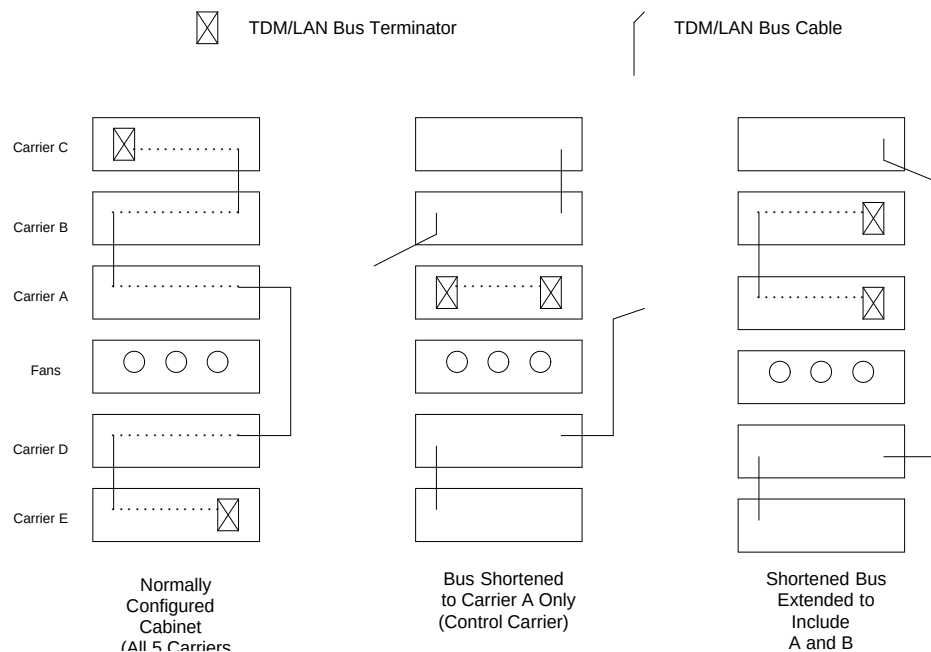
In this procedure, the TDM/LAN Cable Assemblies and TDM/LAN Bus terminators are replaced. If this action does not resolve the TDM Bus fault, the carriers are reconfigured so that certain carriers are disconnected from the TDM Bus. This is done by moving the TDM/LAN Bus terminators (ZAHF4) on the carrier backplane. To terminate a TDM Bus at the end of a particular carrier, the TDM Bus cable that connects the carrier to the next carrier should be unplugged and replaced with the TDM/LAN Bus terminator (see tFigure 9-119). When the length of the TDM Bus is modified the circuit packs that are essential to the

system operation and TDM Bus maintenance (for example, MSSNET and Tone/Clock), must still be connected to the new *shortened* TDM Bus.

**Figure 9-119. Carrier Rewiring Example—Rear View of Five-Carrier Cabinet**

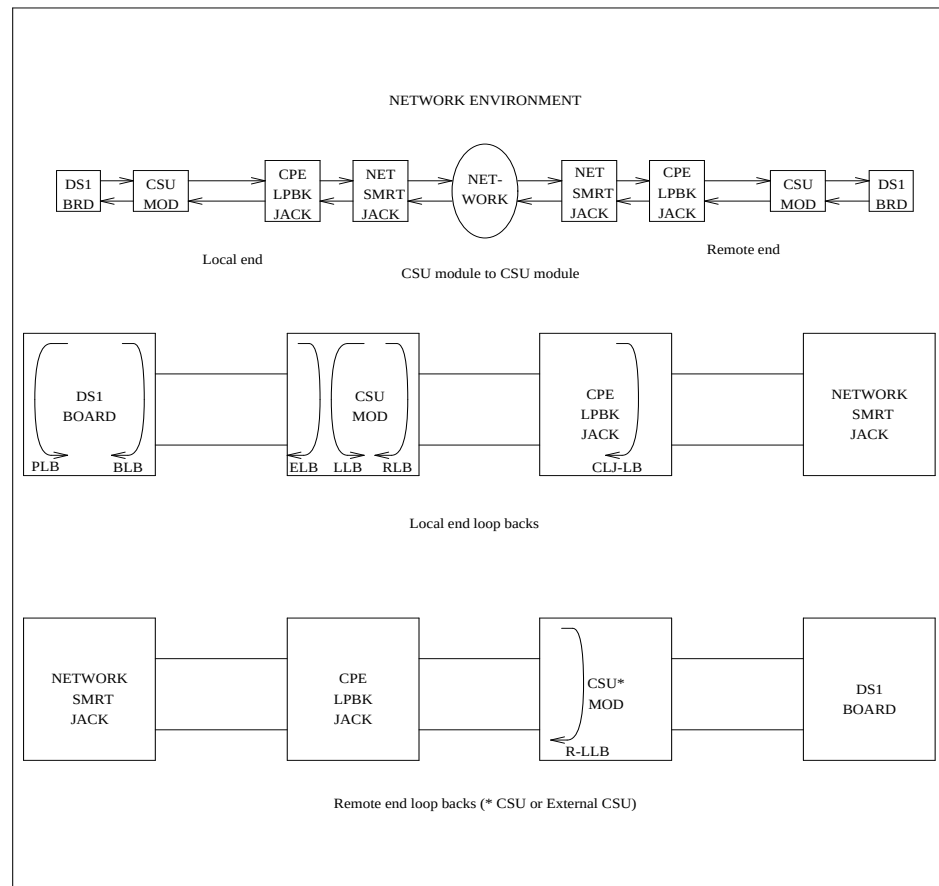
The TN464F and 120A1 CSU Module support on-demand loopback tests that assist in the detection of faults between the TN464F circuit pack and the CSU Module, between the Integrated CSU and the optional Customer Premises Loopback Jack, or between the Integrated CSU and remote CSU. These loopback tests are explained in detail later in this UDS1-BD section, but Figure 9-120 gives a high level overview of the loopback points.

**Figure 9-120. High Level Overview Of Loopback Points**

The following list of acronym definitions are for the Figure 9-120:

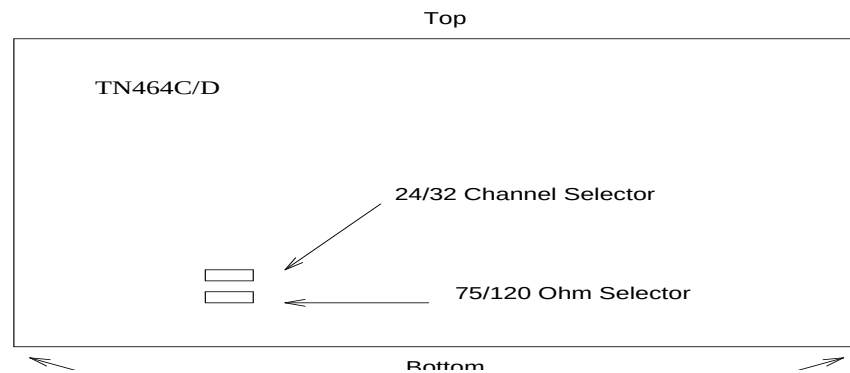
Two option jumpers located on the side of the TN464C/D circuit pack must be installed correctly. The figures on the following page shows how to configure the circuit pack for 24-channel or 32-channel DS1, and for 75\*W (coaxial) or 120\*W trunk connections. The channel selection must match the parameters administered on the corresponding DS1 Circuit Pack Form. (US applications use 24 Channels.)

**Figure 9-121. TN464C/D DS1 Option Jumpers**

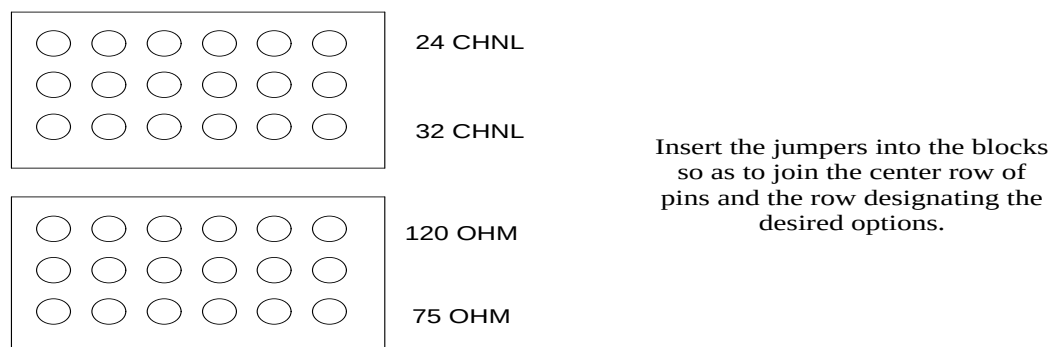
**Figure 9-122. TN464C/D DS1 Option Jumpers (Continued)**

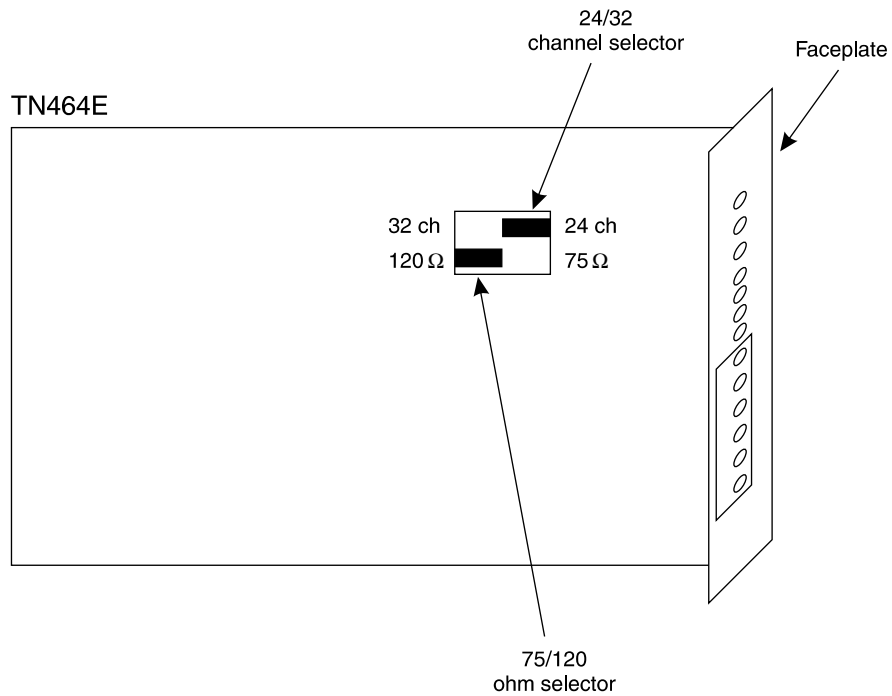
The option switch located on the component side of the TN464E/F circuit pack must be set correctly. Figure 9-123 shows how to configure the circuit pack for 24-channel or 32-channel DS1. The channel selection must match the parameters administered on the corresponding DS1 Circuit Pack Form. (US applications use 24 Channels.)

**Figure 9-123. TN464E/F DS1 Option switches**
