**Lucent Technologies**  
Bell Labs Innovations

**DEFINITY<sup>®</sup>**  
**Enterprise Communications Server**  
Release 6  
Maintenance for R6csi  
Volumes 1 and 2

555-230-129  
Comcode 108215690  
Issue 3  
May 1998

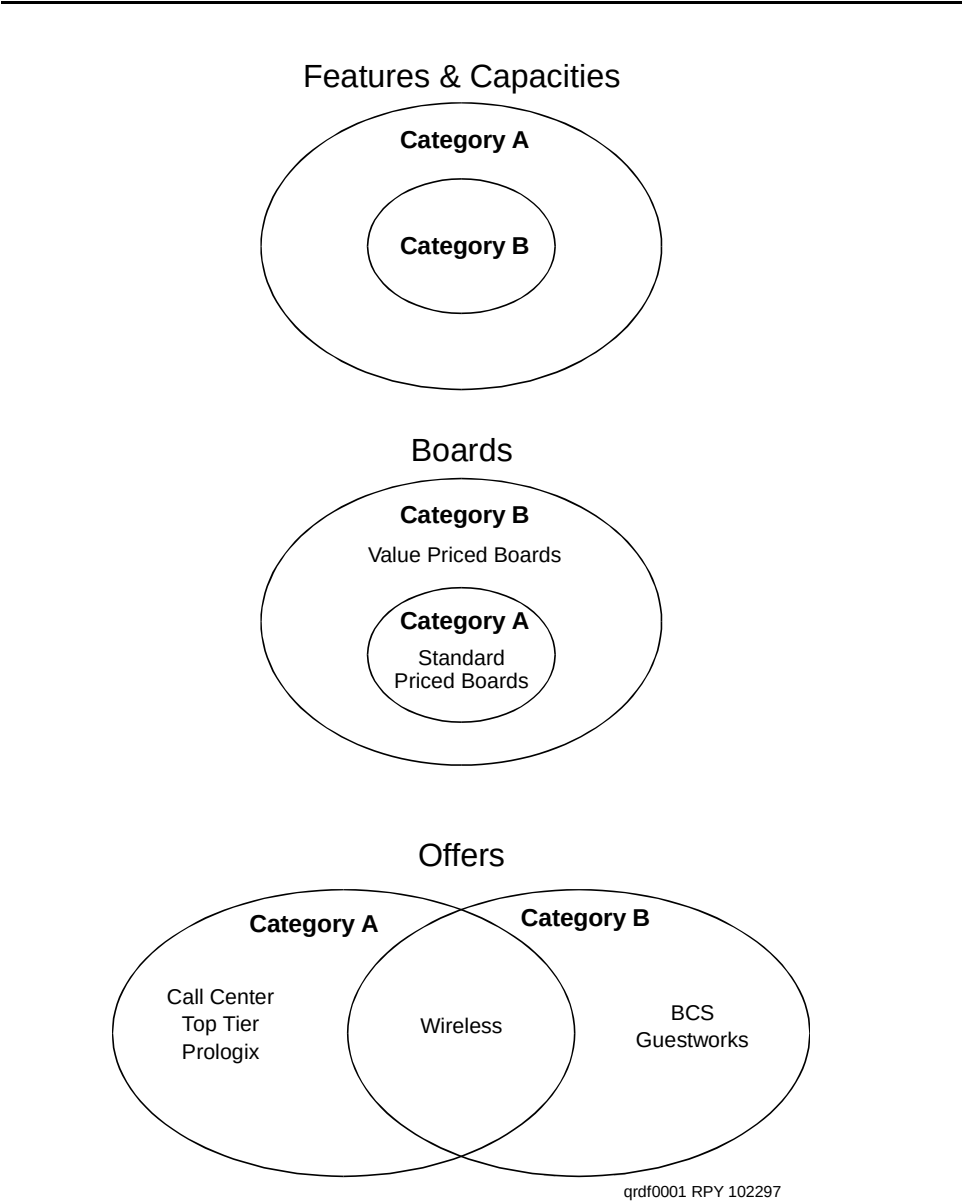
Figure 1-1. Offer categories and related hardware, features, and capacities

System features are classified into two offer categories as shown in [Figure 1-1](#):

- **Category A** [default] refers to top-tier offers and encompasses all current DEFINITY (including ProLogix Communications Solutions) systems.
  - All customer options allowed
  - All features allowed
  - Standard capacities
  - Standard priced hardware *only*

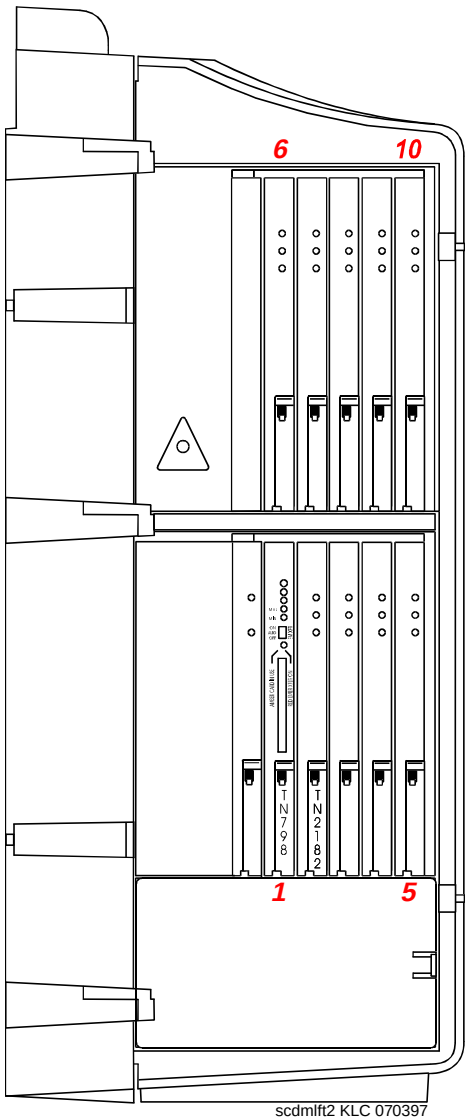
Figure 1-4. Compact Modular Cabinet (CMC) slot configuration

- The CMC cabinet has 2 shelves of 5 slots each (1-5, 6-10) as shown in [Figure 1-4](#). This means that slots 5 and 6 are not contiguous like they are in other DEFINITY cabinet types and that Multi-Function boards such as the TN566 and the MAPD boards (TN800, TN801, and TN802) must be installed in specific slots. For example:

- The TN798 Processor circuit pack incorporates the RISC processor complex, the TN777B NETCON (including PCM flash card interface), and TN765 Processor Interface functions and is always found in slot 1 of the A carrier. (See [Figure 1-4](#))

- The RISC-based TN798 Processor circuit pack must be located slot 1. [Figure 1-4](#) also shows the Flash Memory Card slot for translations.
- TN2182 Tone-Clock must be installed in slot 2. This is the only Tone-Clock circuit pack allowed in the CMC.
- Service circuit packs listed in [Table 1-1](#) are the only packs allowed in the CMC. These “universal” service packs can be located in any slot numbered 3-10.

All circuit pack slots in the Compact Modular Cabinet (CMC) are “universal slots.” That is, any slot can contain any type of circuit pack (port, control, or service), hence the absence of the purple and white slot coding found on other DEFINITY products. The only requirements for slot allocation are:

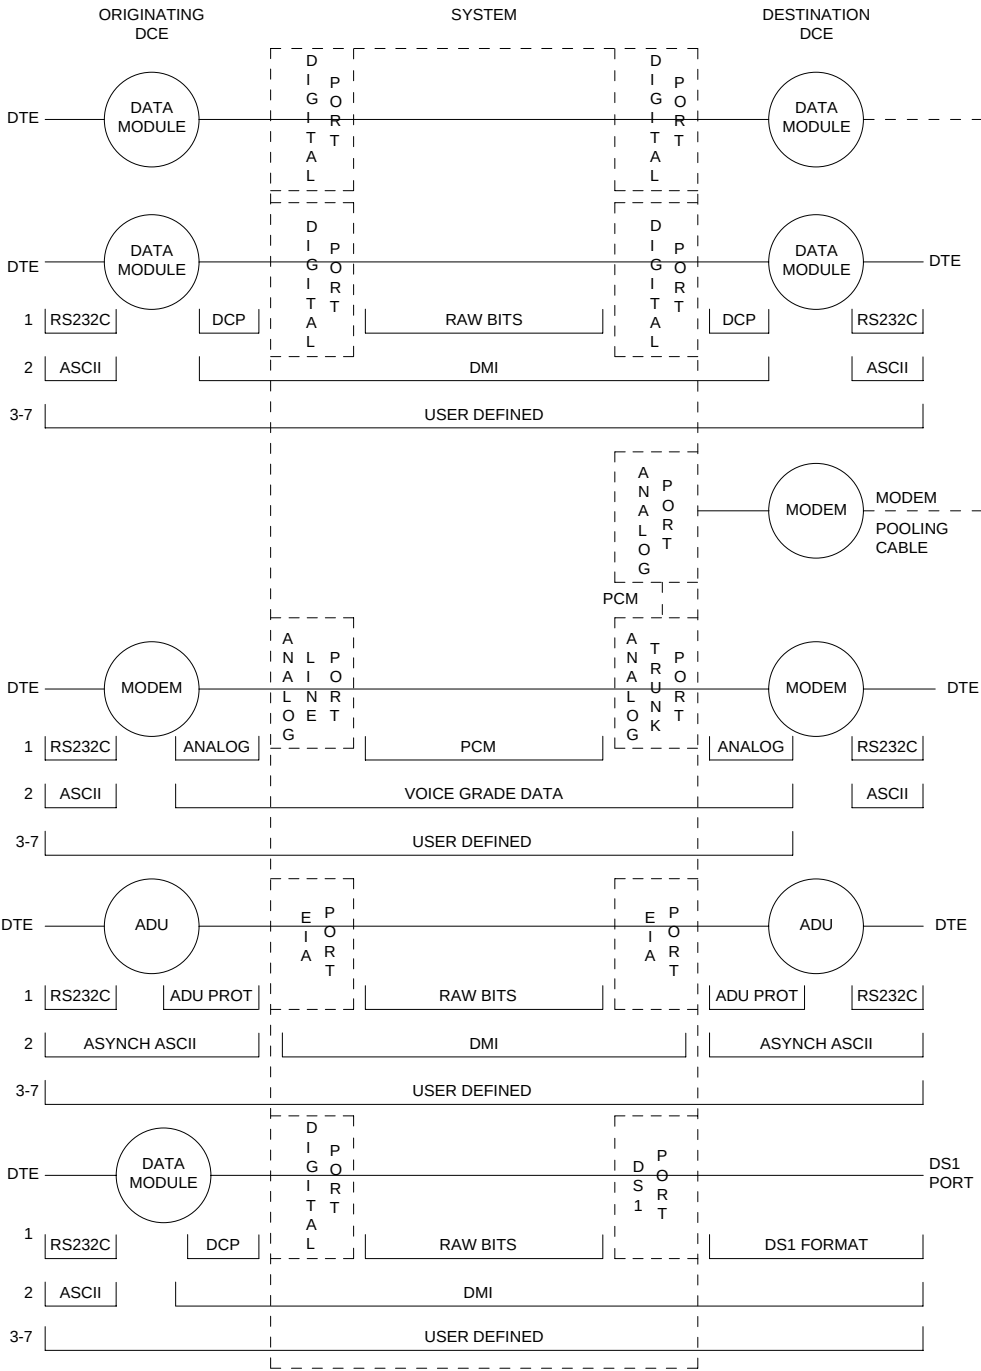
Figure 1-5. Data Transmission States

Layer 2, or the *data-link layer*, refers to code created and interpreted by the DCE. The originating equipment can send blocks of data with the necessary codes for synchronization, error control, or flow control. With these codes, the destination equipment checks the physical-link reliability, corrects any transmission errors, and maintains the link. When a transmission reaches the destination equipment, it strips any layer-2 information the originating equipment may have inserted. The destination equipment only passes to the destination DTE equipment the information sent by the originating DTE equipment. The originating DTE equipment can also add layer-2 code to be analyzed by the destination DTE equipment. The DCE equipment treats this layer as data and passes it along to the destination DTE equipment as it would any other binary bits.

Layers 3 to 7 (and the DTE-created layer 2) are embedded in the transmission stream and are meaningful only at the destination DTE equipment. Therefore, they are shown in the figure as “user-defined,” with no state changes until the transmission stream reaches its destination.

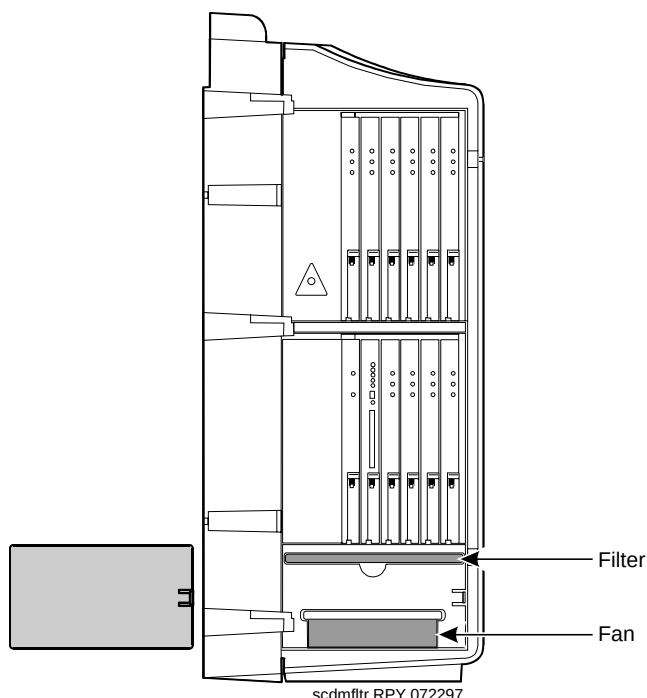
**Figure 1-6. Fan/Filter Removal**

1. Remove the left door.
2. Remove the fan/filter access panel. See [Figure 1-6](#).

1. Remove the fan access panel from the left side of the cabinet.
2. Pull the fan filter from the chassis.
3. Clean (vacuum or wash with water) or replace the filter as needed and slide the filter back into the chassis.
4. Replace the fan access panel.

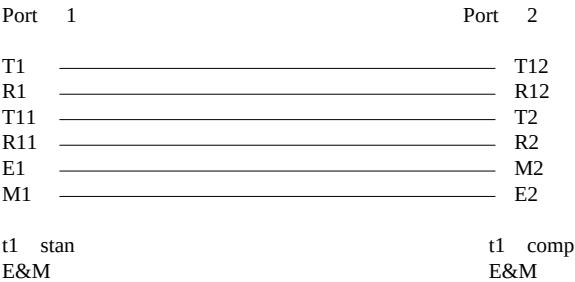
11. At the cross-connect field, disconnect outside trunk facilities from the Tie Trunk ports and mark the disconnected wires for later reconnecting the Tie Trunk ports back to normal operation. The D Impact Tool (AT-8762) is required to perform this step.
12. Use jumper wires (DT 24M-Y/BL/R/G and DT 24P-W/BRN) and the D Impact Tool to connect wiring between the two ports assigned in Step 9 at the cross-connect field. For example, if the two ports on the Analog Tie Trunk circuit pack are port 1 and 2, connect the wirings as shown below:

13. Check all wiring to verify good connections between the two test ports.

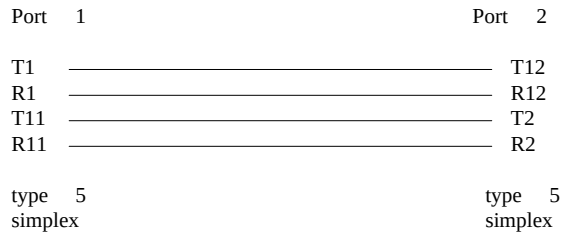
4. Locate the Tie Trunk port terminal connections at the cross-connect field.  
See [Table 1-4](#).
5. At the cross-connect field, disconnect outside trunk facilities from the Analog Tie Trunk ports and mark the disconnected wires for later when the Tie Trunk ports are placed back into normal operation. The D Impact Tool (AT-8762) is required to perform this step.
6. Use jumper wires (DT 24M-Y/BL/R/G) and the D Impact Tool to connect wiring between the two ports assigned in Step 4 at the cross-connect field. For example, if the two ports on the Analog Tie Trunk circuit pack are ports 1 and 2, connect the wirings as shown below:

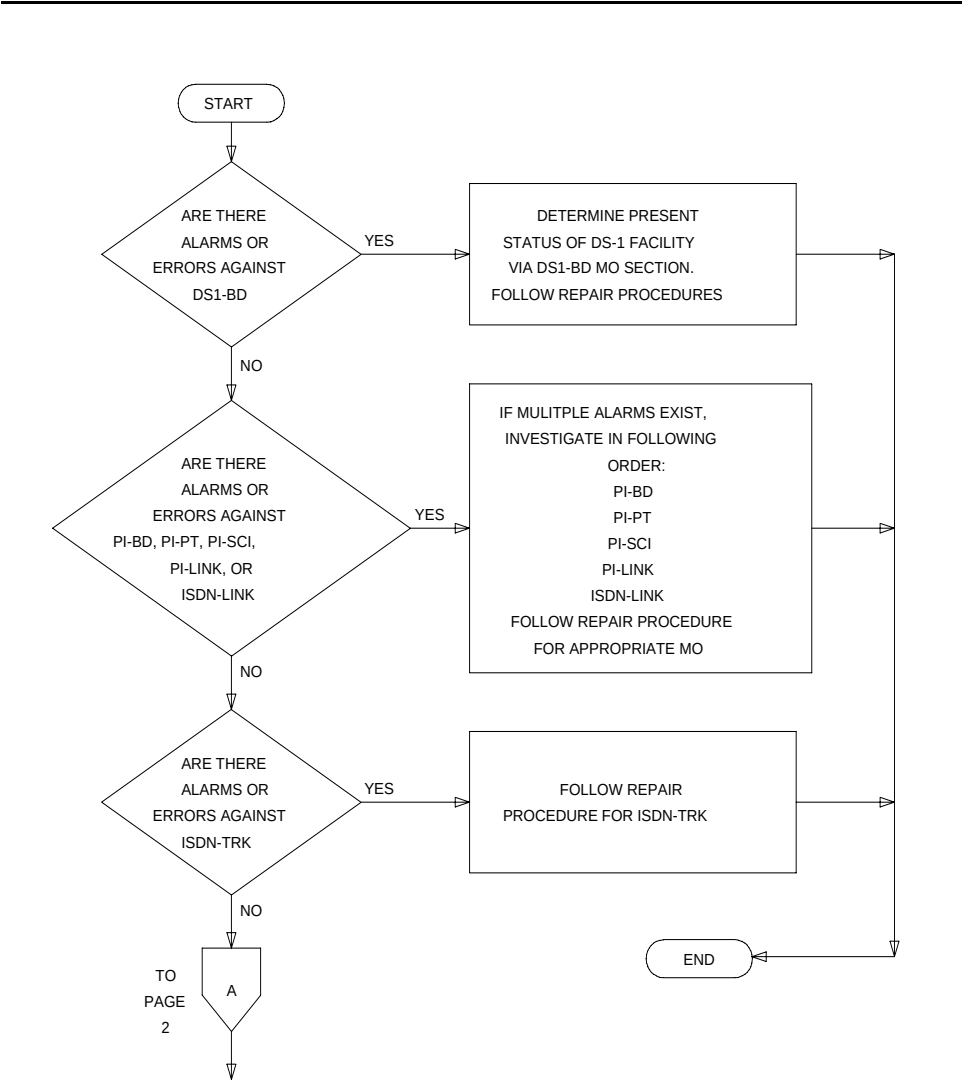
Figure 1-19. Processing of ISDN-PRI Problems (Page 1 of 2)

The following flowchart, [Figure 1-19](#) and [Figure 1-20](#), defines a layered approach when troubleshooting ISDN-PRI problems. Since a problem at a lower layer affects upper layers, layers are investigated from low to high. In the flowchart, the DS1 facility is layer 1, the TN765 Processor Interface is layer 2, and the ISDN trunks are layer 3. Transient problems are diagnosed on Page 2 of the flowchart, [Figure 1-20](#).

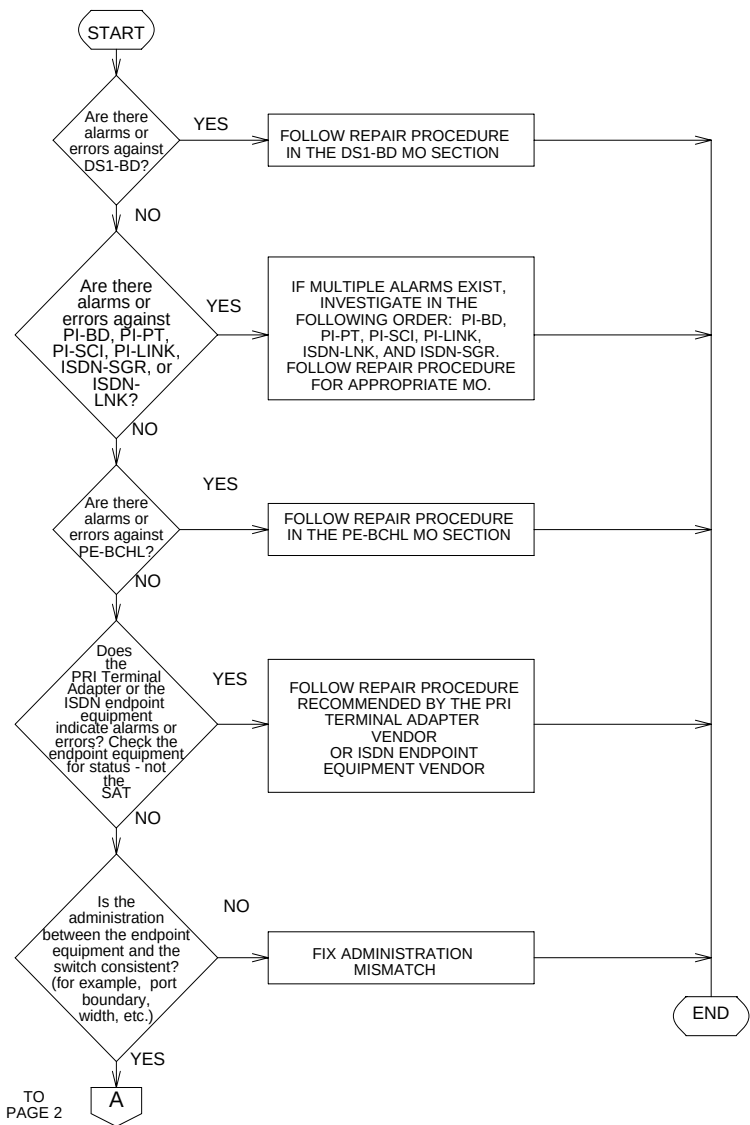
Figure 1-21. Processing of PRI Endpoint Problems (Page 1 of 2)

The following flowchart, [Figure 1-21](#) and [Figure 1-22](#), defines a layered approach when troubleshooting PRI endpoint problems. Since a problem at a lower layer affects upper layers, layers are investigated from low to high. In the flowchart, the DS1 facility is layer 1, the TN765 Processor Interface is layer 2, and the ISDN trunks are layer 3.

The troubleshooting procedure described here diagnoses faults between the switch and the line-side PRI terminal adapter/ISDN-PRI endpoint equipment. Problems encountered on the network-side of a wideband connection or problems with end-to-end equipment compatibility are outside the scope of this manual.

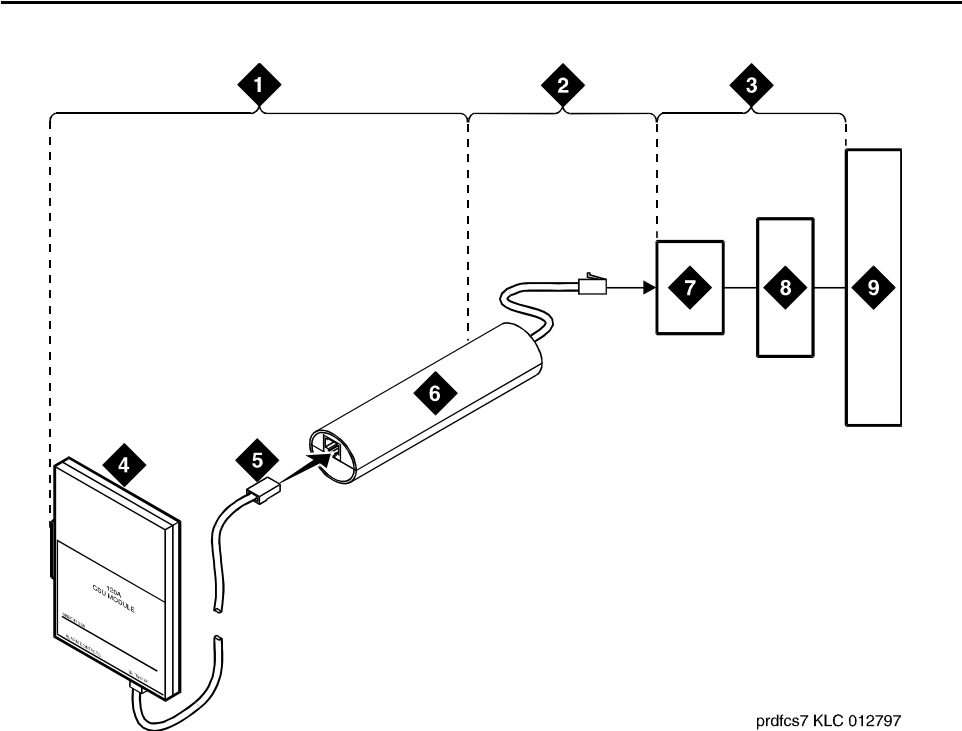
**Figure 1-24. Network Interface at Smart Jack**

| 1. Span Section 1 | 5. RJ-48 to Network Interface (Up to 1000 Feet) (305 m) |

1. If there is no extended demarcation point, install the loopback jack directly at the network interface point as shown in [Figure 1-24](#).
2. If there is an extended demarcation point and the Smart Jack is not accessible, install the loopback jack as shown in [Figure 1-25](#).
3. If there is an extended demarcation point, but the Smart Jack is accessible, install the loopback jack as shown in [Figure 1-26](#).

1. To install the loopback jack, simply disconnect the RJ-48 (8-wide) connector (typically an H600-383 cable) at the appropriate interface point and connect the loopback jack in series with the DS1 span. See [Figure 1-24](#) through [Figure 1-28](#).
2. Plug the H600-383 cable from the ICSU into the female connector on the loopback jack.
3. Plug the male connector on the loopback jack cable into the network interface point.

The addition of the loopback jack and the presence of a Smart Jack divides the DS1 span into 3 separate sections for fault isolation. These sections are shown in [Figure 1-24](#) through [Figure 1-26](#) for the different span configurations. They are:

- Test customer premises wiring (section 1 in the following 3 figures) from the ICSU to the loopback jack as described in “DS1 Span Test.”
- Test the CO-to-network interface wiring (section 3 in [Figure 1-24](#)) using the Smart Jack loopback (CO responsibility). Coordinate this test with the DS1 provider.

Fiber MUXes can take the place of Interface termination feeds as shown in [Figure 1-24](#), [Figure 1-25](#), [Figure 1-26](#), and [Figure 1-27](#). Test these spans using the same procedures as metallic spans. Note the following points:

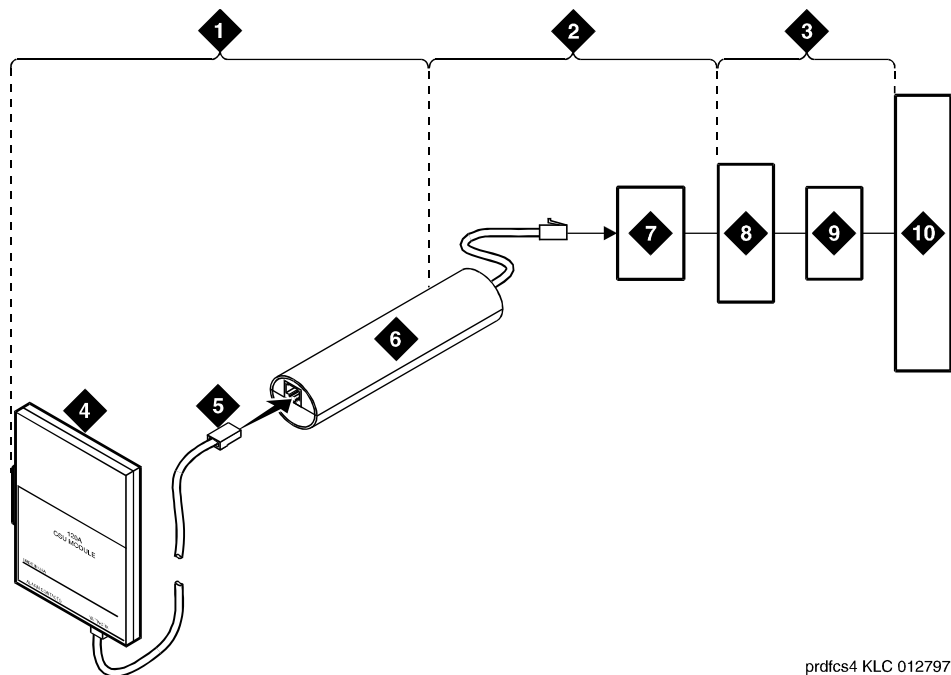
**Figure 1-25. Network Interface at Extended Demarcation Point (Smart Jack Inaccessible)**

| 5. RJ-48 to Network Interface (Up to 1000 Feet) (305 m) | 10. Central Office |

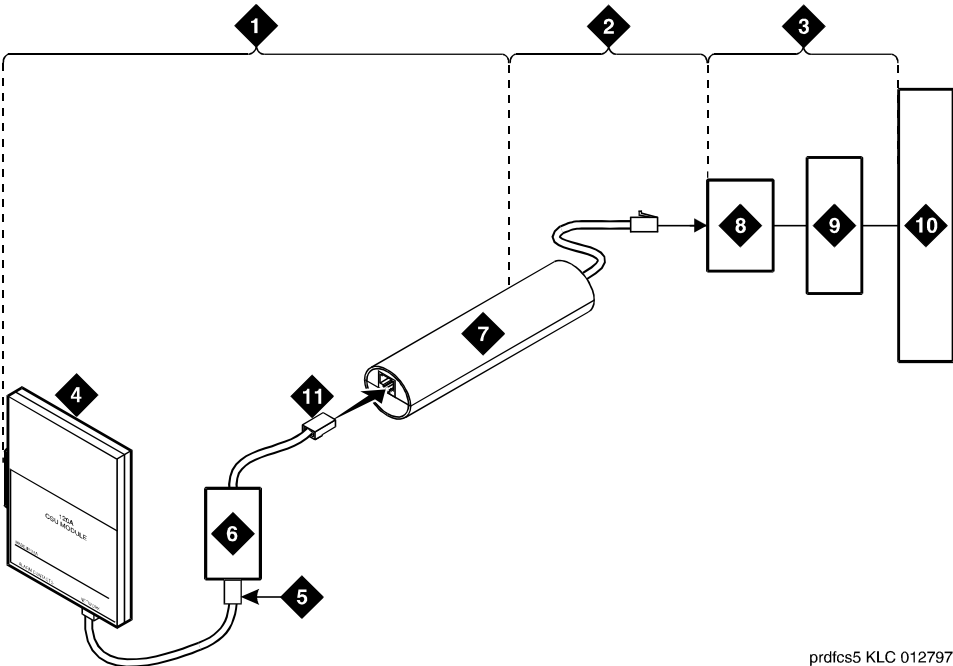
| 1. Span Section 1 | 6. “Dumb” Block (Extended Demarcation) |

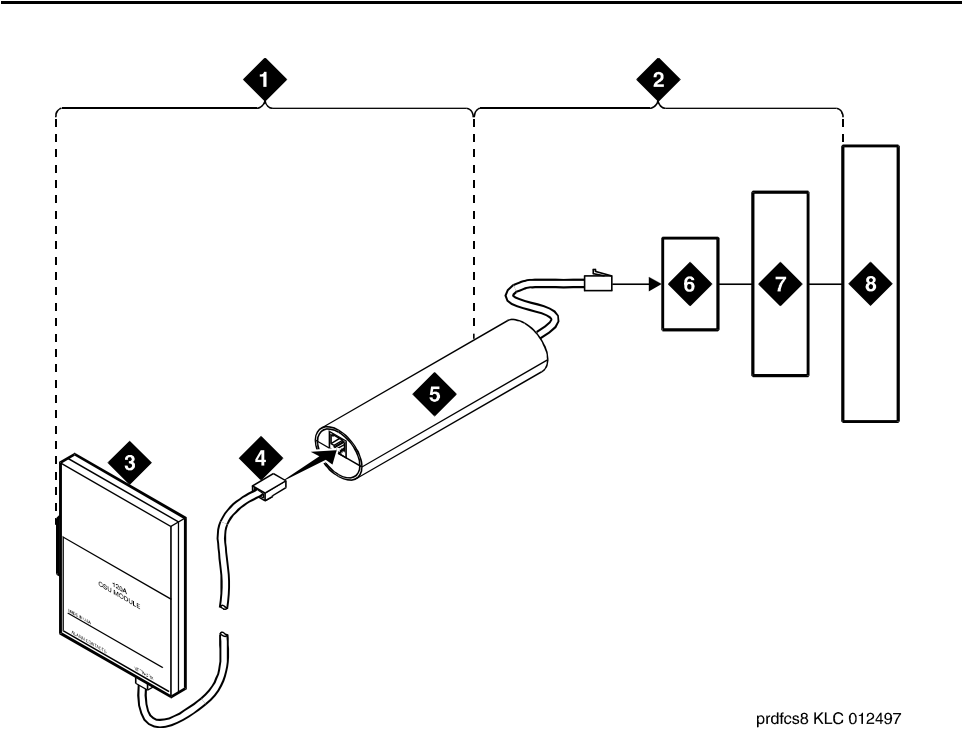
Figure 1-27. Network Interface at "Dumb" Block

When the loopback jack is added to a span that does not contain a Smart Jack, the span is divided into 2 sections. See [Figure 1-27](#) and [Figure 1-28](#).

1. ICSU to the loopback jack.
2. Loopback jack to the Central Office (CO).

| 4. RJ-48 to Network Interface (Up to 1000 Feet) (305 m) | 8. Central Office |

1. Install the loopback jack at the point where the cabling from the ICSU plugs into the “dumb” block. If there is more than one “dumb” block, choose the one that is closest to the Interface Termination feed or the fiber MUX. This provides maximum coverage for loopback jack tests. Refer to [Figure 1-27](#) and [Figure 1-28](#).

1. Test customer premises wiring (section 1 in [Figure 1-27](#)) from the ICSU to the loopback jack as described in the “DS1 Span Test” section.
2. Test the loopback jack-to-“dumb” block and “dumb” block-to-CO wiring (section 2 in [Figure 1-27](#)). This can be done using a loopback that “overlaps” the section of the span. Any of the following loopbacks can do this:

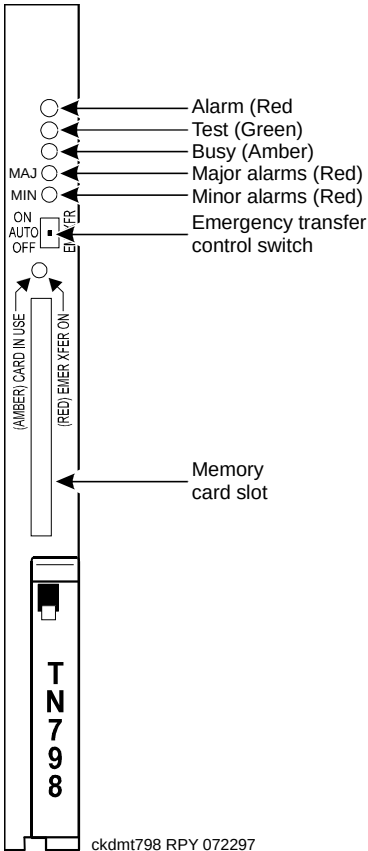
Figure 1-29. LED Indicators on the TN798 Processor Circuit Pack

The front panels of the Processor circuit pack and the Maintenance circuit pack are identical. Each has two groups of LEDs. One group indicates the status of the pack, and the other group (which includes the Major, Minor, and Warning alarms described in the [“Alarm and Error Reporting”](#) section) reflects maintenance conditions in the entire system. See [Figure 1-29](#).

If the AC power cord is unplugged from the control cabinet, the emergency transfer feature invokes, however the EMERGENCY TRANSFER LED (red) is not lit due to loss of AC power.

**NOTE:**  
If the LED just above the Memory Card Slot is alternating red and amber, this indicates both card in use and emergency transfer.

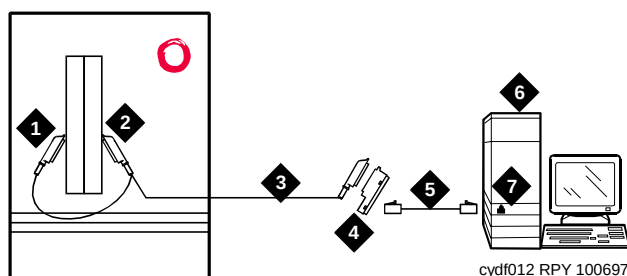
Figure 1-30. Typical ESM connections

The Expansion Services Module (ESM) shown in [Figure 1-30](#) provides T.120 data sharing capability on a MMCH multipoint H.320 video conference. Each conference participant must have endpoints administered and a personal computer with the H.320 video application installed. The DEFINITY ECS must have the expansion service module installed.

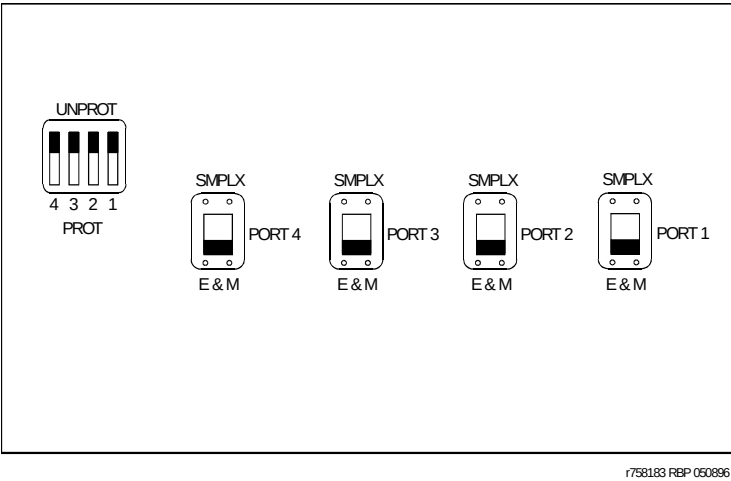
Figure 1-31. TN760D Tie Trunk Circuit Pack (Component Side)

To choose the preferred signaling format ([Table 1-8](#) and [Table 1-9](#)), set the switches on the TN760D and administer the port using [Figure 1-31](#) and [Table 1-10](#).

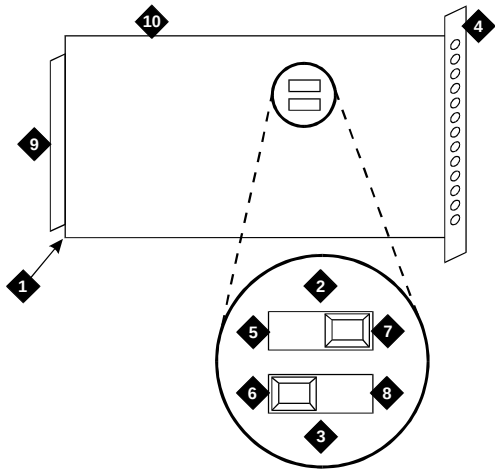
| 32 Channel | 2.048 Mbps |
| 24 Channel | 1.544 Mbps |

1. Backplane Connectors
2. 24/32 Channel Selector
3. 75/120 Ohm Selector
4. Faceplate
5. 32 Channel
6. 120 Ohm (shown selected)
7. 24 Channel (shown selected)
8. 75 Ohm
9. Connector
10. TN464E/F

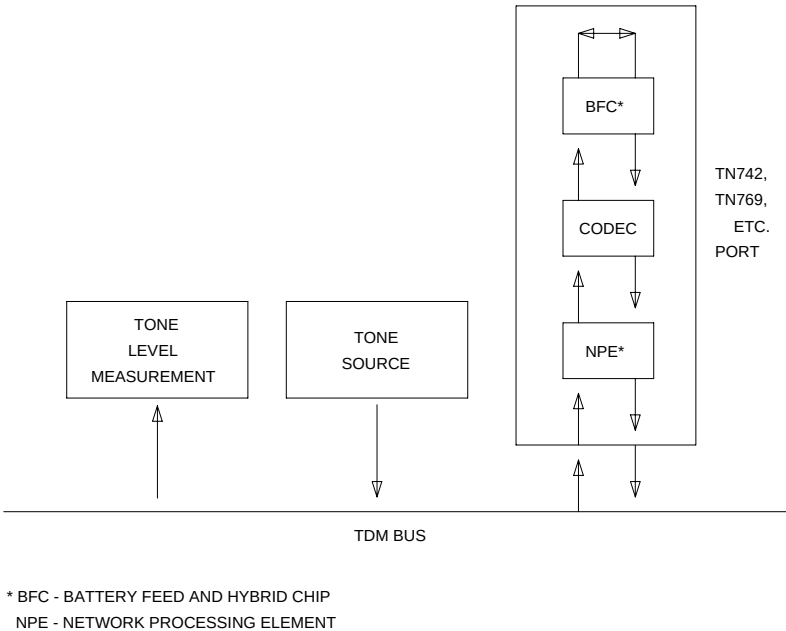
Figure 3-1. Analog Loop Around and Conference Test

This Loop Around Test is sensitive to the length of the loop, the equipment in the loop, or the equipment terminating the loop, such as off-premises stations. If this test is causing a false alarm, then disable the test by changing the Tests field to "no" using the **change station** command for this station.

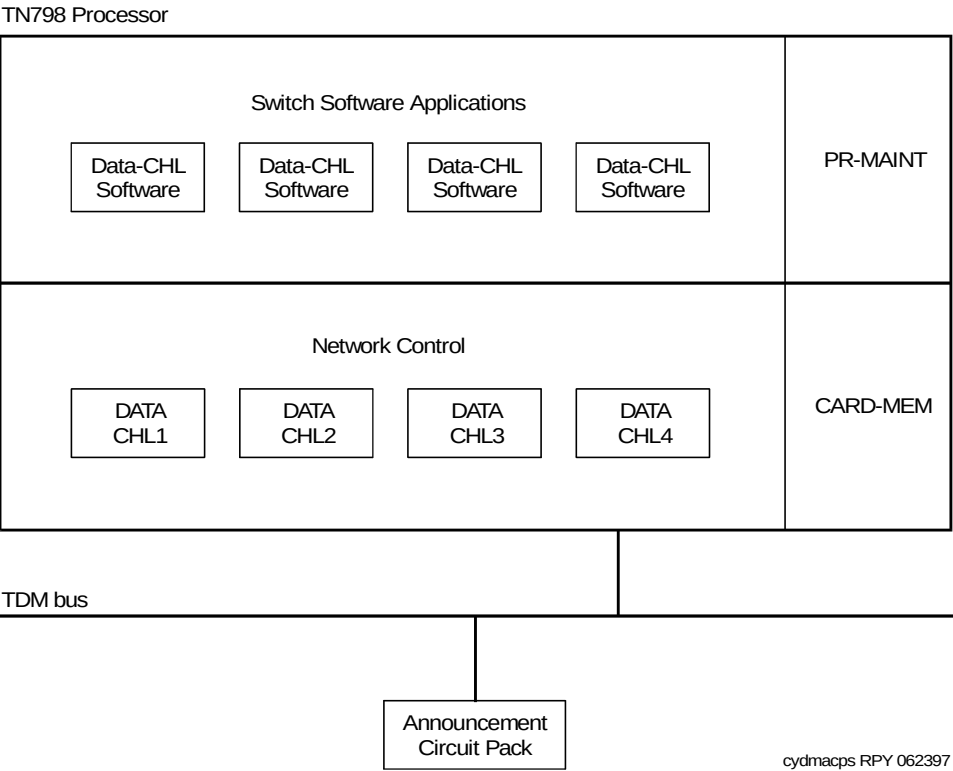
Figure 3-2. Connection of Announcement Circuit Pack to the System

[Figure 3-2](#) shows the connection of the Announcement Circuit Pack to the system. To save or restore announcements, an ANNOUNCEMENT Data Extension must be administered, and at least one DATA-CHL (Network Control Data Channel) must be in the in-service/idle state.

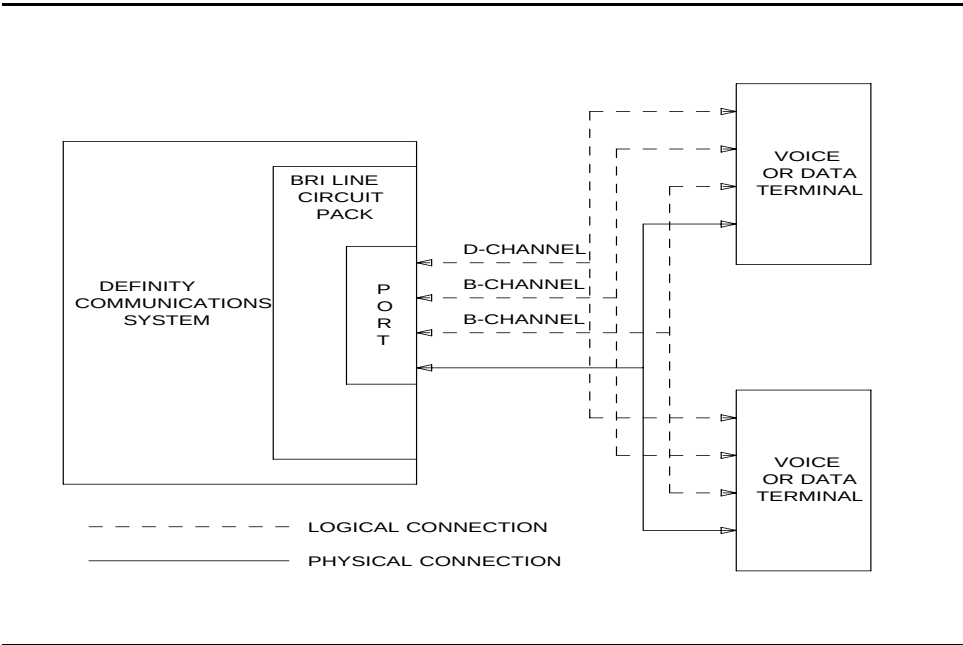
Figure 3-3. ISDN-BRI Port Interactions

[Figure 3-3](#) illustrates the physical connection (solid line) between an ISDN-BRI Port and its associated ISDN-BRI set(s). Each physical connection allows for two B-channels and one D-channel. Each ISDN-BRI circuit pack can support up to 12 of these *physical* connections to different voice and voice/data sets or ASAI or Lucent adjuncts. On a TN2198 each ISDN-BRI circuit pack can support up to 12 *physical* connections to a NT1, which, in turn, connects to 2 terminals.

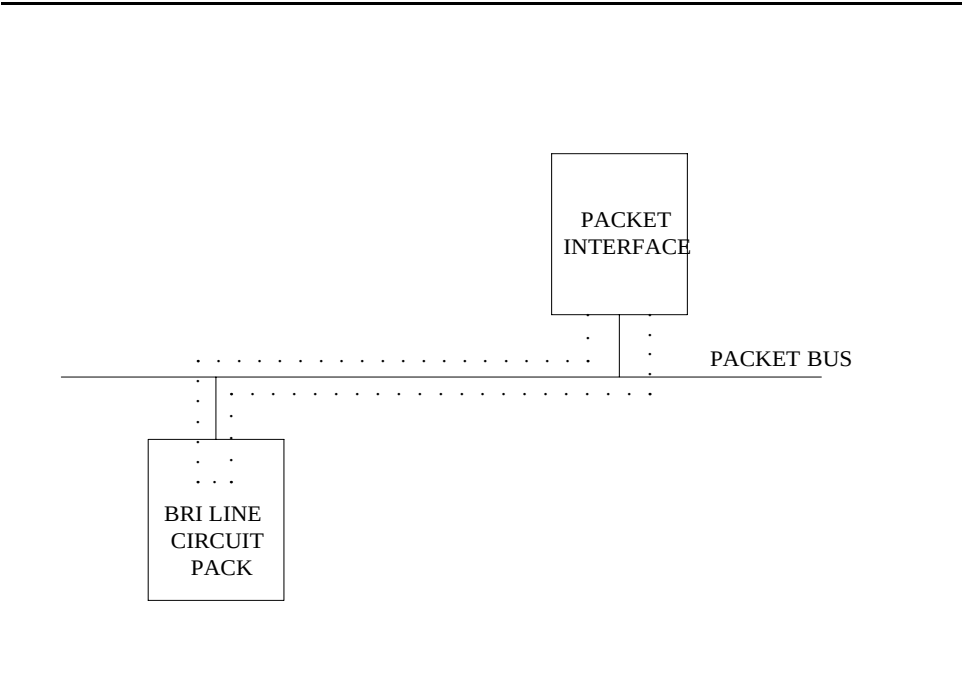
**Figure 3-4. Path of the BRI Port Local LAN Loop Around**

the port are in-progress. Failures of this test indicate either on-board faults associated with the BRI-PORT hardware on the circuit pack or problems with the LAN Bus, which is used to form connectivity between the switch and the BRI-PORT.

The dotted lines in [Figure 3-4](#) show how a Loop Around Test is performed across the Packet Bus for the D-channel.

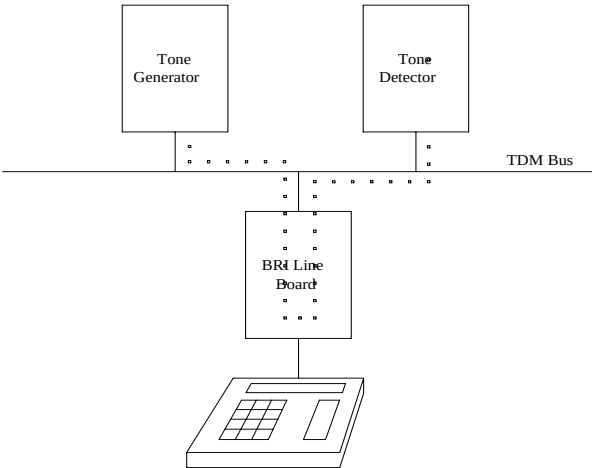
Figure 3-5. Path of the BRI Port Local TDM Loop Around

The dotted lines in [Figure 3-5](#) show how a Loop Around Test is performed for the B-channels. The figure shows a terminal connected to a BRI line board using a TN556. If a TN2198 is used, the terminal would be connected to a NT1, and the NT1 to the BRI board.

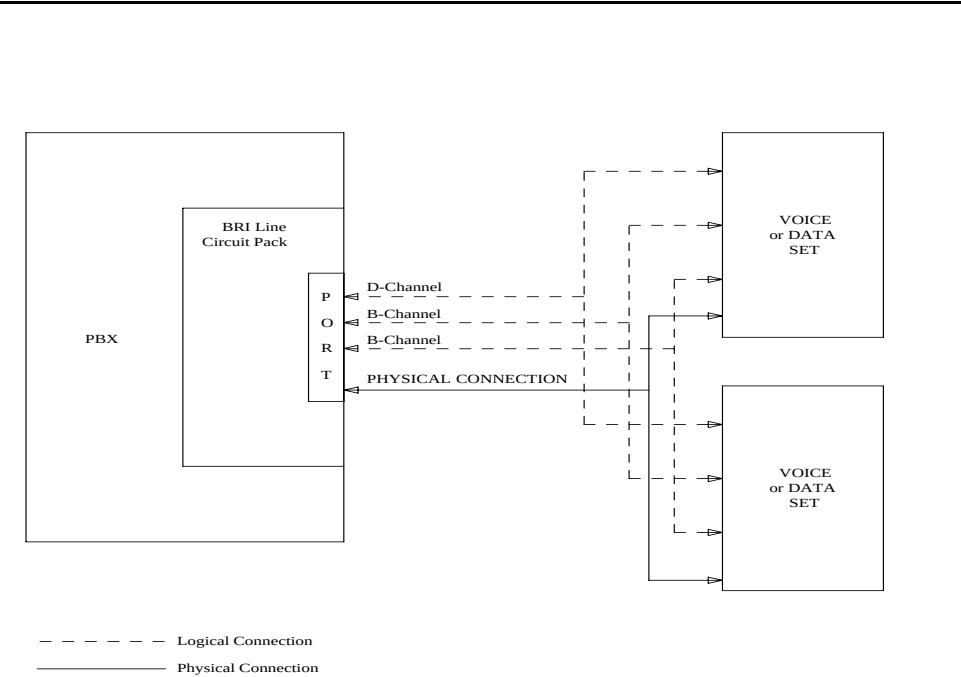
**Figure 3-6. ISDN-BRI Set Interactions**

[Figure 3-6](#) illustrates the physical connection (solid line) between an ISDN-BRI Circuit Pack and a voice or voice/data set. Each physical connection allows for two B-channels, as stated above, plus one D-channel. Each ISDN-BRI circuit pack can support up to 12 of these PHYSICAL connections to different voice and voice/data sets or ASAI and Lucent adjuncts.

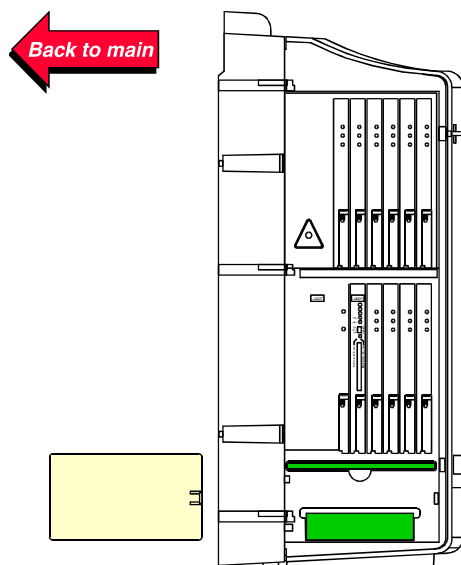
Figure 3-7. Fan/Filter Removal

1. Remove the left door.
2. Remove the fan/filter access panel. See [Figure 3-7](#).

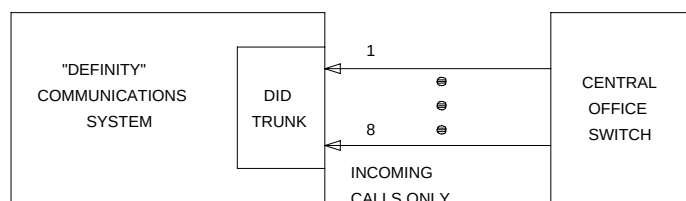
**Figure 3-8. DID Trunk Interactions**

The DID Trunk circuit packs support eight, incoming-only, ports. Each port provides an interface between the 2-wire analog line from the CO and the DEFINITY system. The DID port receives 3 to 5 digits from the CO that is used to directly connect an outside caller to the called station without assistance from an attendant. See [Figure 3-8](#).

For each call, the CO switch signals the system by opening and closing individual DID loops (one of the eight ports) and causing the starting or stopping of loop current.

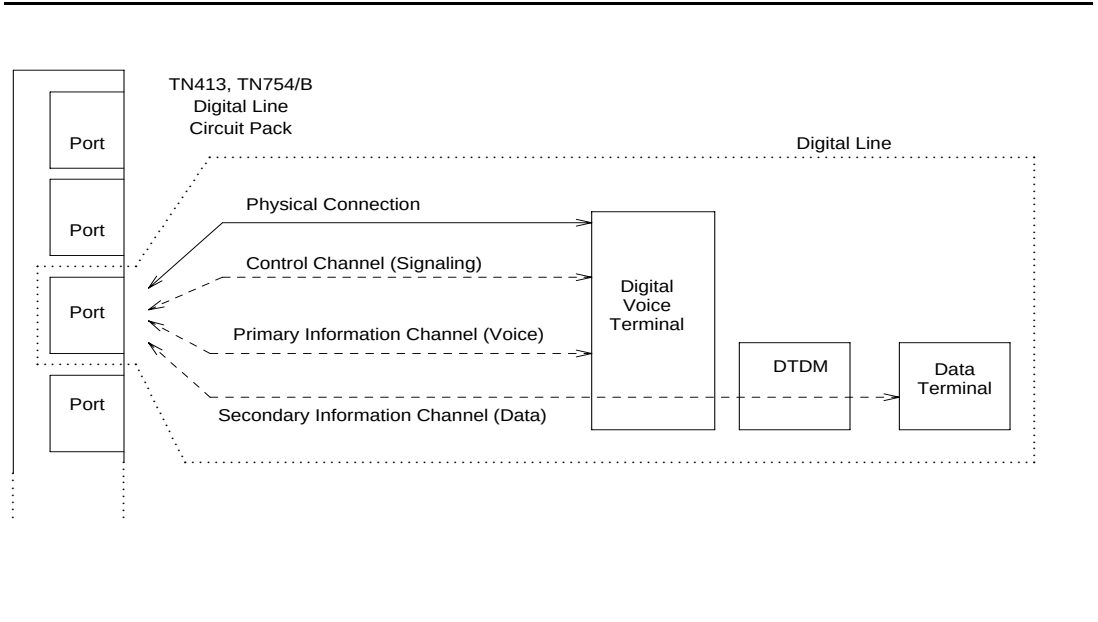
Figure 3-9. Digital Line Connectivity

It should be noted that TN2181 and TN2224 support both modes as shown in [Figure 3-9](#) and [Figure 3-10](#).

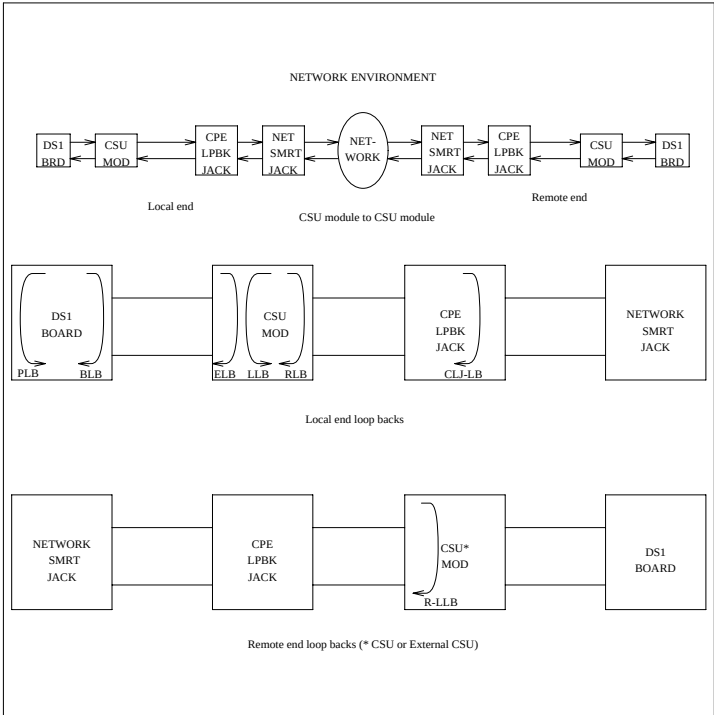
Figure 3-11. High Level Overview Of Loopback Points

The TN767E and 120A CSU Module support on-demand loopback tests that assist in the detection of faults between the TN767E circuit pack and the CSU Module, between the Integrated CSU and the optional Customer Premises Loopback Jack, or between the Integrated CSU and remote CSU. These loopback tests are explained in detail later in this DS1-BD section, but [Figure 3-11](#) gives a high level overview of the loopback points.

- PLB = Payload Loopback
- BLB = Board Loopback
- ELB = Equipment Loopback
- LLB = Line Loopback
- RLB = Repeater Loopback
- CLJ = Loopback Jack Loopback
- R-LLB = Remote Line Loopback
- SMRT = Smart Jack
- LPBK = Loopback

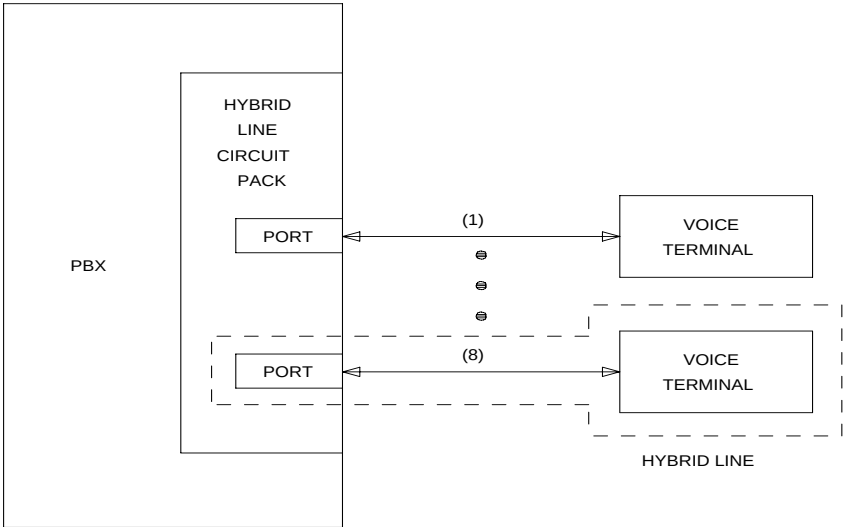
Figure 3-12. Hybrid Station Interactions

The TN762B Hybrid Line circuit pack supports eight of these multifunction analog telephone sets, as shown in the following figure. The Hybrid Line sets use three pairs of wires: an analog voice pair, a transmit/receive pair, and a power pair.

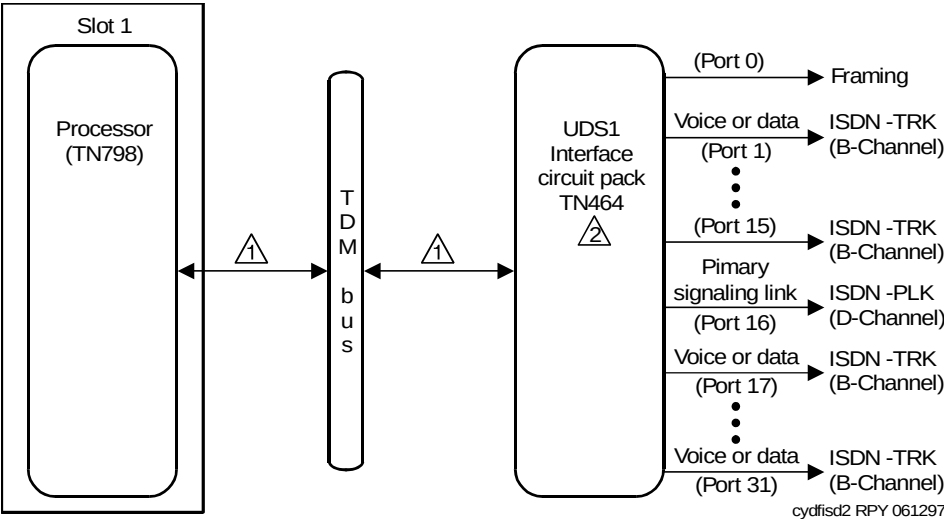
Figure 3-13. ISDN-PRI Signaling Link Port Interactions (32-Channel - TN464)

In a 32-channel system (see [Figure 3-13](#)), the DS1 ISDN Trunk or PRI endpoint port (B-channels) may use any of the ports 1-15 or 17-31, but the ISDN-PRI Signaling Link Port must be the 16th port on the TN464C (or higher) circuit pack. In certain configurations (NFAS), the 16th port may be used as a B-channel. Refer to the [“ISDN-SGR \(ISDN-PRI Signaling Group\)”](#) Maintenance documentation for further details.

1. B- and D-channel messages are routed over the TDM Bus. For additional reliability, a duplex D-channel can be administered for a signaling group and located on a different TN464C (or higher) circuit pack.
2. TN464C or higher

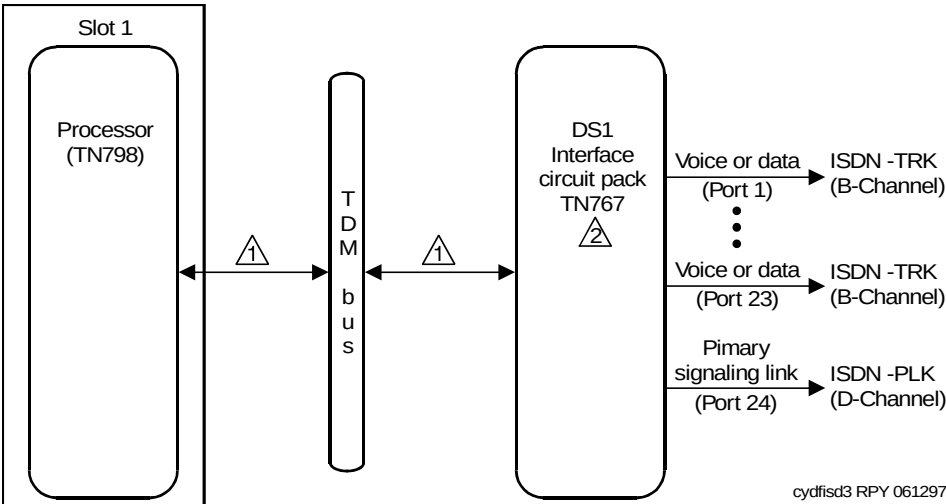
Figure 3-14. ISDN-PRI Signaling Link Port Interactions (24 Channel - TN767/464C)

In a 24-channel system, the DS1 ISDN Trunk or PRI endpoint port (B-channels) may use any of the first 23 ports. The ISDN-PRI Signaling Link Port must be the 24th port (See [Figure 3-14](#)). In certain configurations (NFAS), the 24th port may be used as a B-channel. Refer to the ISDN-PRI Signaling Group (ISDN-SGR) Maintenance documentation for further details.

1. B- and D-channel messages are routed over the TDM Bus. For additional reliability, a duplex D-channel can be administered for a signaling group and located on a different TN464C (or higher) circuit pack.
2. TN767B (or higher) or TN464C (or higher)

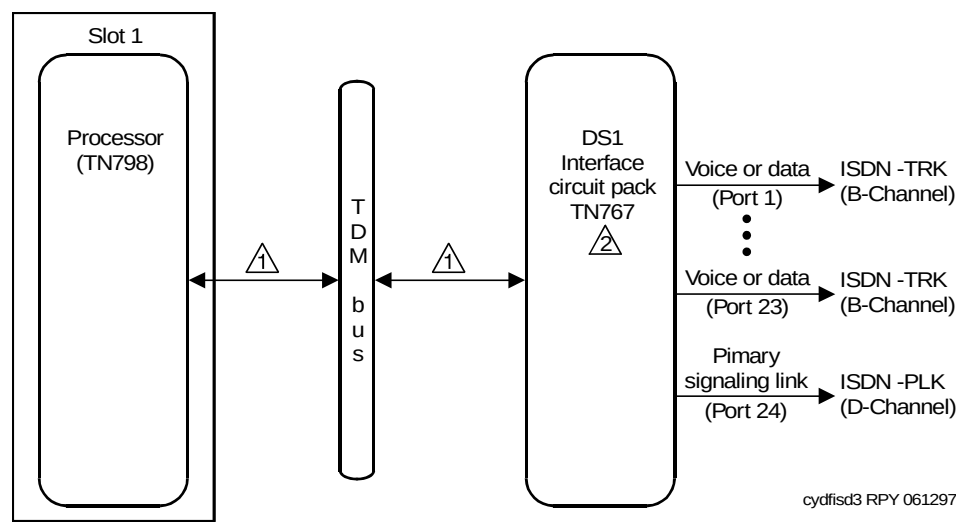
Figure 3-15. ISDN-PRI Signaling Link Port Interactions (24 Channel - TN767/464C)

For 24-channel interfaces, the first 23 ports on the circuit pack are used as B-channels. The 24th port may be used as a B-channel or as a D-channel depending on the type of Signaling Group used (see [Figure 3-15](#)).

1. B- and D-channel messages are routed over the TDM Bus. For additional reliability, a duplex D-channel can be administered for a signaling group and located on a different TN464C (or higher) circuit pack.
2. TN767B (or higher) or TN464C (or higher)

The ISDN-PRI Signaling Link Port itself depends on the health of the DS1/UDS1 Interface circuit pack on which it resides. This test will fail if there are problems with either the ISDN-PRI Primary D-channel port or the DS1/UDS1 circuit pack. See [Figure 3-15](#) for DS1 connections, [Figure 3-16](#) for UDS1 connections.

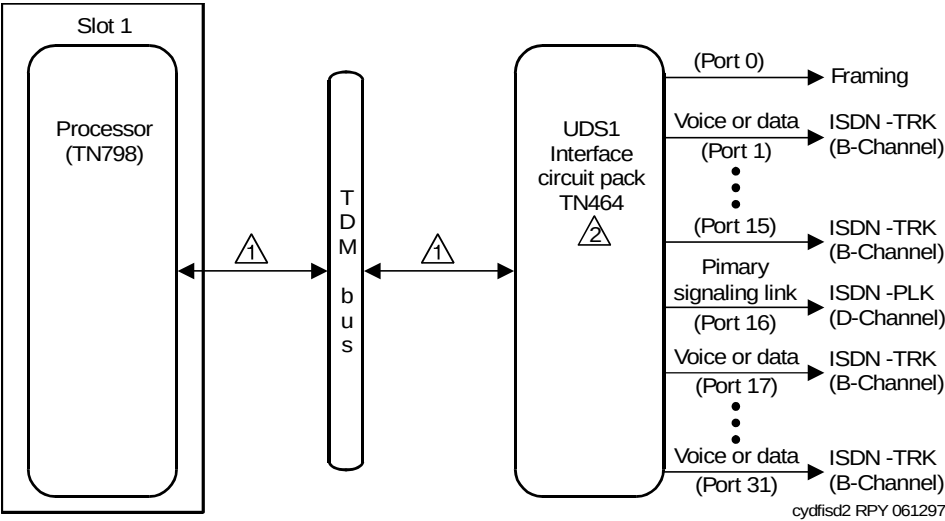
Figure 3-16. ISDN-PRI Signaling Link Port Interactions (32-Channel - TN464)

For 32-channel interfaces, ports 1-15 and 17-31 on the circuit pack are used as B-channels. The 16th port may be used as a B-channel or as a D-channel depending on the type of Signaling Group used (see [Figure 3-16](#)).

1. B- and D-channel messages are routed over the TDM Bus. For additional reliability, a duplex D-channel can be administered for a signaling group and located on a different TN464C (or higher) circuit pack.

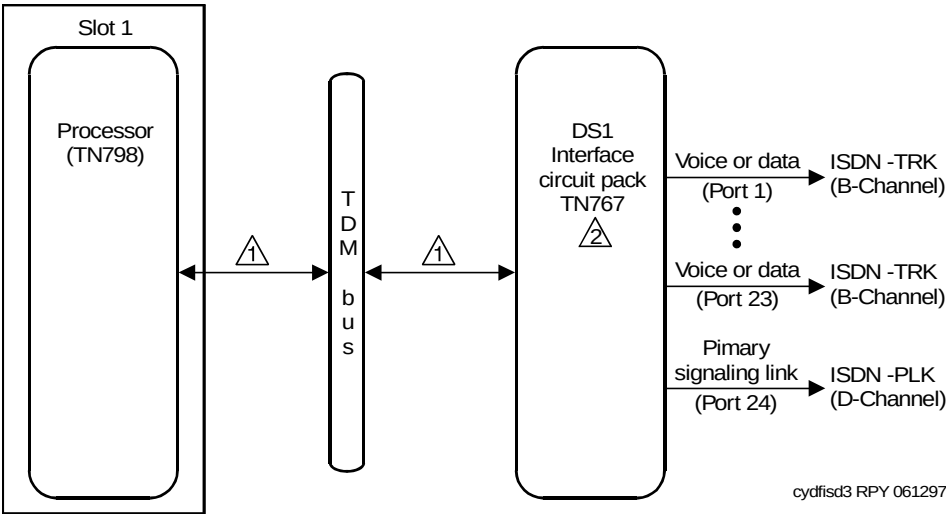
On 24-channel interfaces, any of the first 23 ports on the DS1/UDS1 interface circuit pack can be a B-channel. The 24th port may be used as a B-channel or as a D-channel depending on the type of ISDN-PRI Signaling Group (ISDN-SGR) to which it belongs.

1. B- and D-channel messages are routed over the TDM Bus. For additional reliability, a duplex D-channel can be administered for a signaling group and located on a different TN464C (or higher) circuit pack.
2. TN767B (or higher) for DS1; TN464C (or higher) for UDS1
